Inspection Report

Property Address: 63 Tangerine Court Lake Jackson Texas 77566

PROPERTY INSPECTION REPORT

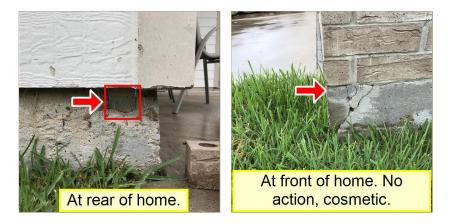
(2) Observed several corner pops around the foundation, which are very normal, but one area at the rear of the home has exposed metal structural reinforcements. To prevent corrosion to the exposed metal, I recommend filling the void with an appropriate material.

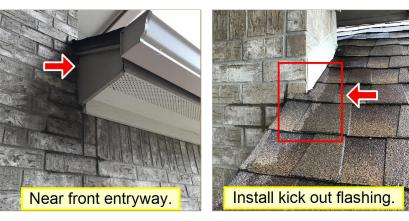
Near the front entry way of the home, an area of wood decay was observed. Recommend replacing and repairing as needed. Also recommend installing a kick out flashing above the affected area to prevent further moisture issues.

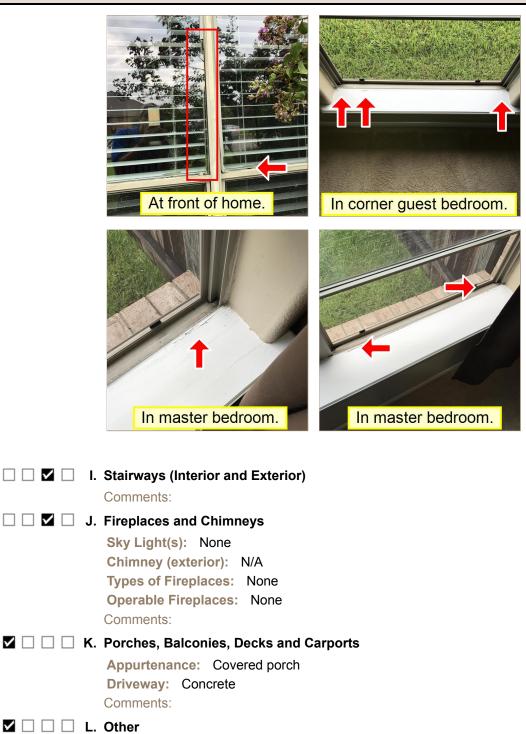
Observer areas of missing window edge glazing as well as interior areas around the windows that have evidence of previous moisture damage. Recommend re-sealing and further evaluating windows to prevent future moisture intrusion. Then repairing/repainting the interior window ledge.

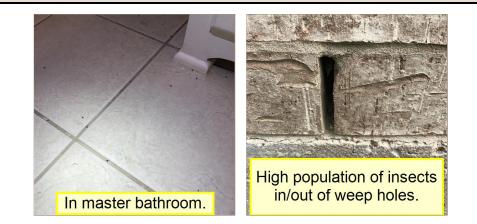
Observed dead insects in the master bathroom of the home and several live ones on the exterior walls. Recommend pest control as needed.
