GLOBAL
REAL ESTATE INSPECTIONS

"STRUCTURAL & MECHANICAL INSPECTION REPORT"

2705 Meadow Lane, La Marque, TX 77568
Toll Free: (877) 647-6616 -- Galveston: (409) 682-4279

Client: Joseph Dispensa
Concerning: 29707 County Road 25
City: Damon
State: Texas

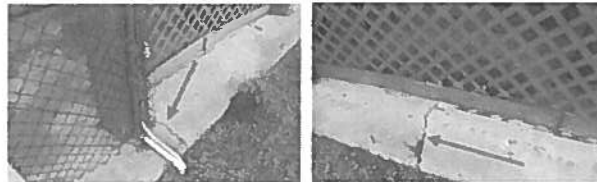
Foundation cracks observed in multiple areas.

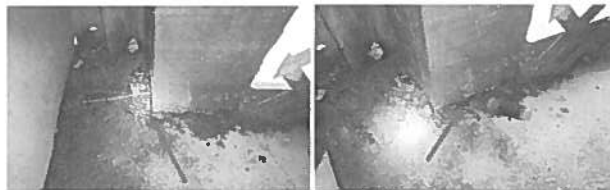
Damage observed to one of the stilts, located on the back left corner in the storage room.

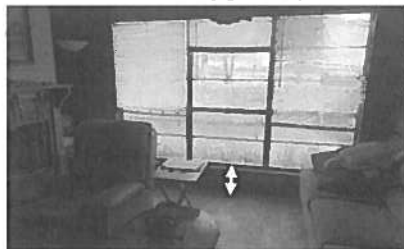
The height of the bottom of the openings of the living room windows do not comply with today's standards. It is recommended window limiters to be installed at such height that prevents an object of more than 4" from freely exiting the window.

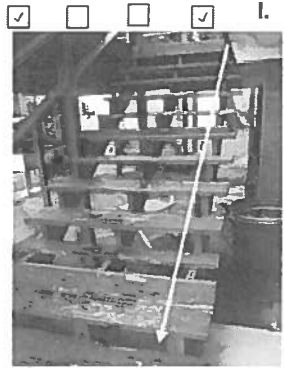
Comments: **The exterior staircase structure does not comply with current standards with regards to riser height, riser opening and the presence of a graspable handrail.**

Damage noted to staircase structure. **Two of the treads have come loose**

Suggest having professional check all stair rails and repair where needed

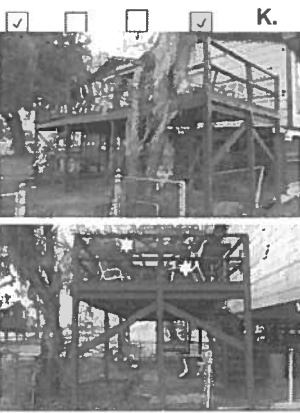
Comments: **A majority of the porch structure does not comply with current standards and is experienced some damage.**

Guard rails loose and/or damaged: **The outer guard rail has come loose.**

Recommend having contractor check all porch and deck structures and repair as needed

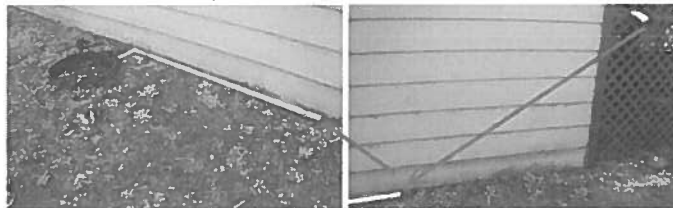
The drain line that terminates on the left side of the exterior appears to be off of the laundry room, and has become damaged, allowing grey water to terminate on grade.

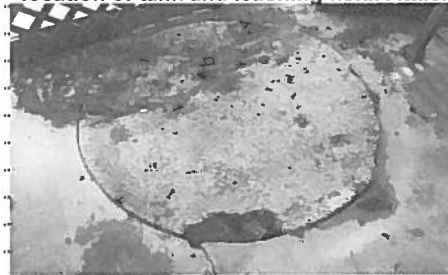
A circular concrete lid is located under the house. If this is the septic tank cover it is damaged and should be checked by a professional. If it is not then suggest checking with seller as to location of tank and leaching field. Attached is a general diagram of a septic system.

Cracked concrete lid
