McCoy & McCoy Home Inspections PLLC

PROPERTY INSPECTION REPORT

Concerning: 6702 & 6704 W. Fuqua St, Houston, TX
(Address or Other Identification of Inspected Property)

By: Thomas A McCoy, Lic #21821 09/14/2019
(Name and License Number of Inspector) (Date)

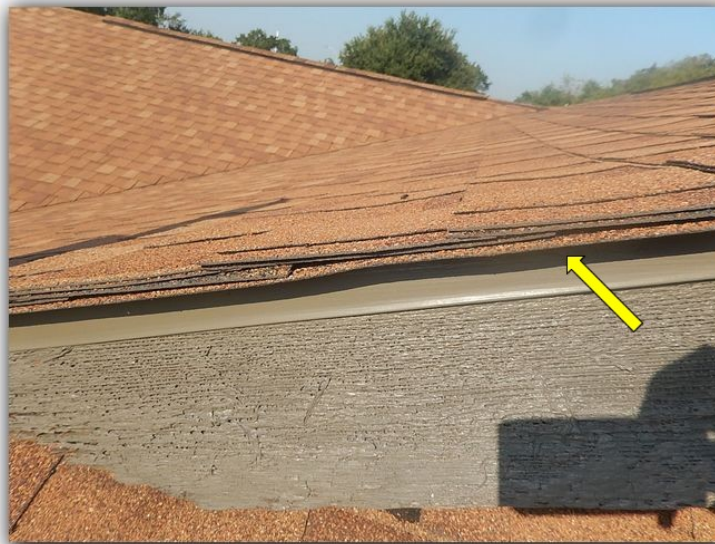
The roof appears to have multiple layers of shingles. extra layer of shingles are likely to trap heat, causing the material to decompose more rapidly and forcing you to replace the roof earlier. Recommend further review/repair by licensed

professional.

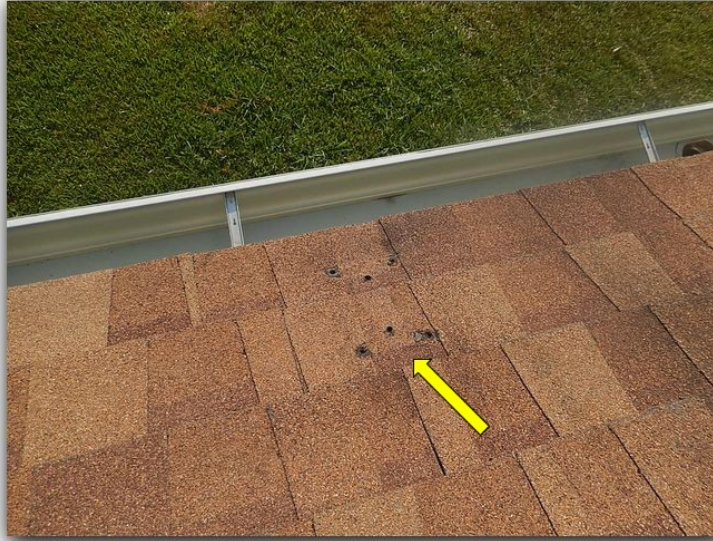
Recommend sealing the holes on the right side of the property.

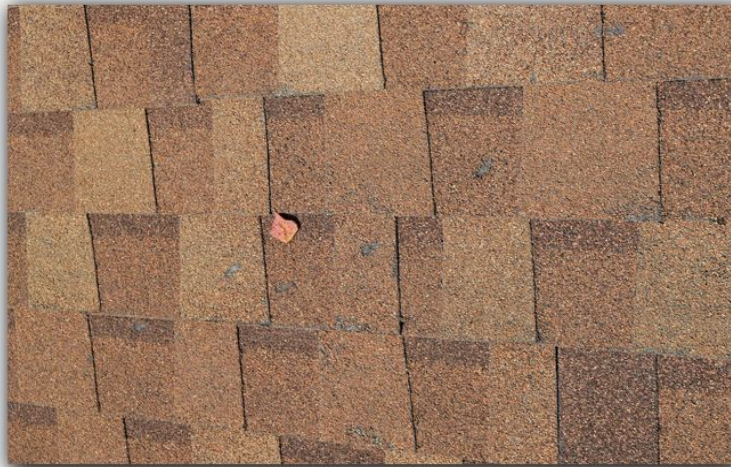
Multiple areas of what appears to be blistering of roof covering. Recommend further review by qualified contractor.

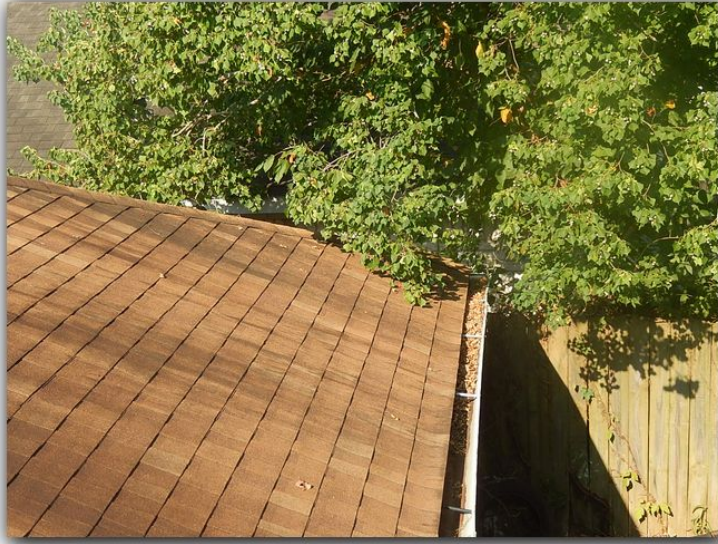
Tree limbs should maintain separation away from the home to avoid damaging the shingles and exterior surfaces.

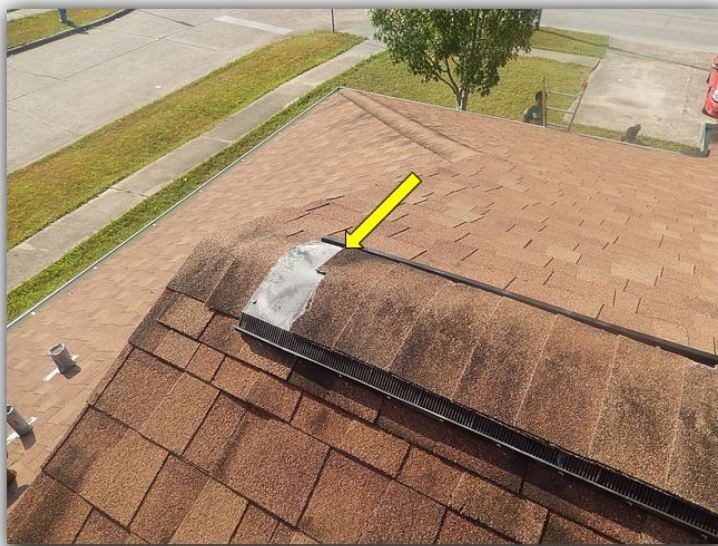
Recommend replacing the missing shingles on the right ridge vent.

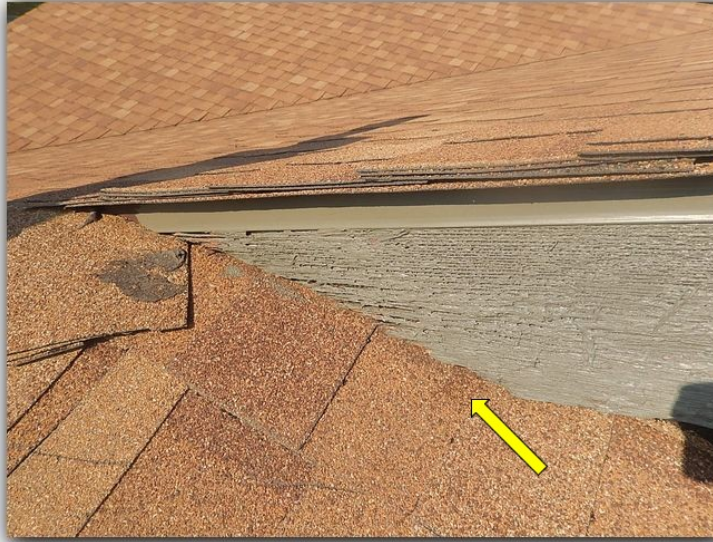
Insufficient gap where vertical wall meets roof. Roofing and siding manufacturers require 2 inch gap to allow leaves/debris a path to wash down. Insufficient gap can also cause water to penetrate via capillary action.

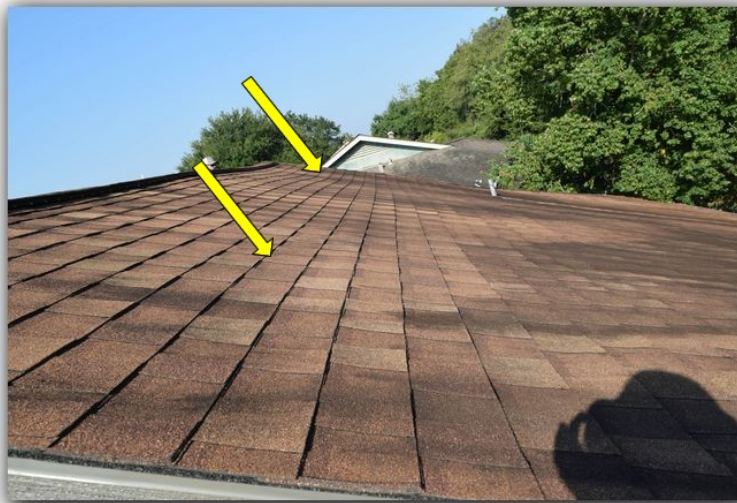
Observed deflection of roof surface. Recommend consulting with qualified contractor for further review as to remedy.

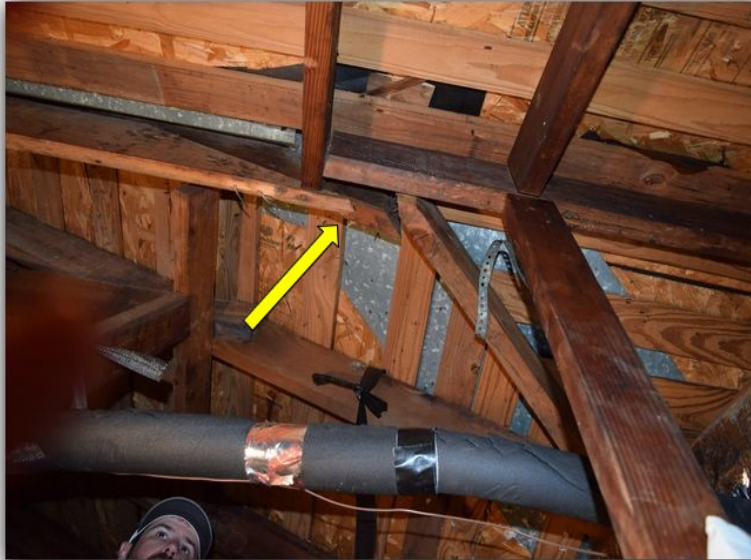
Detached framing member observed. Recommend consulting with qualified contractor as to remedy.

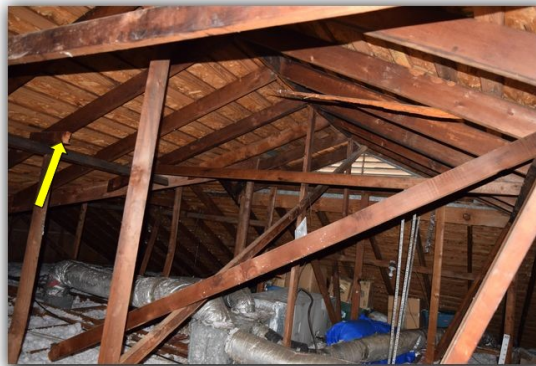
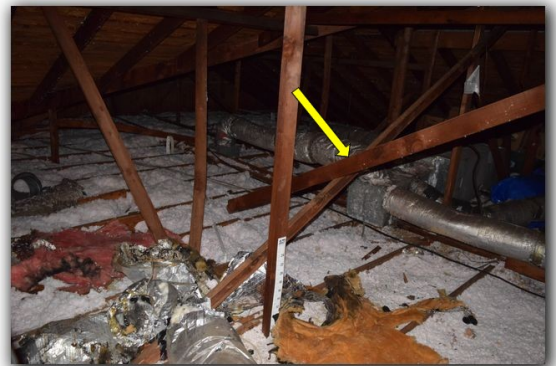
Broken collar tie observed. Recommend repair.

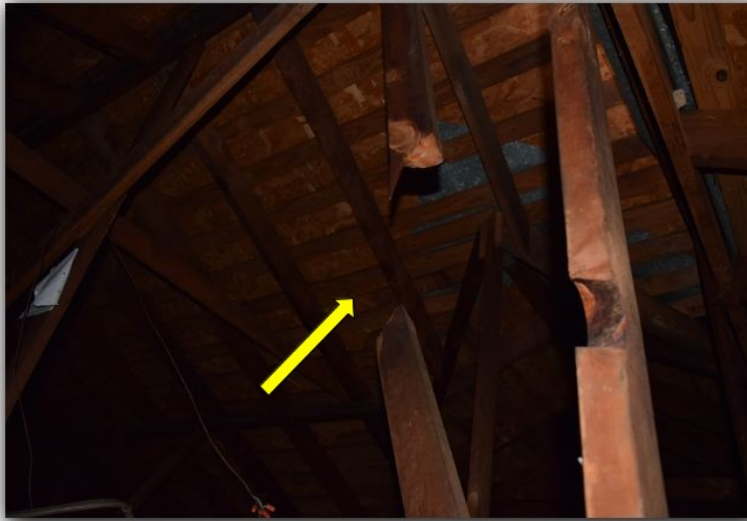
Broken/missing king post observed. Recommend repair.

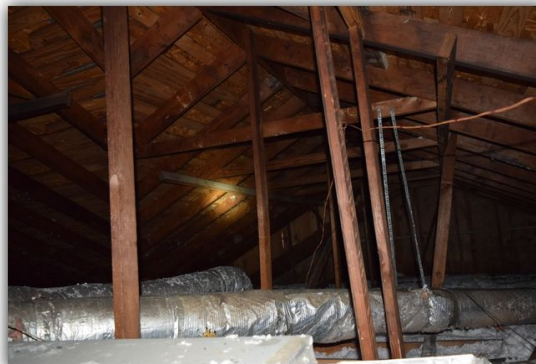
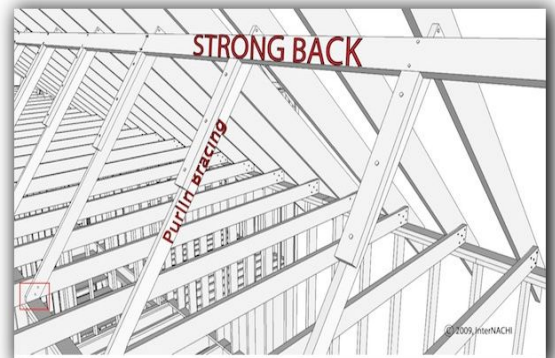
Over spanned purlin bracing observed. Purling bracing should be on four foot centers to provide adequate support.

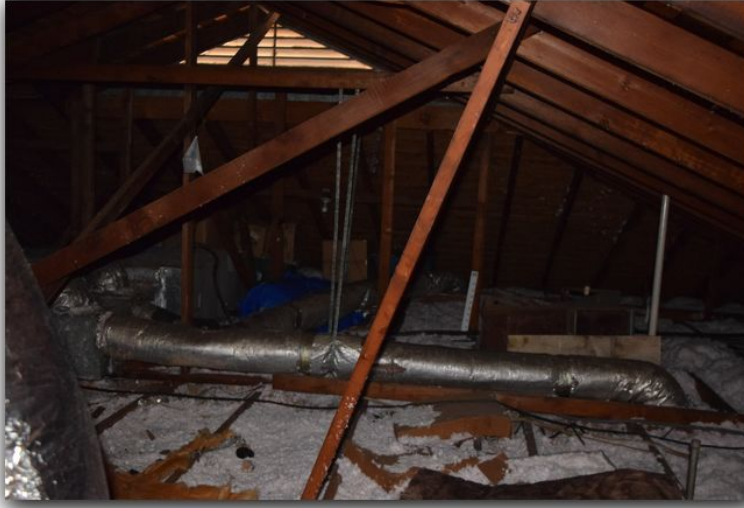
Missing fire wall for multi-unit housing. Recommend consulting with qualified contractor for further evaluation.

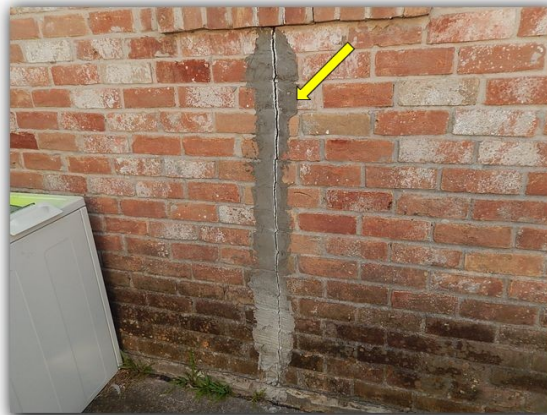
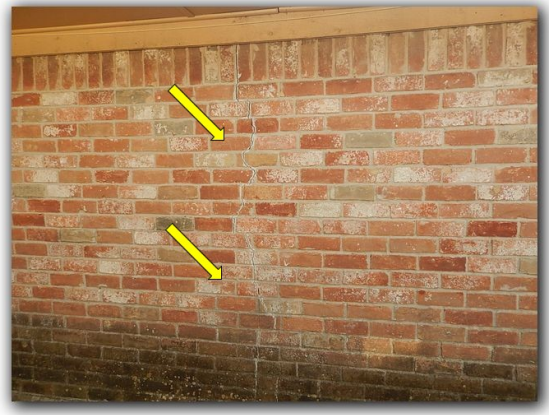
Significant step cracks observed that appeared to be caused by structural

movement. Ongoing movement is an indicator of continued structural movement and a structural engineer would need to be consulted for further analysis if client deems necessary.

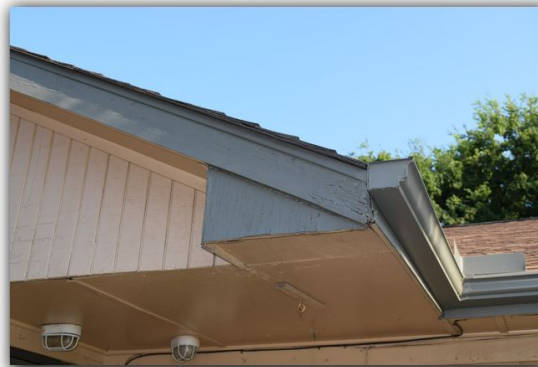
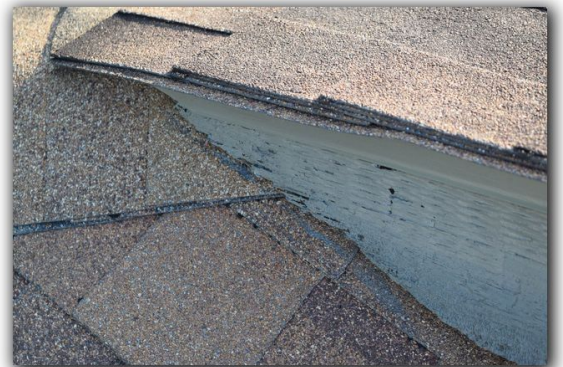
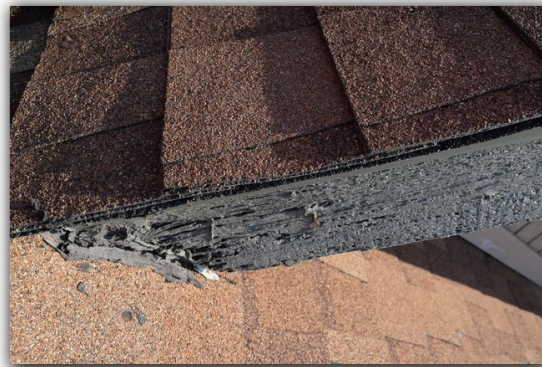
Multiple areas of Rot observed around trim.

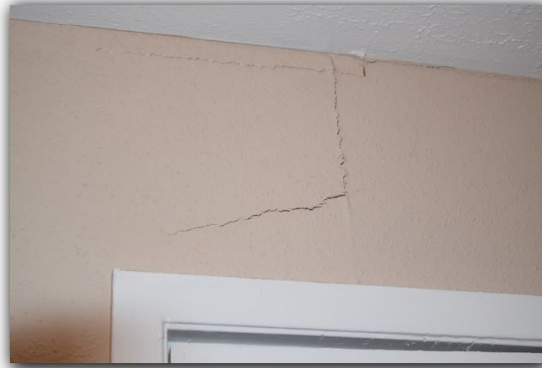
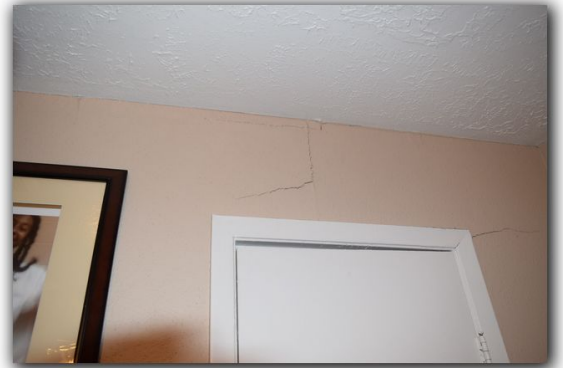
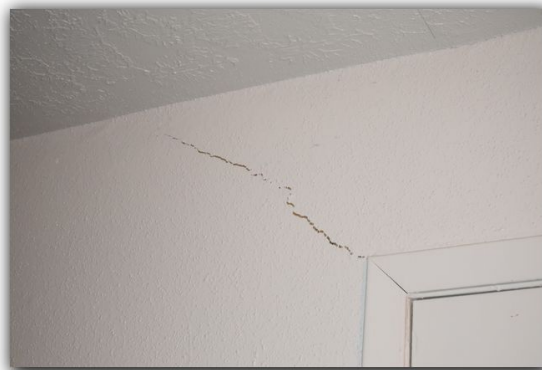
Multiple wall cracks observed in both unit 6702 & 6704 consistent with structural movement. Recommend consulting with qualified contractor as to cause and correction.

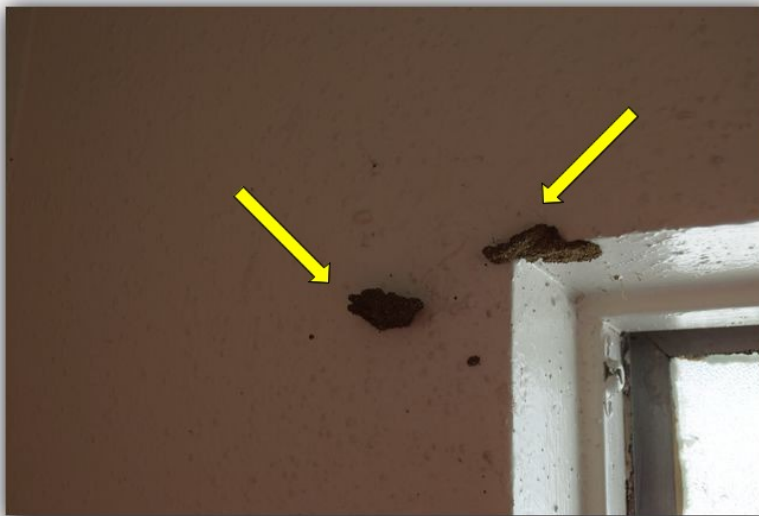
Observed mud/dirt like substance on bathroom wall of unit 6704. Recommend

seeking the advise of qualified contractor as to the cause and correction.

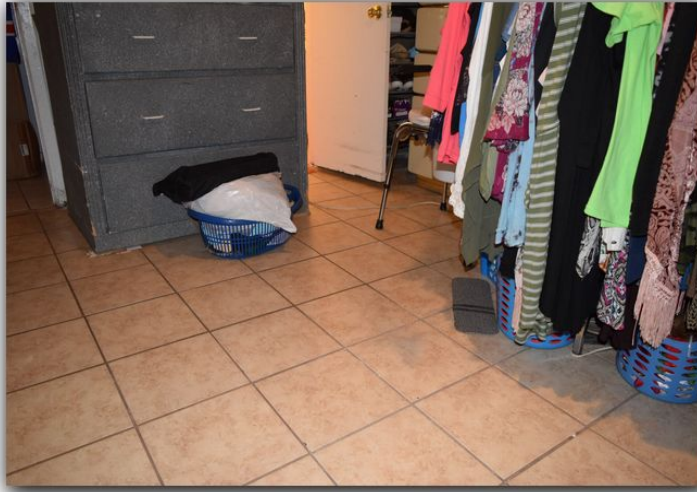
Sloping floors observed in Unit 6702 and 6704 that is consistent with structural movement.

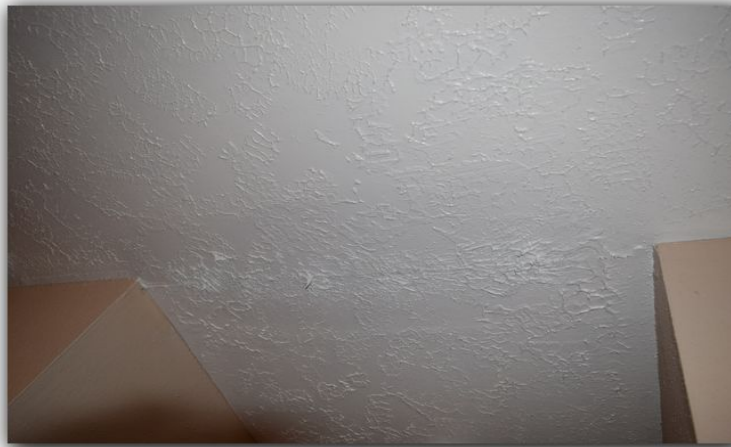
Cracks in both unit 6702 & 6704 ceiling observed.

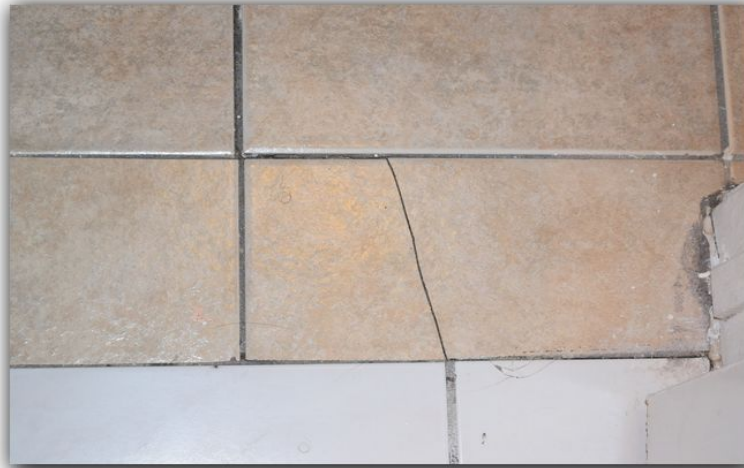
Broken/damaged tiles observed in both units 6702 & 6704.

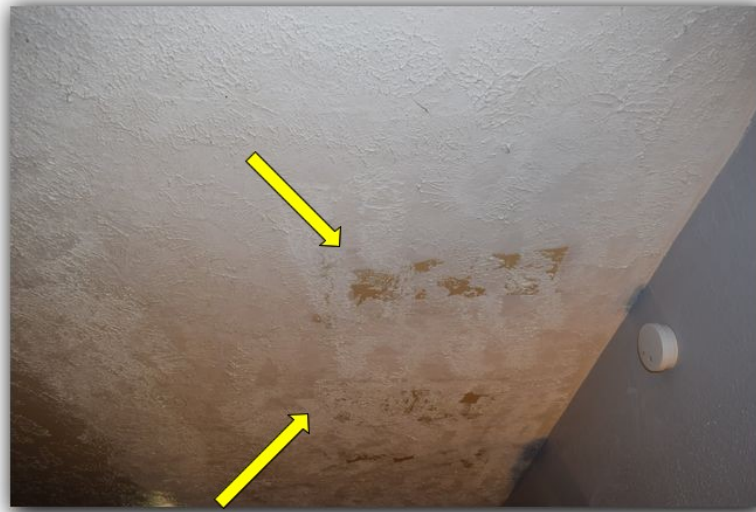
Observed indication of previous moisture intrusion in unit 6704. At the time of the inspection it did not appear to be active when tested.

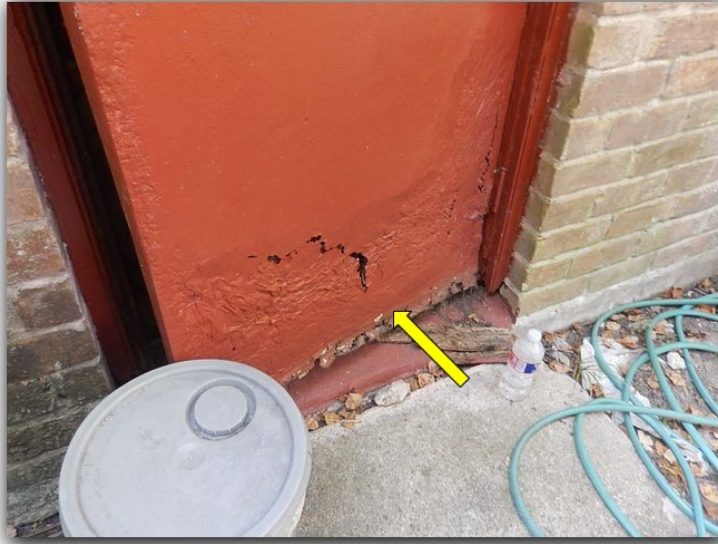
Recommend replacing the damaged rear door of unit 6704.

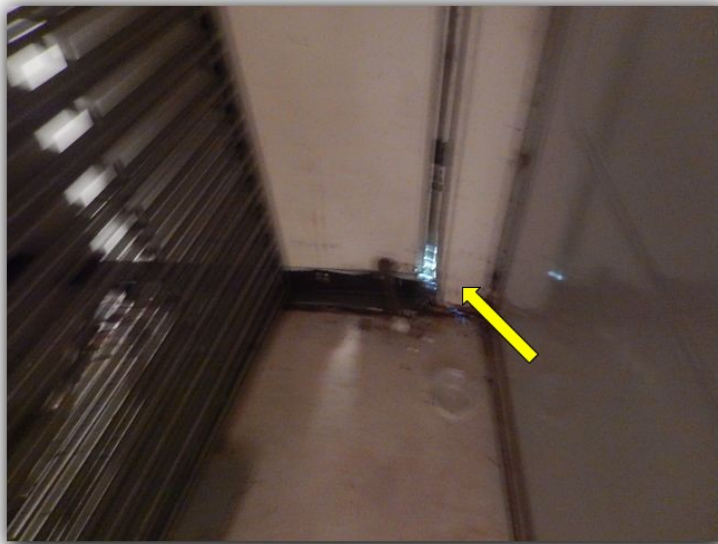
Weather stripping torn/damaged and/or missing on one or more exterior door(s).

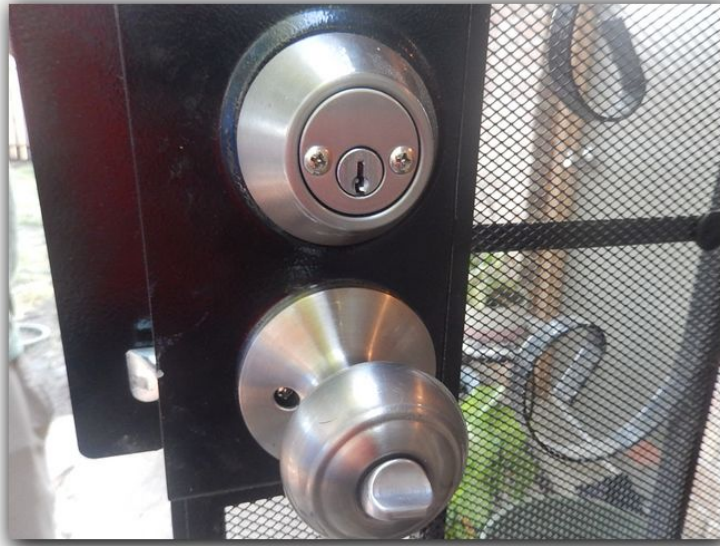
Exterior doors do not have thumb latch to unlock door. All egress doors shall be opened from the inside without the use of a key or special knowledge or effort.

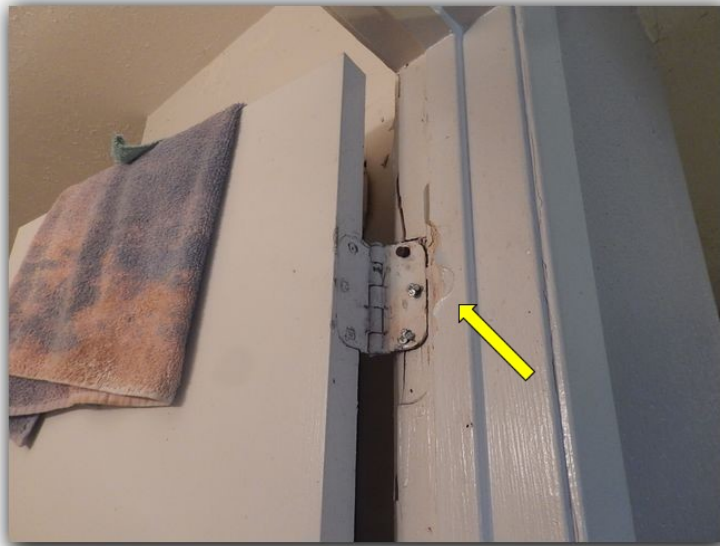
The bathroom door is not properly attached to the door frame in unit 6704. Recommend installing proper fasteners to the door hinges.

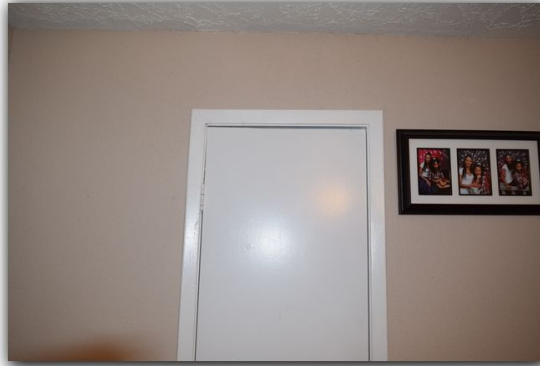
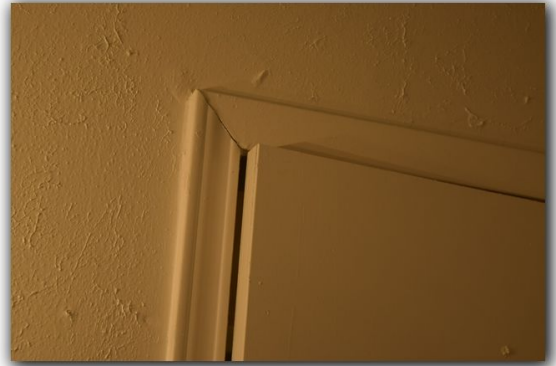
Multiple doors in both unit 6702 & 6704 were out of square or binding consistent with structural movement.

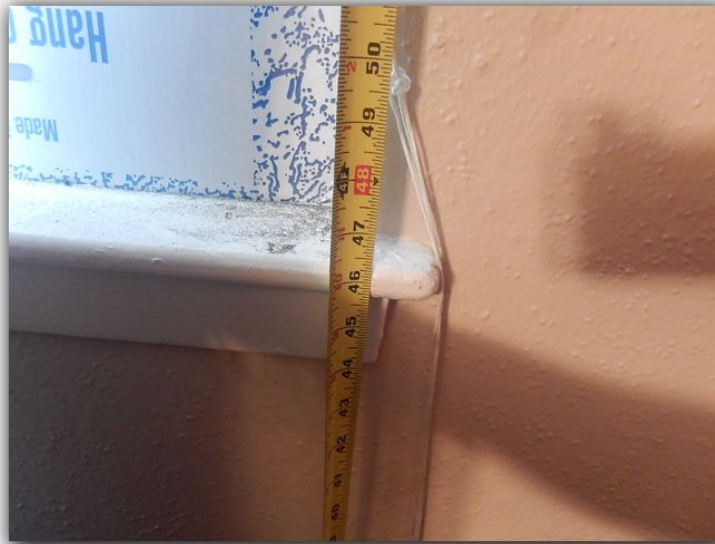
Window in multiple bedrooms sill height are above maximum height of 44" for egress. Both Units.

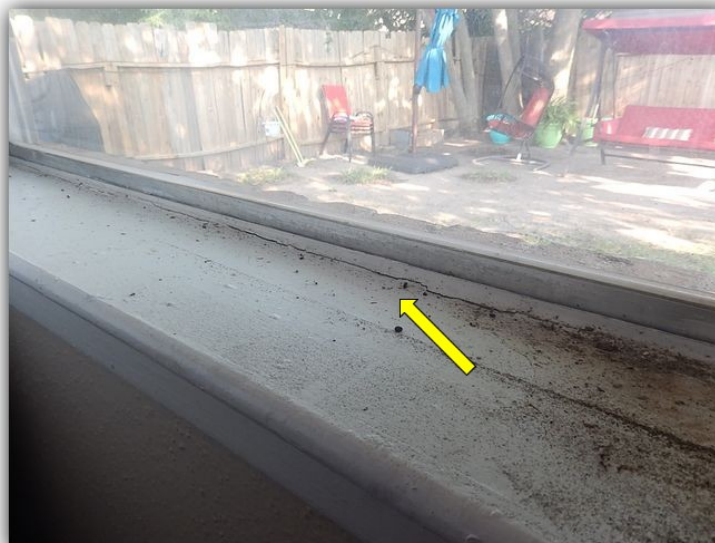
The caulking and glazing around the windows is showing signs of deterioration and may need to be replaced.

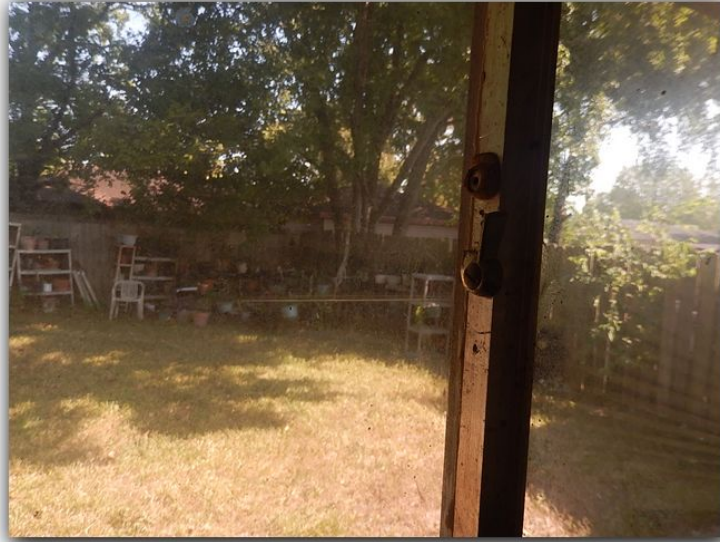
The inspector was unable to lock the rear window in unit 6704. Recommend repair to prevent a possible safety hazard.

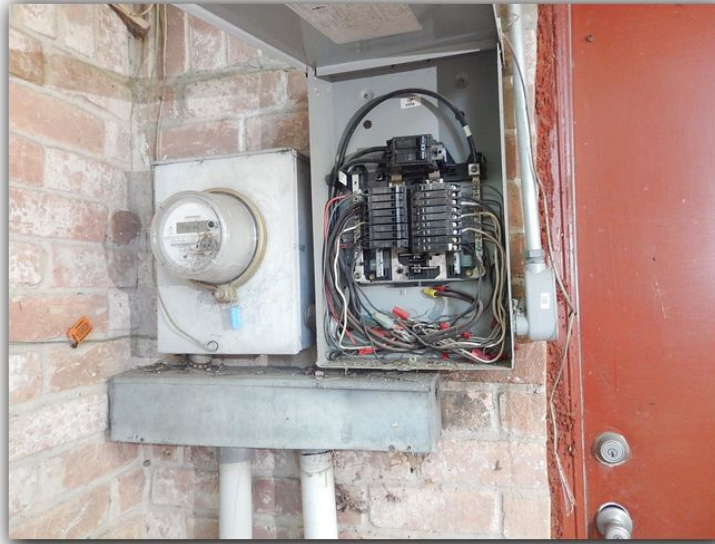
The inspectors observed a missing dead front on units 6704 electrical panel. Recommend replacing the missing dead front to prevent possible electrocution.

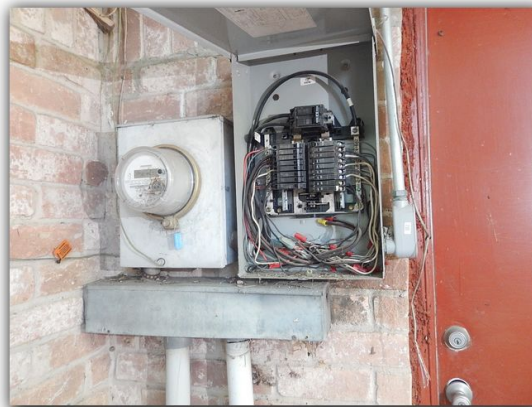
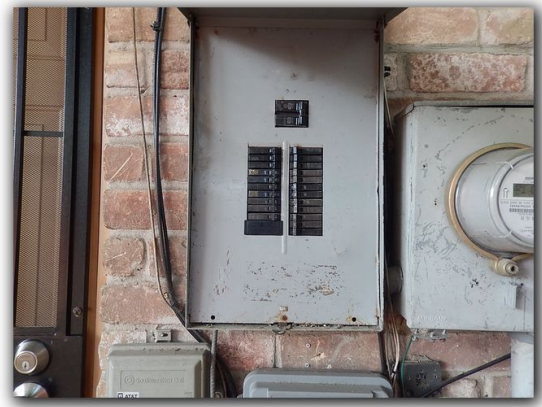
The Circuit Directory label identifying individual electrical circuits was missing from the service panel cabinet. As such it is not possible to determine adequate breaker and conductor sizing. The service panel should contain a clearly-marked label identifying individual circuits so that in an emergency, individual circuits can be quickly shut off. The Inspector recommends that a properly marked Circuit Directory label be installed by a qualified electrician.

Both Units.

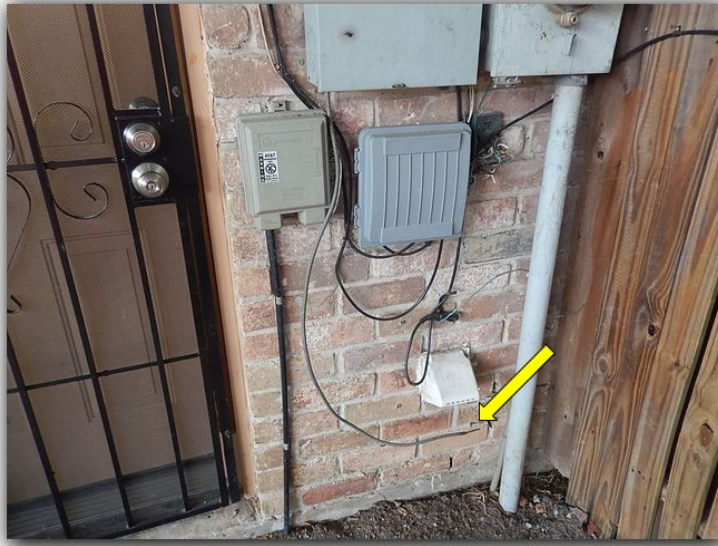
Observed a loose/missing grounding rod for electrical service entry panel/ gas supply. This is a safety hazard as the home is not properly bonded and poses a electrocution/ Fire hazard and should be corrected immediately. Recommend repair by qualified electrical contractor prior to close.

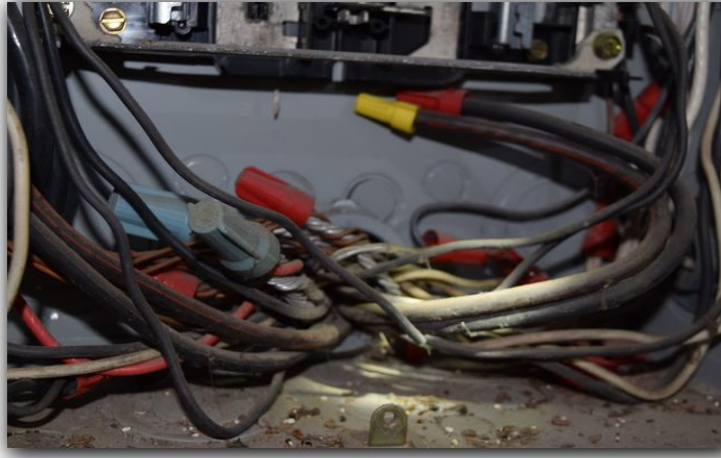
House is wired with aluminum wiring, Acceptance of this condition rests solely with client. Houses wired with aluminum wiring is known by the insurance industry to have higher risk of electrical fires and insurance rates are usually higher for houses with aluminum wiring. Recommend evaluation by an electrician. Both Units: 6702 & 6704

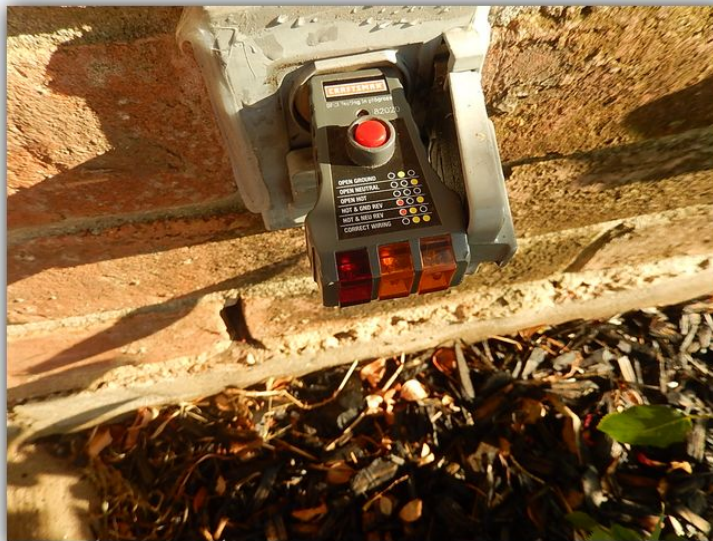
Some electrical receptacles in the home were inoperable at the time of the inspection. The Inspector recommends repair by licensed professional. Front outdoor receptacle.

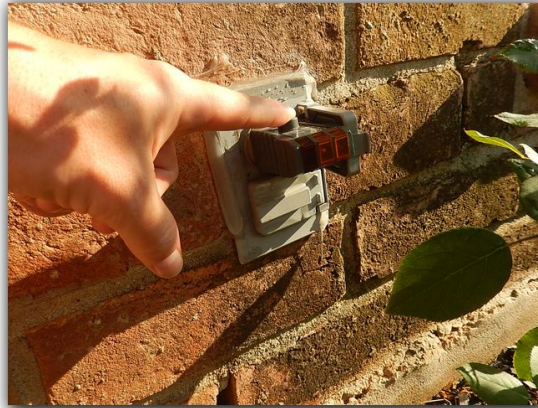
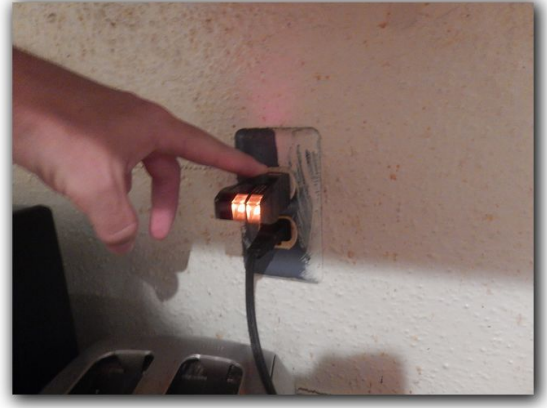
Did not observe GFCI protection of all outlets in required locations, including kitchen, garage, all bathrooms and exterior locations. This condition is a recognized safety hazard and is in need of repair.

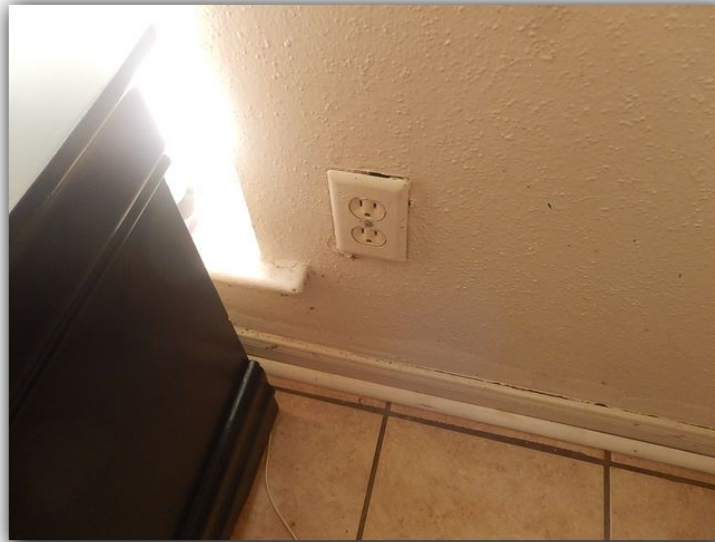
Electrical receptacles at various areas in the home were improperly secured and moved when plugs were inserted. Receptacles should be securely installed to prevent fire, shock and/or electrocution hazard. Loose outlets should be corrected by a qualified electrical contractor.

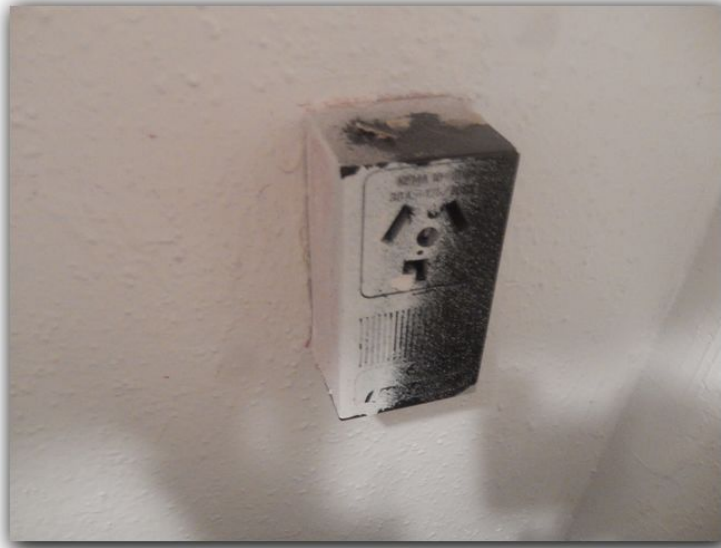
Older style 3-prong outlet for dryer observed. Will not fit newer 4 prong corded electric dryer.

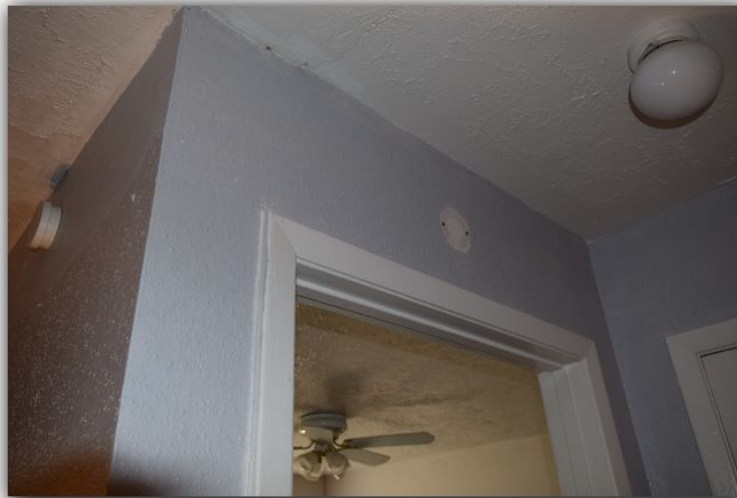
Inadequate number and/or improper location of smoke detectors in unit 6704. Smoke detectors should be located on each level of the home AND inside AND outside of all sleeping rooms. Consult the smoke detector manufacturer's instructions regarding specific placement of detectors.

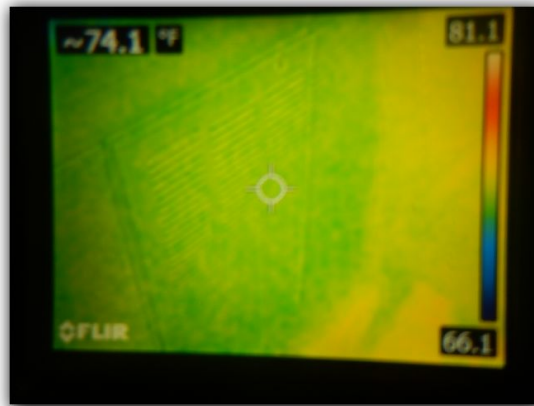
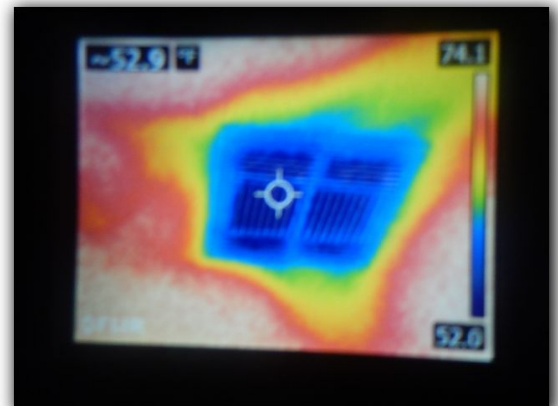
Temperature Differential at time of inspections was 21.1 degrees. Temperature differential should fall between 15-20 degrees for proper cooling. Recommend further review by licensed professional.

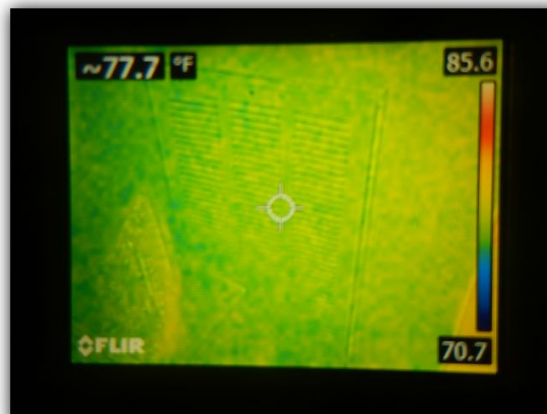
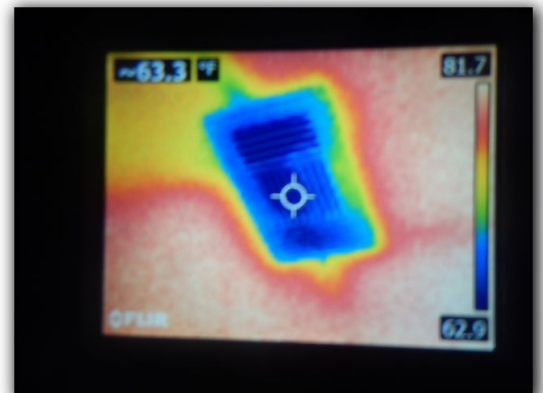
Temperature Differential at time of inspections was 14.4 degrees. Temperature differential should fall between 15-20 degrees for proper cooling. Recommend further review by licensed professional.

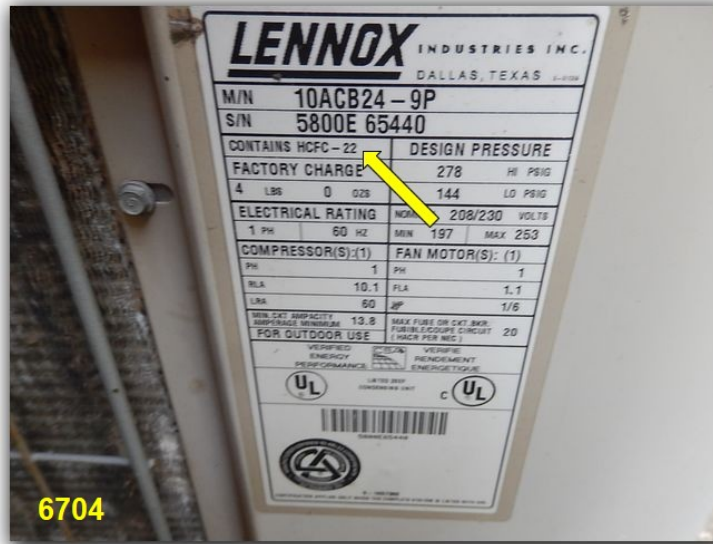
The Condenser data plate indicates the system was filled with R-22 refrigerant which is no longer being produced or imported after 1/1/2020. What is available on the market is a diminishing supply. Therefore if any addition refrigerant for this system is needed the cost will be going up. For more information please visit <http://www.epa.gov/ozone/title6/phaseout/22phaseout.html>

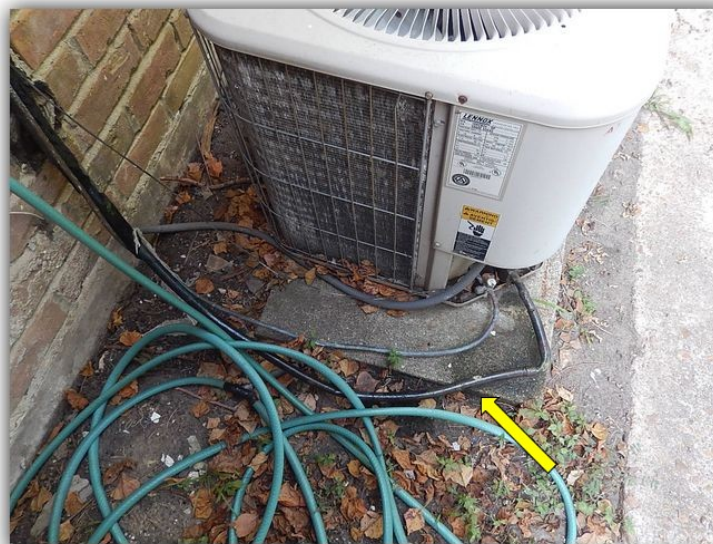
Recommend replacing the damaged/missing suction line insulation.

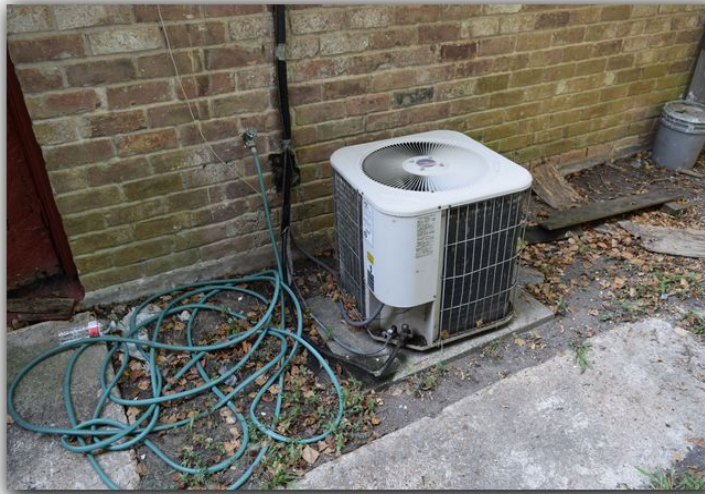
Condensing units in both units insufficiently elevated.

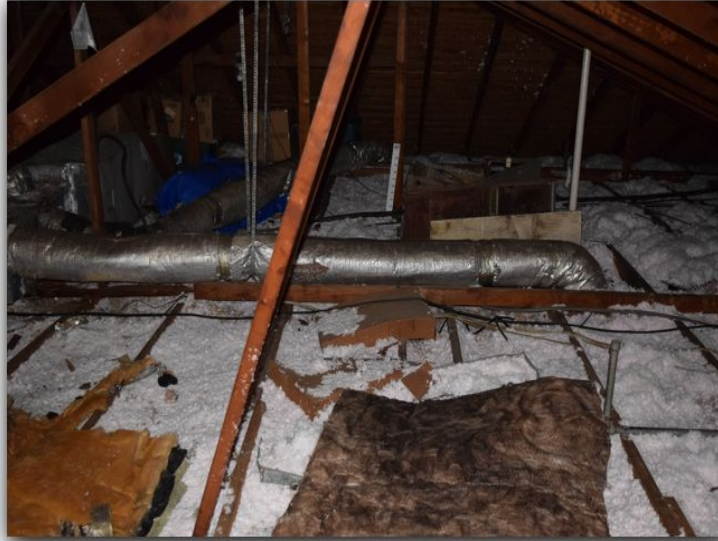
Observed improper duct installation. Duct should be elevated off attic flooring. Recommend repair prior to closing.

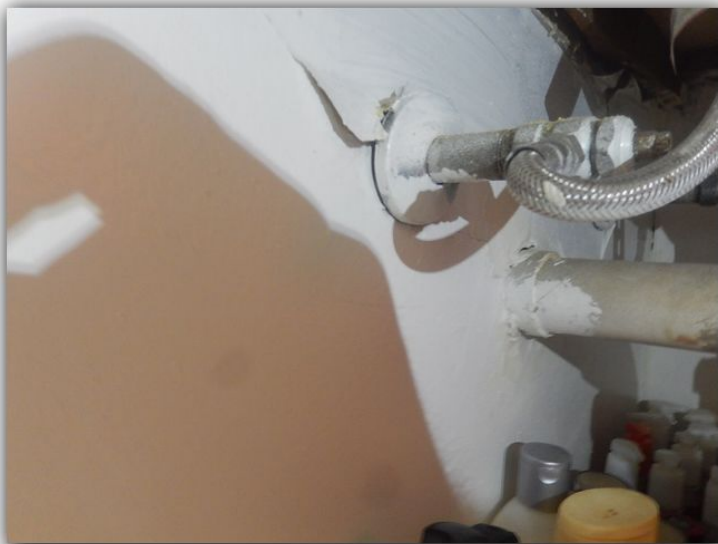
Galvanized piping was observed by inspector. Rusting galvanized piping can greatly reduce water pressure and eventually cause leaks as rust creates holes in pipe walls. Problems are likely to occur on pipes carry hot water, horizontal pipes and at threads. Both Units 6702 & 6704

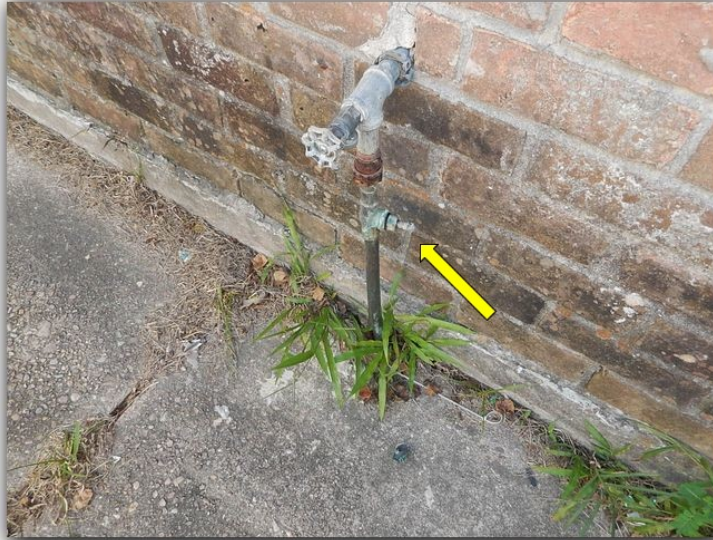
The hose bibs and main water supply lines are not fully / properly insulated.

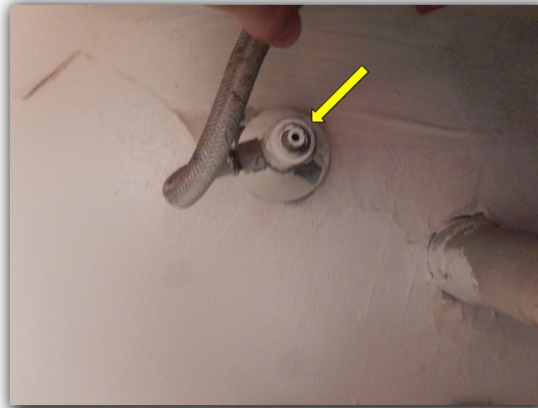
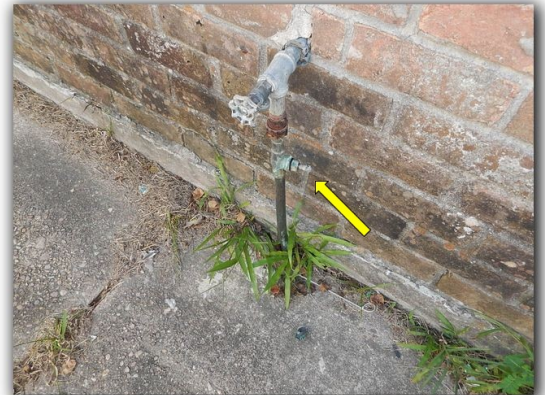
The inspector observed multiple valves missing the on/off wheel. Recommend replacing the on/off wheels to allow the valve to be turned off in the event of a leak.

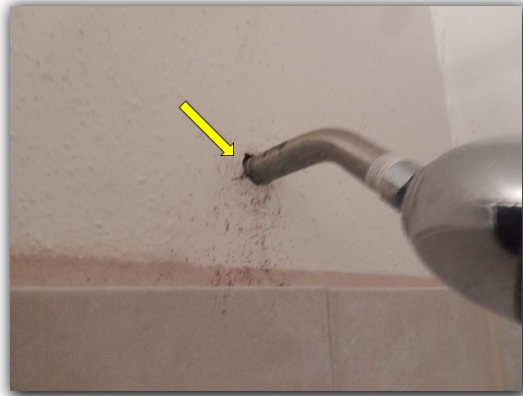
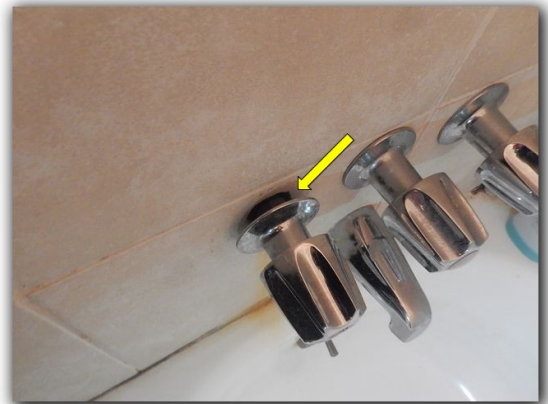
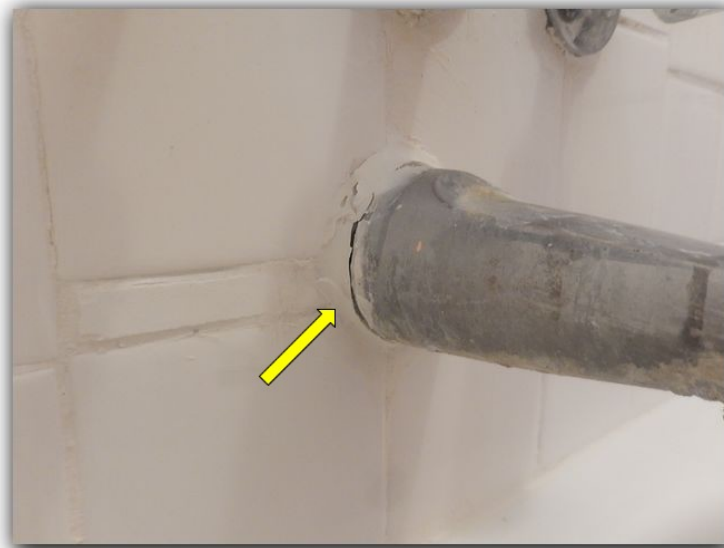
All bathtub wall penetrations and corners should be silicone sealed to help prevent water penetration into the wall cavity. The silicone is missing / deteriorated at the control knob, the tub faucet, and shower head.

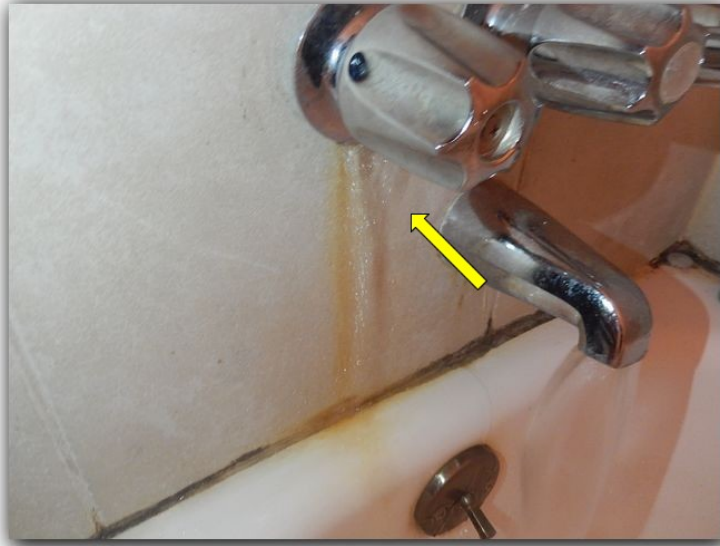
The secondary bathroom on/off valve was observed leaking at the time of inspection. Recommend repair by a licensed professional. Unit 6704.

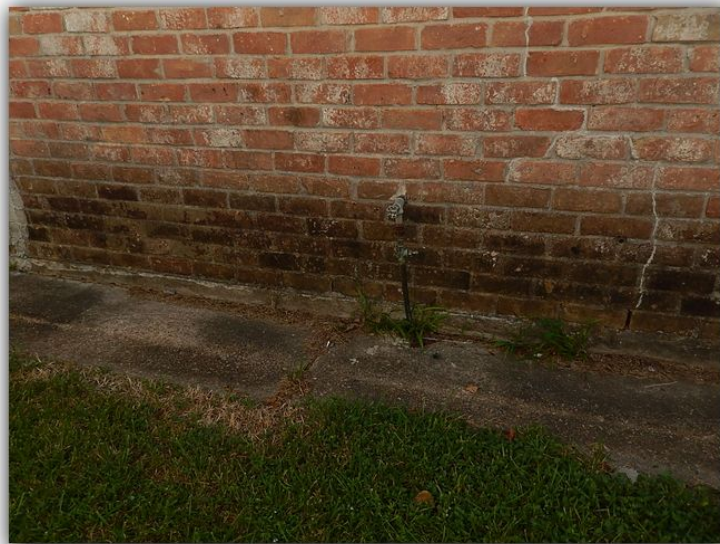
Inspector observed missing anti-siphon devices at multiple locations around home. Anti-siphon valves prevent the introduction of contaminated water from entry the water system and are required on all exterior hose bibs and at dishwasher and food disposal connections. Recommend the installation of devices at location of missing devices.

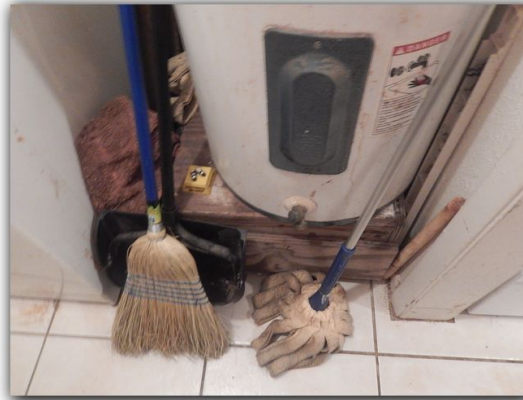
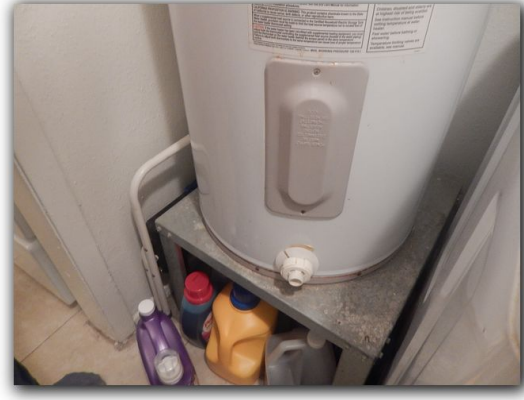
Located in house without benefit of a drain pan. Should water heater leak interior flooring can be damaged. Both units 6702 & 6704

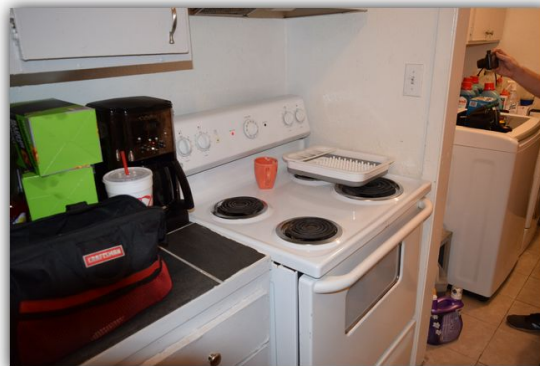
Missing Anti-tip device on Range. Recommend installation of Anti-tip device to prevent possible bodily injury due to range tipping forward. Both Units: 6702 & 6704
