PROPERTY INSPECTION REPORT

Concerning: 6734 and 6736 W Fuqua Drive, Houston, Texas 77489

By: Harold K. Randle License # 10237

September 28, 2019

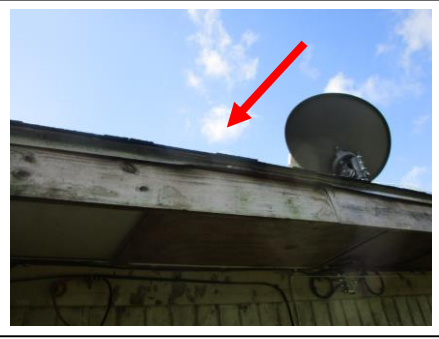
1. Metal roof edge flashing is not installed properly at several locations. Flashing should properly secured to prevent water from roof surface from draining onto roof deck.
2. Tree limbs above roof should be cut back to prevent roof damage.
3. Satellite TV stand has not been properly installed with satellite dish roof jack. The stand has been directly attached to wood decking which can allow water to leak through wood decking at screw penetrations. Screws should be properly sealed where they penetrate decking to prevent water from damaging decking via screw holes. This may be difficult to accomplish as silicone may not be compatible with asphalt shingles and roofing cement or tar can crack and/or deteriorate over time.

Loose Metal Edge Flashing

Recommend having licensed roofing professional further evaluate any item listed above and make appropriate repairs.

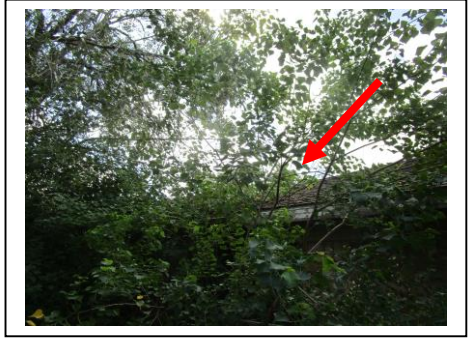
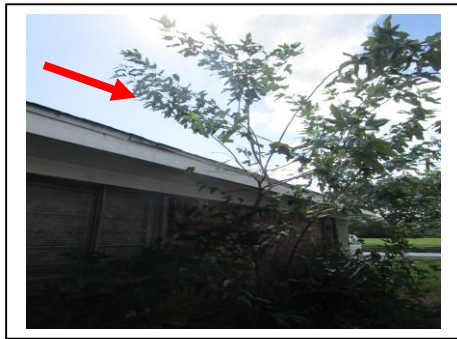
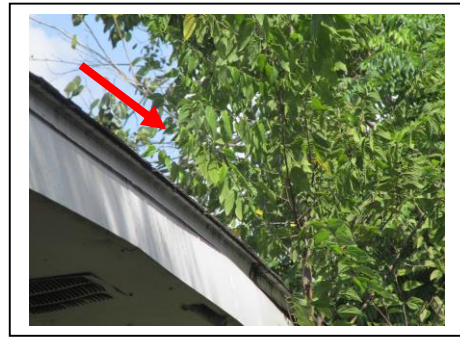
Tree Limbs Above Roof

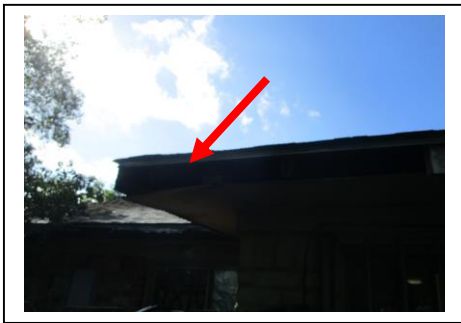
- 1. Unit 6736 attic ladder was sealed shut preventing attic from being inspected.**
- 2. Unit 6736 fascia boards are loose and/or damaged at rear roof locations. This situation should be corrected to prevent pests and rodents from entering the house at the attic level.**
- 3. Unit 6734 attic stair cover is not insulated properly. Cover should be properly insulated and sealed with weather stripping to prevent loss of conditioned air from living space into attic area. Recommend having licensed roofing professional further evaluate any item listed above and make appropriate repairs.**

Fascia Board Damage

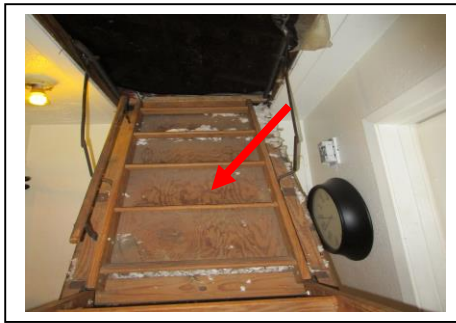
Missing Stair Cover Insulation

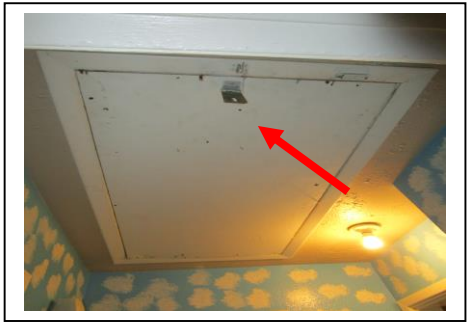
Sealed Attic Stair Ladder

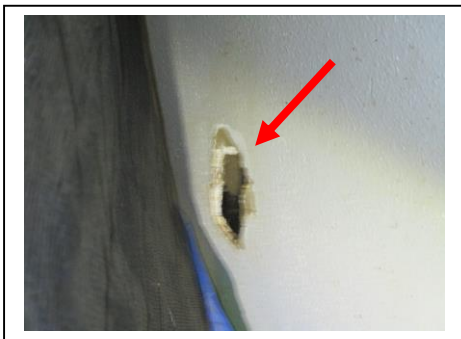
1. Unit 6734 walls are damaged at multiple locations.
 2. Side storage room walls are not finished properly.
- The above areas should be properly re-finished and re-painted. Recommend having licensed contractor evaluate any item listed above and make appropriate repairs.

Wall Hole

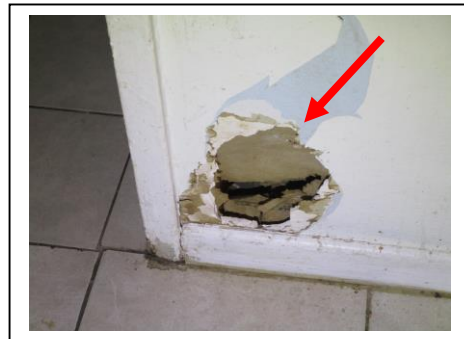
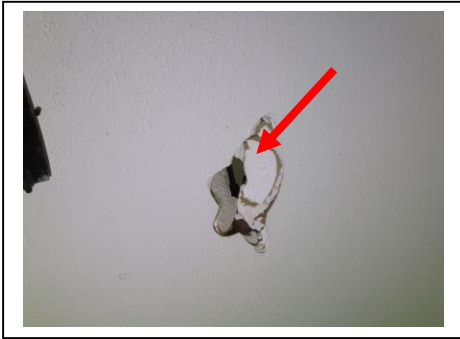
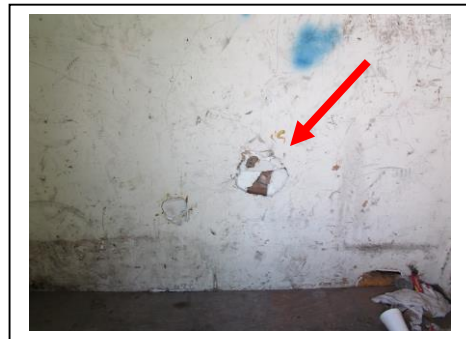
Wall Damage

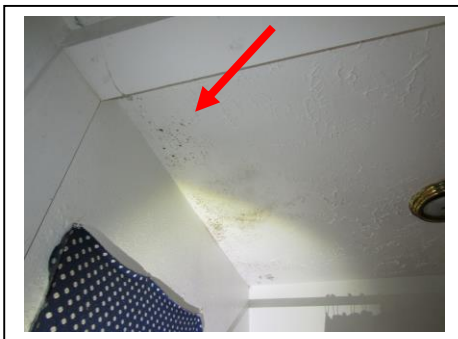
1. Unit 6734 Master Bedroom ceiling has foreign substance on its surface and should be further evaluated by a licensed environmental specialist.
2. Unit 6734 Family Room ceiling is not finished properly. These areas should be properly re-finished and re-painted.
3. Unit 6734 Kitchen floor tiles are damaged. Recommend having licensed contractor evaluate any item listed above and make appropriate repairs.

Foreign Substance On Ceiling

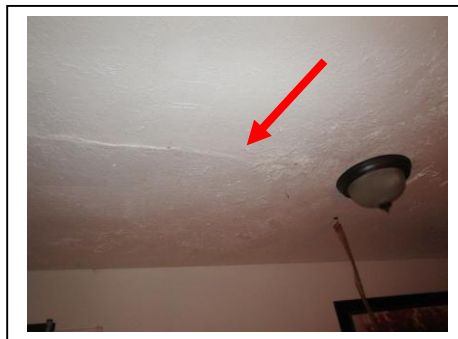
Improper Ceiling Finish

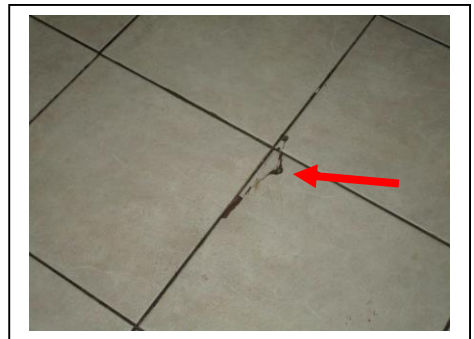
Cracked Floor Tile

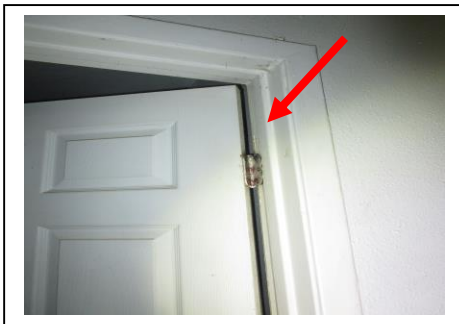
1. Unit 6734 Master Bedroom door did not close properly.
2. Unit 6734 bedroom door has damaged panel.
3. Unit 6736 bedrooms have missing closet doors.
4. Unit 6734 exterior sliding door leading to rear yard did not operate properly.
5. Missing door stops should be installed to prevent doors from damaging walls when opened.

Improper Door Closure

Recommend having licensed contractor evaluate any item listed above and make appropriate repairs.

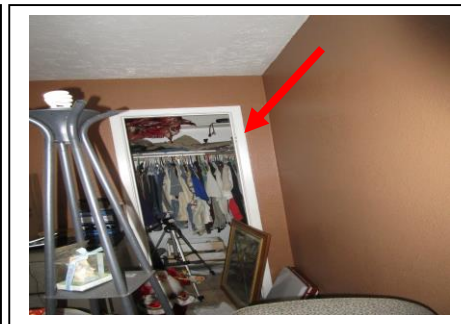
Missing Bedroom Closet Door

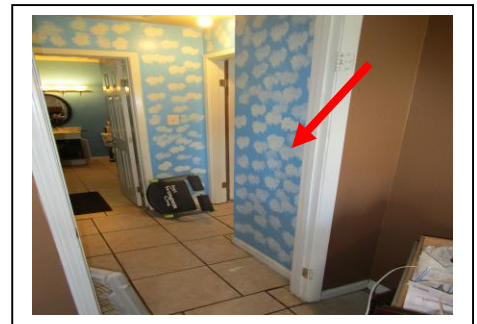
Missing Bedroom Door

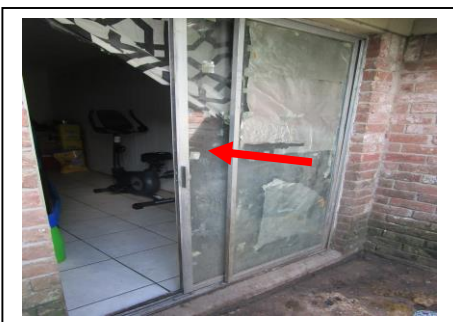
Improper Door Operation

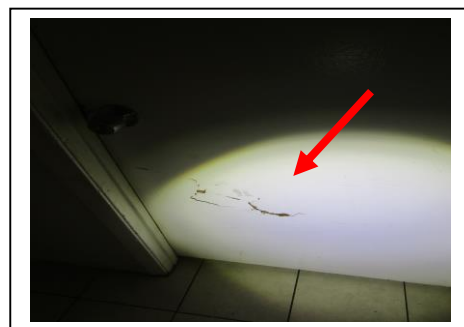
Damaged Door Panel

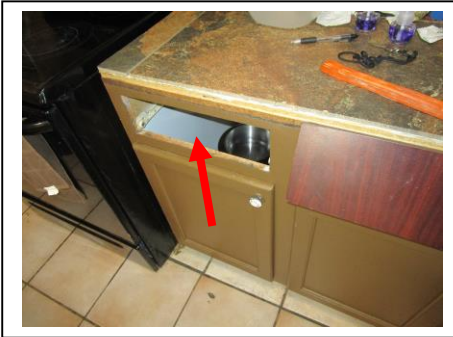
3. Unit 6736 Kitchen cabinet has missing drawer.

Missing Cabinet Drawer

Recommend having licensed contractor evaluate any item listed above and make appropriate repairs.

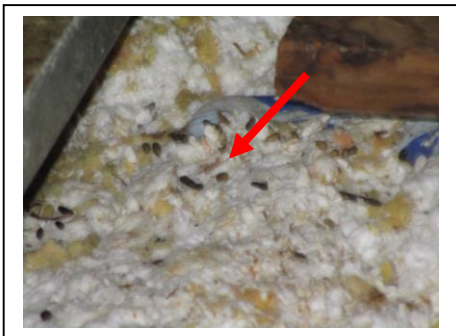
5. Rodent droppings were observed at Unit 6734 attic. Recommend having a licensed pest control company further evaluate this condition and provide appropriate treatment.

Rodent Droppings

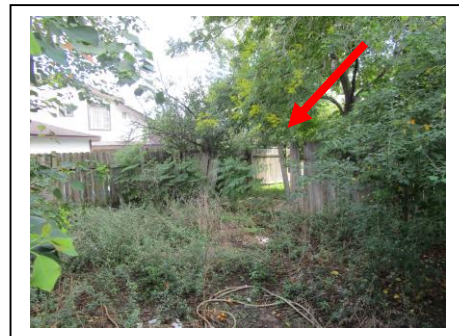
1. Unit 6734 wood fence is damaged at rear yard.

Wood Fence Damage

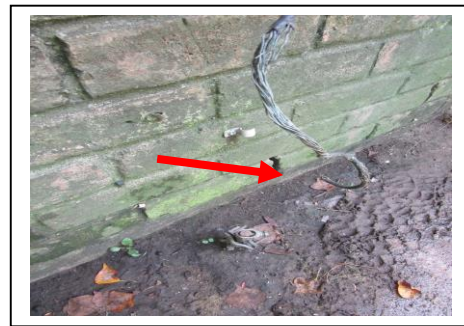
Disconnected Grounding Conductor

Recommend having licensed electrician further evaluate any item listed above and make appropriate repairs.

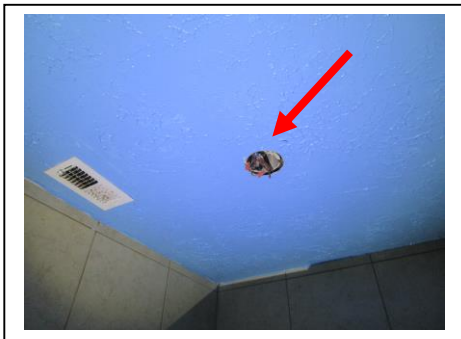
1. Unit 6734 has inoperable wall receptacle at Living Room.
2. Unit 6734 receptacles have damaged cover plate.
3. Unit 6736 Master Bathroom has missing light fixture.
4. Exposed electrical wiring should be properly secured inside of electrical junction box.
5. Smoke alarms should be installed at each sleeping room, outside each separate sleeping area and in the immediate vicinity of the sleeping rooms and utility rooms.
6. Some receptacles were inaccessible due to furniture and were not inspected.

Missing Light Fixture

Recommend having licensed electrician further evaluate any item listed above and make appropriate repairs.

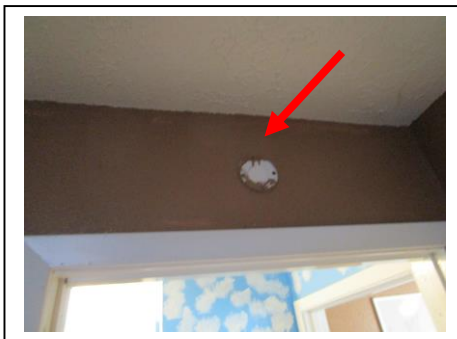
Missing Smoke Alarm

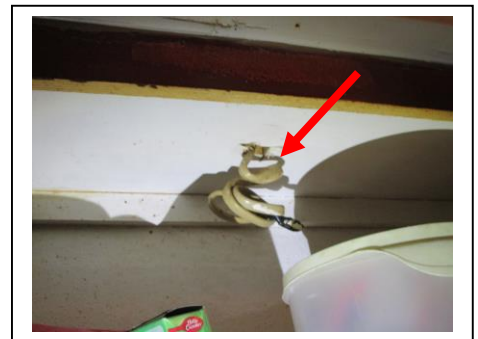
Exposed Electrical Wiring

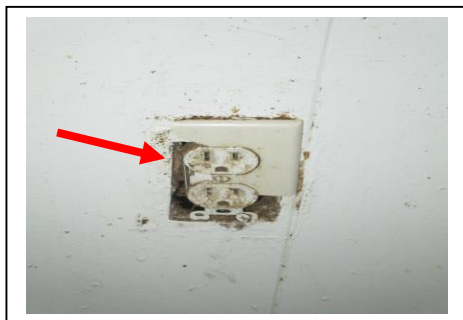
Damaged Receptacle Cover Plate

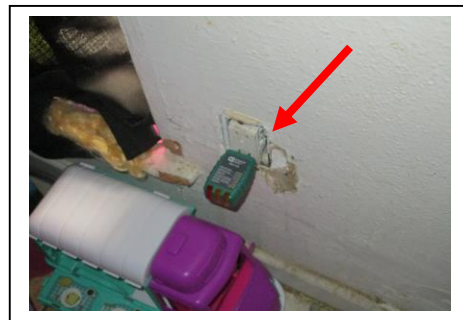
Inoperable Receptacle

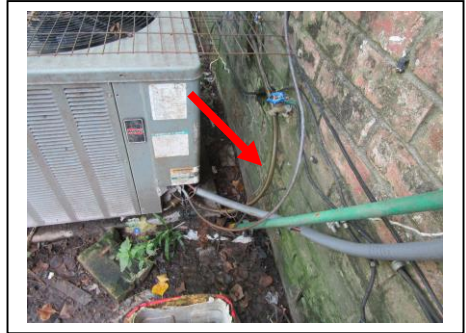
Missing Refrigerant Pipe Insulation

Recommend having licensed heating and air conditioning specialist further evaluate air conditioning system.

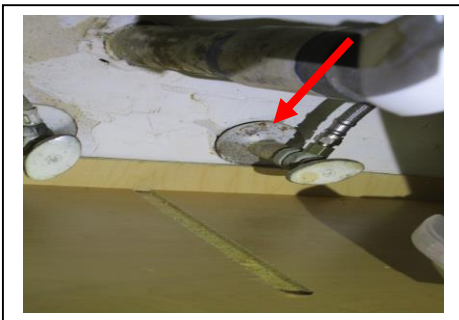
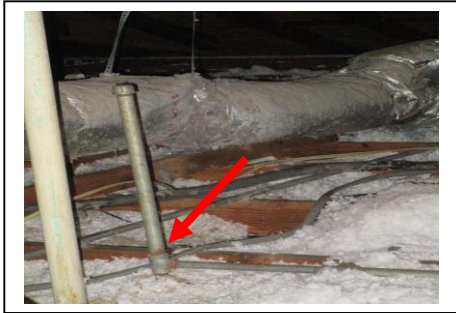
1. Galvanized water piping is approaching its useful life and should be replaced with pipe material that meets current building standards.
2. Water sediment was observed at multiple sinks and bathtub due to apparent corrosion buildup at interior plumbing pipe lining.
3. Unit 6734 hallway bathroom could not be fully inspected due to stored items. Tenant indicated that bathroom floods when plumbing fixtures inside bathroom are used.
4. Main water supply pipe and exterior hose faucets should be insulated to help prevent freezing during cold temperatures.
5. Unit 6736 Master Bathroom bathtub shower diverter has leaking control handles.

Galvanized Water Pipe

Recommend having licensed plumber evaluate any item listed above and make appropriate repairs.

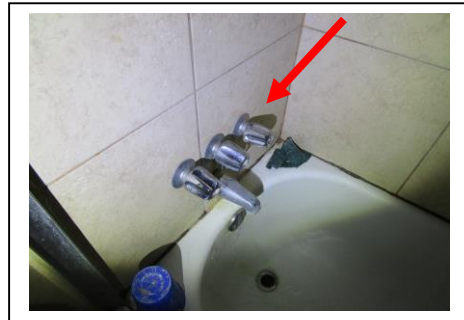
Leaking Bathtub Shower Diverter

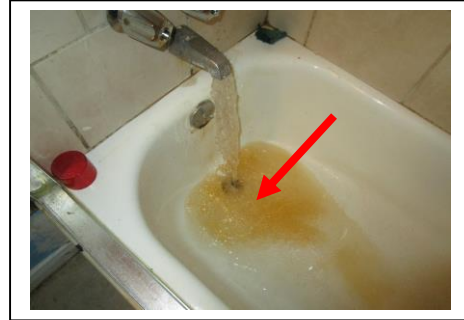
Water Corrosion

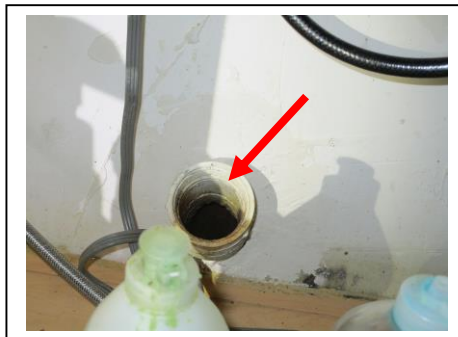
- 1. Unit 6736 Kitchen sink cleanout drain cap is missing. The cap should be provided to prevent rodents and pests from entering property through plumbing piping.**

Missing Cleanout Cap

Recommend having licensed plumber evaluate any item listed above and make appropriate repairs.

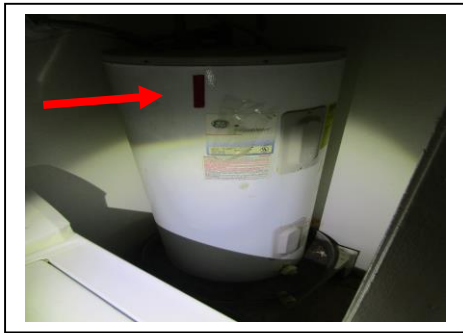
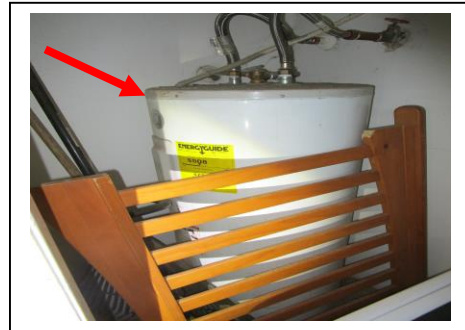
Water Heater

- 1. Water tank should be installed on a stand inside of pan that is piped to property exterior.
Recommend having licensed plumber evaluate any item listed above and make appropriate repairs.**

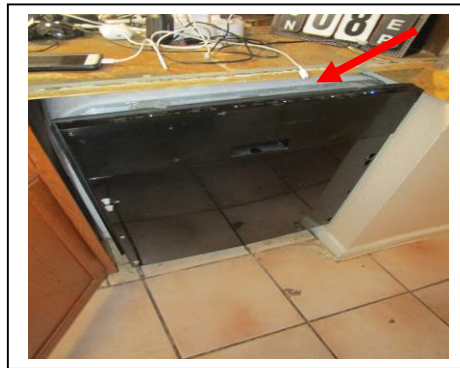
Dishwasher

- 1. Unit 6734 did not have dishwasher.**
 - 2. Unit 6736 dishwasher is not properly attached to countertop and/or cabinets.**
- Recommend having licensed appliance specialist further evaluate this condition.**

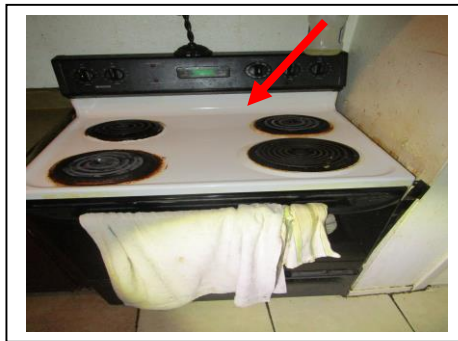
Range

- 1. Unit 6734 Kenmore electric range left rear and right front burners did not operate at time of inspection.**
 - 2. Unit 6736 Frigidaire electric range operated as intended.**
- Recommend having licensed appliance specialist further evaluate this condition.**
