***BE Inspected LLC***  
**Property Inspection Report**

1122c W 22nd St, Houston, TX 77008  
Inspection prepared for: Fernando Blanco  
Date of Inspection: 9/10/2019 Time: 9:00  
Age of Home: 2018  
Weather: Hot and Clear

New Construction. Directional statements are from the perspective of standing at the front door looking in.

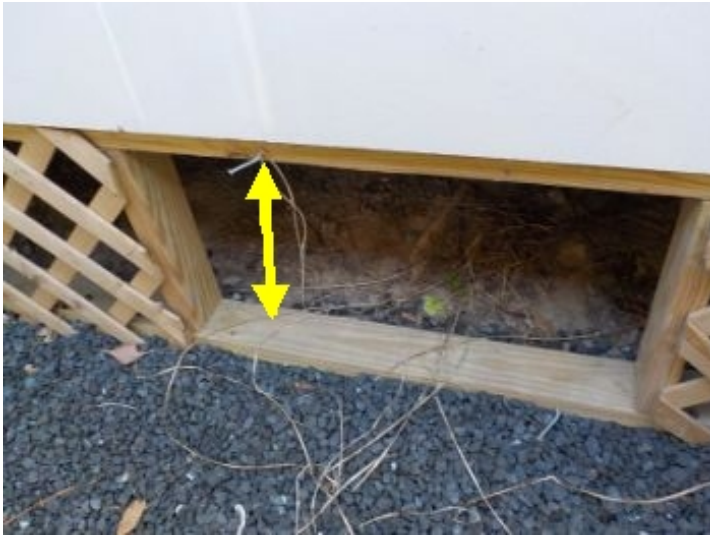
In our opinion, crawl space was not properly accessible. Per common building code, there should be a minimum 18" x 24" opening to enter the crawl space.

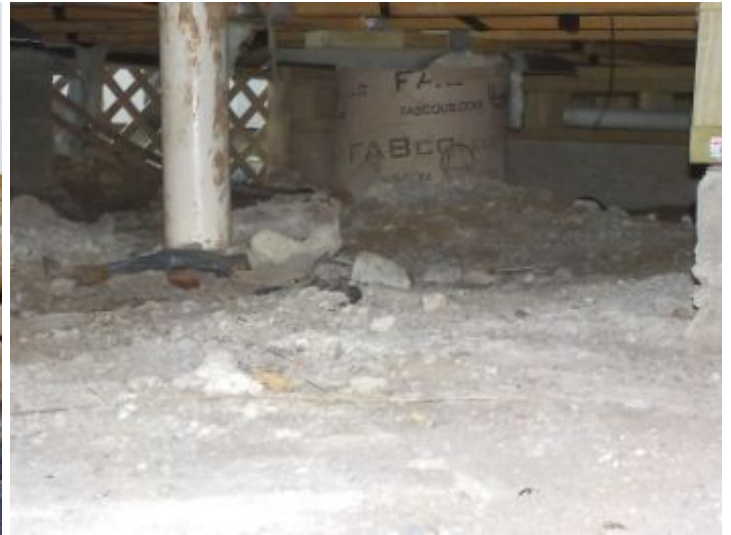
Soil appeared to be uneven and there were visible voids. This could hold water in the crawl space.

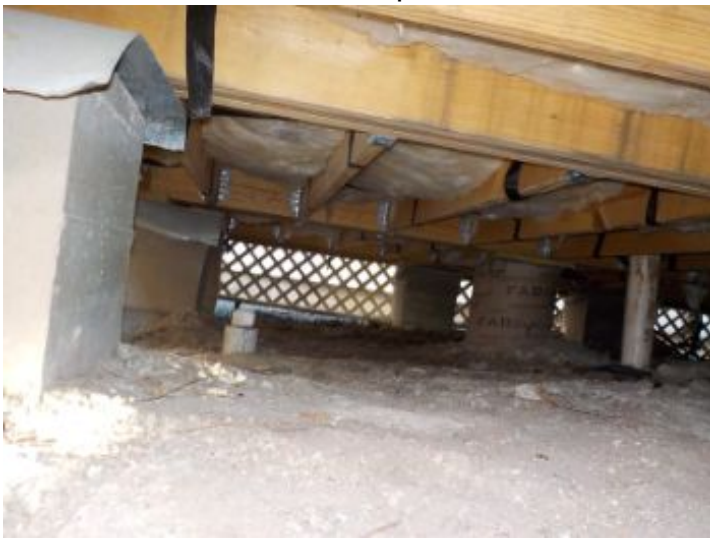
Soil appeared to be uneven and there were visible voids. This could hold water in the crawl space.

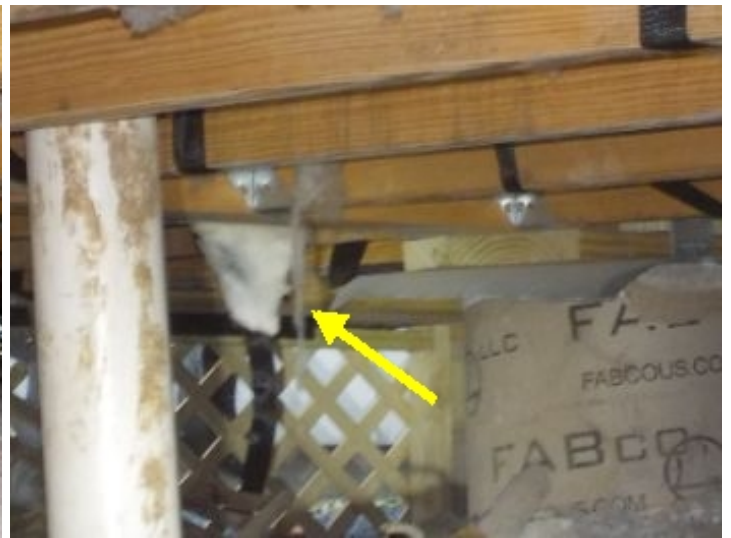
Insulation was hanging and unsecured in some of the crawl space.

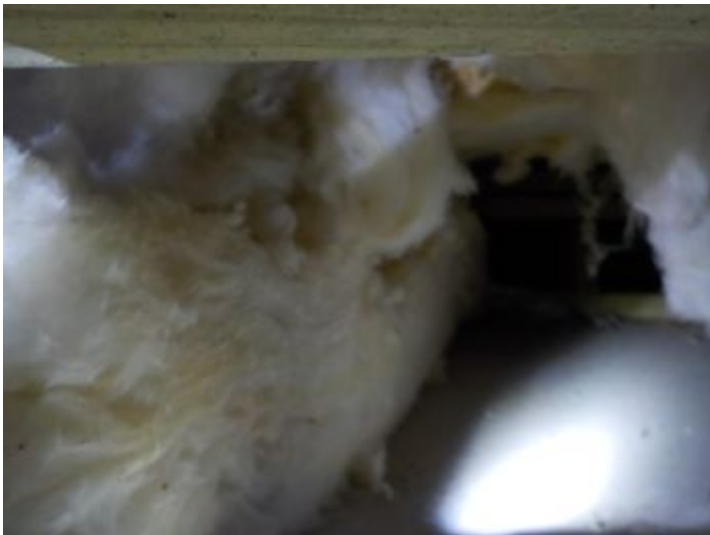
Insulation was hanging and unsecured in some of the crawl space.

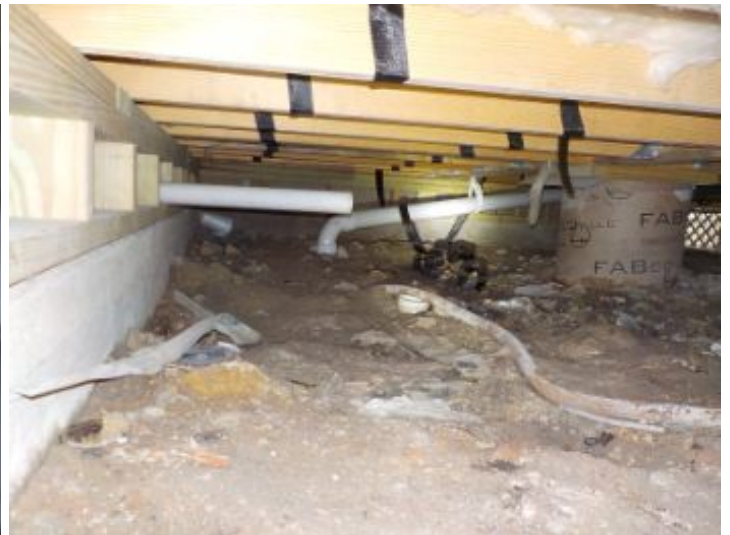
Soil appeared to be uneven and there were visible voids. This could hold water in the crawl space.

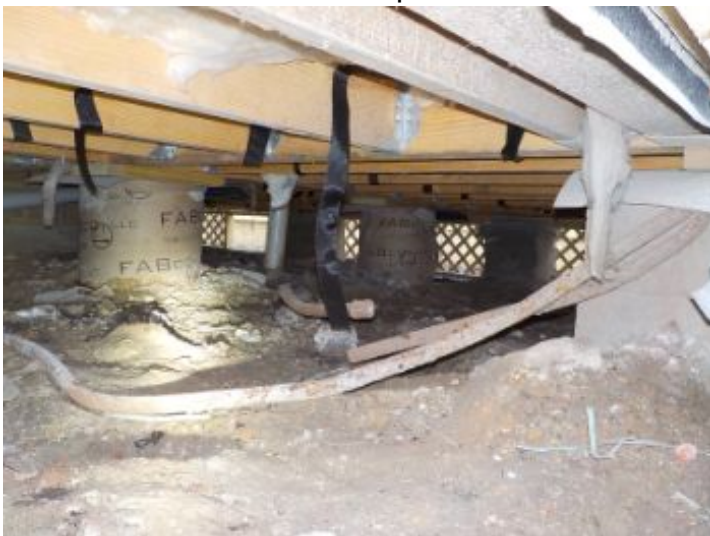
All debris should be removed from the crawl space.

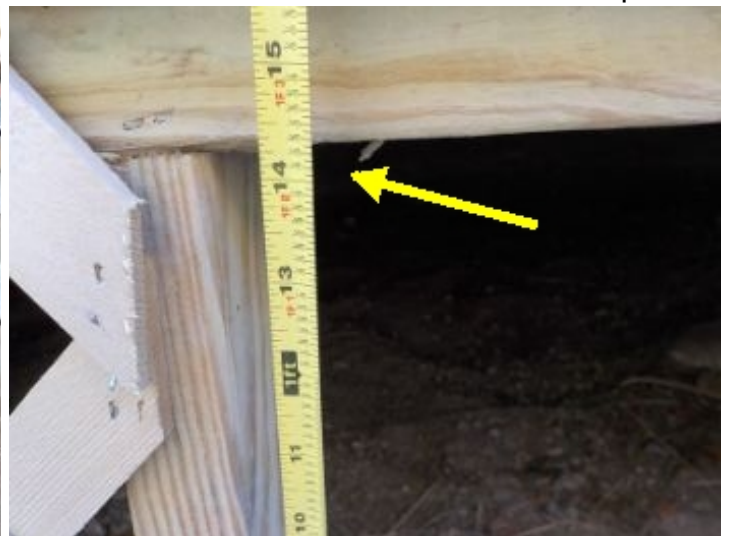
In our opinion, crawl space was not properly accessible. Per common building code, there should be a minimum 18" x 24" opening to enter the crawl space.

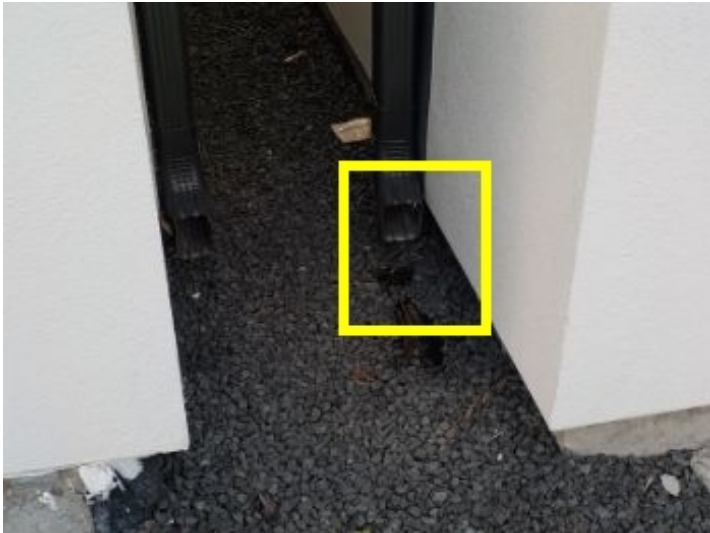
In our opinion, gutter drainage was too close to house.

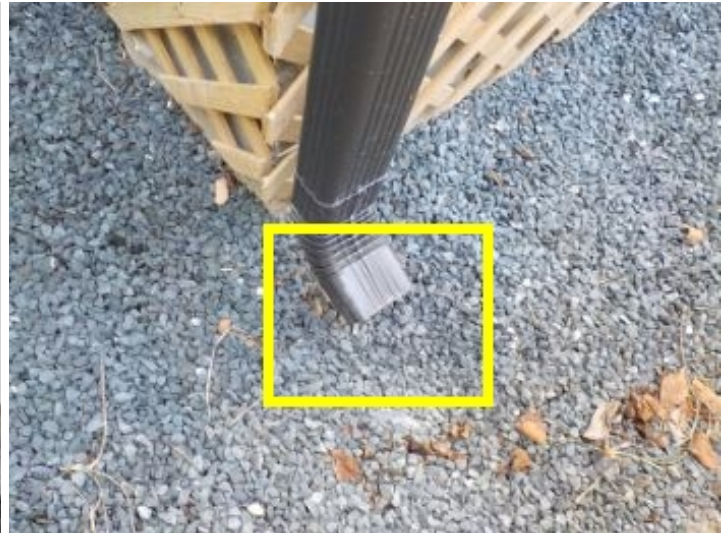
In our opinion, gutter drainage was too close to house.

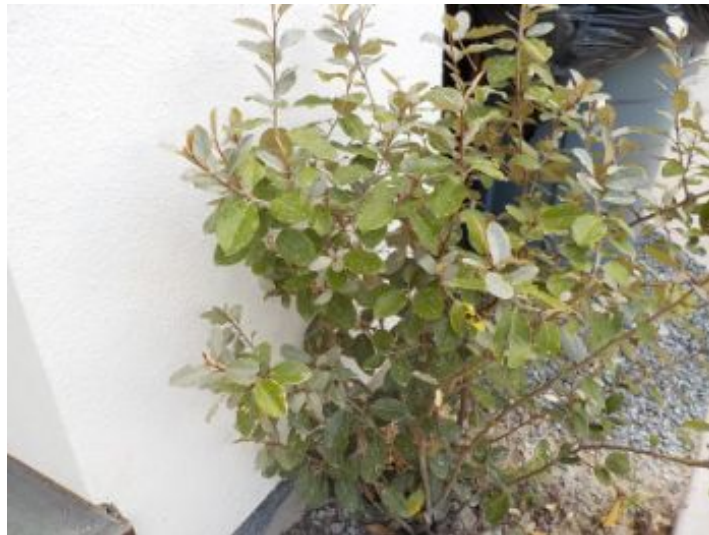
Excessive vegetation was noted in some areas of the home.

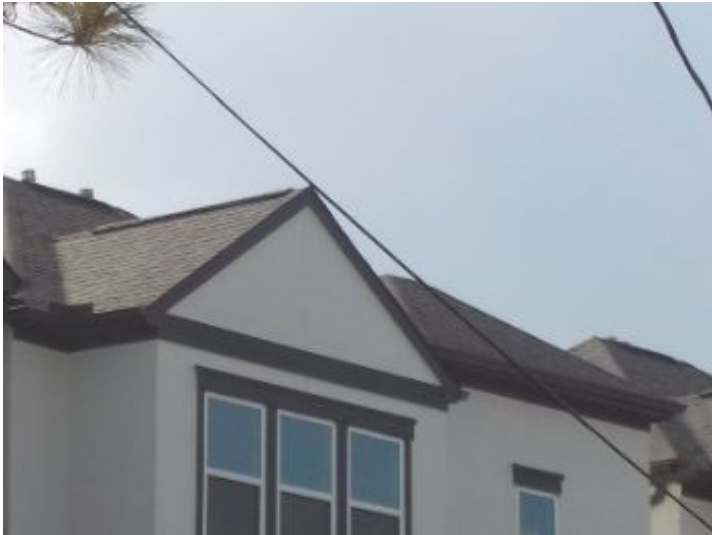
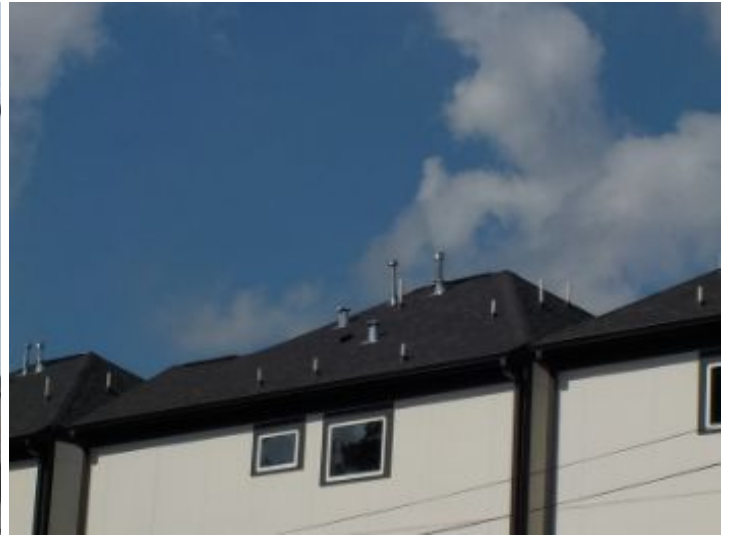
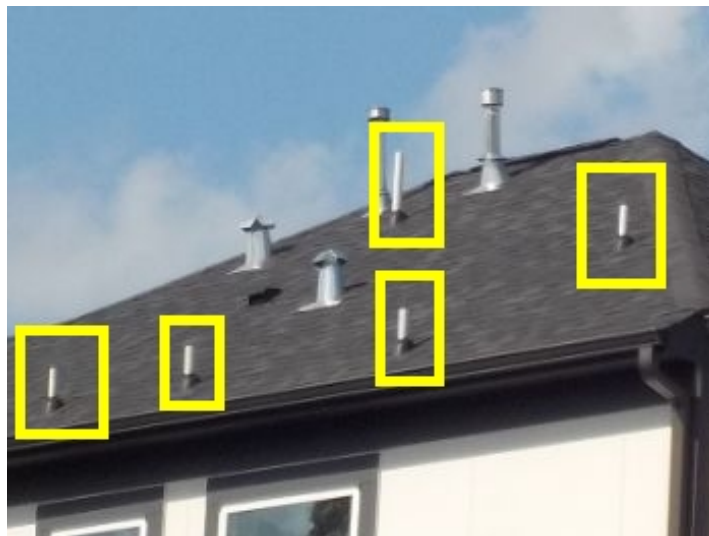
PVC plumbing vents should be painted to avoid UV exposure.

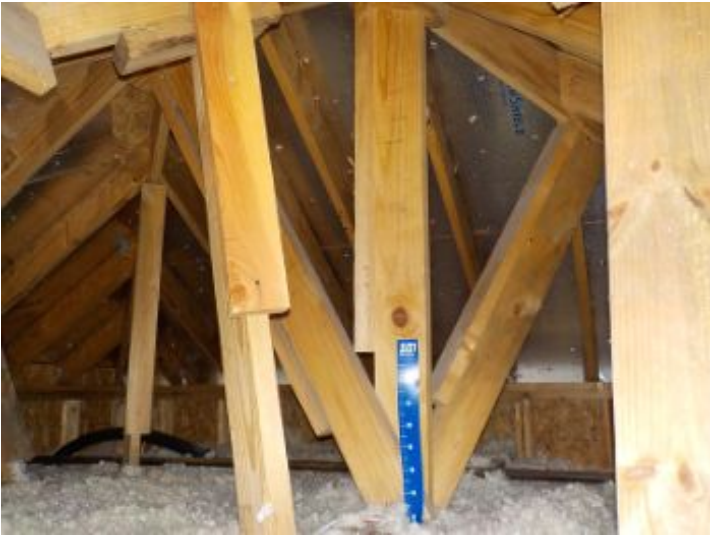
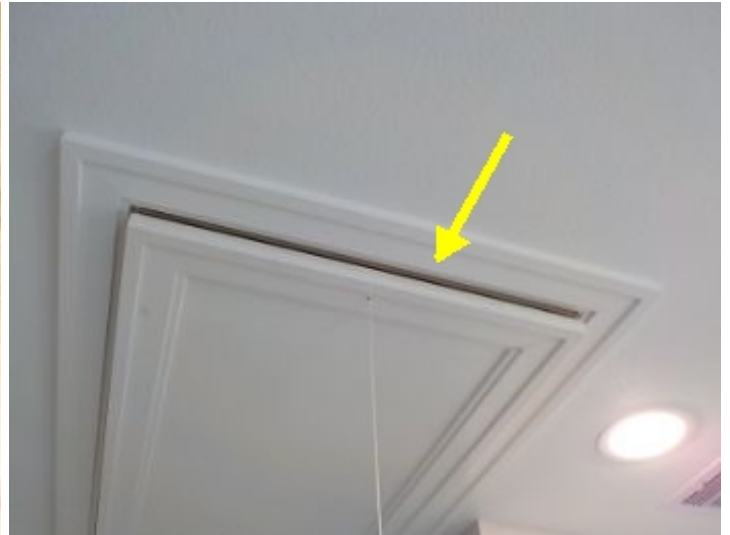
• Access door was not seating properly in the closed position.

Access door was not seating properly in the closed position.

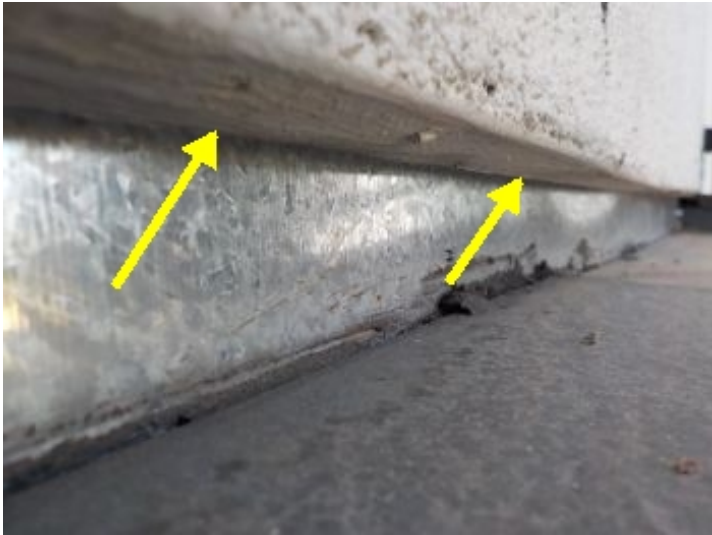
There was no weep screed flashing visibly installed at the bottom of the stucco on the front balcony area.

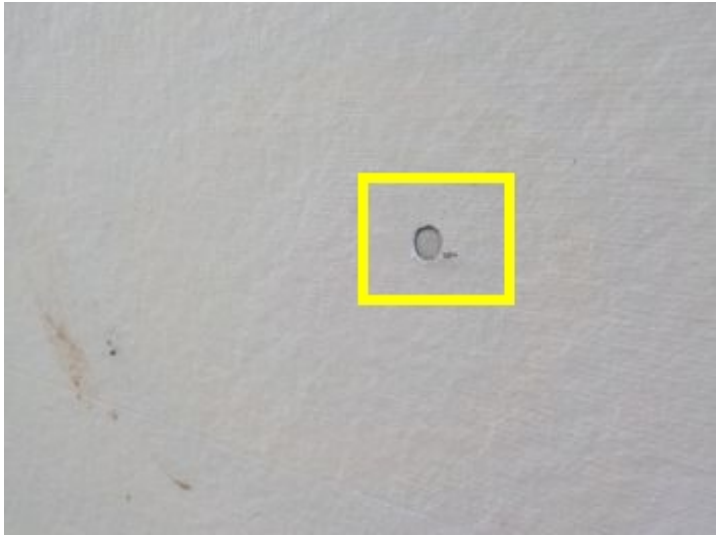
• Wall gaps were observed. Most notably at siding nail heads. Fiber cement siding manufacturers recommend all gaps be sealed. All exterior wall penetrations, changes of materials and direction should be properly sealed to prevent water and pest intrusion.

Wall gaps were observed. Most notably at siding nail heads.

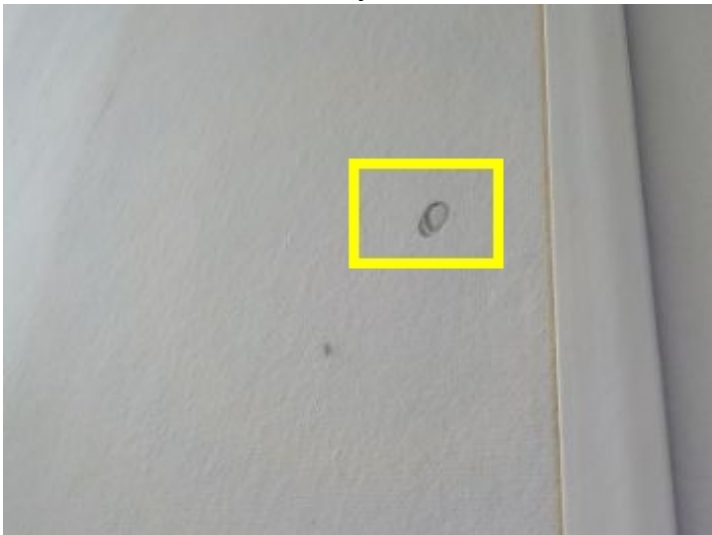
Wall gaps were observed. Most notably at siding nail heads.

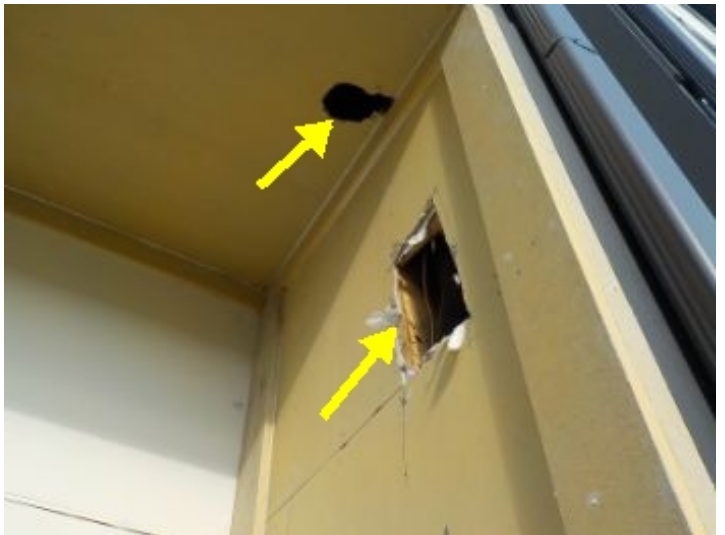
• Holes were observed around the exterior walls. Most notably at the rear, near the electric panel.

Holes were observed around the exterior walls.

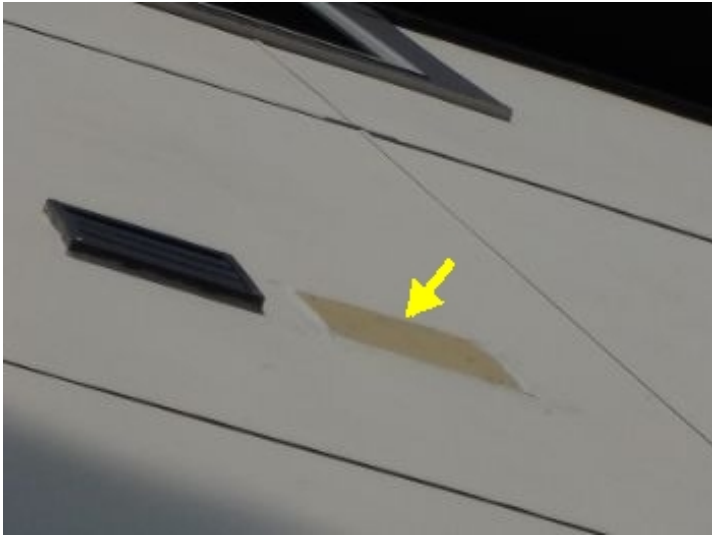
Some of the rear exterior siding did not appear to be finished.

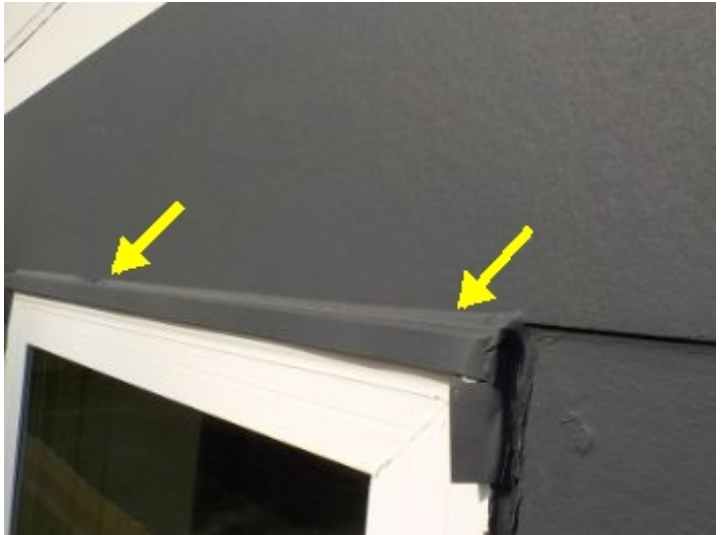
Siding over windows/doors/joints appeared to be caulked, flushed and not properly gapped above the flashings.

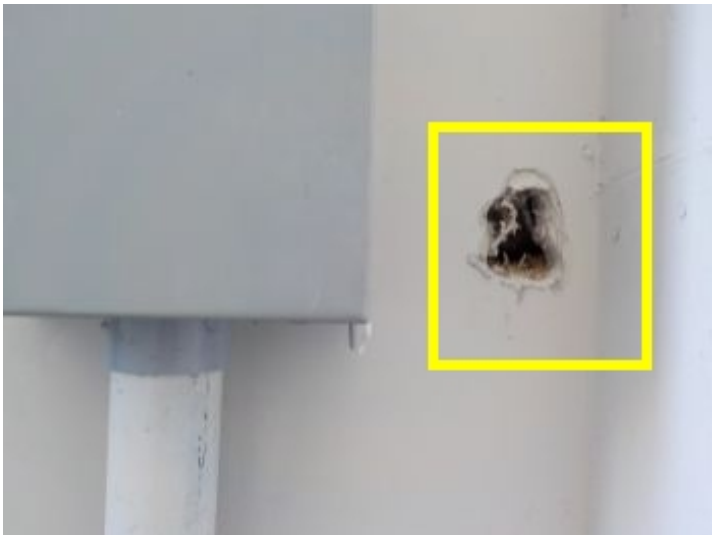
Holes were observed around the exterior walls.

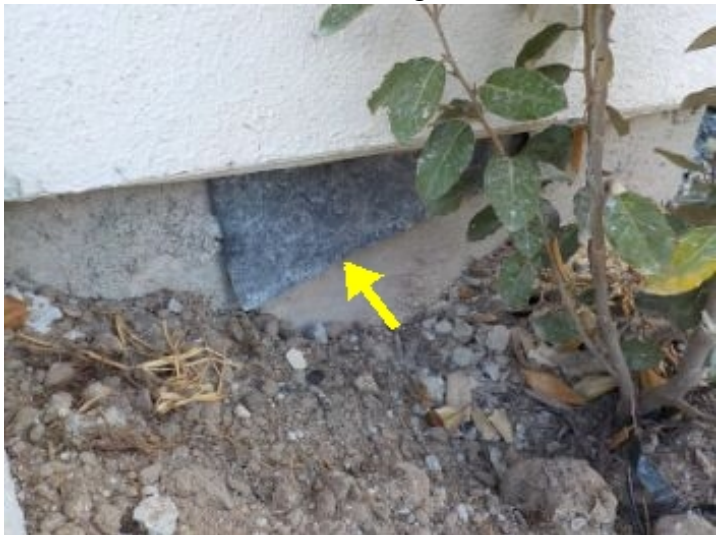
Excess wall sheathing should be removed from the lower wall near the garage.

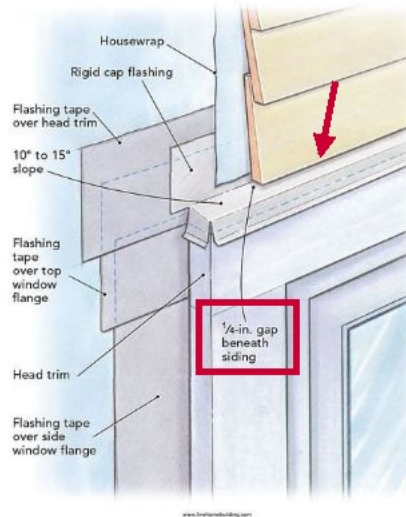
Siding over windows/doors/joints appeared to be caulked, flushed and not properly gapped above the flashings. Typically siding manufacturer's require an uncaulked 1/4" gap.

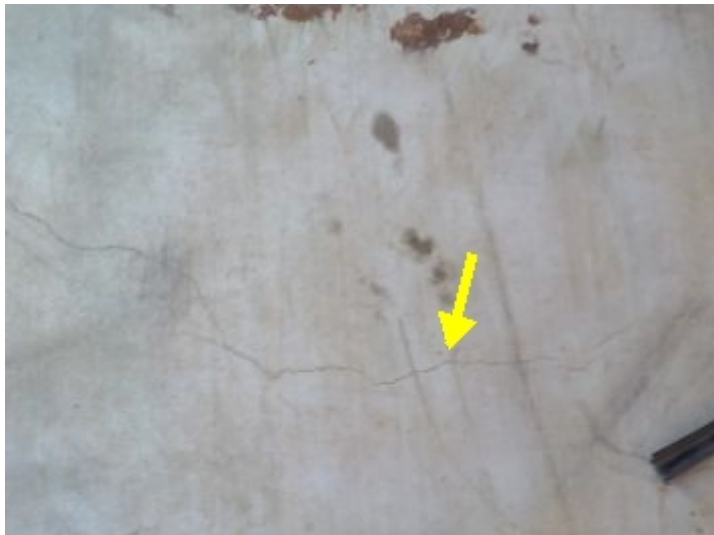
• Some floor cracks were observed. Most notably in the garage. In our opinion, there did not appear to be excessive deflection or settlement in these areas. These should be properly sealed and monitored.

Some floor cracks were observed. Most notably in the garage.

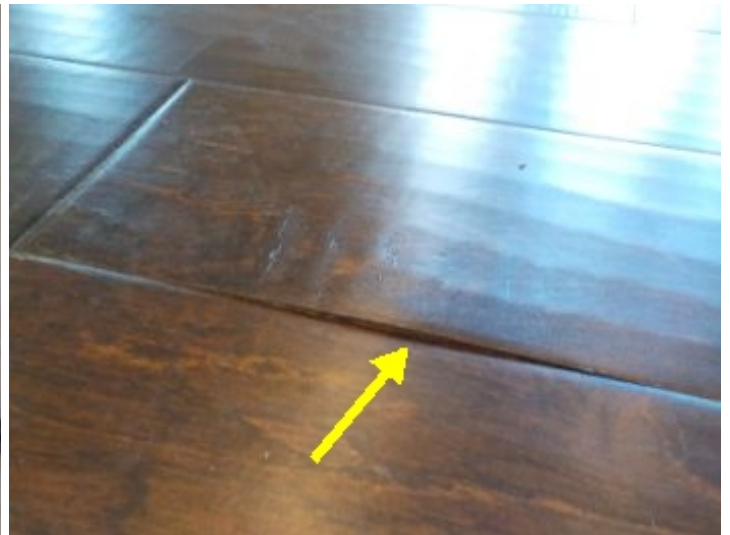
Some wood floor delamination was observed. Most notably in the den area.

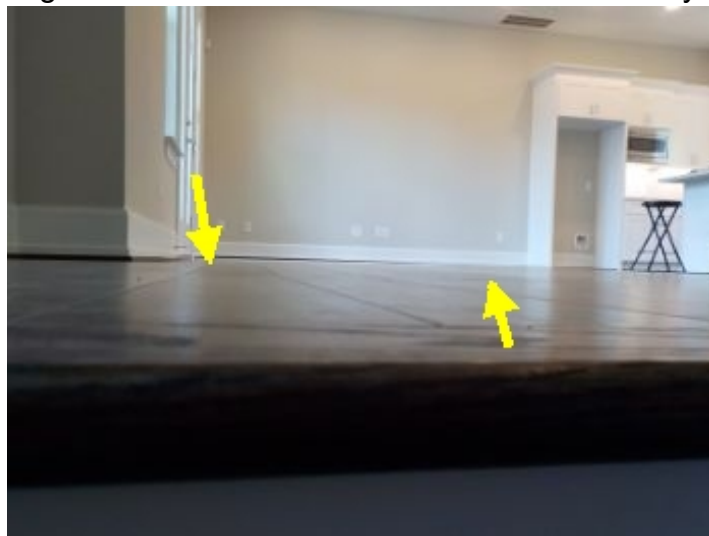
Den area flooring appeared to be visibly uneven.

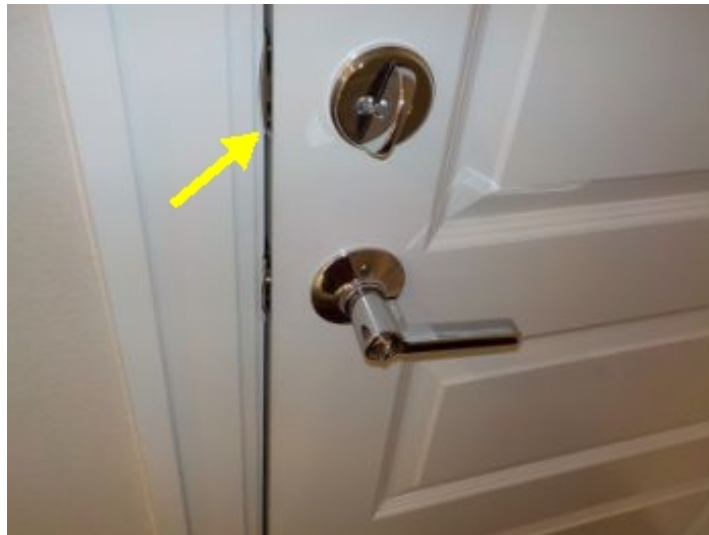
Door lock was not properly aligned at the garage entry door. Lock was inoperable.

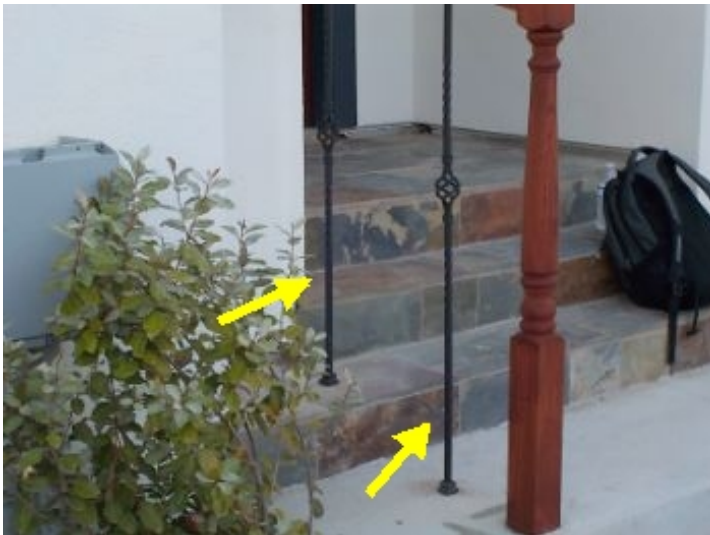
Stair rails were more than 4" apart at the front porch.

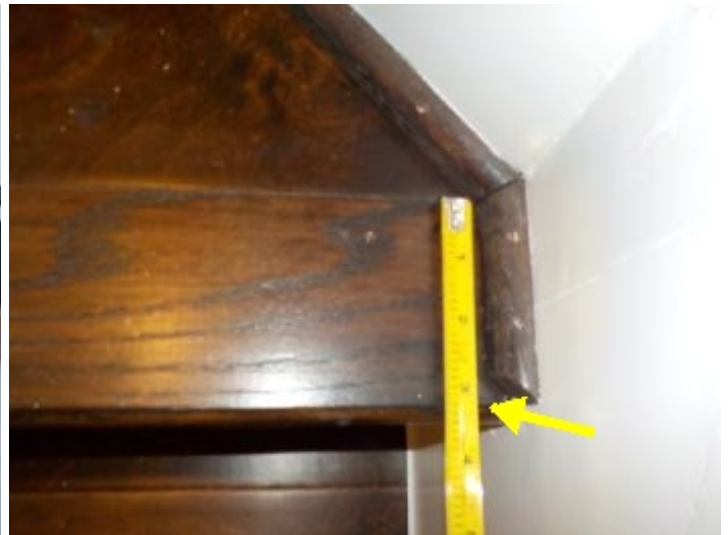
Multiple stairway treads were less than 6" at interior turn.

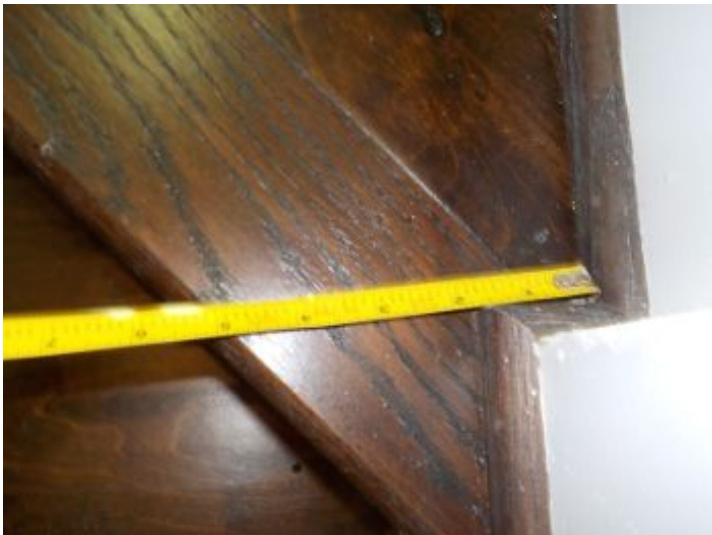
Multiple stairway treads were less than 6" at interior turn.

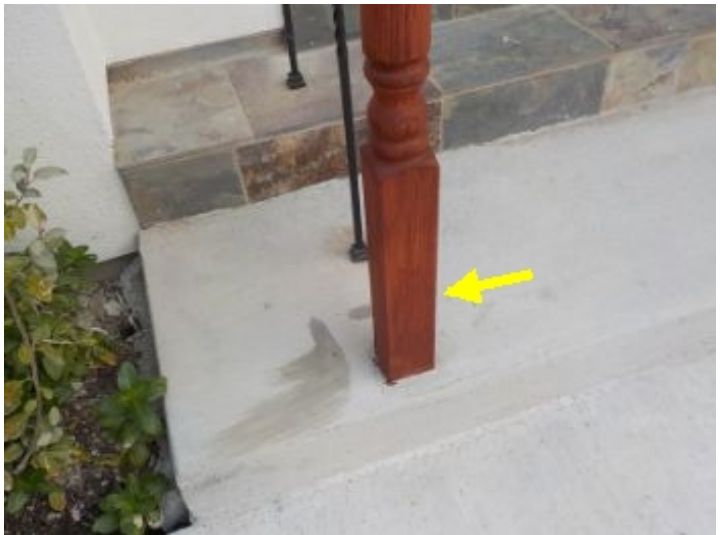
Handrail was loose at the front porch.

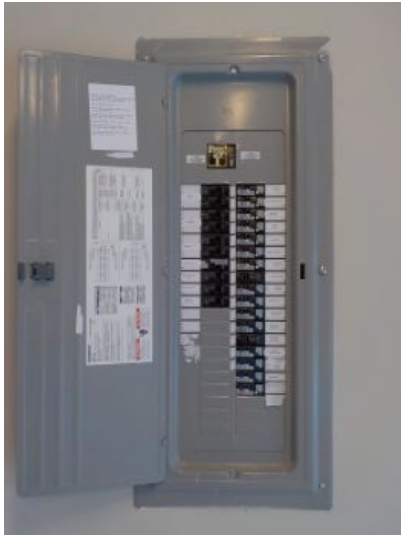
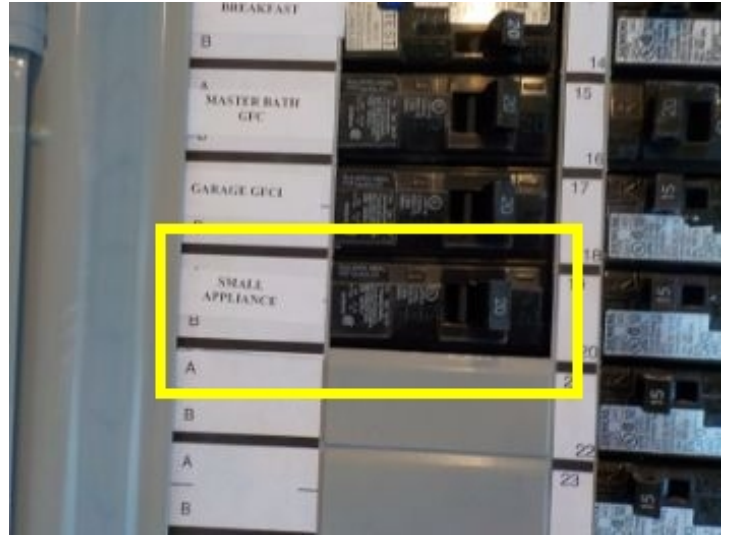
- AFCI breakers may not have been completely installed. There was a 20 amp breaker labeled for small appliances that was not AFCI protected. Per the 2015 NEC (National Electric Code) AFCI breakers are required in most 15 and 20 amp circuits supplying power to household outlets and devices including kitchens and laundry room. They are not typically required in exterior, garage or bathroom circuits. Typically homes prior to 2006 did not have any form of AFCI protection as a part of the original construction. Recommend further evaluation by a qualified licensed electrician.

AFCI breakers may not have been completely installed. There was a 20 amp breaker labeled for small appliances that was not AFCI protected.

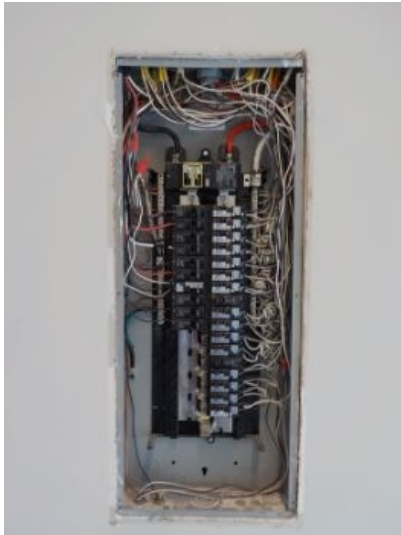
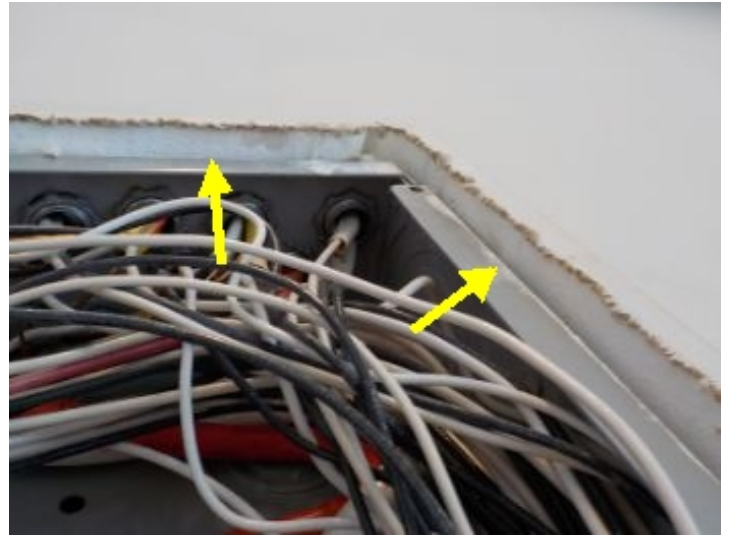
- The dead front cover was not properly flushed with the panel enclosure. The panel enclosure appeared to be recessed well behind the drywall creating a gap between the enclosure and dead front cover. Manufacturer's recommendations should be consulted. Typically, per common building code, there should be a maximum gap of only 1/4".

The dead front cover was not properly flushed with the panel enclosure. The panel enclosure appeared to be recessed well behind the drywall creating a gap between the enclosure and dead front cover.

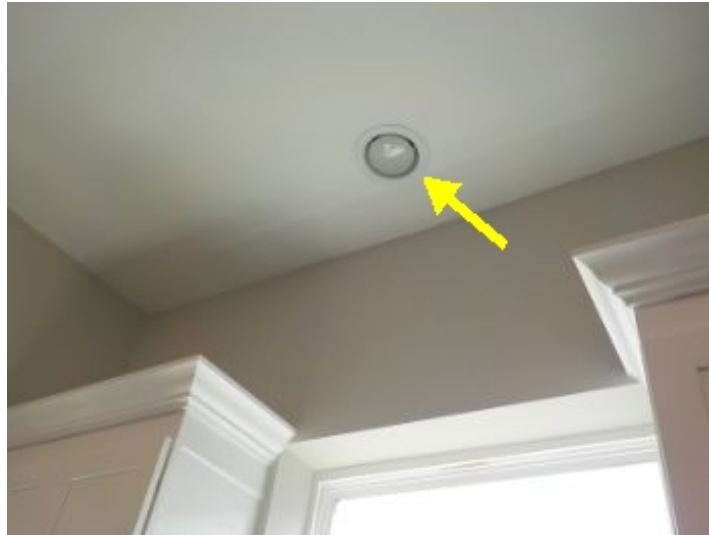
Fixture did not appear to be functioning over the kitchen sink.

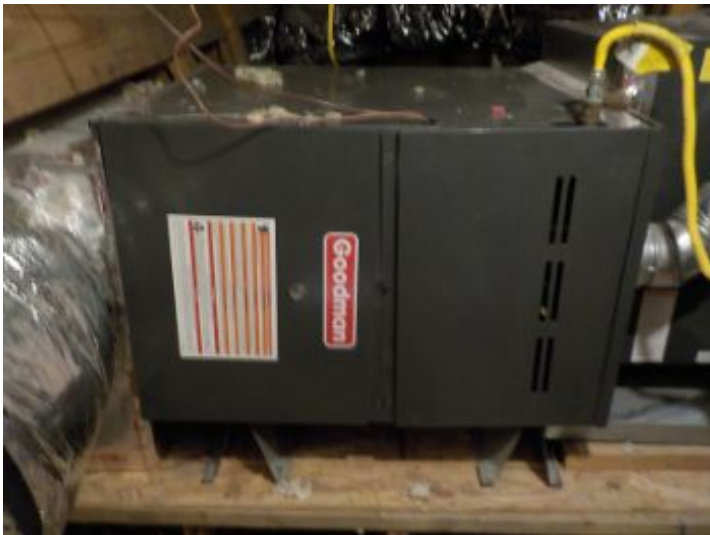
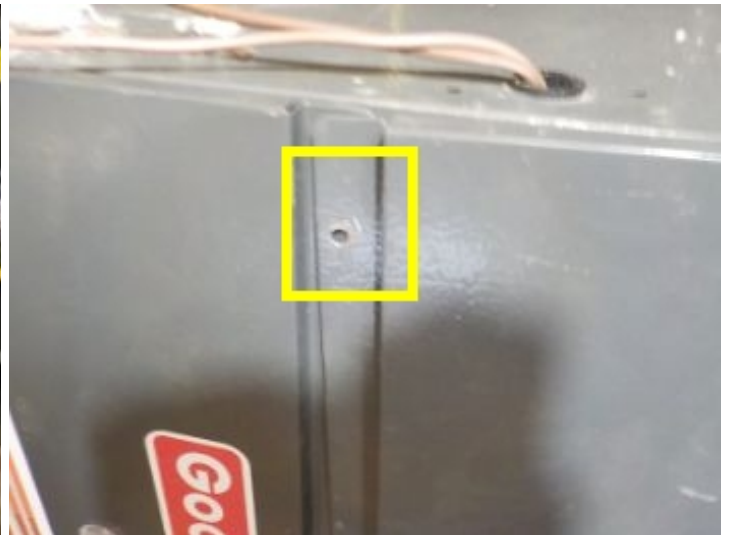
Furnace access door was missing a fastener.

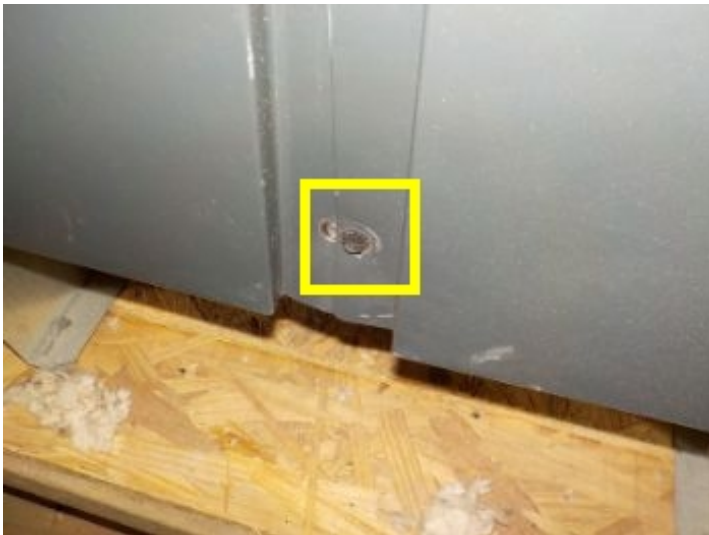
Furnace access door fastener was too tight to remove.

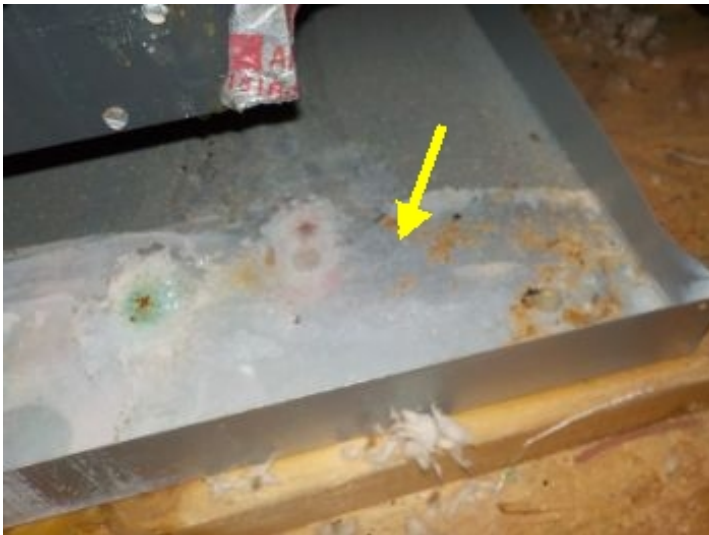
Evidence of possible water stains were observed in the secondary evaporator drain pan.

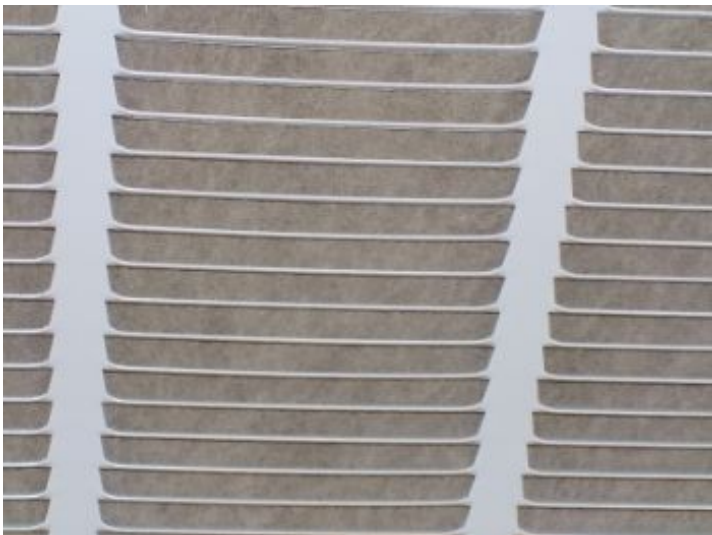
Air filters were dirty.

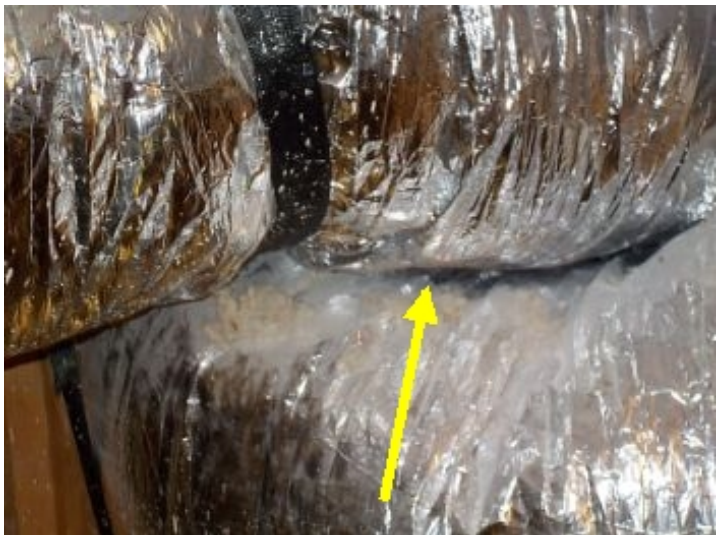
Some air ducts did not appear to be properly supported and were laying on insulation and/or contacting other ducts.

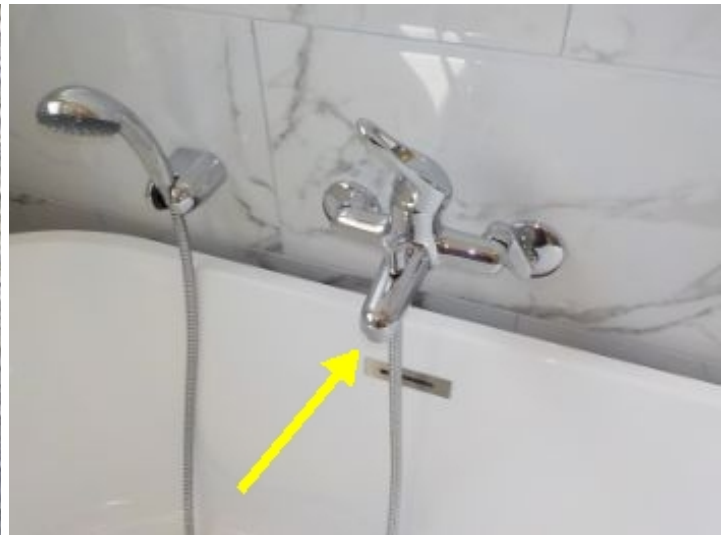
Hot side water supply was inoperable at the master bathroom tub.

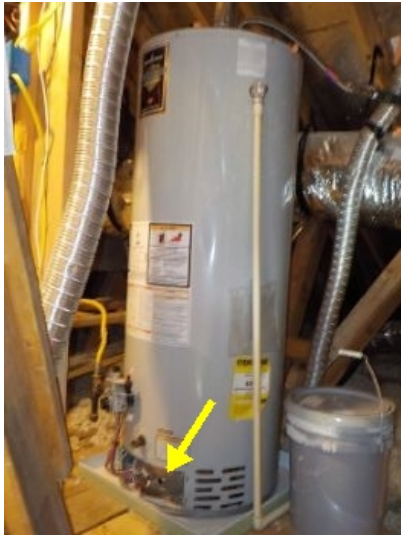
Outer burn shield was not installed.

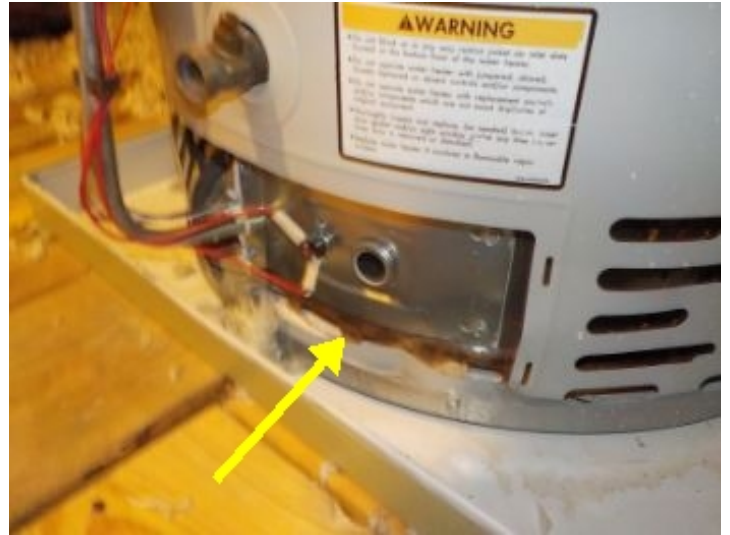
Unit showed signs of rust at the bottom.

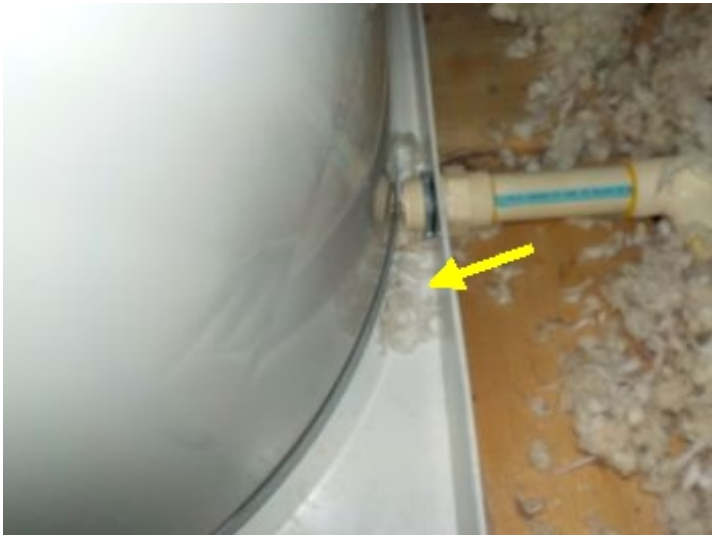
There was debris in the water heater drain pan.

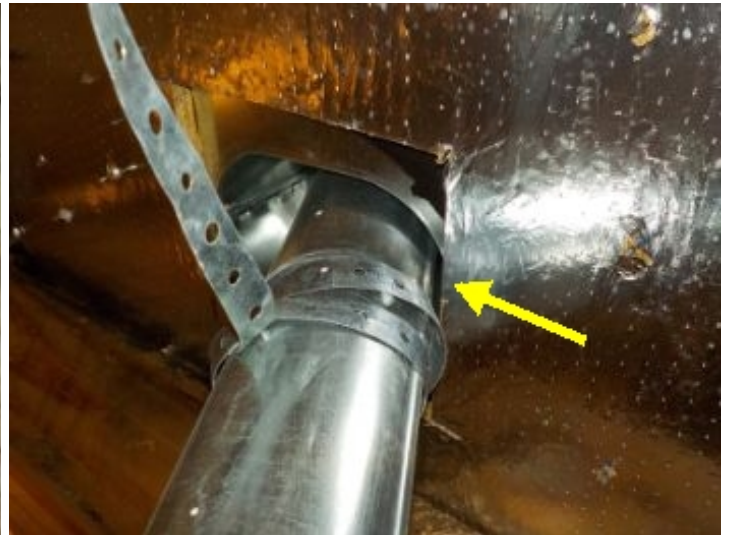
Water heater flue was not proper distance from combustibles in attic. It was too close to the roof decking.

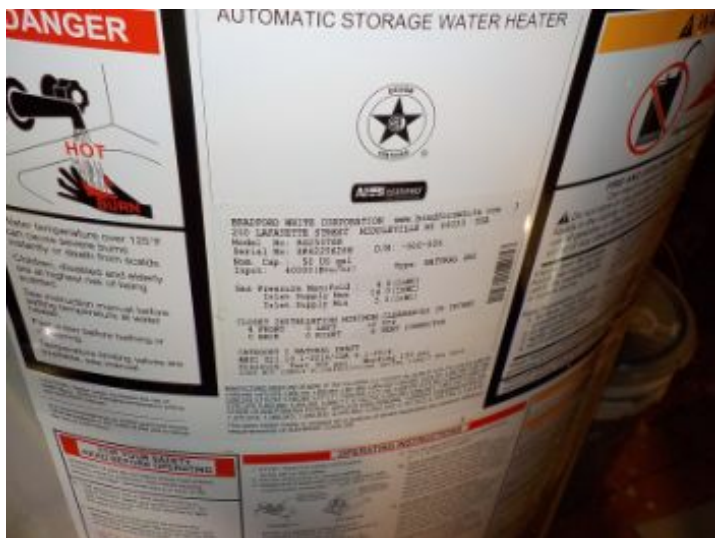
Water heater was inoperable at the time of inspection.

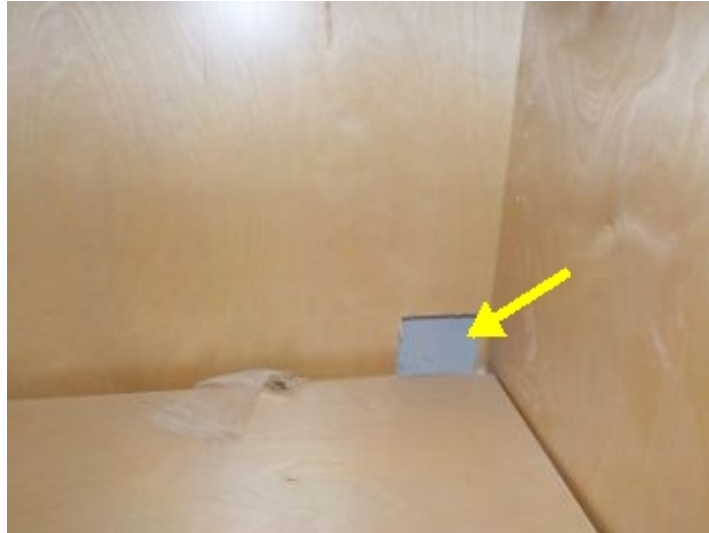
No gas shutoff valve was located at stove connection.

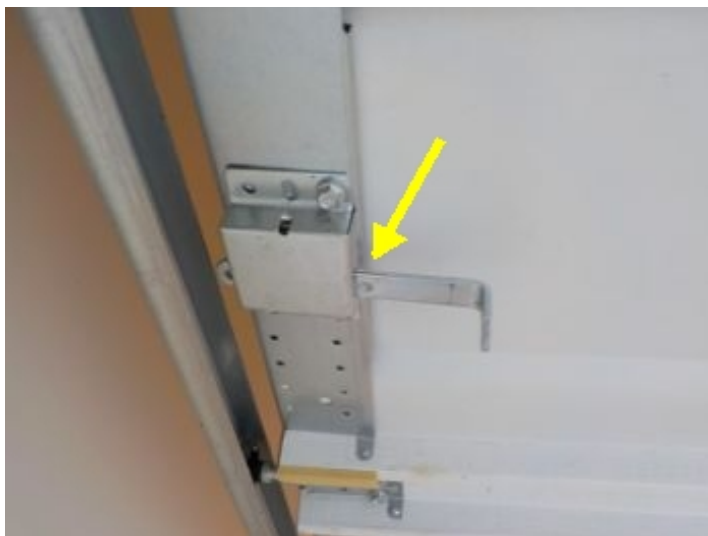
Door lock should be disabled since opener is present.

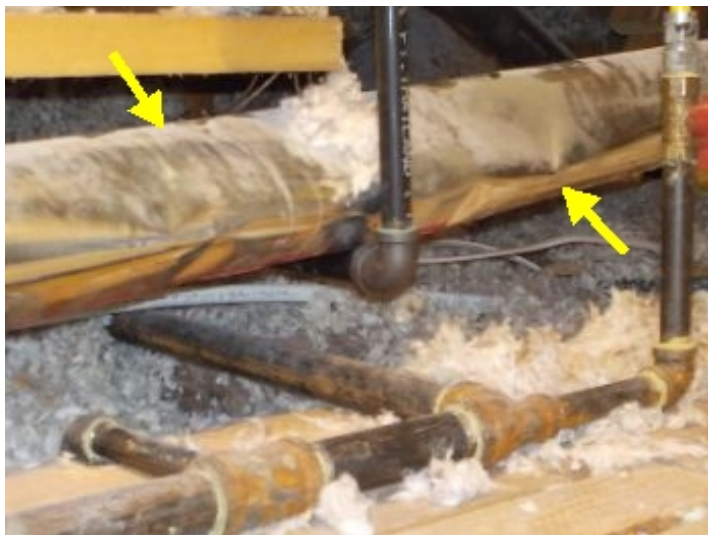
Dryer vent duct was damaged in the attic.
