NationSpec Home Inspection

7027 Brockington Dr, Katy, TX 77494

PROPERTY INSPECTION REPORT

Concerning: 7027 Brockington Dr, Katy TX, 77494
 (Address or Other Identification of Inspected Property)

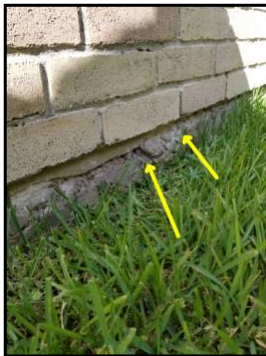
A.2. Recommend sealing all honeycombing or extrusions using an approved material with an epoxy bonding agent. These areas can corrode and create gaps inside the foundation wall where moisture and insects can potentially enter.

Right side, honeycombing

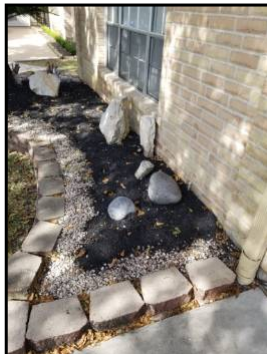
B.2. Grading is too high in areas (see photos). IRC R404.1.6 Height above finished grade. Concrete and masonry foundation walls shall extend above the finished grade adjacent to the foundation at all points a minimum of 4 inches (102 mm) where masonry veneer is used and a minimum of 6 inches (152 mm) elsewhere.

Front, grading is too high

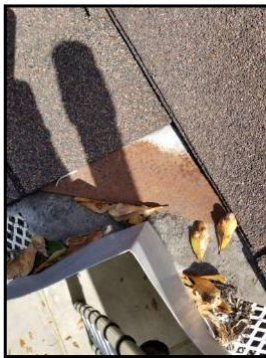
Front, exposed valley flashing is rusted needs paint

C.6. All exposed flashing, vents, and/or raw metal should be painted to prohibit any further rust and/or corrosion

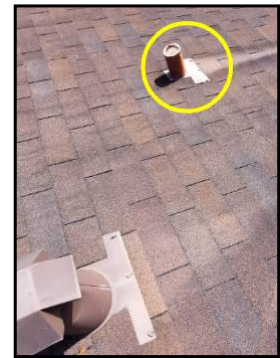
Exposed nails have been resealed, recommend painting vent

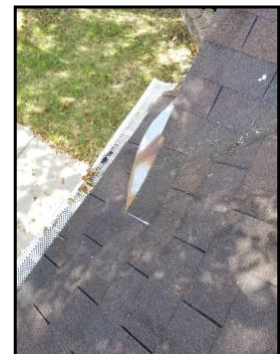
Front, exposed flashing/rusted needs paint

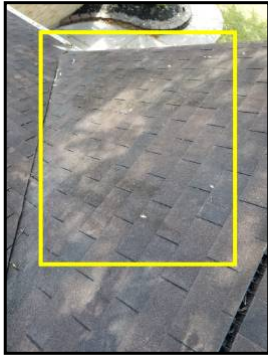
C.4. Grauale loss observed at areas. See photos.

Front, granule loss

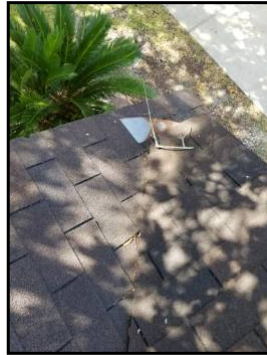
Front exposed flashing is rusted and needs paint

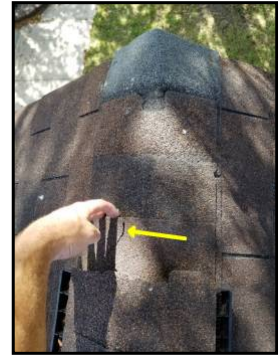
C.3. Some shingles appear loose, damaged, ripped, and/or lifting at one or more areas

Front, ripped shingle

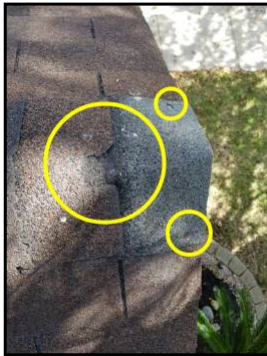
Front, damaged shingle exposed nails

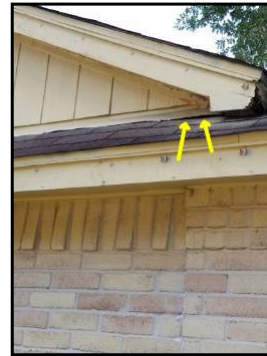
Left side, headwall flashing should be re-seated and sealed

C.8. Flashing repairs and/or sealant needed in areas.

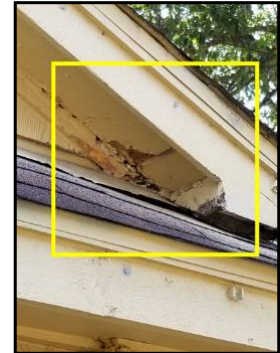
Left side, deterioration to wood

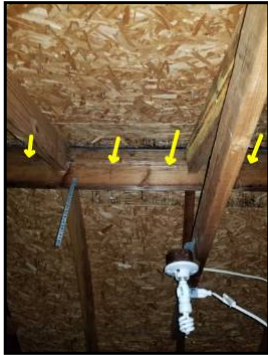
D.12. Top ridge board was observed to split and should be further reviewed/repared

Detail split ridge board

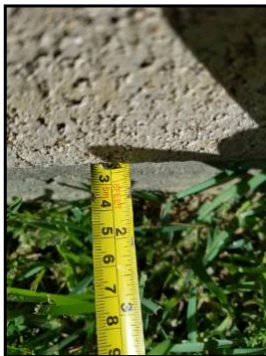
E.7. The ACI standards document for this is ACI 117-90, Standard Specifications for Tolerances for Concrete Construction and Materials. This is a very extensive standards document and for the cases of the foundation ACI specifies that the foundation should be constructed so that the "lateral Alignment" of the foundations footer will cause no more than a 1/2 hangover of the brick.

Right side, brick overhangs brick ledge by 1"

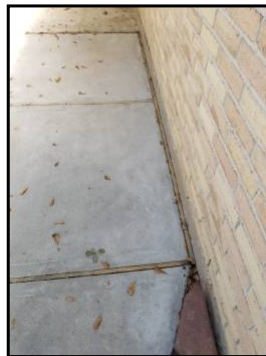
Front, form board left installed conducive conditions for WDI

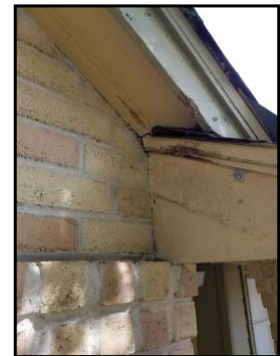
Front, needs caulk

E.1. Elastomeric caulking improvements are recommended between the exterior veneer and the window frames. See photos.

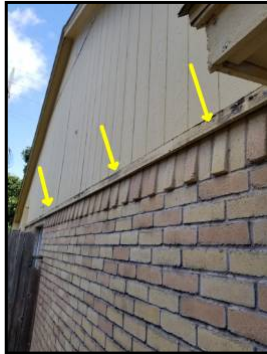
E.3. It was observed that one or more areas of the exterior wood surfaces was in need of repair and/or painting

Left side, wood trim is deteriorated and needs repair

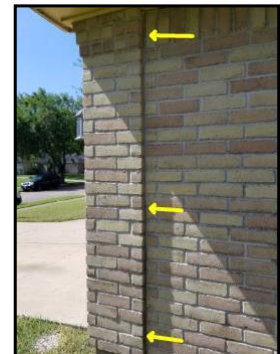
E.6. Mortar improvements/brick pointing is required on the exterior masonry veneer. See photos.

Right side, separation crack needs mortar pointing

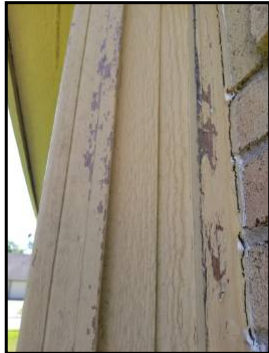
Right side, paint peeling

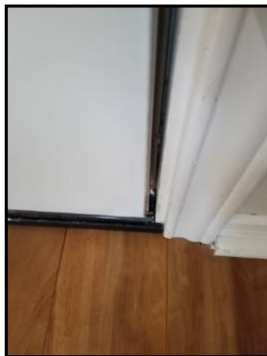
G.2. Exterior doors at one or more locations were observed to need proper weatherstripping and/or bottom sweep

Front door, daylight visible

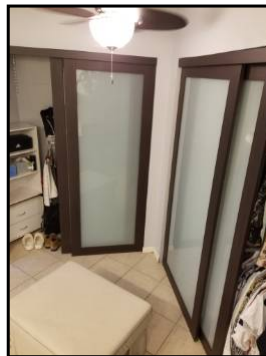
G.4. One or more closet doors were observed to not have a bottom guide/track

Master closet doors are missing bottom guides/tracks

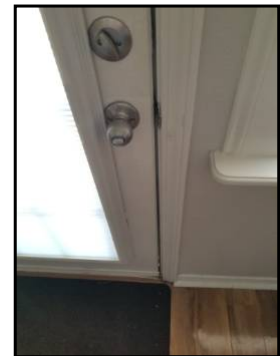
G.5. One or more doors needs a strike plate adjustment

Rear door, daylight visible and deadbolt strike plate needs adjustment

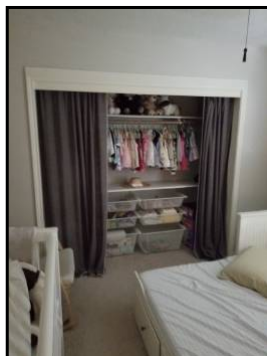
G.3. An interior door was observed to be missing

Back left bedroom, missing closet doors

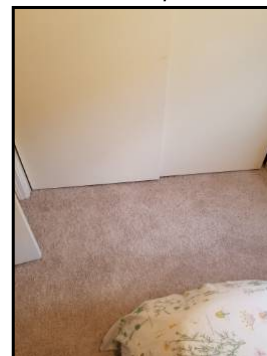
Left side middle bedroom, closet doors have no bottom guide/track

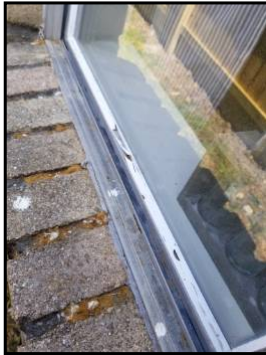
H.3. Weather stripping and/or glazing was either damaged and/or missing at one or more windows

Left side, window glazing is damaged

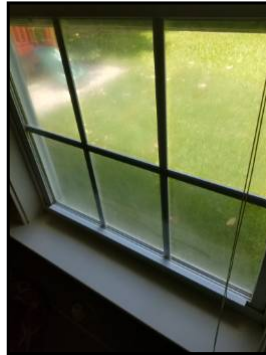
H.1. One or more of the thermal pane windows were observed to have lost their seals. This has resulted in condensation or a fog like film to develop between the panes of glass. The thermal pane windows are no longer functional as designed when the seal is lost and replacement may be necessary

Master bedroom, lost seal

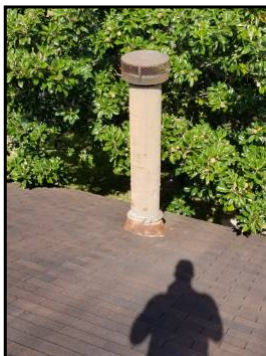
Chimney is rusted should be painted

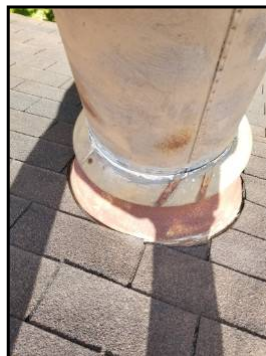
J.3. It was noted that the storm collar needs to be properly sealed and painted

Storm collar needs sealant

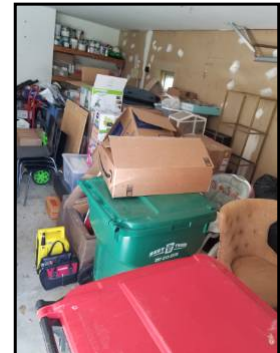
Garage, restrictions

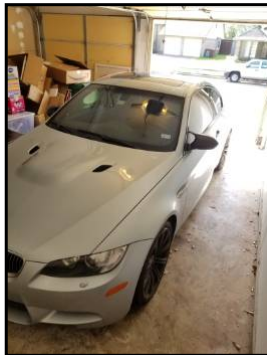
Garage, restrictions

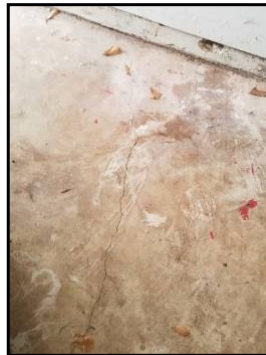
Garage, crack

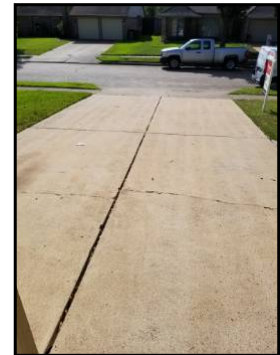
K.3. Cracks were visible in the driveway and rear patio that appear larger than normal settlement cracking and should be monitored

Driveway, cracks

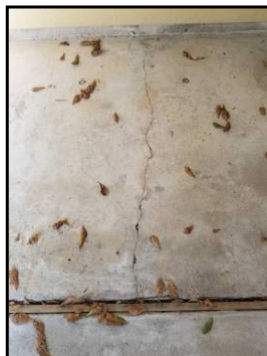
Front porch, crack

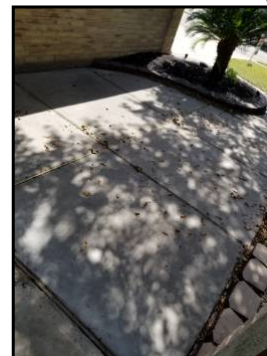
Front patio area, not original construction

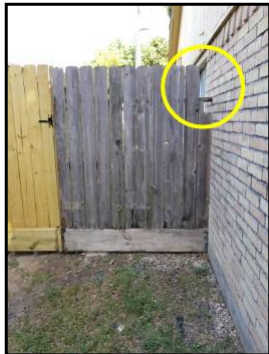
L.1. One or more wood pickets damaged and/or missing in fence line

Front left, damaged picket

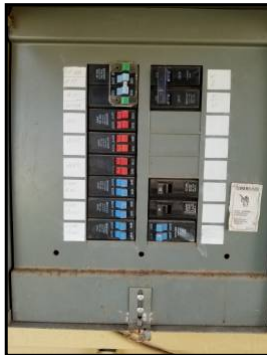
Rear, 100 amp panel, not properly labeled

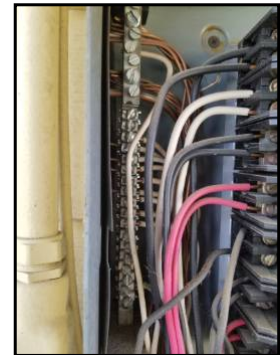
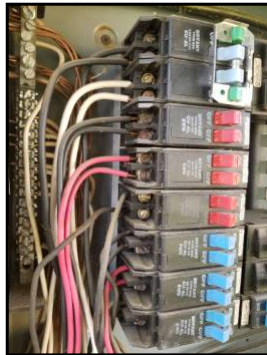
A.5. Some level of corrosion/rust was observed in the service panel recommend further review

Corrosion/rust observed on breaker screw sets

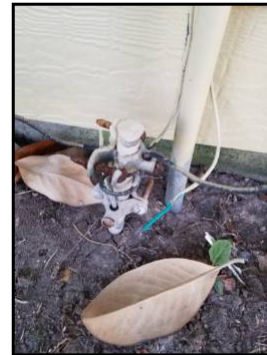
A.6. The grounding connector on the ground rod is loose and should be corrected

Grounding rod, some connections appear to be loose

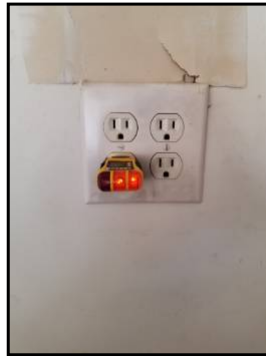
Garage, no GFCI protection and receptacle is loose in wall

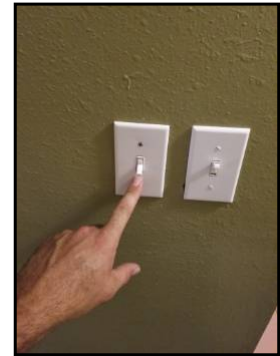
Laundry, unknown switch function

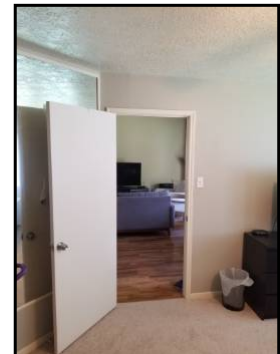
- B.11. Inadequate smoke alarm coverage was observed and it is recommended that additional smoke detectors and CO2 detectors be installed in accordance with current building standards. The NFPA {National Fire and Protection Agency} recommends one smoke alarm on each level, every bedroom and adjoining hallway, above stairwells and a CO2 detector in the garage and outside each bedroom with fuel fired appliances. A primary fire extinguisher is recommended on each level with a UL rating of 2-B:C.

Master bedroom, missing smoke alarm

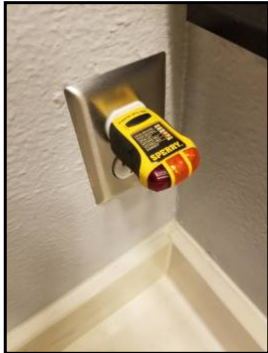
- B.7. This may be an as built condition but is required as of 2004 per the NEC. GFCI protection is required on 15A/20A circuits providing power to kitchens, bathrooms, garages, laundry rooms, exterior receptacles, pools, spas and whirlpool tubs.

Master bathroom, no GFCI protection

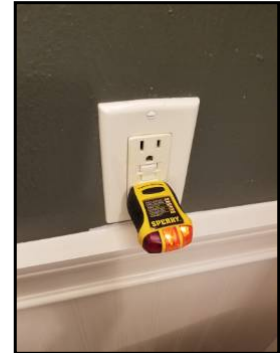
Hallway bathroom, GFCI is non-functional

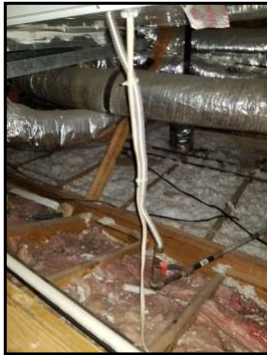
A.2. The flex gas supply was observed entering the heating unit enclosure and is not a safe and acceptable practice under current mechanical standards. Only black rigid gas pipe shall enter the heating unit cabinet

A.3. Missing sediment trap. IRC G2419.4 (408.4) Sediment trap. Where a sediment trap is not incorporated as part of the appliance, a sediment trap shall be installed downstream of the appliance shutoff valve as close to the inlet of the appliance as practical. The sediment trap shall be either a tee fitting having a capped nipple of any length installed vertically in the bottom-most opening of the tee or other device approved as an effective sediment trap.

Gas valve, no sediment trap, flex gas line enter unit, romex is properly secured to housing

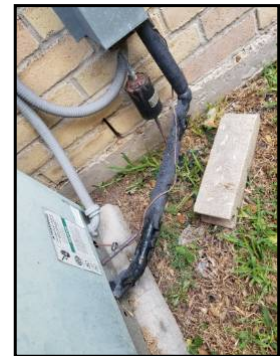
B.5. Refrigerant lines are missing insulation at the outside unit

Missing insulation on refrigerant line

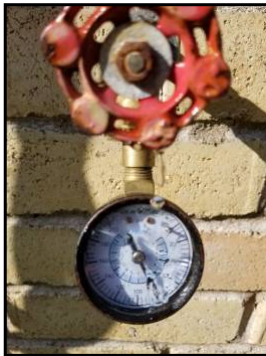
A.1. Hose bib handle leaks when turned on and should be repaired

Right side, hose faucet handle leaks when turned on

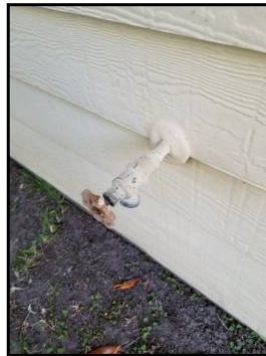
Rear, no backflow preventer

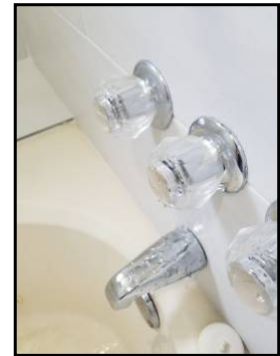
A.3. The tub spout and/or diverter was leaking at the time of inspection in both bathrooms

Master bathroom, shower/tub diverter handle leaks

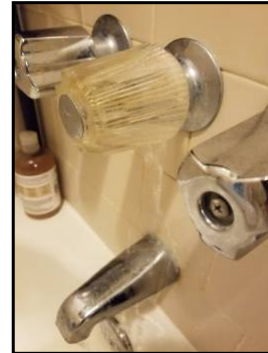
Hallway bathroom, shower/tub diverter handle leaks

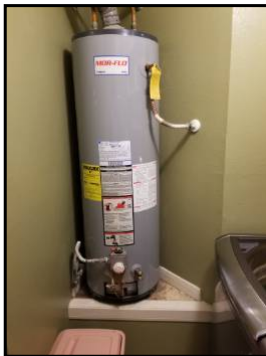
C.5. Water heater was manufactured in 1996. The water heater appears to be reaching the end of its serviceable life. The typical life expectancy and/or operational life of a water heater is approximately {10} years depending on usage and maintenance

Laundry, American/MOR-FLO 40 gallon gas water heater

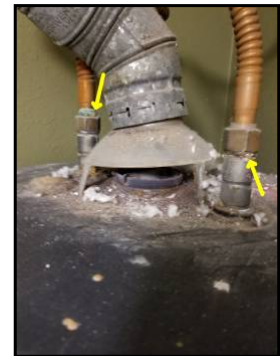
Some rust/corrosion on couplings

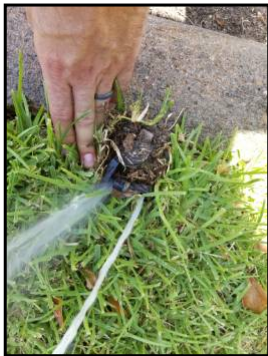
Zone 1, broken sprinkler head

A.3. The sprinkler system requires further evaluation by a licensed irrigation contractor

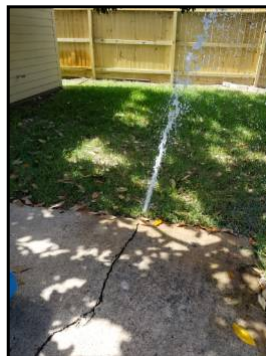
Zone 4, broken sprinkler head

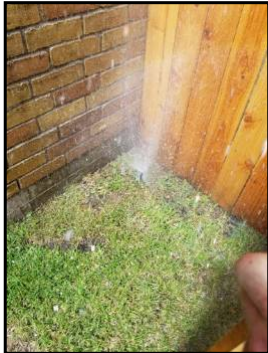
Zone 5, broken sprinkler head
