**STRUCTURAL ENGINEERING FOUNDATION PERFORMANCE EVALUATION**

**18106 Quiet Grove Court  
Humble, Texas**

Monday, August 14, 2017

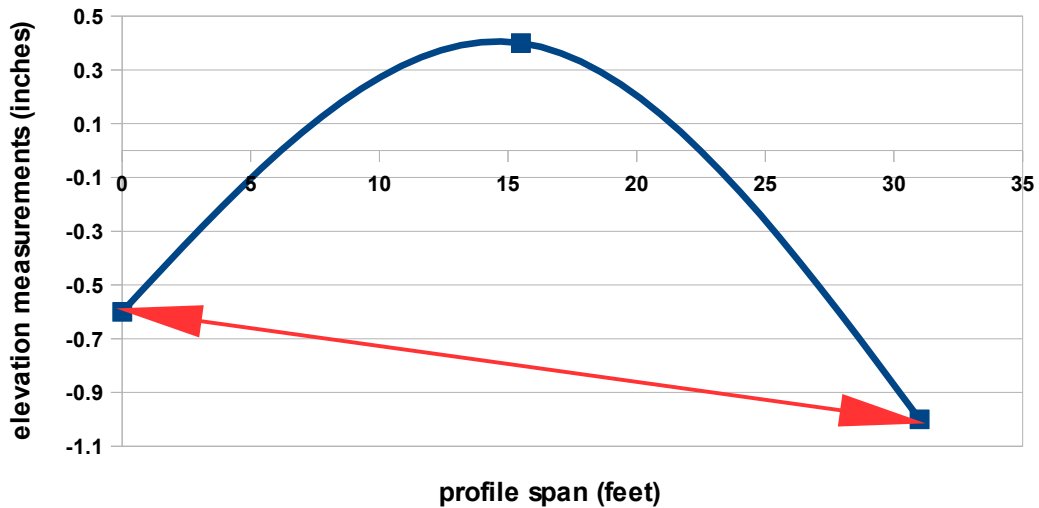
**Middle Transverse (Front to Back) Deflection/Tilt Profile**

profile span (feet)	deflection (inches)	deflection ratio (over 360)	tilt (%)
31	1.2	<b>1.16</b>	0.11

**dominant distortion mode**  
**high center lift with tilt**

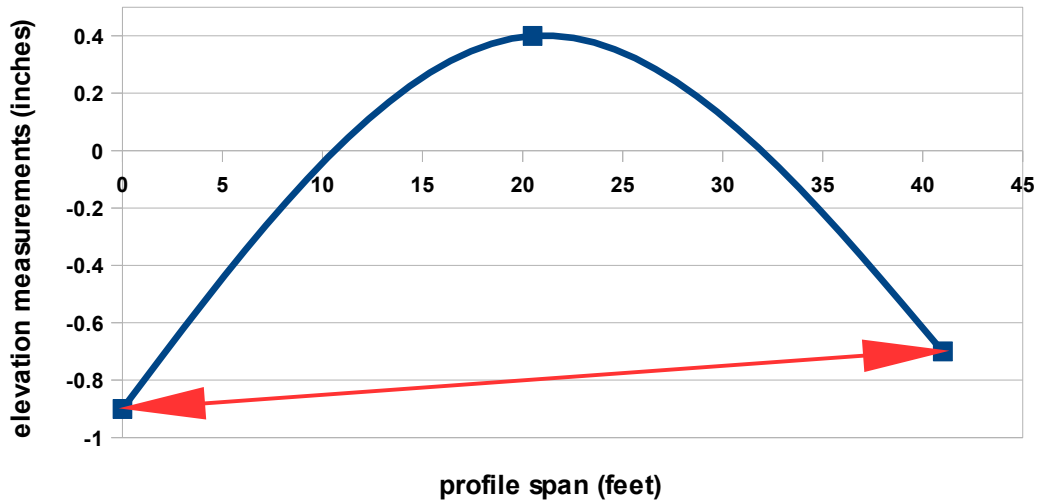
**Center Longitudinal (Left to Right) Deflection/Tilt Profile**

profile span (feet)	deflection (inches)	deflection ratio (over 360)	tilt (%)
41	1.2	<b>0.88</b>	0.04

**dominant distortion mode**  
**high center lift with tilt**

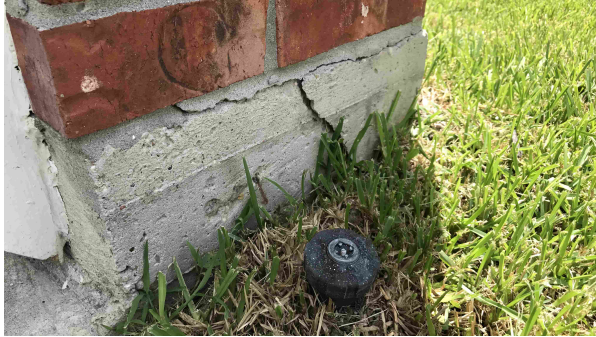
- **Wedge Crack:** The wedge crack at the front right corner of the foundation was caused by differential thermodynamic expansion and contraction of the brick veneer and the concrete foundation. Wedge cracks are not indicative of poor foundation performance. If the wedge comes loose, non-shrink mortar should be used to patch the area so that the brick above remains fully supported.

Wedge crack at front right corner

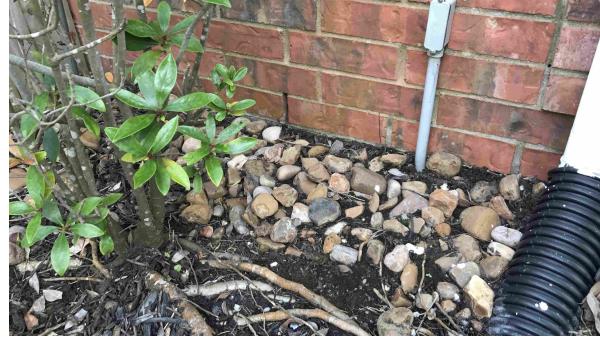
- **Low Slab Clearance:** There was inadequate slab clearance in some locations. This condition is conducive to moisture penetration. 4- to 6-inches of slab clearance is recommended.

Inadequate slab clearance; note the ground in contact with the brick
