PROPERTY INSPECTION REPORT

Prepared For: DENNIS & CATHY ORLANDO
(Name of Client)

Concerning: 15018 RIVERLET CT., CYPRESS, TX 77429
(Address or Other Identification of Inspected Property)

By: Stephen Perry, Lic #7854 05/12/2017
(Name and License Number of Inspector) (Date)

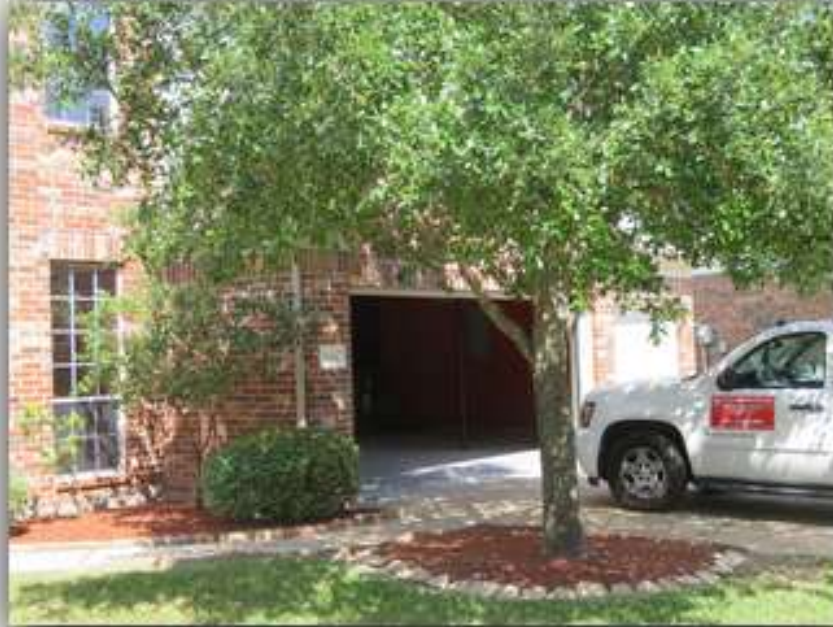
Trees/heavy foliage close to structure; recommend that the trees and shrubs close to the home have a root barrier system installed or roots pruned back between the home and tree. trees close to the home and large roots from trees and shrubs growing underneath the

home can affect foundation performance.

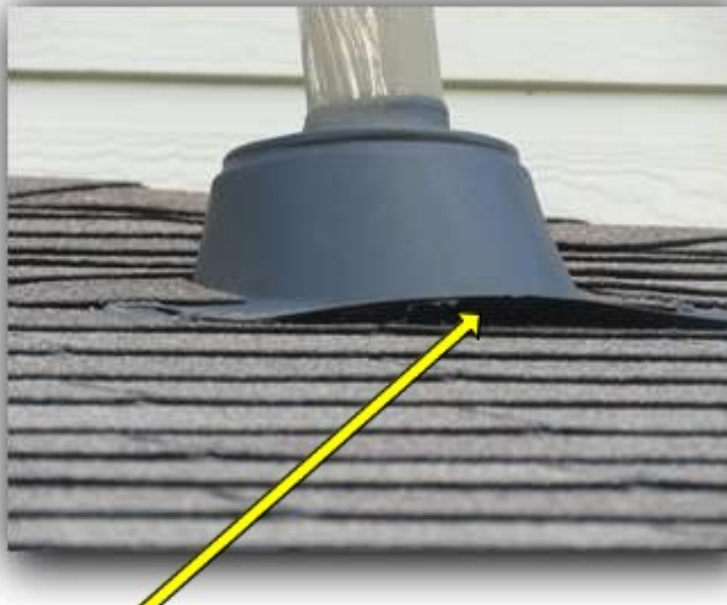
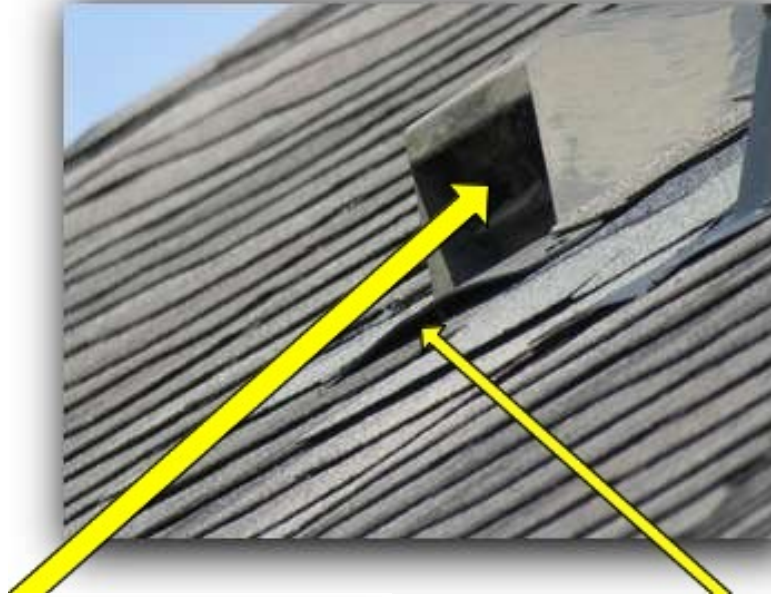
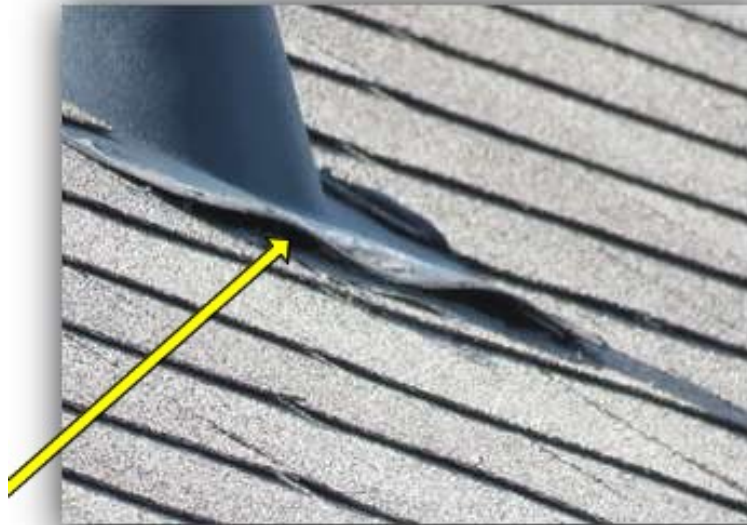
RAISED FLASHING/FLANGE ON THE PLUMBING VENT JACKS THAT

WERE NOT PROPERLY INSTALLED AND NEED TO BE PROPERLY SEALED DOWN TO PREVENT POTENTIAL ROOF LEAKS

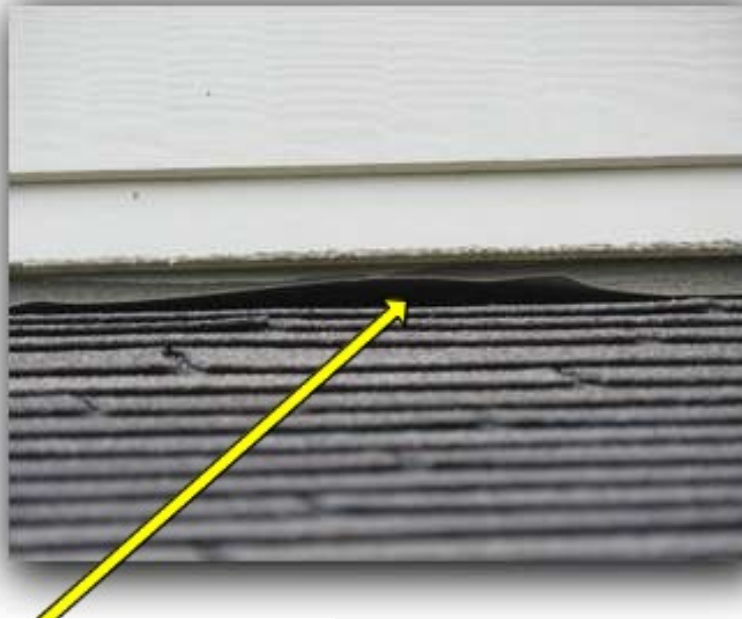
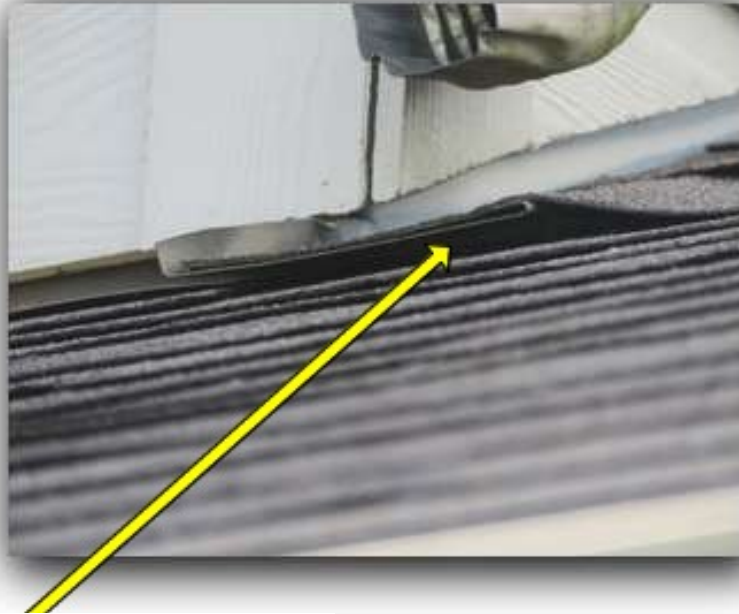
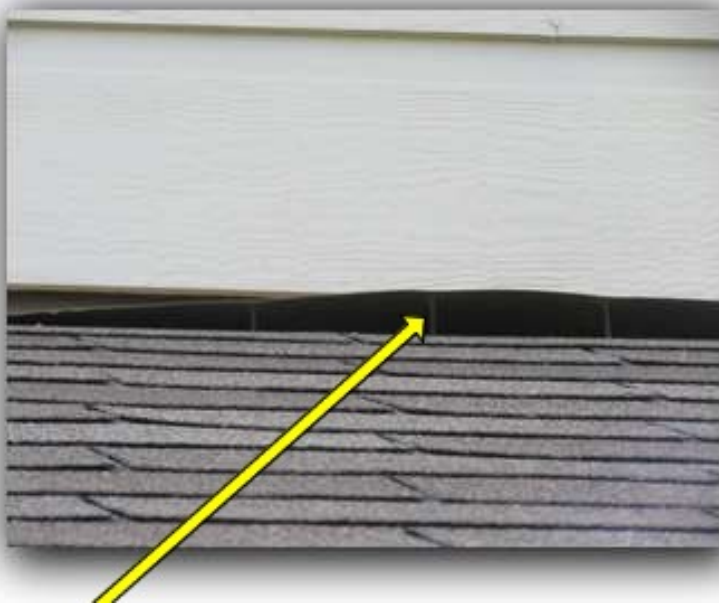
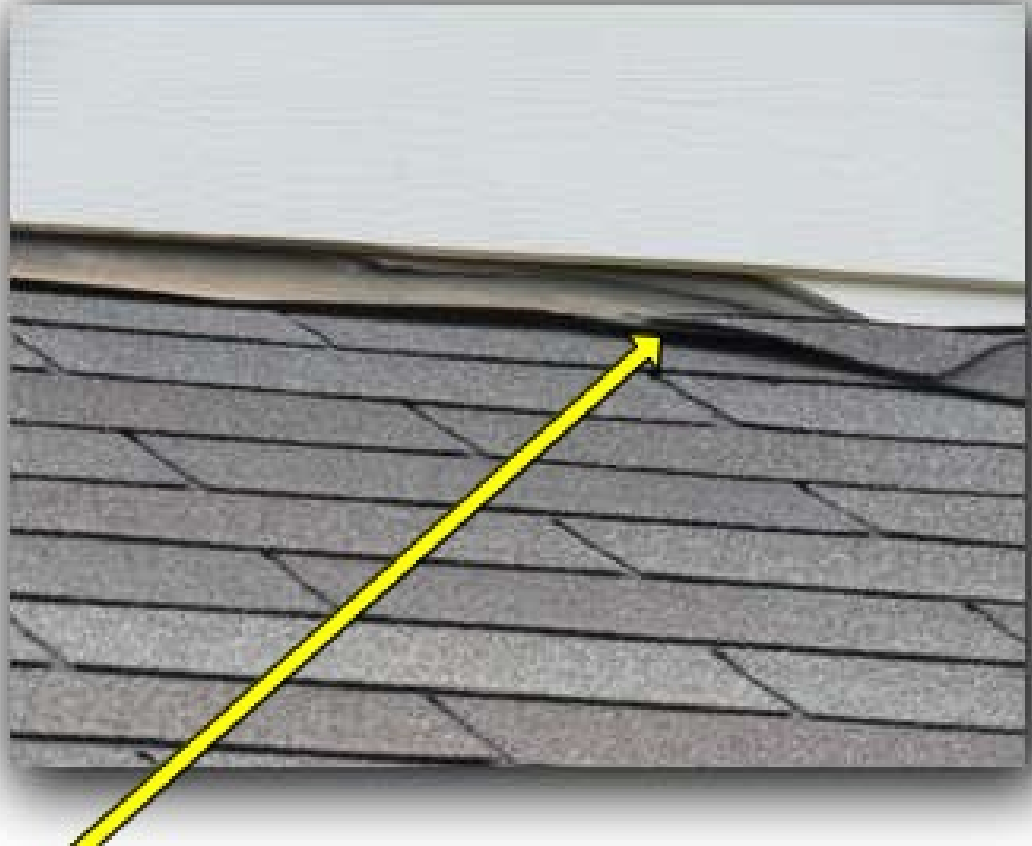
- **THERE IS SOME RAISED FLASHING AT THE UPPER WALL AND**

ROOF INTERSECTIONS THAT NEEDS TO BE NAILED AND SEALED DOWN TO PREVENT POTENTIAL ROOF LEAKS

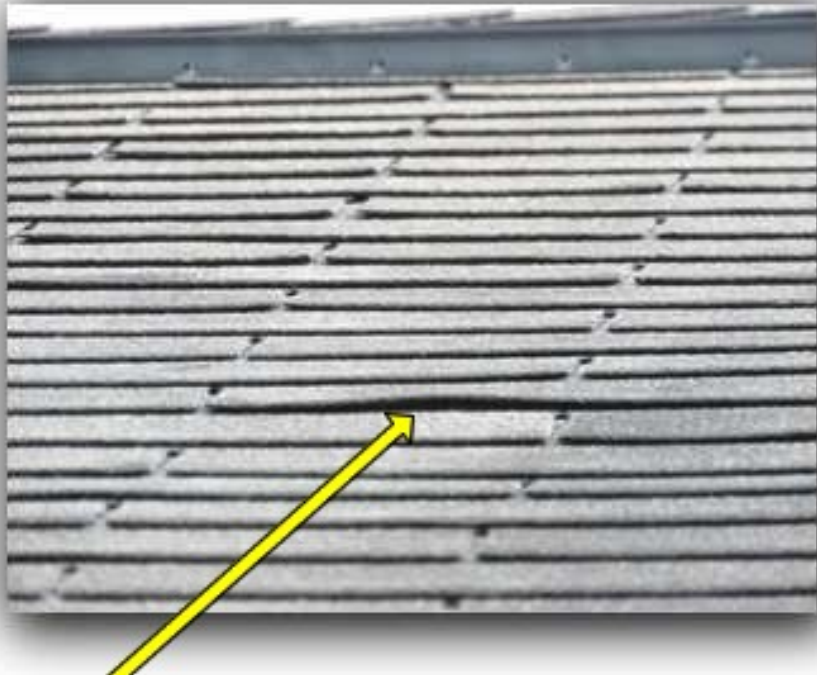
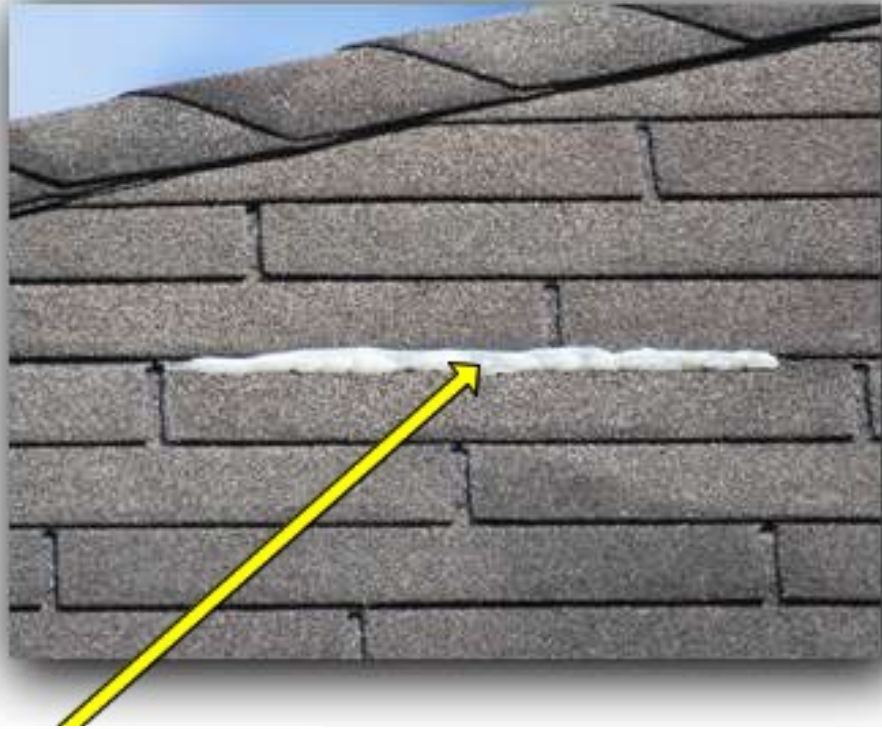
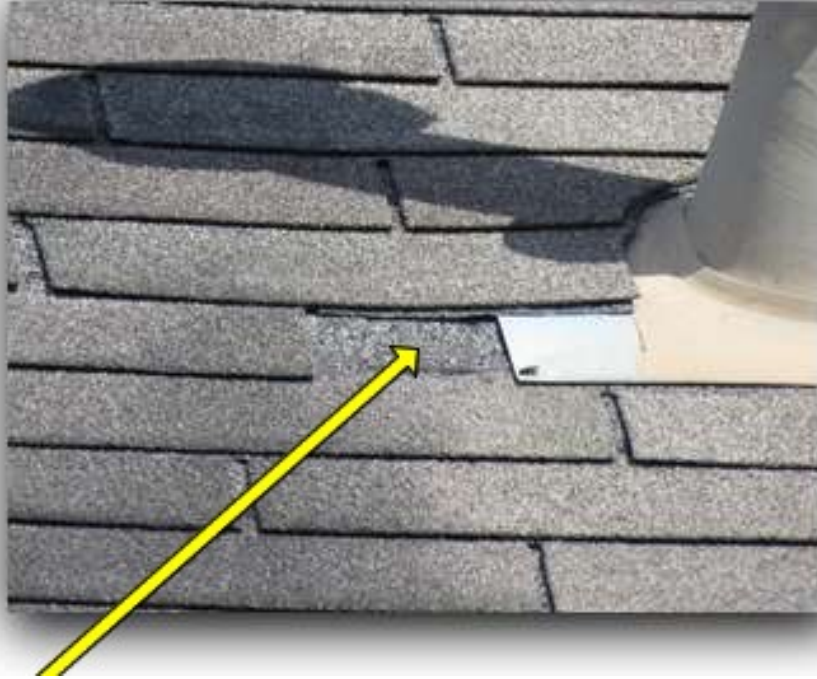
- **THERE IS SEVERAL RAISED SHINGLES IN VARIOUS LOCATIONS THAT NEEDS TO BE REPAIRED AND PROPERLY SEALED DOWN BY A ROOFING EXPERT**
- **DAMAGED/MISSING SHINGLE AND AN IMPROPER ROOF REPAIR USING SILICONE CALKING**

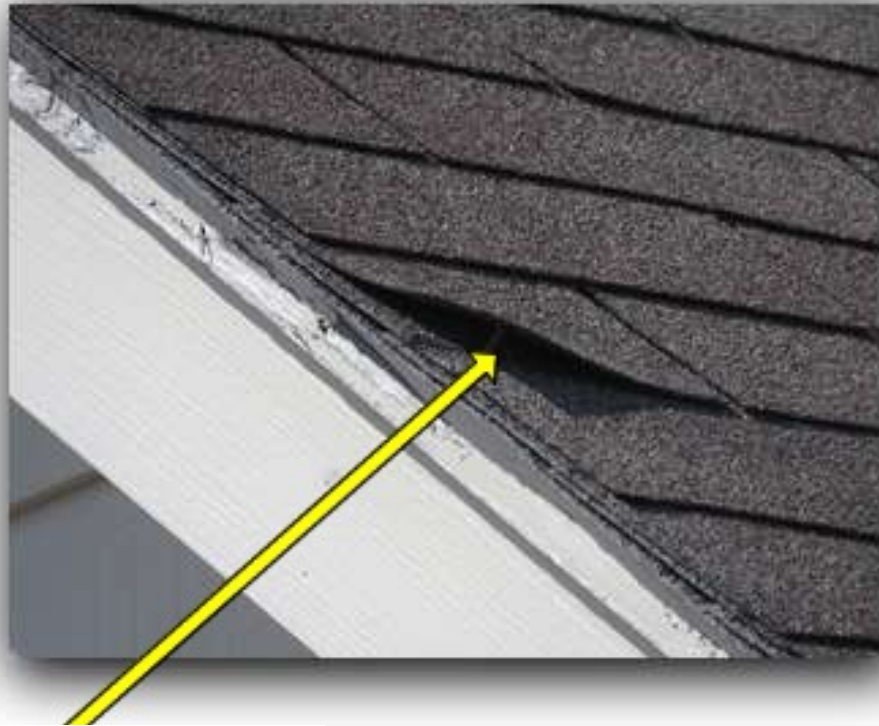
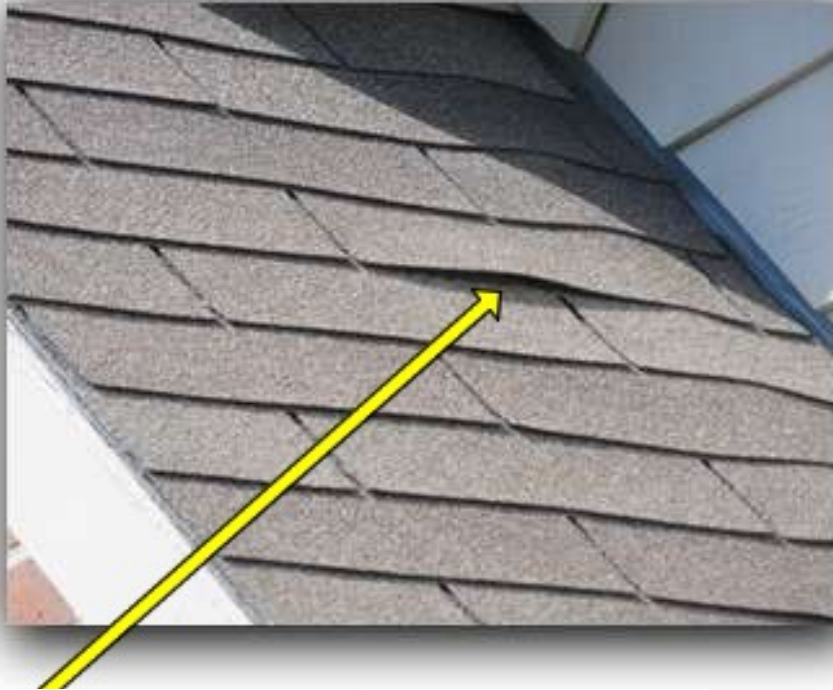
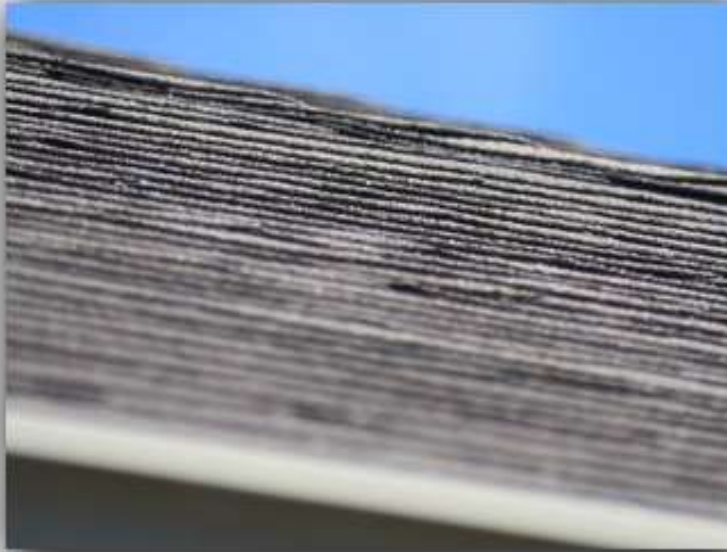
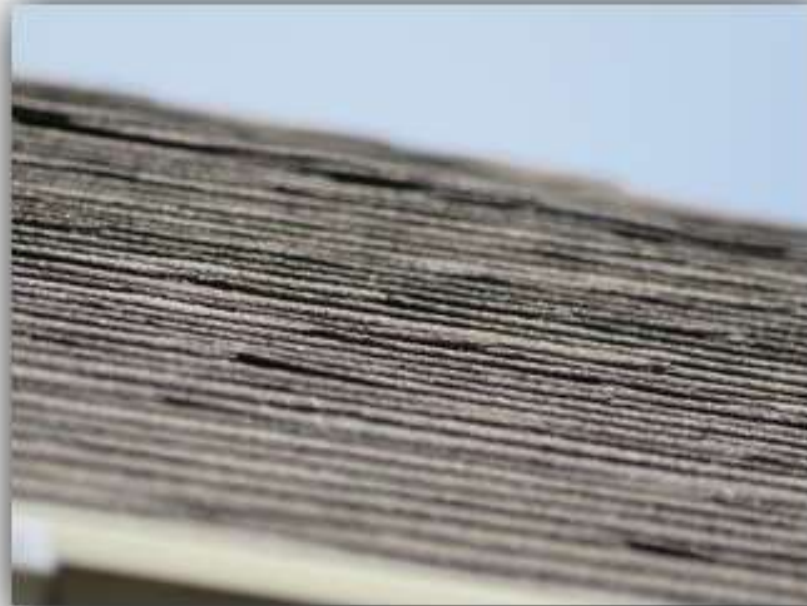
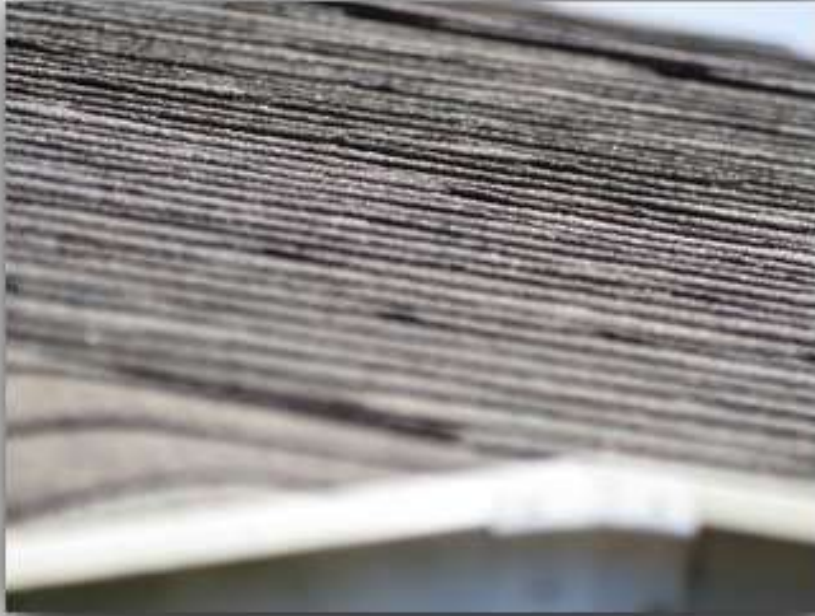
- **THERE IS SEVERAL RAISED SHINGLES IN VARIOUS LOCATIONS THAT NEEDS TO BE REPAIRED AND PROPERLY SEALED DOWN BY A ROOFING EXPERT; RECOMMEND EVALUATION OF THE ROOF BY A ROOFING EXPERT. APPEARS TO BE SOME WIND/STORM DAMAGE IN SOME LOCATIONS AS WELL WITH RAISED SHINGLES IN VARIOUS LOCATIONS.**

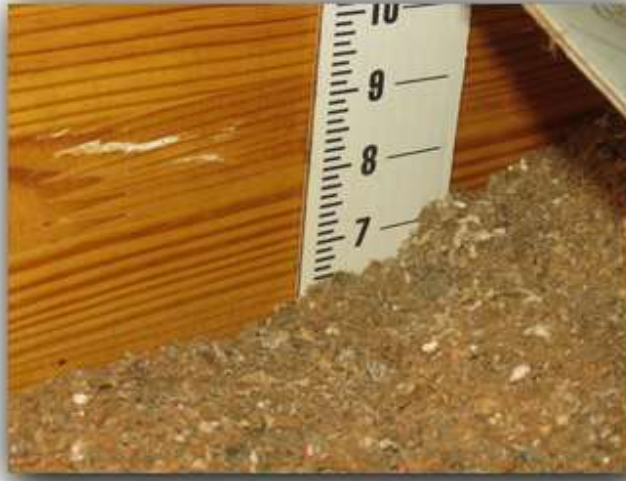
- **THERE IS LOW OVERALL DEPTH OF MISSING INSULATION ON THE ATTIC FLOOR THAT NEEDS ADDITIONAL INSULATION ADDED. (FOR INCREASED ENERGY EFFICIENCY IT WOULD BE RECOMMENDED TO HAVE A MINIMUM R-VALUE OF R-38 14-16 INCHES OF BLOWN-INSULATION, TOTAL DEPTH)**

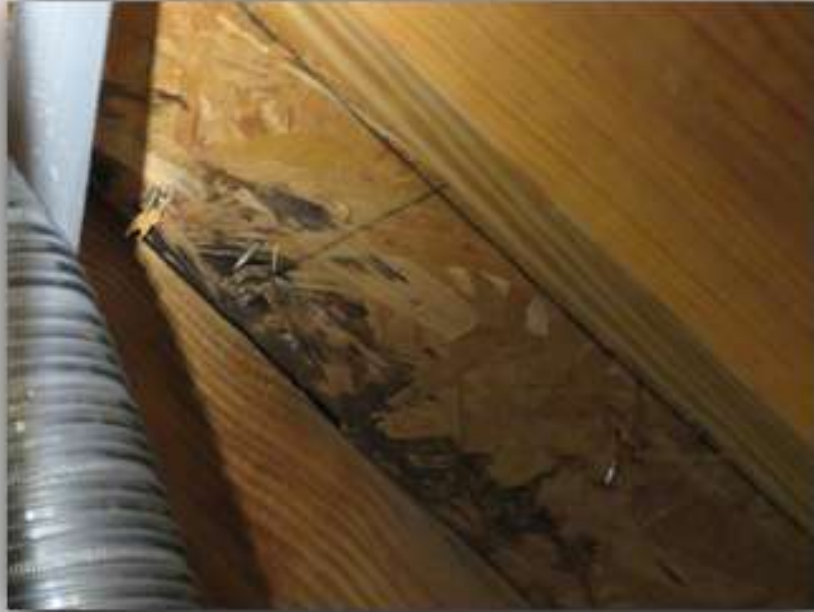
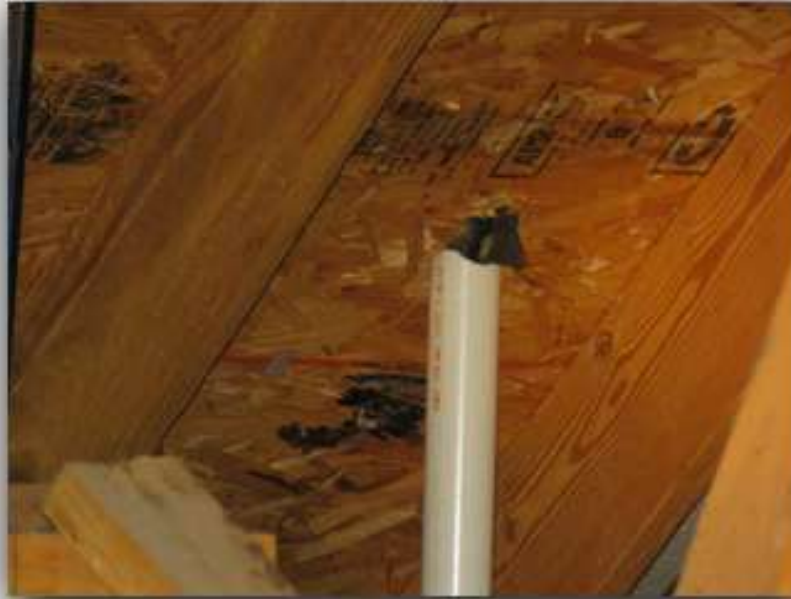
☑ EVIDENCE OF PREVIOUS ROOF LEAKS WITH WATER STAINS ON THE ROOF DECKING THAT NEEDS EVALUATION BY A ROOFING EXPERT AND POTENTIAL REPAIRS TO THE WATER DAMAGED OSB ROOF DECKING

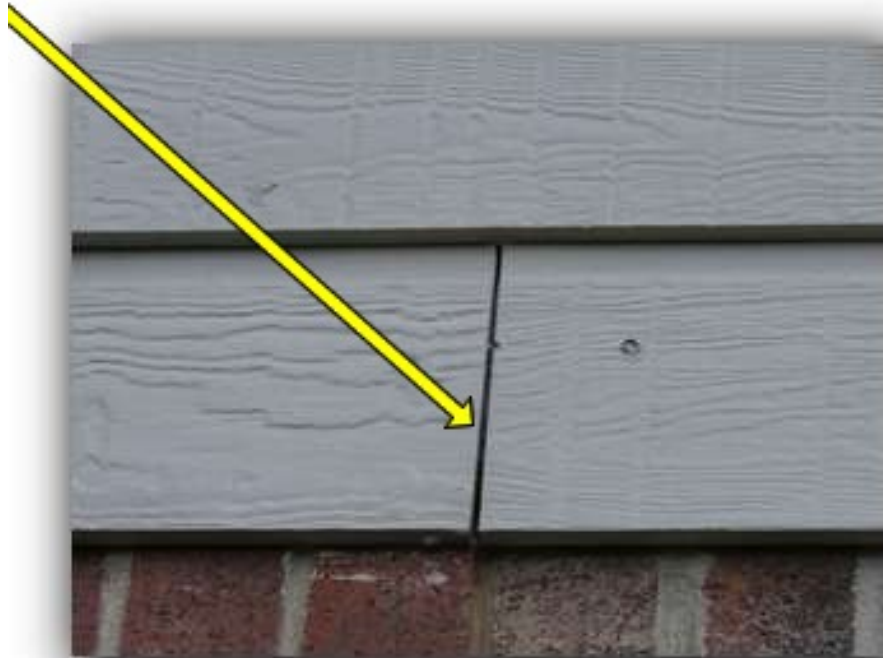
GAPS AT THE SIDING JOINTS THAT NEED TO BE CALKED

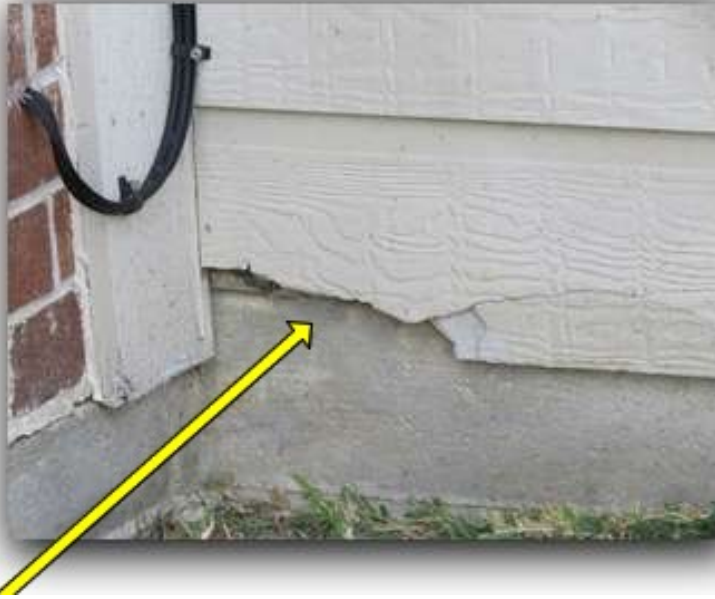
SOME DAMAGED CEMENT BOARD SIDING THAT NEEDS TO BE REPAIRED ON THE SIDE OF THE HOME

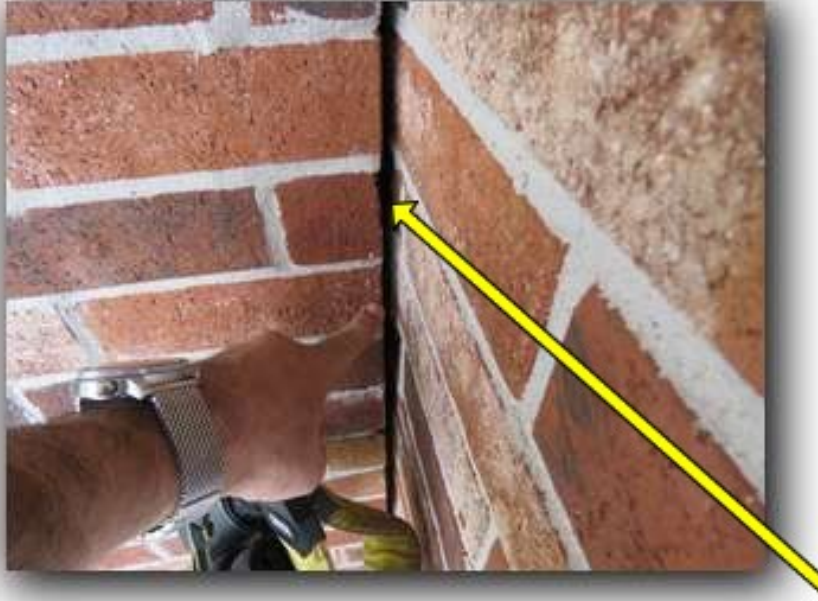
THE BRICK JOINTS NEED TO BE CALKED AND SEALED

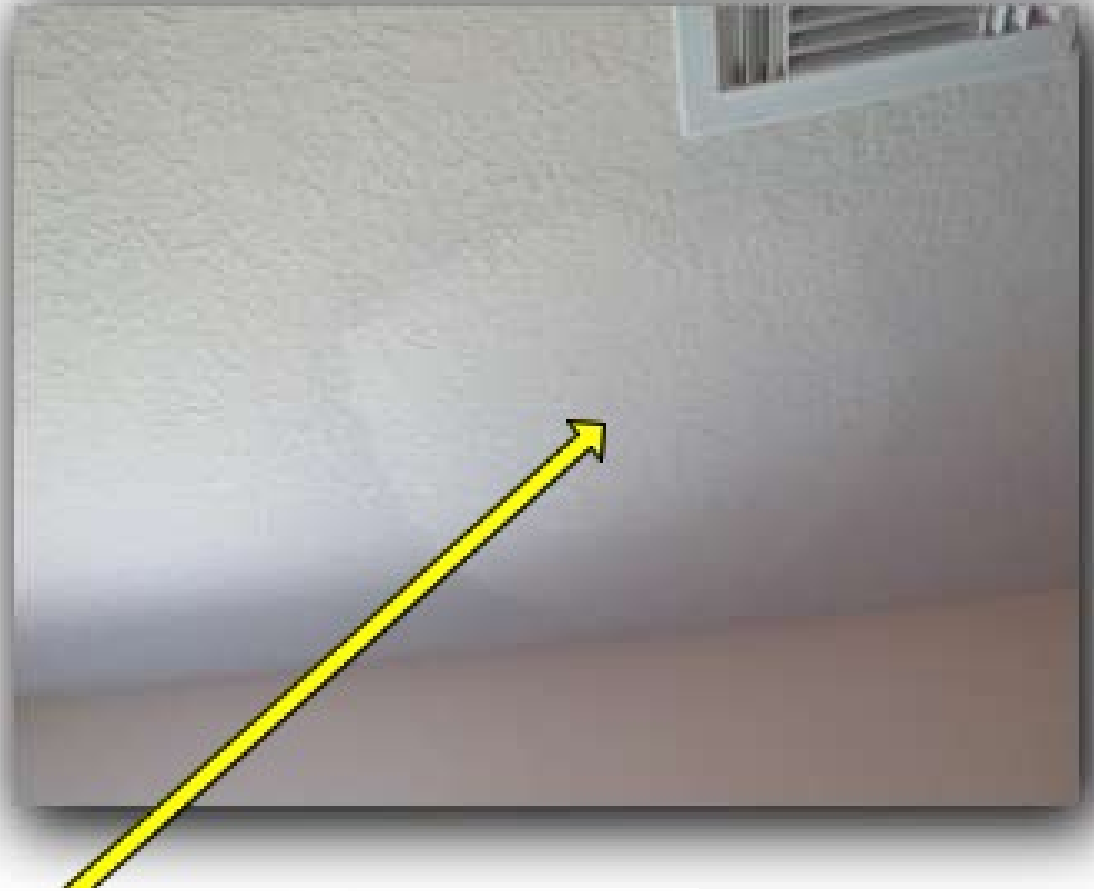
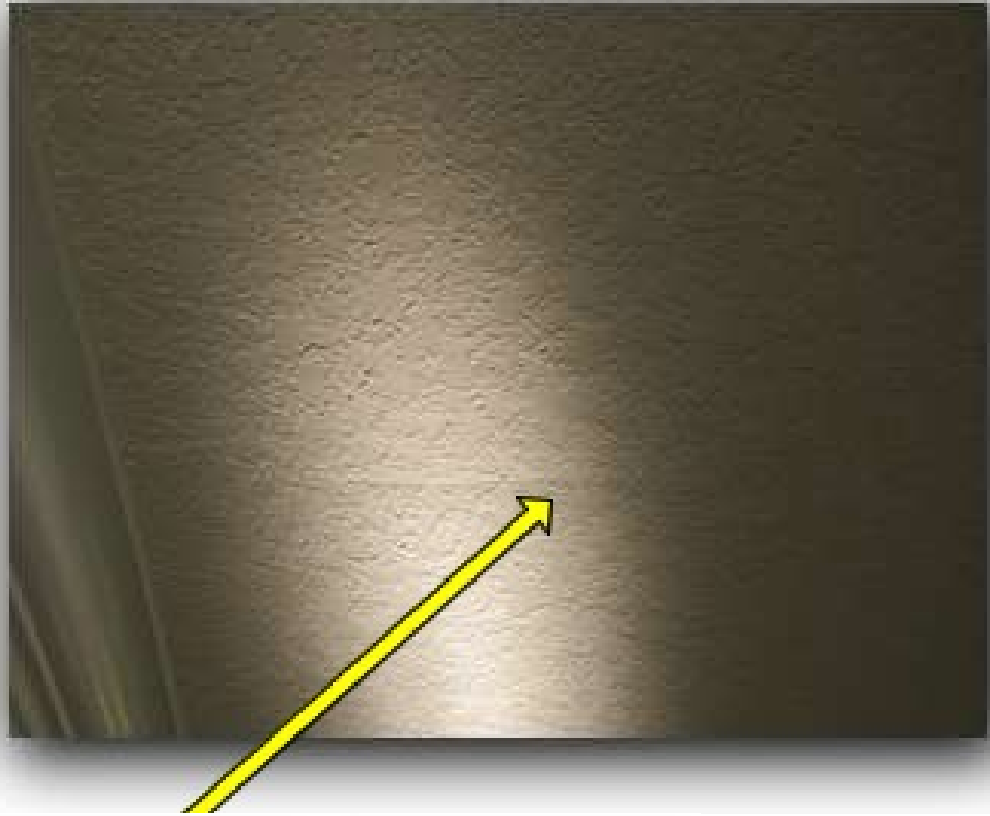
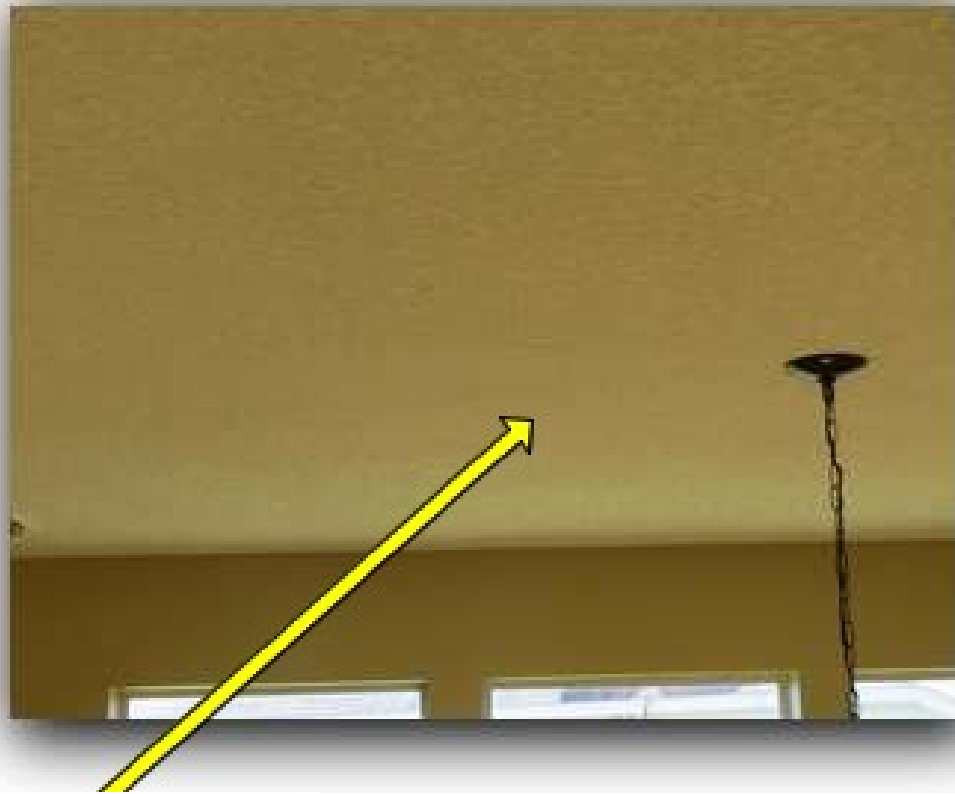
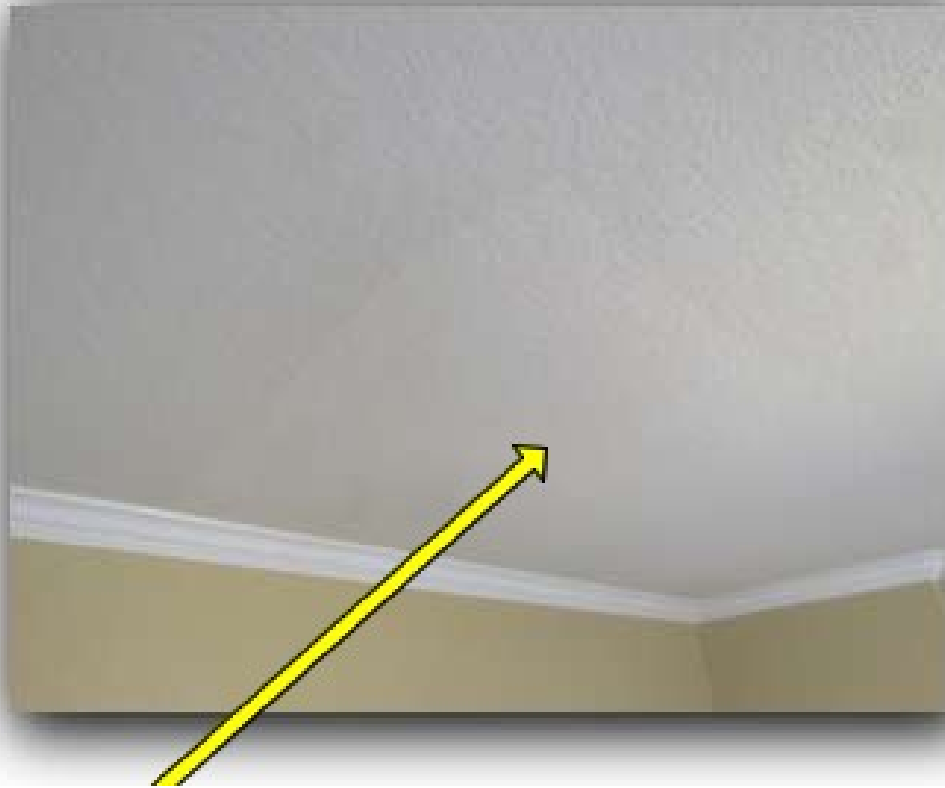
Water stains on ceiling/patchwork in several locations that appears to be from previous water stains and roof leaks that needs further evaluation on the upstairs front bedroom ceiling in two bedrooms and also in the hallway near the stairwell that may have been from the a/c water pan.(all these locations were previously patched/painted over, infrared camera did not show any active moisture)

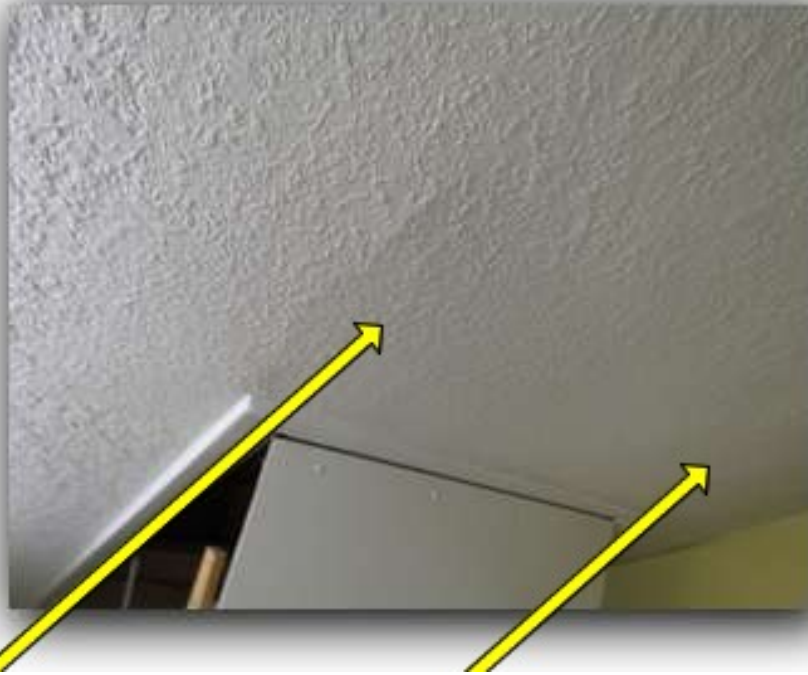
SOME PATCHWORK AROUND THE ATTIC ENTRY ON THE CEILING

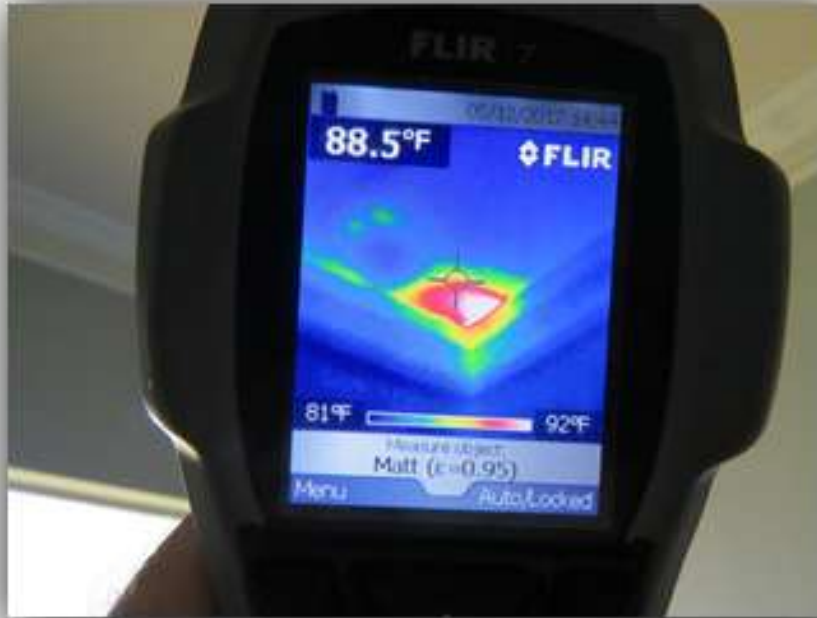
WITH THE USE OF AN INFRARED CAMERA DID SHOW MISSING INSULATION ON THE MASTER BATHROOM CEILING/WALL INTERSECTION THAT NEEDS TO BE PROPERLY INSULATED

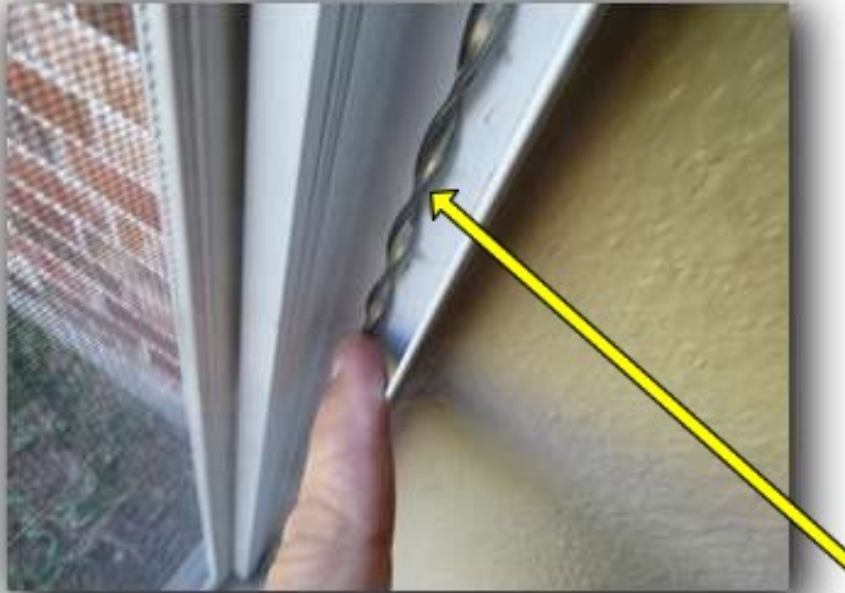
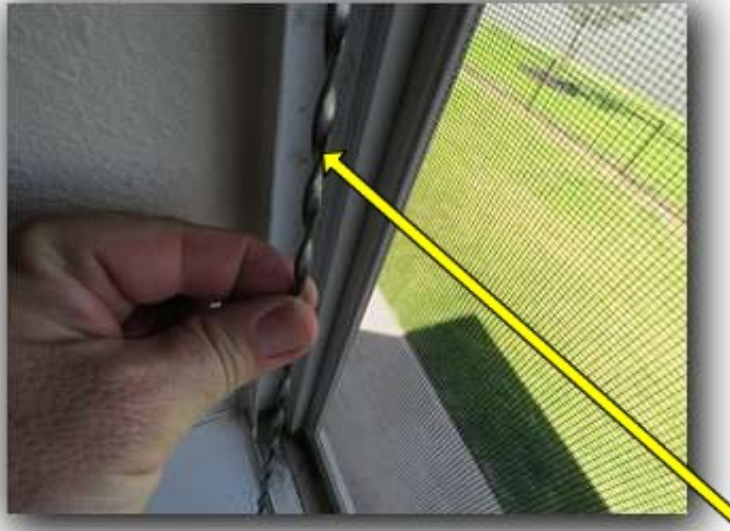
- Some window lift supports are loose, damaged or missing**; many windows have detached springs and unable to stay open. Recommend evaluation of all the homes windows and any needed repairs by a window repair expert.

- Some window screens are damaged or missing**

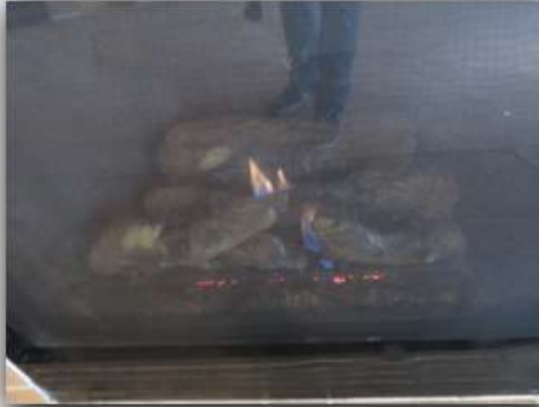
THE GAS FIREPLACE WAS TESTED AND FUNCTIONING PROPERLY AT THE START OF INSPECTION, THEN WHEN TESTING A SECOND TIME AT THE END OF INSPECTION WITH CLIENTS THERE WAS NO PILOT AND DID NOT LITE; RECOMMEND EVALUATION BY AN EXPERT IN THIS FIELD.

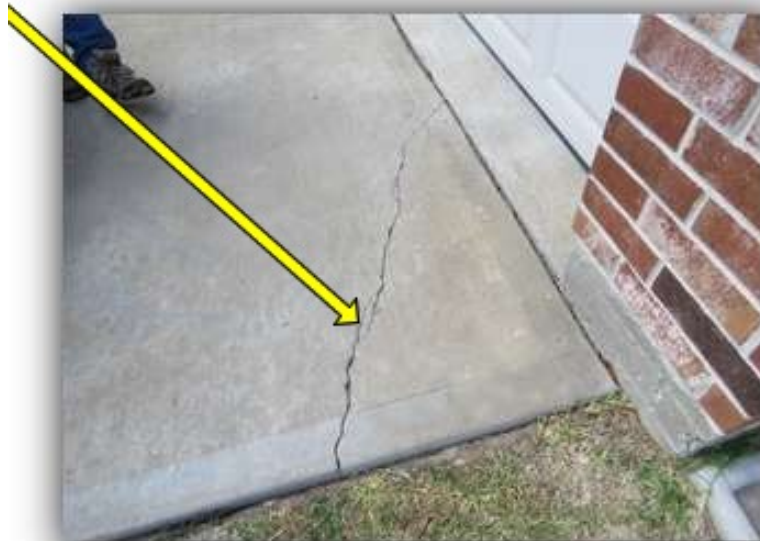
CRACKED DRIVEWAY SLAB THAT NEEDS REPAIRS.

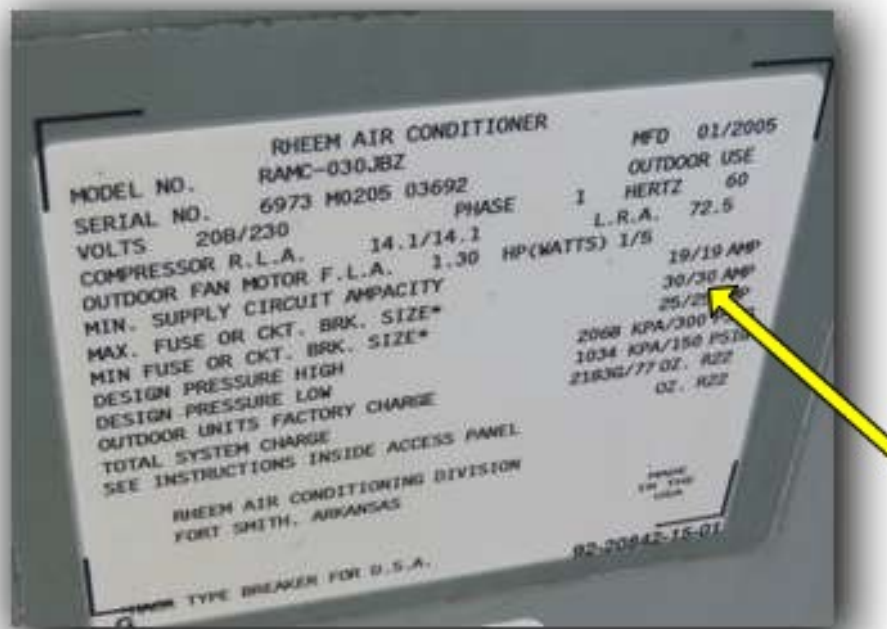
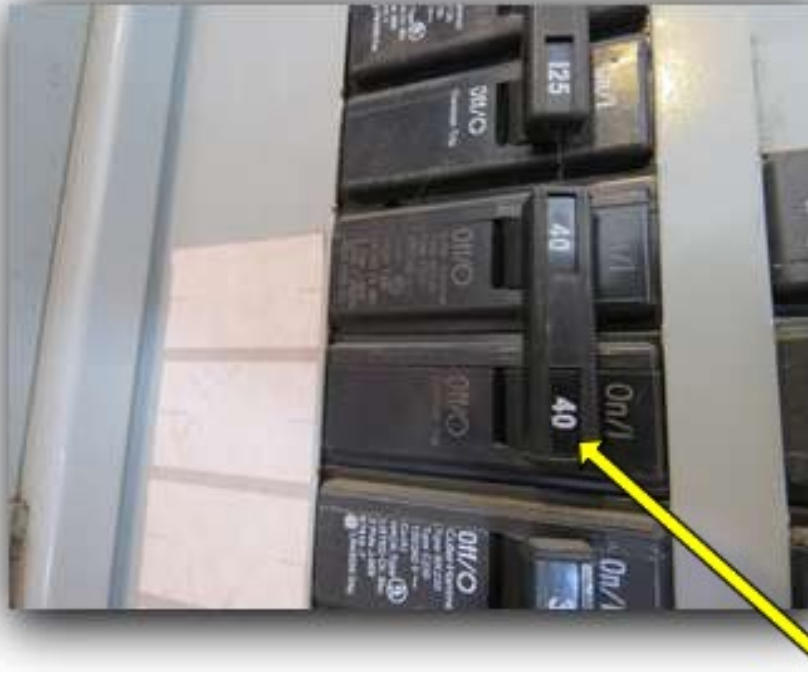
- A/C condensing unit #1:**

Specifies max amp breaker of 30__ and a 40 ____ amp breaker is in use; IN NEED OF REPAIR BY AN ELECTRICIAN

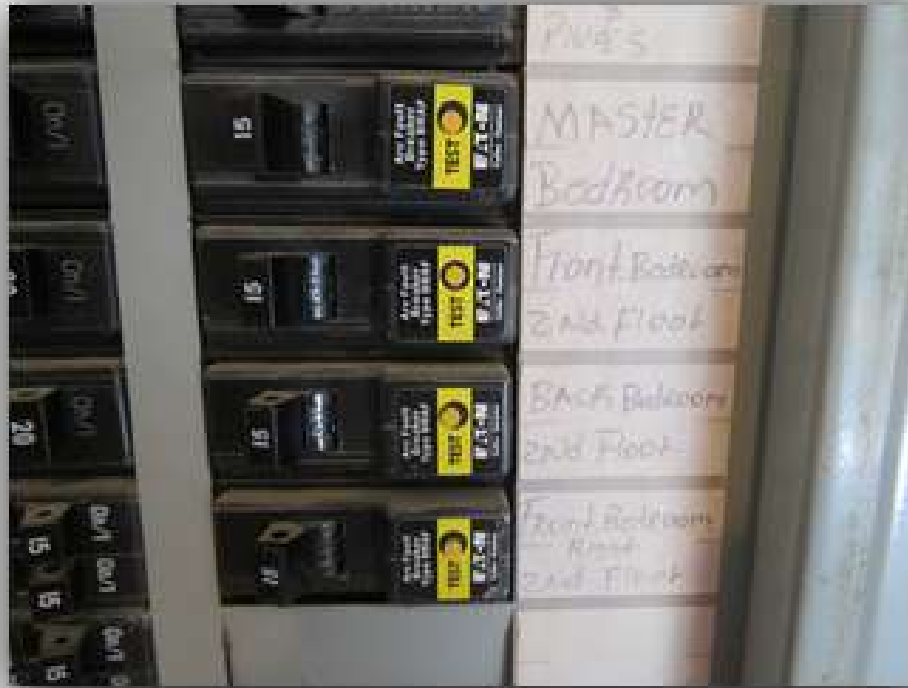
THERE IS NOT AFCI PROTECTION PRESENT IN ALL THE REQUIRED LOCATIONS NOW REQUIRED FOR NEW CONSTRUCTION; THERE WAS AFCI FOR THE BEDROOMS AND SMOKE DETECTOR WHICH WAS THE REQUIREMENT WHEN THE HOME WAS ORIGINALLY CONSTRUCTED. HOWEVER NOW REQUIRED FOR NEW CONSTRUCTION AFCI (ARC FAULT CIRCUIT INTERRUPTION) PROTECTION PROVIDES FIRE SAFETY PROTECTION. NOW REQUIRED FOR NEW CONSTRUCTION IN BEDROOMS, GAME ROOMS, PARLORS, LIBRARIES, DINING ROOMS, HALLWAYS, CLOSETS, SUN ROOMS AND SIMILAR AREAS.

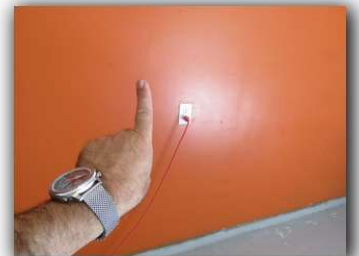
ONLY ONE OUTLET IN THE GARAGE; THERE SHOULD BE AN OUTLET ON EACH WALL IN THE GARAGE, MORE THAN ONE. RECOMMEND EVALUATION BY A LICENSED ELECTRICIAN (there is two on the ceiling dedicated to the garage door openers)

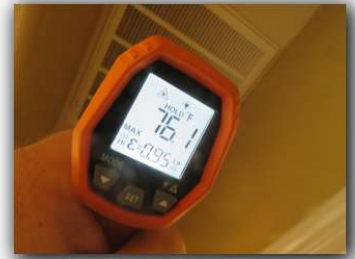
Unit #2:downstairs
 Supply Air Temp: 63 °F Return Air Temp: 76 °F Temp. Differential: 13 °F

Temperature differential is NOT within range of 15-20 degrees Fahrenheit)(FOR THE DOWNSTAIRS UNIT)

- **IN NEED OF EVALUATION AND REPAIR BY A LICENSED HVAC PROFESSIONAL; MAY BE LOW ON REFRIGERANT**

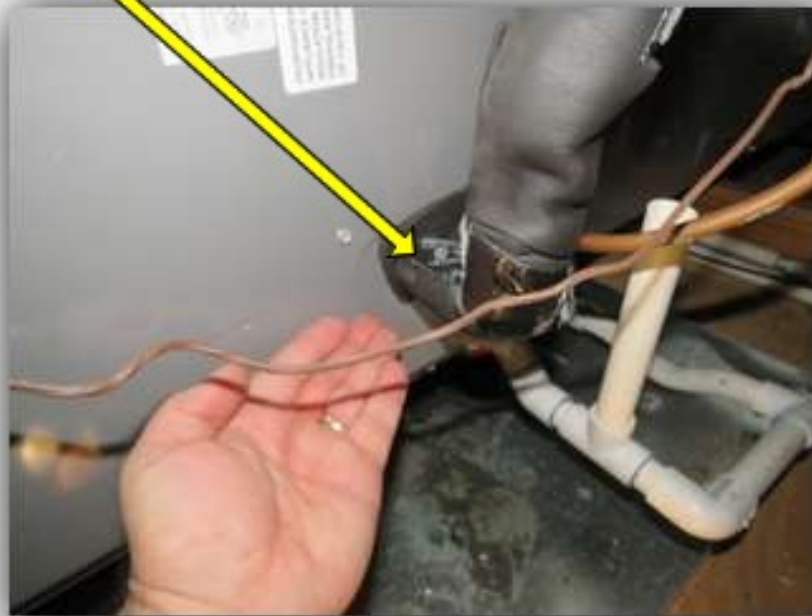
Refrigerant lines not properly insulated at Evaporative

Coil; dripping condensation into the pan; needs to be properly calked and sealed with silicone calking around the cooling line at the air handler termination

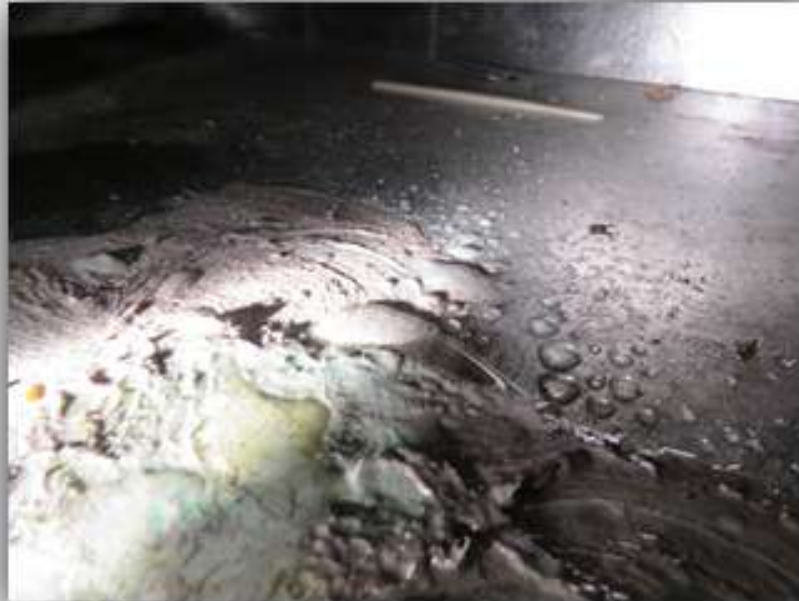
Air handler plenum is not properly sealed;needs evaluation and needs to be properly taped and sealed by a licensed hvac professional.

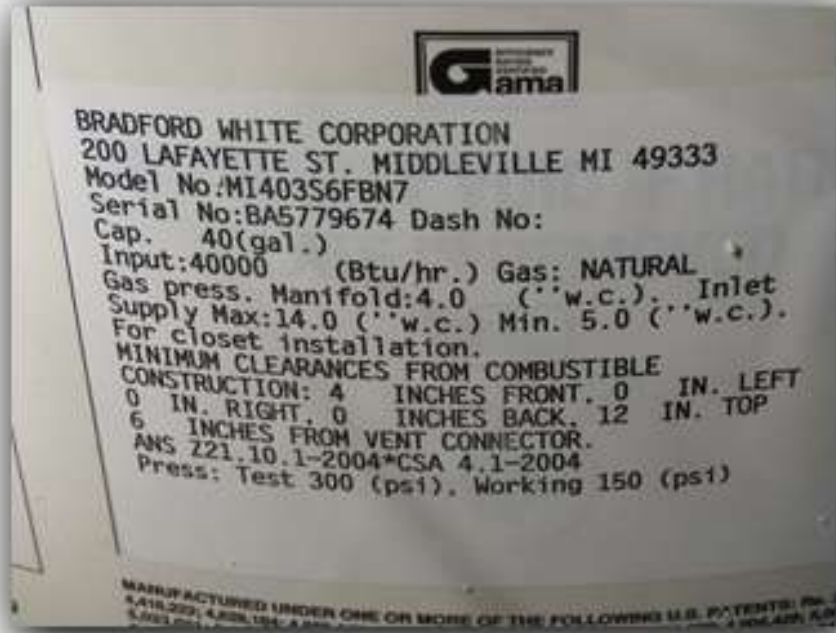
THE T&P VALVES ARE NOT FUNCTIONING WHEN TESTED AND NEEDS TO BE REPLACED.

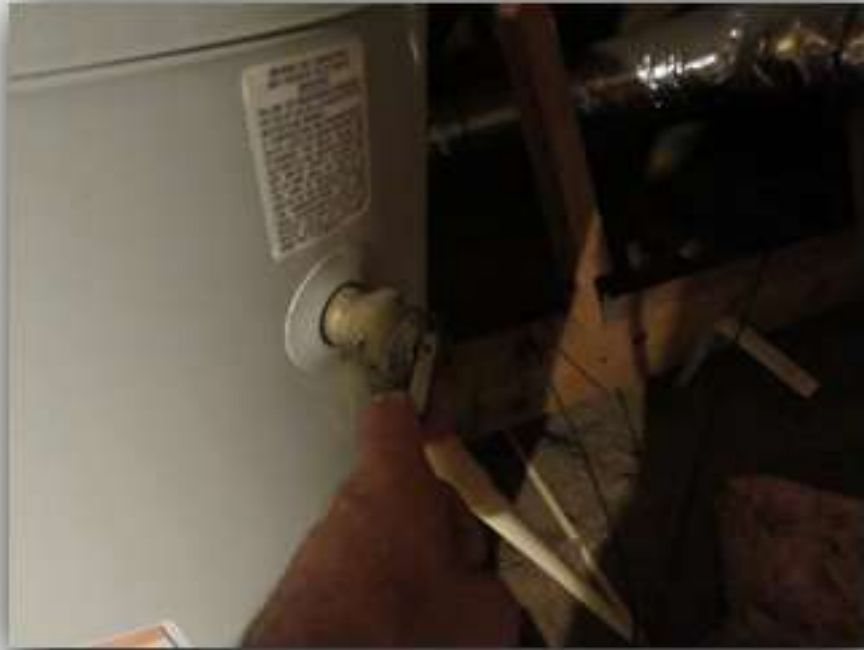
- **Corrosion and/or signs of an intermittent leak at Isolation valve and/or plumbing connections; IN NEED OF REPAIRS BY A LICENSED PLUMBER.**
