PROPERTY INSPECTION REPORT

Prepared For: DENNIS & CATHY ORLANDO
(Name of Client)

Concerning: 15018 RIVERLET CT., CYPRESS, TX 77429
(Address or Other Identification of Inspected Property)

By: Stephen Perry, Lic #7854 05/12/2017
(Name and License Number of Inspector) (Date)

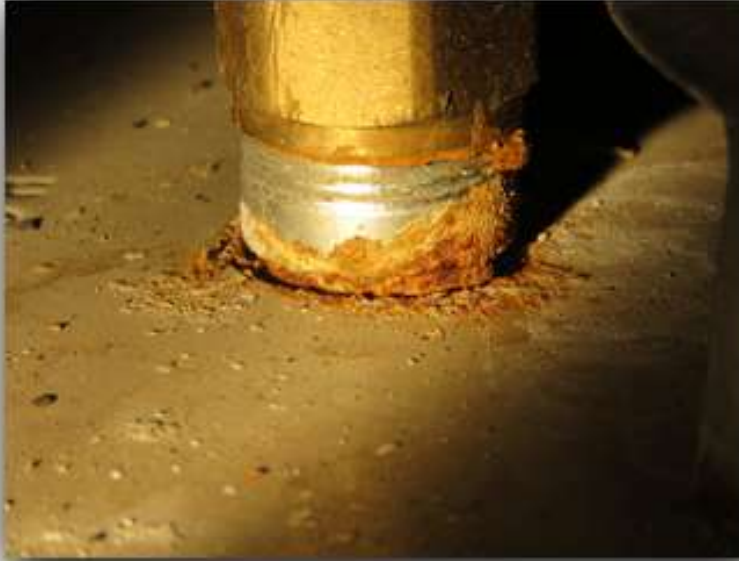
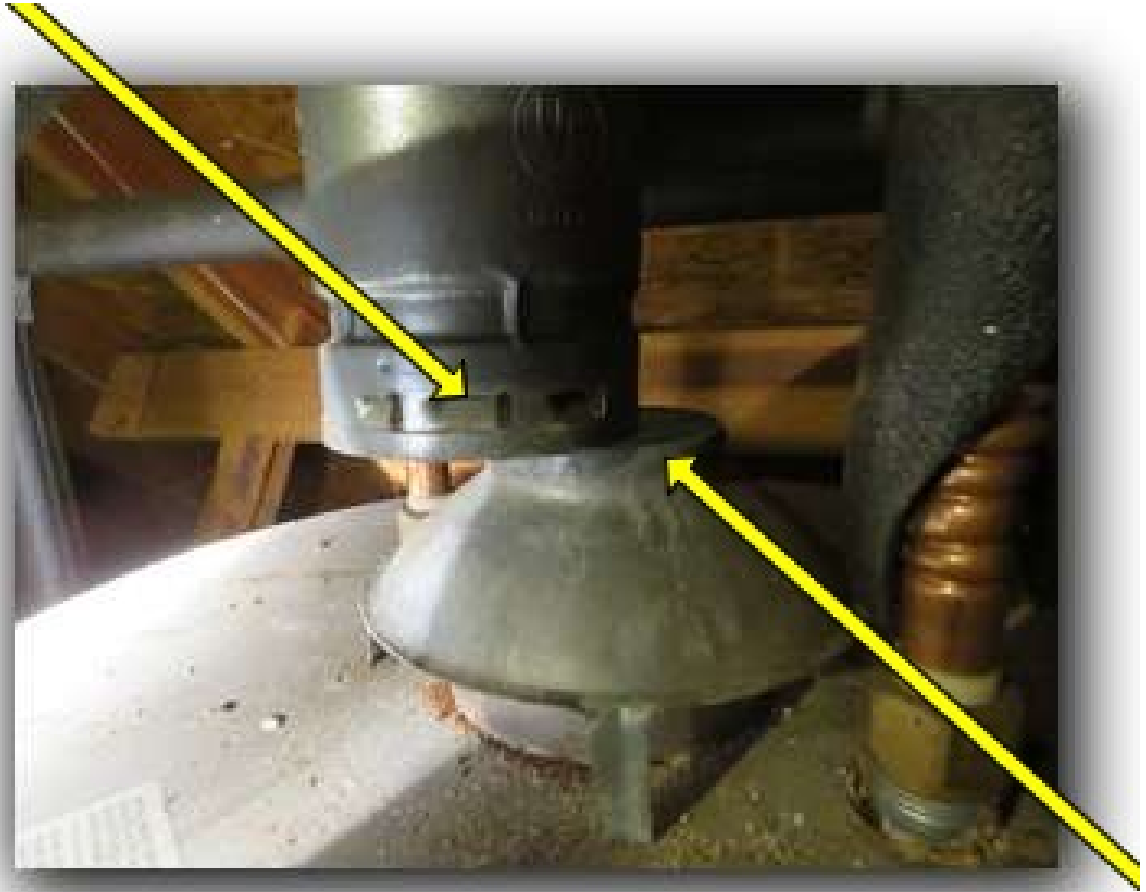
☑ THE B-VENT FLUE WAS IMPROPERLY INSTALLED AND NOT ALIGNED WITH THE DRAFT HOOD ALLOWING EXHAUST TO LEAK INTO THE ATTIC AND A POTENTIAL SAFETY HAZARD/CARBON MONOXIDE. IN NEED OF REPAIR

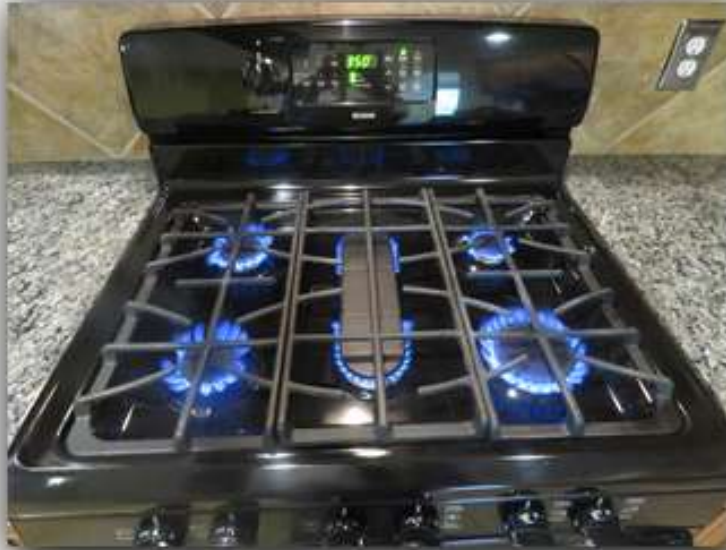
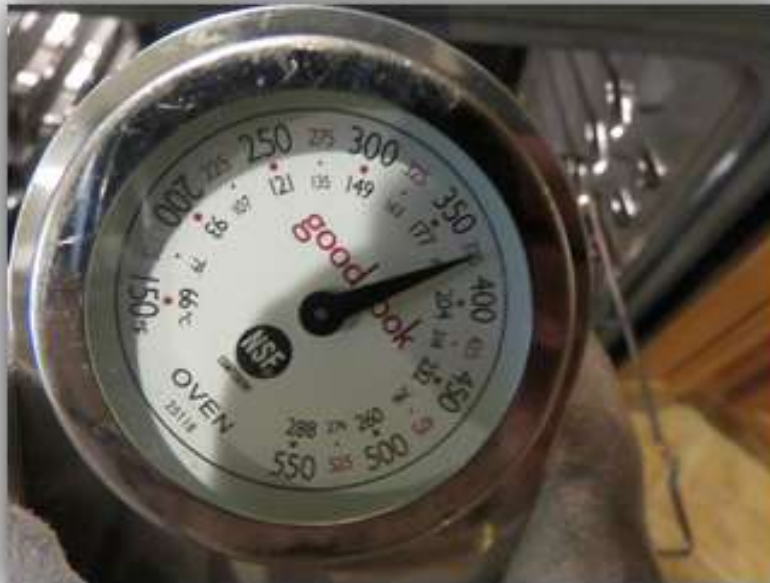
Tested at 350°F, Variance noted: **26 HOT** °F (max 25°F)

IN NEED OF REPAIR BY AN APPLIANCE REPAIR PERSON
