Inspection Report

LOCATED AT:
17818 N White Tail Ct
Houston, TX 77084

INSPECTED ON:
Friday, November 15, 2019

Inspector, Paul Ferguson, TREC # 6883
A Plus Inspections Of Texas

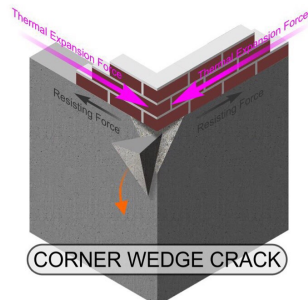
REP Corner pops were present. Normally these are not structural, but may allow for concealed subterranean termite infestation. It is recommended that the soil at these locations be treated periodically by a qualified pest control contractor to help prevent infestation.
