PROPERTY INSPECTION REPORT

Concerning: 11002 Hammerly #40, Houston, TX 77043
(Address or Other Identification of Inspected Property)

By: Scott Carey, Lic# 23052 07/05/2018
(Name and License Number of Inspector) (Date)

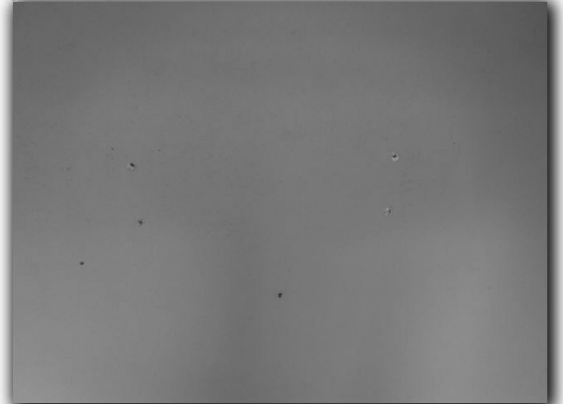
-Multiple areas were observed around the home interior drywall damage / holes and finish. Repair as needed.

Drywall Damage

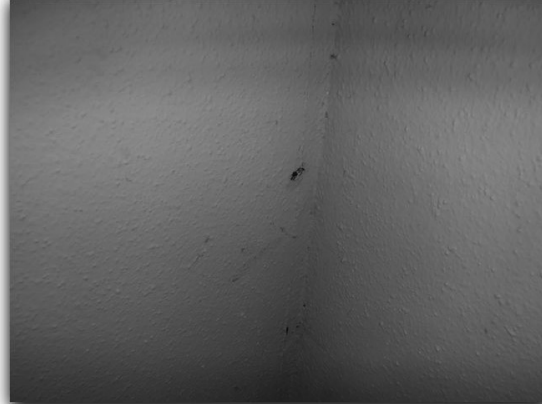
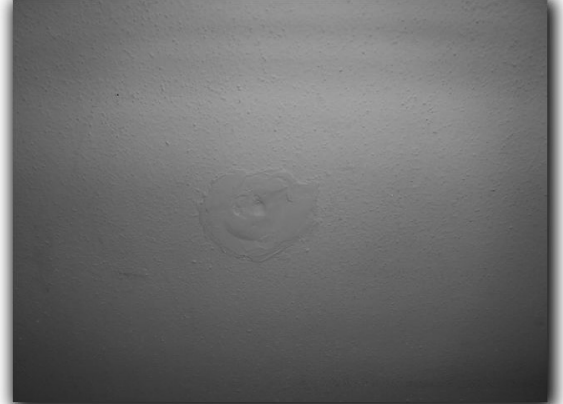
-Multiple ceiling areas were observed to have nail pops and exposed tape joints. These are cosmetic in nature at this time. Recommend monitoring and repair as needed.

Nail Pop(s)

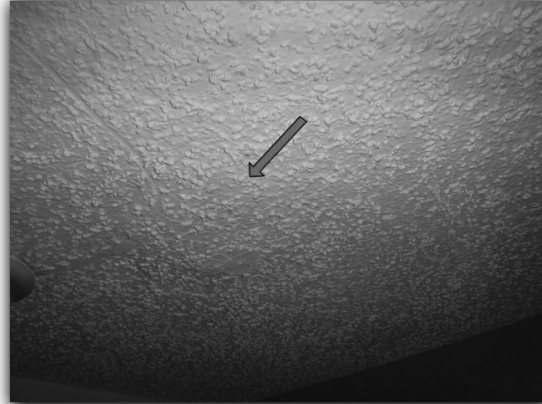
Previous Repair

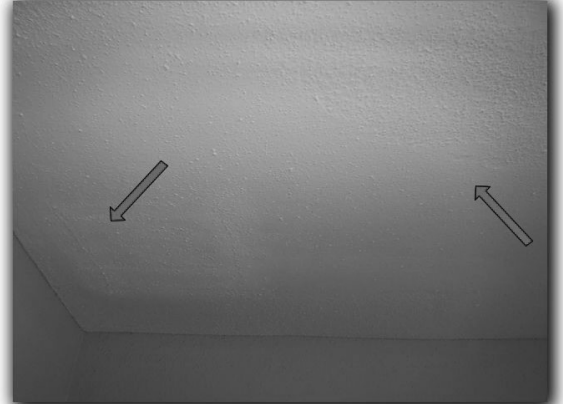
-Previous ceiling repair was observed at front corner at master bedroom and downstairs at stairway ceiling. Recommend monitoring as needed. No active moisture was observed with Thermal Camera.

Previous Repair @ master ceiling

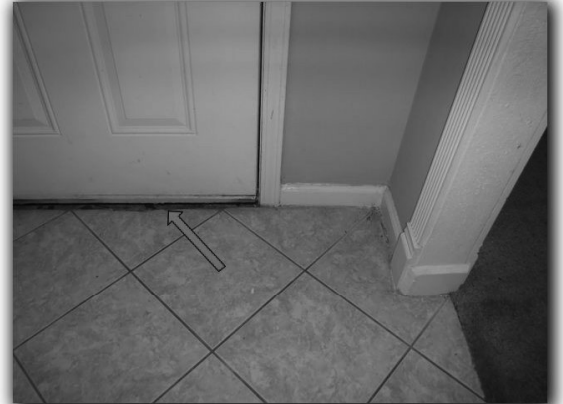
-Floor tiles were observed damaged at front entry at threshold area. Repair as needed.

Tile Damage @ Front Entry

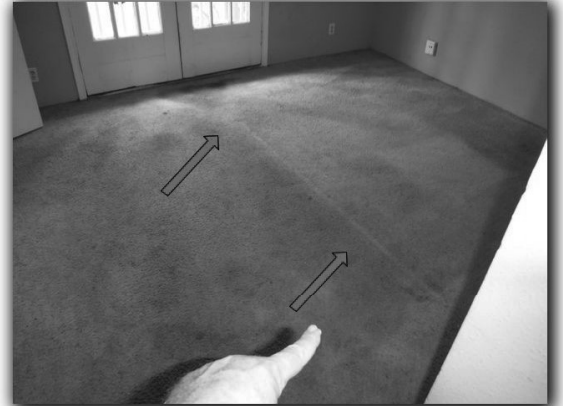
-Deflection was observed in the flooring at upstairs master bedroom, and upstairs hallway at bathroom. Repair as needed.

Deflection

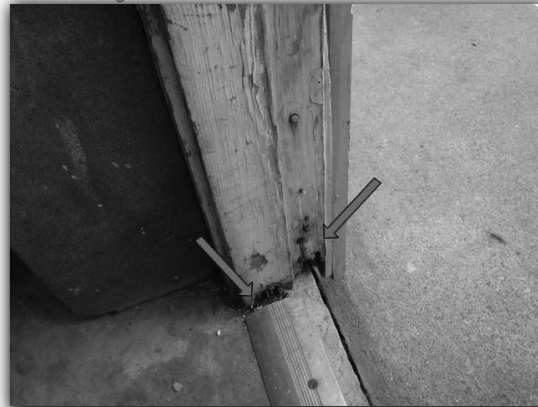
-Moisture damage was observed at both rear patio door and storage room doors. Repair as needed to prevent further deterioration.

Moisture Damage

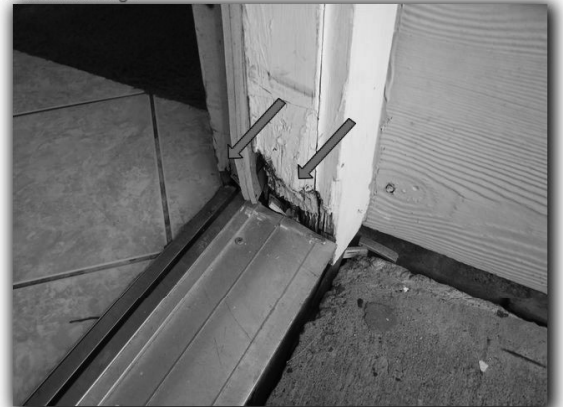
Moisture Damage

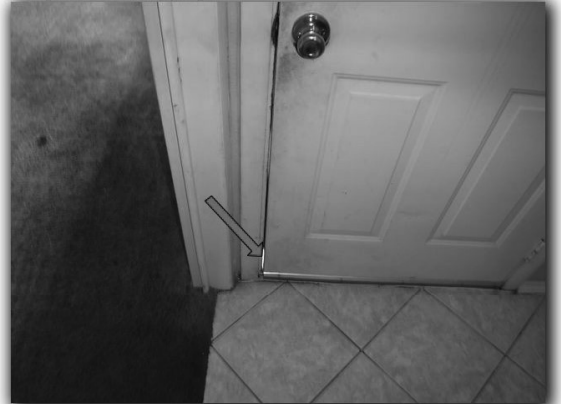
-Weather stripping at front entry, rear patio and balcony door(s) allows small opening at tops and bottom sides. Recommend repair as needed to prevent moisture and possible pest intrusion.

Missing weather Stripping

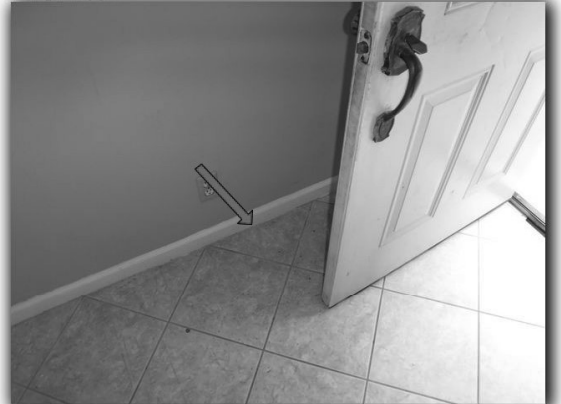
-Multiple door stops were observed missing / damaged at the exterior door at the time of inspection. Recommend repair to prevent door or drywall finish damage.

Missing Stopper

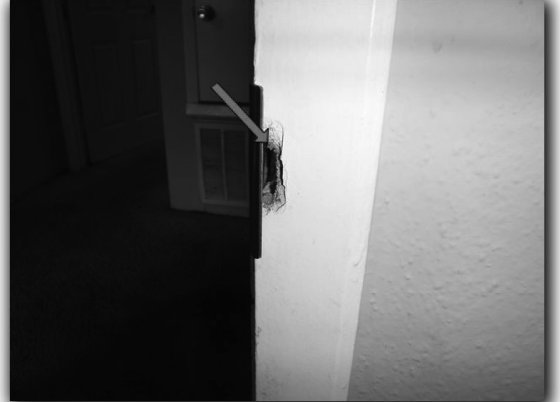
Damaged Door @ Rear Left Upstairs Bedroom Casement

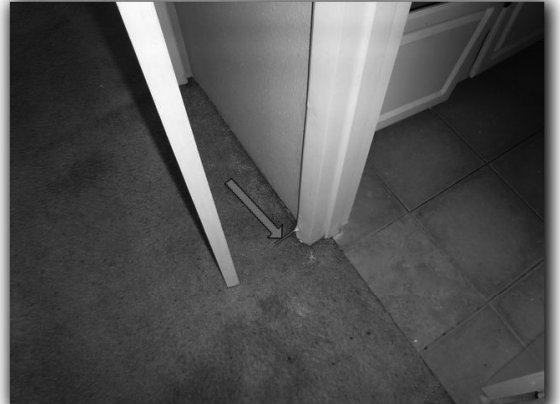
-Multiple door stops were observed missing / damaged at the time of inspection. Recommend repair to prevent door or drywall finish damage.

Damaged Stop

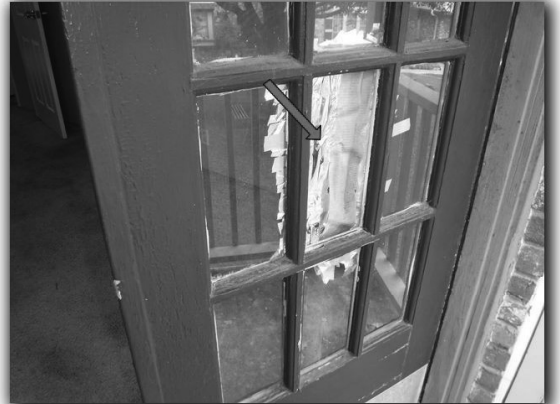
-Broken window, Lock and moisture damage at upstairs master balcony French doors. Repair as needed.

Broken Glass

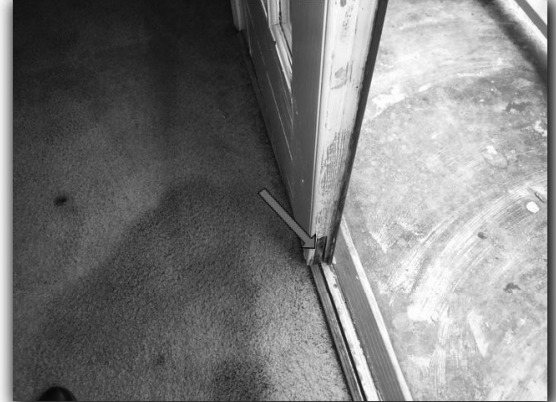
Damaged Lock @ Balcony French Door

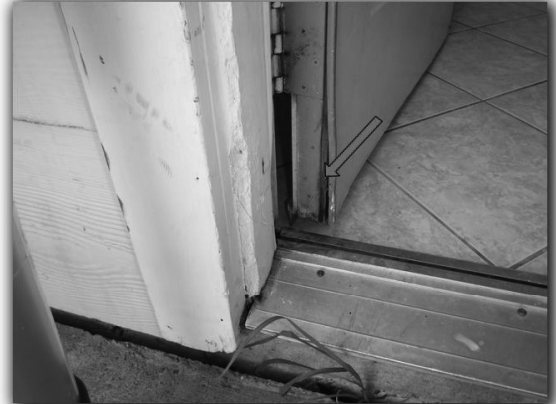
Moisture Damage

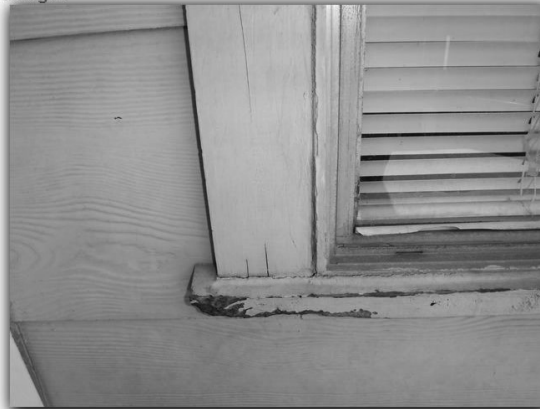
Damaged

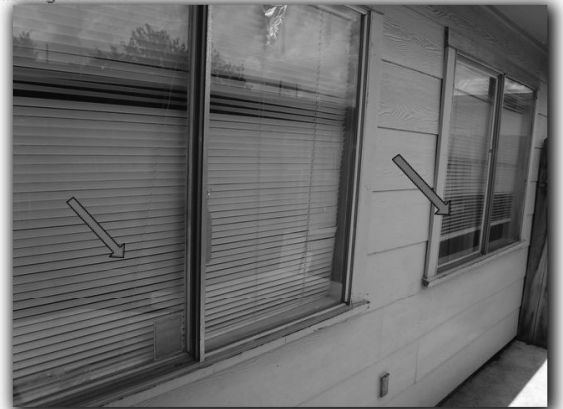
-Multiple window screens were observed damaged or missing at the time of inspection. Repair as needed.

Missing Screens

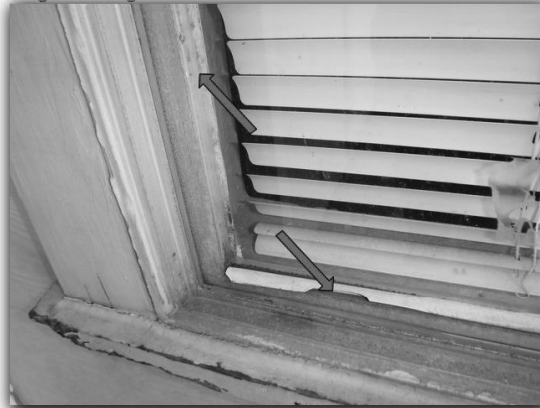
-The plastic glazing bead at various windows appear to be damaged. This condition should be corrected as to reduce the risk of water penetration.

Damaged Glazing

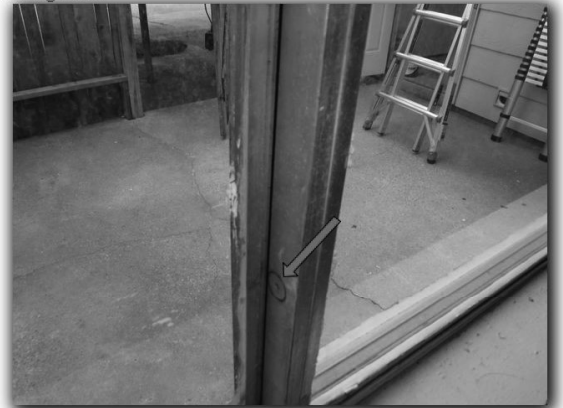
-Multiple window locks were observed to be damage or missing at the time of inspection. Repair as needed for safety.

Missing Lock

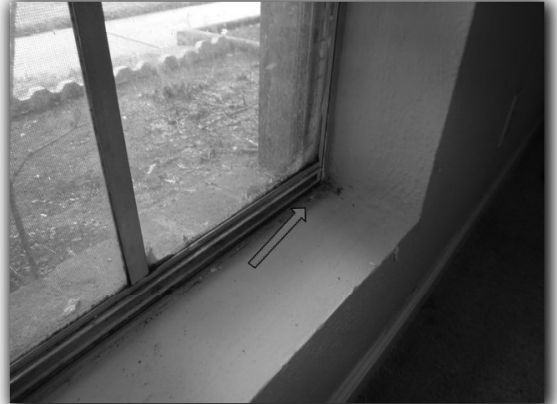
-Evidence of moisture was observed in the drywall finish at multiple window sills. This is a possible result of the metal frame windows condensing. Monitor and repair as needed.

Moisture Damage

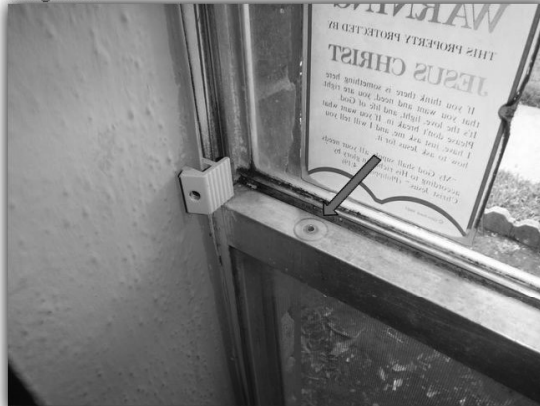
Missing Lock

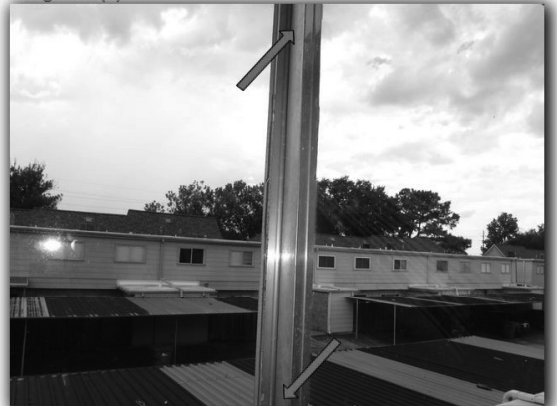
Missing Lock(s)

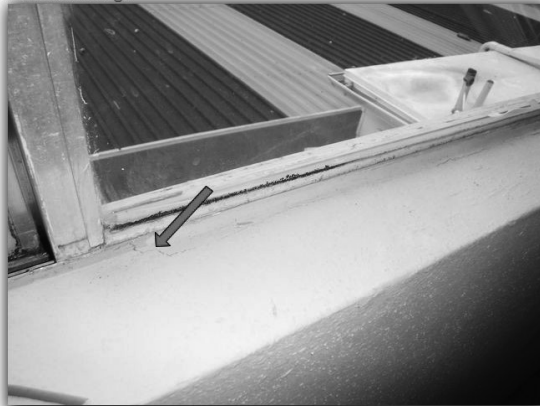
Moisture Damage

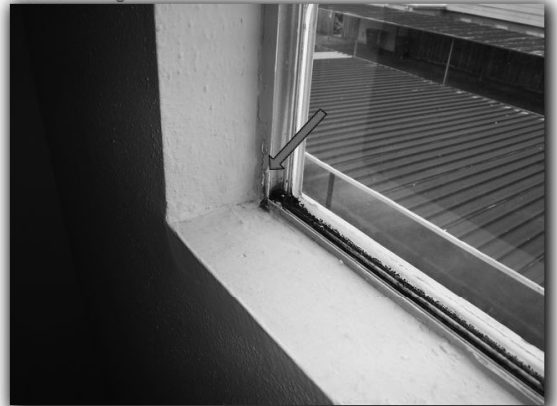
Moisture Damage

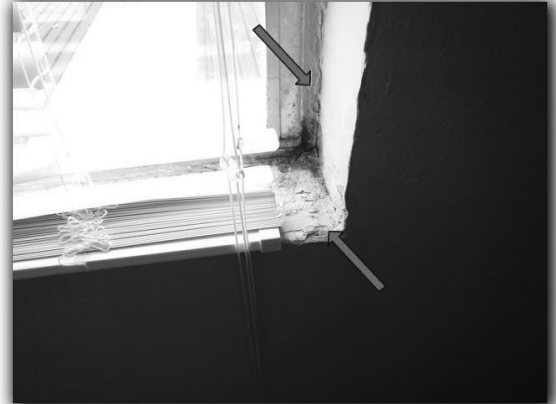
Moisture Damage

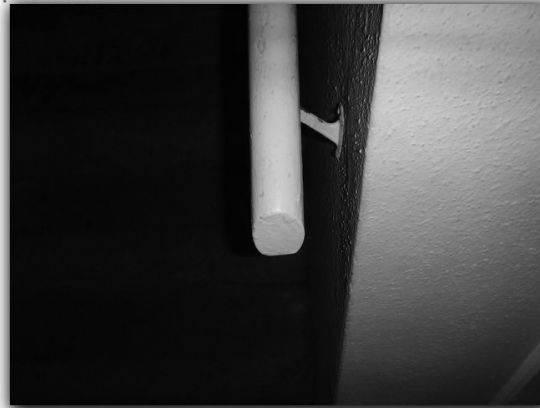
- Handrail for the stairway is set up in a manner that can catch clothes or other articles when navigating the stairway. Recommend it be turned onto the wall to prevent possible injury.
- Handrail was observed loose at lower level. Recommend correction to prevent personal injury.
- The stairway was observed to be too narrow. Stairways should not be less than 36" in clear width when only one handrail is provided.
- The stairway appears to be performing as intended at the time of inspection.

Open - End'd

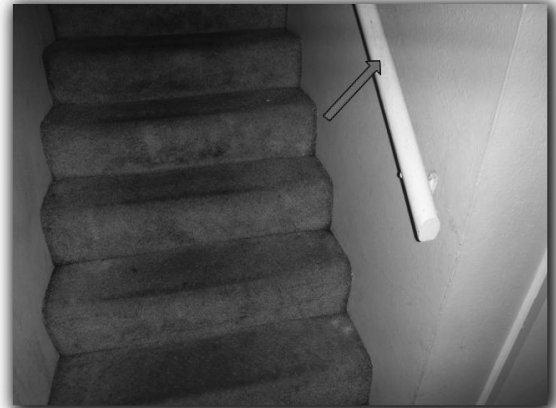
Loose

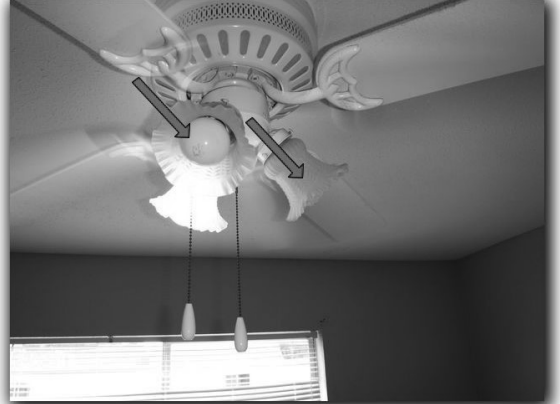
Non Functiong

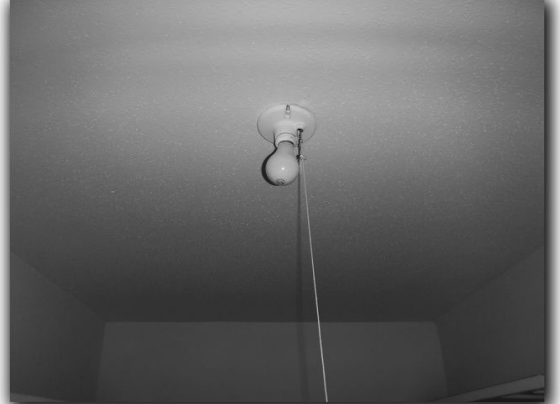
-Multiple light fixtures in closets were missing their bulb covers. recommend correction to prevent damage.

Missing Cover(s)

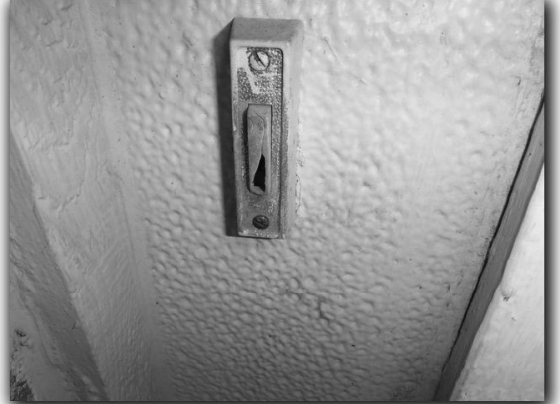
-Front entry door bell cover was observed damaged and non functioning at the time of inspection. Repair as needed.

Damaged / Non Functioning

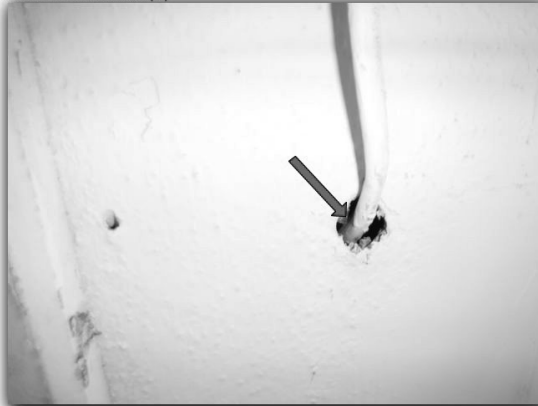
-Undetermined wires were observed at multiple locations around the exterior and interior of the home. Recommend that a licensed, competent professional electrical contractor be consulted to determine the best method for repairs, estimate costs, and perform the repairs.

Undetermined Wire(s)

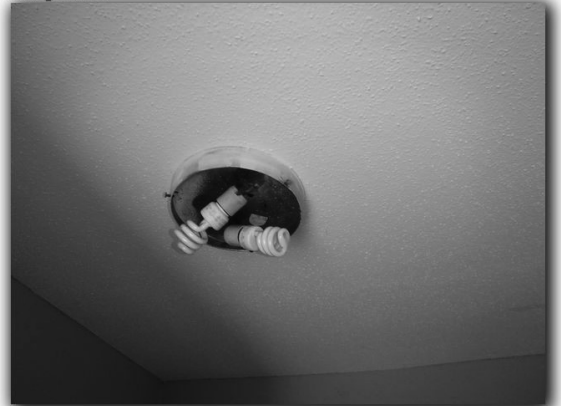
-Multiple outlet / switch covers were observed to be damaged / missing at the time of inspection. Repair as needed.

Missing Cover

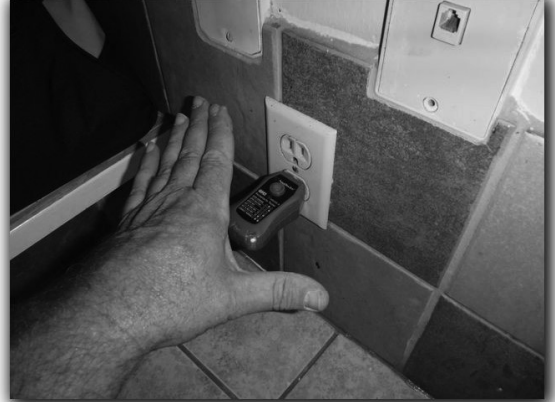
-No GFCI protection was observed at the required locations at kitchen, bathroom and exterior. Repair as needed for safety purposes as all exterior and interior electrical outlets within 6 feet of water source should be GFCI protected.

Loose Outlet / Non GFCI

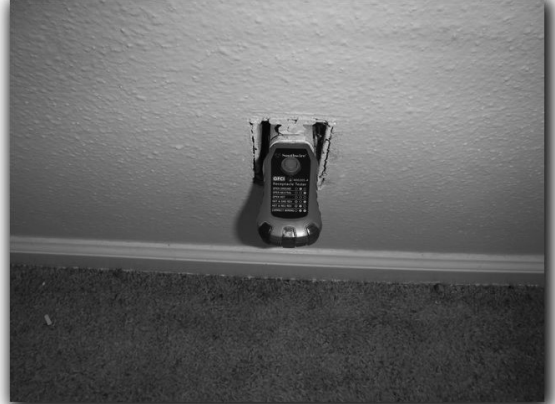
Missing Cover

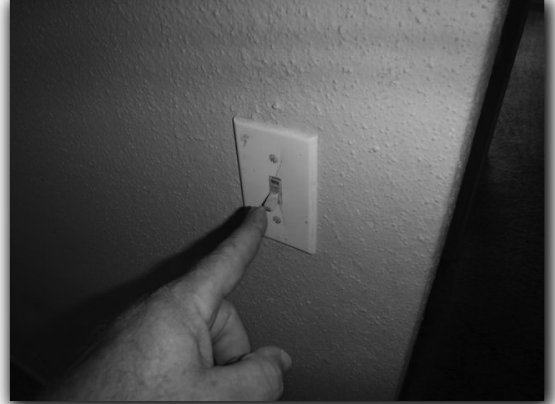
Damaged Cover(s)

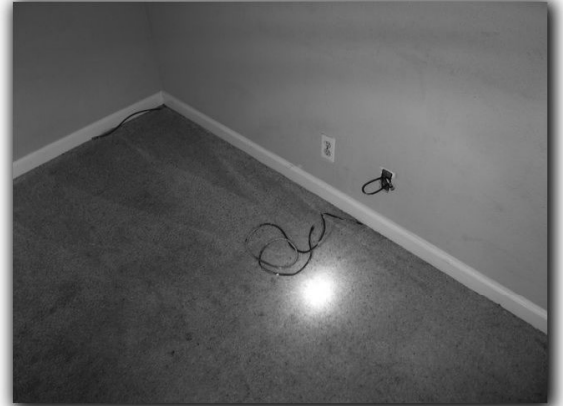
Undetermined Wires

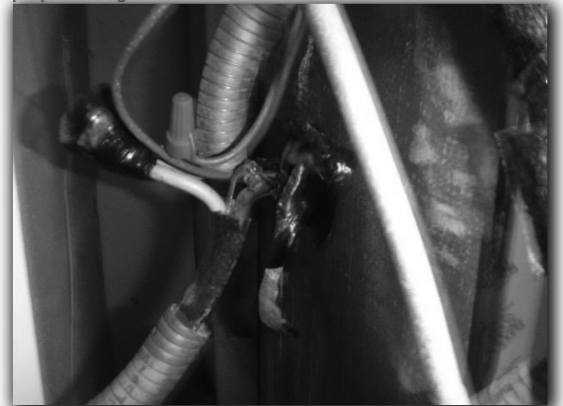
-Electrical connections were not properly terminated in sealed top portion of furnace cabinet. Repair as needed to prevent possible electrical short at wires.

Improper Wiring

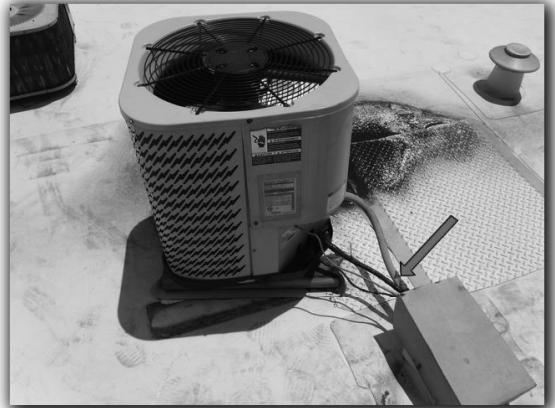
-Conduit for the electrical supply was observed to be deteriorated. Repair as needed to prevent damage to the wiring.

Deteriorated Conduit

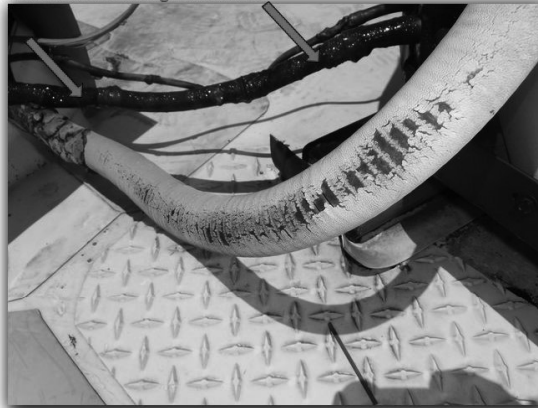
-Low-pressure line insulation shows advance weathering and age. Recommend adding new insulation materials to help reduce condensation issues and promote efficient operation of unit.

Deteriorated / Missing Insulation

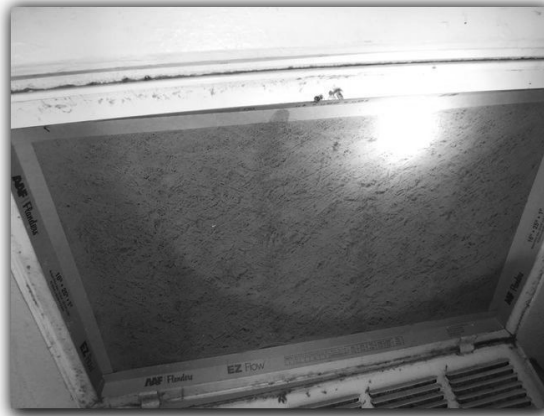
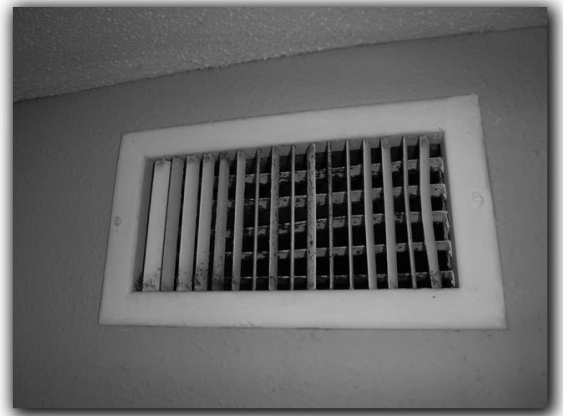
-The return air filter was observed to be dirty. Recommend replacement as needed to allow HVAC to operate at maximum efficiency.

-Air registers were observed to be dirty at vents. Recommend cleaning of all air ductwork to allow system to operate at maximum performance and efficiency.

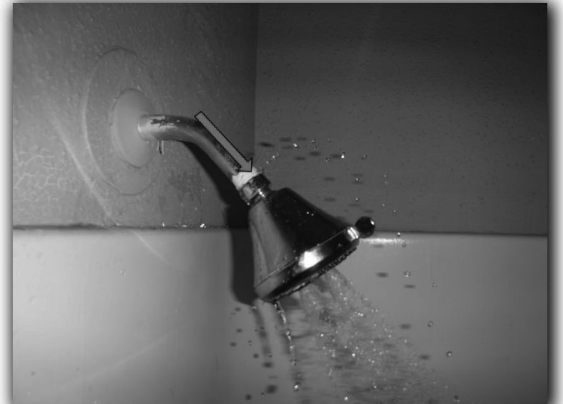
-Shower fixture connection at upstairs master bathroom was observed to leak at the time of inspection. Repair as needed for water conservation purposes.

Leaks

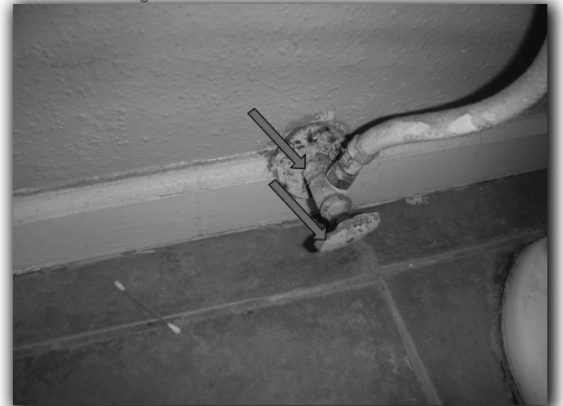
-Corrosion was observed at the water connections at downstairs commode connection. Recommend monitoring for possible leaks.

Corrosion / Damaged Handle

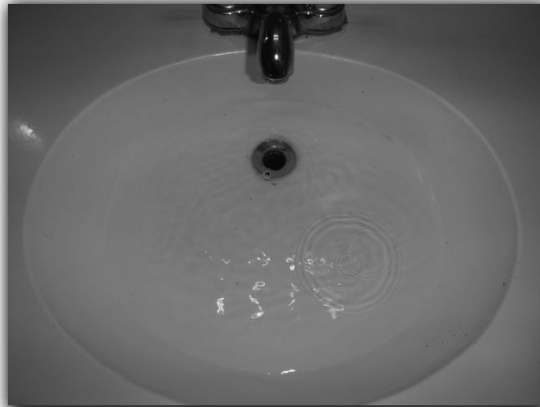
- The upstairs hallway bathroom sink and tub were observed to drain very slowly at the time of inspection. Recommend further evaluation and repair to allow drain to function as intended.
- Drain stoppers at both upstairs bathroom sinks and bathtubs were observed missing at the time of inspection. Recommend repair / replacement to fixture stoppers to operate / close as intended.
- Corrosion was observed at the downstairs half bath sink to drain connection. Recommend monitoring for possible leaks.
- All other drains, wastes and vents appear to be functioning as intended at the time of inspection.

Slow to Drain

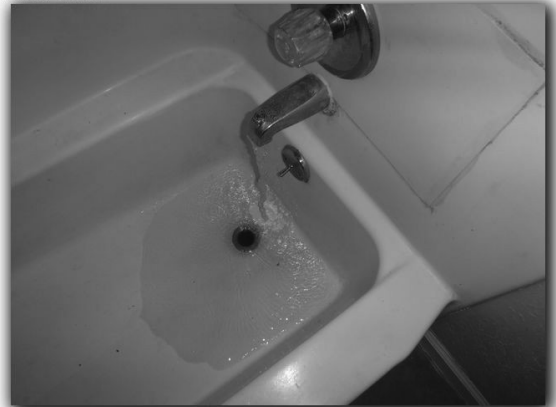
Slow to Drain

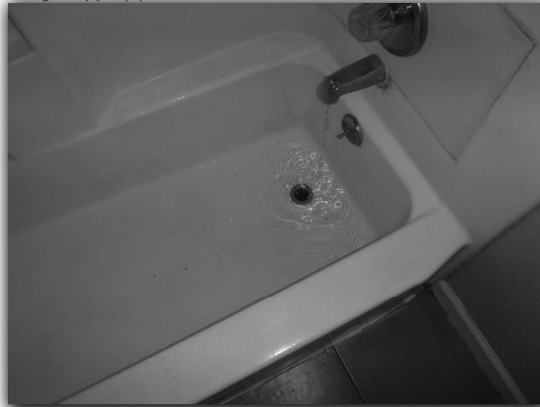
Missing Stopper(s)

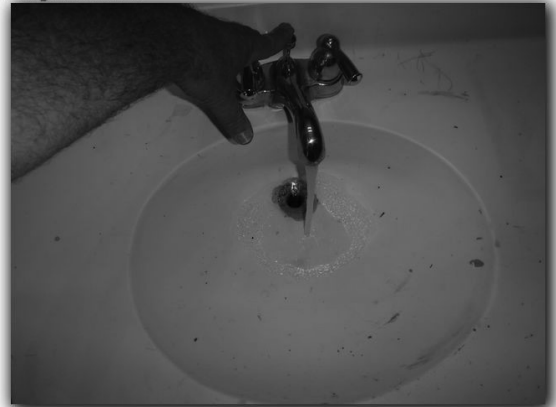
- The surfaces for the upstairs master bathroom sink and bathtub were observed damaged / deteriorated. Repair as needed for ease of cleaning.

Damaged Surface

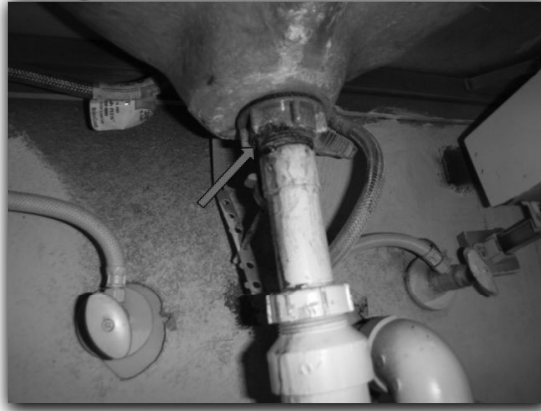
Corrosion @ Drain Connection

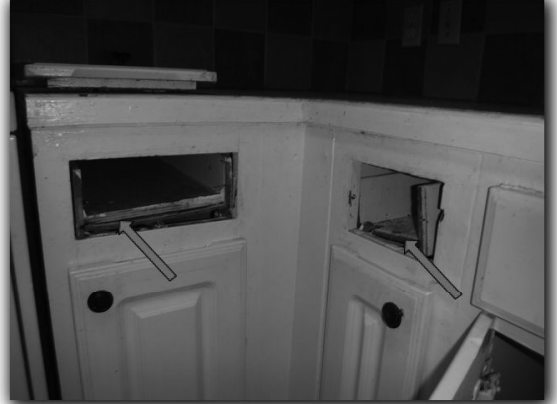
drawer fronts as intended. Repair as needed.

Missing Drawer Fronts

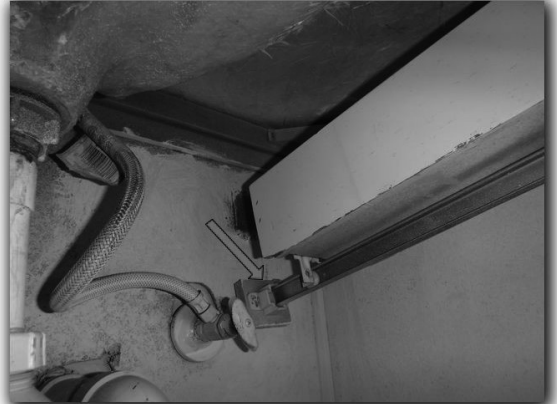
Damaged Drawer Slide

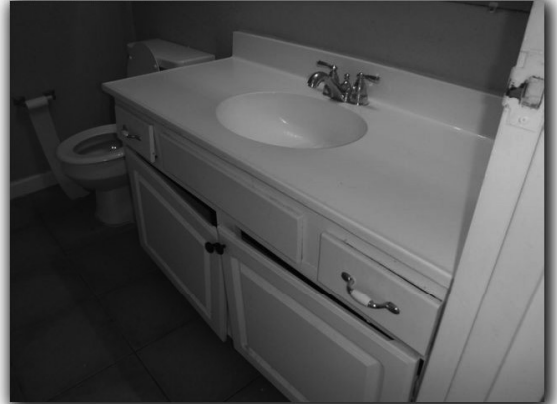
Damaged Door Fronts

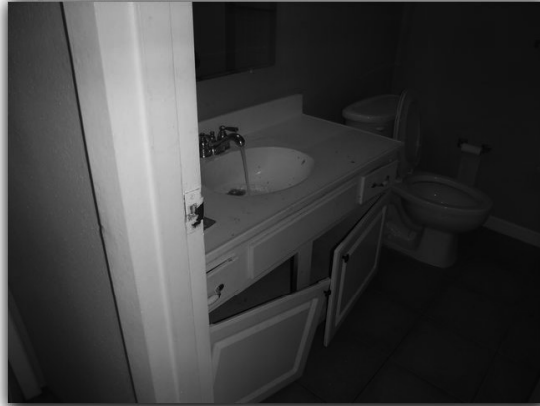
Damaged Door Fronts

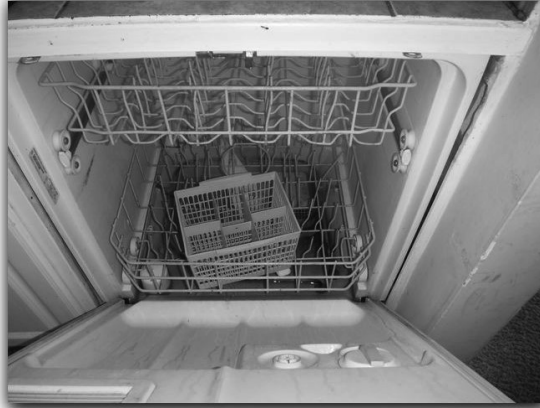
-The dishwasher was observed to be full of water at the time of the inspection. Repair as needed.

Standing Water

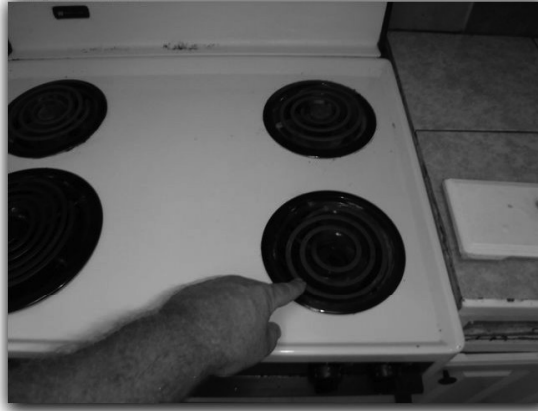
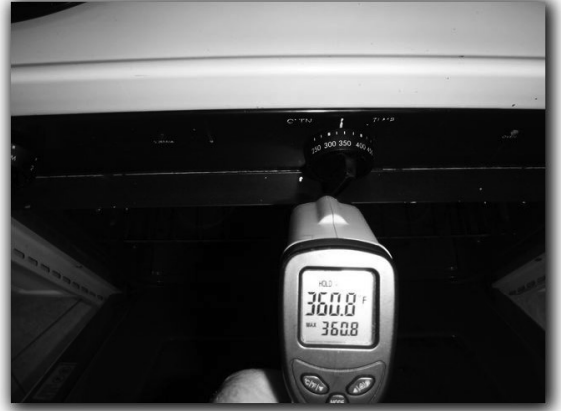
Missing Coil Stand

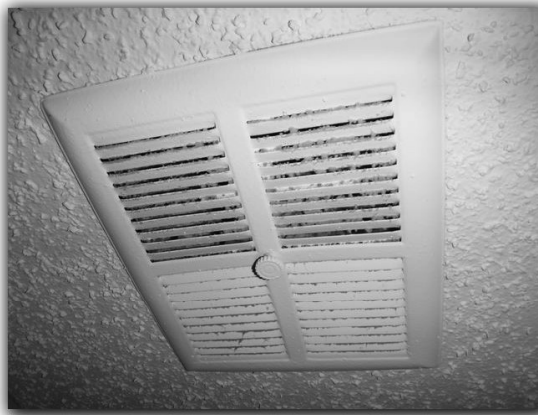
-Exhaust fan covers were observed to be dirty. Recommend cleaning covers to allow units to operate at maximum efficiency.

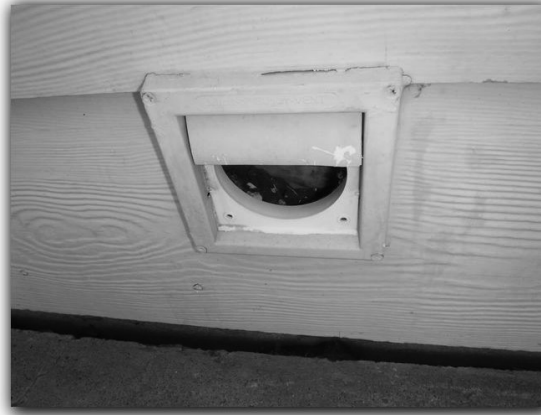
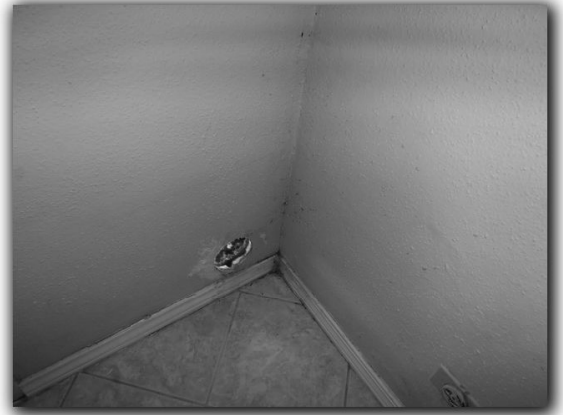
-The dryer vent cover was observed to be damaged / missing at the time of inspection. Repair / Replace as needed to prevent moisture and possible pest intrusion.
