Inspector: Gene Goodwin

Inspection Report

3310 Village Falls Court

PROPERTY INSPECTION REPORT

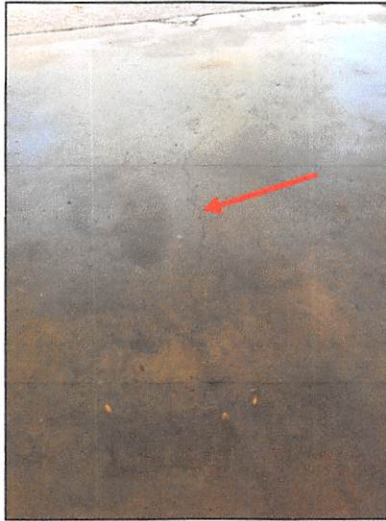
- Cracks observed extending from the right side to the left side of the garage. Suggest sealing all concrete cracks in the surfaces to prevent water penetration as a routine maintenance effort.

Cracks observed extending from the right side to the left side of the garage

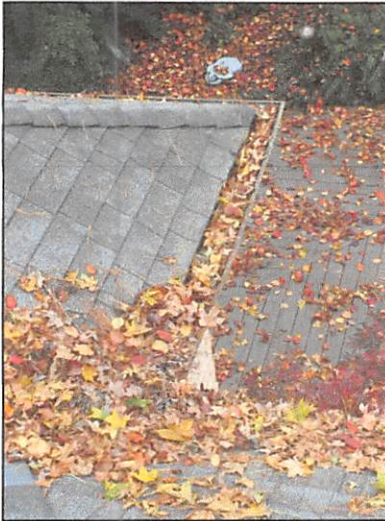
Recommend leaves and debris be cleaned from gutters and downspouts as necessary for more effective drainage of roof runoff water

- Recommend leaves and debris be cleaned from gutters and downspouts for more effective drainage of roof run-off water. Rain guard installation can be effective at keeping debris build-up to a minimum.

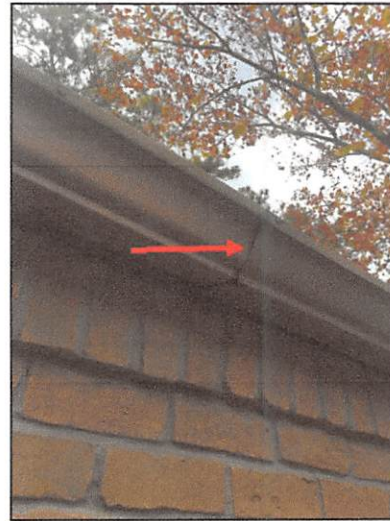
- A gutter system was installed, which is used to centralize collection and removal of water from roof runoff. Gutters are prone to leakage at the joints, which can cause damage to the fascia trim (there were multiple gutter joints/seams around the home). The downspouts are not checked for proper water flow. Regular cleaning is required in order for the gutter system to function properly.

There were multiple gutter joints/seams around the home

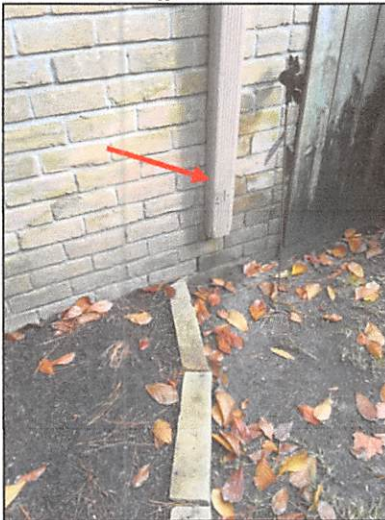
Some of the 90-degree downspout elbows were missing

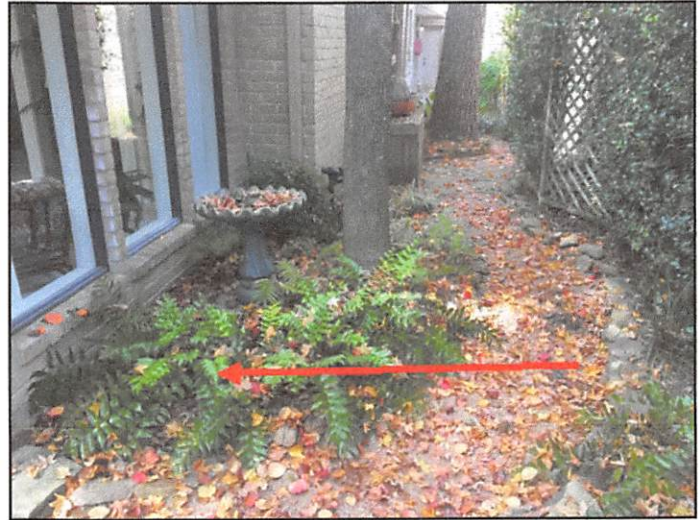
Grading appeared to be inadequate and does not slope away from the foundation on all sides of the home

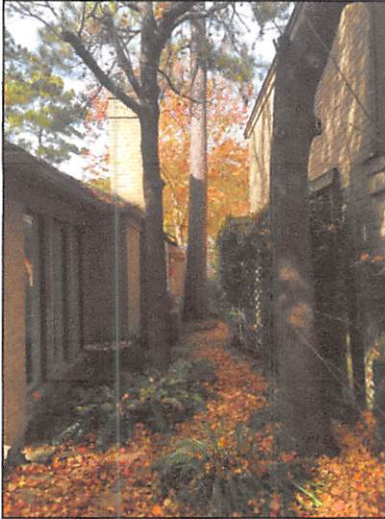
- 5 trees were located within 15 feet of the foundation on the left side and back side of the home. Trees and roots may cause foundation movement due to moisture extraction. If additional or seasonal movement occurs, root pruning and/or barriers may be considered. Keep in mind that removing a large tree next to a foundation could also cause problems as the soil will retain more moisture, affecting the foundation. Recommend contacting a qualified structural engineer and tree specialist for more information and monitor the foundation/wall/roof to ensure damage free conditions.

5 trees were located within 15 feet of the foundation on the left side and back side of the home

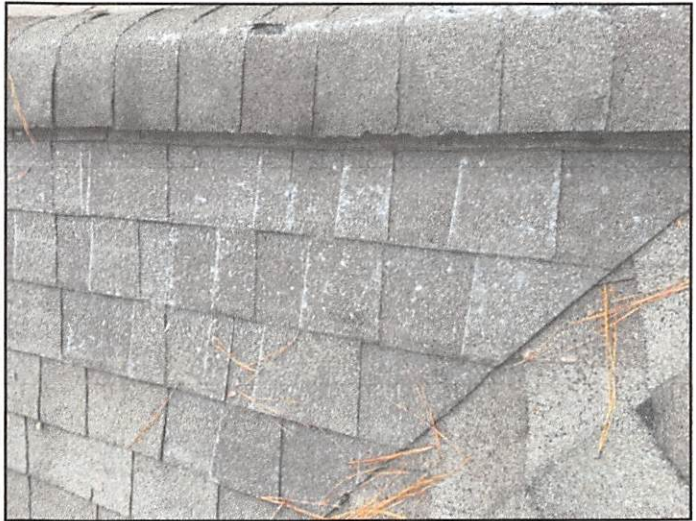
- Indications of granular loss, exposed felt and pitting observed to the shingles indicating aging of the roof system. Recommend review by a qualified roofer.

Observed exposed felt on the roof shingles

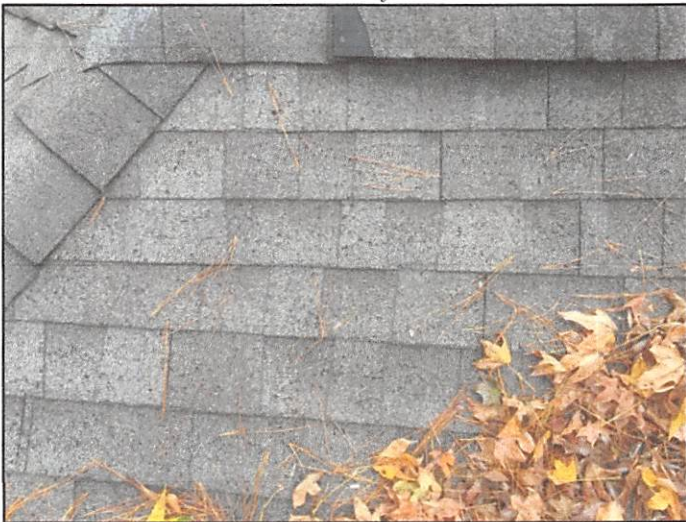
Observed pitting on the roof shingles

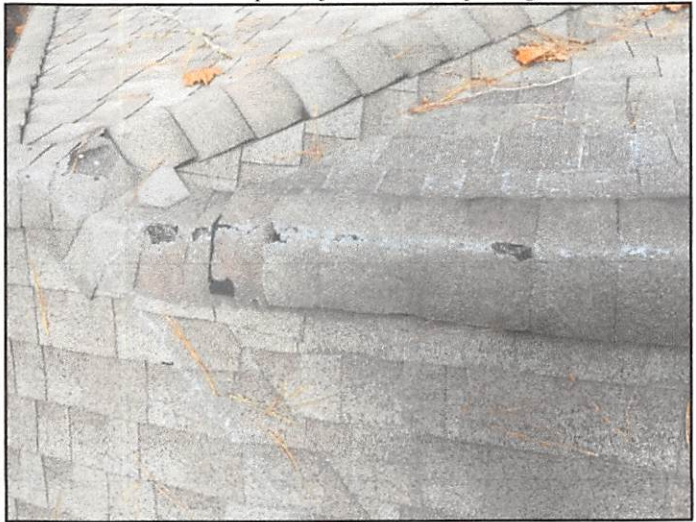
Observed deteriorated ridge shingles

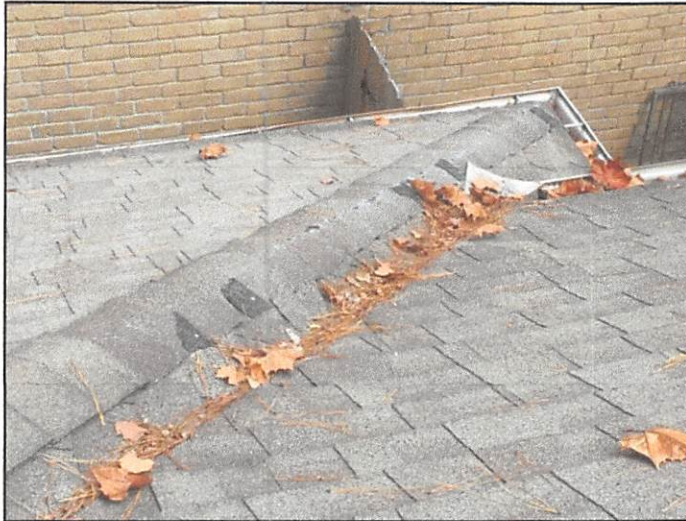
Observed deteriorated ridge shingles

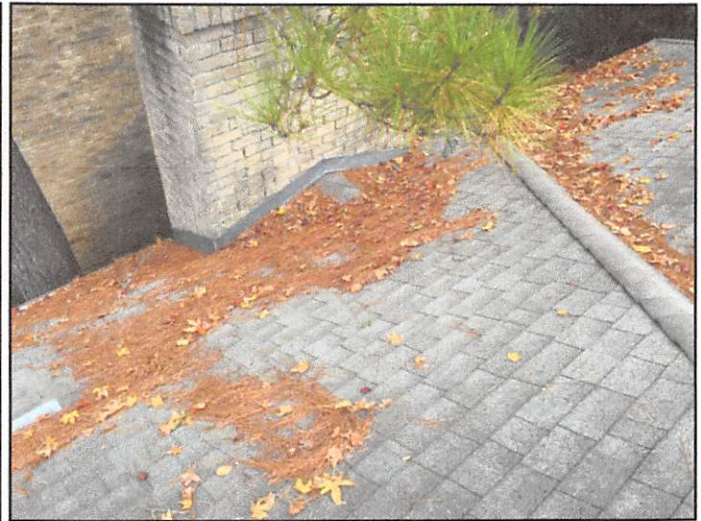
- Debris observed on the roof and valleys limits the view of the roof and prevents the roof from draining or drying out. Debris in the valleys may cause water to dam and flashings to leak. Suggest periodic removal of debris as part of routine maintenance.

Debris observed on the roof/valleys limits the view of the roof and prevents the roof from draining or drying out.

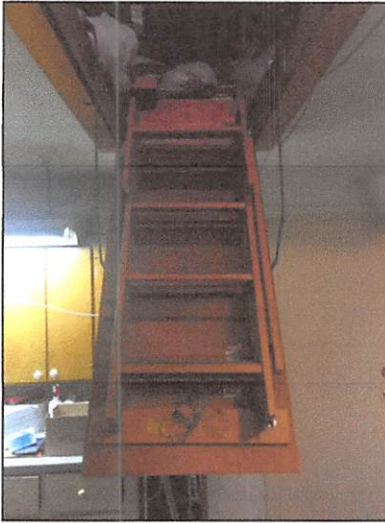
The garage stair assembly was not fire rated

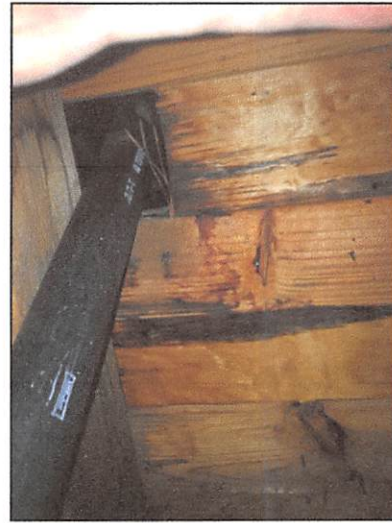
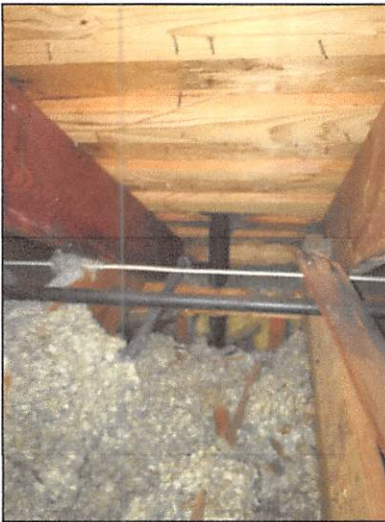
- Dry stains observed on the roof sheathing next to 2 plumbing vent penetrations on the left side of the attic (above the garage access). The stains were probed with an ExTech Moisture Meter, which showed no moisture present at time of inspection. Recommend consulting with the home owner to see if repairs were made and monitoring the area during the next heavy rain for possible issues.

Moisture stain on the roof sheathing at a plumbing vent penetration on the left side of the roof

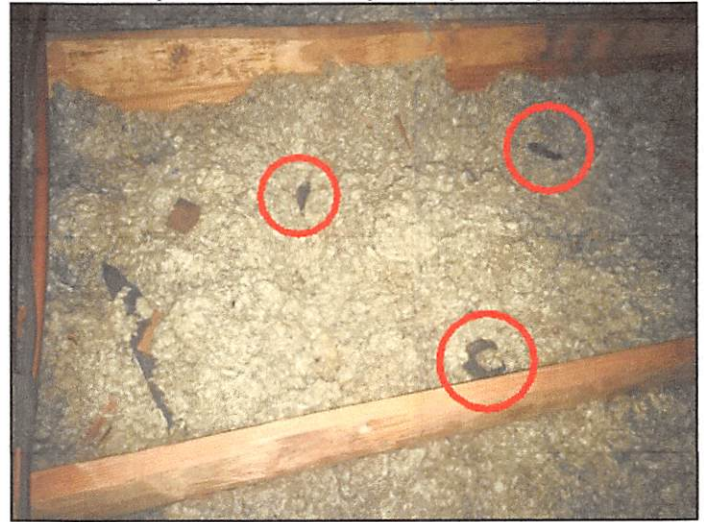
- Indications of rodent droppings observed in the attic. Recommend eliminating access points onto the roof and into the home. This may involve cutting tree branches away from the roof and sealing openings into the home at roof soffits and garage doors (there was an opening into the attic space above the roof overhang at the breakfast room exterior door).

Indications of rodent droppings observed in the attic

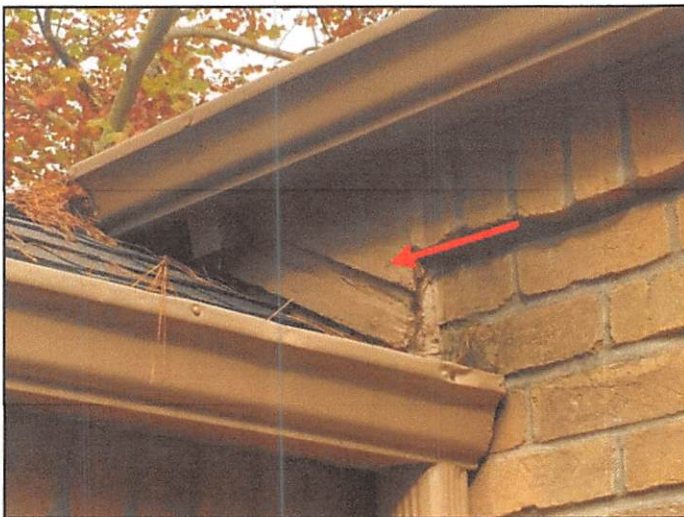
- Observed moisture deteriorated siding at the roof/wall junction near the back right corner of the garage roof. It appeared the siding at the roof/wall junction near the back left corner of the garage roof had been repaired with a siding patch and sealed. There were also indications of previous moisture on the inside of both of these walls as seen from inside the attic space. Both locations appeared to receive moisture runoff from the gutters directly above. The garage ceiling stain (discussed in the "Ceilings and Floors" section) appeared underneath the roof/wall junction near the back left corner of the garage roof.

Observed moisture deteriorated siding at the roof/wall junction near the back right corner of the garage roof

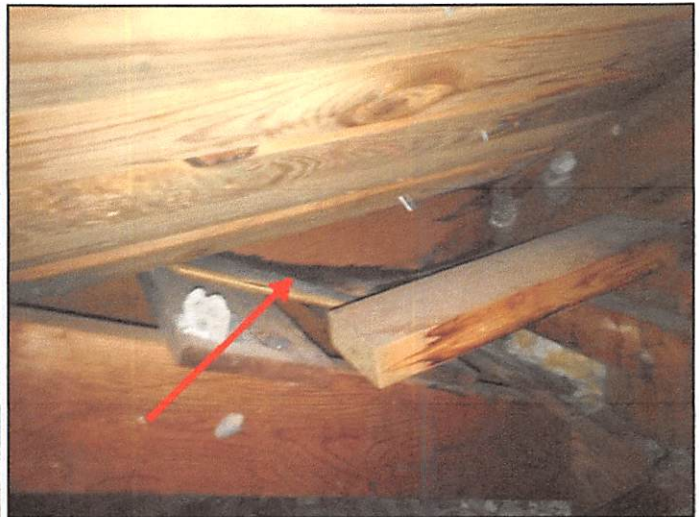
Moisture stain below the roof/wall junction near the back left corner of the garage roof as seen from the attic

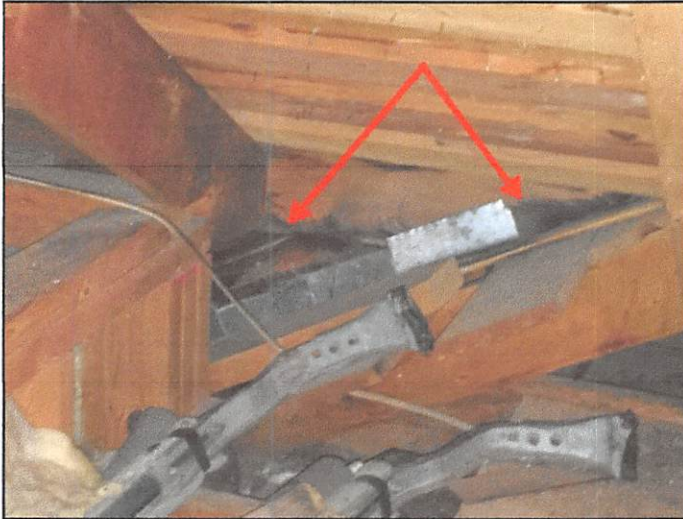
Moisture stain below the roof/wall junction near the back right corner of the garage roof as seen from the attic

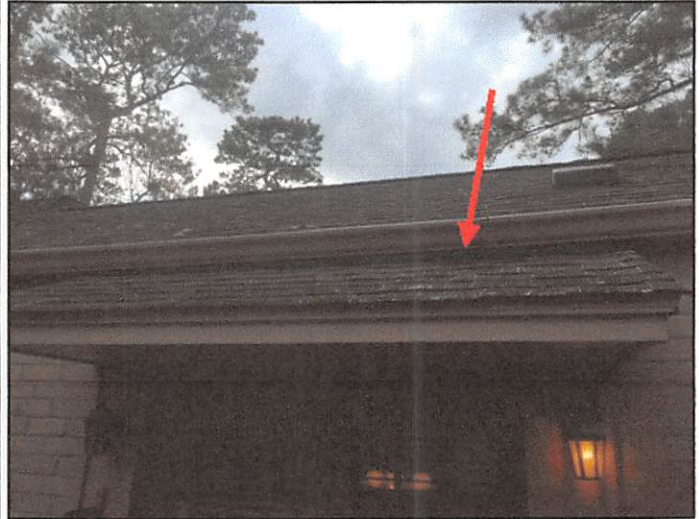
There was an open gap into the attic above the roof overhang by the breakfast room exterior door

- There was an open gap into the attic above the roof overhang by the breakfast room exterior door. Recommend sealing this area to prevent rodent entry.

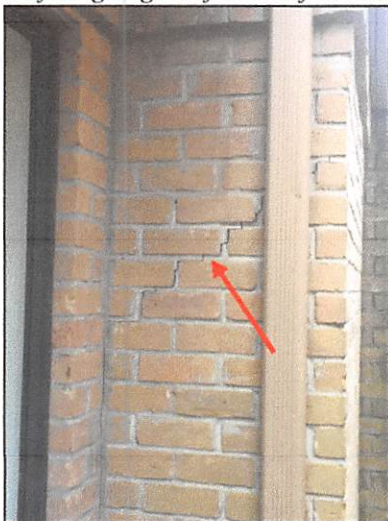
- Stress crack observed in the brick veneer on the back left side of the home. This was an indication that previous deflection or thermo expansion had occurred at this location. Inspector was unable to determine when this occurred or if additional cracking is likely. All buildings settle with minor wall and foundation cracking visible at some point. Recommend sealing the crack to prevent moisture intrusion and monitor for further movement.

Stress crack observed in the brick veneer on the back left side of the home

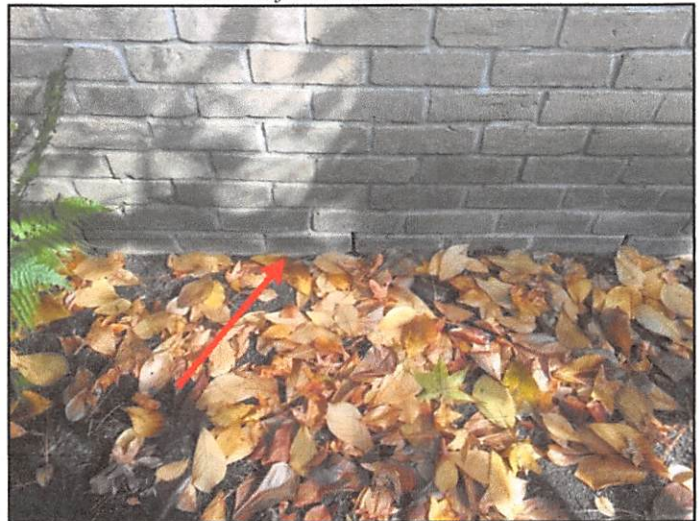
- Weep holes (small openings in brick wall mortar joints) were at grade level on the front side, left side and right side of the home. Weep holes allow airflow for ventilation and allow moisture to drain. This condition can allow water to enter the interior of the wall and cause related moisture problems. Recommend grade improvements and/or landscape alterations to ensure all water drains away from the homes foundation.

Weep holes (small openings in brick wall mortar joints) were at grade level on the front side, right side and left side of the home

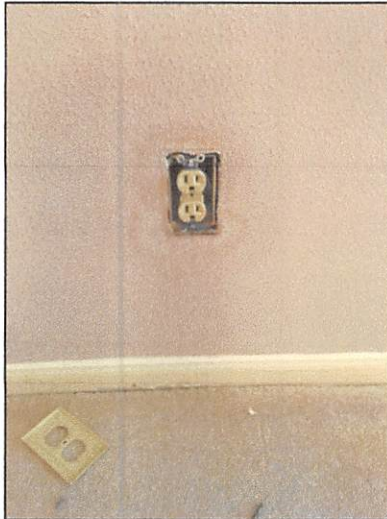
- Observed a dry stain on the right wall of the back bedroom. The inspector probed the stain with an ExTech Moisture Meter, which showed no moisture present at time of inspection. Client is advised to consult seller to determine the source of staining and verify that corrections have been made.

Observed a dry stain on the right wall of the back bedroom

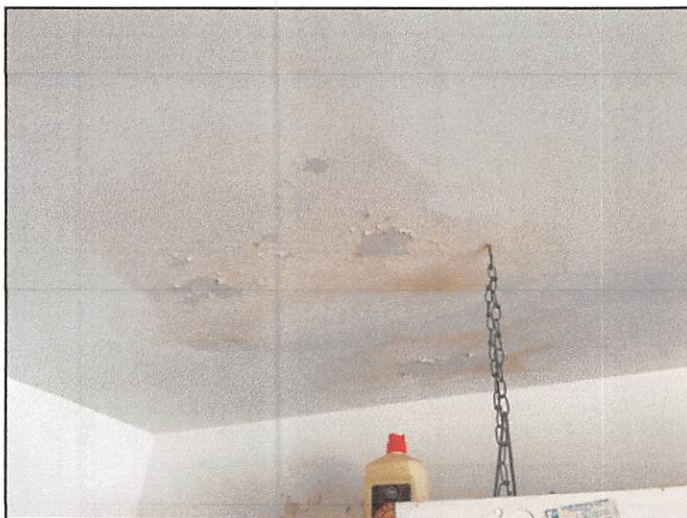
Dry ceiling stain observed near the back left corner of the garage

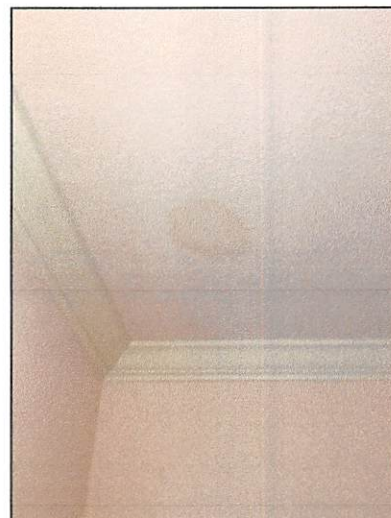
Observed a dry stain on the front bedroom ceiling

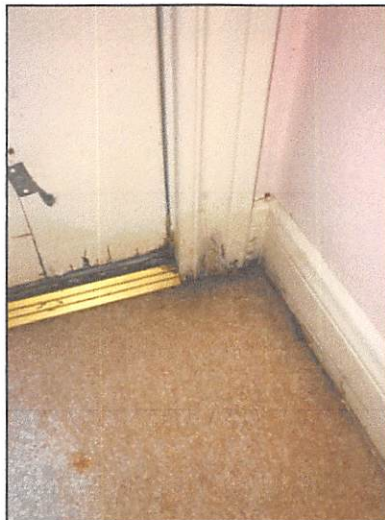
- Indications of previous moisture at the bottom right corner of the front bedroom exterior door, apparently from a door leak. Recommend consulting the owner for more information.

Indications of previous moisture at the bottom right corner of the front bedroom exterior door, apparently from a door leak

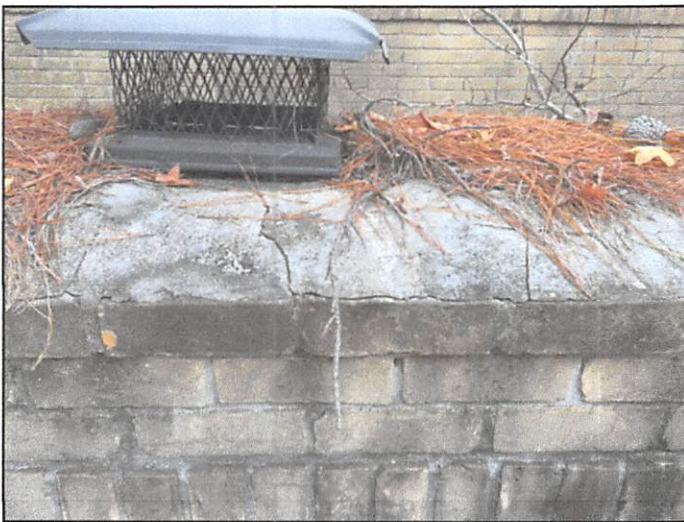
- The chimney crown was cracked and needs to be sealed/replaced to prevent moisture from entering the chimney.

The chimney crown was cracked and needs to be sealed/replaced to prevent moisture from entering the chimney

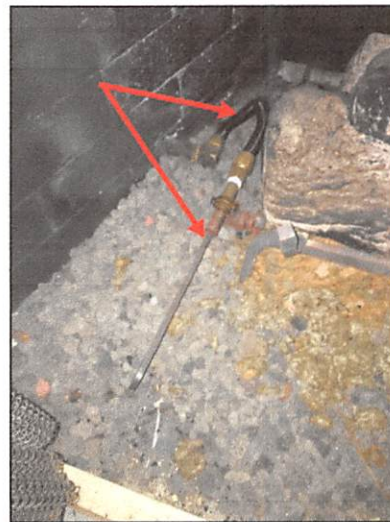
- Both the gas valve and a flexible gas line were located inside the firebox. Recommend consulting a fireplace specialist for safety reasons prior to using this fireplace.

Both the gas valve and a flexible gas line were located inside the firebox

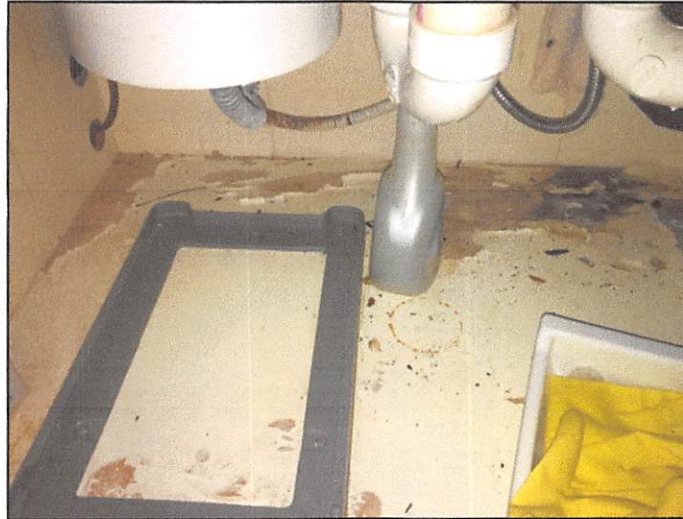
- Indications of previous moisture observed on the bottom shelf of the kitchen sink cabinet. No leaks were detected at the time of inspection.

Indications of previous moisture observed on the bottom shelf of the kitchen sink cabinet

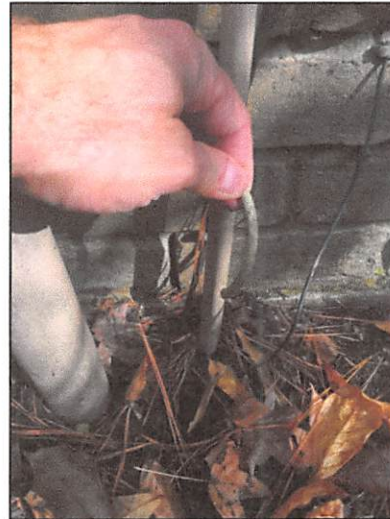
The grounding electrode conductor was disconnected from the exterior grounding rod clamp

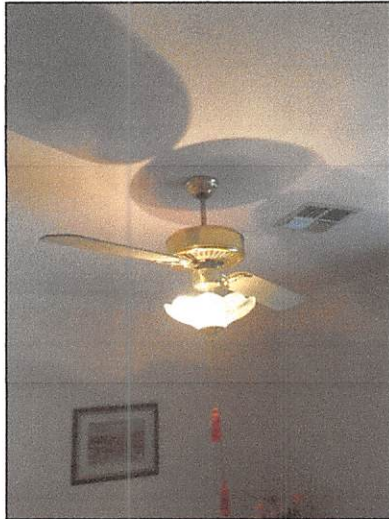
The ceiling fan in the front bedroom was missing 2 fan blades

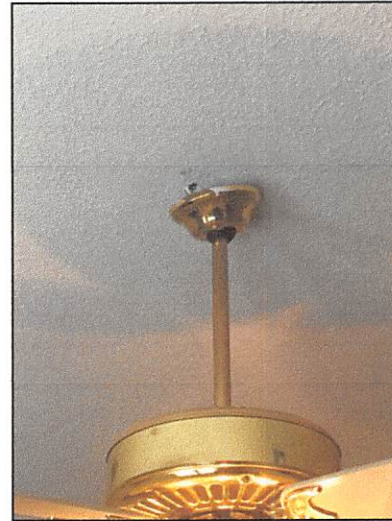
The fan canopy was not secured to the ceiling in the master bedroom

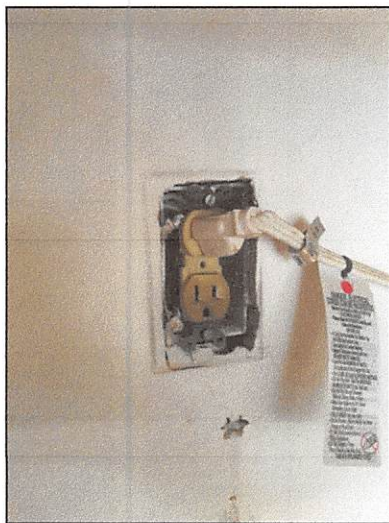
The receptacle on the left wall of the garage was damaged

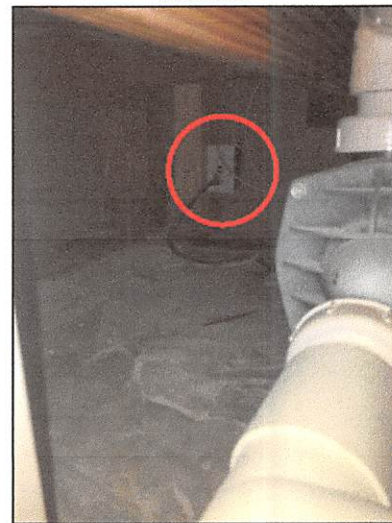
The GFI receptacle for the hydro massage tub was located in an inaccessible location inside the access panel underneath the hydrotub

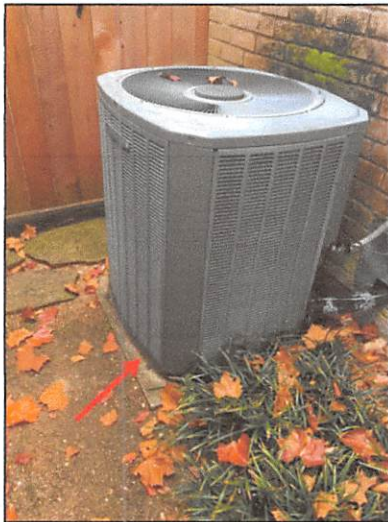
- The condenser pad was at ground level. Recommend raising the pad a minimum 3-inches above ground level to prevent corrosion to the base of the condenser unit.
- The A/C condensers was located 3 inches from the exterior wall (should have a 12-inch minimum clearance from exterior walls); recommend correction for proper cooling.

Recommend raising the pad a minimum 3-inches above ground level to prevent corrosion to the base of the condenser unit

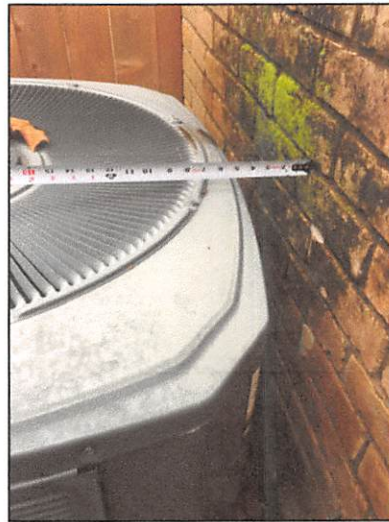
There was inadequate clearance between the condenser and exterior wall

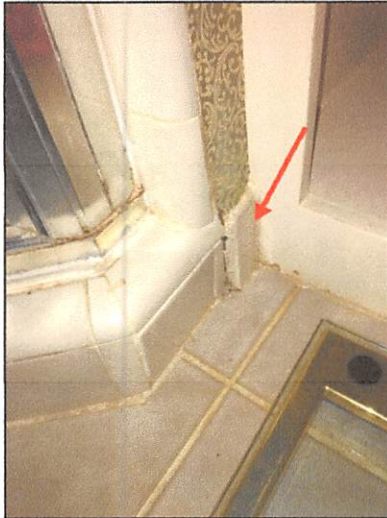
Observed a loosely attached tile outside the master bathroom shower

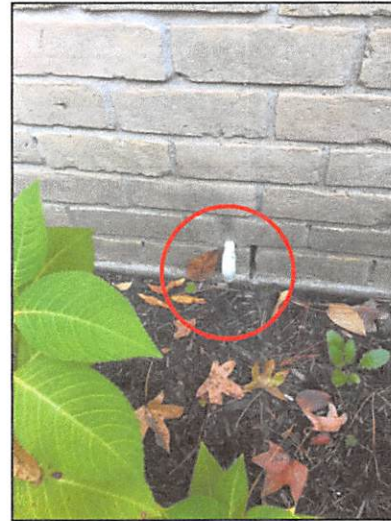
The water heater TPR valve discharge line terminated on the right side of the home

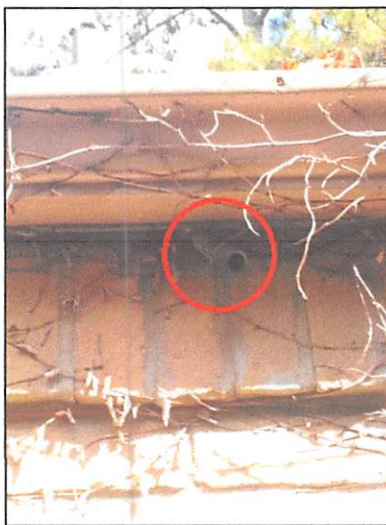
The water heater overflow pan drain line terminated incorrectly at the roof soffit on the right side of the home

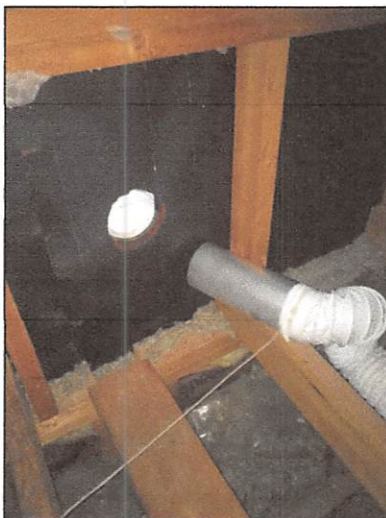
The small bathroom vent was disconnected from the exterior wall connection

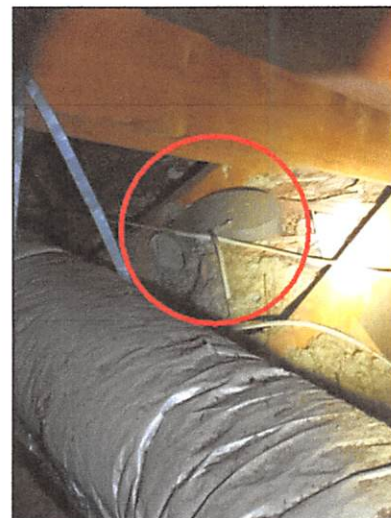
- The master bathroom exhaust fan vibrated or was excessively noisy. This may indicate a worn armature or bearings.
- The master bathroom exhaust fan was venting to the attic, which allows moist air into the attic. The small bathroom exhaust vent was disconnected from the exterior wall (as seen from inside the attic space) and was also venting into the attic. Current inspection standards call for bathroom vents to terminate to the exterior. Recommend extending master bathroom fan exhaust to the exterior through a roof vent when the roof is replaced and reconnecting the small bathroom vent to the exterior wall connection.

The master bathroom exhaust fan was improperly venting to the attic, which allows moist air into the attic

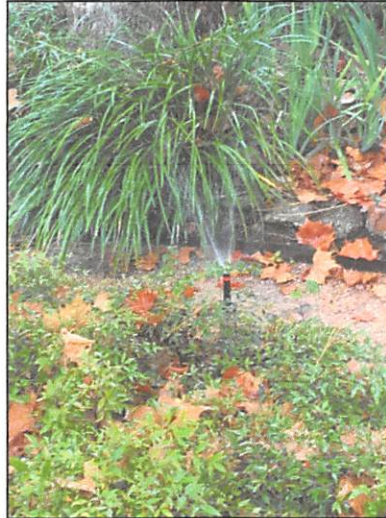
2 sprinkler heads in zone 1 and 1 sprinkler head in zone 2 were malfunctioning
