PROPERTY INSPECTION REPORT

Concerning: 19103 Putting Green Dr, humble, TX 77346
(Address or Other Identification of Inspected Property)

By: James Lee, Lic #23485 05/24/2019
(Name and License Number of Inspector) (Date)

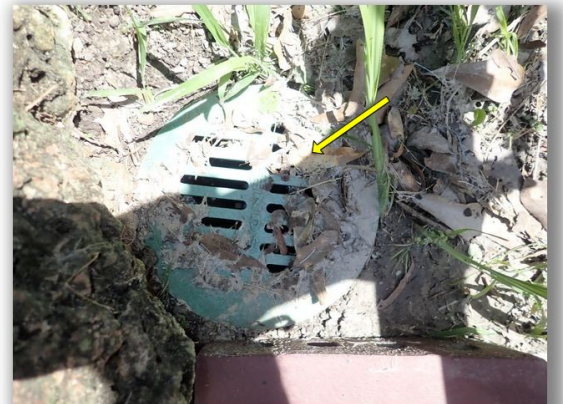
- Marginal site drainage was observed on the north side of the structure. Proper drainage is needed to help prevent water from standing and/or ponding next to the foundation beam. Corrective measures may be needed if the water stands within 10-feet of the foundation perimeter beam for more than 24-hours.
- There is an underground and/or surface drainage system in place. It appears that the surface water collector(s) and/or drain(s) are clogged and/or filled with debris. This condition will adversely affect the performance of the drainage system and corrected measures are needed at this time.

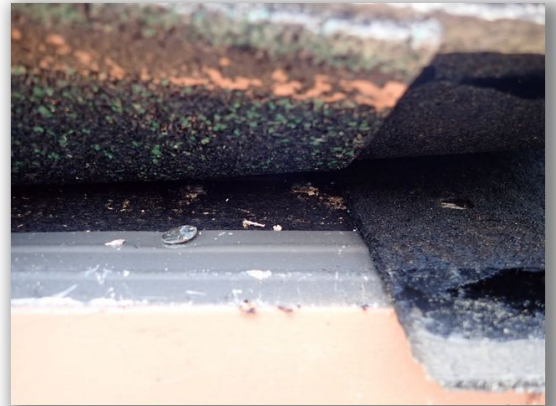
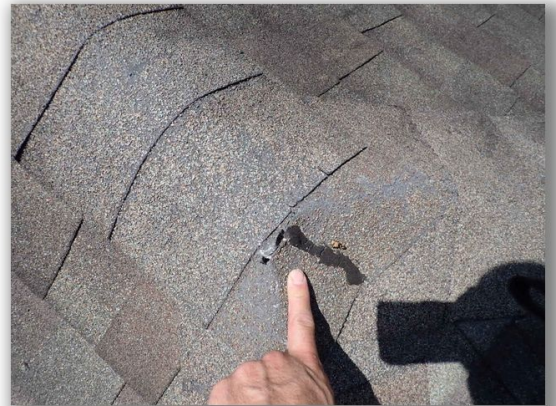
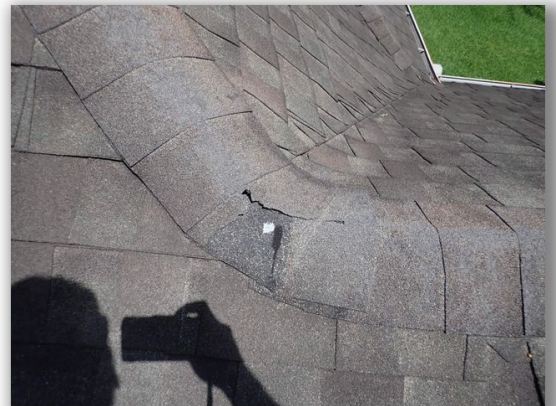
- Damaged shingles were observed on the south side of the roof structure.
- Shingle fasteners (staples and/or nails) were observed to be pushing through the roofing material in various locations.
- The composition roofing material has experienced considerable granular loss in various locations throughout the roof.
- Tree and shrub branches need to be trimmed away from the roofing material at all times to help prevent damage to the roofing material. It is the opinion of this Inspector that there are some branches too close to the roofing material at this time and corrective measures are needed.

Note: Roof fasteners (nails and/or staples) were observed to be exposed and should be properly sealed at the ridge caps and flashing areas.

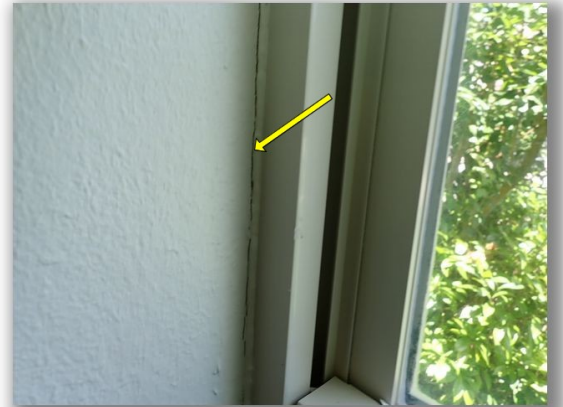
- Wall surface damage was observed in the kitchen, breakfast area.
- Interior wall joint cracks were observed in the master bedroom.

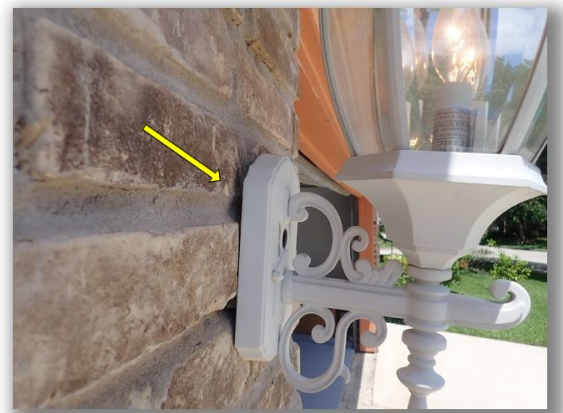
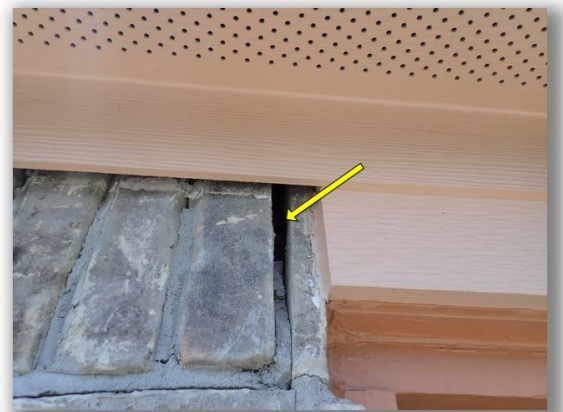
- Mortar improvements are recommended for the exterior masonry veneer on the south side, east side, north side of the structure.
- The wood veneer trim has some deterioration or damage on the south side of the structure.

Note: Minor mortar and/or brick cracks were observed in the exterior veneer on the south side, east side of the structure.

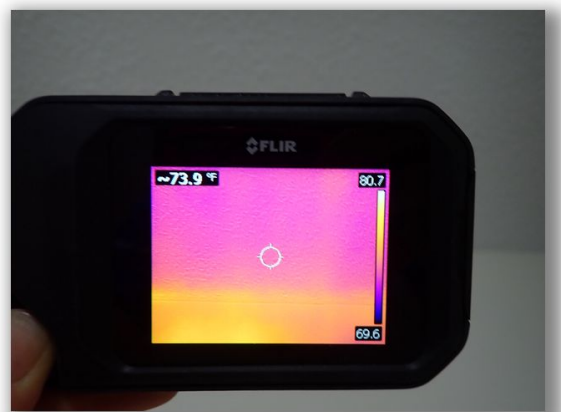
- Ceiling joint cracks were observed in the kitchen.
- Water stains and water damage was observed on the ceiling finishes in the upstairs rear middle bedroom. The cause and remedy should be further evaluated and corrected as necessary.

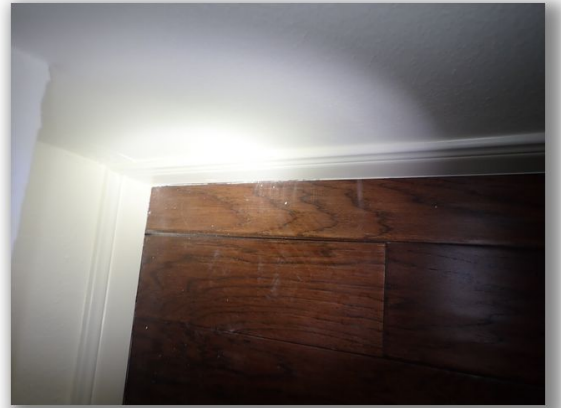
- The floor covering was observed to be missing in the utility room.

Note: The upstairs sub-floors (flooring) observed to squeak when walked over.

Note: Some cracking of the garage concrete floor finish was observed.

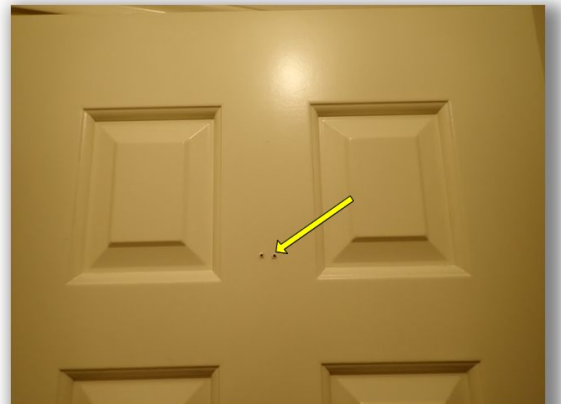
- The door is not latching properly to the laundry room, upstairs rear corner bedroom closet, Jack and Jill bathroom.
- The door frame has some damage to the laundry room.
- The door has some surface damage to the upstairs rear corner bedroom closet.
- The door hardware is missing to the upstairs rear middle bedroom closet.

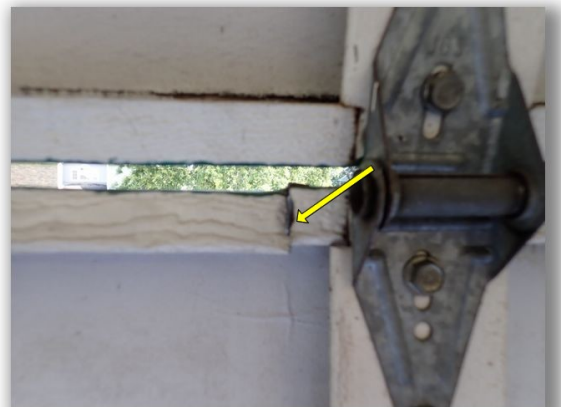
- The weather-stripping at the bottom of the overhead garage door is damaged and repairs or replacement may be necessary.
- The overhead garage door panel(s) and/or panel trim has some deterioration and/or damage.

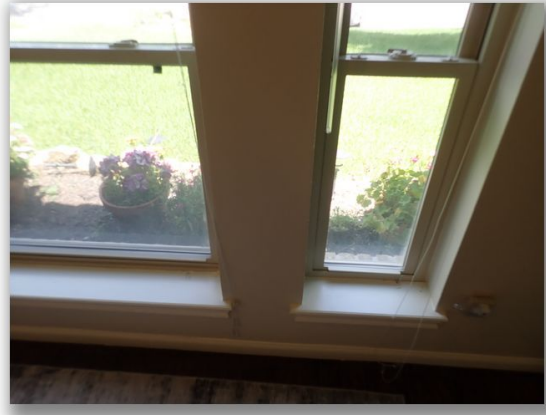
- One or more of the window screens were observed to be missing.

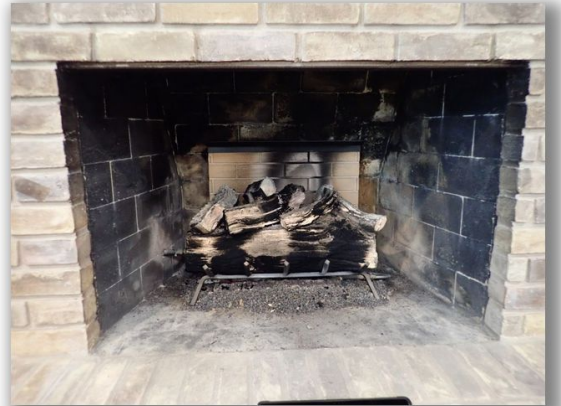
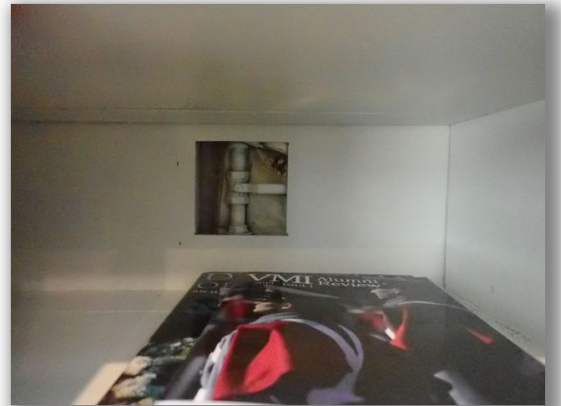
- The chimney flue needs to be cleaned by a Qualified Chimney Sweep. A creosote / soot build-up was observed in the visible flue area.

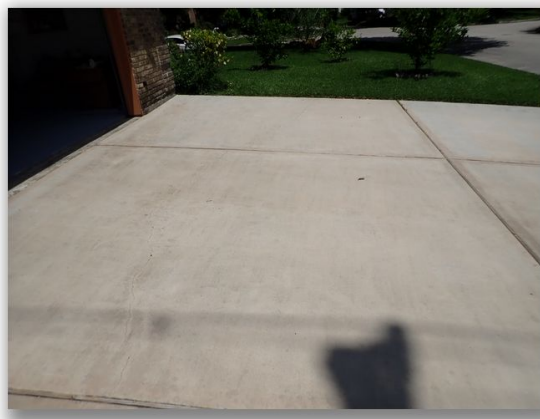
- Minor cracks and/or deficiencies were observed in the driveway.

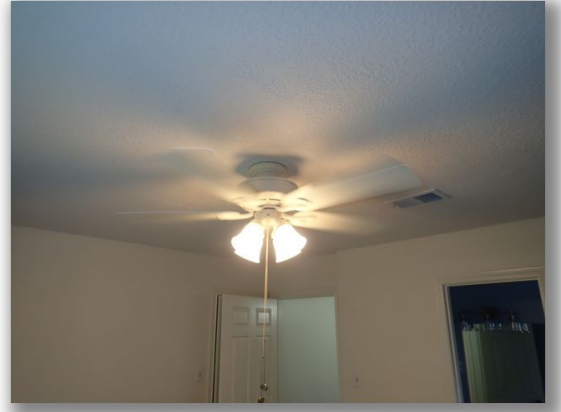
- One or more of the closet light fixtures appear to be installed without globes and/or covers. Safety precautions should be taken around these light fixtures.
- The ceiling fan was observed to be noisy when operated in the upstairs front middle bedroom.

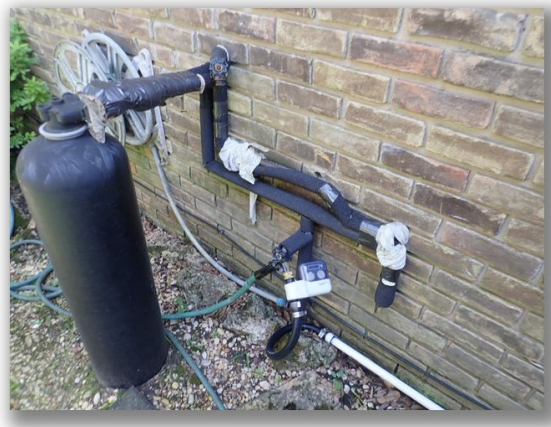
- There are galvanized water lines in use at the time of this inspection. This is an older obsolete water supply system that is prone to water leaks. Full evaluation of all of the galvanized water line components and the integrity of those components are beyond the scope of this inspection. You are strongly encouraged to have the integrity of all of the galvanized water line components further evaluated by a qualified plumber prior to the expiration of any time limitations such as option or warranty periods. All plumber recommended repairs should be made. It would be wise to budget for replacement of all the older galvanized water supply system and to make a conversion over to a newer type of water supply system as soon as it is financially feasible.

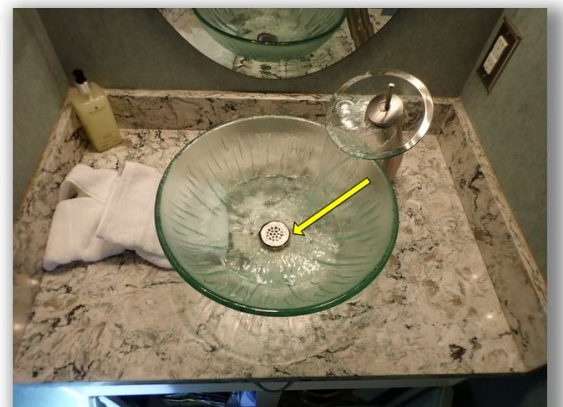
- The stopper does not appear to be functioning properly.
- The sink was observed to drain slowly, suggesting that an obstruction may exist.
- The faucets hot/cold water orientation is reversed.

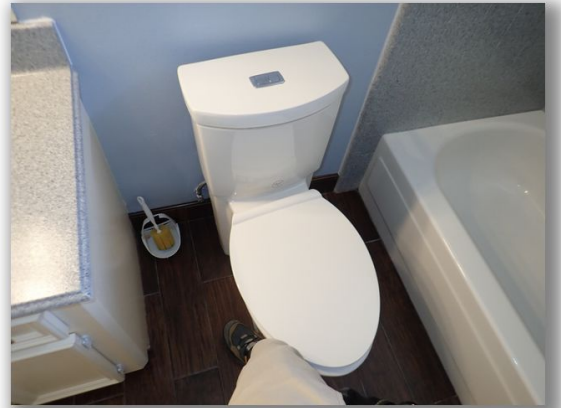
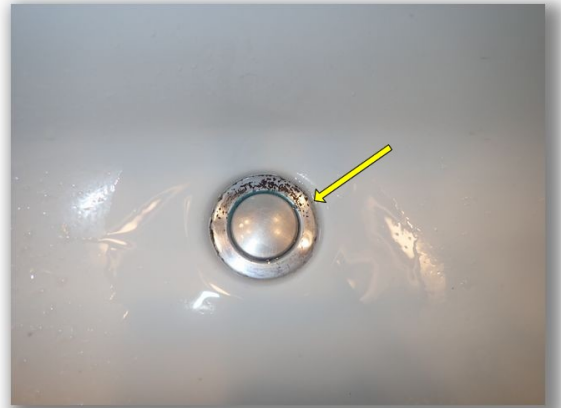
- The faucet assembly is not sealed at the wall. This condition has the potential to allow water to leak back into the wall cavity.
- The tub spout is not sealed at the wall. This condition has the potential to allow water to leak back into the wall cavity.
- The shower spout is leaking at the neck connection.

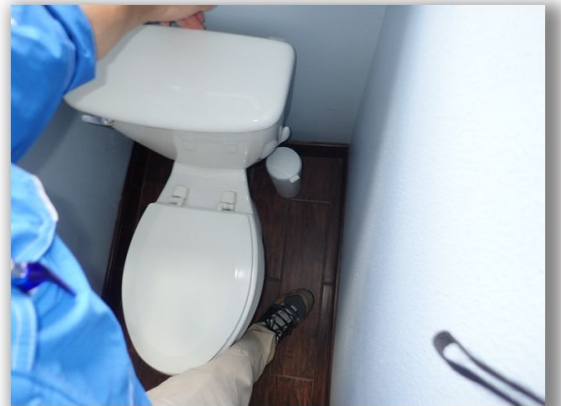
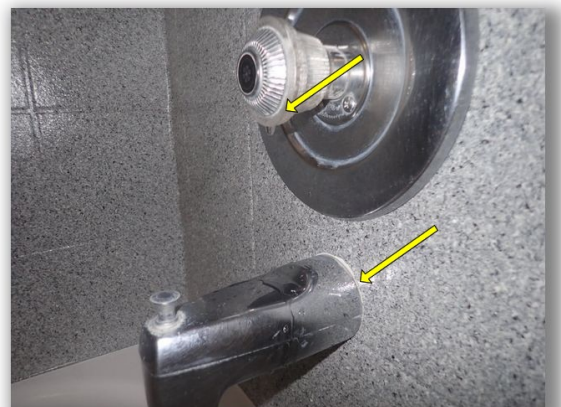
- The faucet assembly is not sealed at the wall. This condition has the potential to allow water to leak back into the wall cavity.
- The faucet leaks at the handle when on.
- The stopper has some surface damage.

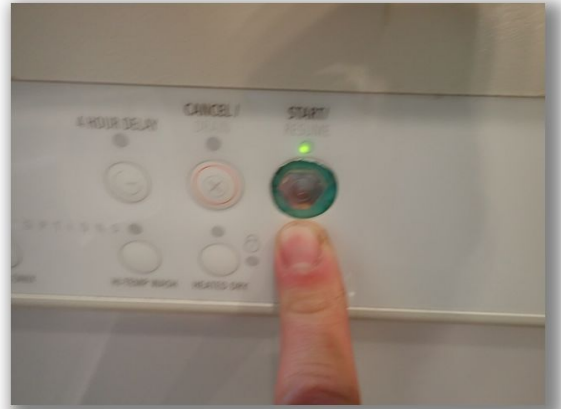
- Some rusting of the dishwasher interior components was observed.
- Some damage to the dishwasher controls and/or control panel was observed.

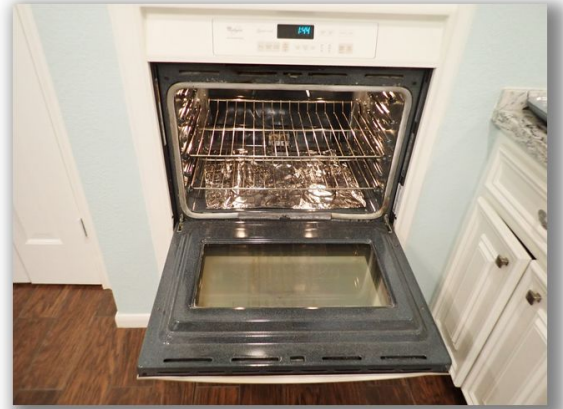
- The door handle is loose at the time of inspection.

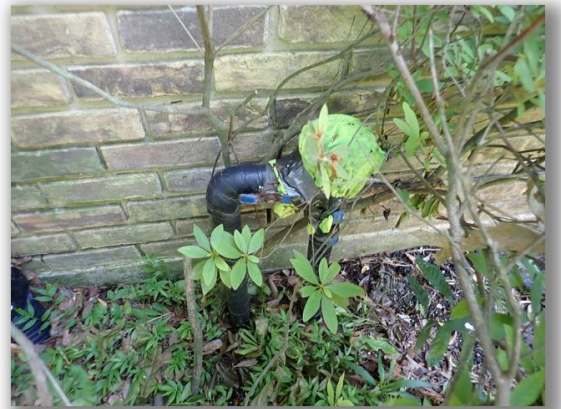
The sprinkler system did not respond to the controls when tested in the manual setting. The cause and remedy should be further evaluated and corrected as necessary.

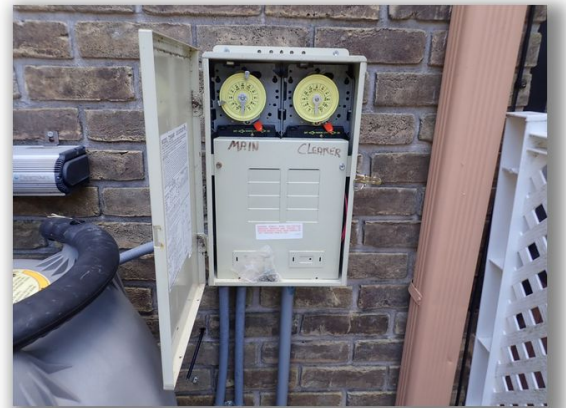
- There appears to be a water leak at the above ground plumbing lines at and around the equipment. The cause and remedy should be further evaluated and corrected as necessary.
- It is recommended to paint all exposed PVC pipes to prevent UV break down.
- There is a visible water leak at and around the filter housing.
- Some cracking of the deck was observed.

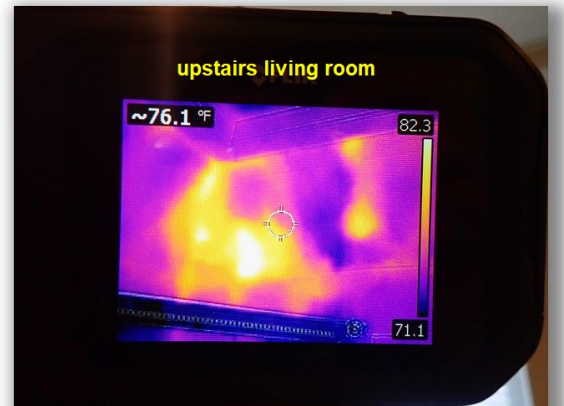
- Missing insulation was observed within the wall cavity in the dining room, upstairs living room.
