**MAIN GATE REAL ESTATE INSPECTION**

# Property Inspection Report

**Property Address:** 10510 Autumn Meadow Ln, Houston, TX 77064-5033

**Date of Inspection:** 07/18/2019

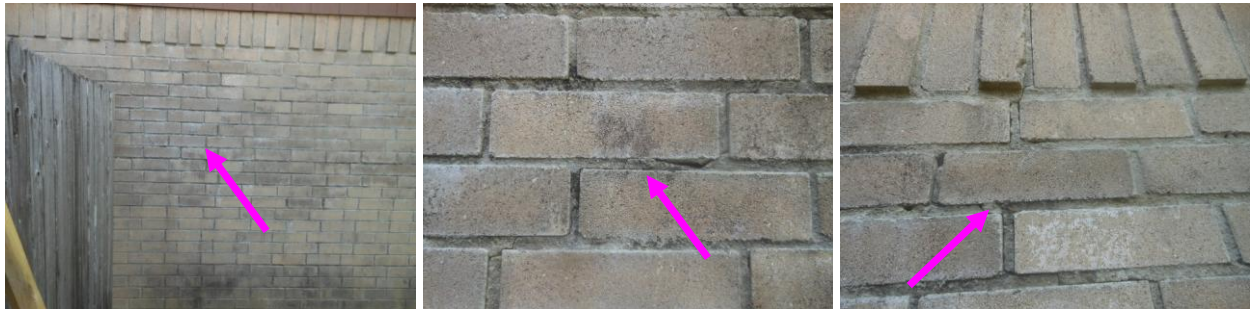
1. Z-cracked/separated brick veneer; on the right side of the building

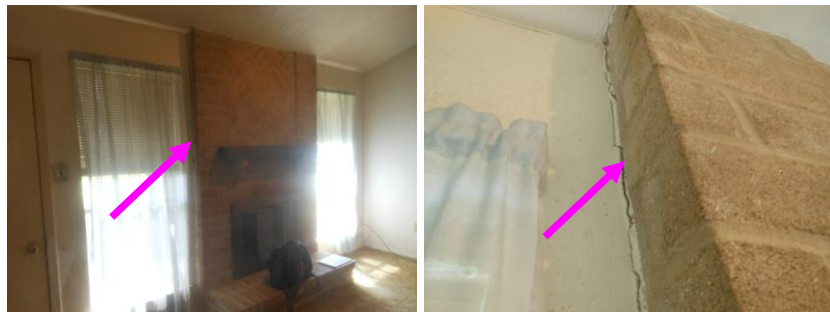
2. Separated brick to sheetrock wall at fireplace

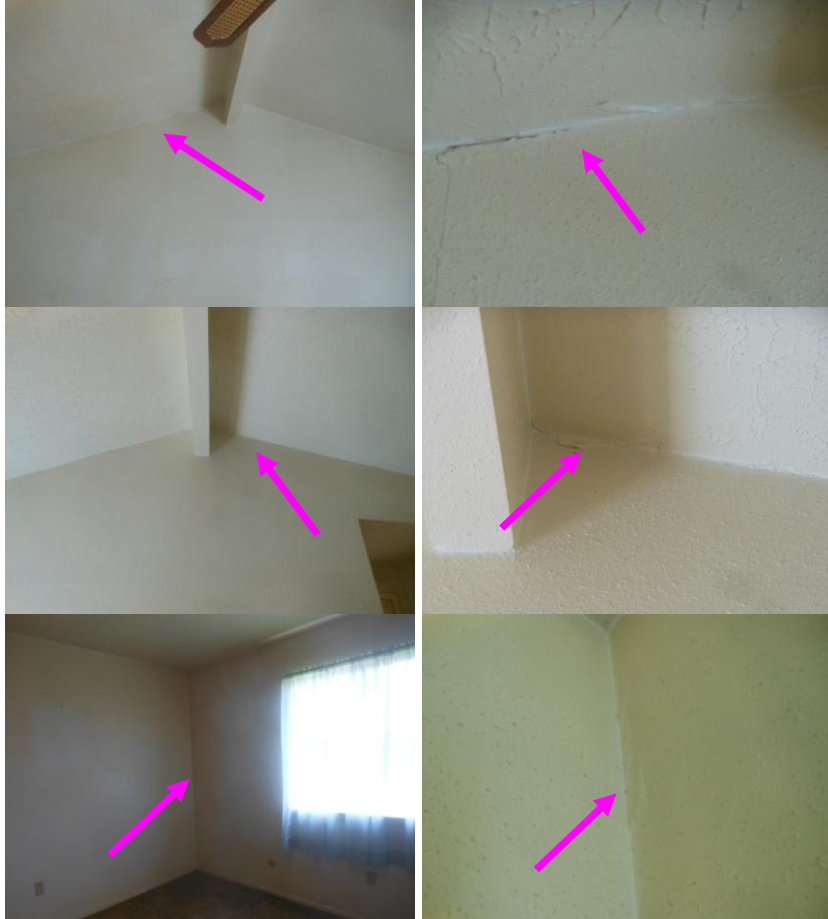
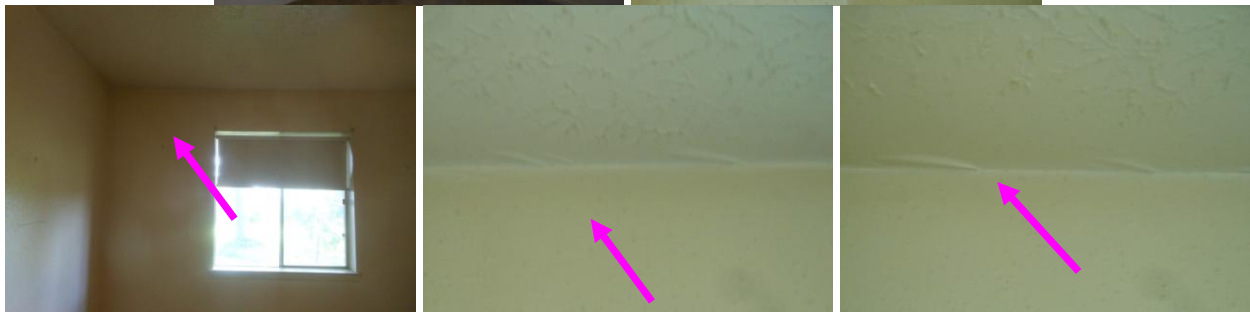
3. Wrinkle sheetrock tapes at ceiling to wall joints and/or wall to wall joint(s); in living room, in rear bedroom and in master bedroom

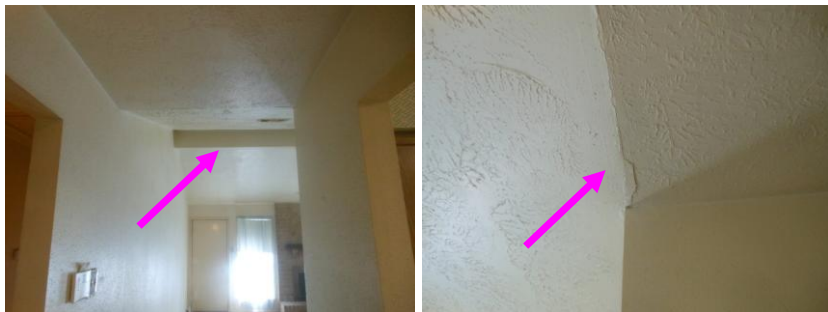
4. Cracked/separated ceiling; at hallway leading to in living room

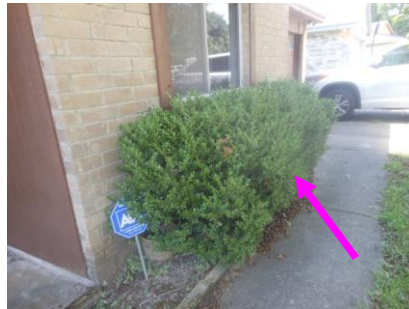
1. Shrubberies concealed view. This condition will hold moisture and is conducive for insect activity. Cutting back the foliage in this area is recommended

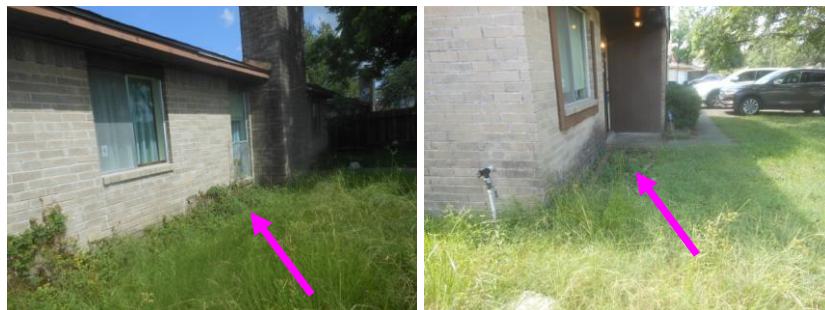
2. Uncollected water from roof will stand in eroded ground areas/in low ground areas/flat areas along the perimeter of the foundation in front and rear of the building during and/or after rains. Poor drainage can have an adverse effect of the performance of the foundation. Water from roof should be collected and discharged at least 5 feet away from the foundation. Proper drainage should include adequate slope of the ground directed toward drainage devices that are capable of carrying surface water run-off (it should be constructed with gradual slope in such a manner as to shed water away from the foundation). Client(s) is recommended to install a complete rain gutter system with downspout(s) to direct roof water to appropriate drainage areas.

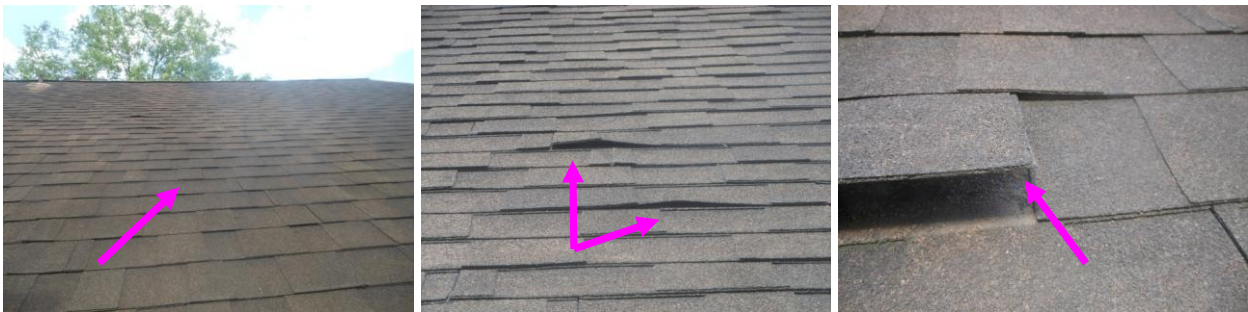
1. The composition in roof surface displays evidences of deterioration; loose, lift and wear-and-tear shingle tiles.

**Recommendation:** It is unknown exactly the age of the roof covering and since the roof covering has reached toward the end of its useful life, second opinion and/or further evaluation by qualified roofing contractor for repair/replacement

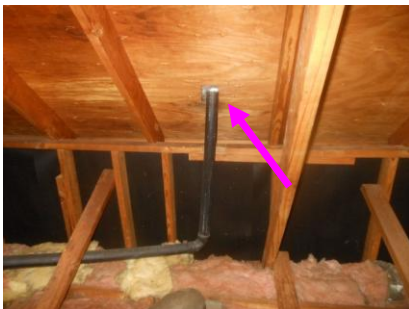
2. Water entry point was noted on roof at main plumbing vent, it does not appear to be proper installation, open area/sunlight was observed from the attic through roof

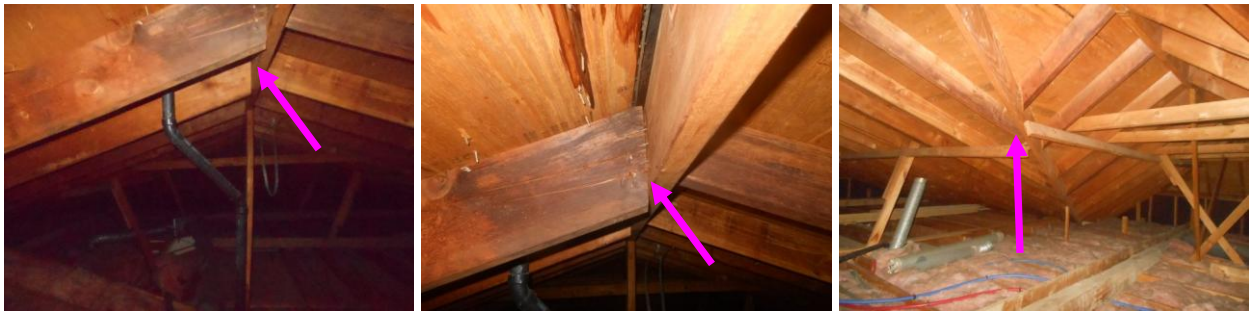
1. Roof structure shows a damaged/broken rafter (refer to left and middle photographs below) and missing a vertical brace at front middle hip rafter (refer to right photograph below), conventional roof structure requires installing of a vertical braising for a hip rafter with 9-12 foot long; with current configuration the hip rafter at this location has no adequate support and the roof would be sagging. Further evaluation and repair/replacement by a qualified professional is expected

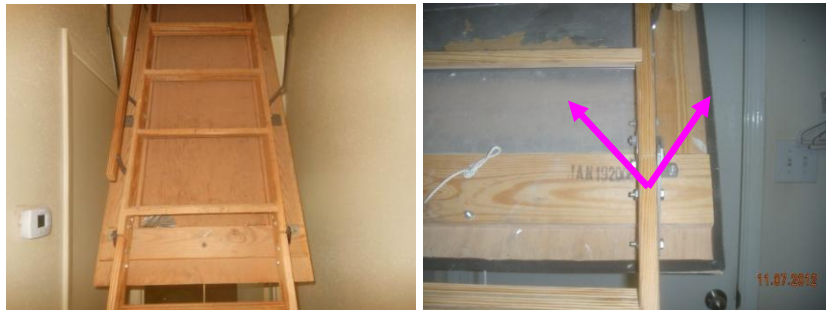
2. Insulation and weather stripping installed at the staircase access to attic are missing. This is a part of the attic and the installations of foam insulation and a weather stripping are required to close up the gap at the staircase to the ceiling to conserve energy (refer to right photograph below for correction).

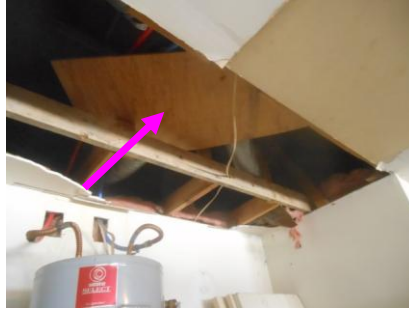
1. The ceiling above the garage was removed probably due by previous plumbing leak, review Seller Disclosure, consult seller(s) through your agent or further evaluation to verify and repair is expected

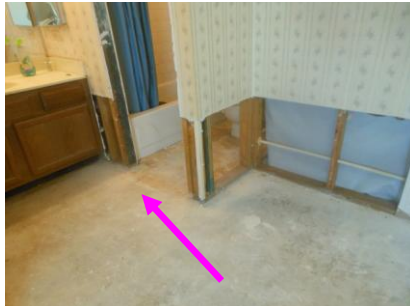
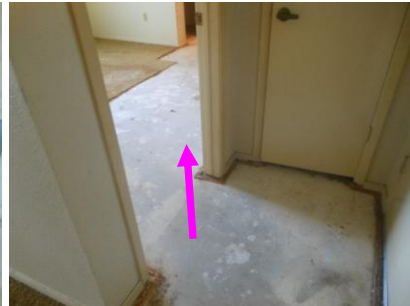
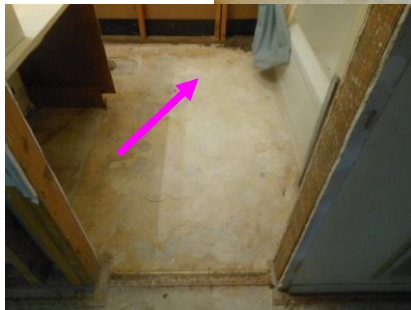
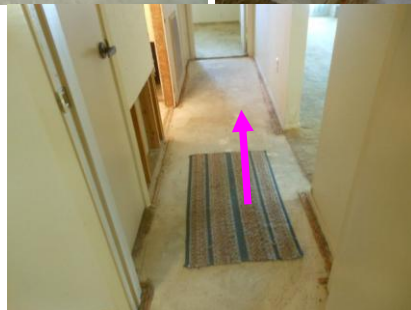
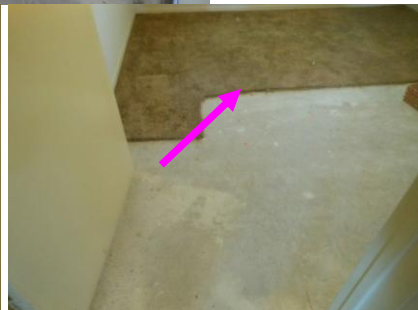
2. Bare floors were visible in front bedroom, at bedrooms hallway, in shared bathroom, in master bedroom and in master bathroom probably due by previous plumbing leak, review Seller Disclosure, consult seller(s) through your agent or further evaluation to verify and repair is expected

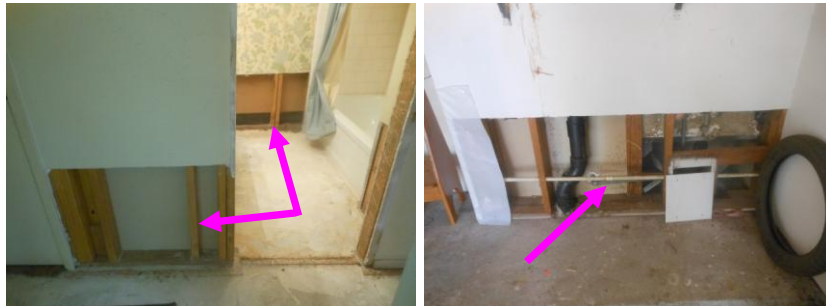
3. Sheetrock walls at bedrooms hallway, in shared bathroom, in master bathroom, and in garage were removed probably due by previous plumbing leak, review Seller Disclosure, consult seller(s) through your agent or further evaluation to verify and repair is expected

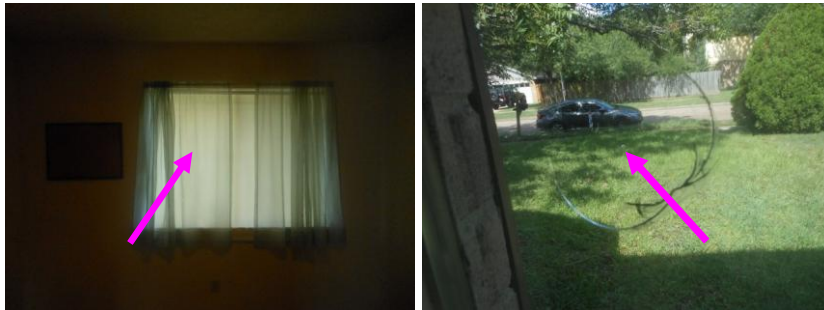
**Comments:** Window in front bedroom has broken glass

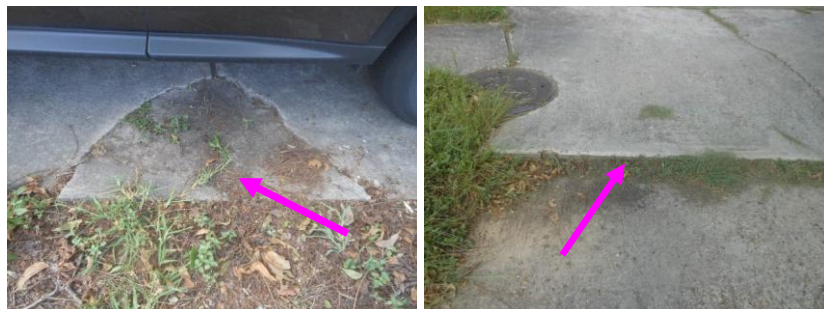
**Comment(s):** Driveway concrete flatwork is broken. Portion of the concrete flatwork is heaved creating potential trip/safety hazard.

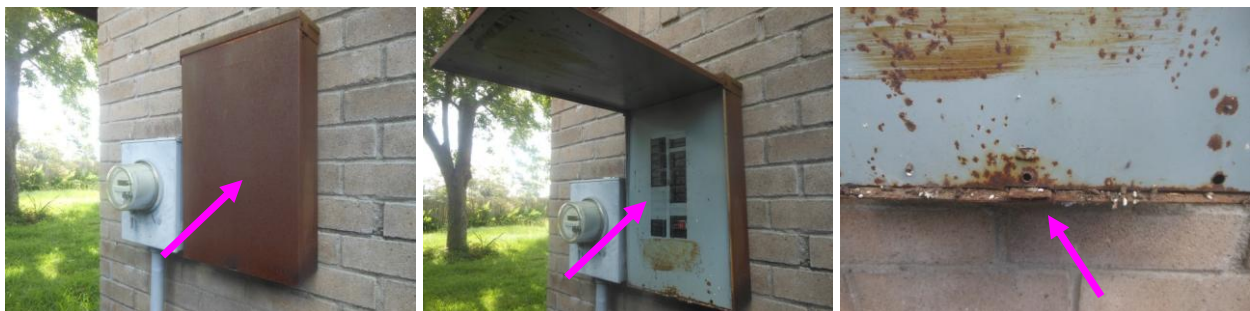
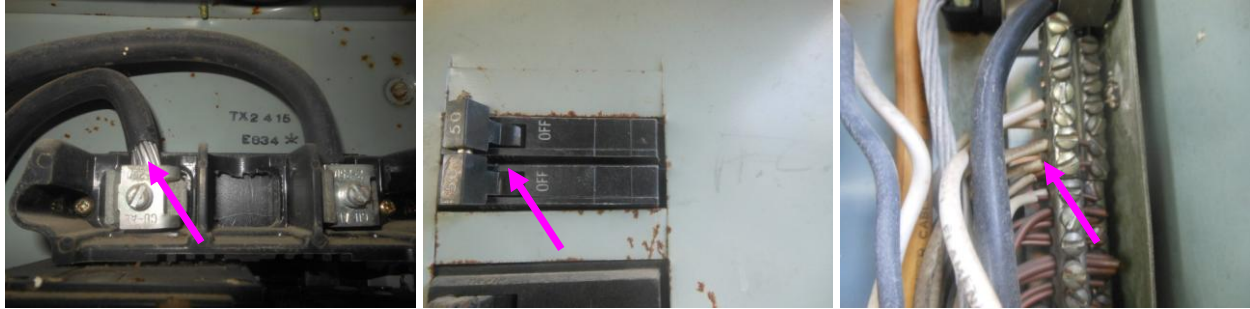
2. Service panel shows rusted housing cover panel, broken latching/locking device (refer to photographs below), no main disconnection, unprotected entrance aluminum wirings (the aluminum entrance wirings in the breaker box are not protected from oxidization, anti-oxidized paste should be applied at the wiring terminations) and over breaker circuit protection (a 30-Amp breaker should be installed as manufacturing's suggestion as the maximum instead of the existing 50-Amp breaker), and double wiring (several groups of two neutral wires shared/connected at same terminals/lugs and this is prohibited by current safety codes). I highly recommend contacting an electrician for replacement cost

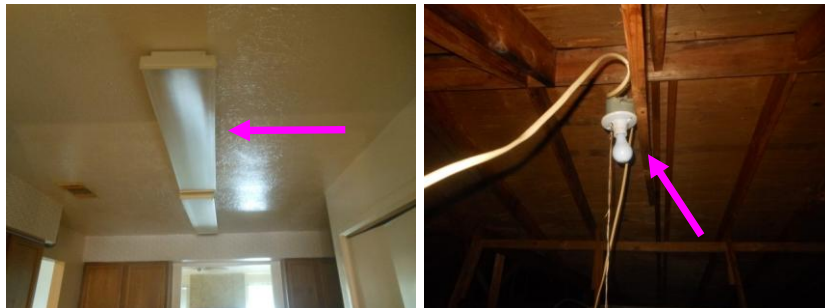
1. Receptacle outlet(s) installed at kitchen counter space (within 6 feet from the sink), in master bathroom (one of them), in garage, at outdoors and in both bathrooms are not installed with GFCI (ground fault circuit interception) protection. TREC requires inspectors to listing this as deficiency and recommend an upgrade.
2. Cover plate for one of the receptacle outlets installed in front bedroom is missing/broken.
3. Light fixture(s)/light tube(s)/light bulb(s) installed in kitchen area and in attic space are not working

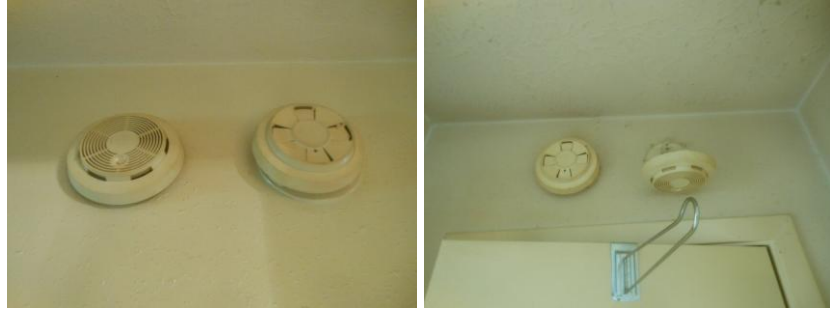
4. Two smoke detectors was/were found in the dwelling. Current safety codes require hard-wiring installation of smoke alarms inside of all bedrooms, and in any rooms designated for the purpose of sleeping, and outside within the proximity of the doors to those rooms. It is also essentially recommended by manufacturers to replace smoke detectors that are 10 years of age and/or older. Test all smoke detectors prior to occupancy.

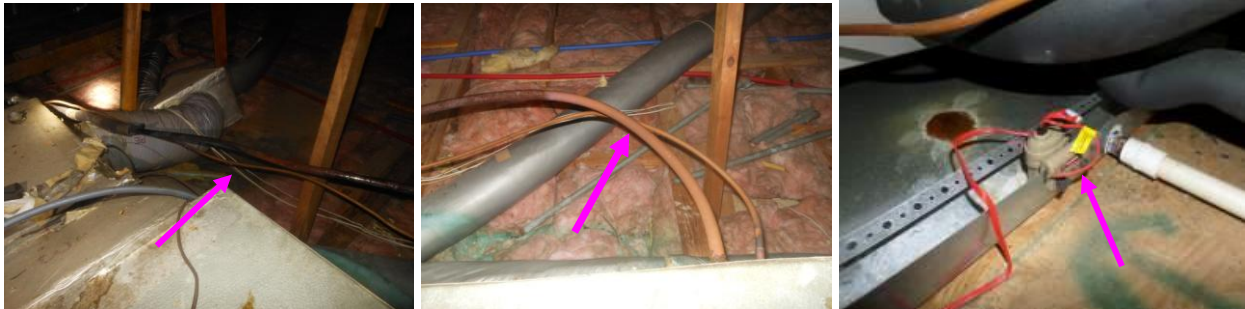
2. Lack of/missing insulation was visible at the refrigerant line, repair is expected to prevent condensate water seepage on attic floor, and no float switch(s)/device(s) installed at AC overflow drain pan(s) to disable the AC system(s) when condensate line is/are clogged up (refer to photograph on right below for correction).

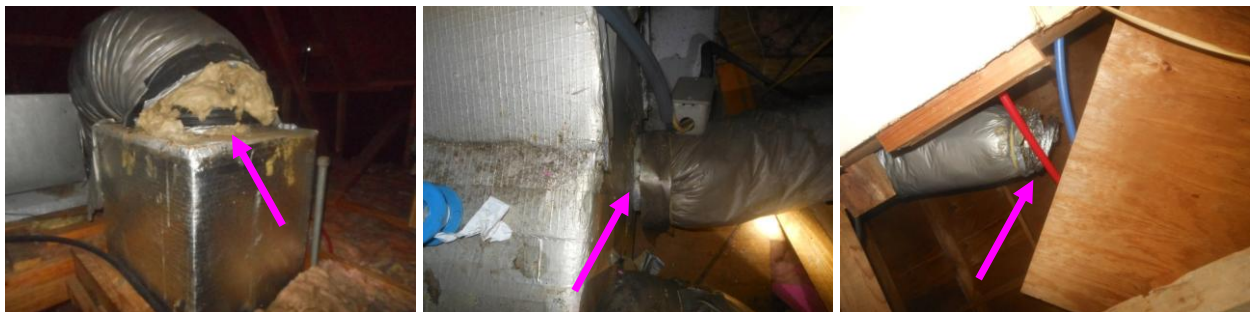
1. Observed broken/unsealed and disconnected AC ducts in attic space; at the return and supply plenum and to the master bedroom

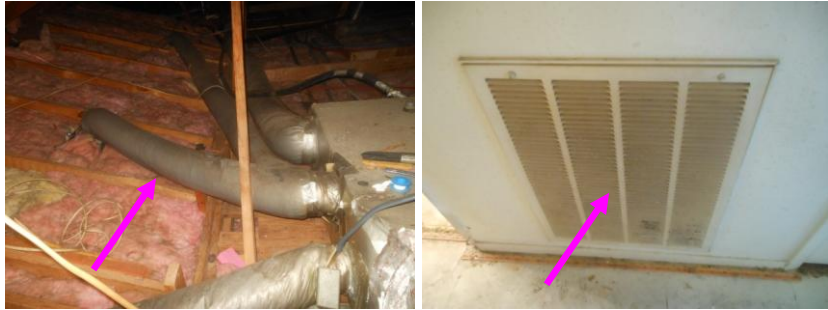
3. There was dust visible at AC filter(s)/returned register(s).

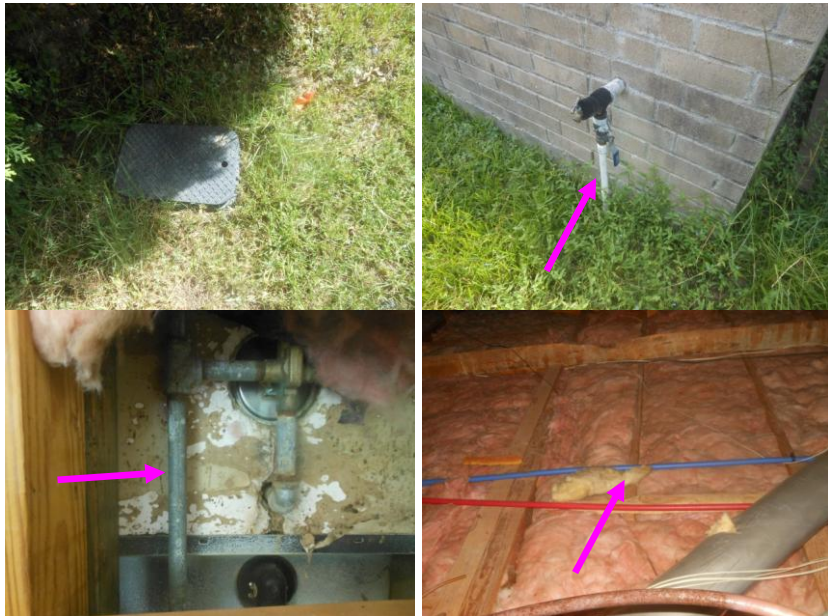
1. There is no insulation visible at water entry pipe (refer to right photograph above). This should be repaired to prevent the pipe from freezing in winter time
2. Observed faulty vanity sink faucet and missing water commode in shared bathroom
3. Observed low water pressure at tub faucet and no water to water commode in master bathroom

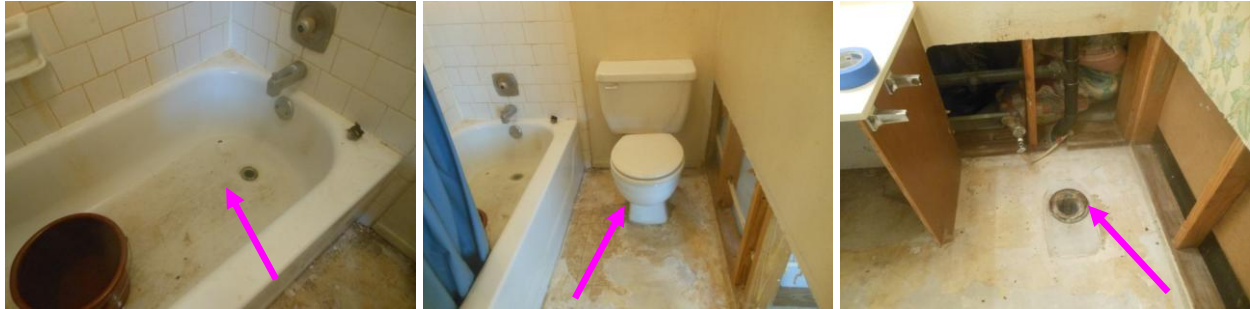
**Comment(s):** Tub drain line for master bathroom tub was very sluggish, water commodes drain lines in both bathrooms were not able to check due to missing and inoperable toilets. A license plumber with camera equipment(s) is recommended to inspect the drain system, or perform a hydro static test to determine if there are any unseen damaged drain lines

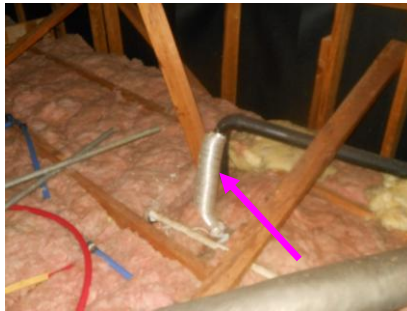
**Comment(s):** Exhaust vent pipes for both bathrooms terminate in attic space. Extend the pipes to terminate outdoor

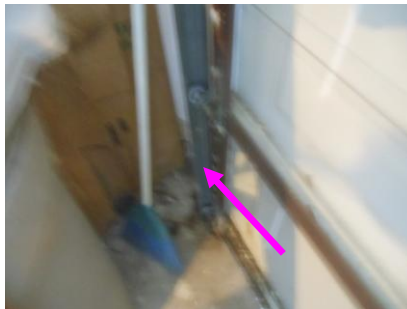
**Comment(s):** Garage overhead door was slamming at closing. There is no child protective sensor installed for the garage overhead door, this safety device is required to be installed if the door is equipped with an electronic opener
