PROPERTY INSPECTION REPORT

Concerning: 4930 Laurel Hill Ct, Sugar Land, TX 77478
(Address or Other Identification of Inspected Property)

By: John Tatum, Lic #9459 07/16/2019
(Name and License Number of Inspector) (Date)

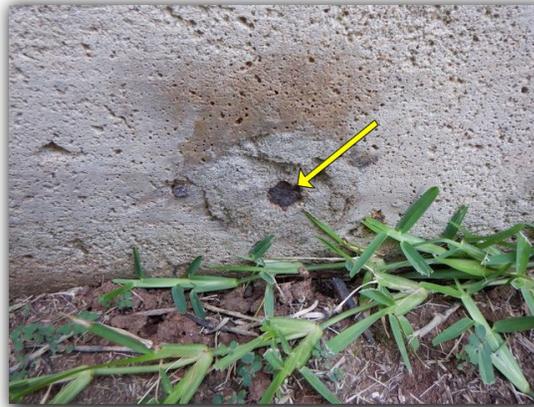
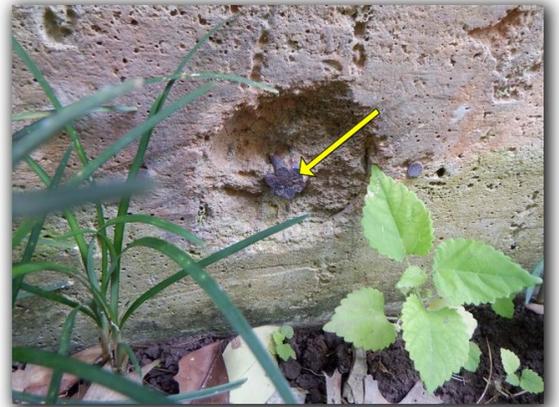
Post tension cable live ends are exposed, should be covered with non-shrink grout. Recommend repair before more extensive repairs become needed.

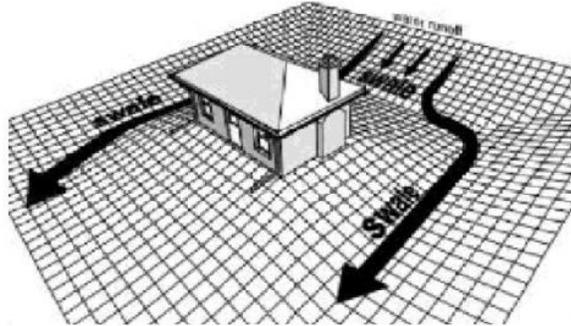
Drainage swale is not continuous at sides. The drainage swale must be kept clear and continuously sloped in order to drain water properly.

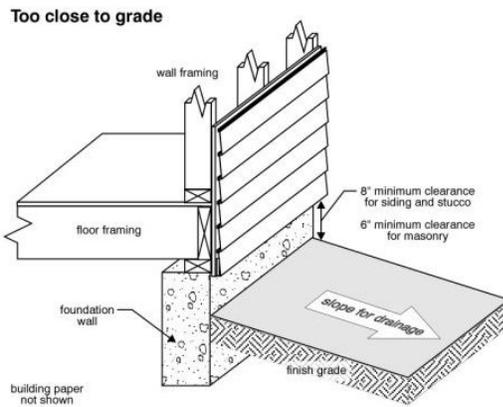
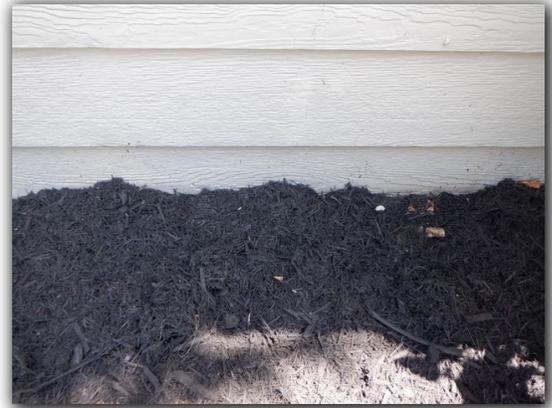
Soil level too high around areas with wood siding. Code and common industry practice requires a clearance of 6-8 inches from bottom of wood veneer to soil. High soil level near wood siding promotes water/termite penetration and wood rot.

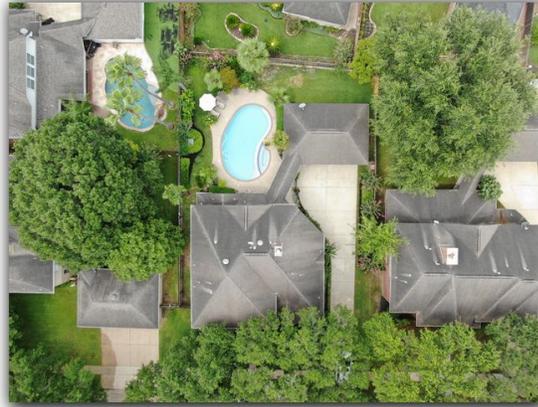
Older roof, nearing end (last 1/4 to end) of serviceable life. Observed Brittle, cracked, curled ends, and/or excessive granular loss of shingles.

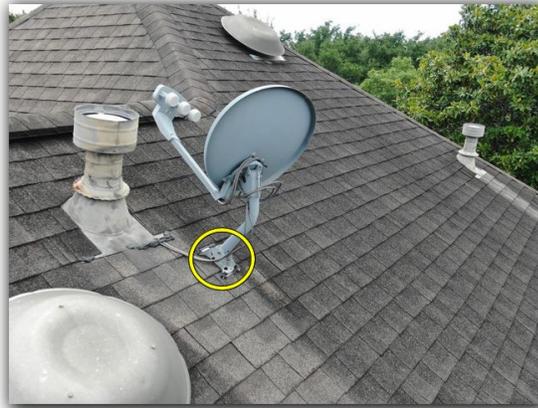
Buyer's note: Satellite bracket attachments can be conducive for water penetration.

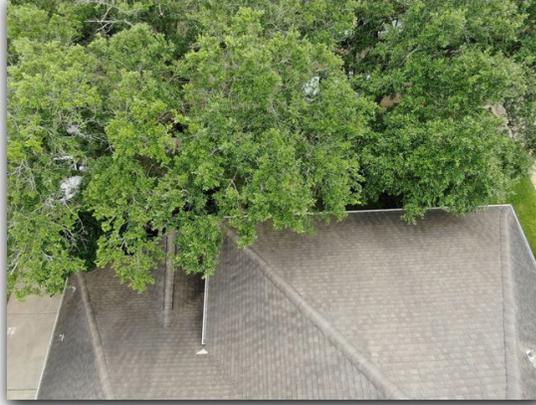
Buyer's note; Keep leaves from collecting on roof, especially in valleys and keep tree limbs away from roof to prevent damage to shingles.

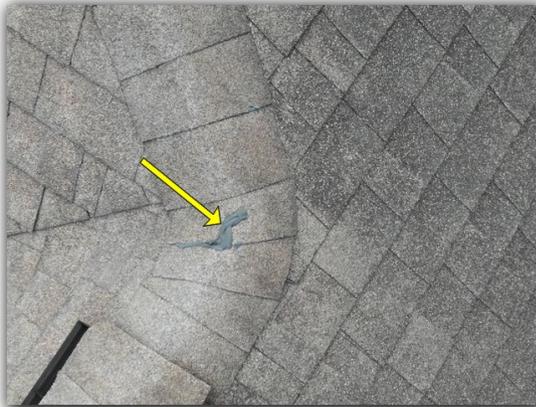
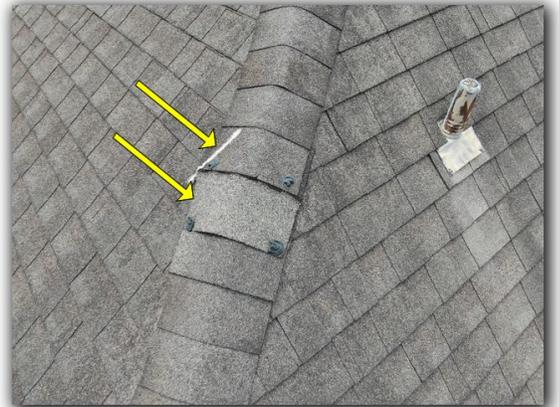
Multiple poor / amateurish repairs were observed to the roof surface.

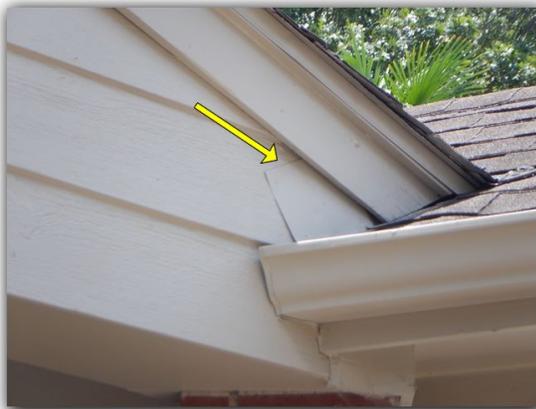
Flashing missing and/or improperly installed. (Breeze way connection to the house)

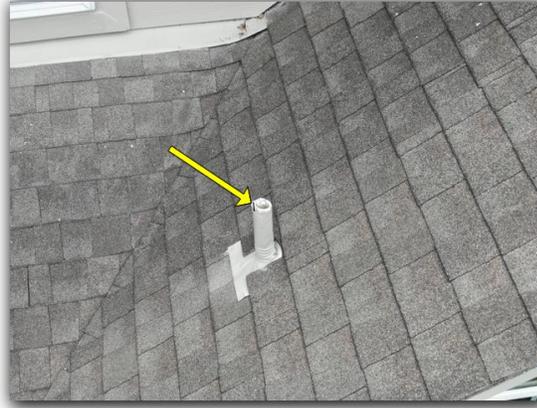
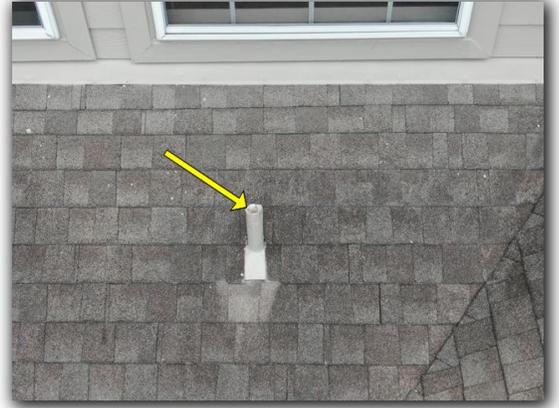
Not all lead flashing of drain waste vents are properly rolled down interior of plumbing vent pipes and/or are damaged by squirrels, may allow some rain water entry.

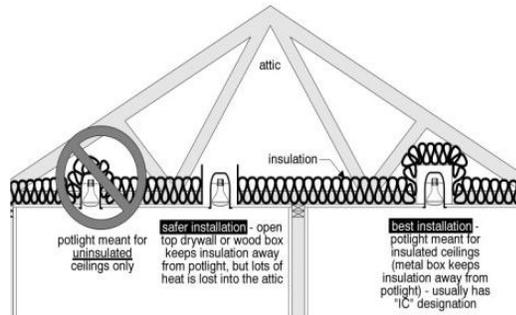
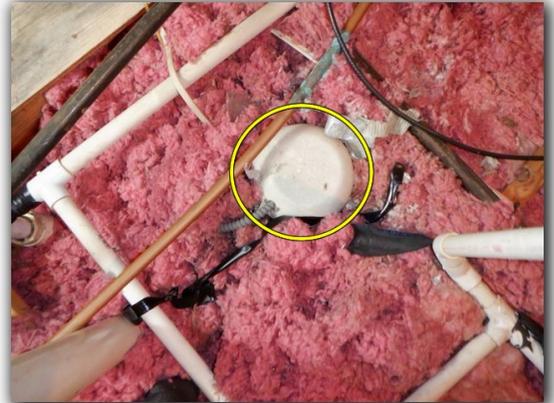
Potlights in insulated ceilings

Ensure insulation is maintained a minimum of 3 inches and wood a minimum of 1 inch from around all recessed lights to reduce possible fire hazard.

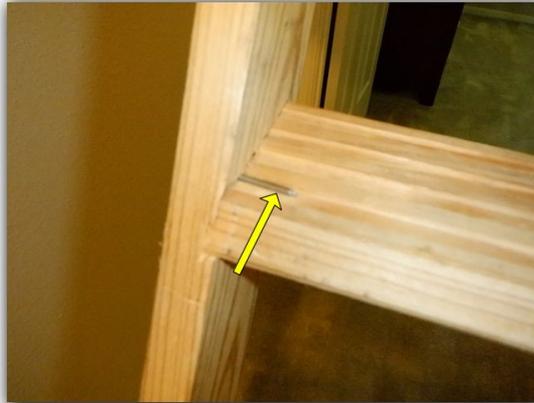
A nail was protruding from one of the steps on the attic stairway. Safety hazard exists.

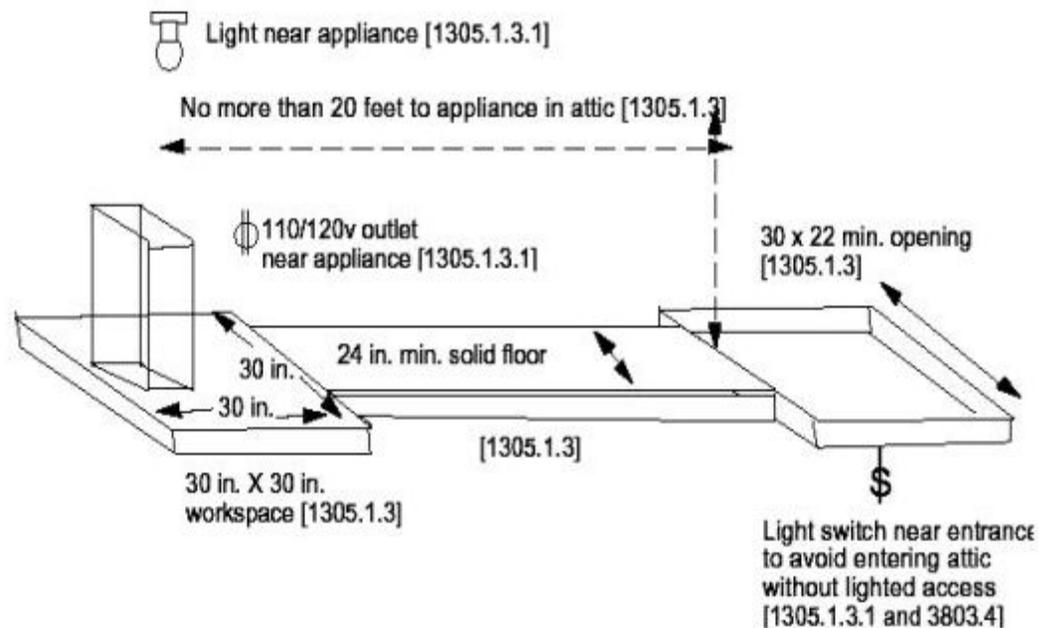
Inadequate attic walkway and/or platform to mechanical equipment in attic. Code violation, [UMC 908 & CABO 1401.5] requires 30 inch head clearance and a minimum 24 inch wide SOLID (no gaps or obstructions), floor to equipment for servicing and a 30 inch deep solid platform in front of equipment.

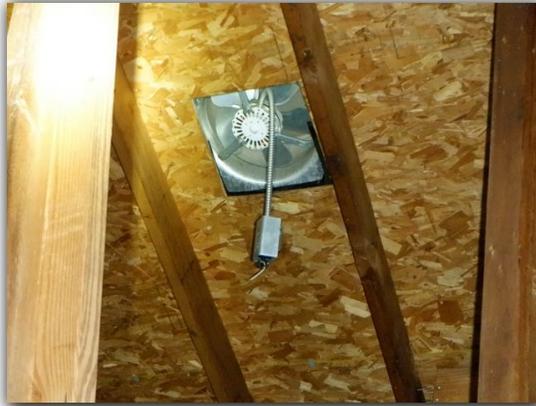
Attic power fan is not operational, appears to have been disabled.

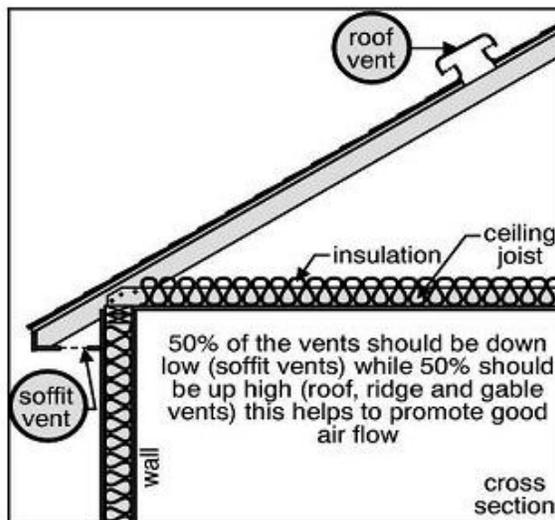
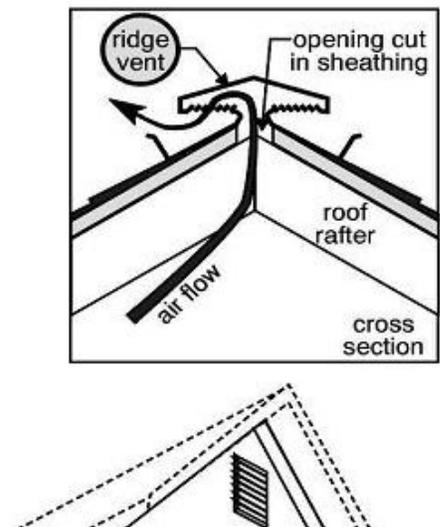
Types and locations of vents

Inadequate amount of soffit or roof venting to allow proper ventilation of attic, owner incurs larger utility bills as well as shortened roof life with poor attic ventilation.

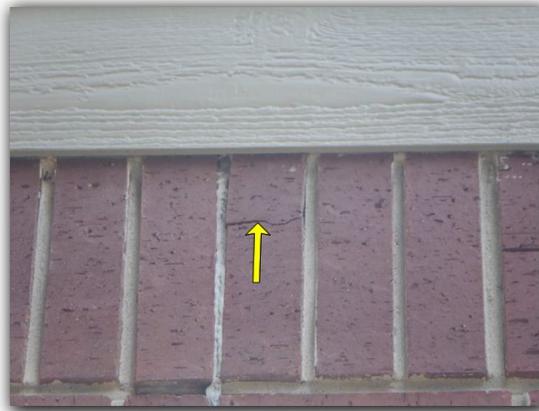
A damaged / cracked brick was observed at the upper wall of the west exterior.

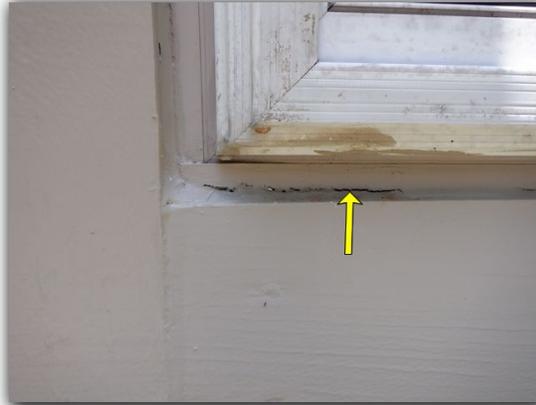
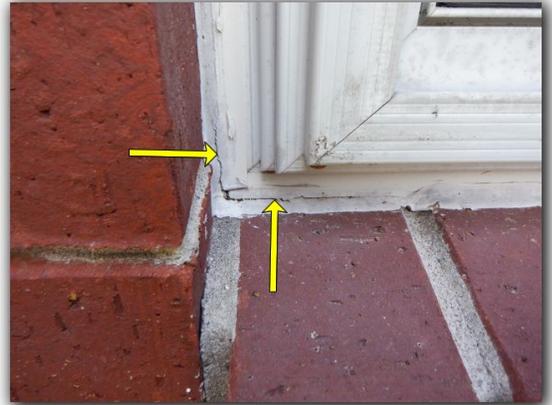
Caulking deficient around one or more windows, will allow water penetration during heavy / wind driven rains.

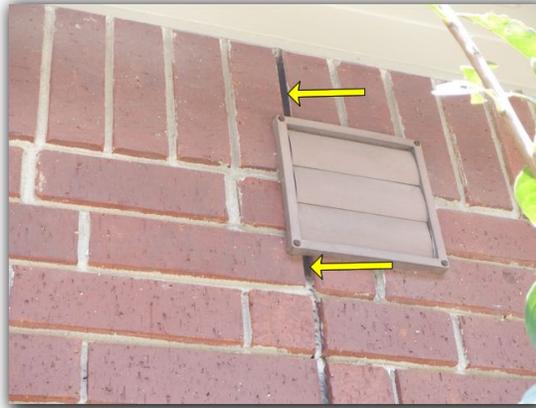
Expansion joint(s) and / or inside corners in brick veneer need caulking. Ensure any mortar present in expansion joint is first removed before sealing.

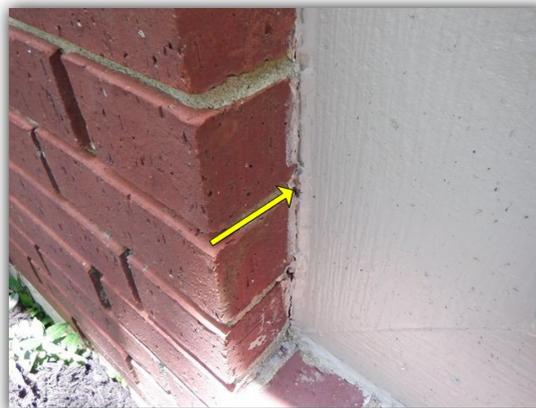
Caulking missing and/or deficient around vertical trim boards may allow wind driven rain entry.

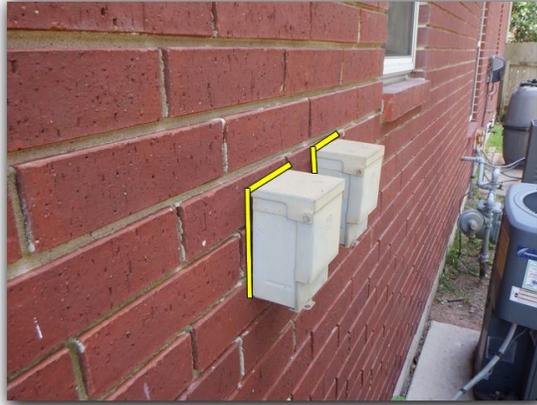
Recommend caulking around electrical disconnect box(s) of A/C unit(s) to prevent water entry behind disconnect(s).

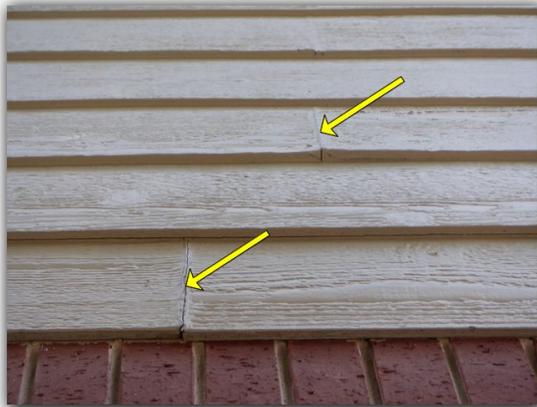
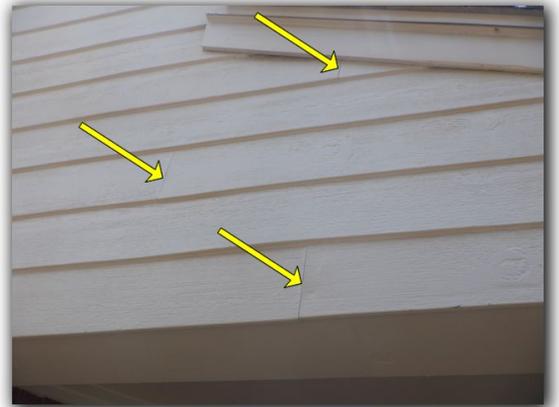
Caulking missing and/or deficient at vertical joints in siding; may allow wind driven rain entry.

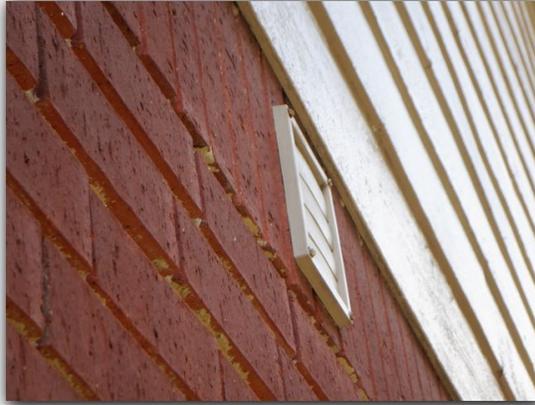
Need sealing / caulking around all holes and exterior siding penetrations on top and both sides, (leave bottom open) to prevent water entry. Including but not limited to dryer, bath and range top vents, light fixtures, etc. Need sealing / caulking around all holes and exterior siding penetrations on top and both sides, (leave bottom open) to prevent water entry. Including but not limited to dryer, bath and range top vents, light fixtures, etc.

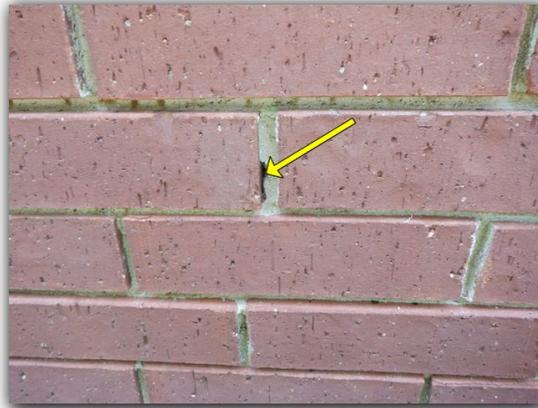
Mortar joints between brick ends is deficient in areas, indication the brick layer might not have properly "struck" the bricks (used enough mortar), recommend re-pointing areas where voids in mortar are present.

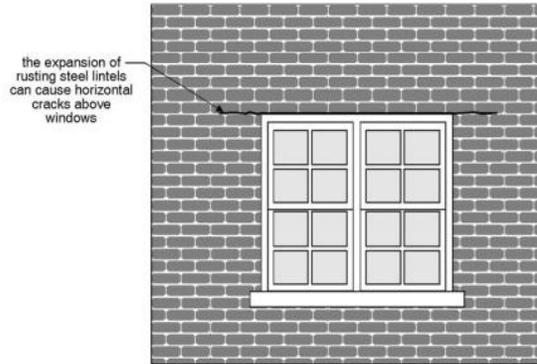
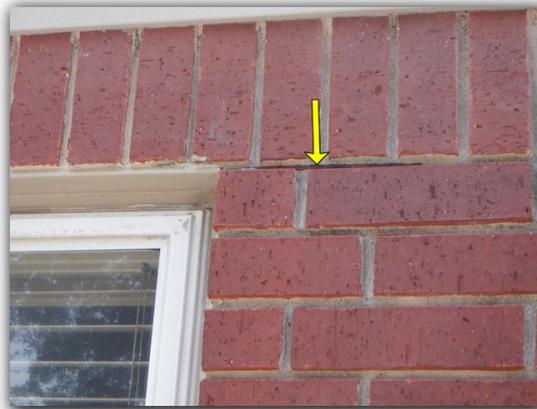
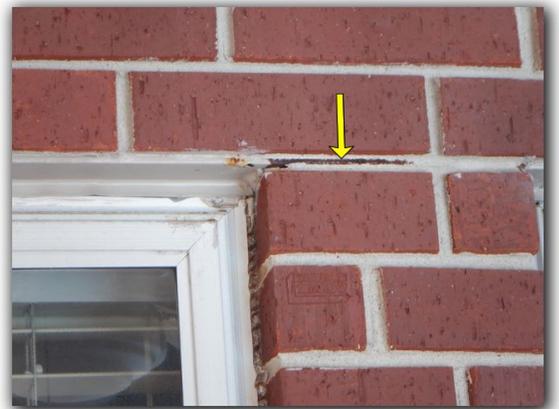
Rusting lintels

Metal lintel(s) over window/door openings are rusting and / or lintel ends are improperly exposed.

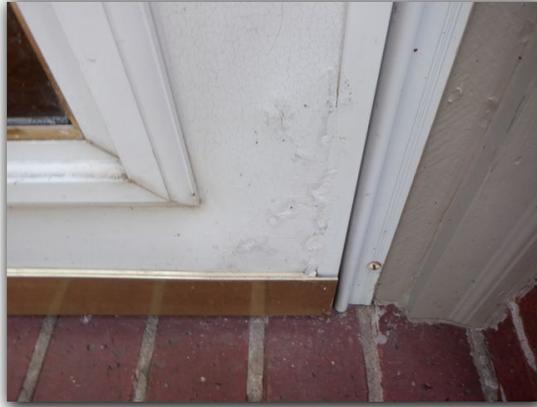
Damage was observed to the base of the metal door at the exterior side of the front entry.

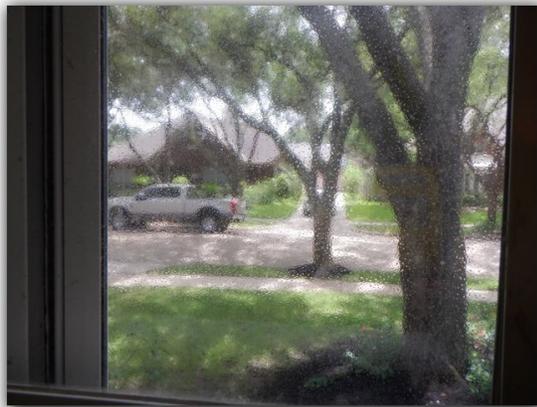
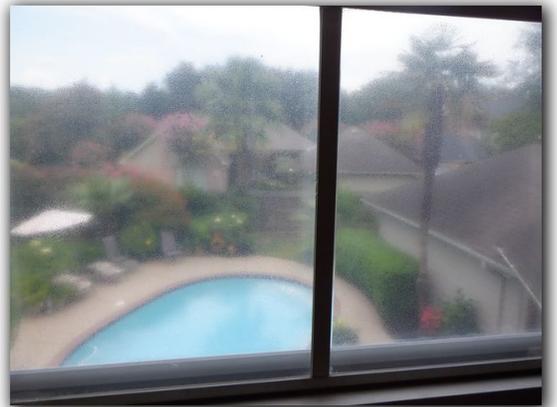
The window film was damaged / discolored at many windows.

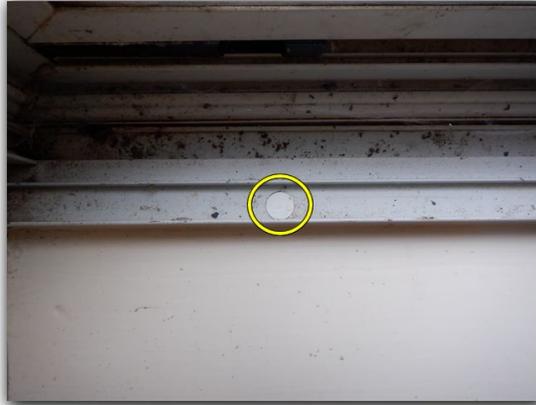
Window jamb alarm sensors need to be sealed with silicone seal to prevent water entry.

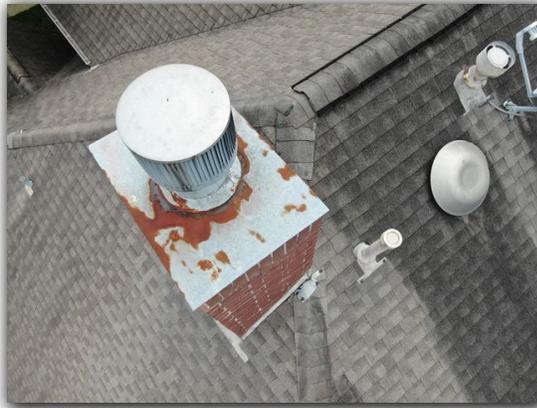
It is recommended to clean and paint the rusted chimney cap in order to discourage further deterioration.

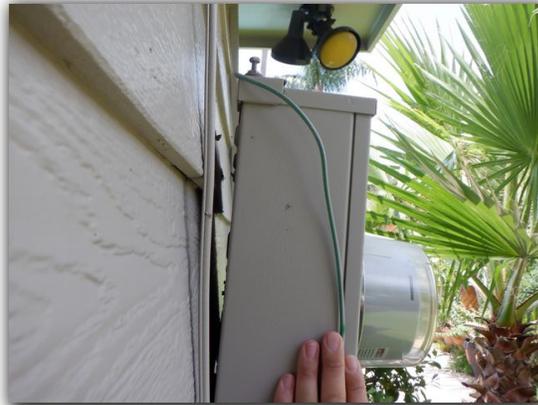
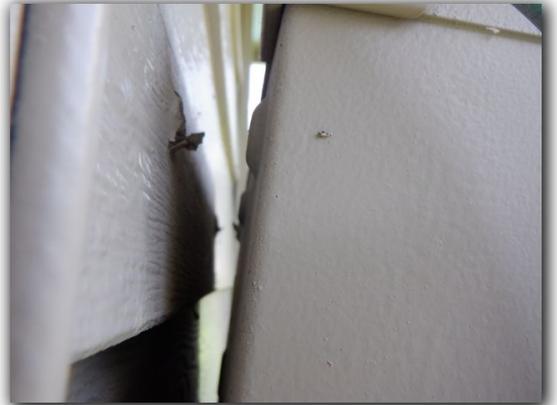
Electrical service meter is not secured to house / garage.

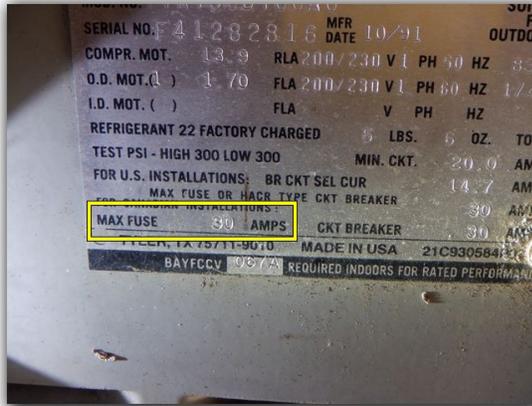
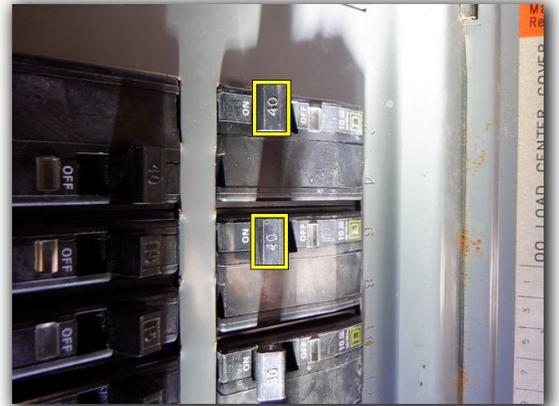
Breaker is oversized per data plate on side of A/C unit. (2nd floor unit)

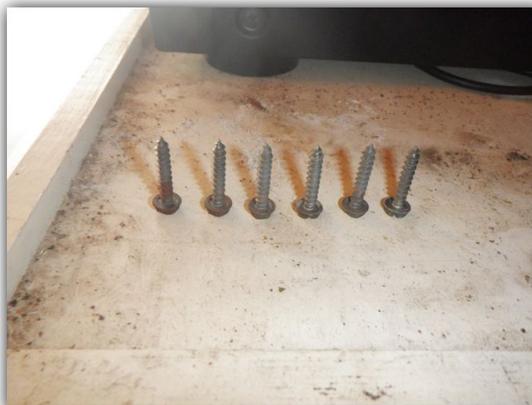
Dead front is not secured with proper screws with blunted ends, Sharp ends can pierce electrical wire insulation.

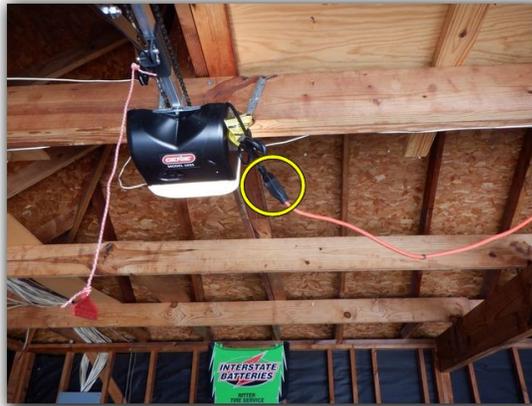
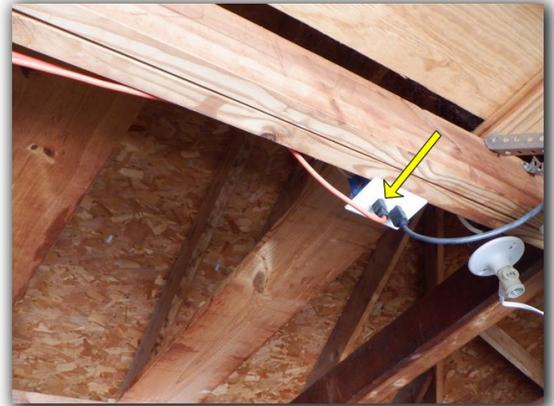
Extension cord wiring used improperly as permanent wiring to garage door opener.

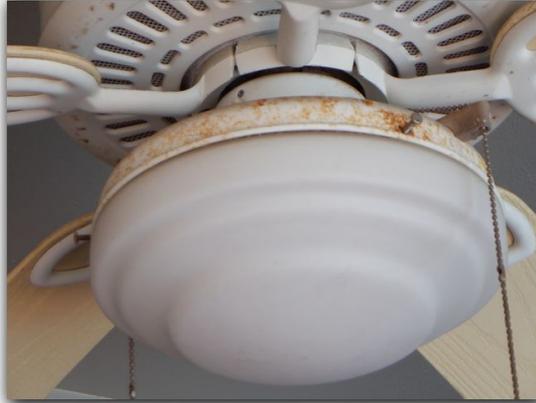
Some corrosive damage was observed to the back patio fans.

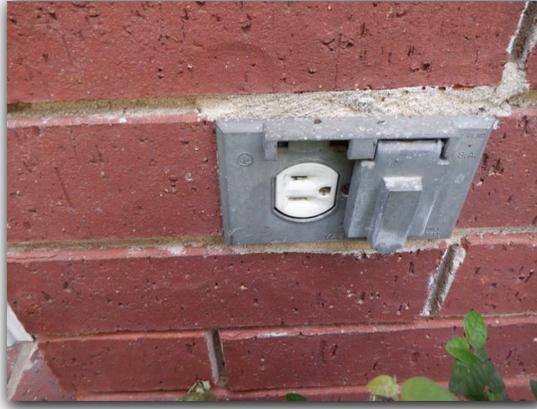
Exterior outlet damaged, missing weather proof cover.

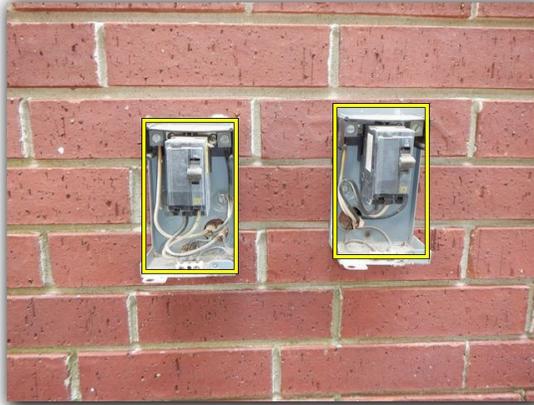
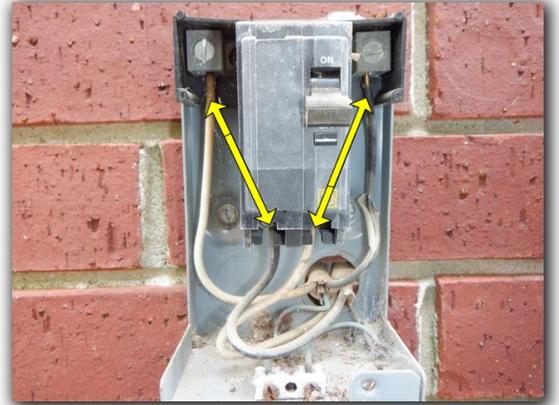
A/C unit electrical disconnect wiring reversed, line / load connections are backwards.
Live electrical wiring to wrong side of electrical disconnect when power turned off at disconnect will result in shock hazard, repair. (Both units)

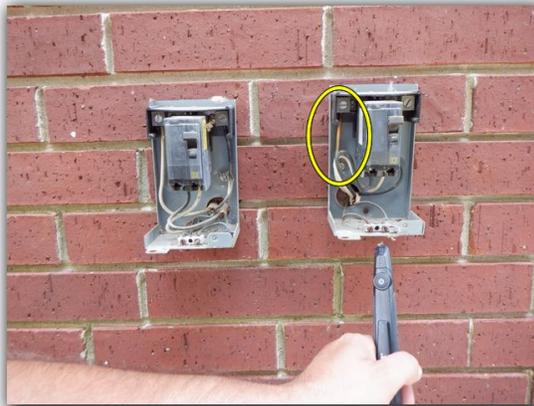
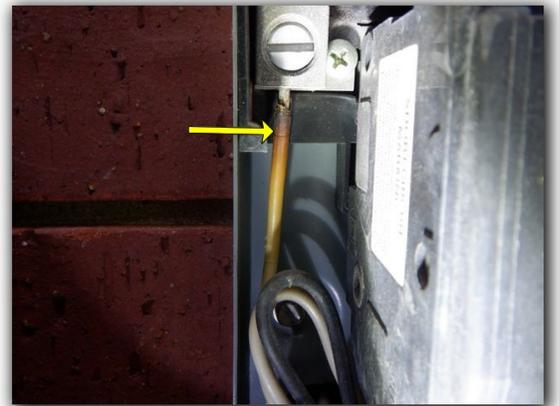
Wire insulation damaged from over heating. (Southern A/C disconnect)

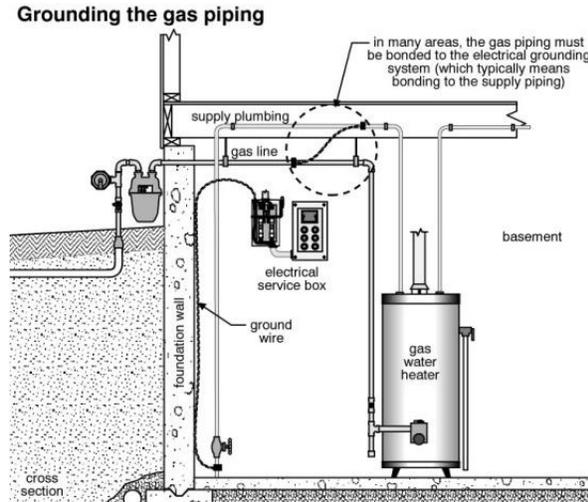
Gas and hot / cold water lines are not properly bonded near water heater. Does not comply with most recent electrical code. NEC 250-80b.

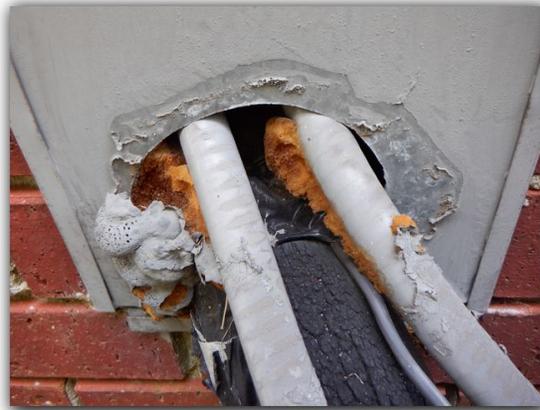
Recommend sealing exterior where AC lines enter house.

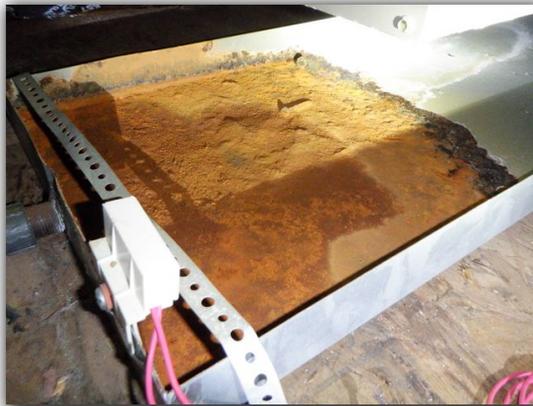
Secondary drain pan is very rusted, recommend replacement. (1st floor unit)

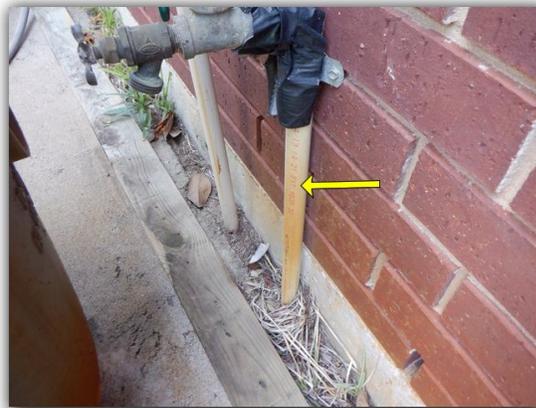
Recommend insulating exterior water line(s) to prevent freeze damage.

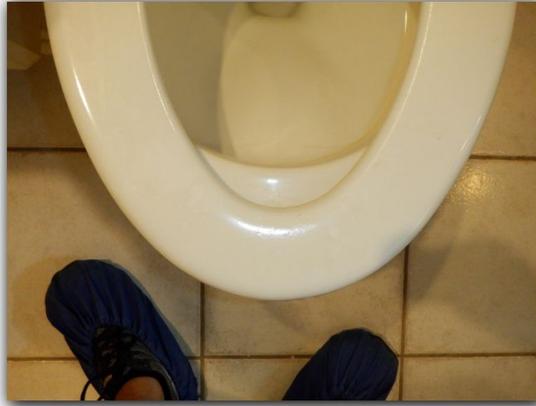
The wrong design / shape of toilet seat was present at the commode in the 2nd floor Jack & Jill bathroom.

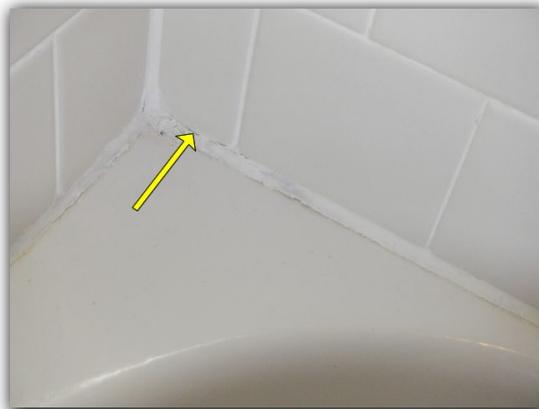
Grout / caulking needed at vertical tile corners, cracks in tile and/or mortar between tiles, and where tile meets tub to prevent water entry behind wall.

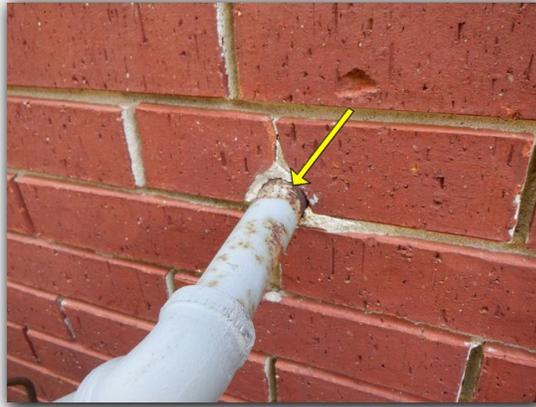
Gas piping not sleeved as it passes through masonry wall as required by Code [CABO 2608.3] IRC 2603.3.

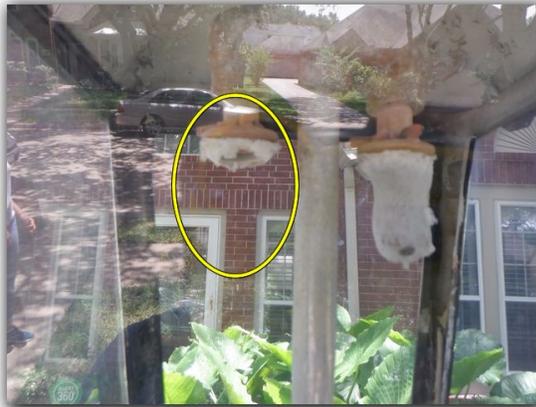
The gas yard lamp was not lit at the time of inspection. One of the burners was observed to be damaged. Recommend service / repairing as necessary.

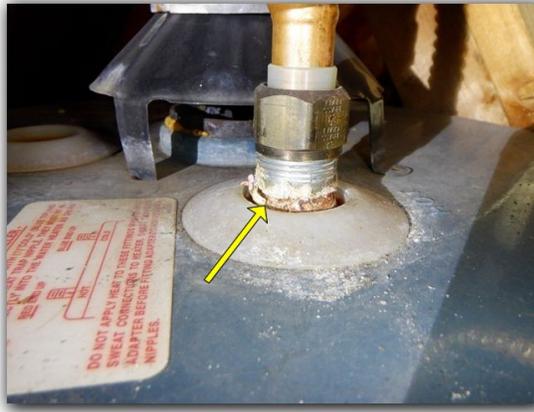
Corrosion observed at shut off valve and/or connections on top of water heater.

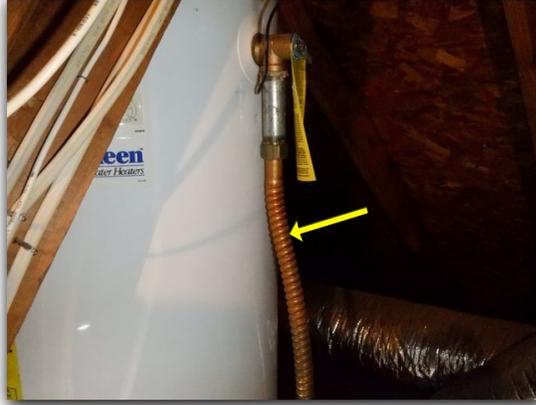
Drain line improperly reduced in size using flexible connector, considered a recognized safety hazard; REF.: 1991 Standard Plumbing Code 1213.7.4 IRC 2803.6.1.

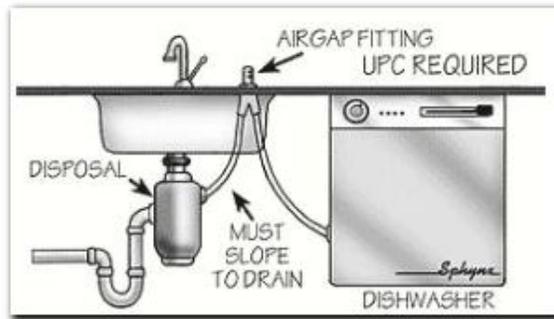
Drain line needs to be elevated above side inlet of disposal to underside of countertop to prevent debris and gray water from draining down line from disposal and back into dishwasher.

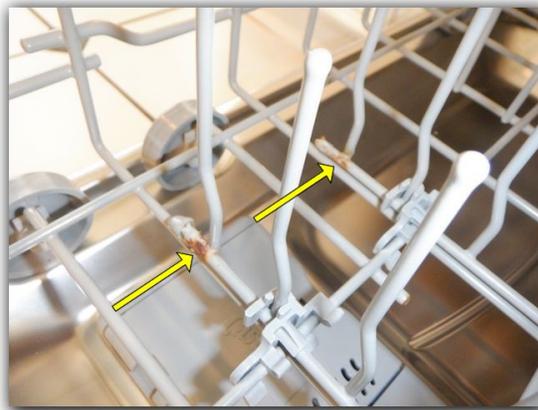
Dish racks contain some rust / deterioration.

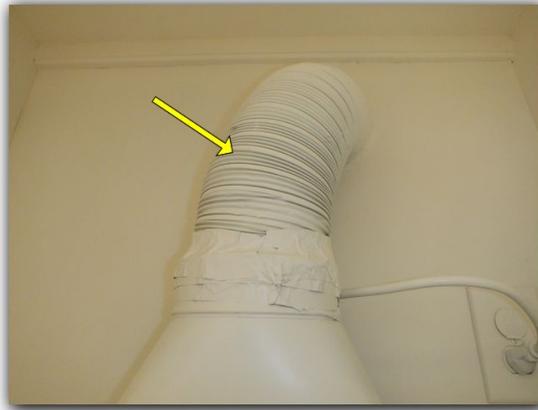
Improper vent duct material used, *Current industry standards; CABO sections 1802.1 and 1804.1 and UBC section 504.2 requires " Smooth interior single-wall duct constructed of galvanized steel, stainless steel or copper. The duct serving the hood shall have a smooth interior surface." Not aluminum dryer or vinyl type duct IRC 1502.1.*

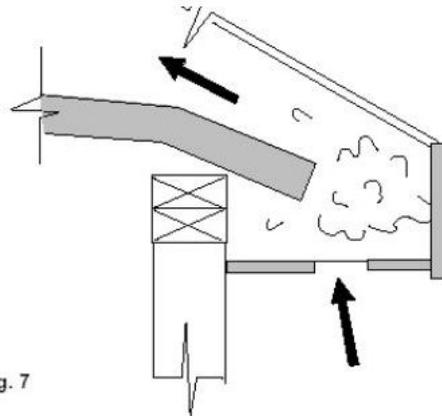
Fig. 7

Improperly vents to soffit. Should vent to exterior.

Terminating exhaust fans to soffits/eaves builds up condensation moisture within the soffit that can deteriorate the fascia board, soffit and/or plywood roof decking and cause paint peeling. A soffit/eave is part of attic air space where exterior air is drafted in to the attic space with the exhaust duct fumes and moisture.

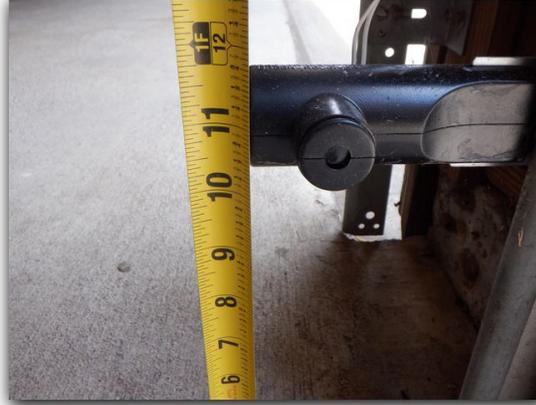
Electronic sensing eyes are improperly installed; should be no more than 6 inches above floor.

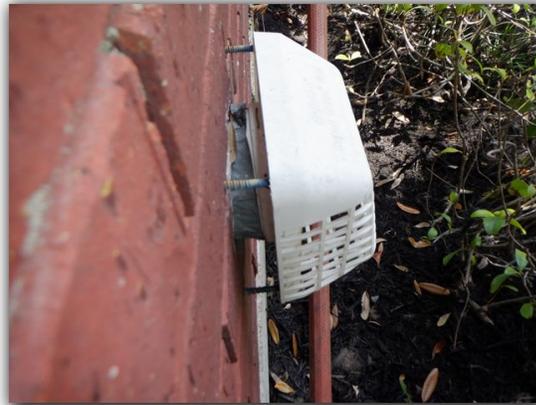
The dryer vent was not properly installed flush with the wall and sealed at the southeast exterior.
