Inspection Report

Property Address:
119 White Oak Drive
Lake Jackson TX

PROPERTY INSPECTION REPORT

By: Brad Summers TREC #22343 / SumTex Inspections 11/5/2019

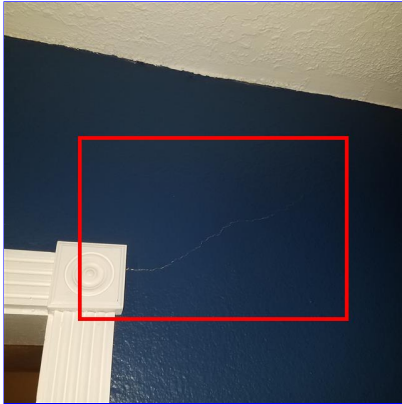
A. Item 1(Picture) formal dining room

(1) Moderate Minor cracks at the corners of doors and windows through out home appeared to be the result of foundation movement.

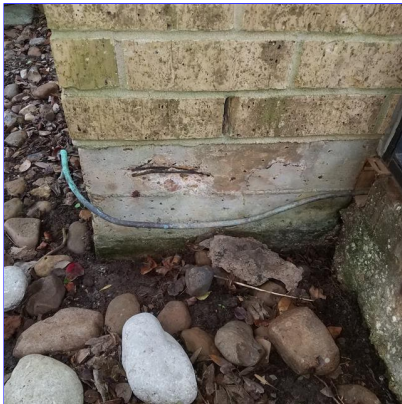
A. Item 3(Picture) back right of home

(2) Exposed rebar needs to be sealed. Exposed rebar is at risk of eventual corrosion failure.

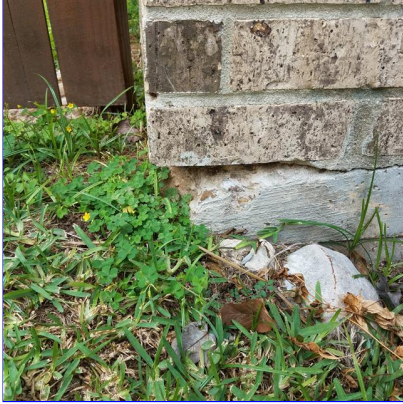
A. Item 5(Picture) left side of garage

(3) Corner popping was observed at the time of the inspection. Corner Popping of a foundation is considered a cosmetic, non structural issue until either the concrete of the slab corner starts to deteriorate extensively or the bottom of the corner brick or stone is exposed excessively and/or if there is cracking in the above brick, stone and/or mortar joints above the brick lug of the foundation.

Will be remedied before this weekend SWR

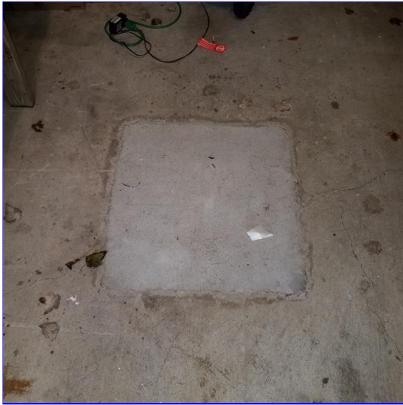
A. Item 7(Picture)

(4) The foundation had signs of previous repair. The buyer should ask seller about the foundation repair and obtain any documentation the seller may have about the repair.

This work was done by Church Services a year ago. Lifetime fully transferable warranty. SWR

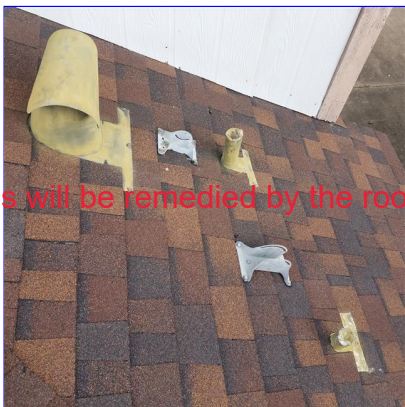
C. Item 2(Picture)

(2) There is a satellite dish bracket mounted on roof that is screwed directly through roofing surface. This is not considered to be today's standard. Wood trim and siding boards should terminate 1 in to 2 in above the roof surface to prevent moisture damage and wood decay.

This will be remedied by the roofers this week SWR

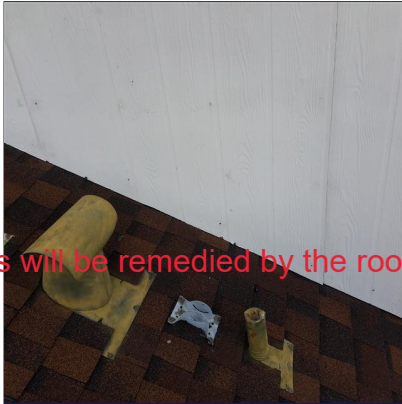
C. Item 4(Picture) rear of home

(3) Wood trim and siding boards should terminate 1 in to 2 in above the roof surface to prevent moisture damage and wood decay.

This will be remedied by the roofers this week SWR

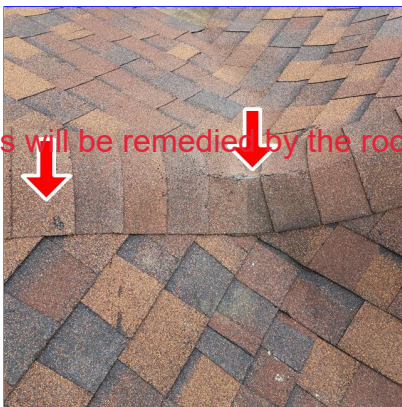
C. Item 7(Picture) rear of home

(4) Damage shingles at the time of the inspection.

This will be remedied by the roofers this week SWR

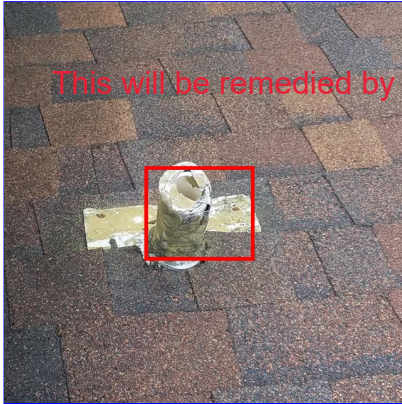
C. Item 8(Picture)

(5) Squirrels have damaged the lead flashing boots that cover the plumbing vent pipes. Vent boots should be replaced to prevent moisture from entering the home.

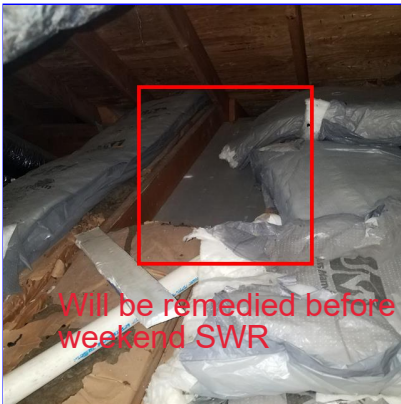
D. Item 4(Picture)

(2) The attic was missing insulation over areas of significant size. This condition can result in increased heating and cooling cost and reduced comfort levels.

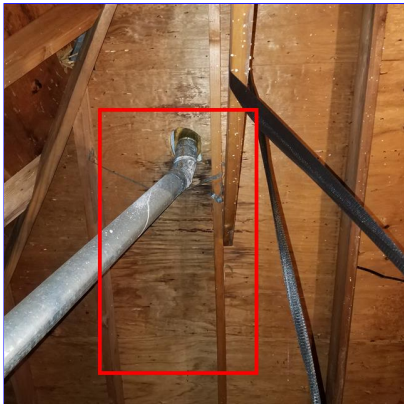
D. Item 6(Picture)

(3) Water stains on the roof decking were visible at the time of the inspection. The inspector was unable to test with moisture meter do to unsafe conditions.

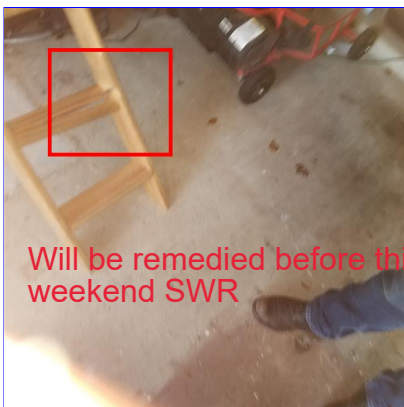
D. Item 7(Picture)

(4) The garage attic stairs are broken at the time of the inspection.

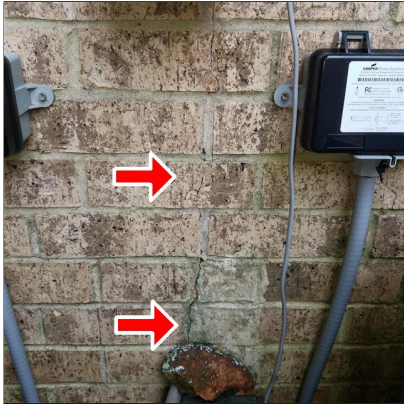
E. Item 1(Picture) right side of home

(1) Vertical cracks located at multiple locations. I crack does not appear to be from foundation movement at the time of the inspection.

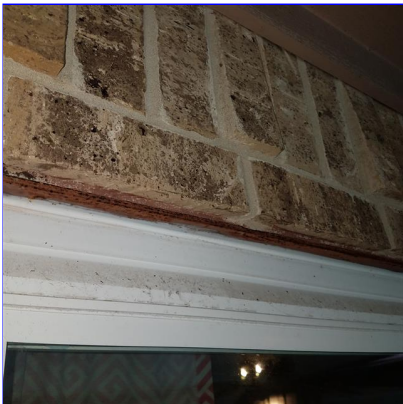
E. Item 8(Picture)

(2) The lintels above the windows, and doors were visibly rusted at the time of the inspection. Not all occurrences were photographed.

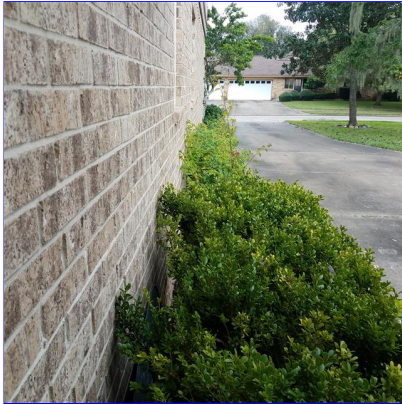
E. Item 10(Picture) left side of home

(3) Bushes in contact with home may introduce insects, pests and/or accelerate deterioration of the exterior wall covering by retaining moisture. The Inspector recommends removal of the vegetation from exterior walls.

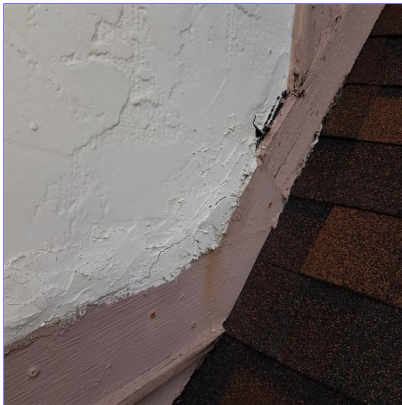
E. Item 12(Picture)

(4) Wood rot and previous signs repairs on the front side of the home. The rotten wood should be repaired and properly sealed to prevent future moisture intrusion.

This will be remedied by the roofers this weekend SWR

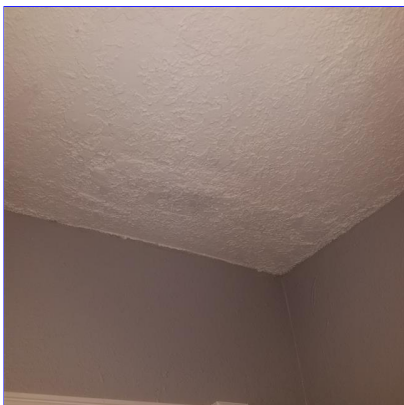
F. Item 1(Picture) front foyer

(1) Previous signs repair in multiple locations around the home. Buyer should inquire about repairs from seller.

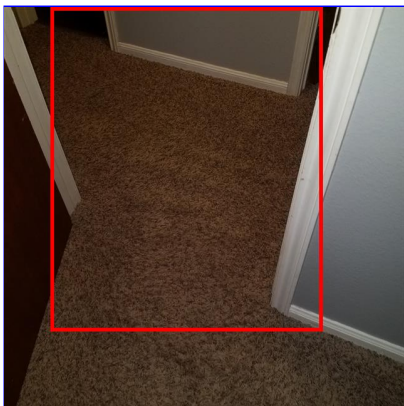
F. Item 4(Picture)

(2) The carpet was loose and has multiple ripples in the upstairs hallway. The carpet should be stretch to prevent tripping hazards.

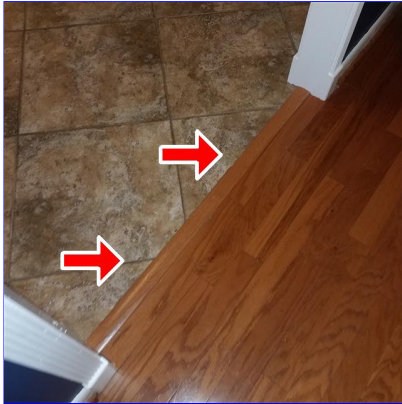
F. Item 5(Picture)

(3) The transition pieces in the formal dining room are loose and should be properly secured.

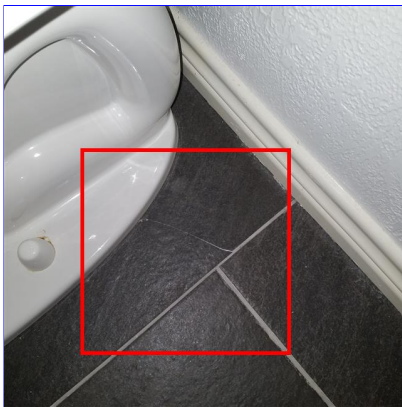
F. Item 7(Picture)

(4) Cracked tile in the upstairs bathroom at the time of the inspection.

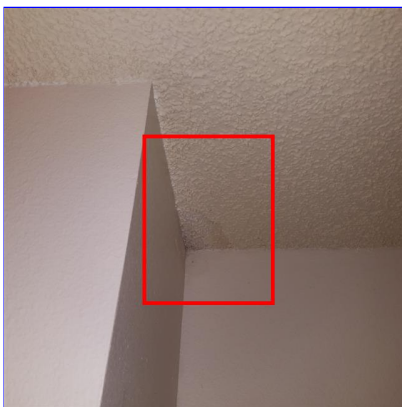
F. Item 8(Picture)

(5) Water stain located front right bedroom. Moisture meter showed elevated levels of moisture at the time of the inspection meaning the source of moisture is still present. The moisture appears to be coming from the water heater.

The water heater and leaking valve were replaced 11/12/19

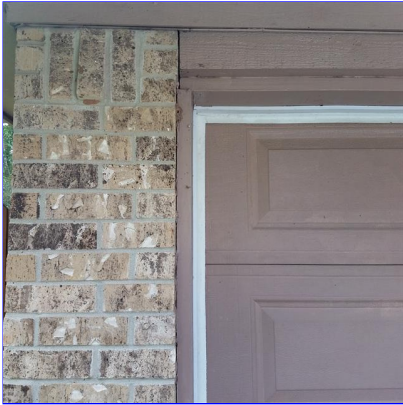
G. Item 1(Picture)

(1) Garage door trim boards should be caulked and sealed painted to prevent moisture intrusion.

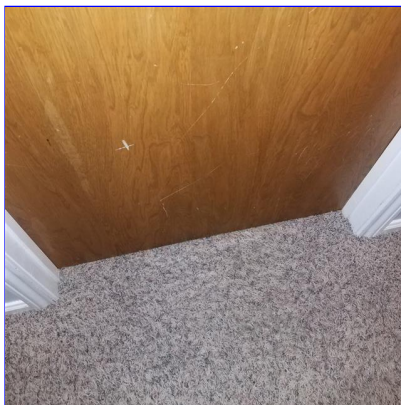
G. Item 5(Picture)

(2) Some interior doors in this bedroom rubbed on the carpet and needed to have the bottoms cut. Cutting the bottom of the bedroom doors insures adequate air flow for the HVAC systems to work properly.

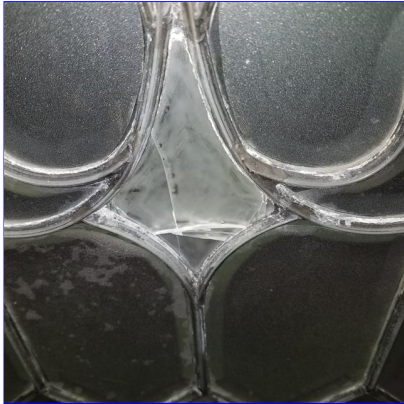
G. Item 6(Picture)

(3) Decorative glass on the front door is broken at the time of the inspection.

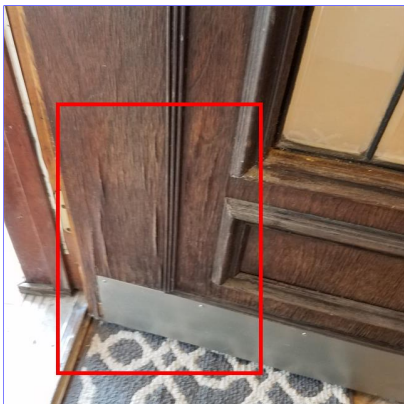
G. Item 7(Picture)

(4) Front door is weathered and is starting to delaminate. Door should be repaired to prevent future damage.

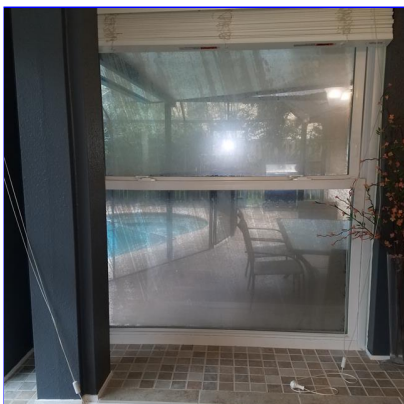
H. Item 1(Picture) breakfast nook

Condensation and stains visible on the glass of a double-pane window indicated a loss of thermal integrity.

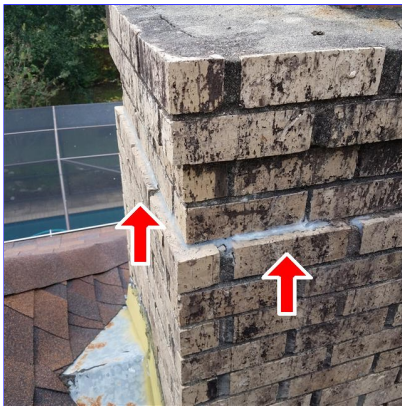
J. Item 1(Picture)

(1) Previous signs repair on chimney.

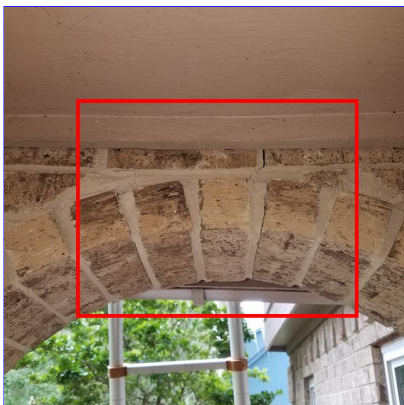
K. Item 1(Picture)

Crack in brick archway in the front porch. Crack should be repaired to prevent possible injury to falling brick.

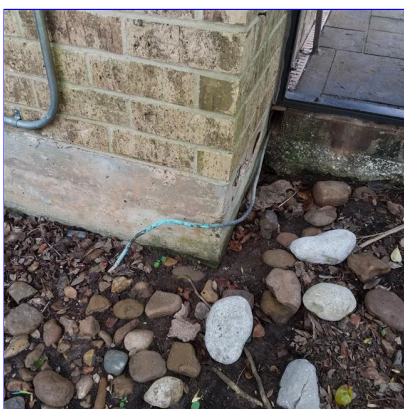
L. Item 1(Picture)

(1) Unprotected gas copper line on the back right of the home.

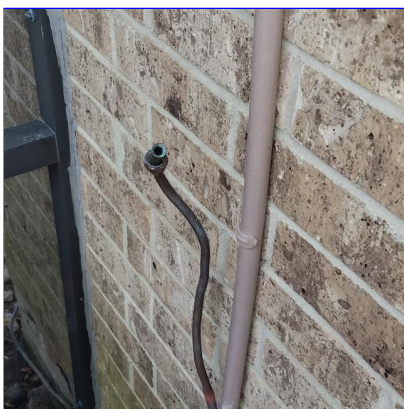
L. Item 2(Picture)

(2) Gas line should be properly capped at the back right of the home.

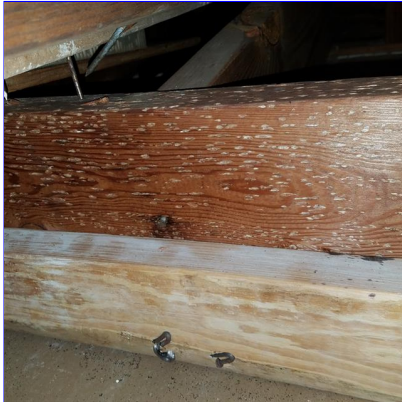
L. Item 3(Picture)

(3) Drywood termite damage located in the garage attic at the time of the inspection. The damage rafter is

no longer supporting the structure and should be repaired by a qualified contractor. No active termites were visible at the time of the inspection.

This was later diagnosed as beetle damage that happened before the tree was cut into boards. To be absolutely sure, some insecticide will be sprayed on this board 11/15/2019 by Stewart Pest Control with a transferable 5 year warranty.

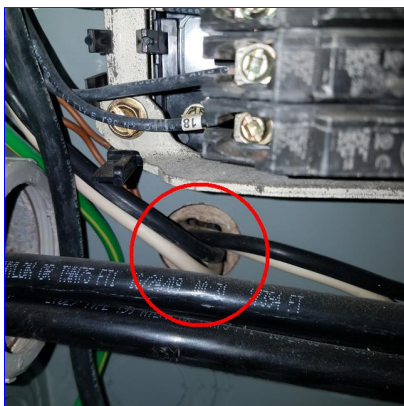
A. Item 1(Picture)

(1) Missing service panel protective knock out grommets. Exposing electrical wiring to sharp metal edge and possible damage.

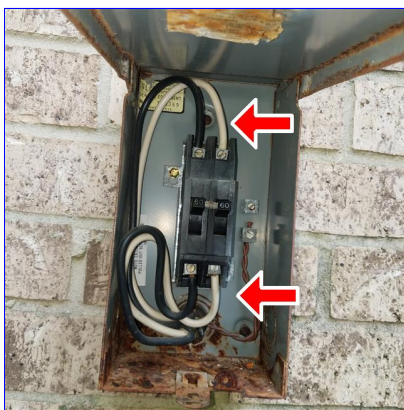
A. Item 2(Picture)

(2) Missing dead front cover on the HVAC shut electrical shut off.

Improper wire color used for hot (ungrounded) wire. You may use a wire with white or gray insulation as a hot (ungrounded) conductor if the wire is part of a cable (such as NM) and if you permanently mark it as hot (ungrounded) conductor at all places where the wire is visible and the accessible.

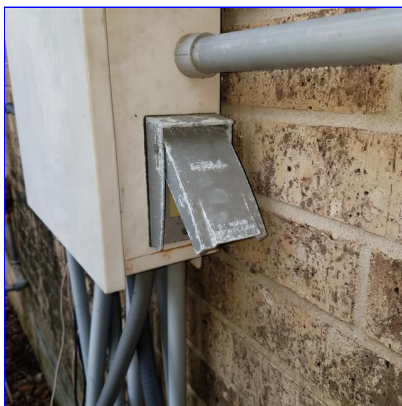
B. Item 3(Picture)

(3) No weatherproof covers on outside outlets. Outlets installed in a wet location shall have an enclosure that is weatherproof whether or not the attachment plug cap is inserted.

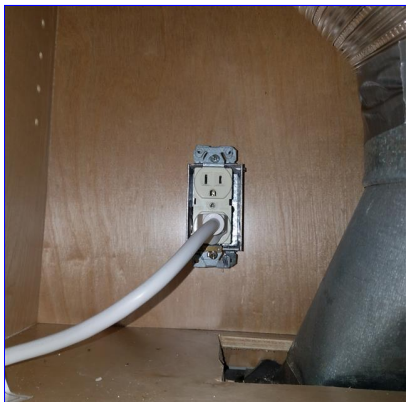
B. Item 4(Picture) above
microwave

(4) Missing outlet covers. Outlet covers should be replaced to prevent shock.

This will be remedied before this weekend SWR

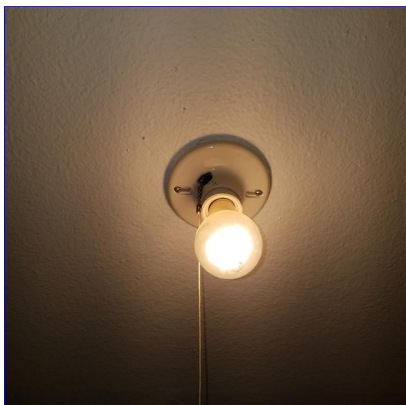
B. Item 5(Picture) closet under stairs

(5) The lighting in the closets, garage and attic were not properly protected. Suggest replace the fixture with proper guard.

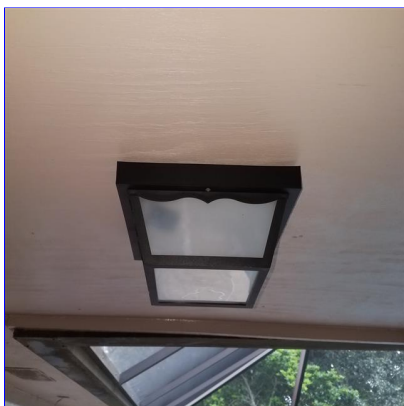
B. Item 12(Picture) back porch

(7) Light fixtures did not respond to the switch. The bulb may need to be replaced or there may be a problem with the switch, wiring or light fixture.

This light can be controlled by 2 different switches. The inspector wasn't aware of how to turn on the light.

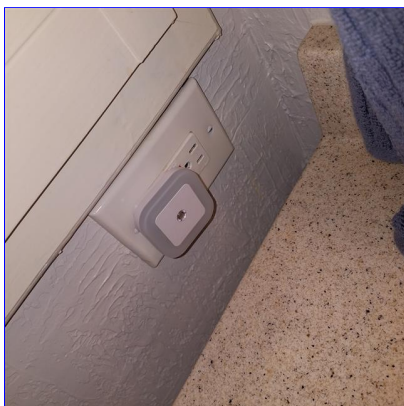
B. Item 13(Picture) upstairs bathroom

(8) A ground fault circuit interrupter (GFCI) electrical receptacle did not respond to testing, did not re-set, was slow to re-set or made a buzzing sound when re-set. The Inspector recommends replacement of the receptacle to ensure that it works correctly when required.

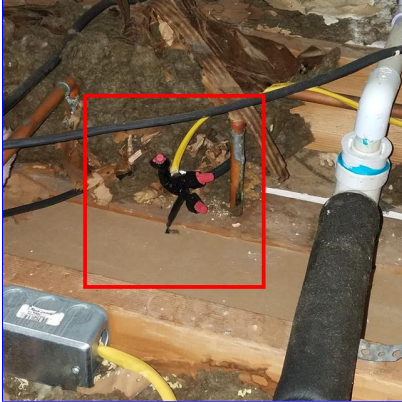
B. Item 14(Picture) Attic

(9) Improperly terminated electrical wires were visible in the home at the time of the inspection. Wires should terminate in an approved junction box with a listed cover plate installed. These wires should be examined and terminated correctly.

This will be remedied before this weekend SWR

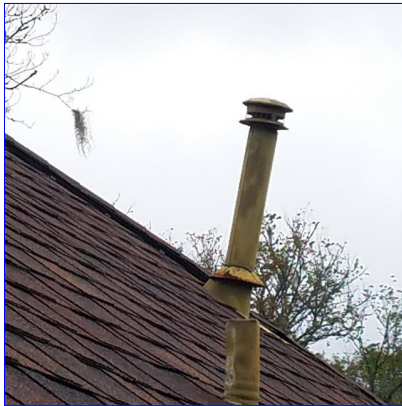
A. Item 1(Picture)

- (1) The downstairs heating unit is a heat pump and are not tested when the outside temp is above 65°.
- (2) Improper flue height. Exhaust flues require a minimum of 3 ft of vertical height above the roof line and 2 ft above any part of the building.

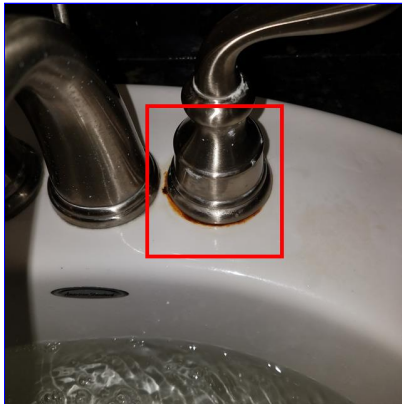
A. Item 1(Picture)

(1) rust observed on the sink on in the master bedroom on the right side at the time of the inspection.

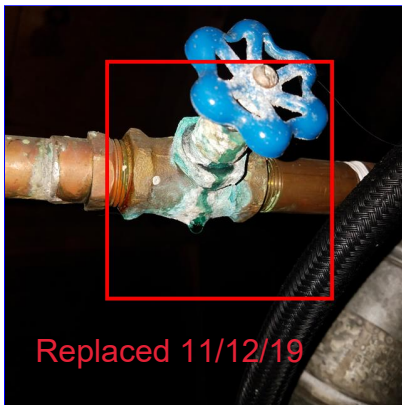
A. Item 3(Picture)

(5) Water heater shut off valve is leaking and should be repaired

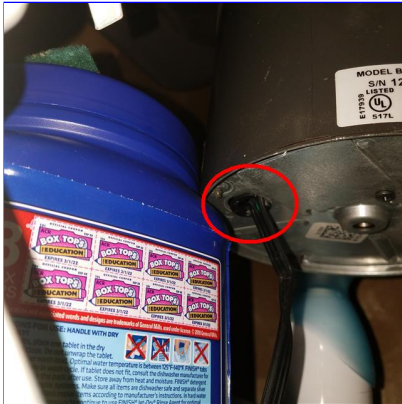
B. Item 1(Picture)

The electrical connection to the garbage disposal is missing the cable clamp connector. The cable clamp connector protects the wire from damage.

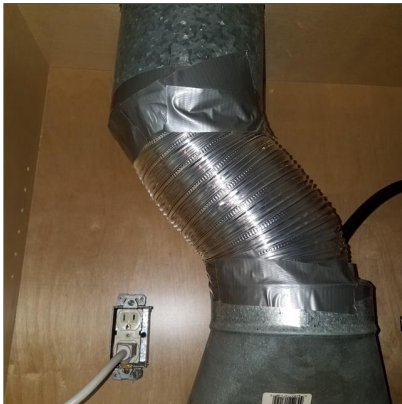
C. Item 1(Picture)

Improper material used for exhausts duct. Single-wall ducts serving range hoods shall be constructed of galvanized steel, copper or stainless steel.

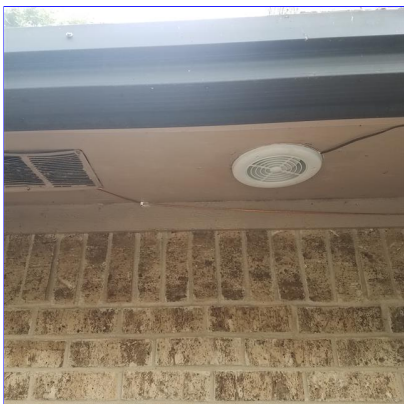
F. Item 1(Picture) back right of home

Comments:
(1) The bathroom exhaust vents terminate in the attic soffit. This condition is improper and allows moist air from the bathroom to enter the attic. The exhaust vent should terminate at the roof line.

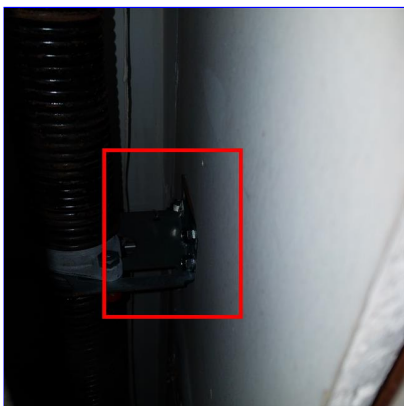
G. Item 1(Picture)

(1) Most manufactures do not allow header bracket to be installed over drywall. Header bracket needs to be fastened directly to structural support.

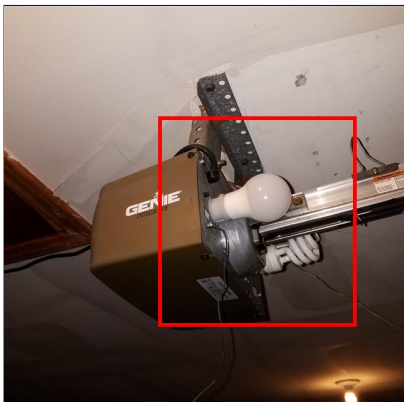
G. Item 2(Picture)

(2) The garage door opener is missing the light cover at the time of the inspection.

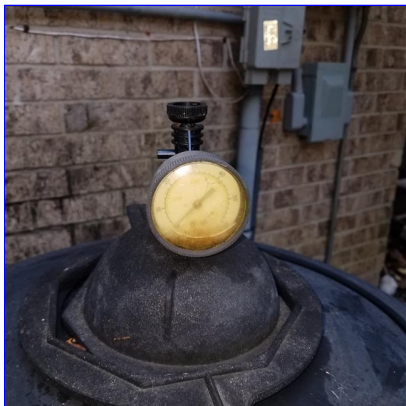
B. Item 1(Picture)

(1) Damage to pressure gauge at the time of the inspection.

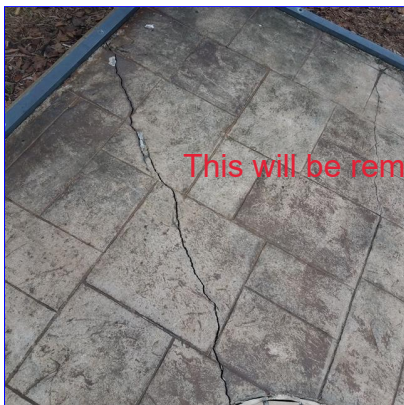
B. Item 2(Picture)

(2) Pool decking is cracked in multiple locations. The decking should be sealed to prevent moisture intrusion.

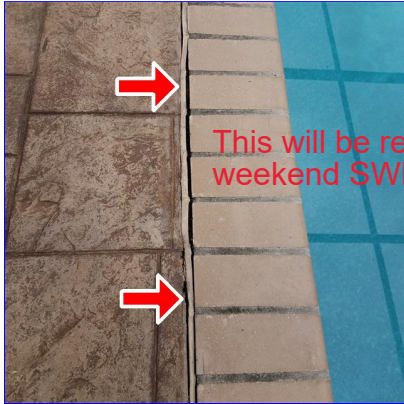
B. Item 7(Picture)

(3) The coping and deck should be properly sealed to prevent moistures intrusion.
