Total Home Inspection

Property Inspection Report

16122 Wimbledon Forest Dr, Spring, TX 77379
Inspection prepared for: Claud During
Real Estate Agent: Kathy Hinds - Abby Realty

Date of Inspection: 10/2/2019 Time: 1:00 PM
Age of Home: 1995 Size: 5300
Weather: Partly Cloudy

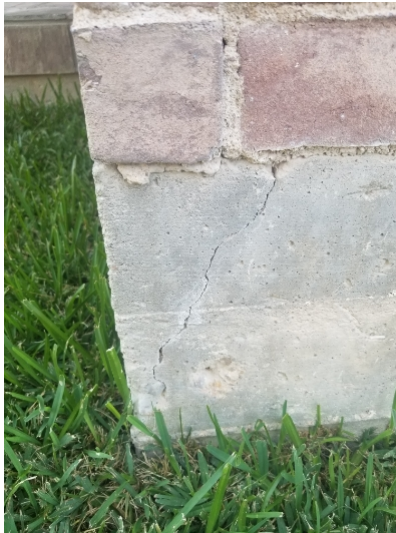
Cosmetic corner cracks were present on some corners. These should be properly sealed to prevent potential insect intrusion.

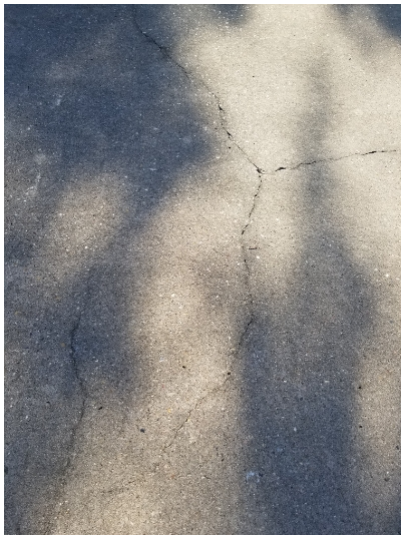
There were cracks on flat work around the home.

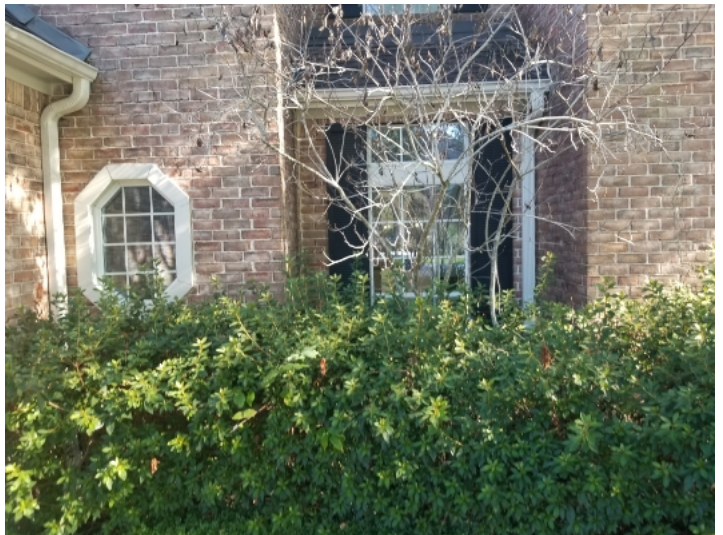
Excessive vegetation was noted in some areas of the home. In our opinion vegetation should be cleared at least 12" from the exterior walls.

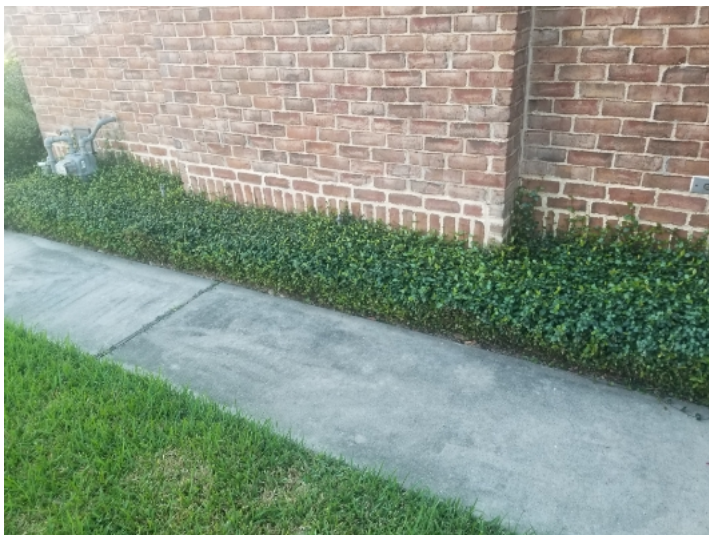
Excessive vegetation was noted in some areas of the home. In our opinion vegetation should be cleared at least 12" from the exterior walls.

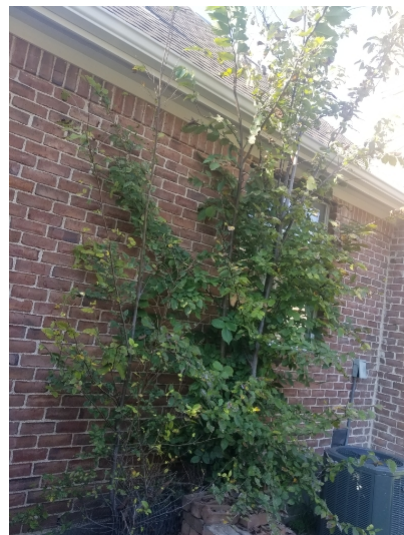
Excessive vegetation was noted in some areas of the home. In our opinion vegetation should be cleared at least 12" from the exterior walls.

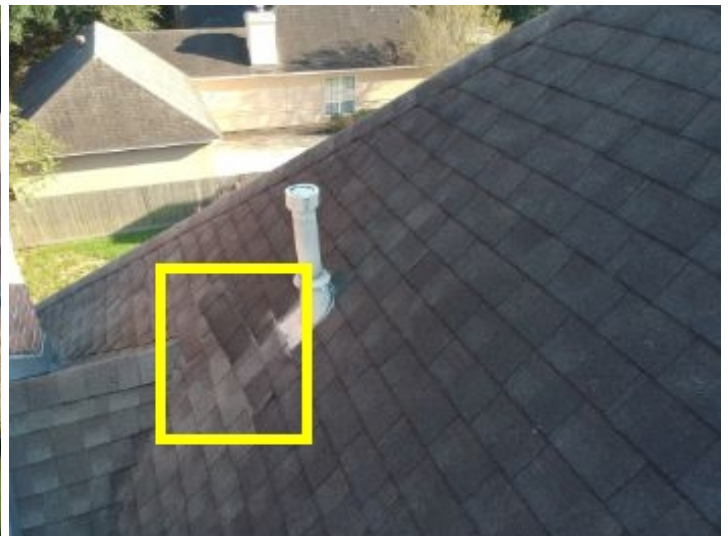
Shingles were loose/falling in front of backside chimney.

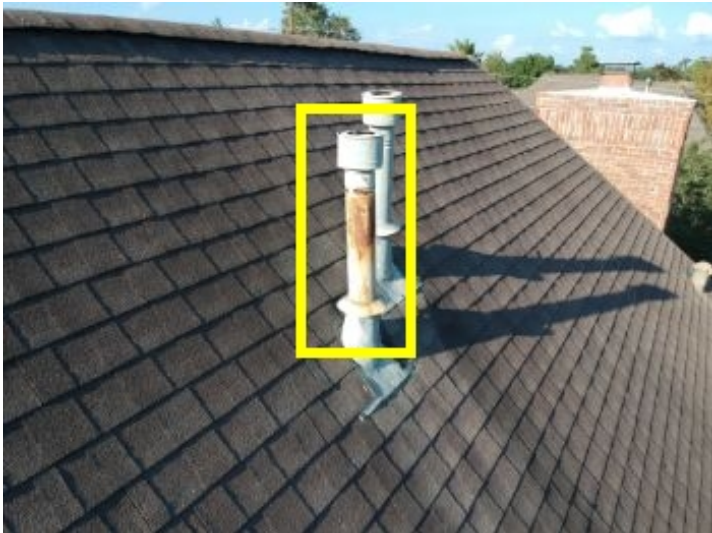
Rusting was observed on some B-Type vents. They should be readjusted, resealed and monitored for further rust.

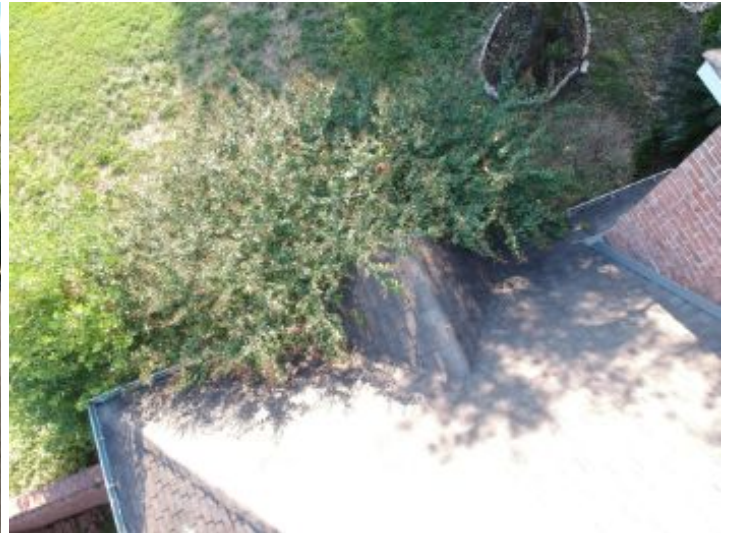
Trees were contacting the roof surface. Tree limbs and vegetation may prematurely wear or damage shingles.

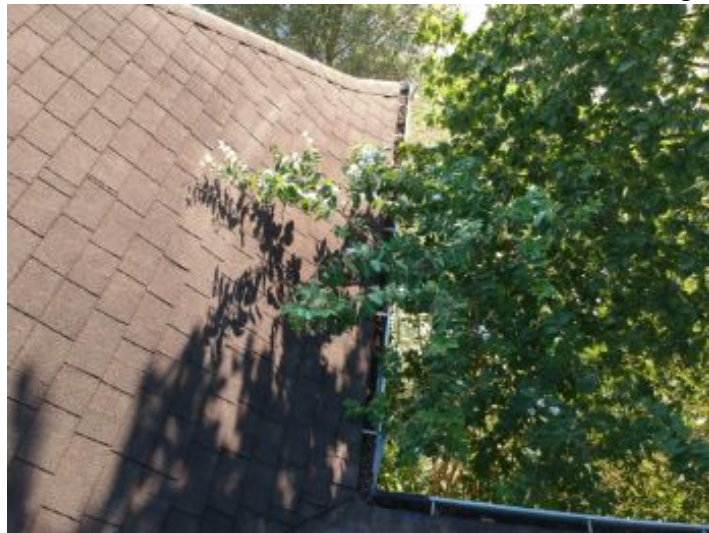
Trees were contacting the roof surface. Tree limbs and vegetation may prematurely wear or damage shingles.

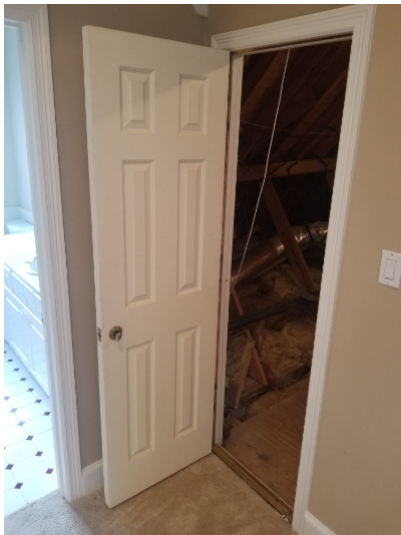
Attic access doors should be weather-stripped and have self closing hinges when gas appliances are present.

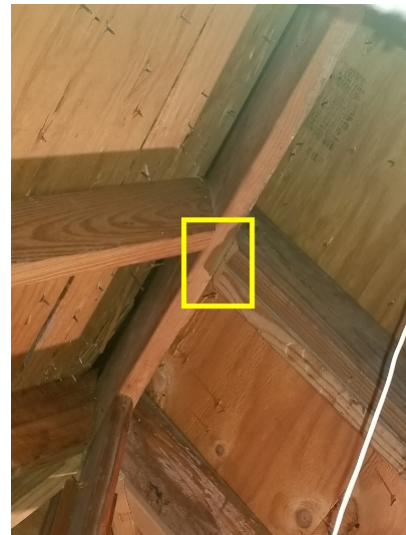
It appeared that the cut edge of the rafters were larger than the ridge board due to original construction methods. Rafters should be supported fully a the ridge board.

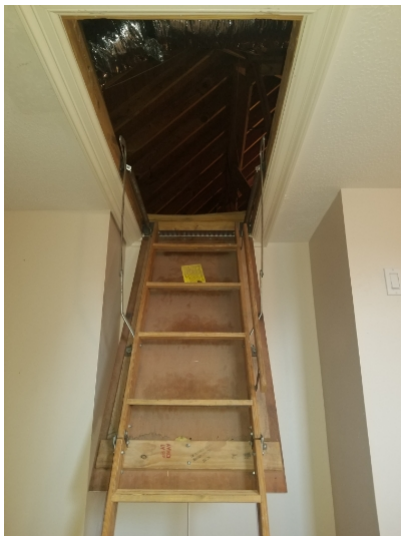
Attic access door was inadequately sealed and insulated.

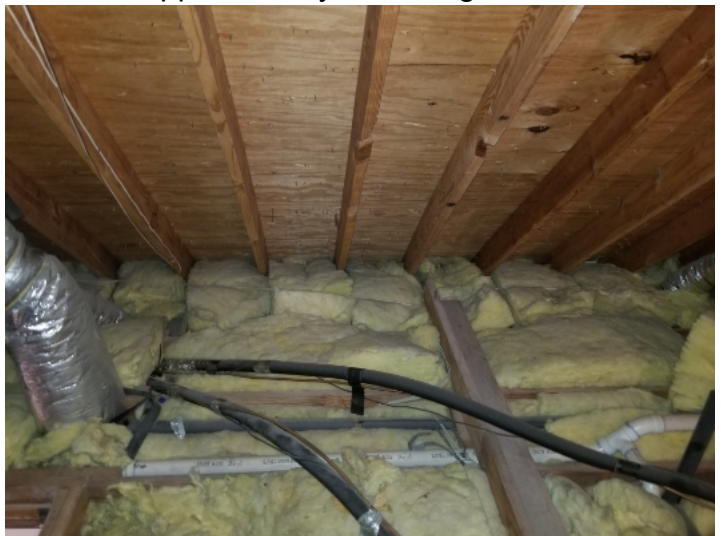
Baffles were either missing or covered. This can cause insulation to obstruct circulation at attic vents.

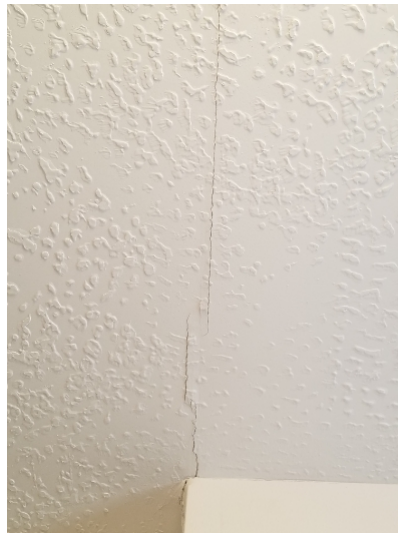
Minor ceiling cracks were noted in the living room and 2nd level storage room. In our opinion, there did not appear to be excessive deflection or settlement in these areas.

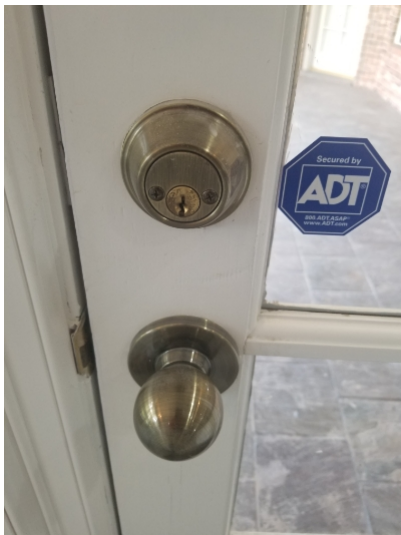
Some entry doors were double keyed. Egress doors should be openable from the inside without the use of a key or special knowledge or effort.

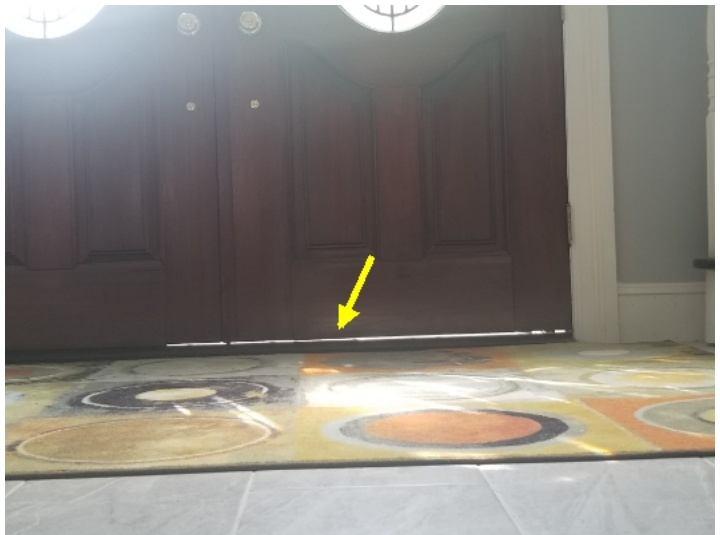
Weatherstrip was missing or damaged at the entry doors. Gaps were observed.

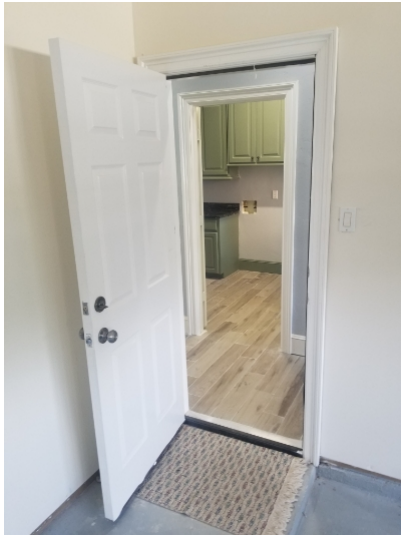
Self closing hardware was missing or ineffective at the garage pedestrian door.

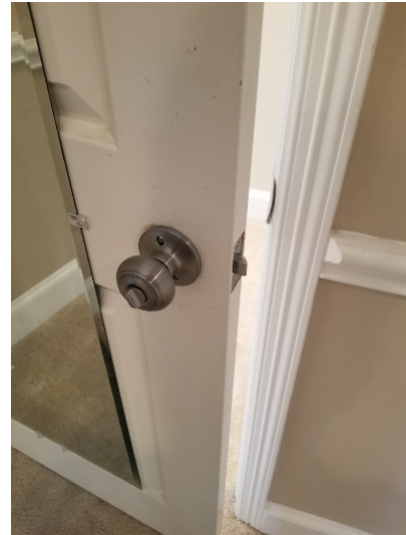
The 2nd level front left bedroom door was not latching properly and should be adjusted.

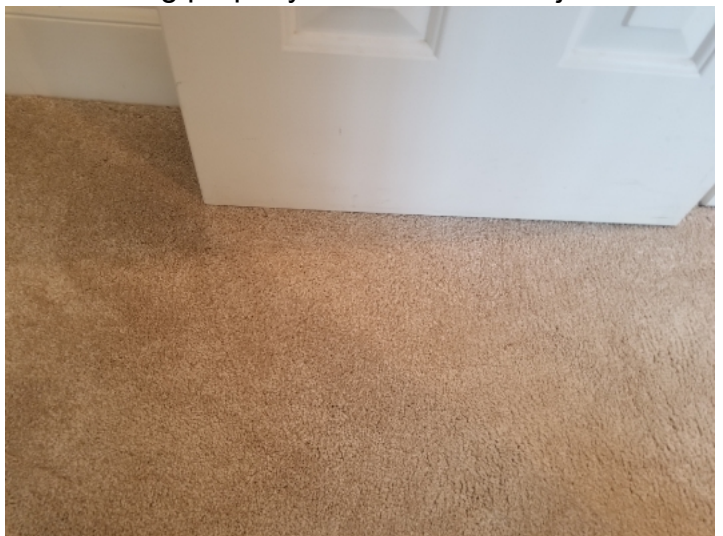
Some bedroom closet doors were contacting and rubbing the carpet. This will cause wear or damage on the carpet in these areas.

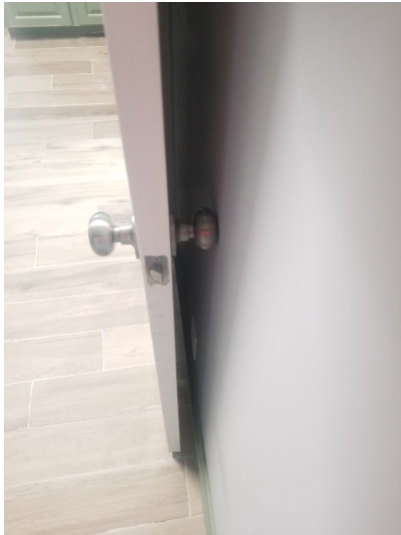
Some doors were missing stoppers; door or wall damage can occur as a result.

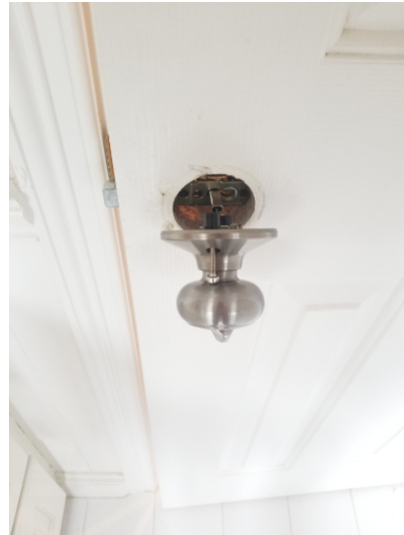
Door hardware was loose at some doors around home.

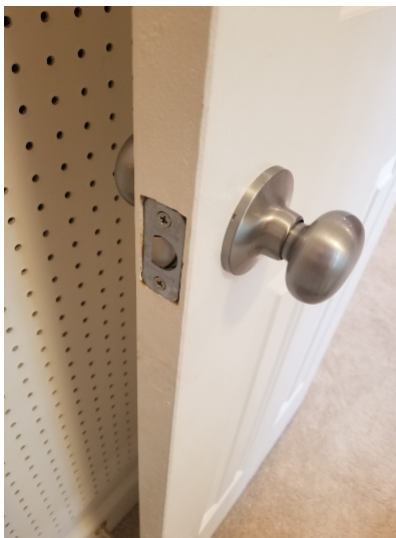
Some door hardware sticks.

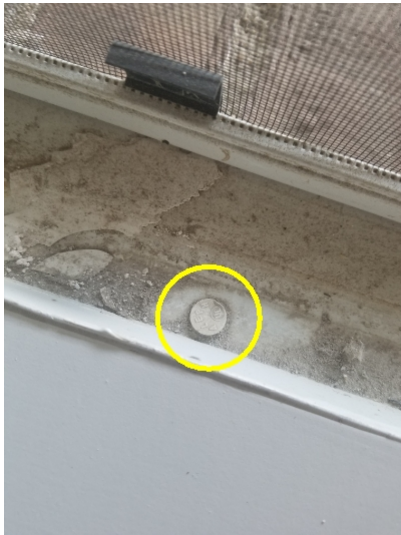
Lower window frames were drilled for security sensors. This may not adhere to manufacturers recommendations. The sensors should be sealed and checked periodically to prevent water intrusion.

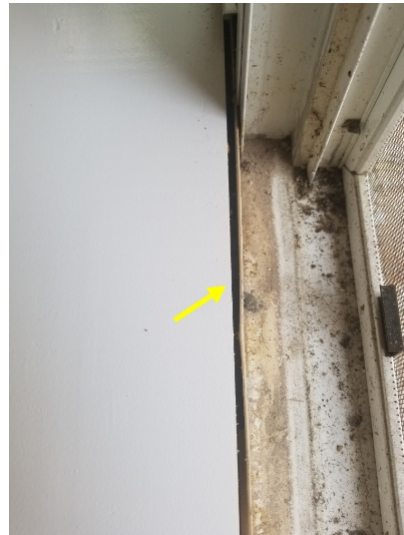
Some windows had gaps in the caulk seal around the framing/drywall junction and require a caulking upgrade.

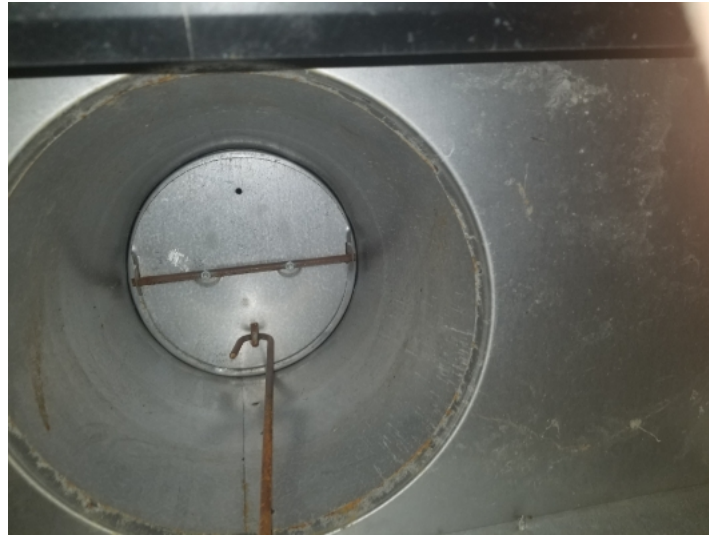
Gas starters are present and dampers should be blocked open with the presence of gas accessories.

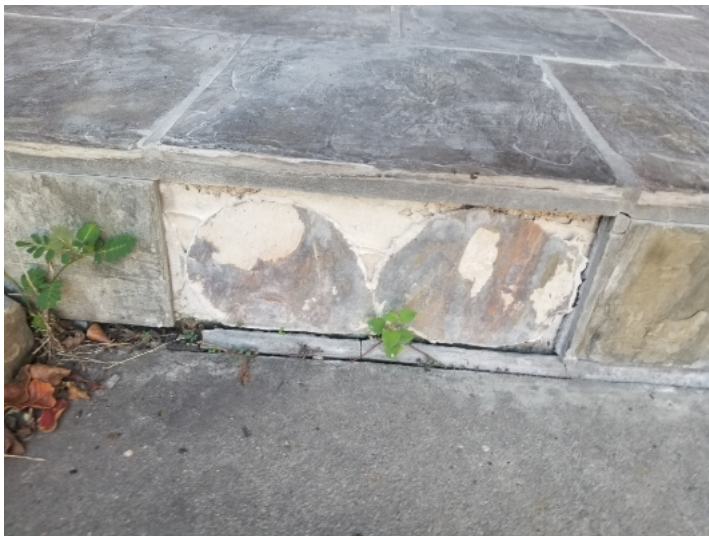
Missing slate tile piece was noted at the dining room back porch.

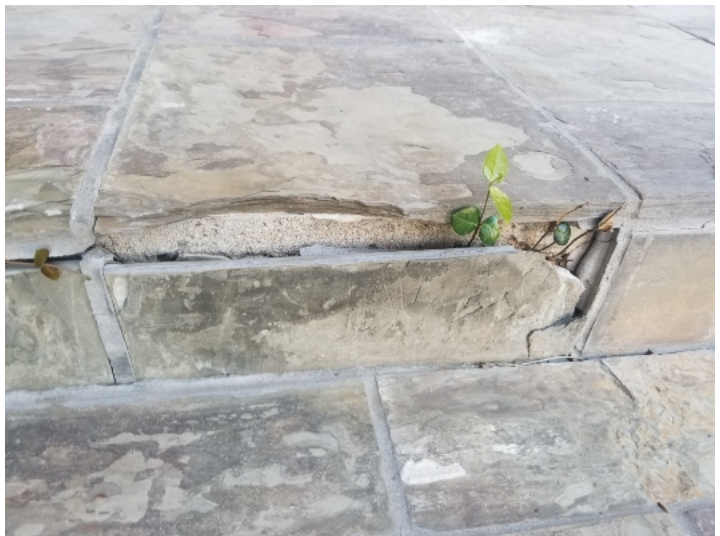
Chipped slate tile piece was noted at the back bathroom/garage back porch.

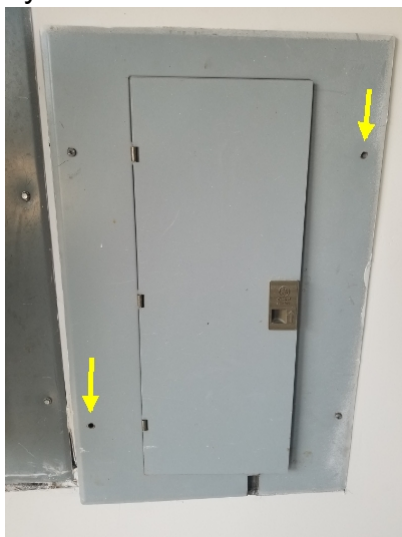
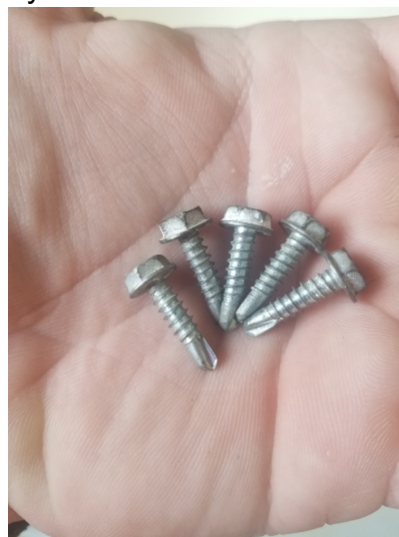
Some fasteners were missing for the panel covers.

Pointed screw fasteners installed to secure metal "dead-front" cover on electrical panel box which is an "electrical-hazard" and screws can penetrate wiring inside box (replace with blunted-end type screws).

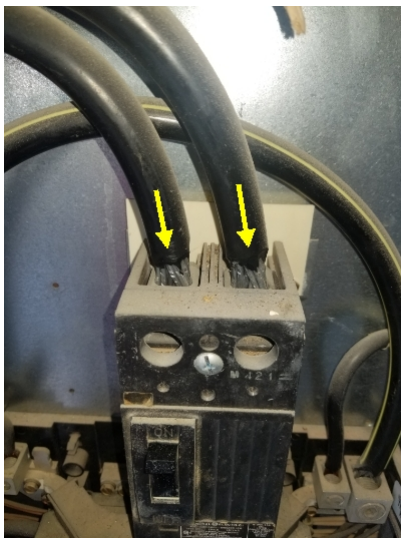
It did not appear that there were anti-oxidants used on the aluminum wire connections.

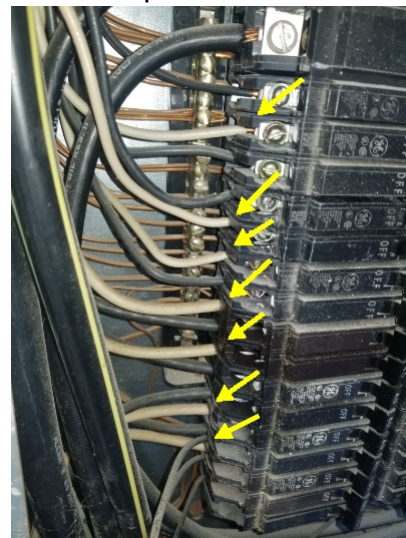
White wires were connected directly to breakers in the panel. Typically white wires should be designated as neutral only. These should be marked appropriately.

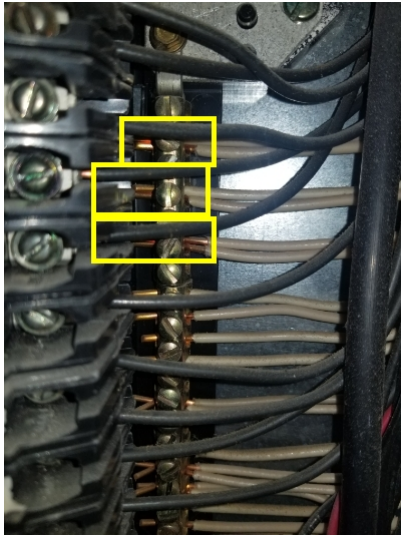
There were neutral wires in the panel that were sharing terminals on the bus bar. One neutral wire per terminal screw is permitted.

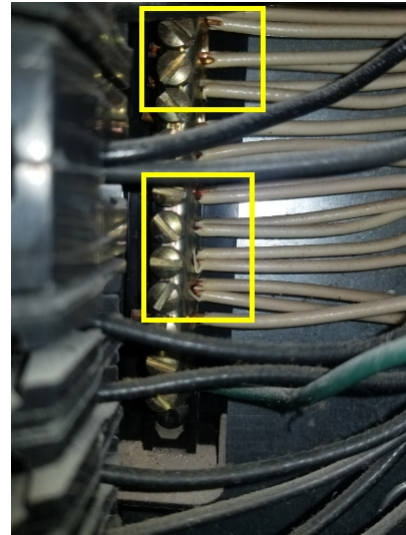
There were neutral wires in the panel that were sharing terminals on the bus bar. One neutral wire per terminal screw is permitted.

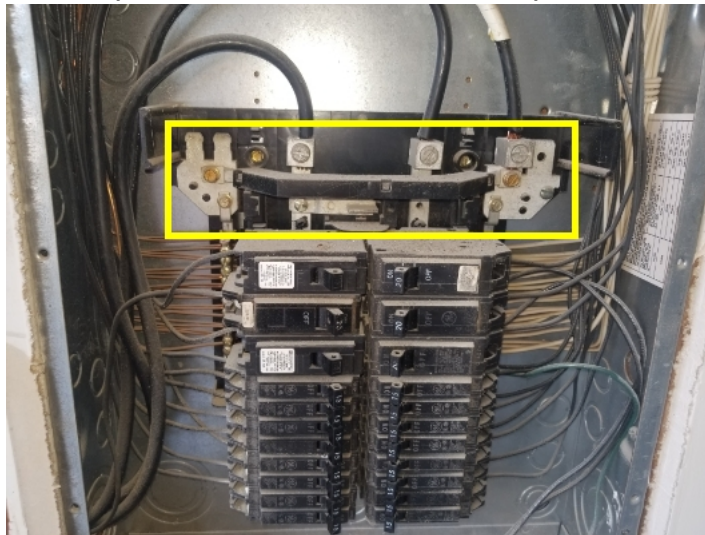
Neutral and ground wires were bonded in the electrical sub panel. Common practice requires that these be separated in any sub panels. This should be further evaluated and by a qualified electrician.

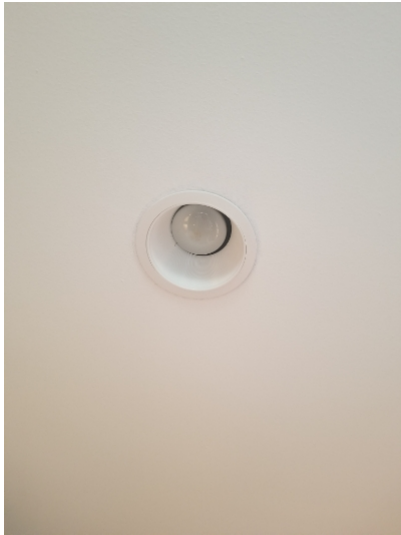
Fixtures were not functioning in the kitchen, butler's pantry, garage and several other areas. Light bulbs were not tested.

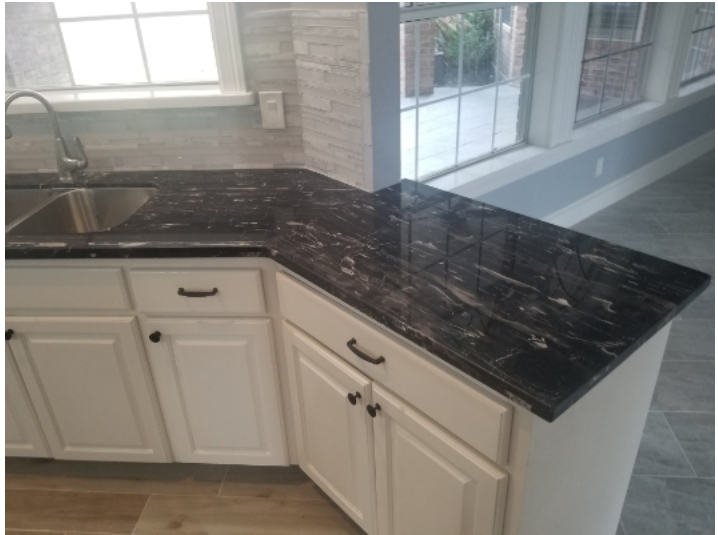
There were an insufficient number of outlets on the kitchen counters due to original construction. Receptacle outlets should be installed so that no point along the wall line is more than 24" from a receptacle outlet. Additionally, a receptacle outlet should be installed at each wall counter space 12" or wider.

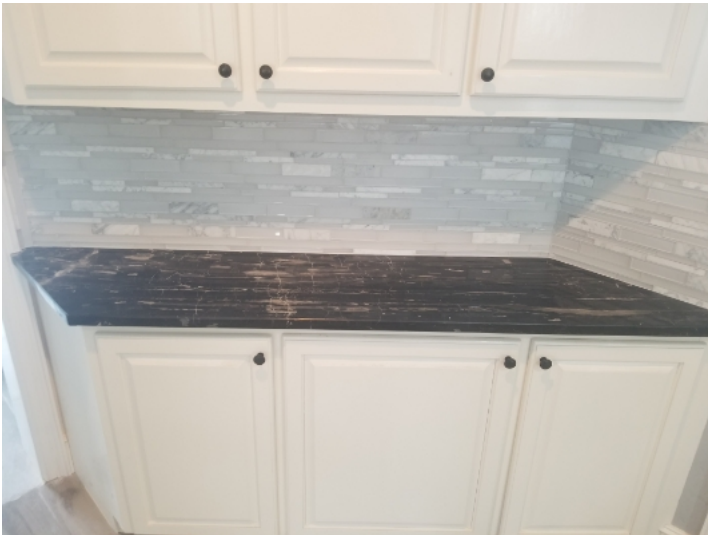
There were an insufficient number of outlets on the kitchen counters due to original construction. Receptacle outlets should be installed so that no point along the wall line is more than 24" from a receptacle outlet. Additionally, a receptacle outlet should be installed at each wall counter space 12" or wider.

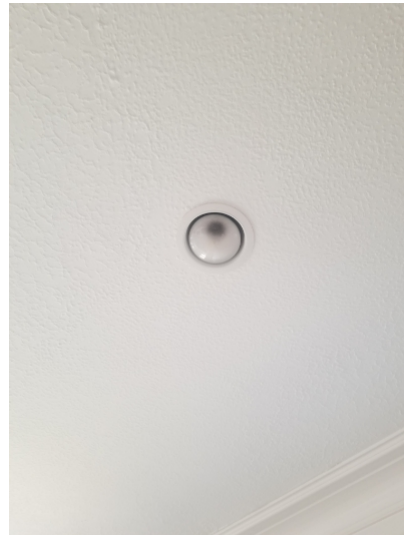
Fixtures were not functioning in the kitchen, butler's pantry, garage and several other areas. Light bulbs were not tested.

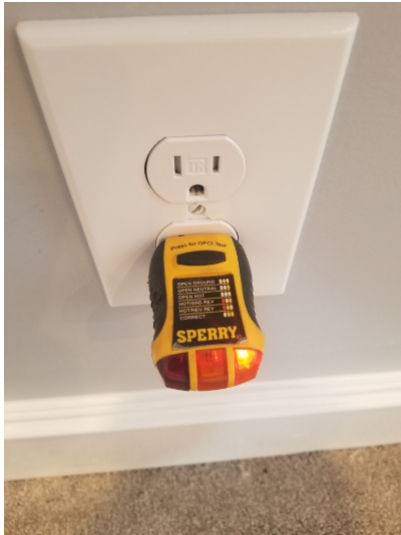
Open neutral was detected on outlets in master bedroom.

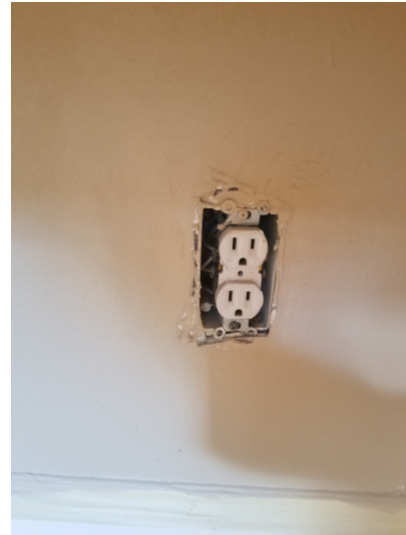
Outlet cover was missing in the 2nd level front right bedroom.

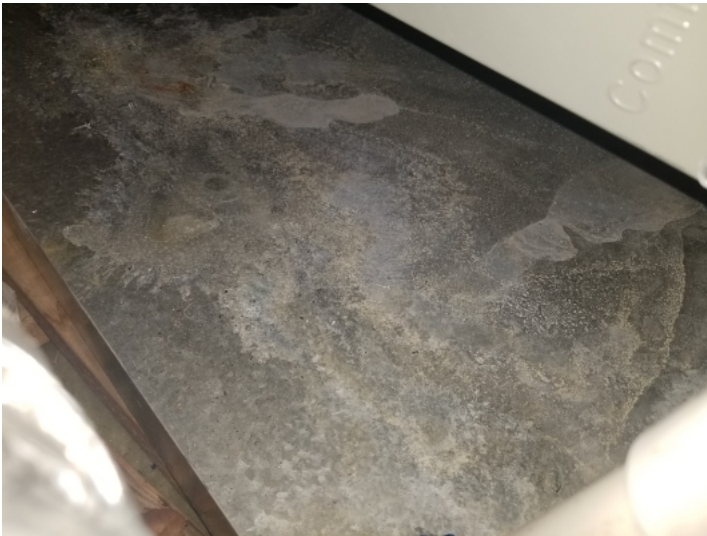
Evidence of water stains and rust in secondary evaporator drain pan. Suspect this could be from typical condensation, however, this could be a sign of improper drainage of the main drain line. Recommend that unit be evaluated and serviced by an HVAC professional.

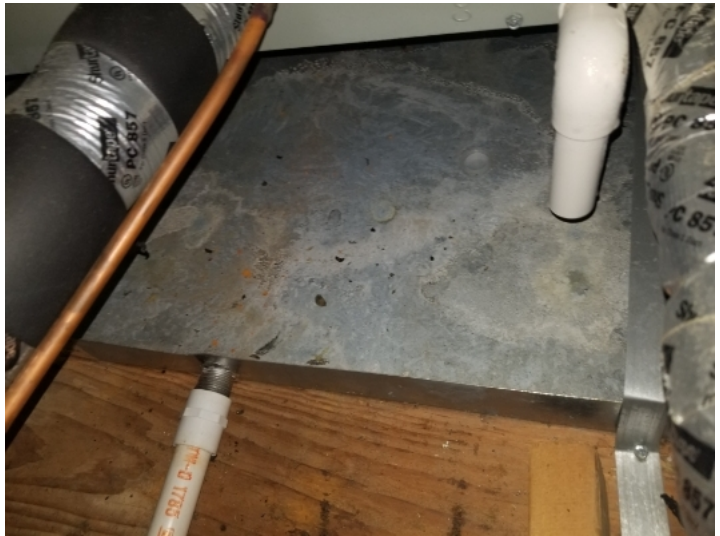
Evidence of water stains and rust in secondary evaporator drain pan. Suspect this could be from typical condensation, however, this could be a sign of improper drainage of the main drain line. Recommend that unit be evaluated and serviced by an HVAC professional.

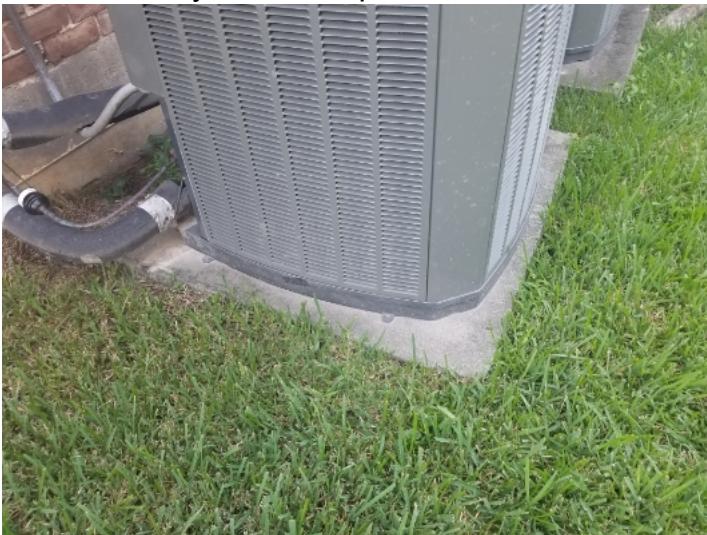
Condensing unit is not elevated. Common building code requires condensers to be elevated at least 3" from the ground.

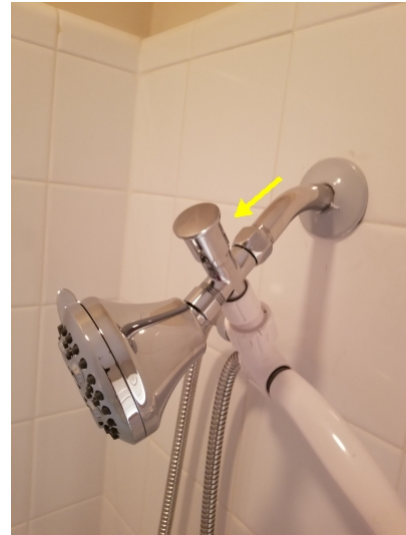
Shower diverter was not working properly in 2nd level back bathroom.

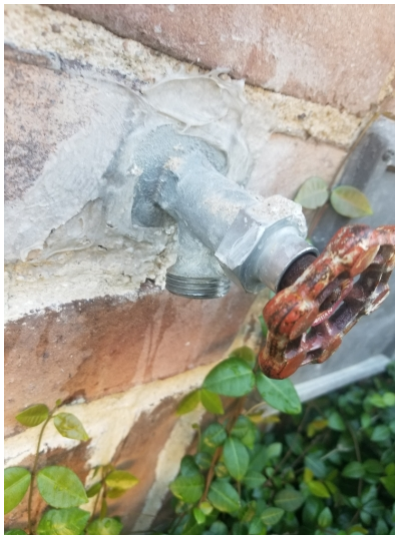
No backflow prevention devices were observed on exterior hose bibs.

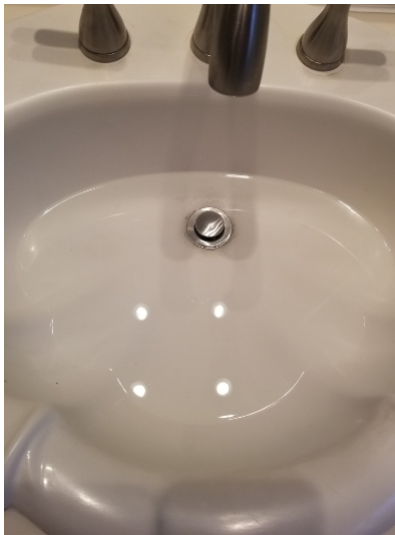
2nd level left bathroom sink drain appeared to be draining slowly.

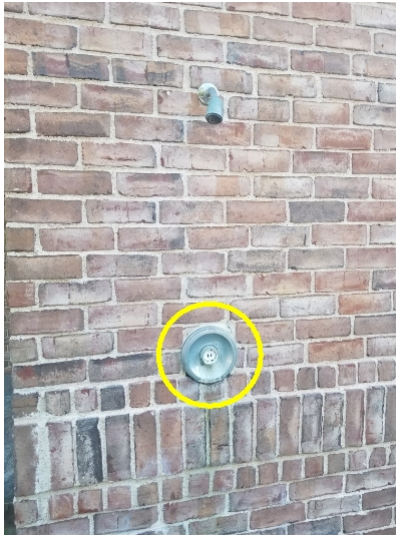
Outdoor shower had a broken handle/valve and did not appear to be operational.

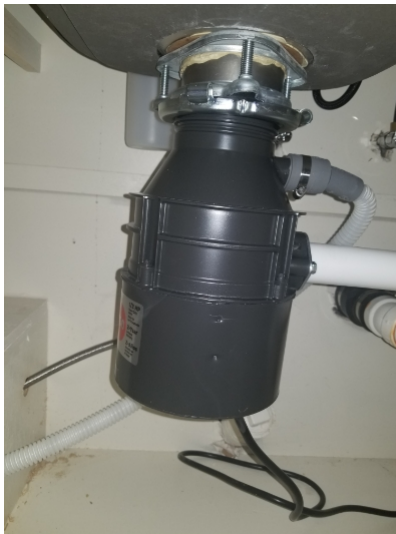
Kitchen sink ISE garbage disposal did not operate.

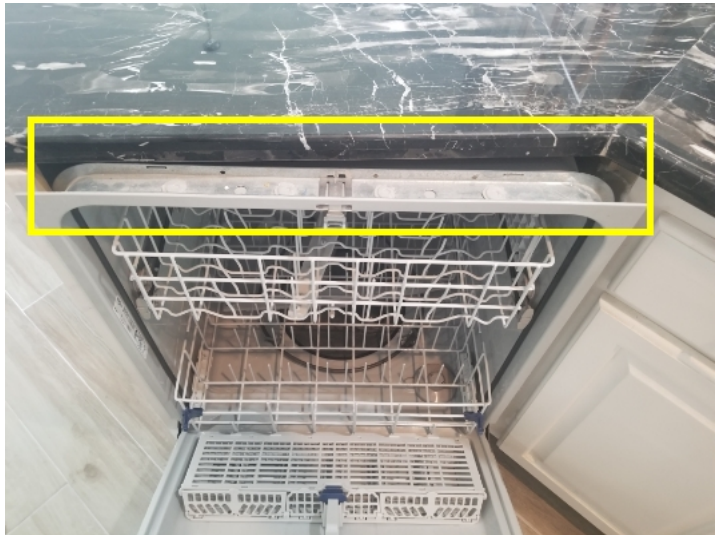
There was no anti-siphon device or high loop on the dishwasher drain. The dishwasher drain hose may be attached to the bottom of the counter top under the sink. This would prevent water flowing back to the dishwasher in the event the sink backed up.

Unit was not properly secured to the cabinet.

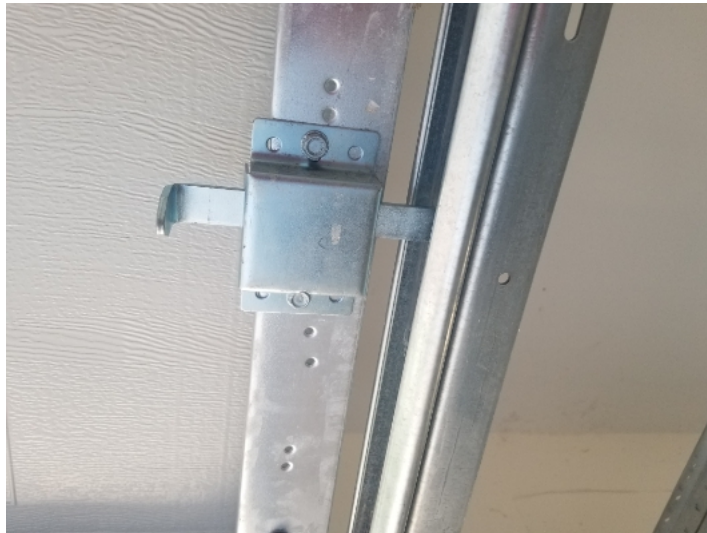
Door lock should be disabled since opener is present.

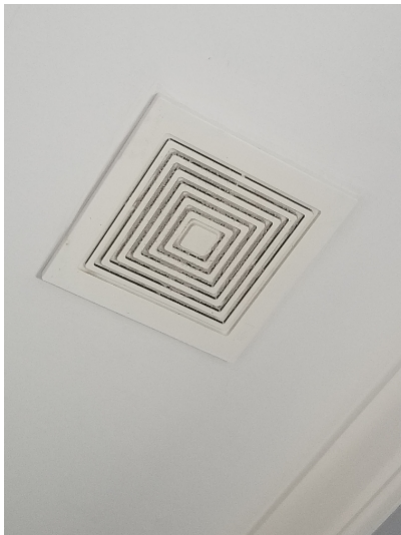
Units should be cleaned of dust and dirt build up to improve air flow.

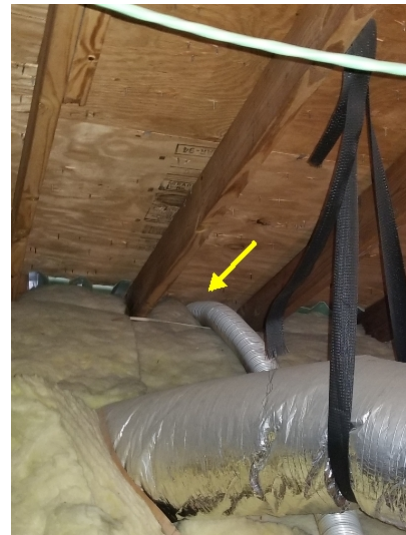
Bath fans terminate in soffit vent area of the attic. In our opinion, moisture may not be sufficiently exiting the attic.
