Inspection Reveal, LLC

Property Inspection Report

1477 River Oaks Dr.. Huntsville , TX 77340

Date of Inspection: 9/11/2019 Time: 7:30 am to 2:00pm
Age of Home: 1986

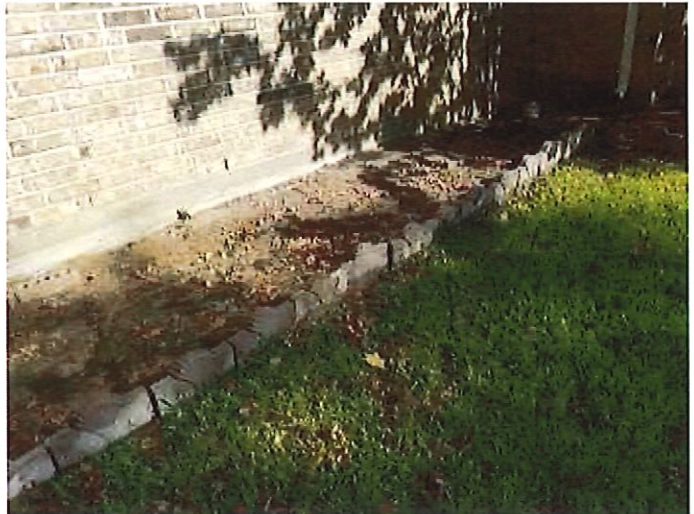
- All components were found to be performing and in satisfactory condition at the time of the inspection.
- Slab not visible due to floor coverings.
- Corner pop noted on rear of foundation. Does not appear to be effecting performance of foundation.
- Spalled concrete noted at front of garage area. Does not appear to be effecting performance of foundation. Consideration should be given to patching area when time and budget permits.
- Small cracks in garage floor appear to be normal shrinkage / settlement cracks.

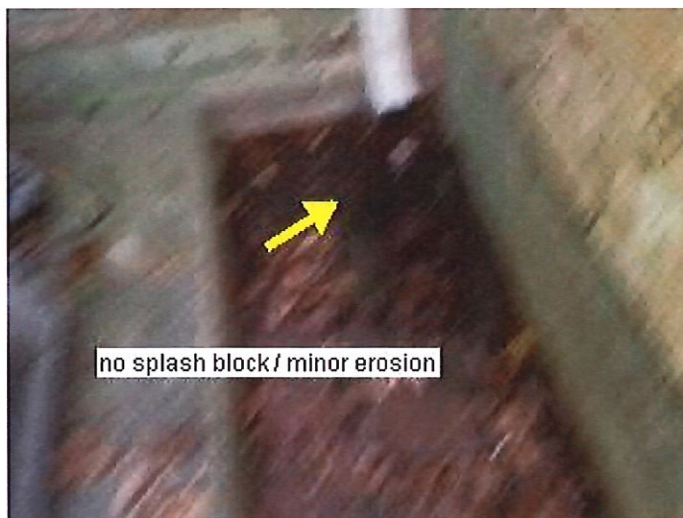
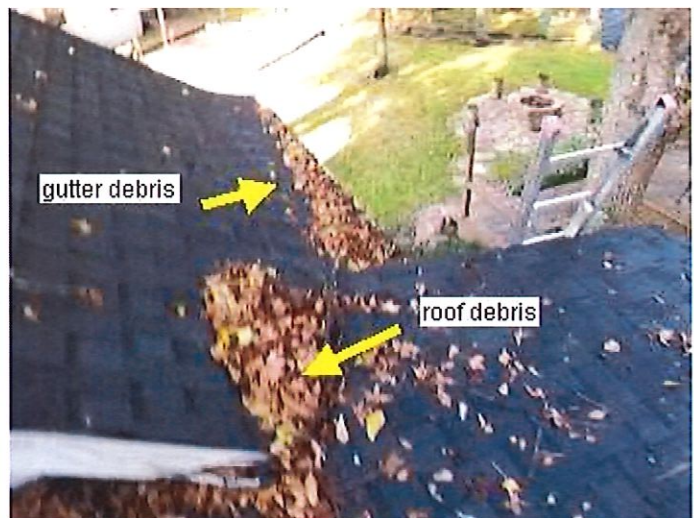
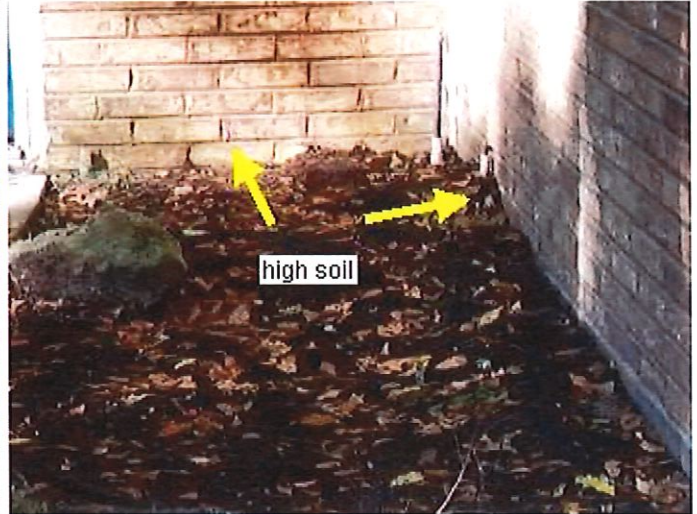
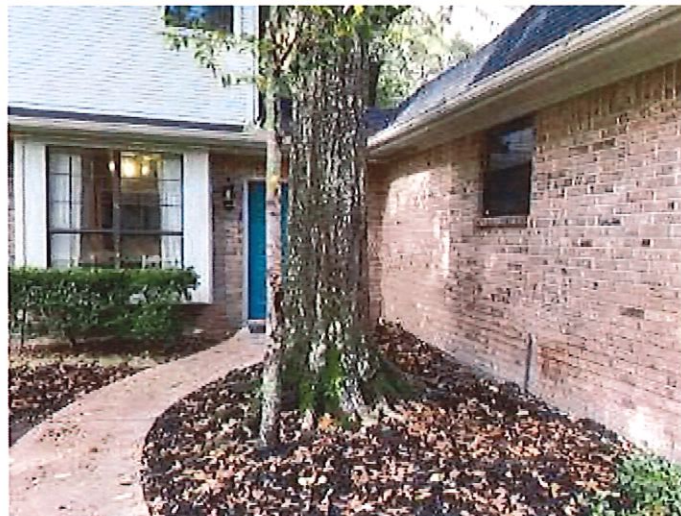
- Trees too close to structure. Tree roots could possibly cause damage to foundation and sidewalks. Future evaluation is recommended.
- Surface and french drains observed and not tested at the time of inspection. Recommend keeping all drains clear of debris.
- **High soil observed promoting earth to wood contact. Recommend lowering soil to expose 4 inches of foundation.**
- **The gutter system was partially blocked with debris and one or more downspouts or splash blocks were missing. Recommend keeping gutters clean and replacing splash blocks to prevent erosion of soil.**

STRUCTURAL SYSTEMS		
Page 5 Item: B	Grading and Drainage	<ul style="list-style-type: none"> • High soil observed promoting earth to wood contact. Recommend lowering soil to expose 4 inches of foundation. • The gutter system was partially blocked with debris and one or more downspouts or splash blocks were missing. Recommend keeping gutters clean and replacing splash blocks to prevent erosion of soil.
Page 10 Item: E	Walls (Interior and Exterior)	<ul style="list-style-type: none"> • It was observed that one or more areas of the exterior wood sidewall surfaces was in need of repair. This was typical around the house in areas close to peak of roof under soffit. Recommend further evaluation by qualified contractor and repair as needed. • The exterior window casings were observed to have some level of deterioration and/or damage. • One or more locations on the exterior cladding showed evidence of wood decay / rot. Recommend repairs / replacing by qualified contractor. • Area where gas pipe enters soffit by generator should be properly sealed.

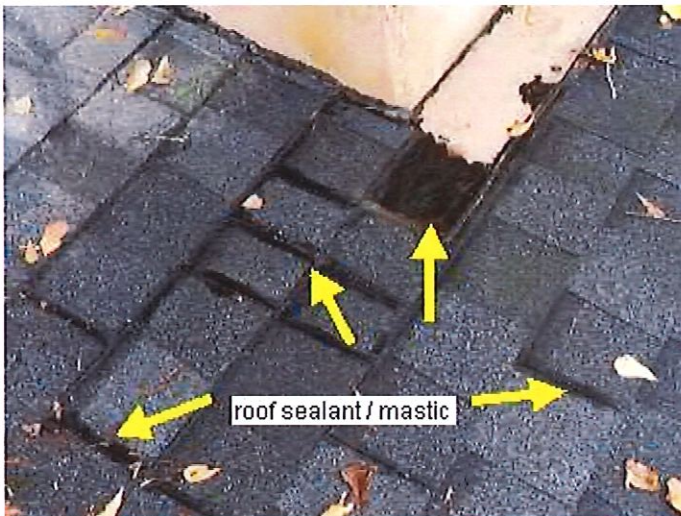
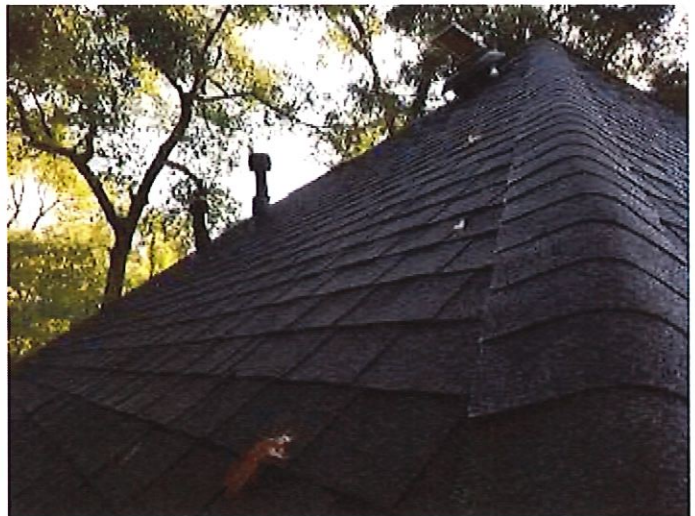
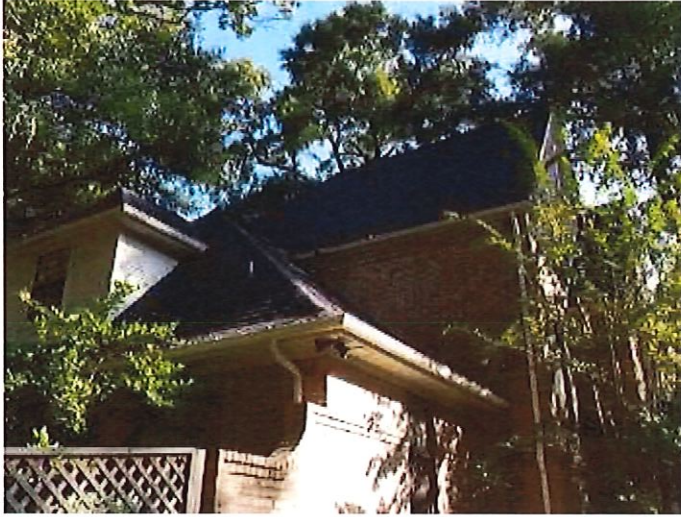
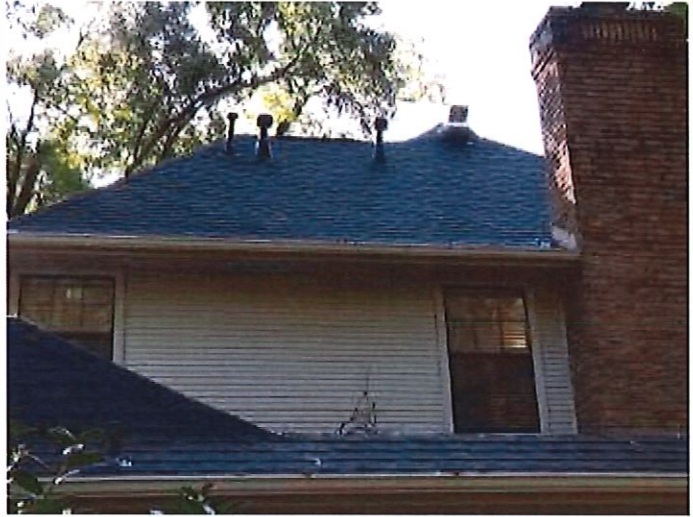
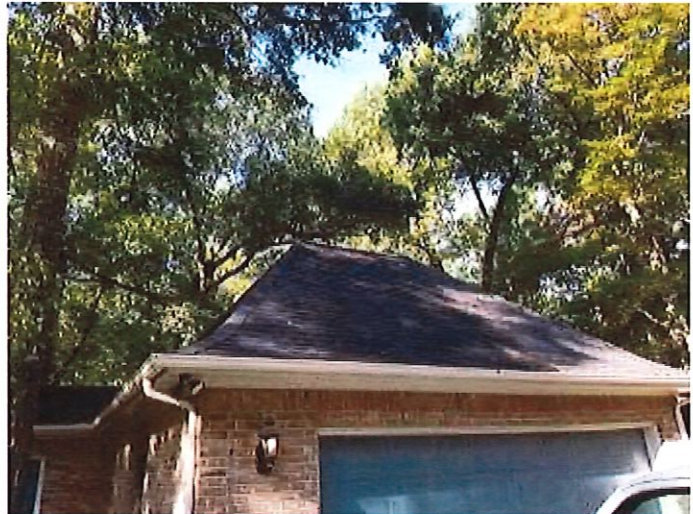
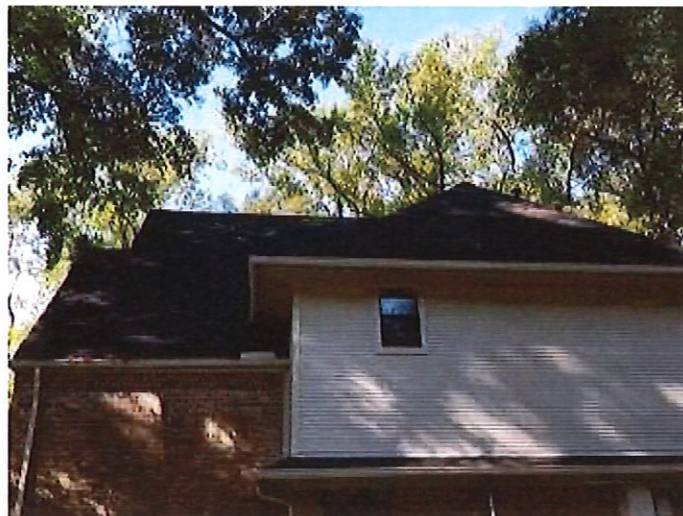
- All components were found to be performing and in satisfactory condition at the time of the inspection.
- Inspector could not access all areas of the roof due to either roofing material, dangerous slope of roof and/or above the reachable height; therefore, the roof was observed from ground level with optical lenses.
- Appears to be signs of previous roof repair around chimney area. No sign of water penetration in residence. May consider asking current owner about repair.
- Ridge vents were noted at the time of the inspection.
- Galvanized steel / aluminum gutters and downspouts were noted.
- The gutter and downspout system was observed to be connected to underground drainage piping in one or more locations.
- Recommend keeping debris cleaned off roof surface.

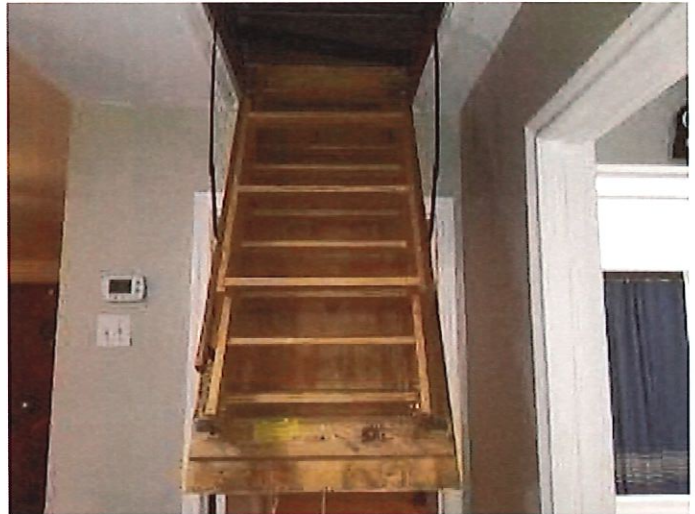
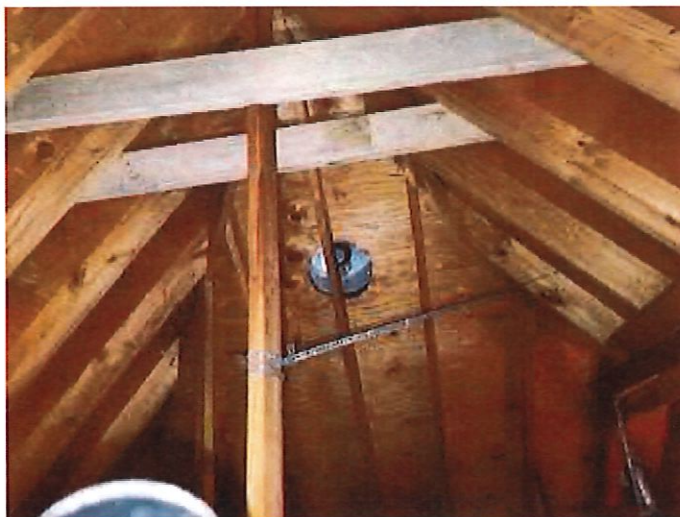
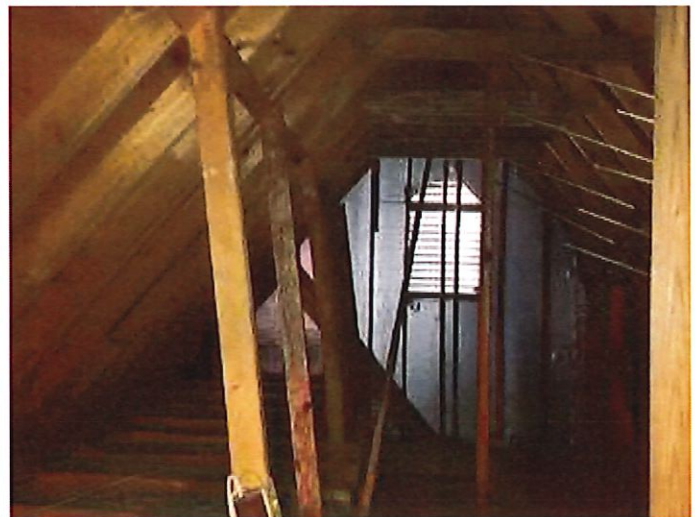
- The pulldown attic ladder is not insulated or weather stripped at this time. This is an "As Built" condition that does not meet current energy standards. It is recommended to insulate the hatch door after taking ownership of the property.
- The fascia board has some deterioration in one or more locations. Recommend repairs / replacing when time and budget permit.

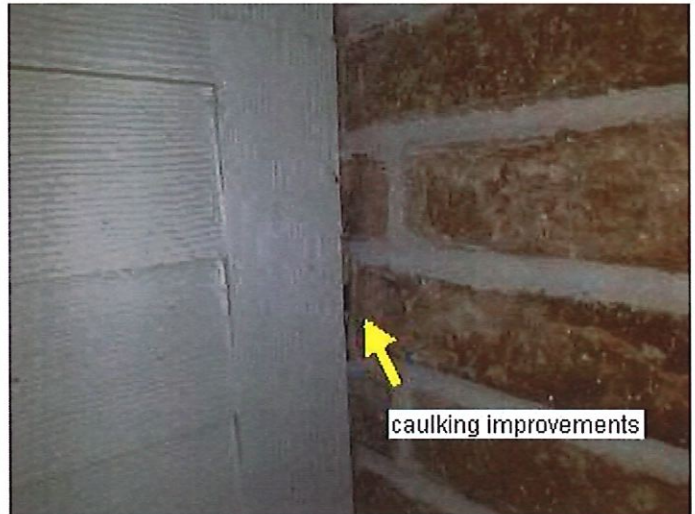
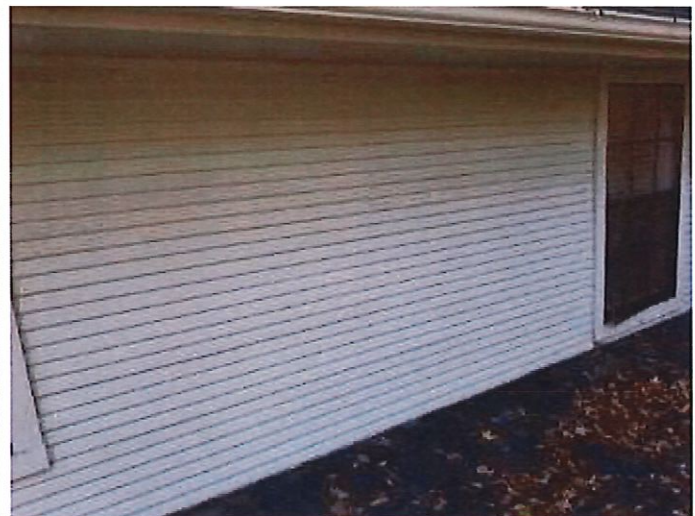
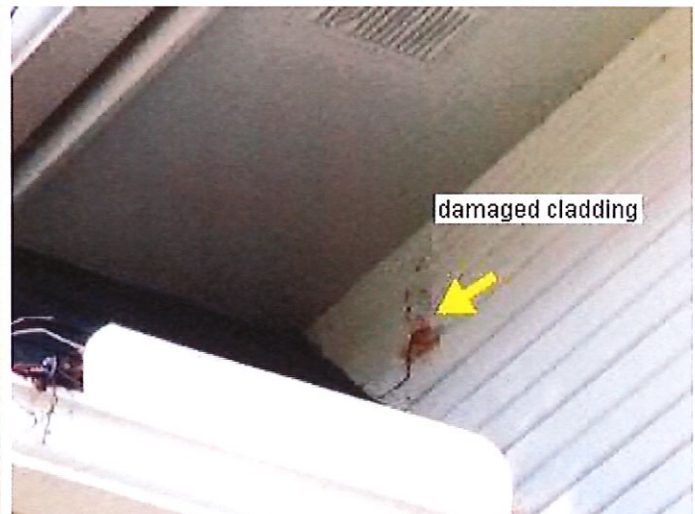
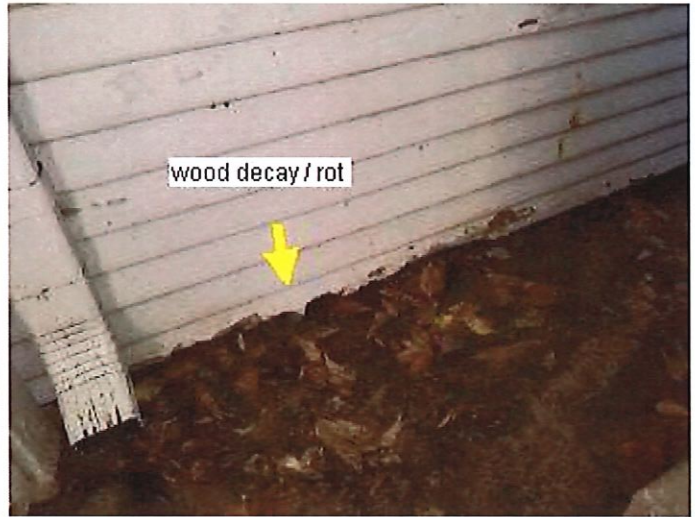
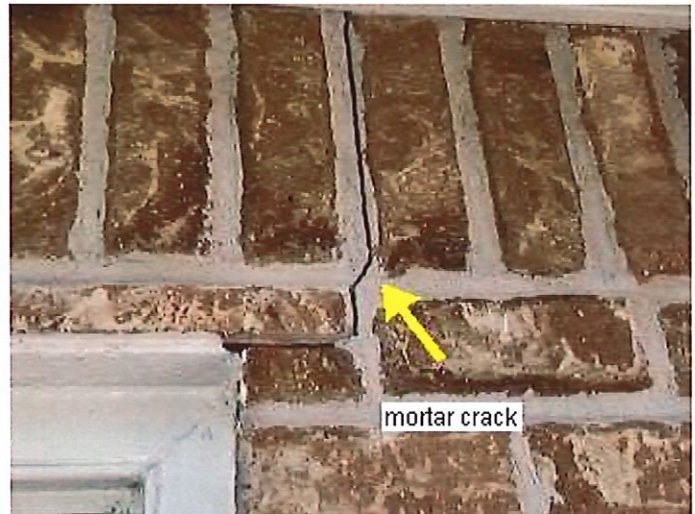
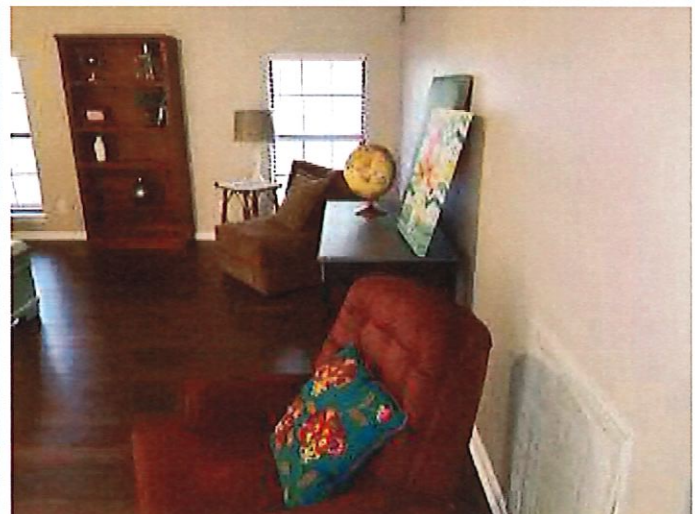
- Elastomeric caulking is recommended for the area between the exterior brick veneer and exterior hardi / wood cladding trim boards.
- Mortar joint crack noted over side entrance door. Crack does not appear to be effecting the performance of wall.
- **It was observed that one or more areas of the exterior wood sidewall surfaces was in need of repair. This was typical around the house in areas close to peak of roof under soffit. Recommend further evaluation by qualified contractor and repair as needed.**
- **The exterior window casings were observed to have some level of deterioration and/or damage.**
- **One or more locations on the exterior cladding showed evidence of wood decay / rot. Recommend repairs / replacing by qualified contractor.**
- **Area where gas pipe enters soffit by generator should be properly sealed.**

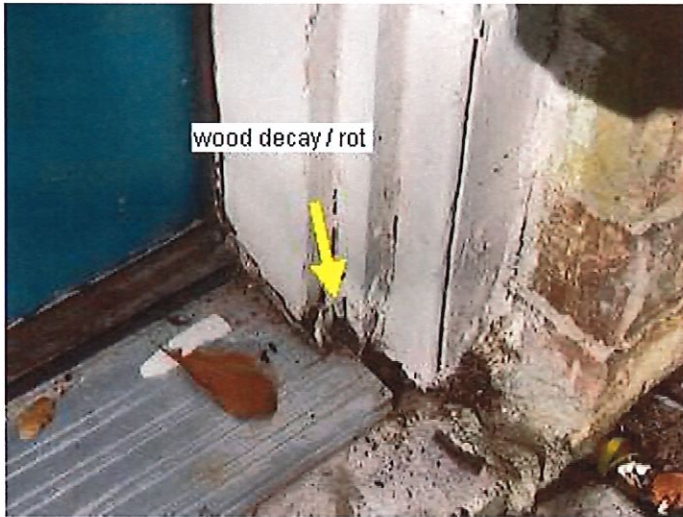
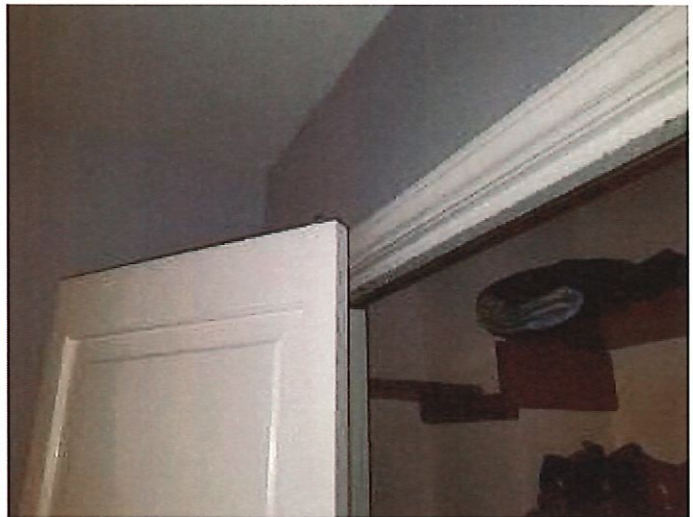
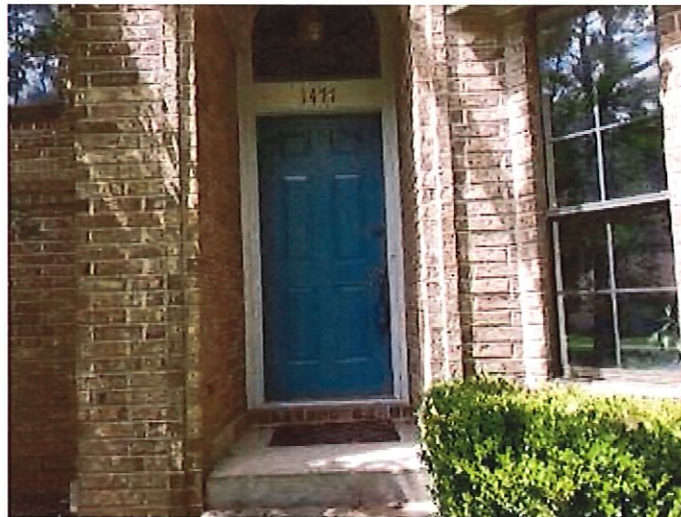
- The garage entry door is not equipped with a self closing device.
- A bi-fold closet door was observed to be missing top guide. Recommend repair by qualified contractor.
- Exterior side door was noted having wood decay / rot on bottom of exterior casing. Recommend repair by qualified contractor.

Page 14 Item: G	Doors (Interior and Exterior)	<ul style="list-style-type: none"> • A bi-fold closet door was observed to be missing top guide. Recommend repair by qualified contractor. • Exterior side door was noted having wood decay / rot on bottom of exterior casing. Recommend repair by qualified contractor.
Page 15 Item: H	Windows	<ul style="list-style-type: none"> • One or more of the thermal pane windows were observed to have lost their seals. This has resulted in condensation or a fog like film to develop between the panes of glass. The thermal pane windows are no longer functional as designed when the seal is lost and replacement may be necessary.
Page 17 Item: K	Porches, Balconies, Decks, and Carports	<ul style="list-style-type: none"> • The deck structure was observed to have either dry rotted, water damaged and/or insect damaged areas and further evaluation is recommended. • Loose deck board noted in one or more areas. Recommend repair by qualified contractor.

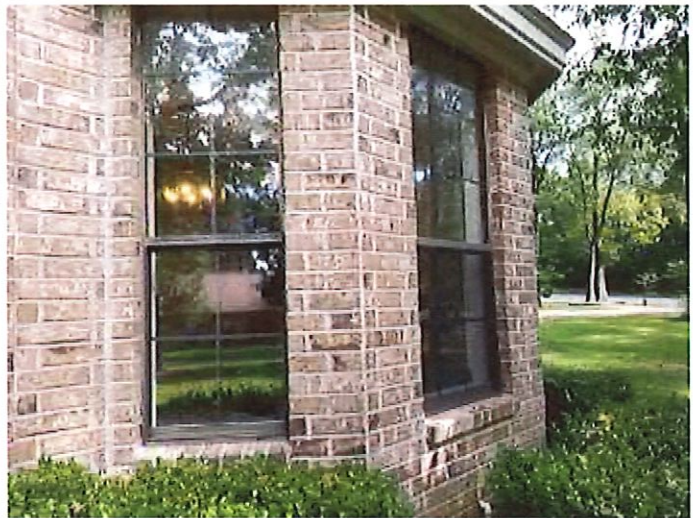
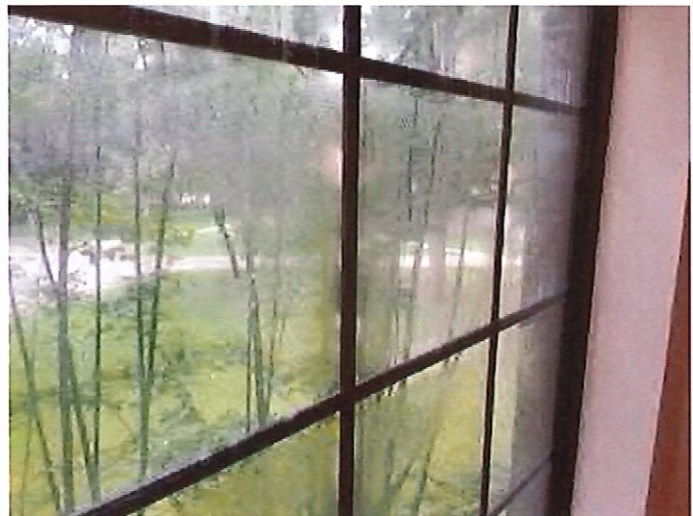
- One or more of the thermal pane windows were observed to have lost their seals. This has resulted in condensation or a fog like film to develop between the panes of glass. The thermal pane windows are no longer functional as designed when the seal is lost and replacement may be necessary.

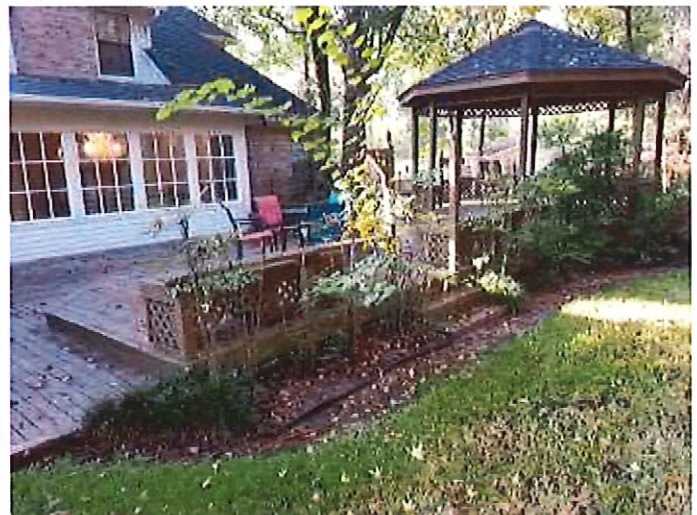
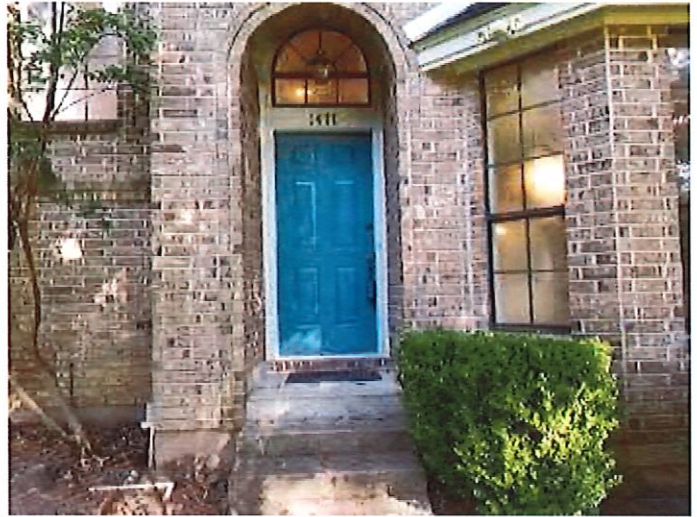
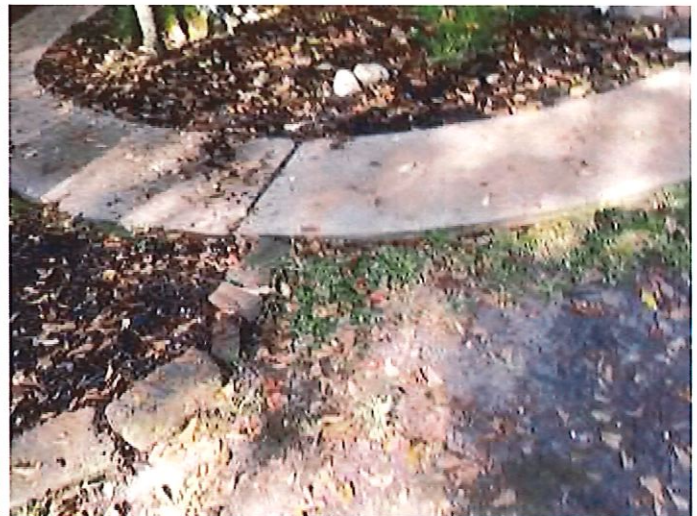
- Concrete driveway was noted.
- Concrete sidewalks were noted. Cracks noted in sidewalks do not appear to be effecting performance.
- **The deck structure was observed to have either dry rotted, water damaged and/or insect damaged areas and further evaluation is recommended.**
- **Loose deck board noted in one or more areas. Recommend repair by qualified contractor.**

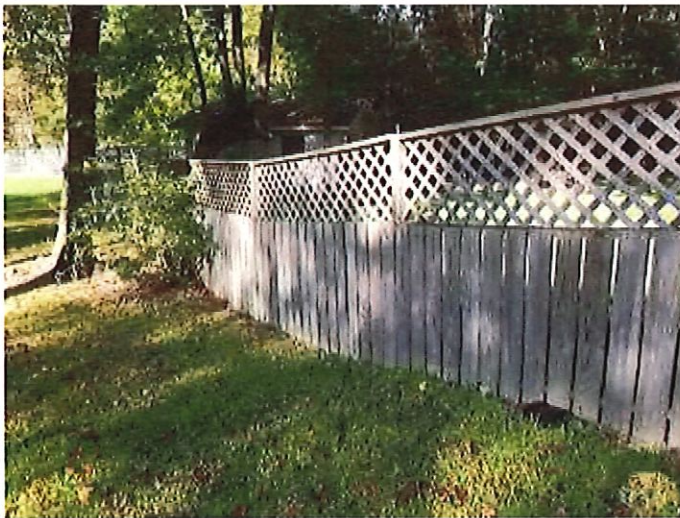
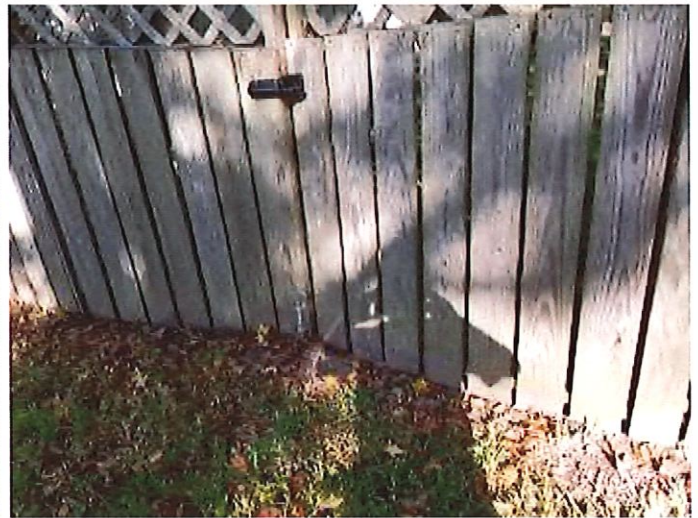
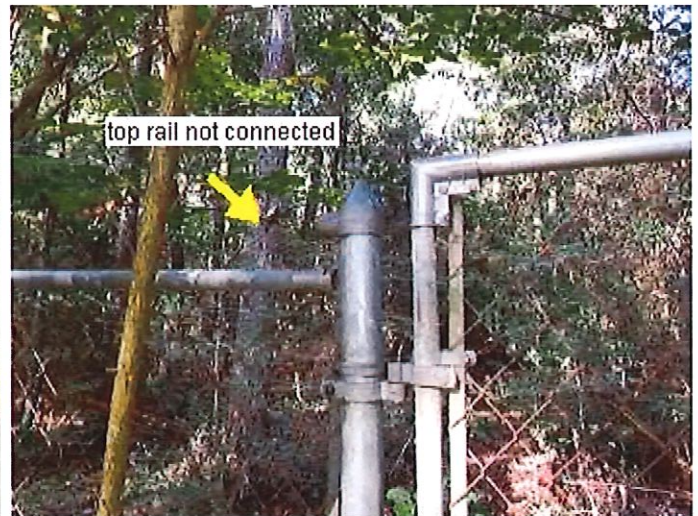
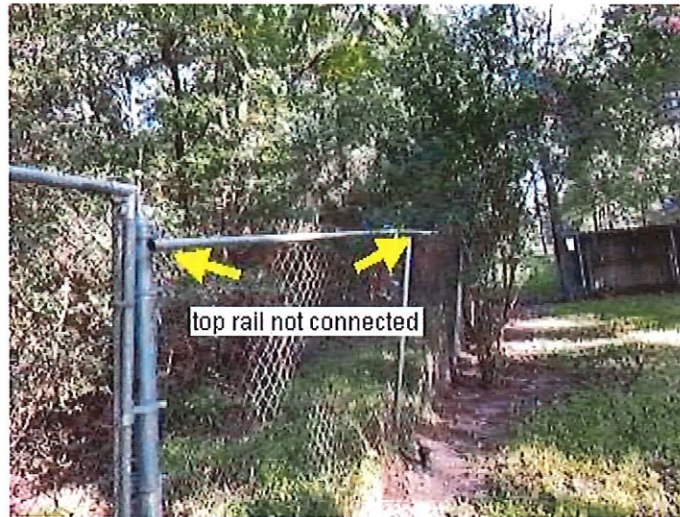
- One or more gates did not appear to swing freely. Recommend repairs when time and budget permit.
- The horizontal top rail was not connected in one or more areas.

Page 19 Item: L	Other	<ul style="list-style-type: none"> • One or more gates did not appear to swing freely. Recommend repairs when time and budget permit. • The horizontal top rail was not connected in one or more areas.
ELECTRICAL SYSTEMS

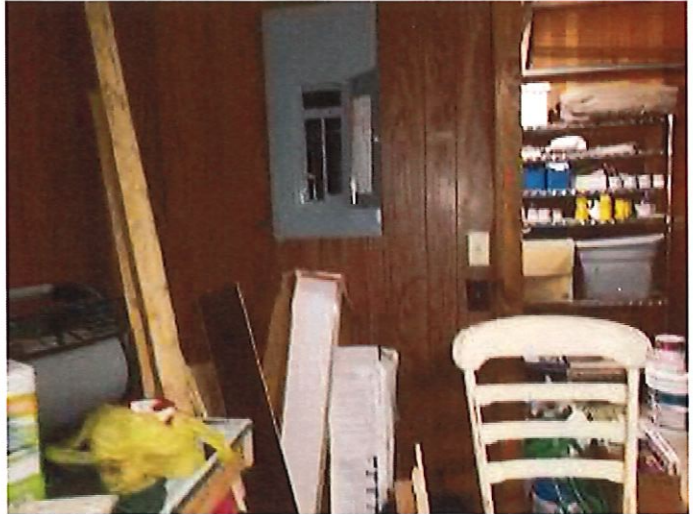
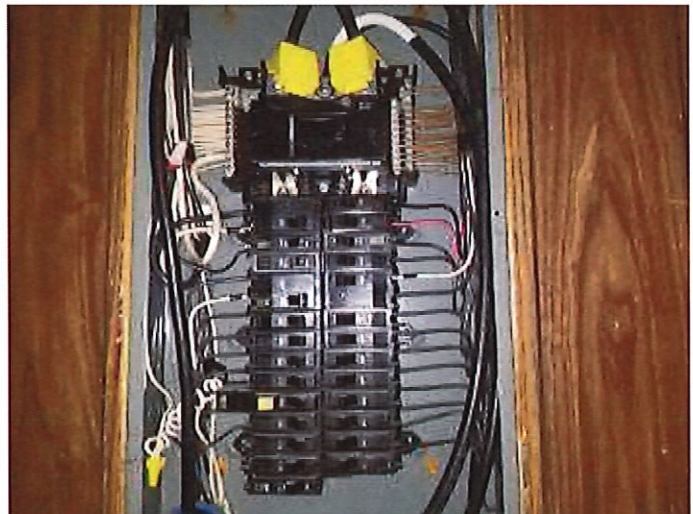
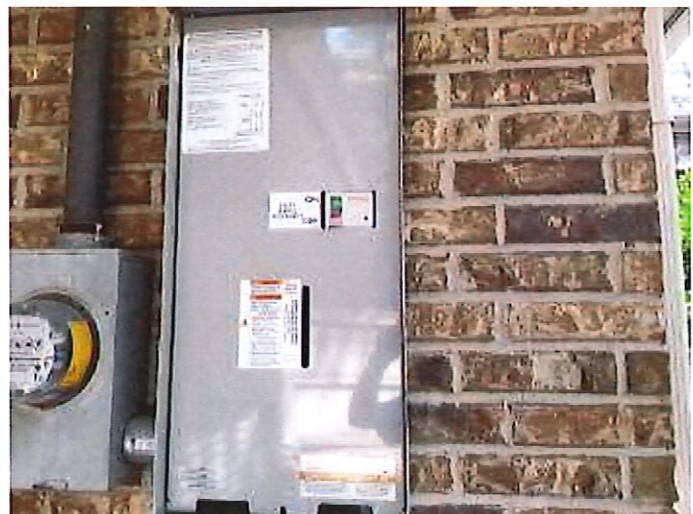
- All components of the main service panel appear to be properly installed and functioning as intended
- Service entrance wiring is overhead.
- No ARC fault breakers {AFCI} were observed at the service panel at the time of the inspection; although this may not have been a requirement when the home was built. Beginning in 2008; AFCI breakers are required in the panel for 15A/20A branch circuits providing power to family rooms, dining rooms, living rooms, libraries, dens, bedrooms, sunrooms, recreation rooms, closets and hallways. ARCI breakers provide fire protection by opening the circuit when an arcing fault is detected. Consideration may be given to upgrading breakers.
- Emergency generator and transfer switch noted. Appeared to be functioning as intended at time of inspection.

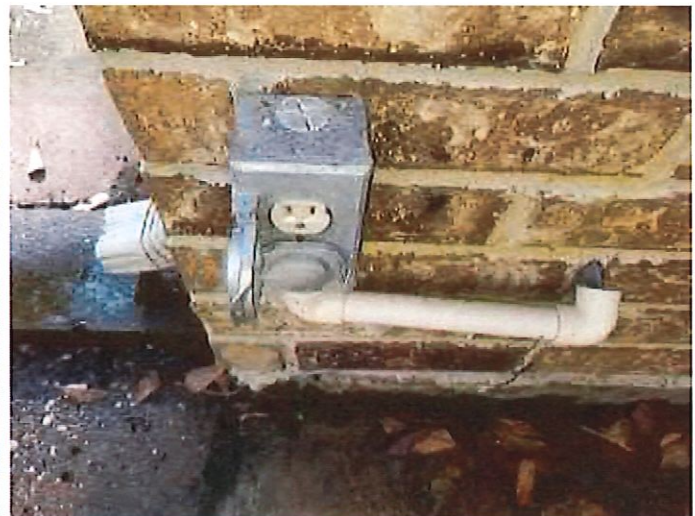
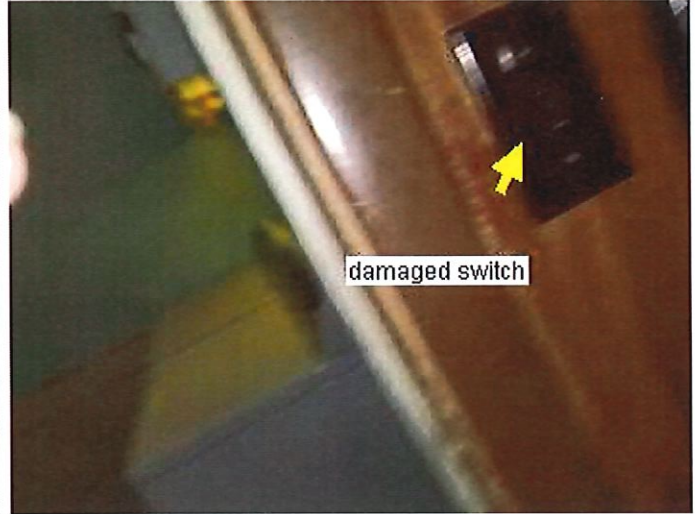
- The doorbell was NOT functional at the time of the inspection.
- GFCI receptacles were not observed in all required locations at the time of the inspection. Recommend having licensed electrician evaluate and repair as needed to meet current standards.

- Inadequate smoke alarm coverage was observed and it is recommended that additional smoke detectors and CO2 detectors be installed in accordance with current building standards. The NFPA {National Fire and Protection Agency} recommends one smoke alarm on each level, every bedroom and adjoining hallway, above stairwells and a CO2 detector in the garage and outside each bedroom with fuel fired appliances. A primary fire extinguisher is recommended on each level with a UL rating of 2-B:C.

- Damaged and/or missing outlet and/or switch covers were observed. This situation creates a Safety Hazard and should be corrected.

Page 22 Item: B	Branch Circuits, Connected Devices, and Fixtures	<ul style="list-style-type: none"> • The doorbell was NOT functional at the time of the inspection. • GFCI receptacles were not observed in all required locations at the time of the inspection. Recommend having licensed electrician evaluate and repair as needed to meet current standards. • Inadequate smoke alarm coverage was observed and it is recommended that additional smoke detectors and CO2 detectors be installed in accordance with current building standards. The NFPA {National Fire and Protection Agency} recommends one smoke alarm on each level, every bedroom and adjoining hallway, above stairwells and a CO2 detector in the garage and outside each bedroom with fuel fired appliances. A primary fire extinguisher is recommended on each level with a UL rating of 2-B:C. • Damaged and/or missing outlet and/or switch covers were observed. This situation creates a Safety Hazard and should be corrected.

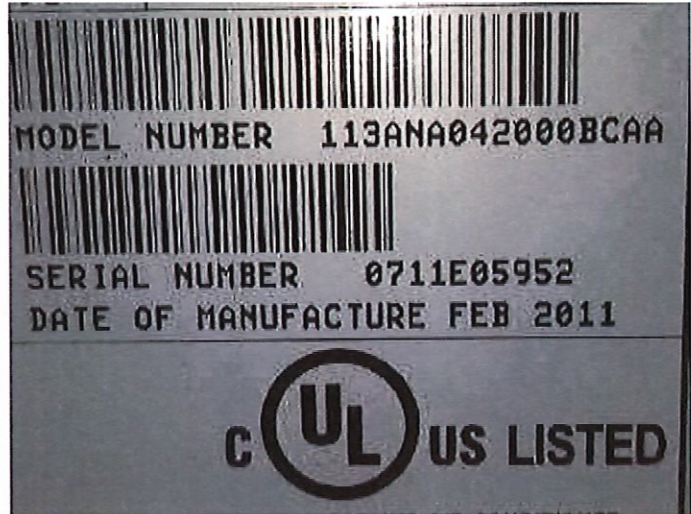
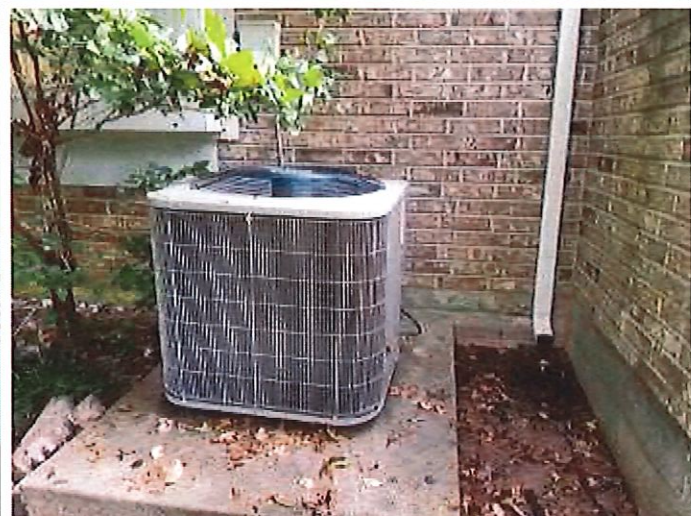
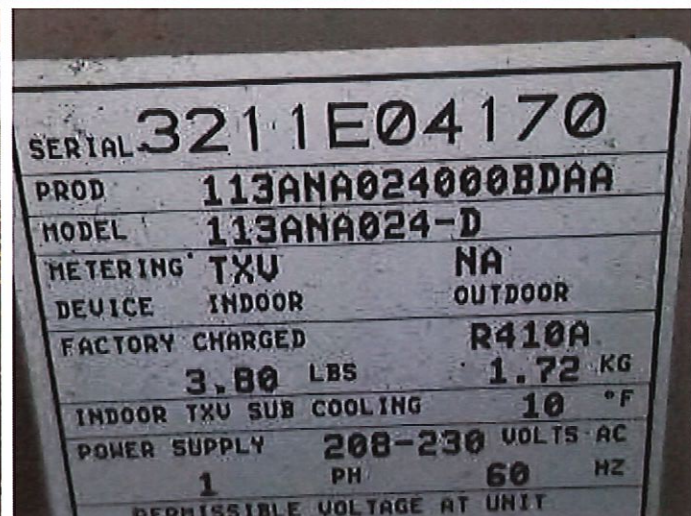
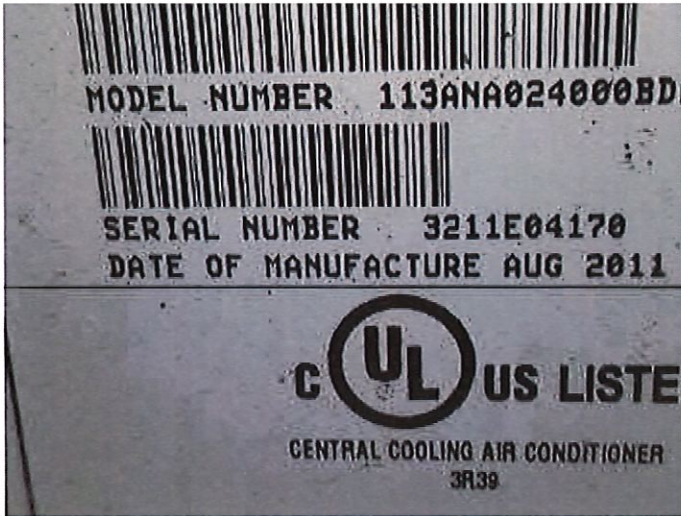
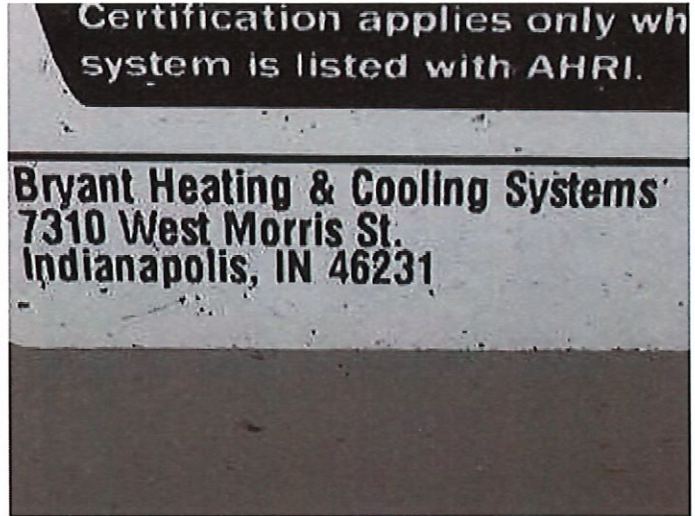
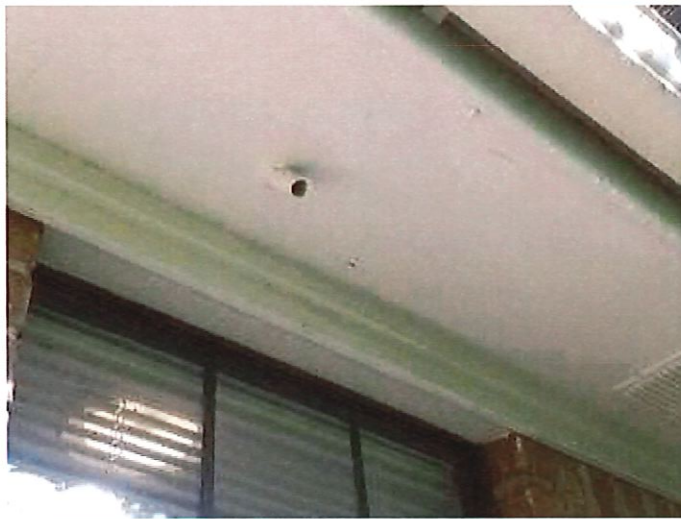
• The upstairs unit did not appear to be performing to industry standards. Temperature differential was approximately 10 degrees. Industry standards: Supply air typically +/- 55 degrees. Return air should be between (14 - 22) degrees greater. Recommend having qualified HVAC technician evaluate system and repair as needed.

Page 24 Item: B	Cooling Equipment	<ul style="list-style-type: none"> • The upstairs unit did not appear to be performing to industry standards. Temperature differential was approximately 10 degrees. Industry standards: Supply air typically +/- 55 degrees. Return air should be between (14 - 22) degrees greater. Recommend having qualified HVAC technician evaluate system and repair as needed.
-----------------	-------------------	---

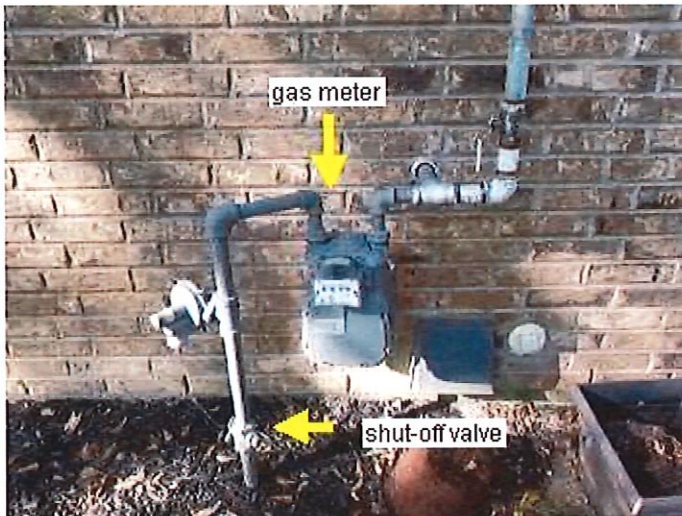
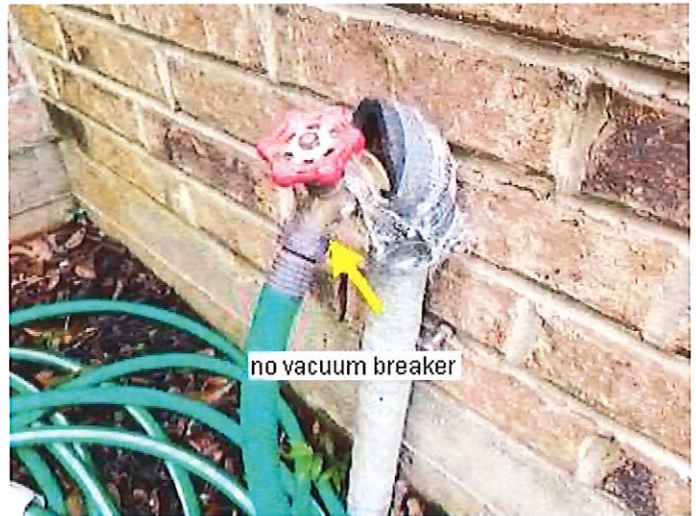
- The anti static water pressure was observed at approximately 75 psi.
- One or more of the exterior water hose bibs {faucets} was not equipped with a back flow and/or anti-siphon {vacuum breaker} device. An anti-siphon device prevents unsanitary water from being pulled back through a garden hose and/or lawn sprinklers and contaminating the household water system and should be considered for safety reasons.
- The anti static water pressure readings are typically at {40-70 psi} in the normal operating range. Pressure exceeding these limits or higher than {70 psi} is likely to put excessive pressure on the household water system. It is recommended that a licensed plumber and/or the city water department further evaluate in the event a pressure reducing valve is required for safety concerns.

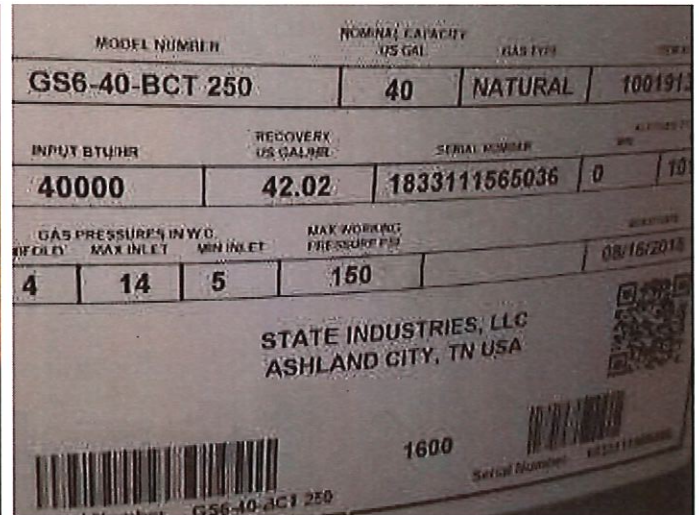
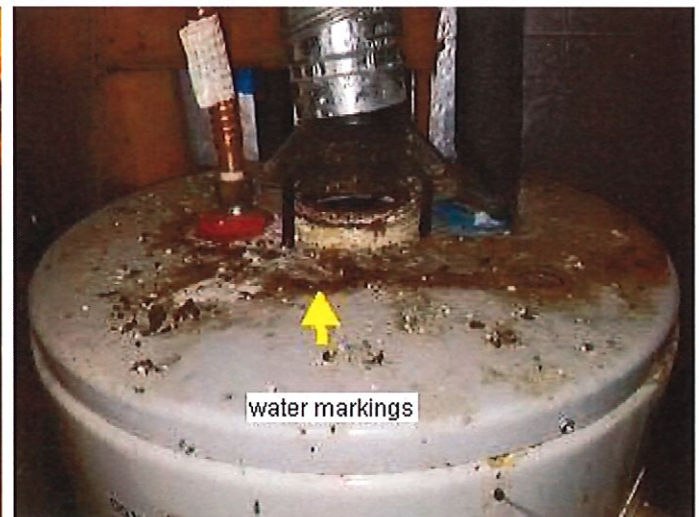
- The water heater and its components were found to be performing and in satisfactory condition at the time of the inspection.
- Water markings noted on top of GE water heater. Appeared to be previous leak above water heater (possibly roof jack / vent). Recommend future monitoring to ensure leak is repaired.

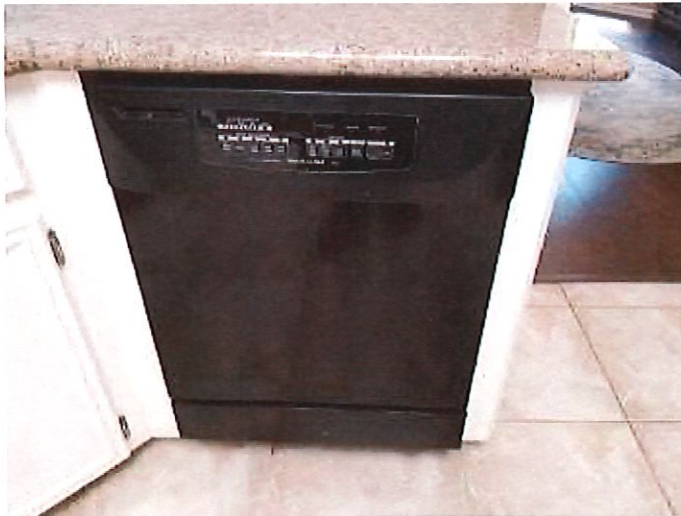
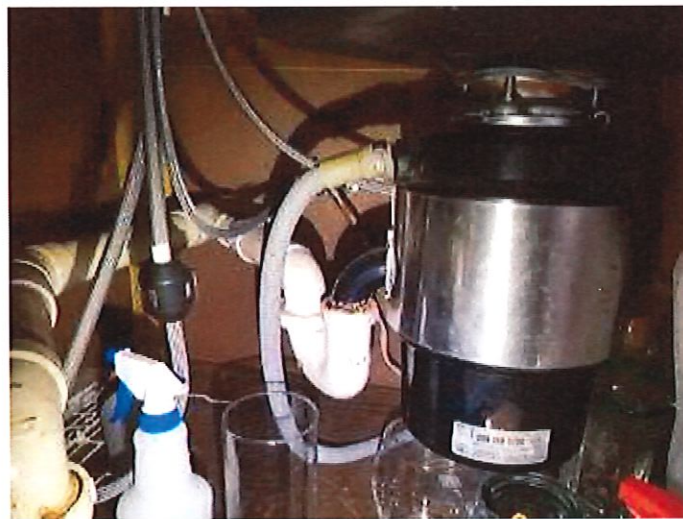
- Lack of a proper air gap noted and/or high loop drain line at dishwasher. In the event of a sewer backup this device prevents sewer matter from entering into dishwasher. Recommend having a qualified plumber install a air gap to prevent possible contamination.
- Top spray arm did not appear to be functioning properly. Recommend evaluation by qualified technician.

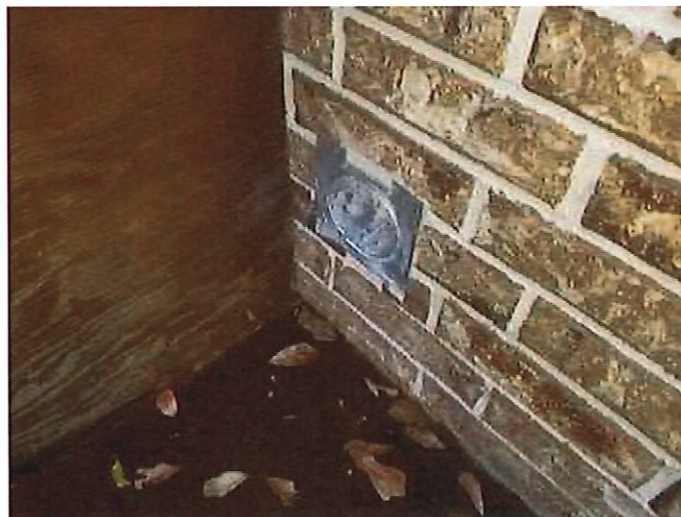
- No backdraft damper door observed on the dryer vent.

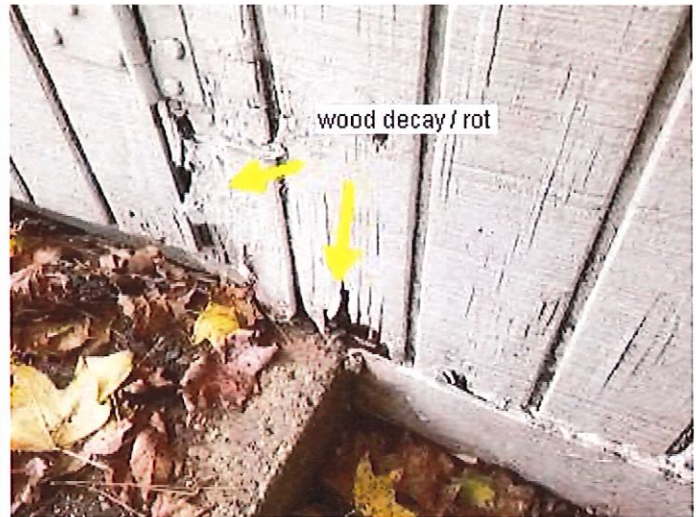
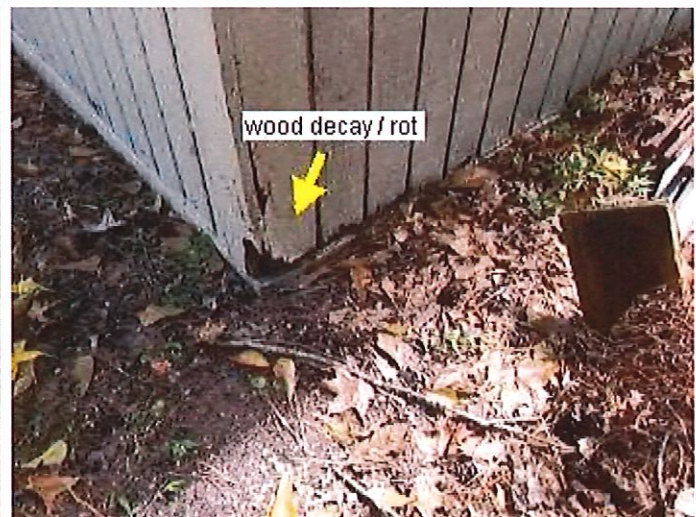
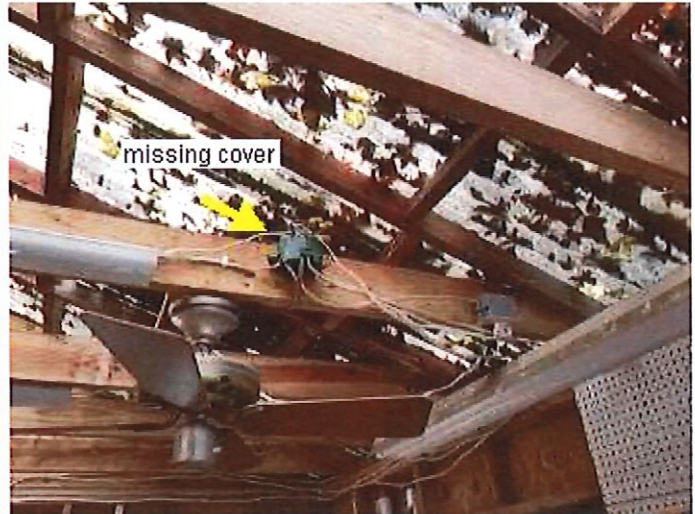
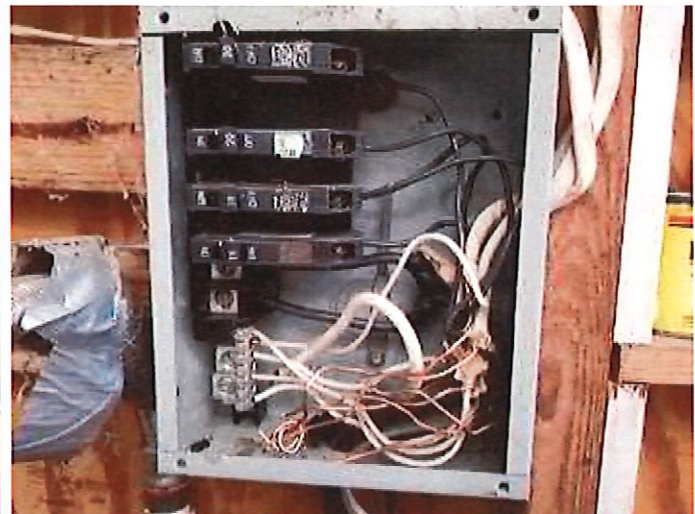
- The shed was observed to have wood rot and/or damage and should be further evaluated.
- Sub panel in building did not appear to have a ground. This is a safety hazard and should be corrected by licensed electrician. Sub panel was not tested to see if it was live at time of inspection. Recommend having licensed electrician evaluate panel and repair as needed to meet current standards.

Page 40 Item: C	Outbuildings	<ul style="list-style-type: none">• The shed was observed to have wood rot and/or damage and should be further evaluated.• Sub panel in building did not appear to have a ground. This is a safety hazard and should be corrected by licensed electrician. Sub panel was not tested to see if it was live at time of inspection. Recommend having licensed electrician evaluate panel and repair as needed to meet current standards.
-----------------	--------------	--
