PROPERTY INSPECTION REPORT

Prepared For: William Lumpkin
(Name of Client)

Concerning: 14035 Embry Stone Lane, Houston, TX 77047
(Address of Inspected Property)

By: Jared Owen, TREC #21225 09/14/2017
(Name and License Number of Inspector) (Date)

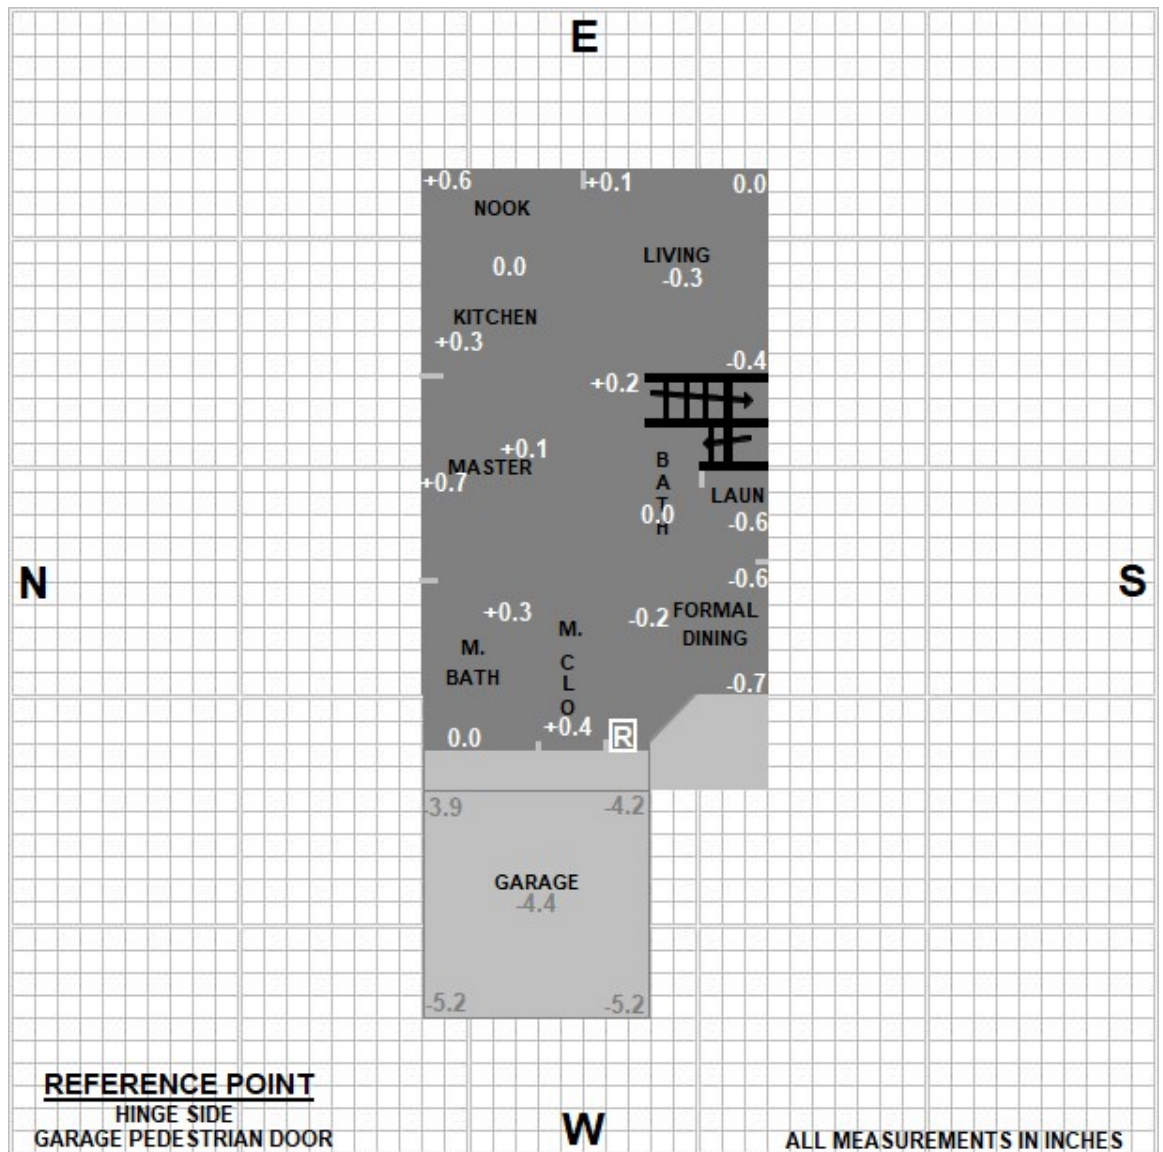
Performing intended function. No evidence suggesting significant foundation movement at time of inspection.

A foundation elevation survey was conducted during the inspection. The floor plan below represents data gathered using a Zip Level and adjusting for floor covering height differences. i.e. differences between tile, carpet and wood flooring (except in garage). Greatest variance was 1.4". Not drawn to scale

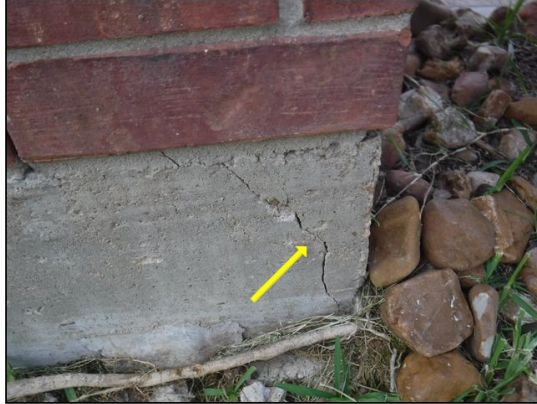
Spalling (i.e., corner pops) at one or more corner(s), Corner spalling is common to slab foundations and does not affect the structural integrity of the foundation.

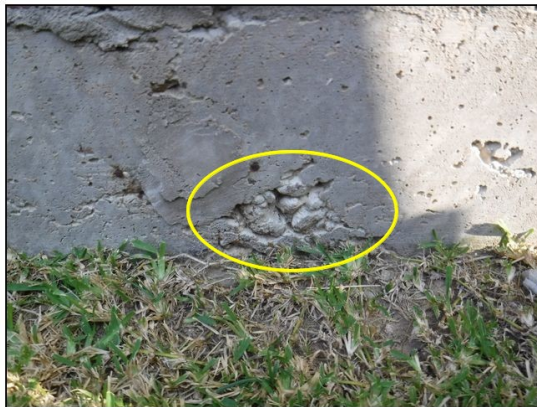
Honey comb in foundation observed at one or more locations.

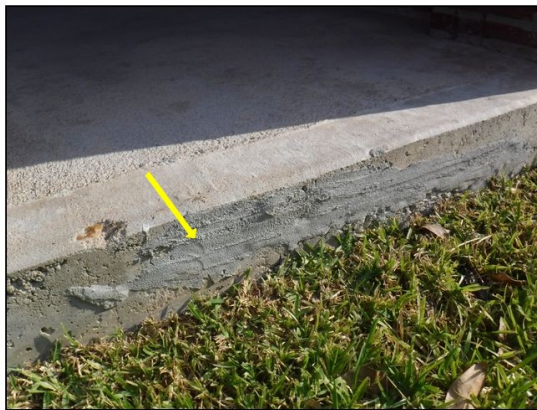
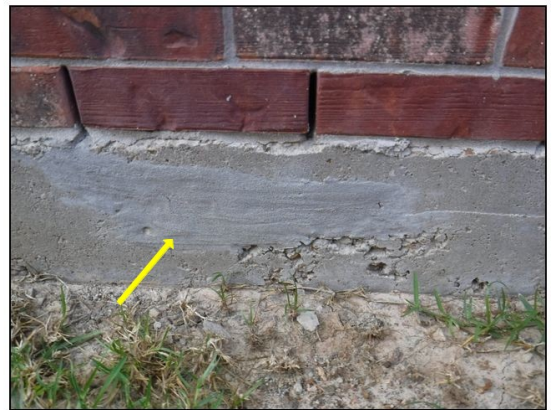
Slab dressing observed at one or more areas of foundation.

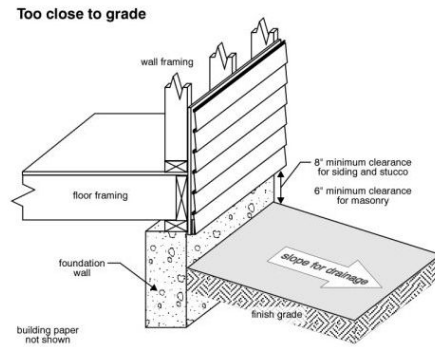
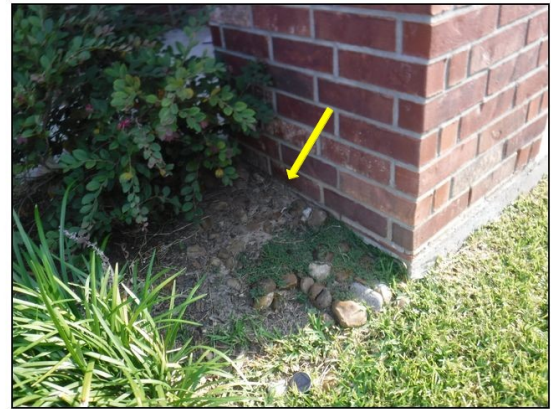
Soil level too high around areas with brick siding at front flower beds . Common industry practice requires a clearance of at least 4 inches from bottom of brick veneer to soil. High soil level near brick siding promotes wood rot and is considered a conducive condition to termite activity and water penetration.

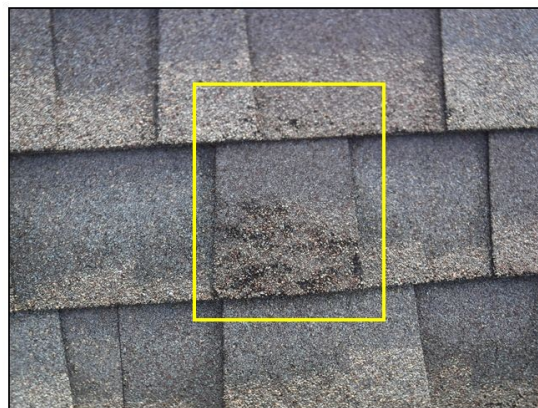
Observed scuffed / damaged shingles. Scuffing the mineral surface off of a composition shingle exposes the asphalt to ultraviolet light which causes it to deteriorate and can greatly reduce the life of the shingle. Replace scuffed shingles.

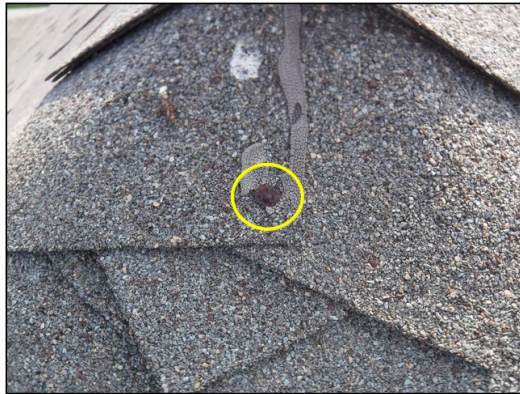
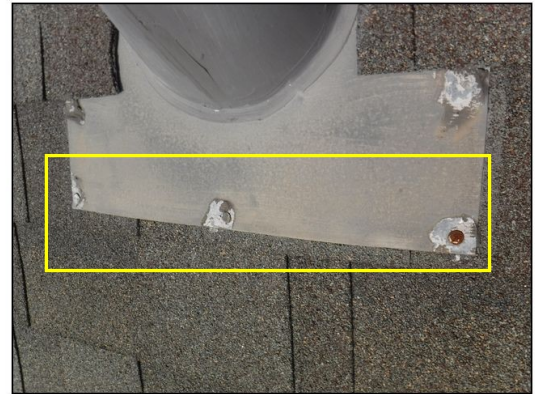
Exposed staples / nail heads / fasteners observed on roof are not properly sealed. Water entry possible.

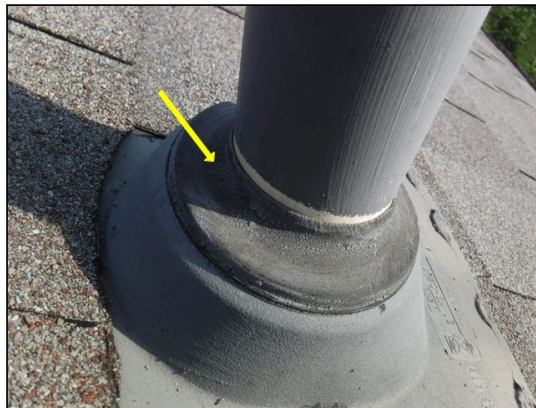
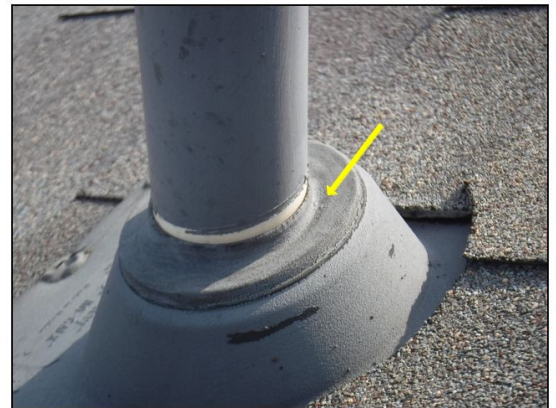
Rubber gasket of drain waste vent is inverted, may allow water entry.

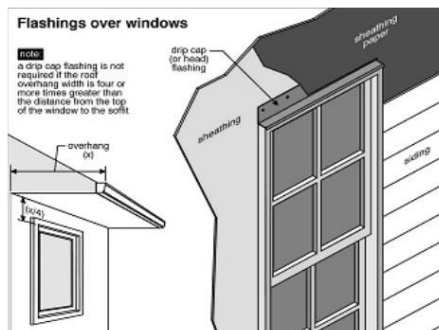
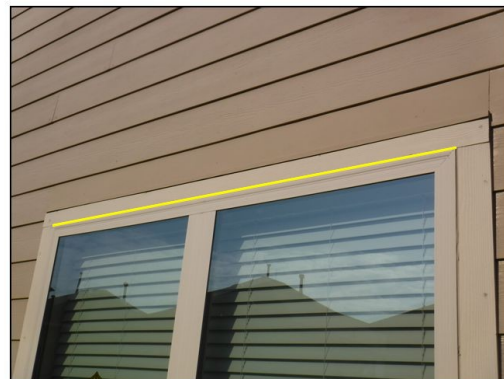
Did not observe head flashing over some windows / doors. Head flashing helps prevent water penetration. Without head flashing windows/ sealing must be maintained as the only defense against water penetration.

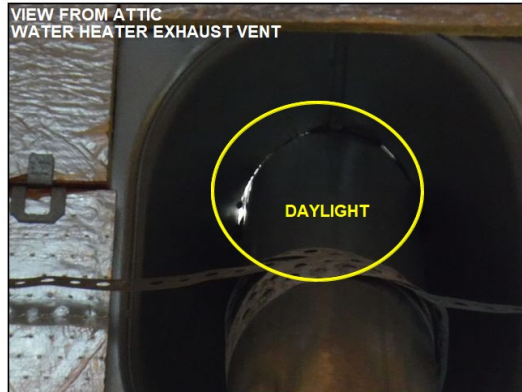
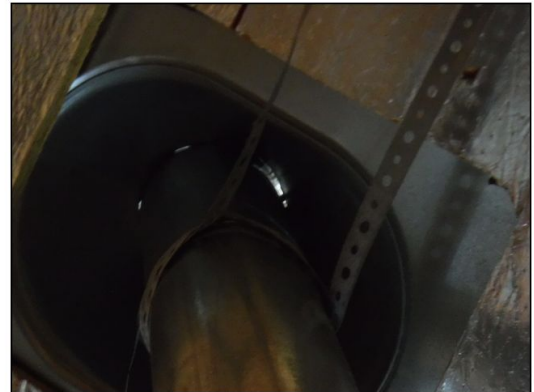
Storm collar / roof jack not properly sealed on all house and water heater vent pipes.

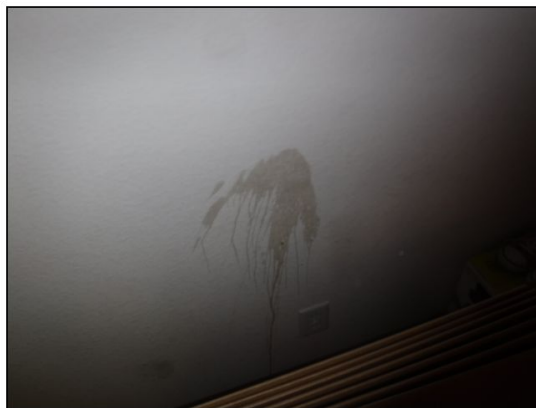
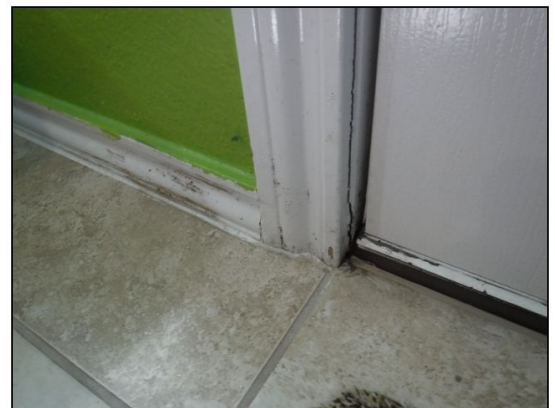
Water stains, damage or repairs observed, moisture detection equipment indicated that stains are not active (wet) at time of inspection; first floor hallway, back door.

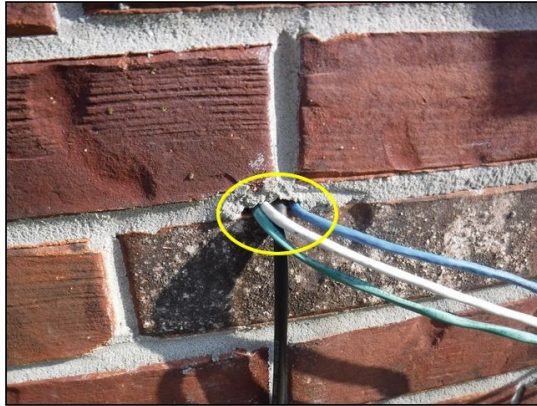
Need sealing / caulking around all holes and exterior siding penetrations on top and both sides, (leave bottom open) to prevent water entry. Including but not limited to dryer, bath and range top vents, light fixtures, etc.

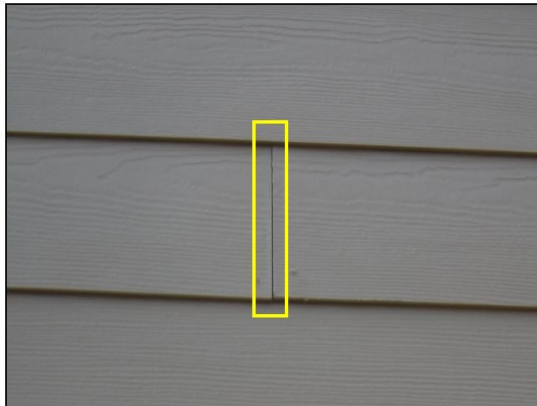
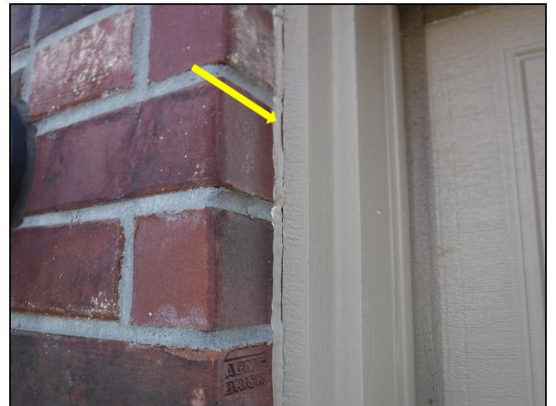
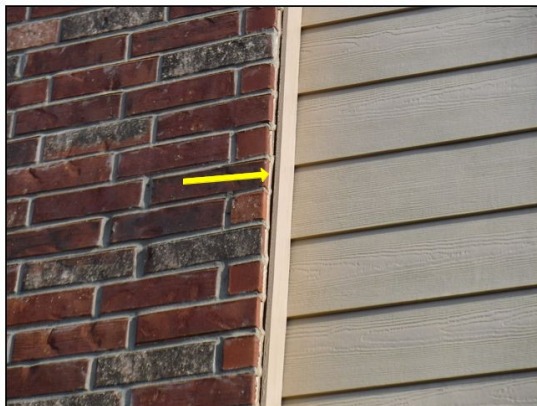
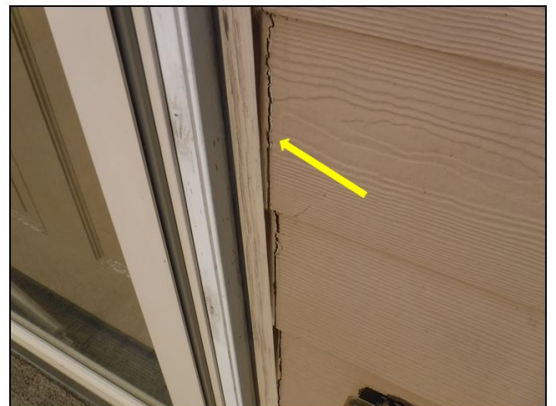
Caulking missing and/or deficient around vertical / horizontal trim boards / joints in siding, may allow wind driven rain entry.

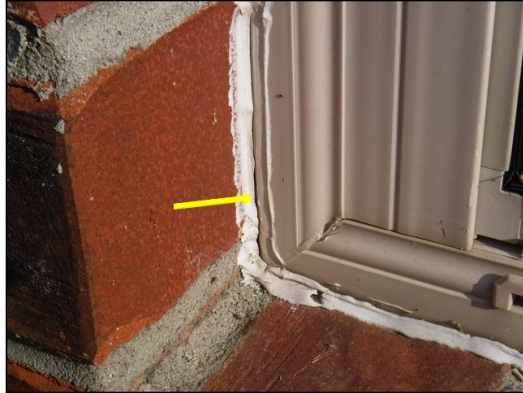
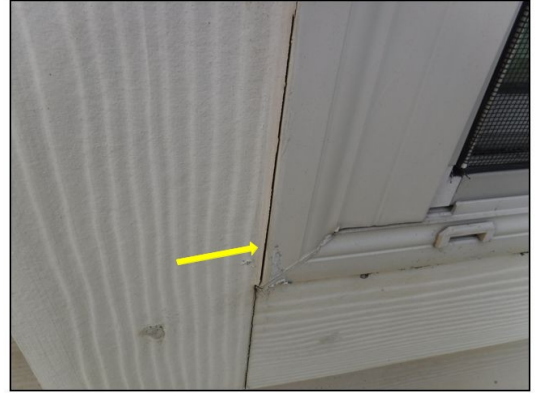
Caulking deficient around one or more windows / doors, will allow water penetration during heavy / wind driven rains.

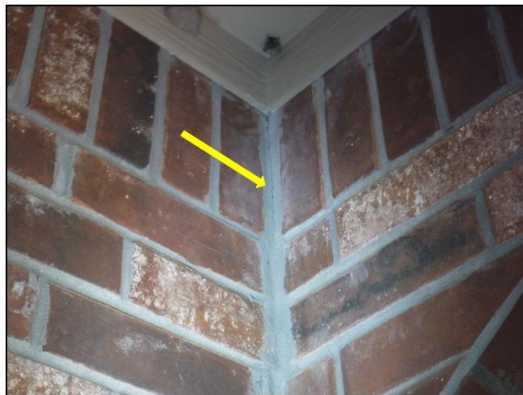
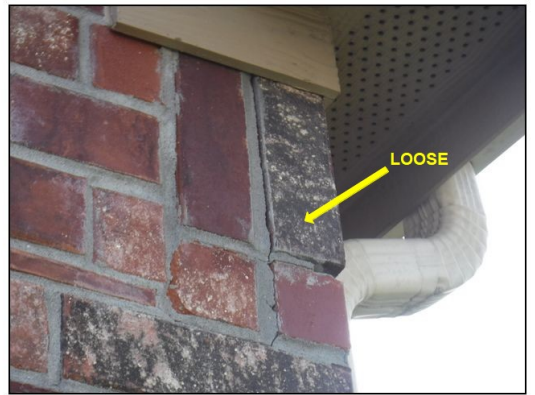
Cracks in brick veneer and/or repairs, one or more locations, Recommend buyer take photographs of cracks, their location, and width [ruler across the crack] with a high resolution camera that has a date stamp for future reference. Loose bricks are hazardous.

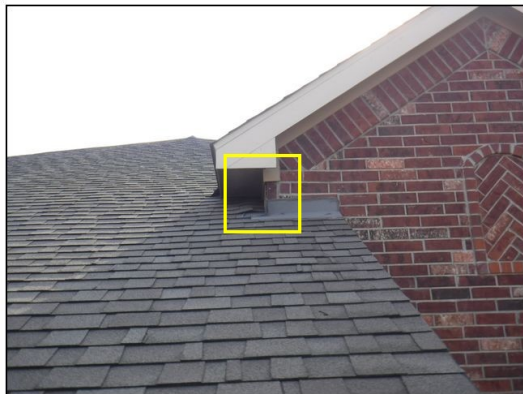
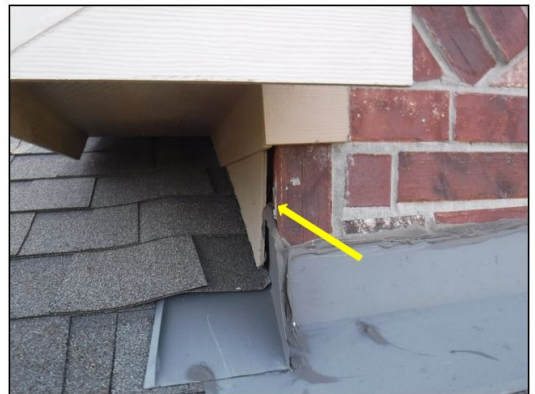
Potential pest / rodent entry; west roof-wall intersection.

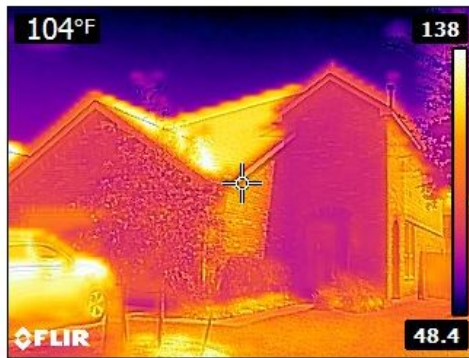
No significant thermal anomalies observed at time of inspection.

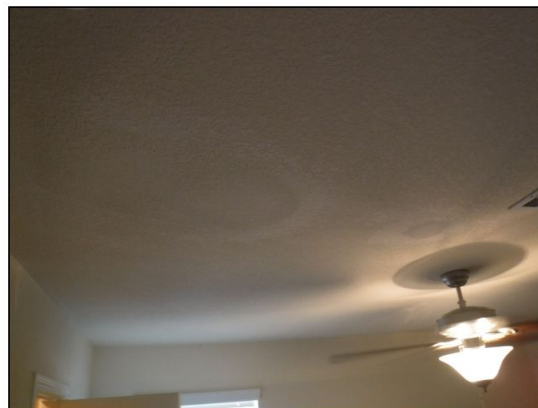
Patches / repairs noted at NE bedroom; This inspection does not rate the substance or adequacy of these repairs. Recommend inquiry of seller.

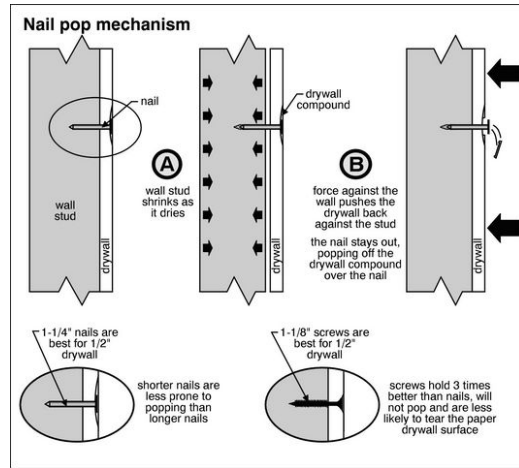
Nail heads were observed to be pushing through the interior finish in one or more locations of the home.

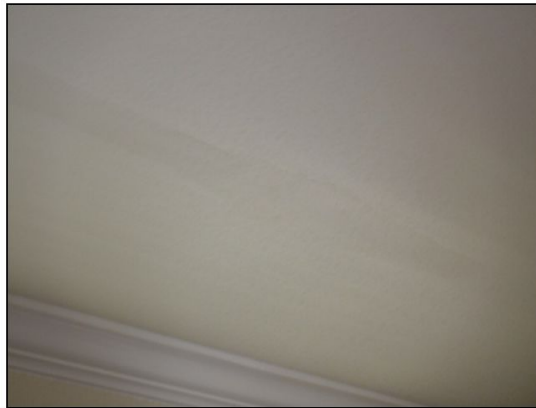
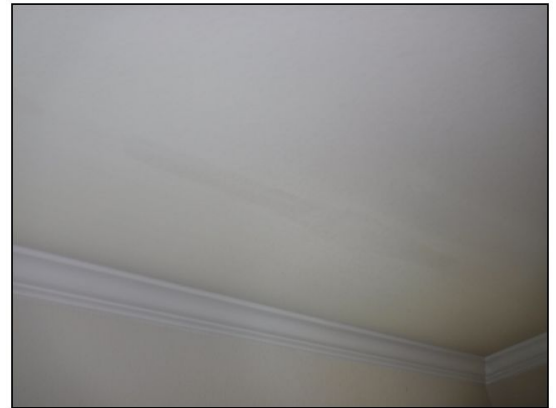
Water stains, damage or repairs observed, moisture detection equipment indicated that stains are not active (wet) at time of inspection; formal dining.

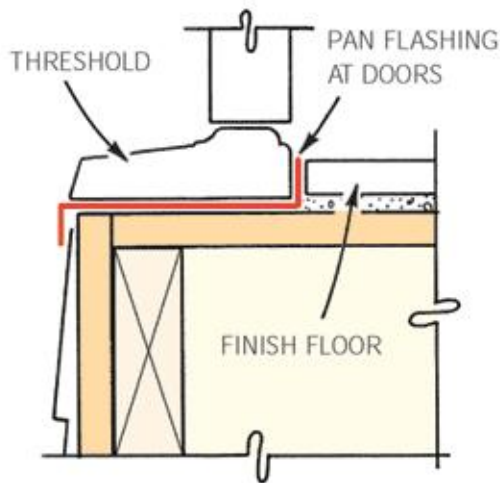
Did not observe door pan flashing at exterior door location(s). Properly installed door pan flashing helps prevent wind driven rain / water penetration from damaging interior building components. High risk areas include exterior doors with little to no roof or balcony overhang protection from the elements. For additional information you may watch a 5 minute video on flashing where the first few minutes shows door pan flashing by clicking this link [YouTube - Class Exterior Door Pan Flashing](#)

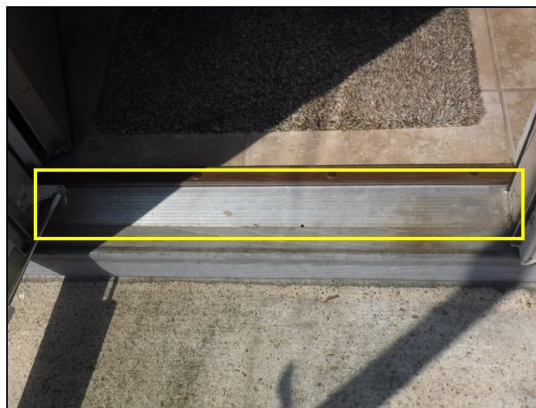
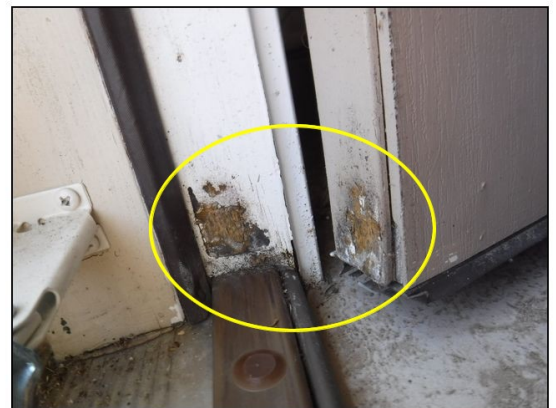
Improper threshold used on exterior doors with little to no roof overhang protection from wind driven rains can result in water damage from intermittent water entry.

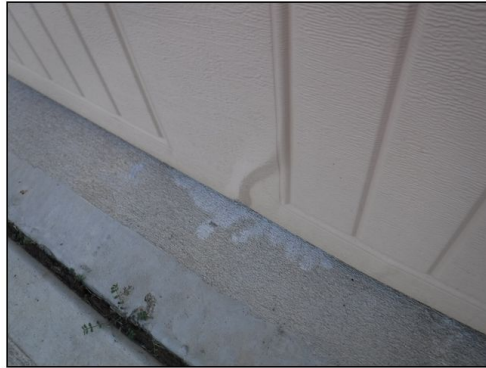
Section of steel garage door is damaged / bent.

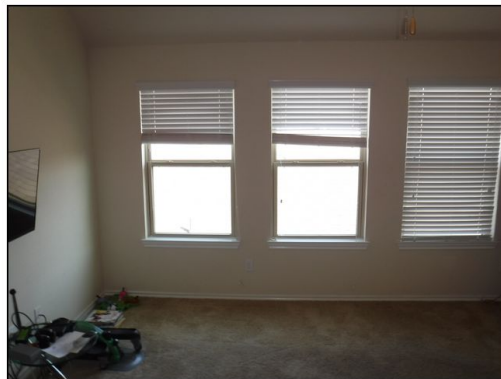
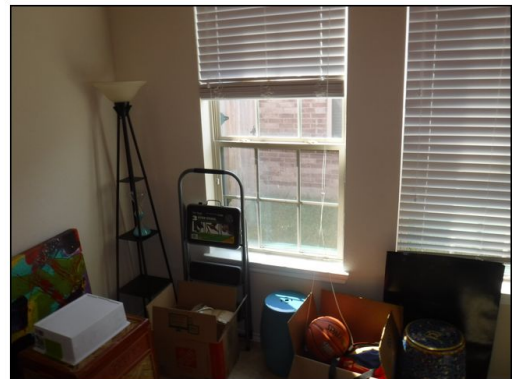
One or more windows will not fully latch / lock; (2) second floor living, formal dining.

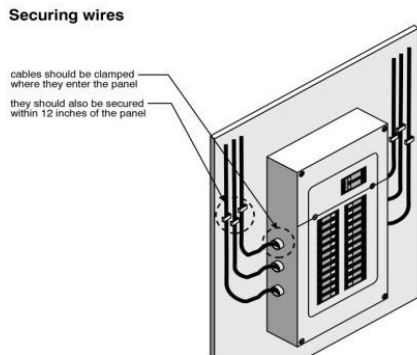
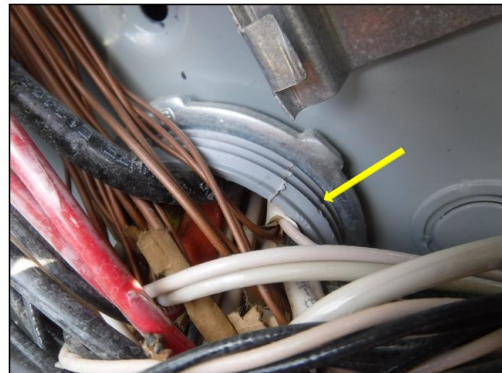
Protective bushing not present around electrical conduit as it passes through metal box.

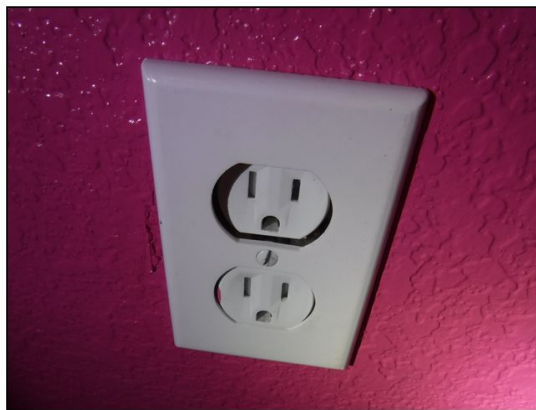
Observed one or more outlets / switches improperly recessed / not flush to face plate.

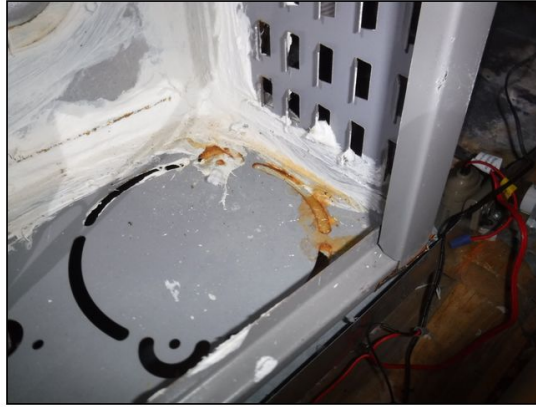
Water / Rust stains on unit, indication of possible water penetration from venting / roof, repair as needed.

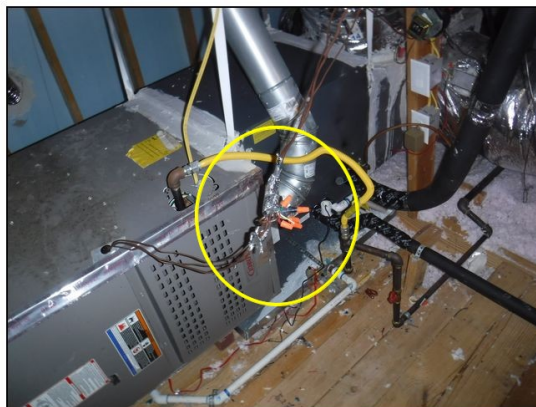
Thermostat wire splices hanging directly in front of HVAC unit, highly susceptible to damage from personnel servicing equipment.

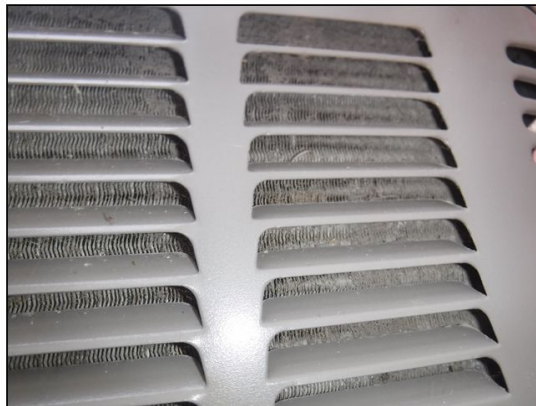
Coils are dirty, needs cleaning. Dirty coils reduce air flow and create high head pressures at the compressor, thereby unduly stressing and reducing life span of system.

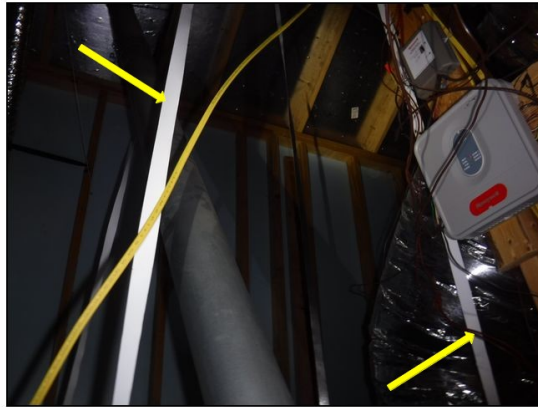
Metal support straps for unit should be wrapped with tape to prevent injury / cuts.

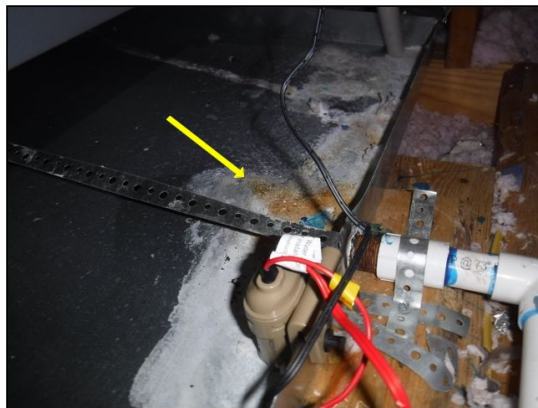
Water / rust stains in secondary drain pan; indication coil (or previous coil) has history of leaking/dripping condensation into pan.

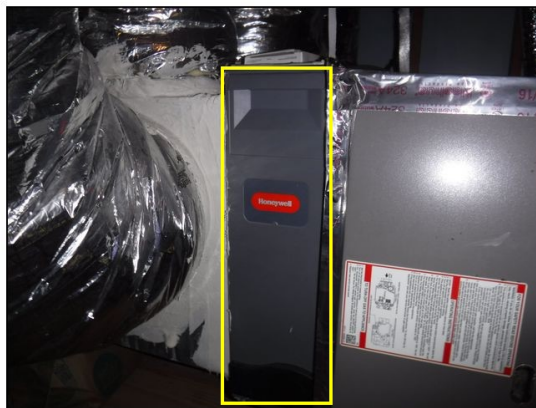
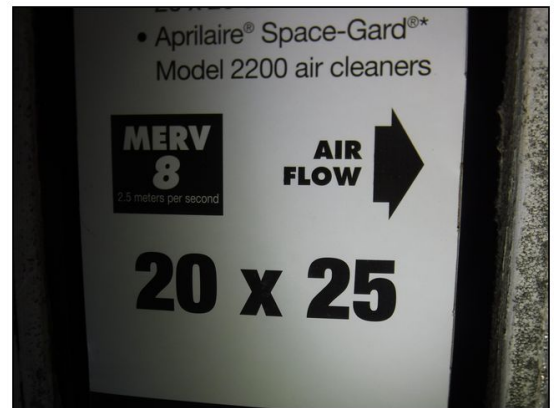
Media air filter(s) located in attic that requires changing/cleaning every 6 months, recommend checking guide for proper maintenance information.

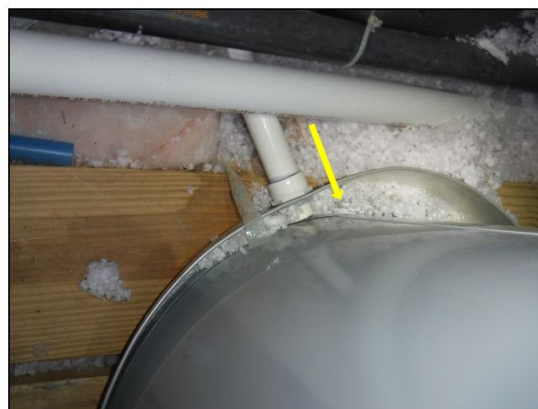
Insulation / debris in drain pan needs to be removed to prevent clogging of drain line.
