PROPERTY INSPECTION REPORT

Prepared For: Frank Galloway
(Name of Client)

Concerning: 5700 Bullard Dr, Austin 78757
(Address or Other Identification of Inspected Property)

By: George Corwill, Lic #TREC #21093 07/06/2017
(Name and License Number of Inspector) (Date)

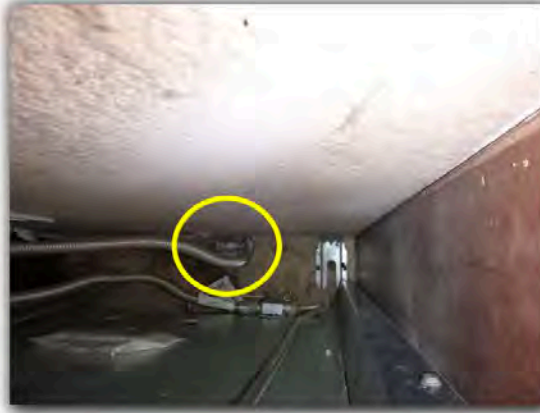
Rear left burner(s) failed to operate.

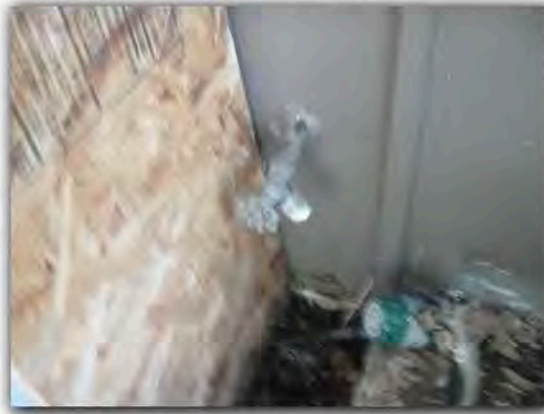
Exterior faucets has leak at rear.

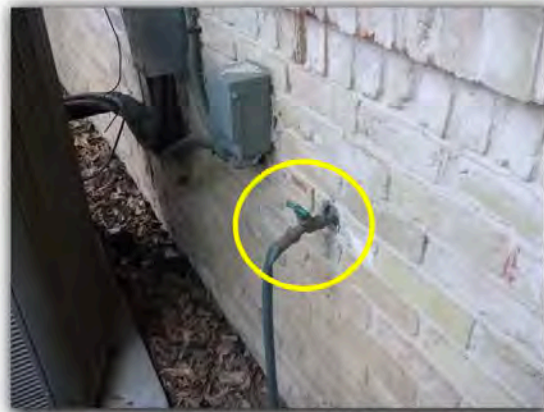
No anti-siphon protection observed on exterior hose bibs/faucets at left side. This is a basic safety attachment to the end of faucets that will protect from a cross connection or back-flow of water into the house.

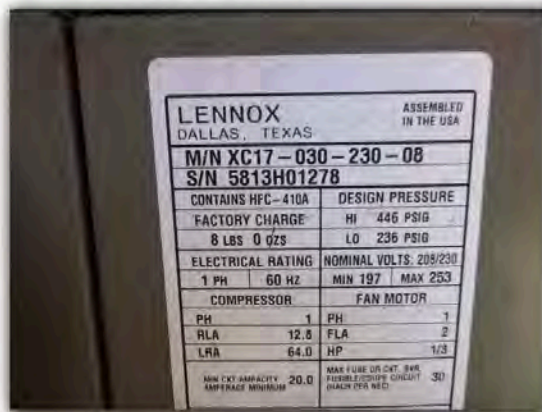
Exterior unit installed too close to obstruction on sides. 12" minimum recommended by most manufacturers.

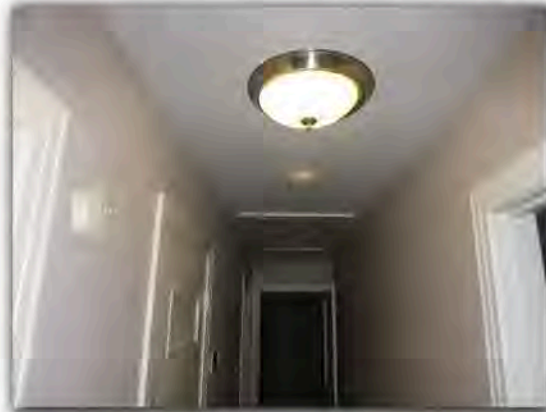
Smoke detectors are not present in all required locations. Smoke detectors should be installed in all sleeping areas & levels of the structure. None installed in sleeping areas. Alarms installed in Hallway appeared old and did not function with test button. Manufacturers recommend replacing alarms every 10 years or less.

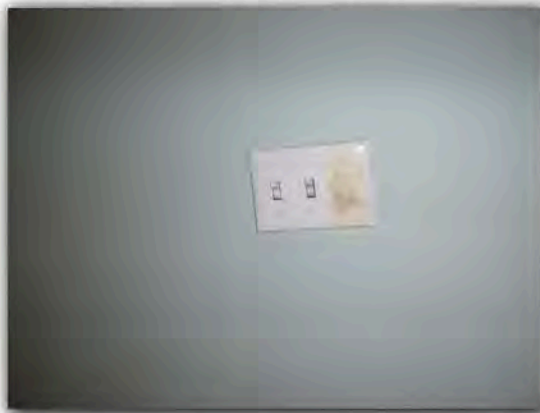
Switch taped for unknown reason in Master bedroom.

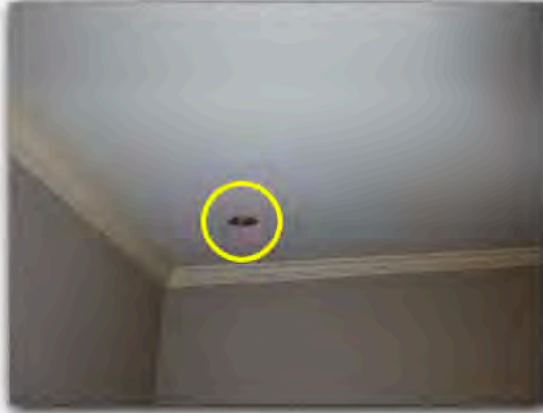
Cover is missing from junction box - left rear Bedroom.

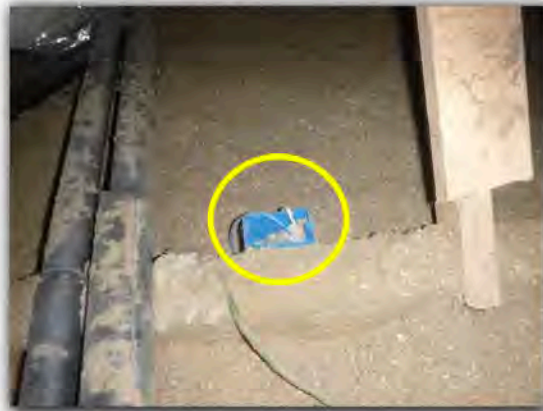
Open junction box observed in attic.

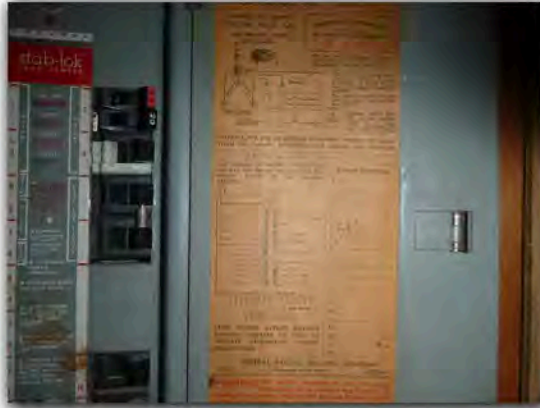
Two or more neutral wires are connected to a single lug on the bus bar. Move the wires to create one to one connection between wires and lugs.

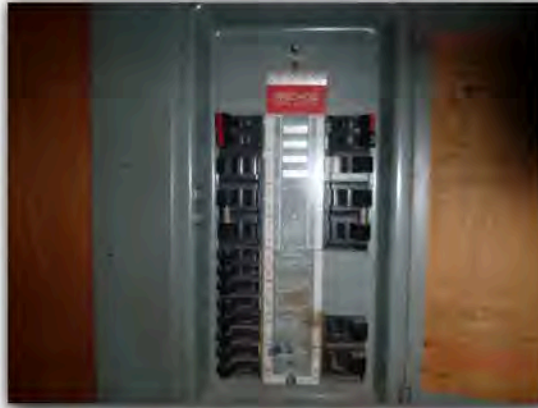
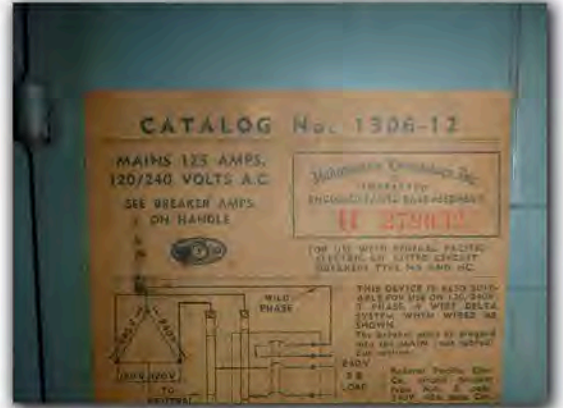
commonly used from the mid 1950's to early 1980's. In 1982 The Consumer Product Safety Commission tested 122 FPE breakers under UL 489 test conditions. The rate of failure to de-energize the circuit exceeded the tolerances allowed by the standards. The buss needs to be checked for scorching and the breakers should be checked for overheating, proper fit into the buss, as well as proper operation. An adequate evaluation of this panel requires removal of the breakers as breakers burn out from the back towards the front. Evaluation of this panel goes beyond the scope of this inspection. A qualified, competent electrician should evaluate this panel.

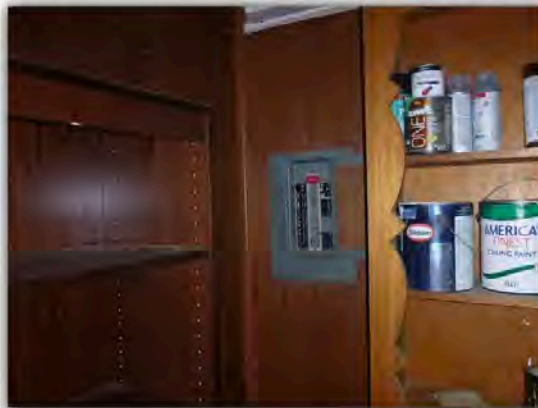
Improper clearance and/or access to panel.

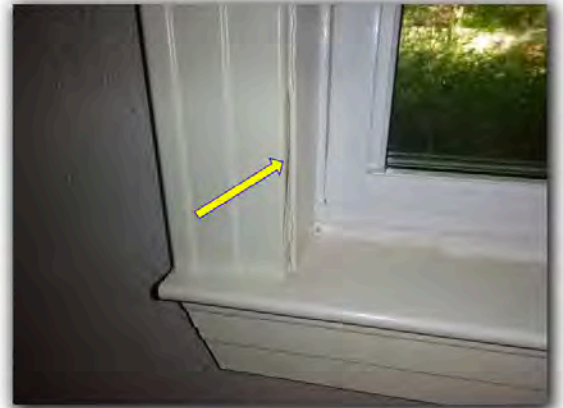
Seal exterior windows where needed around structure.

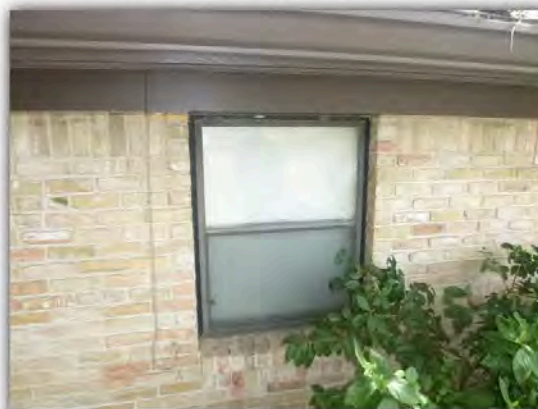
Noted that window at left side was the only one not replaced and the built-in bookcase is installed against this opening.

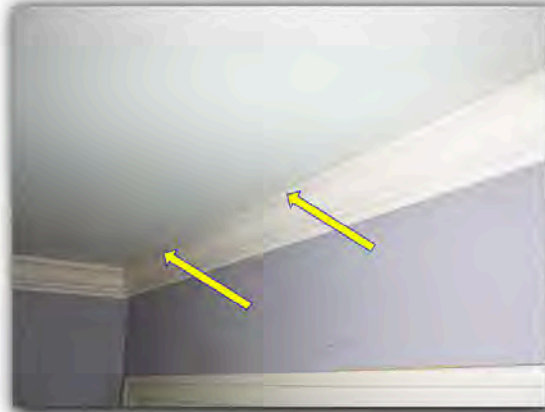
Previous patching and current fractures noted on ceiling in Master bedroom and left rear Bedroom.

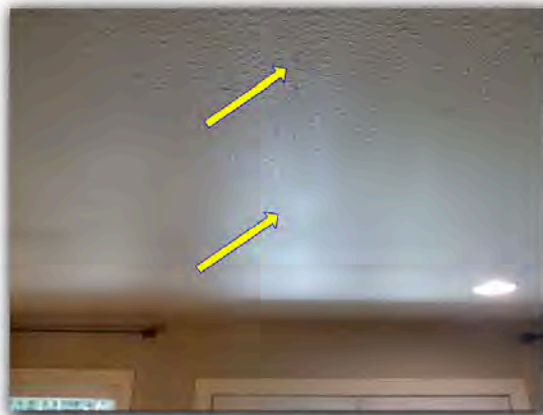
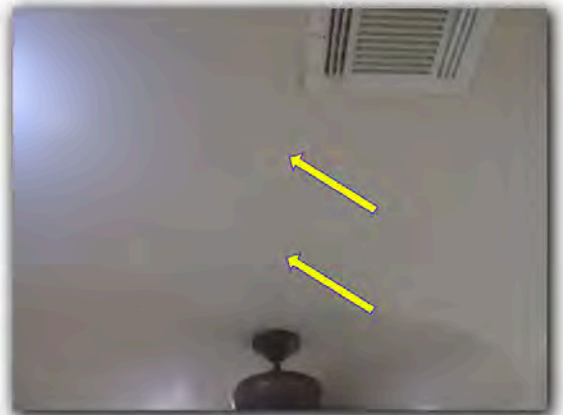
Fractures are present on ceiling between Kitchen and Living room and in Living room area.

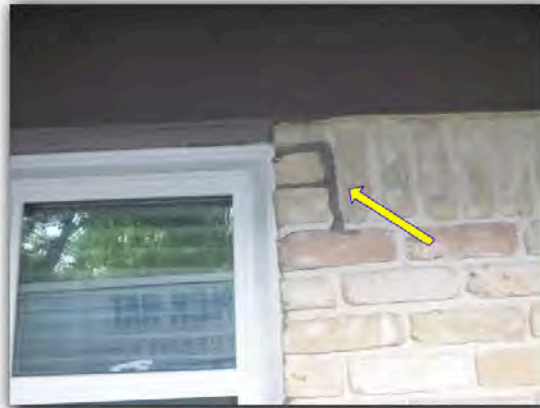
Brick/mortar crack at rear.

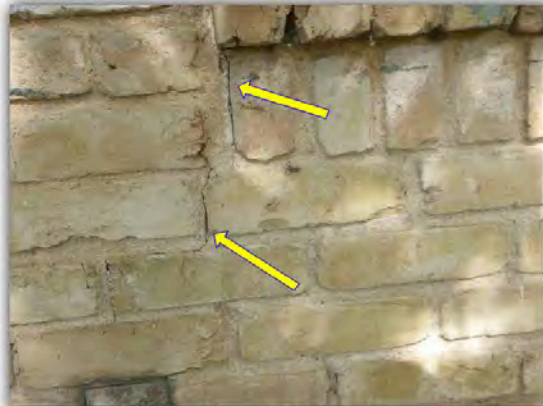
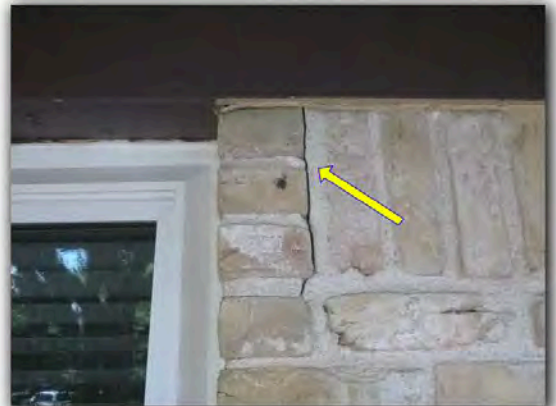
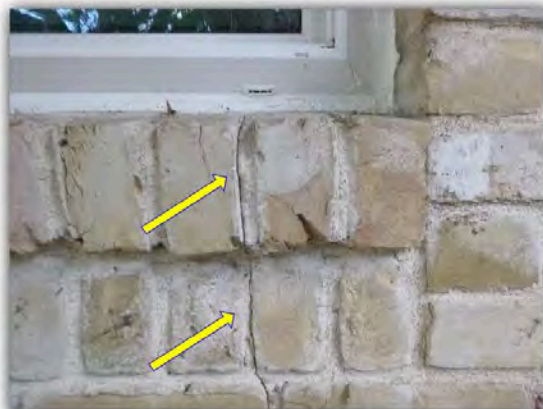
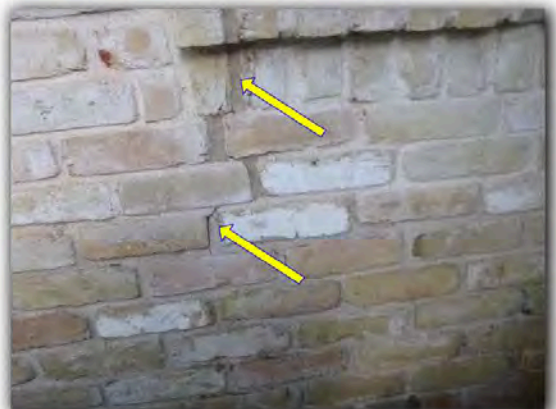
Brick veneer/mortar fractures - under front left window, under/over front window, and under window near entrance. These may be indications that a slight structural movement may have occurred at some point in time. Recommend repair/repointing to prevent further damage.

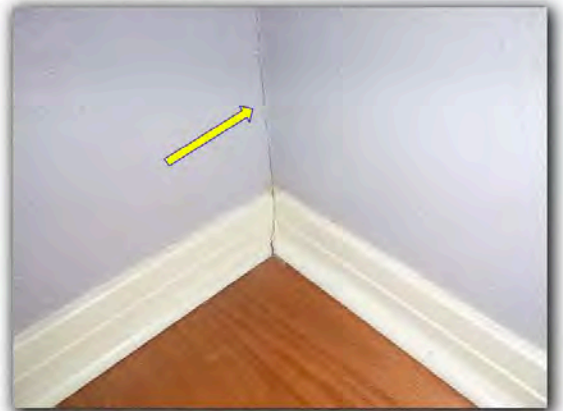
Crack at wall joint in Living room and at far right corner of right Bedroom.

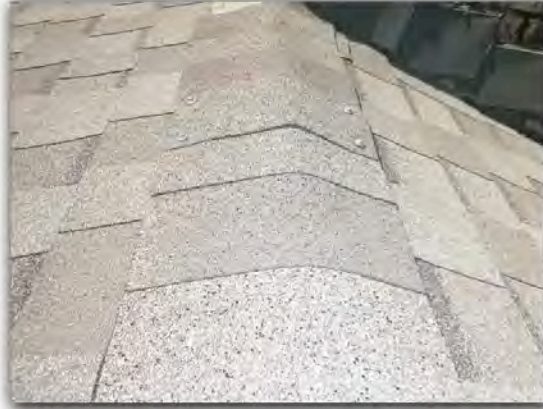
Noted that flashings and roof peak shingles were fastened with screw & rubber washer fasteners which are commonly used for metal screw-down roofs.

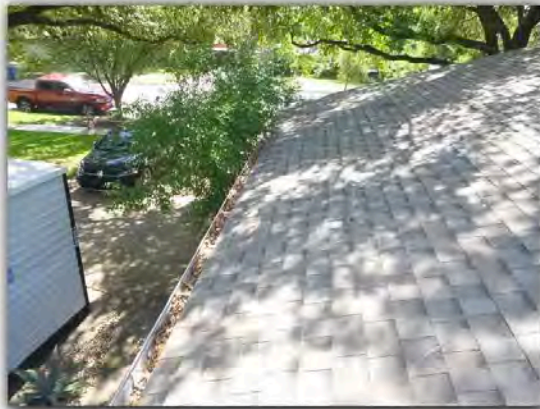
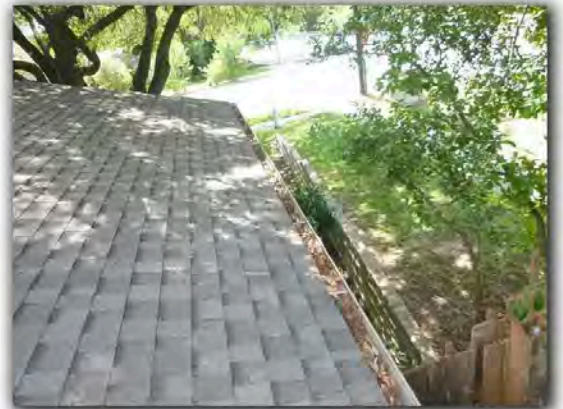
Gutter(s) are filled with debris. (Leaves, sticks, and/or aggregate.) Debris may have restricted full viewing at some areas.

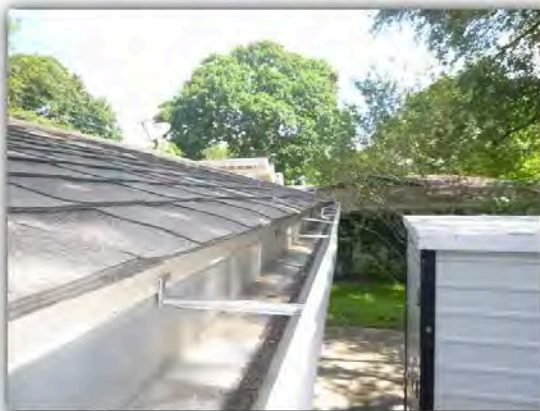
Gutter is sloped improperly and holding water. Rehang, repair with proper slope.

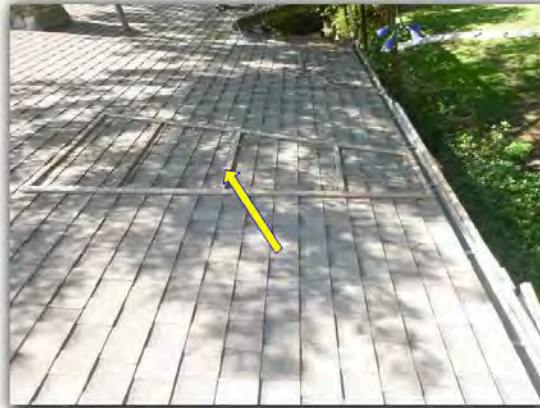
Back patio arbor construction is not properly secured.

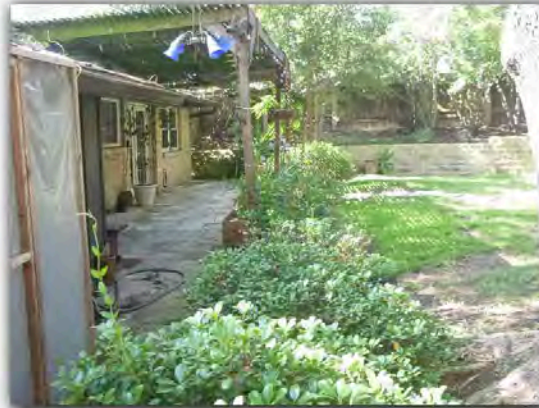
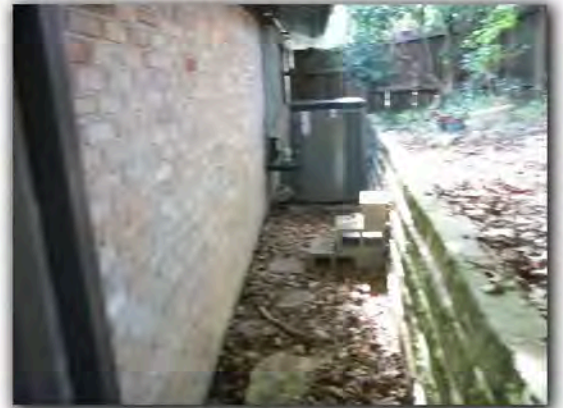
Soil installed too high to siding of house. Lower soil properly below base of siding and maintain proper slope away from foundation.

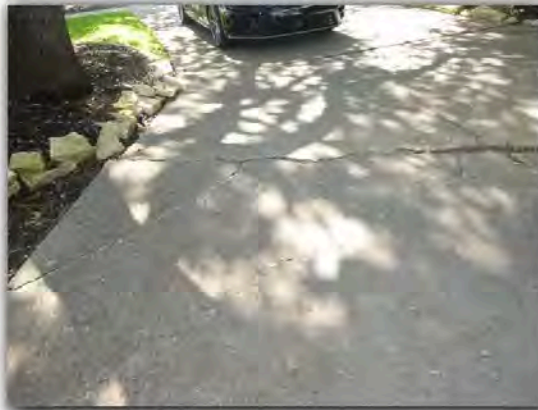
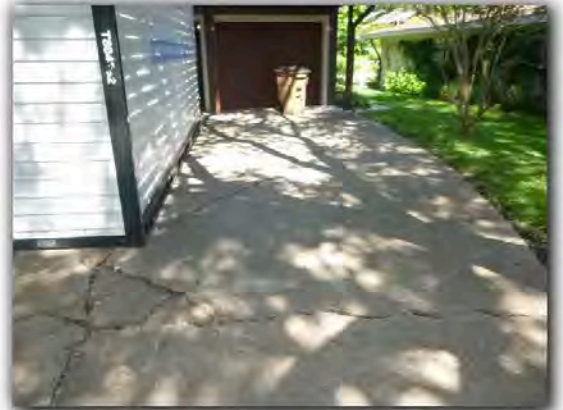
Differential settlement of flatwork (driveway) has occurred.

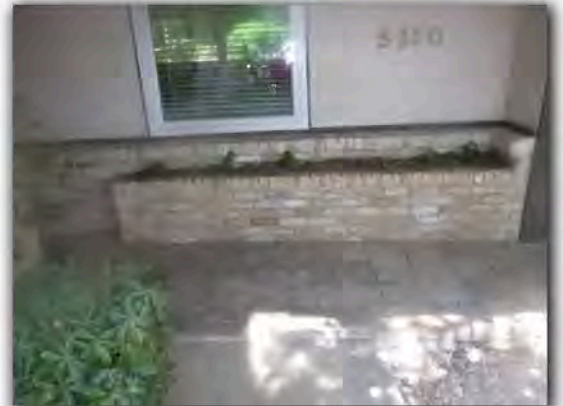
Soil high on siding, planters and shrubs touching structure are conducive conditions for entry of wood destroying insects.
