COMPLETEPRO
HOME INSPECTIONS, PLLC

Home Inspection Report

5729 Lakeside Villas Ct, Conroe, TX 77304

Monday, August 12, 2019

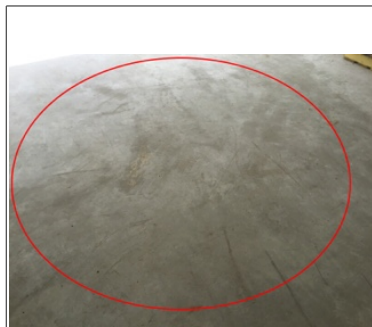
DEFICIENCY: The garage floor has been scratched and etched. Recommend sealing with epoxy floor treatment by a licensed contractor.

DEFICIENCY: The garage floor has been scratched and etched.

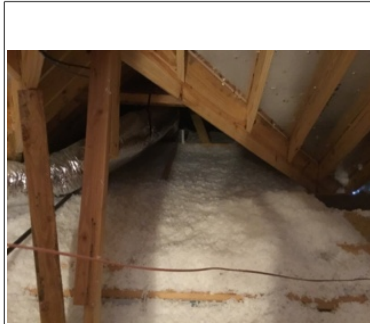
SATISFACTORY: Blown in insulation

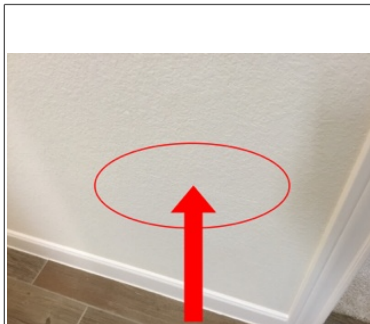
DEFICIENCY: Texture scratch blemish on main hallway wall. Recommend repair by a licensed contractor.

DEFICIENCY: Texture scratch on main hallway wall.

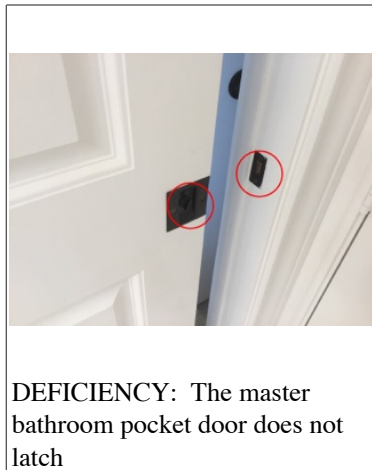
DEFICIENCY: The master bathroom pocket door does not latch. Recommend repair by a licensed contractor.

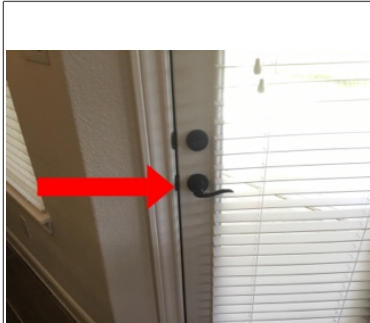
DEFICIENCY: The side exterior door latch for the knob needs adjustment to hold the door firmly against the weatherstripping. Recommend repair by a licensed contractor.

DEFICIENCY: The side exterior door latch for the knob needs adjustment

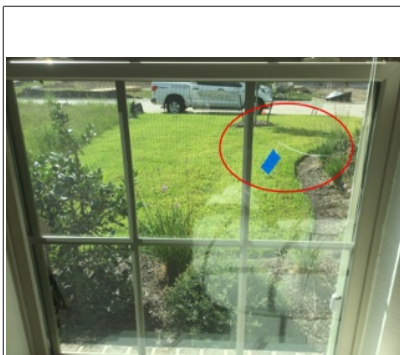
DEFICIENCY: The front living room window pane has a blemish inside the double pane. Recommend replacement by a licensed contractor.

DEFICIENCY: The front living room window pane has a blemish inside the double pane.

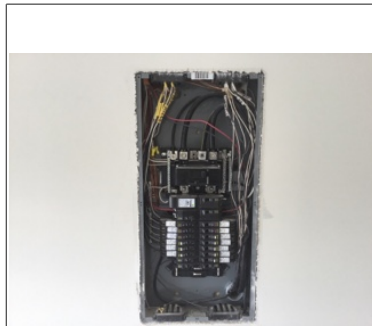
SATISFACTORY: Electrical Service Panel wiring

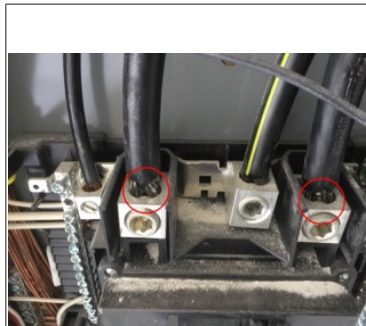
DEFICIENCY: There was no anti-oxidant gel observed on the exposed aluminum service conductor terminations. Recommend having a licensed electrician apply anti-oxidant gel.

DEFICIENCY: There was no anti-oxidant gel observed

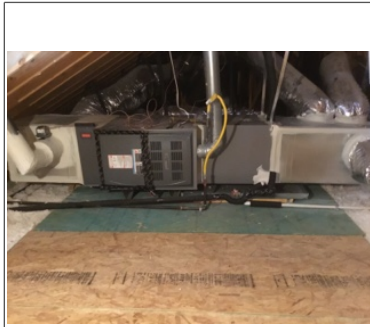
SATISFACTORY: HVAC system in attic

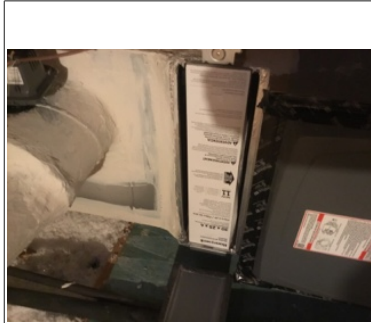
SATISFACTORY: Whole home air filter 20x25x4

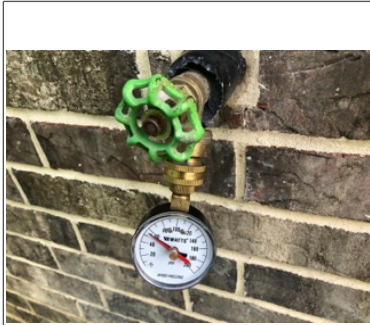
SATISFACTORY: Water pressure 58PSI

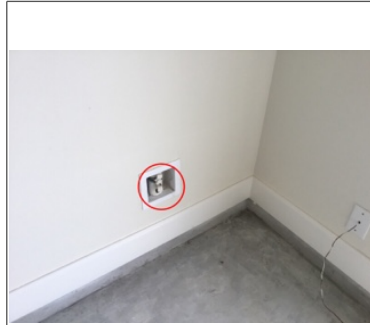
SATISFACTORY: Whole home water shut off valve

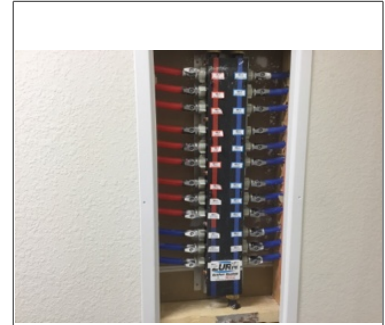
SATISFACTORY: Water manifold

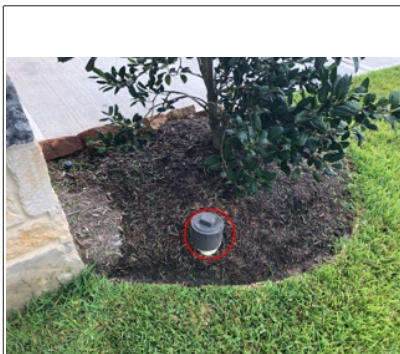
SATISFACTORY: Sewer clean out left of driveway

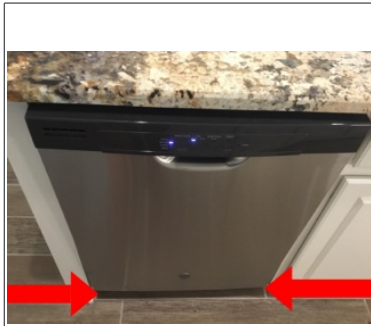
DEFICIENCY: The dishwasher is not secured at the bottom and moves when the dishwasher door is opened or closed. Recommend adjusting the legs to fully secure dishwasher in the cabinet.

DEFICIENCY: The dishwasher is not secured at the bottom

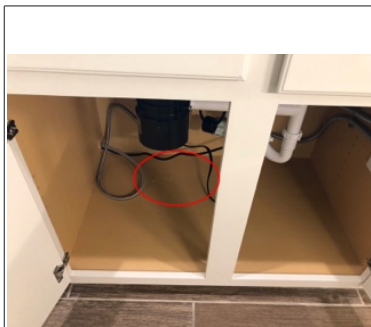
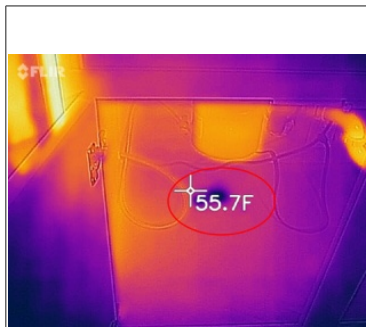
DEFICIENCY: There is a water leak that appears to be coming from the food disposal when in use. Recommend repair by a licensed contractor.

DEFICIENCY: There is a water leak that appears to be coming from the food disposal

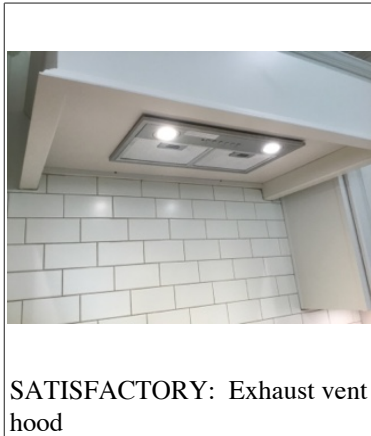
SATISFACTORY: Exhaust vent hood

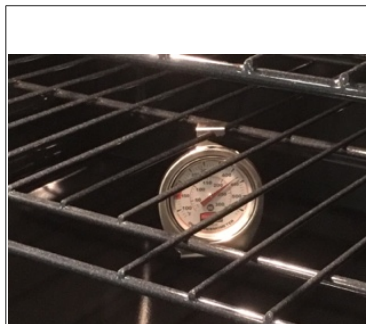
DEFICIENCY: The oven heated to **430 Degrees°** when set to **350 Degrees°** and held that temperature. This is not within the acceptable range of 25 degrees +/-

DEFICIENCY: The oven heated to 430 Degrees when set to 350 Bake

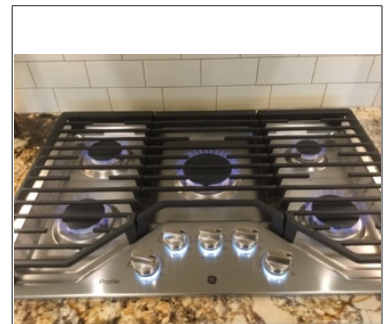
SATISFACTORY: Gas cooktop

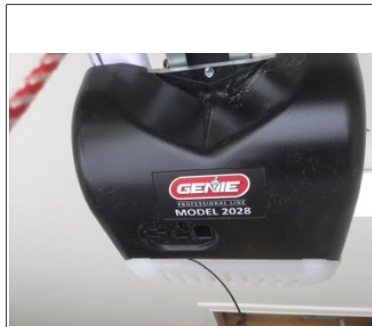
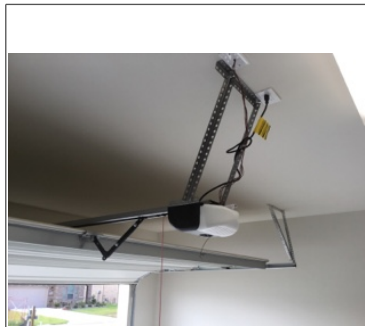
SATISFACTORY: Garage door operator

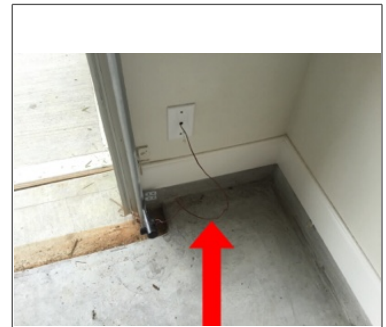
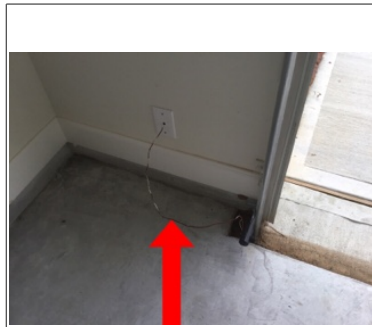
DEFICIENCY: The wiring for the garage door sensors is not properly secured to the wall. Recommend attaching wire to the wall to minimize the risk of damage.

DEFICIENCY: The wiring for the garage door sensors is not properly secured

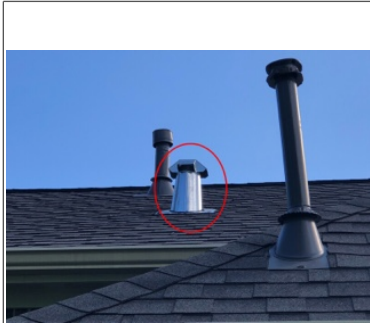
DEFICIENCY: The dryer exhaust flashing is not painted for protection. Code Violation. Recommend repair by a licensed contractor.

DEFICIENCY: The dryer exhaust flashing is not painted for protection. Code Violation.

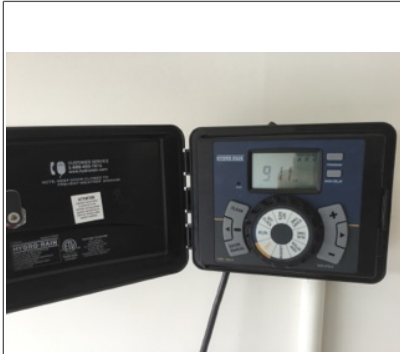
SATISFACTORY: Sprinkler controller

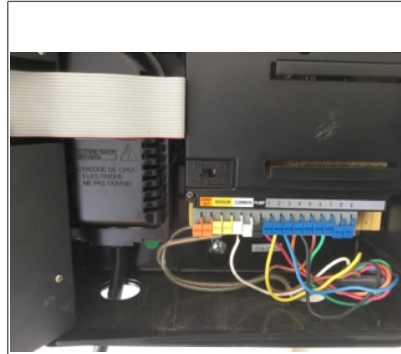
SATISFACTORY: Controller wiring

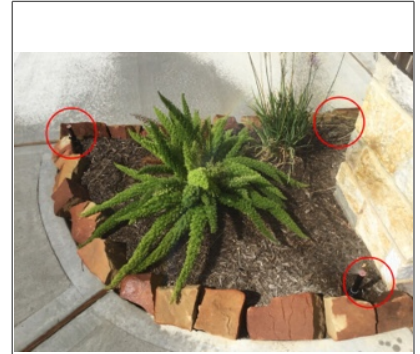
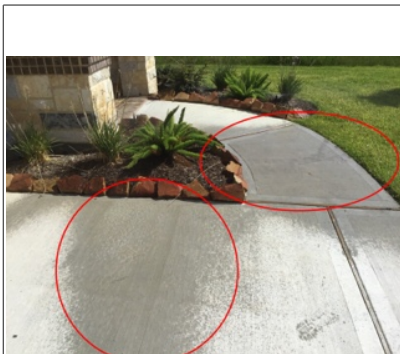
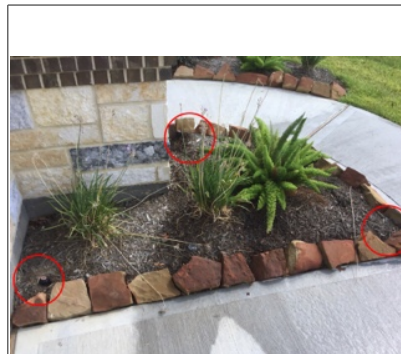
DEFICIENCY: Not all spray-heads work on zone #1 and the one that do work need adjusting. Recommend repair by a licensed contractor.

DEFICIENCY: Not all spray-heads work on zone #1 and the one that do work need adjusting.
