FIG Services LLC d/b/a FOX INSPECTION GROUP
Property Inspection Report #180323GM-510 Tabor Street
11227 Endicott Lane Houston, TX 77035

PROPERTY INSPECTION REPORT

Concerning: 510 Tabor Street, Houston, TX 77007
 (Address of Inspected Property)

By: Grant Miller, TREC PI: 20975 03/23/2018
 (Name and License Number of Inspector) (Date)

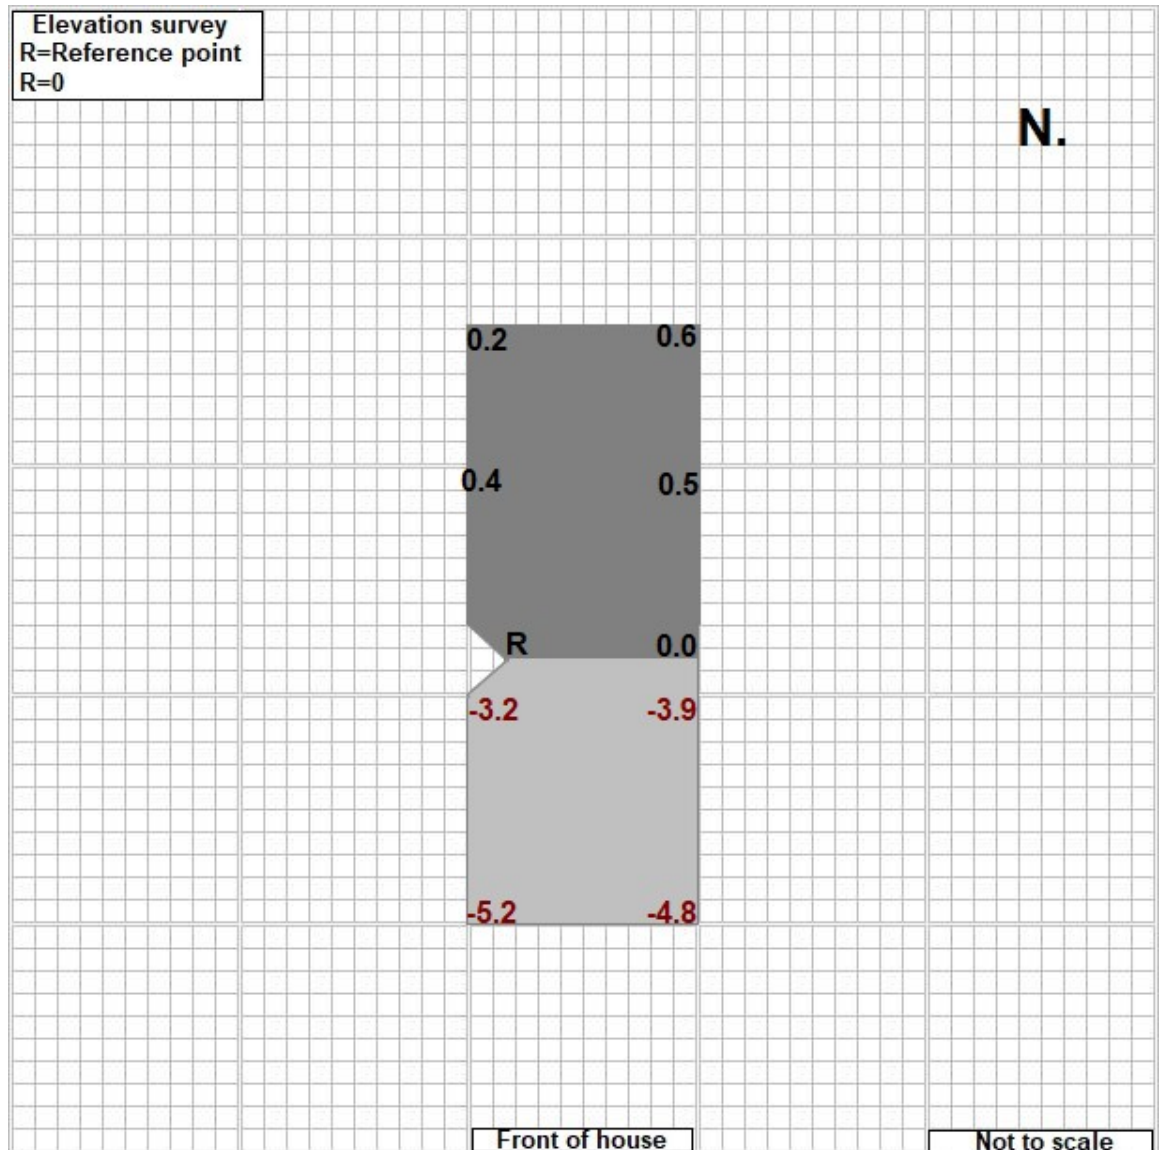
Comments: Performing intended function. No evidence suggesting significant foundation movement at time of inspection.

A foundation elevation survey was conducted during the inspection. The floorplan below represents data gathered using a Zip Level or similar instrument and adjusting for floor covering height differences. i.e. differences between tile, carpet and wood flooring. Measurements are listed to the nearest 1/10th of an inch. Greatest variance was 0.6".

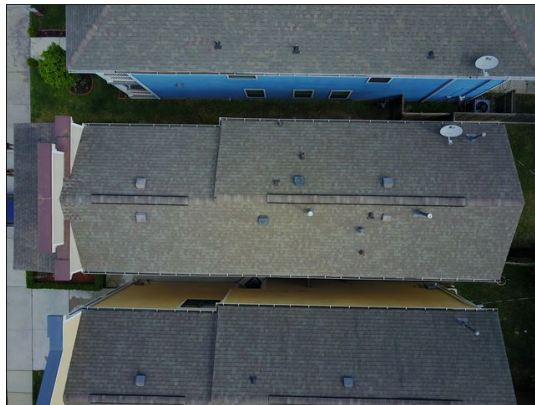
Exposed staples / nail heads / fasteners observed on roof are not properly sealed. Water entry possible.

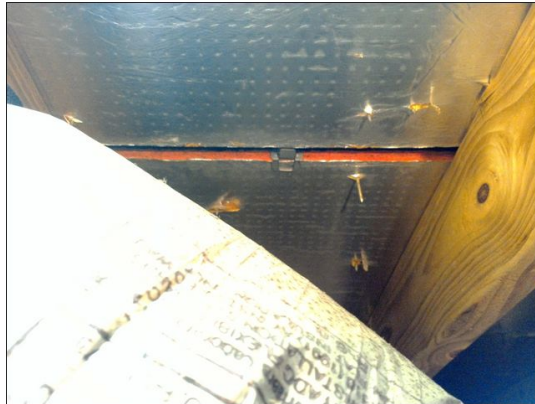
Roof deck improperly cut, not resting in H-clip.

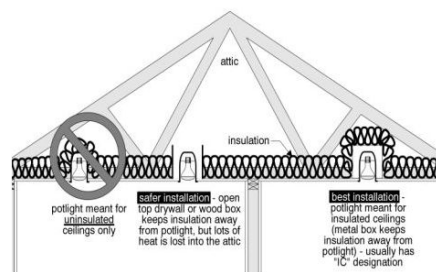
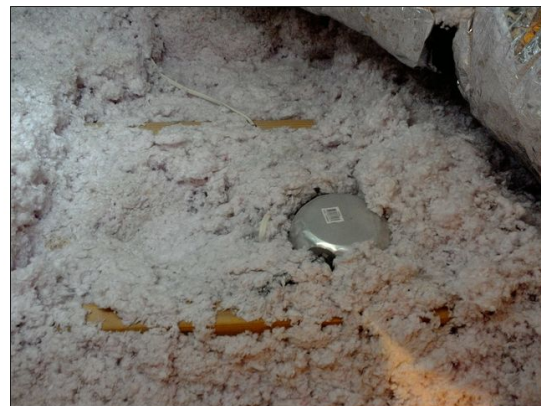
Potlights in insulated ceilings

Ensure insulation is maintained a minimum of 3 inches and wood a minimum of 1 inch from around all recessed lights to reduce possible fire hazard.

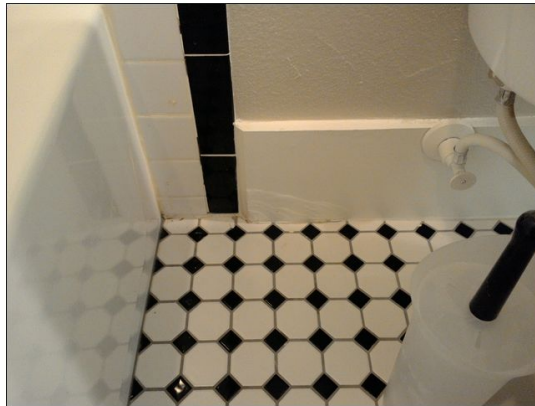
Water damaged base board around hall tub.

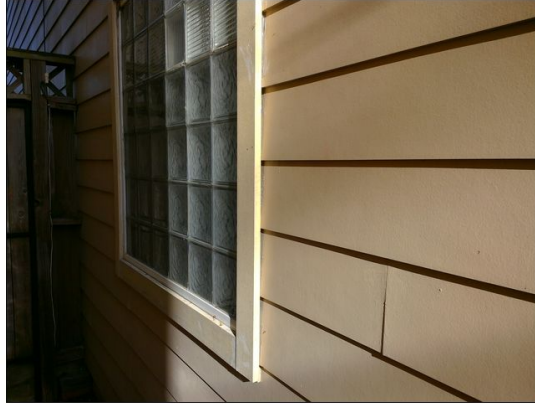
Caulking missing and/or deficient around vertical trim boards may allow wind driven rain entry.

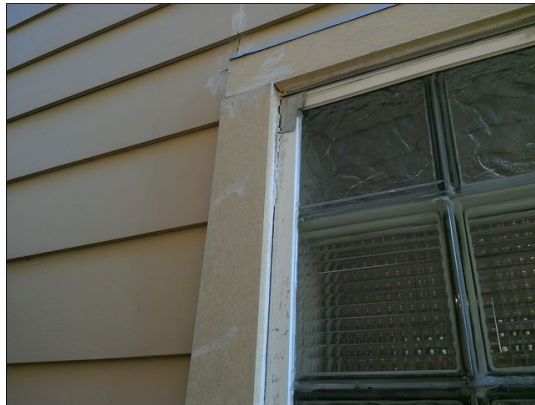
Caulking deficient around one or more windows, will allow water penetration during heavy / wind driven rains.

Trim and siding around window replaced, re-caulked, and repainted

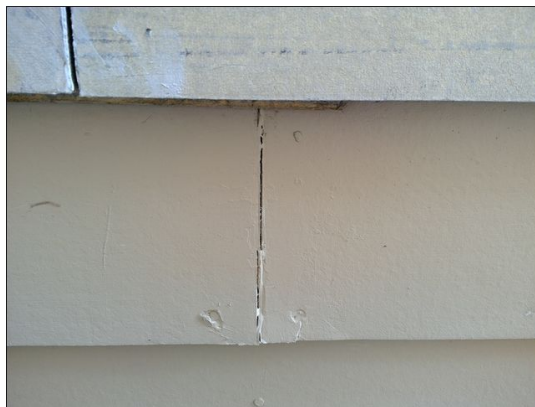
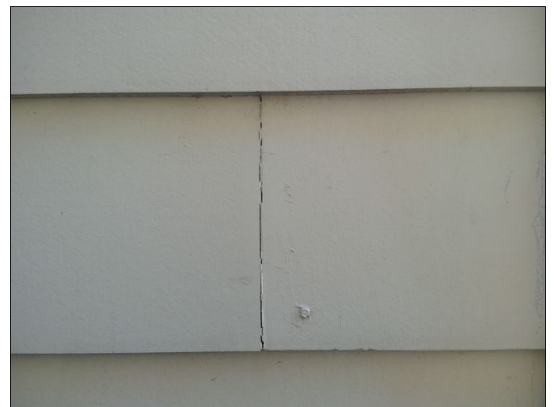
Caulking missing and/or deficient at vertical joints in siding; may allow wind driven rain entry.

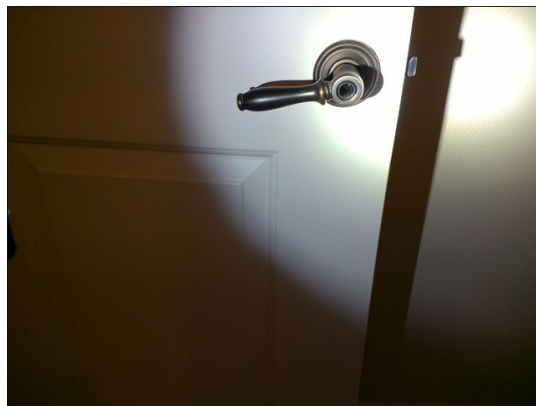
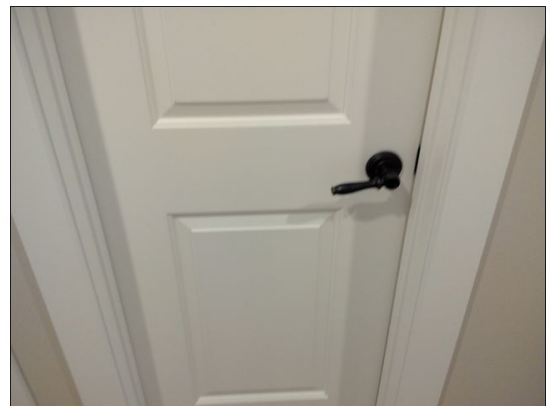
Door handle missing latch cover.

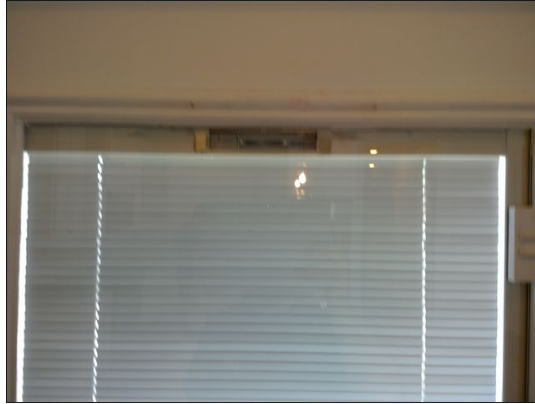
In door blind missing magnet.

Magnet replaced

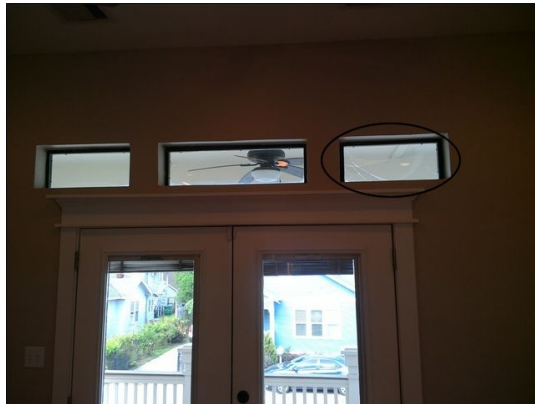
One or more windows had cracked / broken glass pane(s).

Broken window replaced

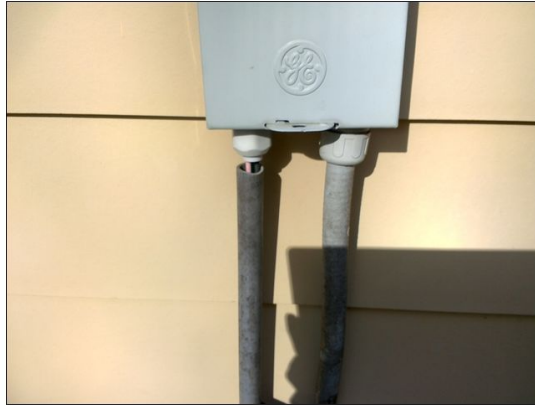
Electrical conduit not secured in place.

Conduit re-attached

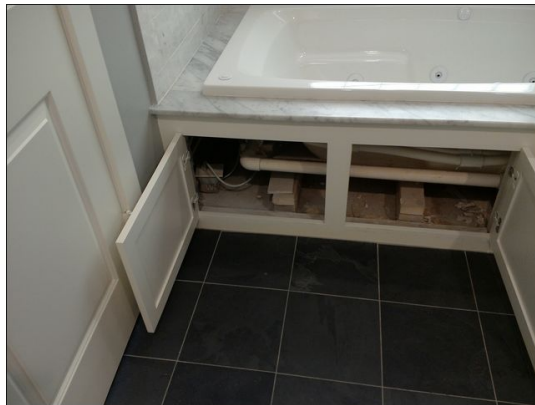
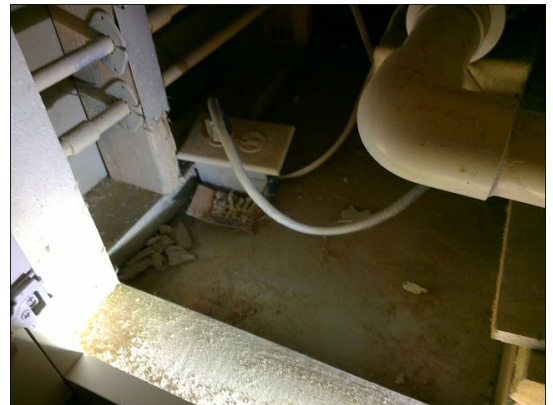
Any/all flooded electrical should be replaced.

Receptacle replaced

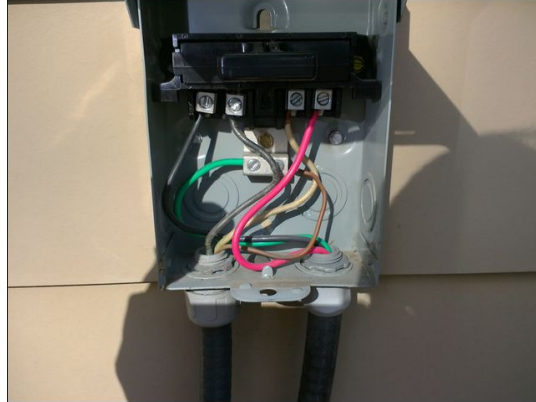
A/C unit electrical disconnect wiring reversed. *Line / load connections are wired backwards.*

Wiring corrected

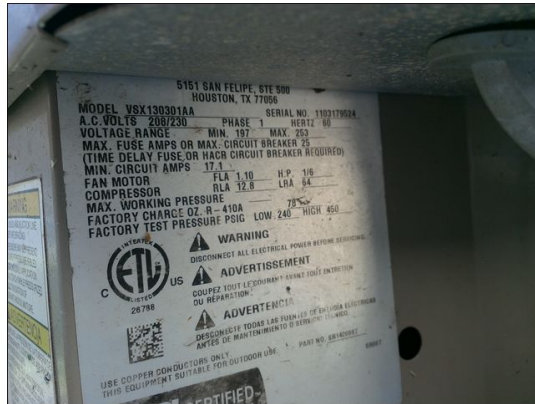
1ST FLOOR CONDENSING UNIT: Goodman (2011)(2.5 Ton)

Recommend qualified/licensed HVAC technician service/repair/replace as needed. Not cooling well.

Condensing unit coils chemically cleaned

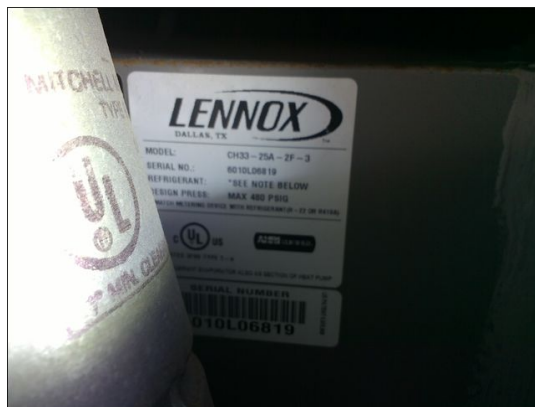
1ST FLOOR EVAPORATOR COIL:Lennox (2010)(2.5 Ton)

Unit appears to be leaking oil, recommend further investigation by qualified HVAC Tech. This year of unit may be associated with lawsuit against Lennox.

Evaporator coil replaced

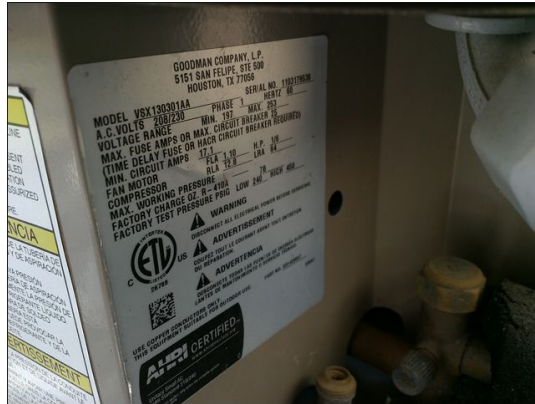
Goodman (2011)(2.5 Ton)

Recommend qualified/licensed HVAC technician service/repair/replace as needed. Not cooling well.

Condensing unit coils chemically cleaned

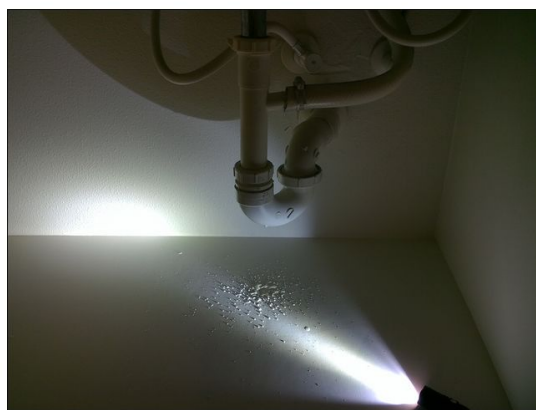
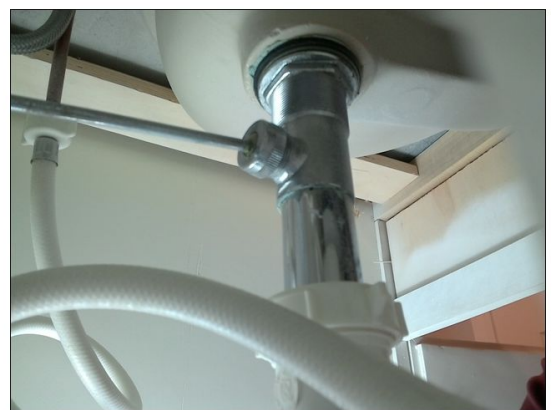
Small water leak from drain stopper lever fitting below sink;Hall bath.

Fitting tightened to stop leak

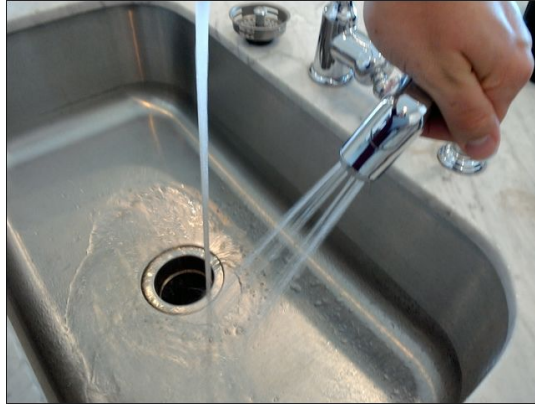
Kitchen spray wand does not operate properly, does not direct all water to wand.

Kitchen faucet replaced

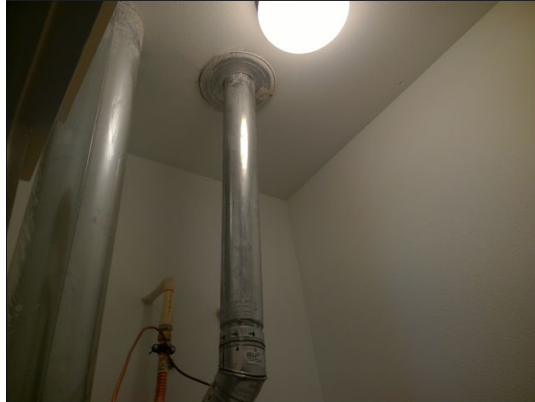
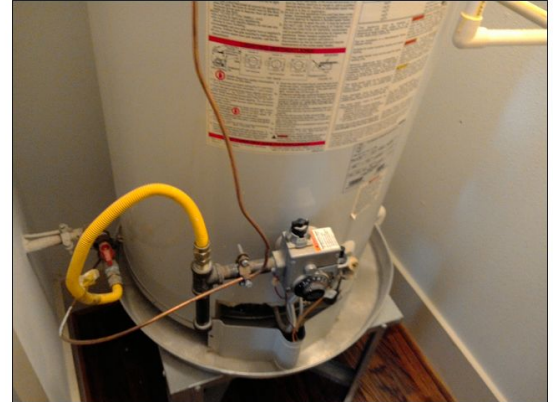
Inadequate provisions for combustion air as required by manufactures installation instructions. Common industry standards (CABO Code 2002.1) require; One opening at top and bottom 12" of door, Each opening shall have "free area" (grills reduce free area) equal to a minimum of 1 square inch per 1,000 Btu/h rating of all appliances installed within the space, but not less than 100 square inches IRC 2407.10.

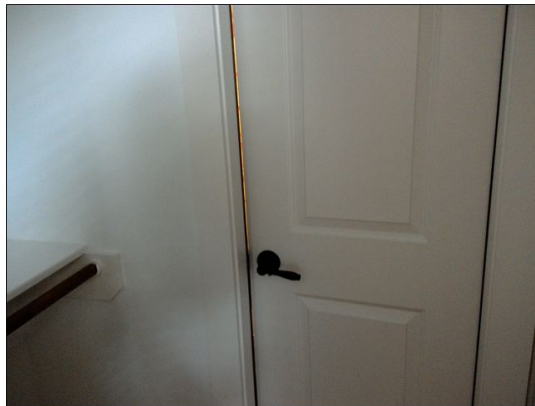
Auto / self closing device on door to water heater closet as required by code needs adjustment to operate properly.

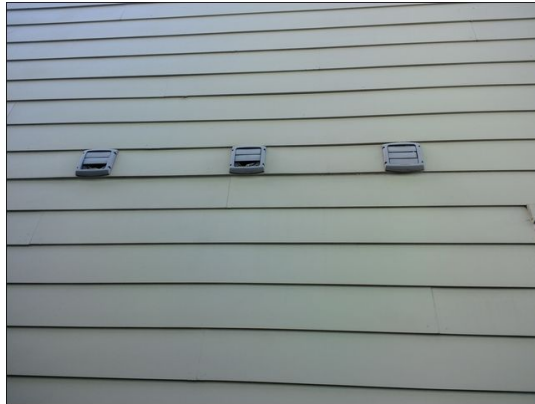
One or more vent terminations damaged.

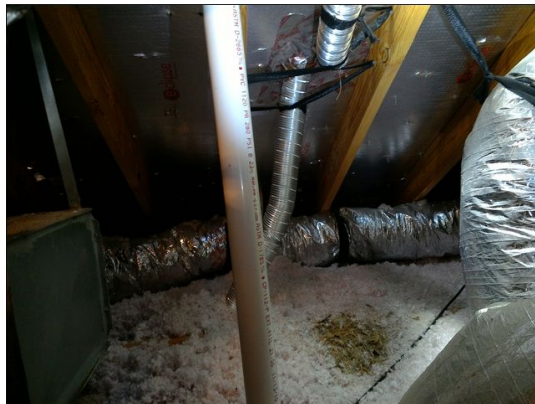
Exhaust duct is crimped/crushed/damaged.

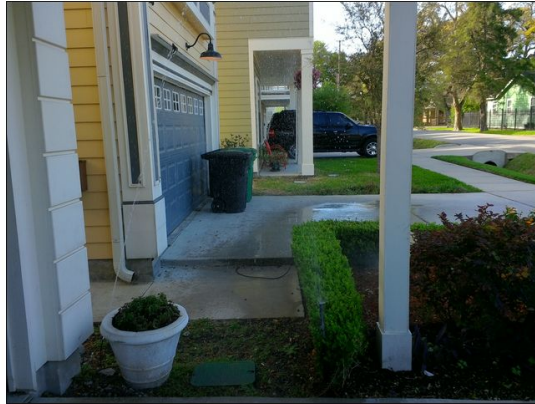
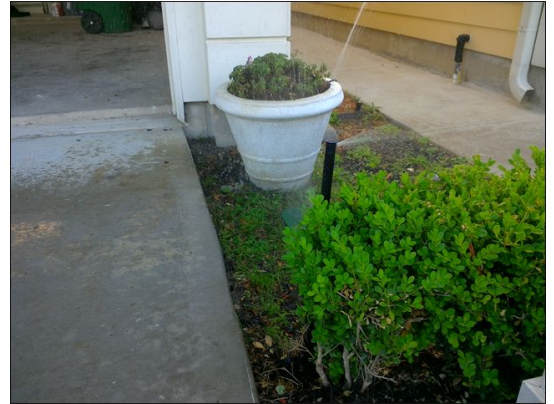
Damaged water line, water gusher in yard; Station(s) # 3.

Damaged line replaced
