510 Tabor St.

1A. Green Team Pest Name of Inspection Company 1B. 0759610 SPCB Business License Number

5. Residence - 2 story Slab

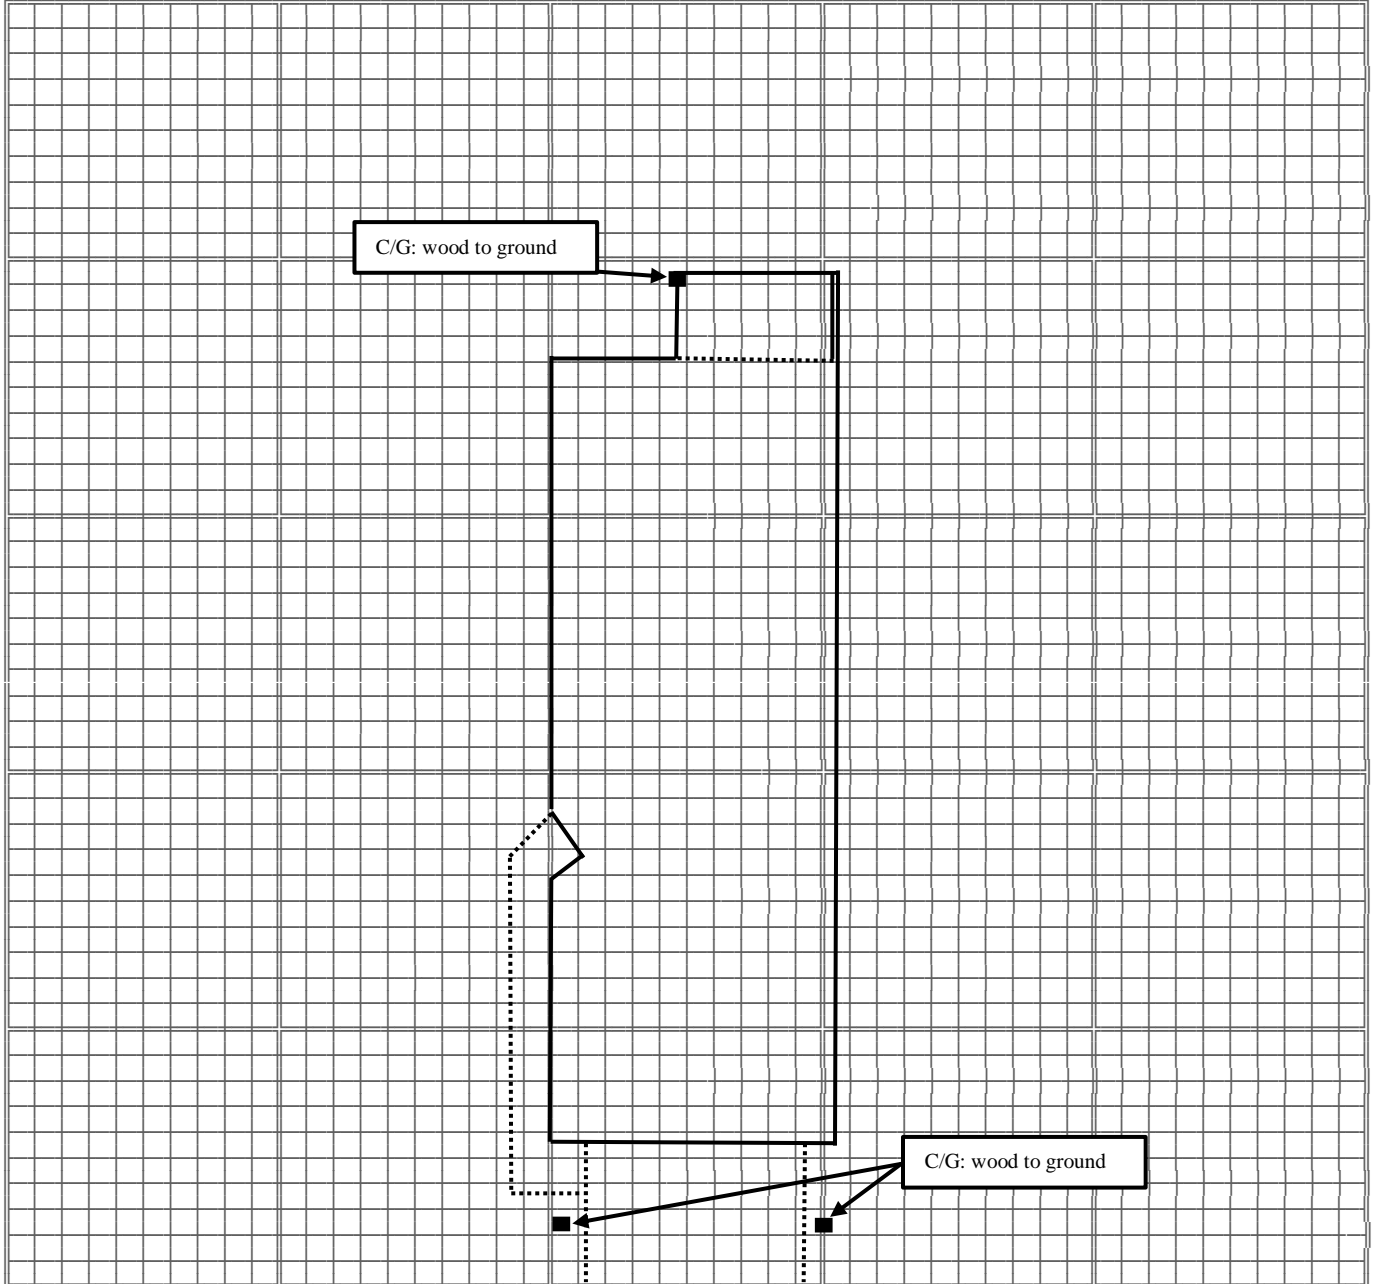
Diagram of Structure(s) Inspected

Specify reason: (G) Wood to ground contact on front posts – recommend a preventative treatment or altering contact;
Refer to Scope of Inspection Part J
