A STRUCTURAL INSPECTION REPORT

HOUSTON AREA URBAN COMMUNITY DEVELOPMENT CORPORATION

807 15TH AVENUE N

TEXAS CITY, TEXAS

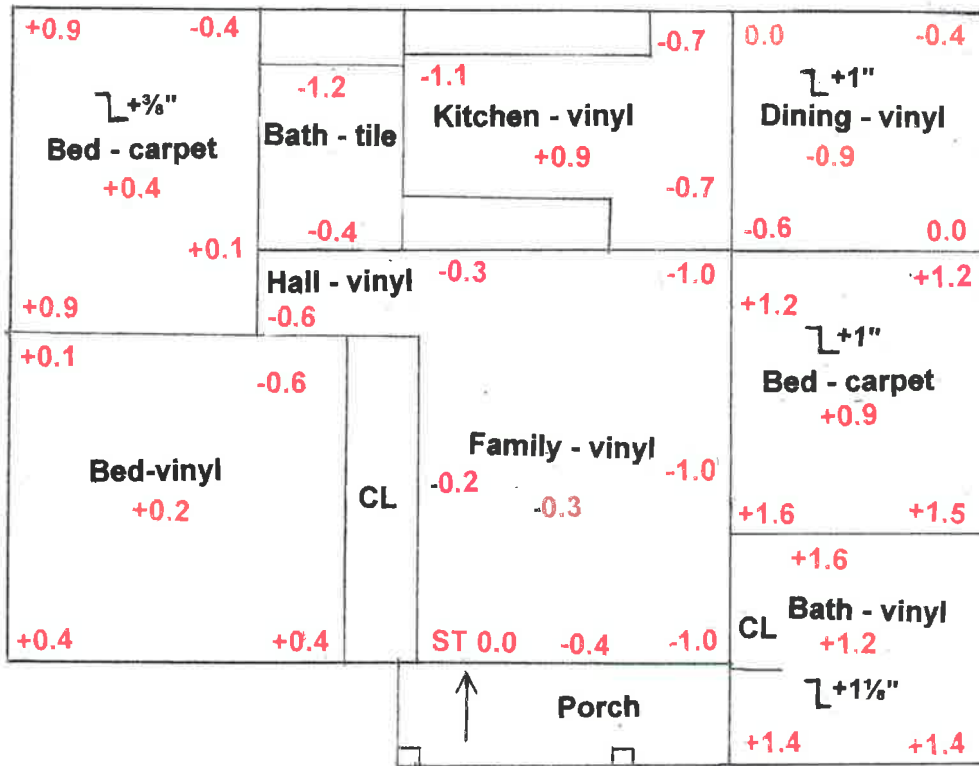
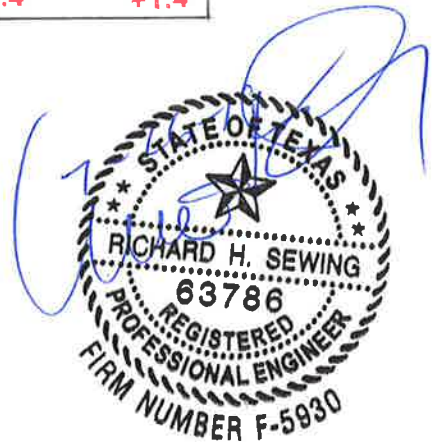
807 15TH AVENUE N
 TEXAS CITY, TX

Floors are generally level (See floor elevation drawing). Floor surface elevation changes on the rear left bedroom carpet, right center bedroom carpet, dining room vinyl and front right bath vinyl (see drawing). Floor surface has fallen in at rear right dining room.

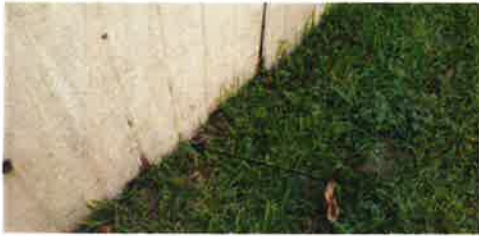
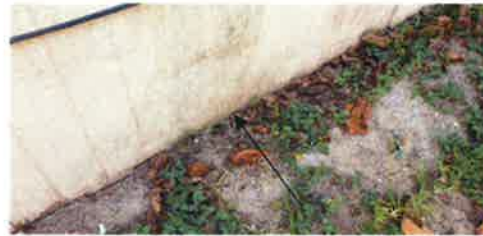
No gutters. Soil is sloped adequately to drain water away from the foundation perimeter. Soil is in contact with siding at the sides and rear.

Soil is in contact with siding at the sides and rear

- Repair rotted wall studs and bottom plates at rear open wall area.
- Grade soil to slope away from foundation and eliminate wood contact with soil at sides and rear.

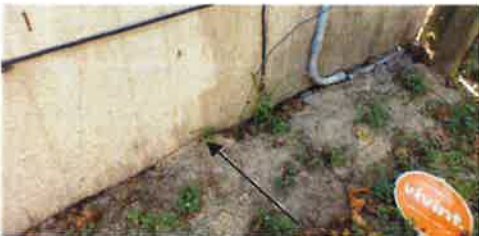
Soil is in contact with siding at the sides and rear

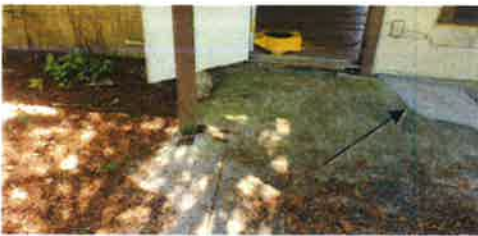
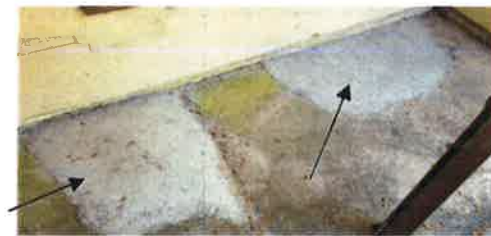
Foundation has been previously repaired evidenced by patched concrete repair holes at the front porch and rear patio (documents not on site). It appears that foundation repair piers have been installed around the exterior perimeter.

Foundation was previously repaired evidenced by patched concrete repair holes at the front porch and rear patio

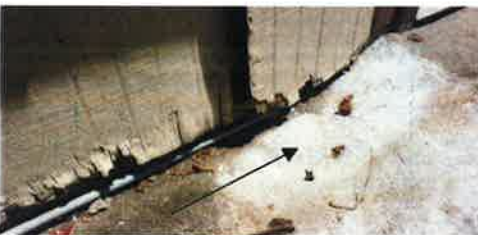
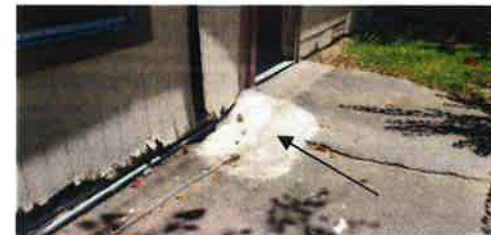
Foundation was previously repaired evidenced by patched concrete repair holes at the front porch and rear patio

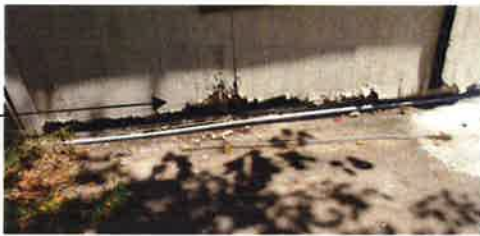
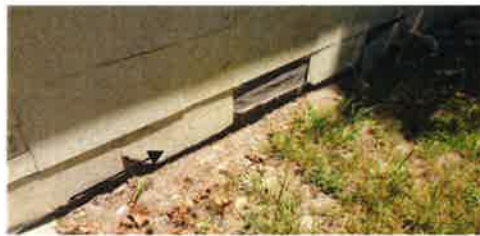
There is no evidence of excessive movement or settlement on the exterior siding. Siding base areas are open at rear exposing rotted wall studs and bottom plate.

Siding base areas are open at rear exposing rotted wall studs and bottom plate

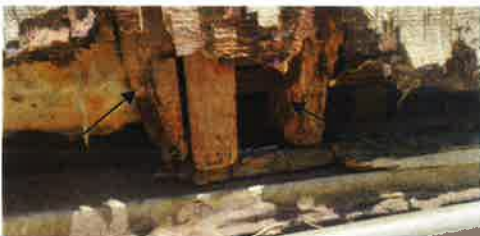
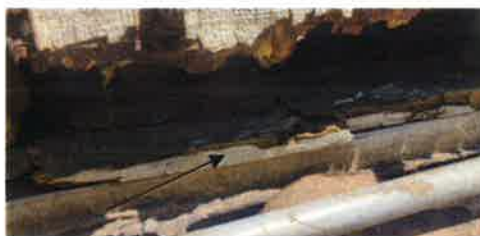
Siding base areas are open at rear exposing rotted wall studs and bottom plate

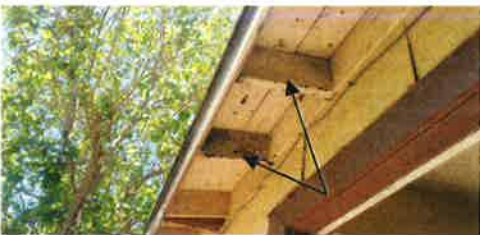
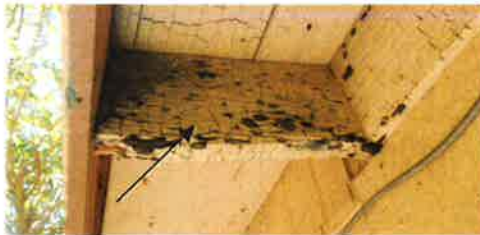
There is no evidence of excessive movement or settlement on the roof's surface. Several rafter tail ends are rotted at rear cornice.

Several rafter tail ends are rotted at rear cornice

- Repair rotted rafter tail ends at rear cornice as needed.

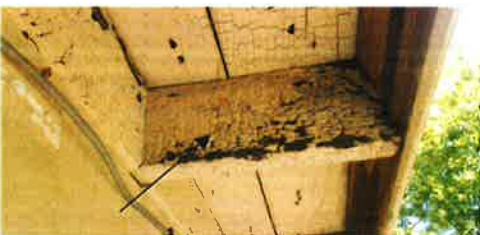
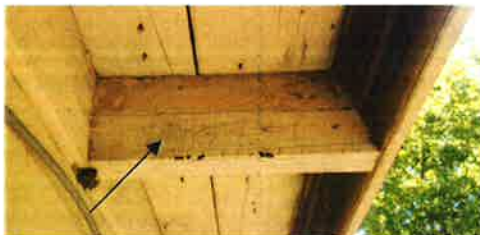
Several rafter tail ends are rotted at rear cornice

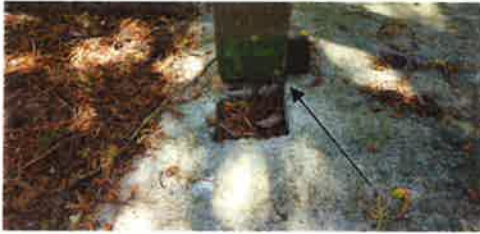
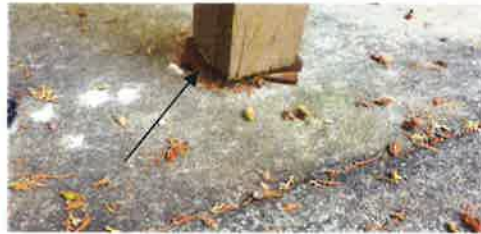
Porch wood structural support posts are not secure properly at base.

Porch wood structural support posts are not secure properly at base

- Secure front porch wood structural support posts properly at base.

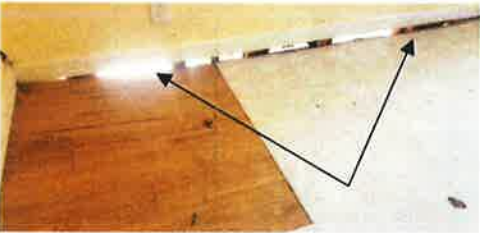
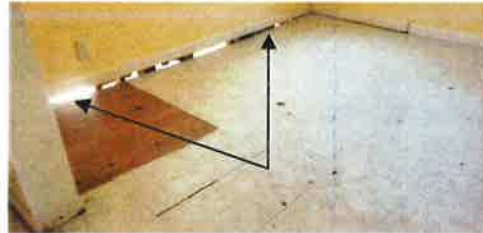
Floor surface has fallen in at rear right dining room

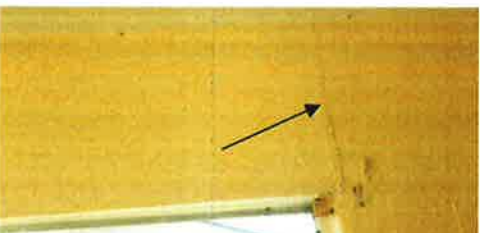
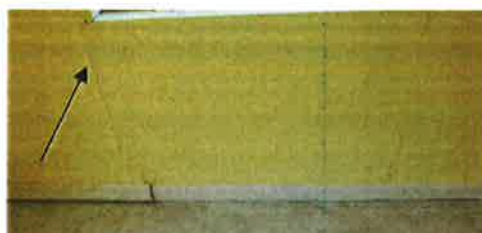
There is evidence of movement on interior walls and ceilings. There are vertical wallboard joint cracks above and below windows and above doors throughout. There are vertical wall corner and wall – ceiling taped joint cracks as several locations.

There are vertical wall corner and wall – ceiling taped joint cracks as several locations

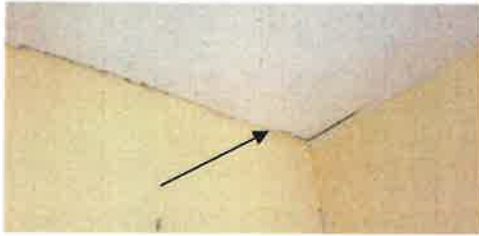
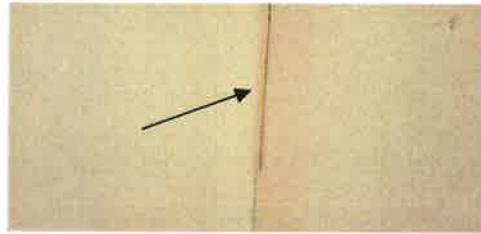
There are vertical wall corner and wall – ceiling taped joint cracks as several locations

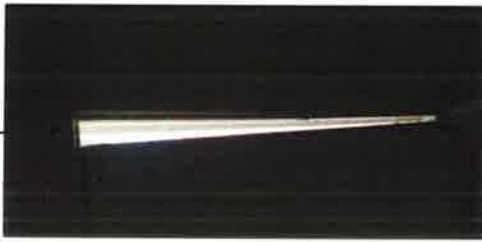
Doors all open and close properly except door sticks in door frame at the left center bedroom entry and door does not fit squarely in door frame at the right bedroom entry.

Door does not fit squarely in door frame at the right bedroom entry.

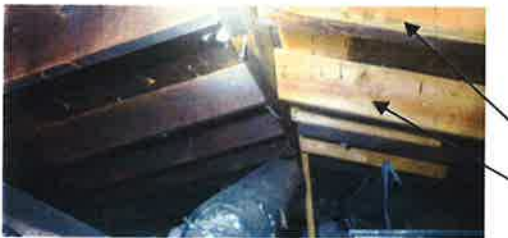
There is evidence of additional bracing installed at the wood structural attic area members

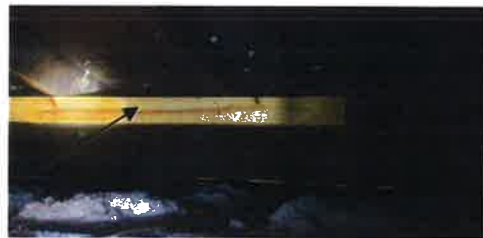
Wood structural attic area members are installed and braced adequately. There is evidence of additional bracing installed at the wood structural attic area members. Several rafters have separated approximately 1" from ridge board junctions at the front center and have been repaired (spliced).

Several rafters have separated approximately 1" from ridge board junctions at the front center and have been repaired (spliced)
