This Home Inspection is exclusively prepared
for:
Chris Colluro
By:
David Moore
TREC#5509

TEXAS REAL ESTATE CONSUMER NOTICE CONCERNING HAZARDS OR DEFICIENCIES

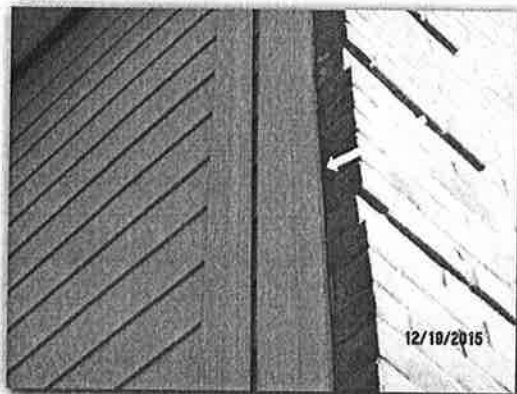
X: The vertical siding trim caulk is incomplete on several sides of the house.

recaulked

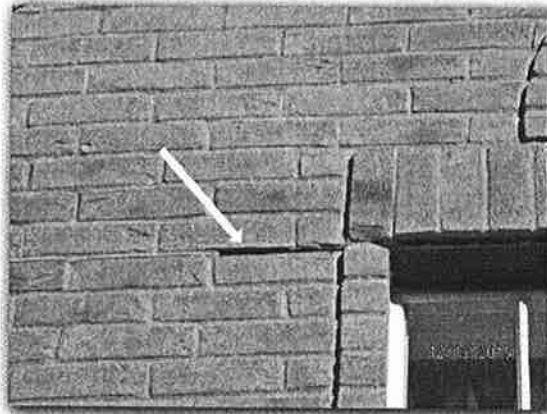
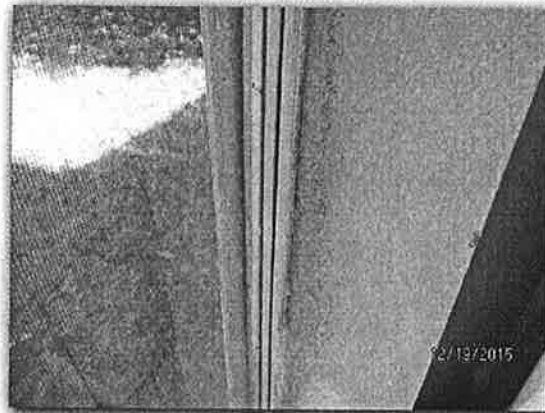
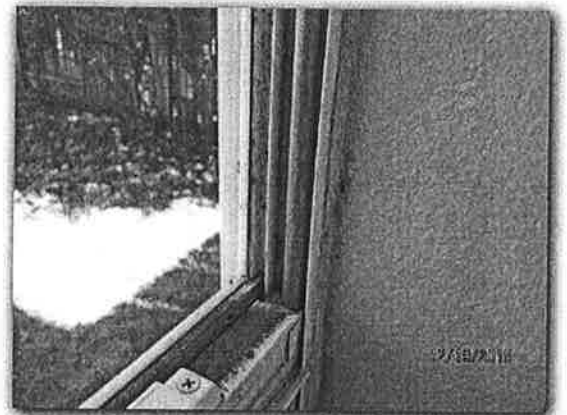
X: The interior walls at the Master bedroom windows have organic growth. Possible water intrusion at the windows.

all windows replaced

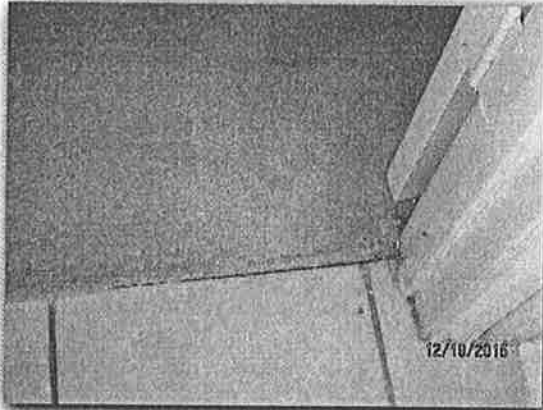
X: The siding joints appear to be sealed with the wrong type caulking at the Rear porch ceiling.

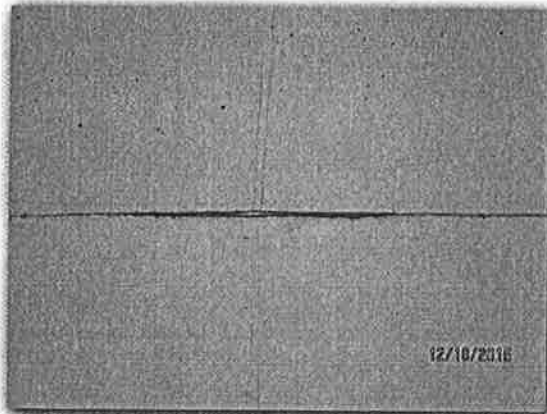
*Sheetrock
examined, most
likely due to
settling*

^: Sheet rock repair noted at the Master bedroom ceiling. Cause is unknown.

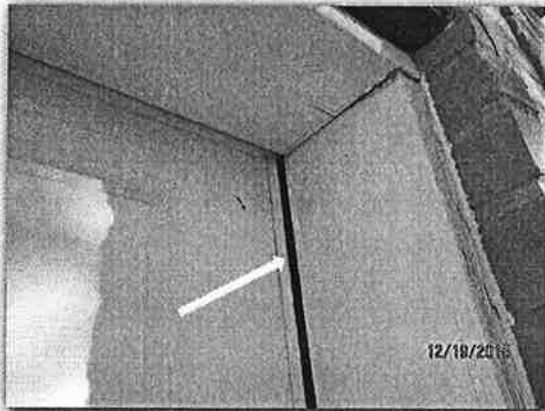
X: The top latch is defective at the double doors in the Master bathroom.

top
↑
latch not defective, must first to push latch in

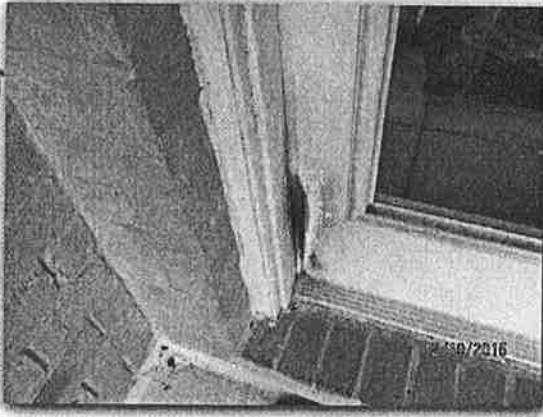
X: Caulking around several exterior windows is deteriorated.

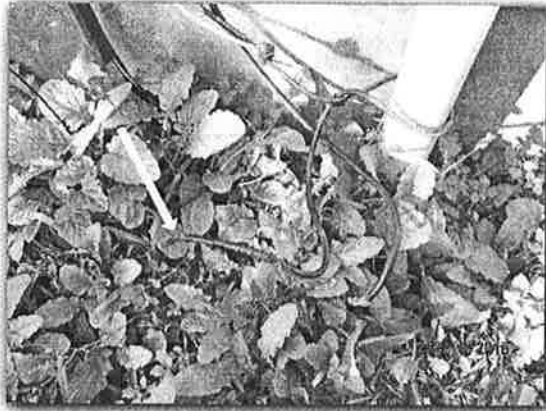
X: The grounding wire connections are loose at Both grounding rods.

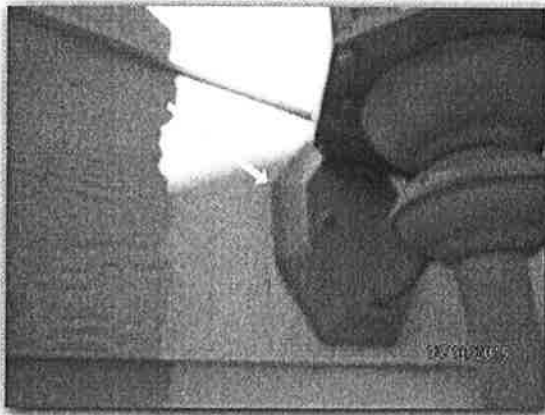
X: The exterior light fixtures are not properly sealed.

replaced/repaired
replaced

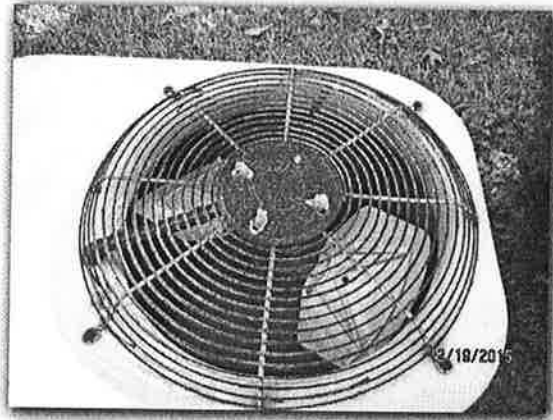
X: The Front AC Condensing unit appears to be old and appears to be nearing the end of it's useful life. HVAC unit should be serviced by licensed HVAC technician to determine any necessary repairs.

↑
Main ac unit
↓ replaced

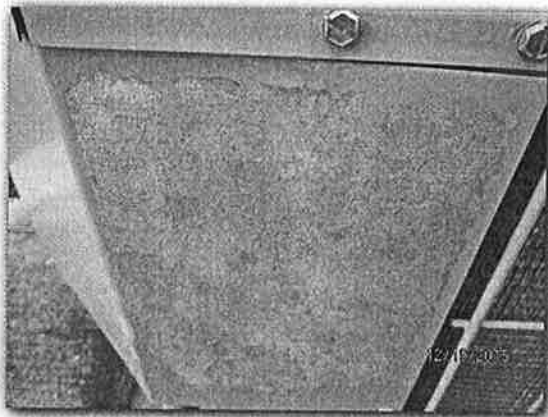
X: The label at the Front AC condenser was worn and Not readable. Unable to determine size and age of the unit. AC units should be inspected by licensed HVAC technician to determine size and age.

← fixer when ac replaced

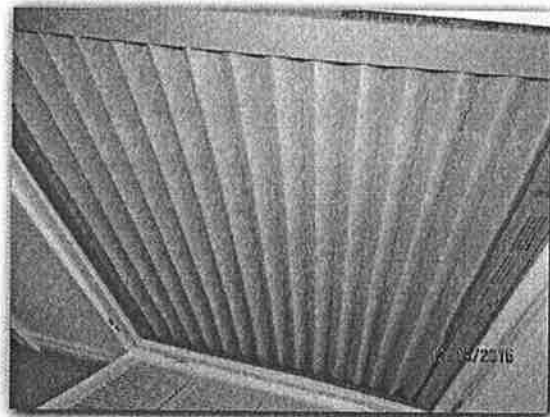
X: The HVAC filters are extremely dirty. Recommend replacing filters and the units be checked and cleaned.

↑ New filters

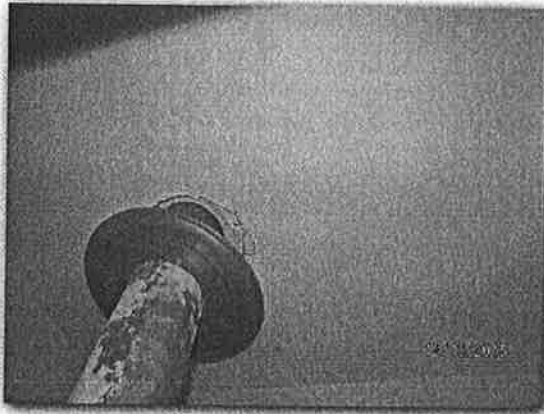
X: The water heater exhaust vent flue is not properly sealed where it exits the ceiling.

↑
fixed
heater
when
water
replaced

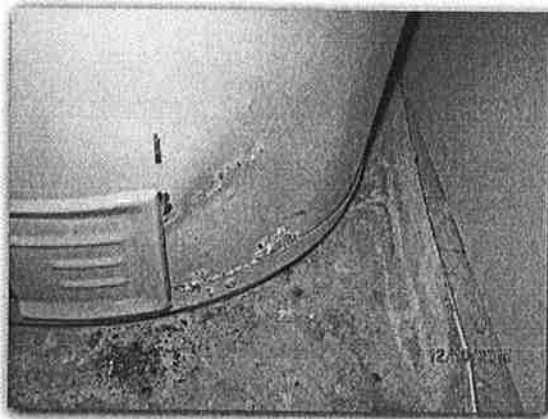
X: Water heater appears to be the original unit, is rusted at the base, and appears to be nearing the end of it's useful life. Recommend further evaluation from licensed plumber.

↑
replaced
water
heater
↓

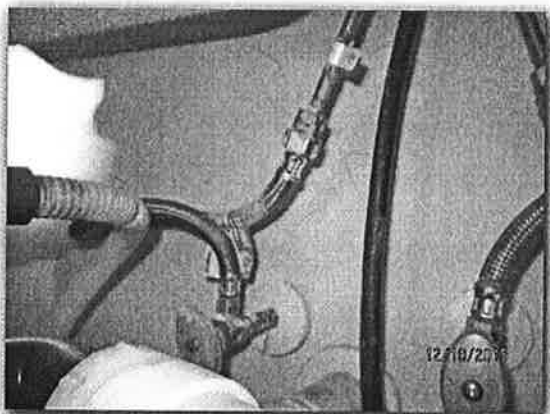
X: The Kitchen sink faucet leaks at the base and the sprayer is inoperable.

X: The water lines are corroded under the Kitchen sink.

*replaced faucet
fixed leak*

lines have been cleaned

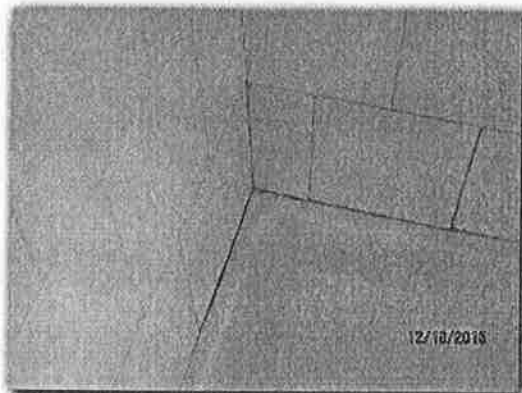
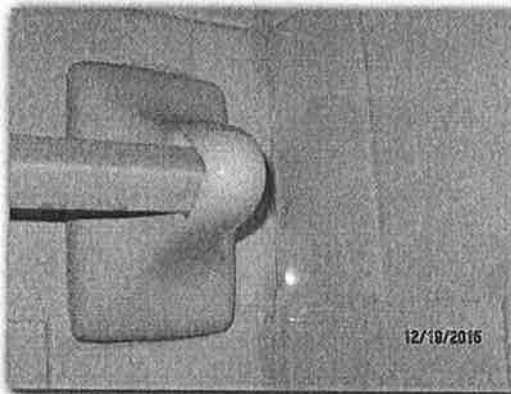
X: The Powder bathroom and Master bathroom toilets do not properly flush. Defective flush mechanisms.

X: The Master shower door hinge is loose at the top and does not properly close.

X: The shower head leaks at the upstairs bathtub.

toilets replaced

head replaced

shower and tub recaulked

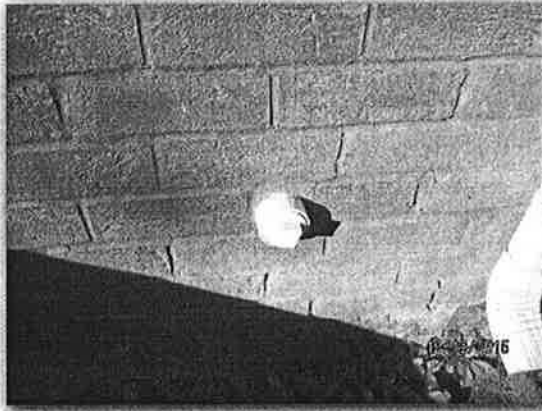
X: The exterior PVC plumbing clean-out pipes and caps are not properly painted.

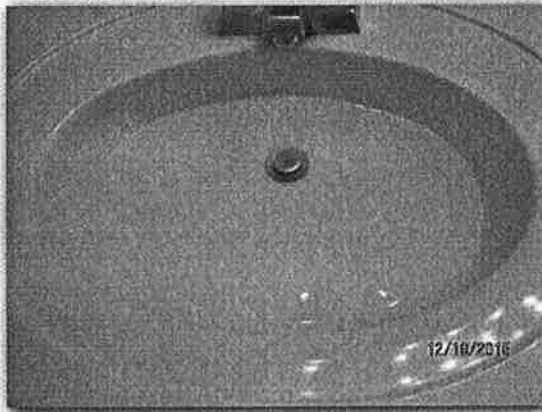
X: The Left side sink drain line in the upstairs Hall bathroom is Slow draining. This is particularly problematic given that this is a sink with an AC drain line connected.

↑
Partial
and
class
fixed
found

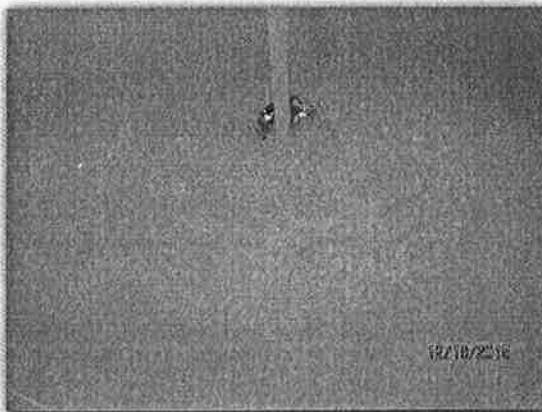
X: Both sinks in the Master bathroom are Slow draining.

↑
Problem
fixed

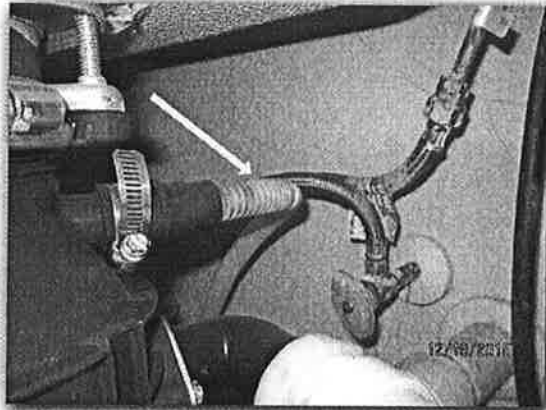
X: No loop in drain line or anti siphon device installed to prevent the back flow of contaminated water from sink drain to dishwasher.

↑
fixed

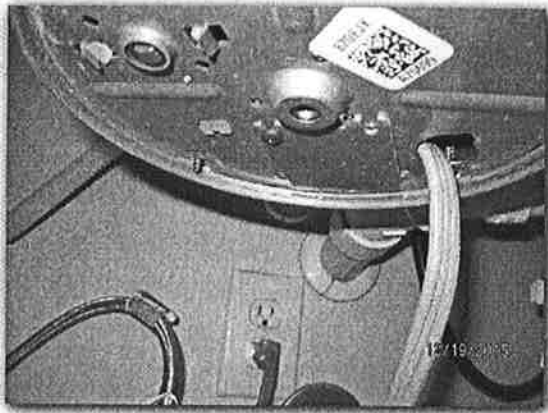
X: The electrical wires at the base of the disposer are missing a protective bushing where they enter the unit.

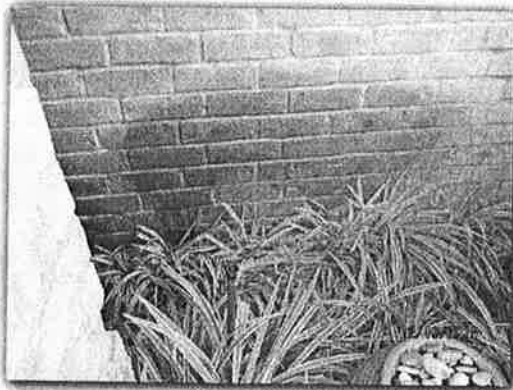
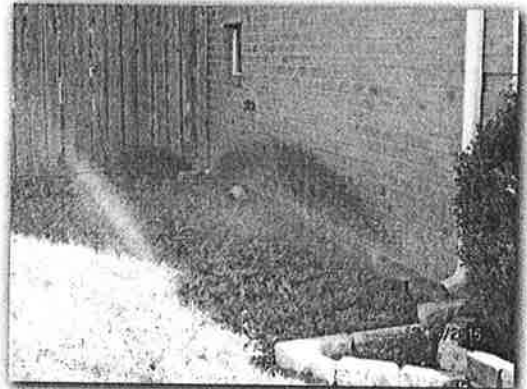
X: There are several clogged sprinkler heads in Zone 2 & Zone 6. ← fixed
X: Sprinkler heads are damaged or broken in Zone 2. Recommend sprinkler specialist be consulted for further evaluation and repair cost.

↑ damaged heads replaced

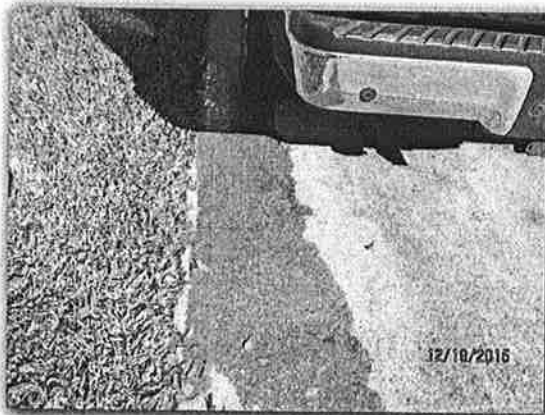
↙ Not supposed to rotate, only 5 rotate to zone

X: Several sprinkler heads in Zone 4 do not properly rotate. Recommend sprinkler specialist be consulted for further evaluation and repair cost.

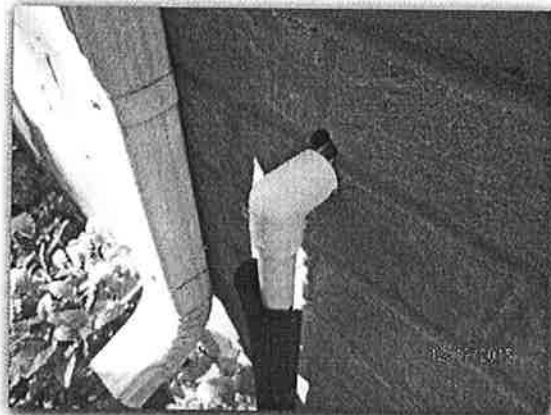
X: Sprinkler wiring protective PVC conduit is not properly painted and sealed.

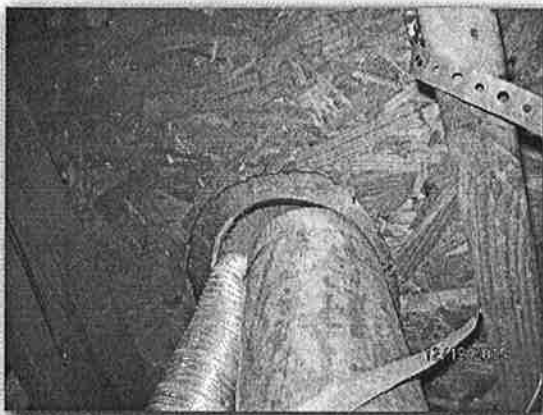
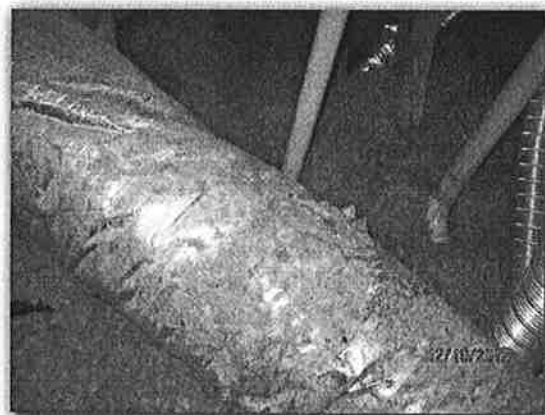
X: The dryer vent flue is not properly sealed where it exits the roof jack and lint is being deposited into the attic.

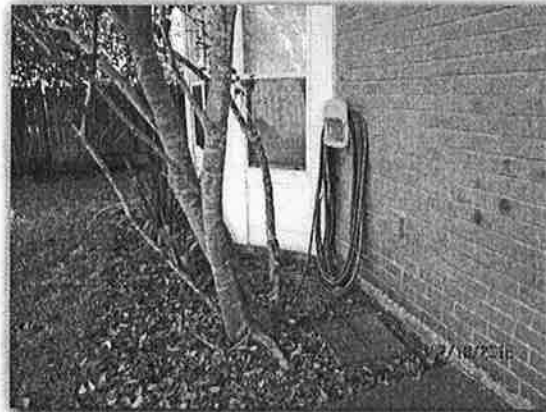
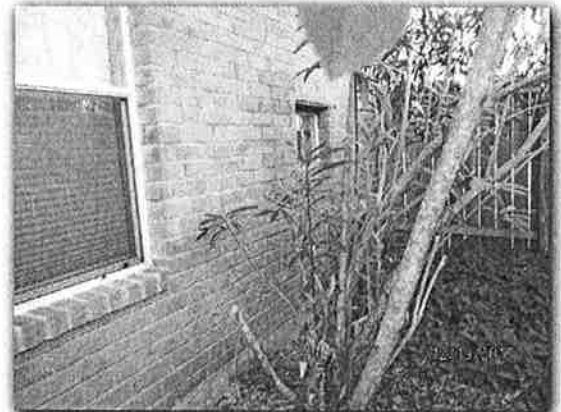
X: There are trees planted too close to the Rear & Left side foundation. This can cause future foundation failure.

both trees removed →

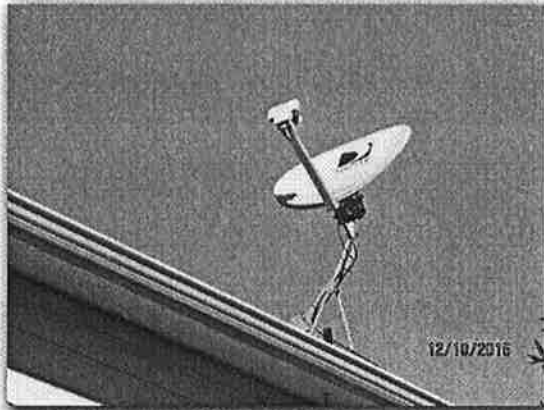
^: There are satellite dishes installed on the roof slope. Monitor securing bolts and keep sealed or remove the dishes and repair the roof.

↑
bolts secured

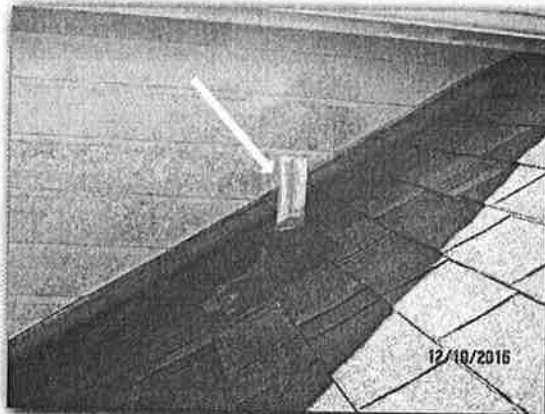
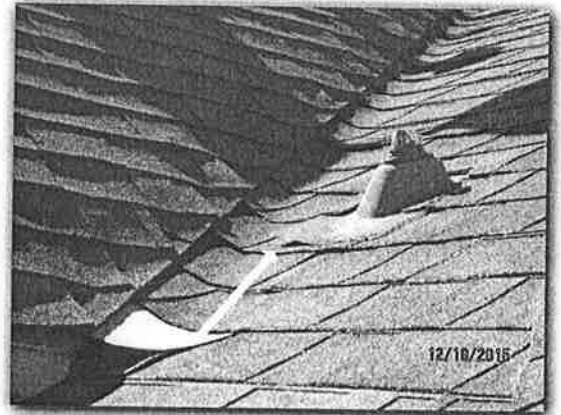
X: The plumbing vent PVC pipes are not fully painted and the roof flashing is loose at several vents. PVC exposed to ultraviolet light becomes brittle and can crack and leak. Paint affords some protection and is a standard procedure.

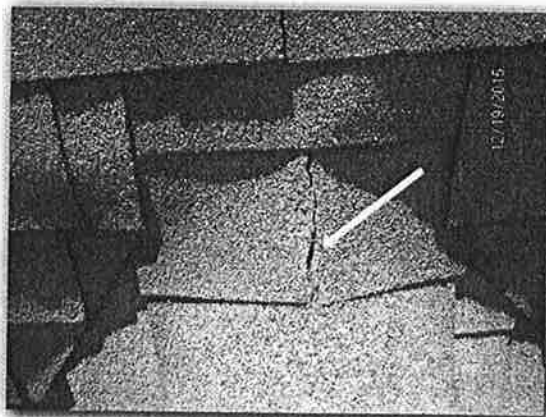
X: Several ridge shingles are worn and damaged.

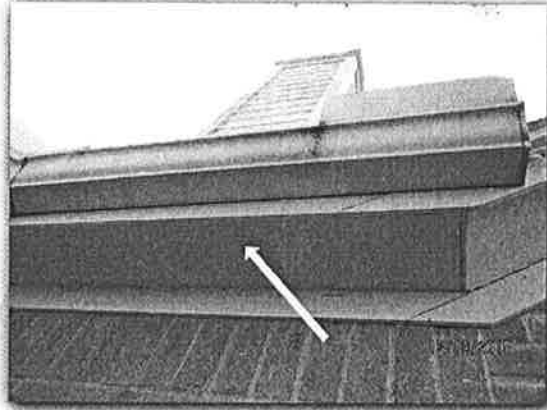
X: No soffit or passive vents are installed at the eaves at the Front & Rear roof to allow an upward circulation of air by convection through the attic space.

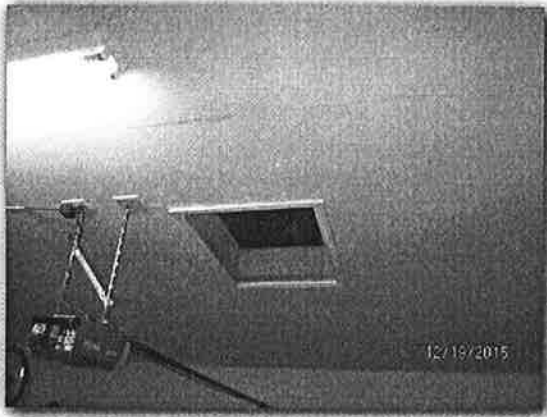
X: The attic pull down stairs are improperly installed. Manufacturers require 16d nails or lag screws. Finishing nails and deck screws are forbidden.

X: The attic entrance hole is not properly fire-blocked in the Garage.
