## PROPERTY INSPECTION REPORT

Concerning: 3119 Pine Chase Drive , Montgomery, TX 77356  
(Address or Other Identification of Inspected Property)

By: Eric Phillips Lic.#: TREC #21717 09/05/2019  
(Name and License Number of Inspector) (Date)

Inspection No. 521157-1-212

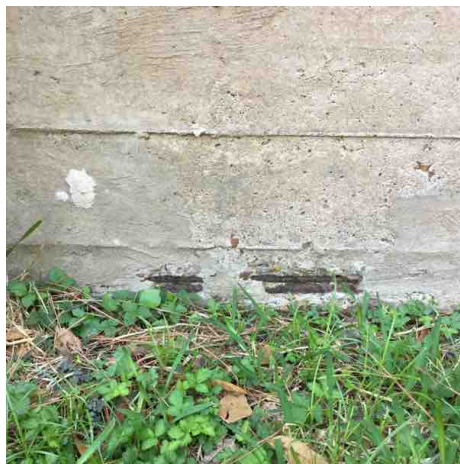
- Overall, the foundation appears to be supporting the structure with no visible evidence of major shifting, cracking or excessive floor slope.
- Exposed steel reinforcement was noted on foundation edge and should be checked, primed and sealed to prevent concrete spalling from expansion of rusting steel.

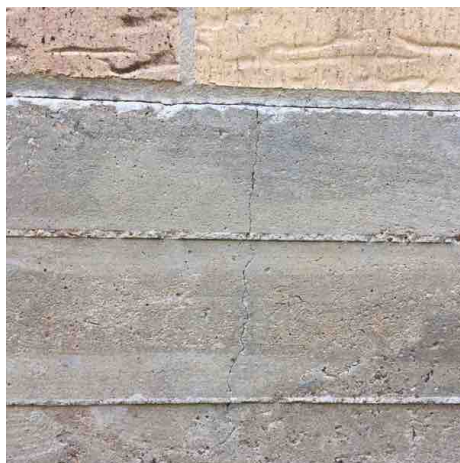
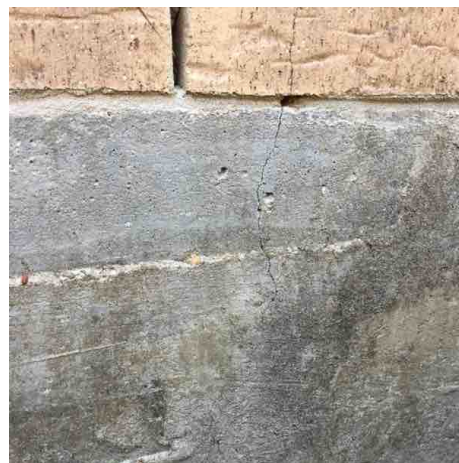
- Hairline cracks were noted in the expose grade beam in a few places. These are considered typical for settling of the structure on these soils. Monitor areas for future performance.

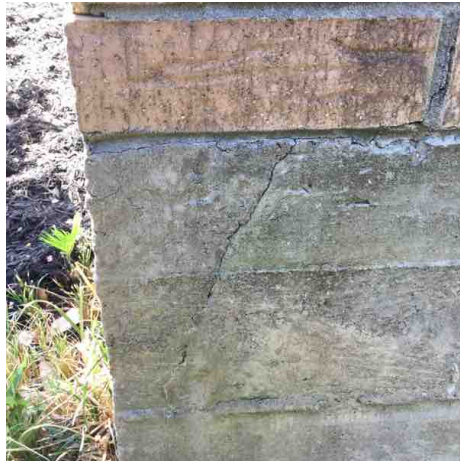
- Wedge cracks noted in corner(s) of exposed grade beam. This is not a structural issue, but repair/repointing is recommended. A good article explaining the cause of these cracks can be found at <https://tinyurl.com/m88xc5o>

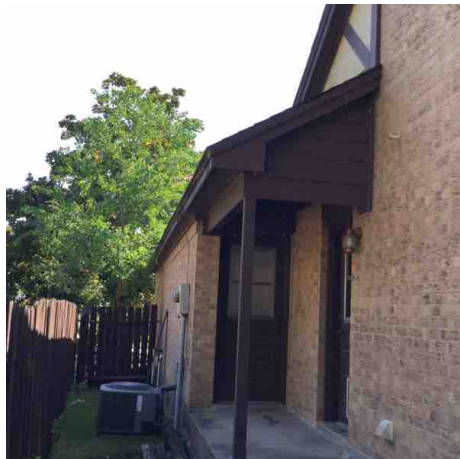
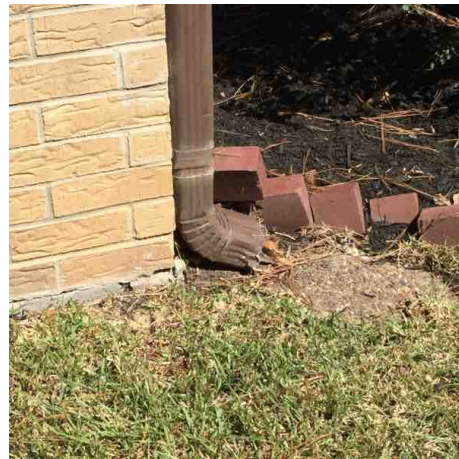
- It is strongly recommended that a gutter and downspout system be installed along the drip edges of the ENTIRE house to a) minimize erosion around the foundation and b) minimize water absorption by expansive clays and any resultant foundation movement.

Extend all leaders from gutters to discharge at least 6' away from building to reduce moisture penetration and foundation damage. Splash blocks are a less effective but secondary alternative.

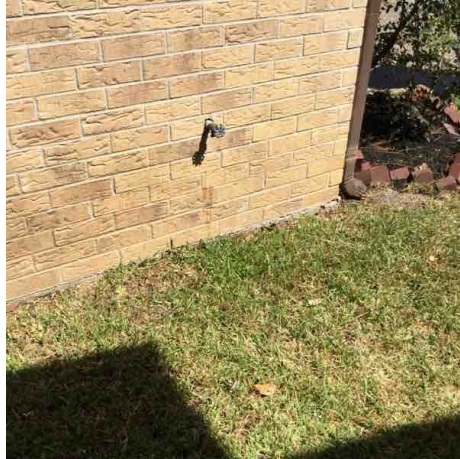
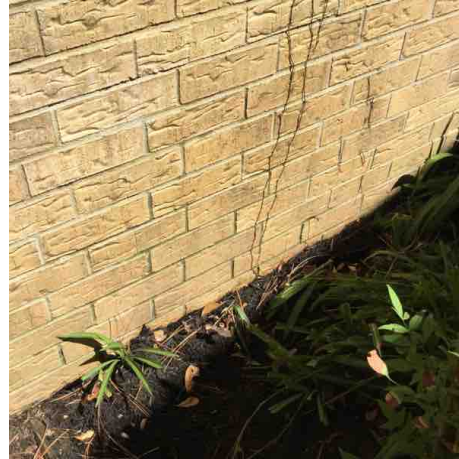
- Soil/grass/mulch is too high on exterior wall in some areas, creating vulnerability to water and insect intrusion and which will ultimately present moisture problems inside the wall structure. Recommended clearances are 4 inches for brick/masonry and 6 inches for wood/siding.

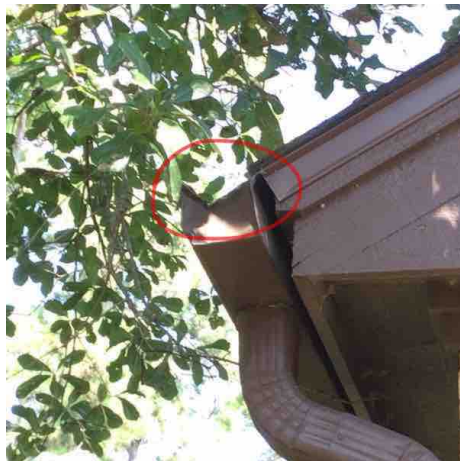
- Repair any damage to gutters or downspouts.

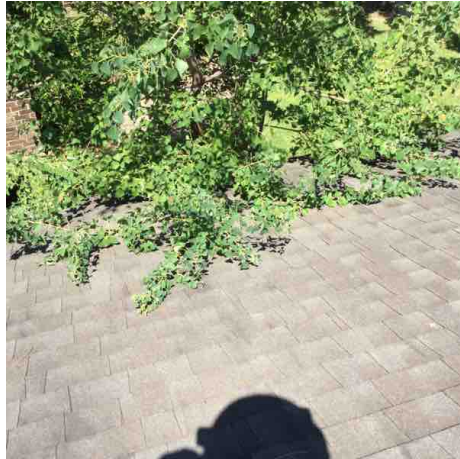
- Tree limbs are contacting roof, which will increase wear in these areas. All tree limbs should be trimmed back 4 feet from the roof surface, monitored for growth and controlled on a continuing basis.

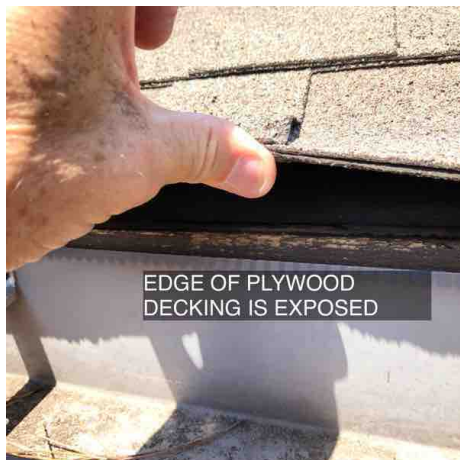
- Not all areas of drip edge have flashing (behind gutters). This could result in moisture related problems. All areas of the roof perimeter should be flashed.

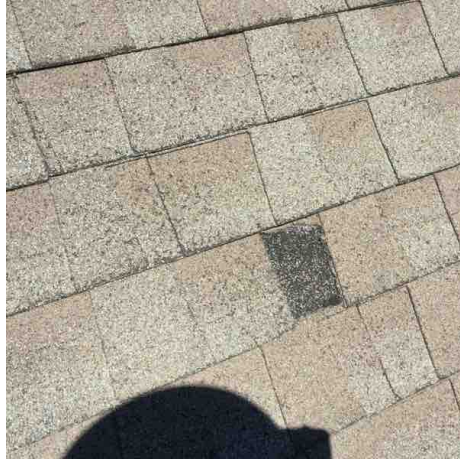
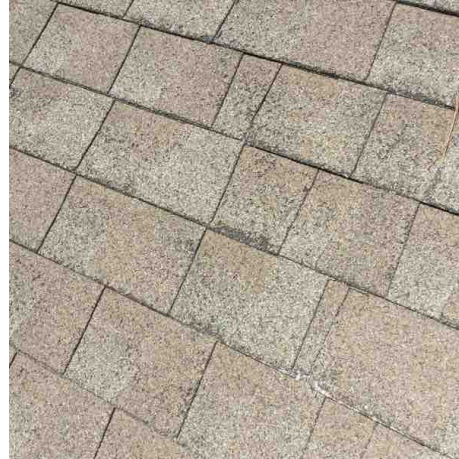
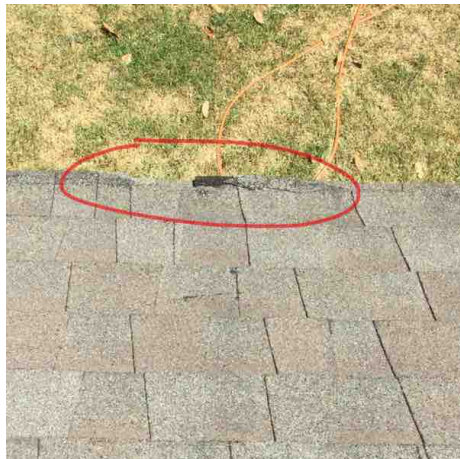
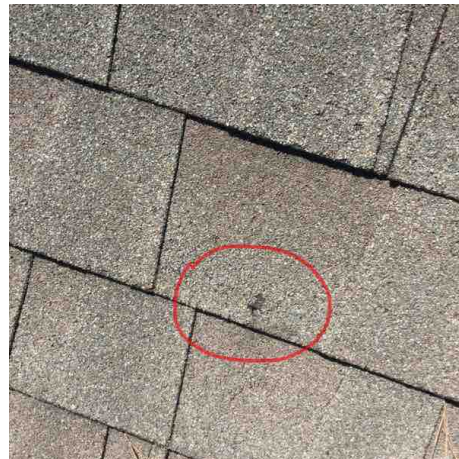
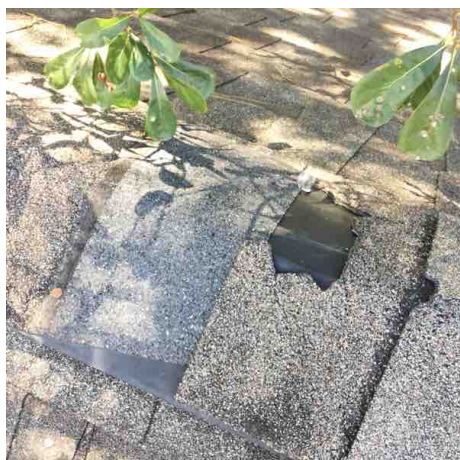
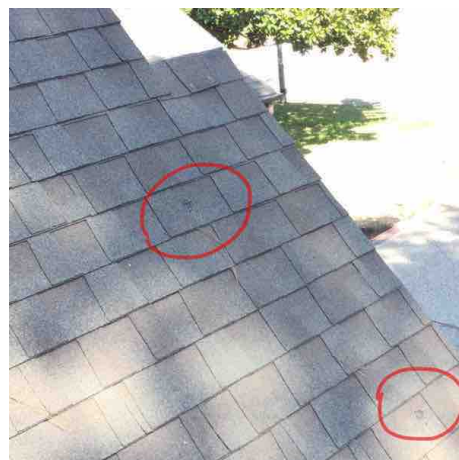
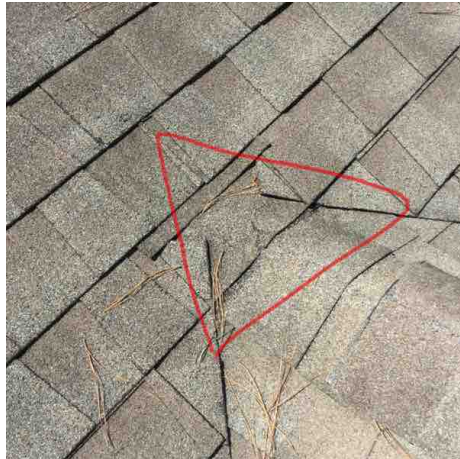
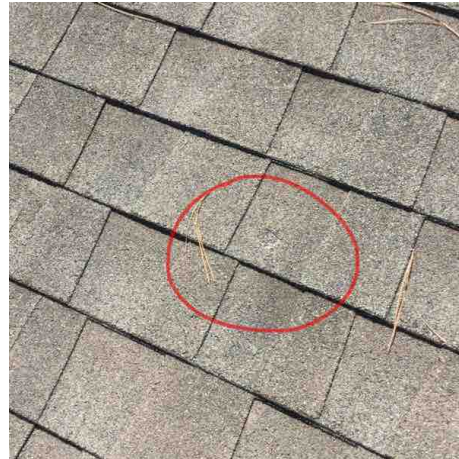
- Damaged shingles were noted that should be replaced. Although not currently exhibiting signs of leaking, these damaged shingles will wear before surrounding shingles and could present premature roof problems.
- Roof covering appears to be nearing the end of its life expectancy, but appears to be functioning and should be able to be maintained in the short term with monitoring and minor repairs. Covering should be budgeted for replacement in the near future.

• Damaged shingles were noted that should be replaced. Although not currently exhibiting signs of leaking, these damaged shingles will wear before surrounding shingles and could present premature roof problems.

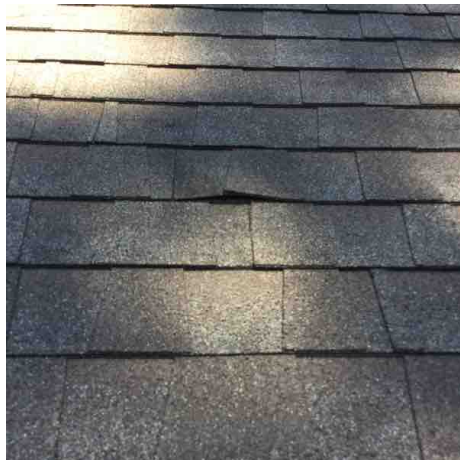
- "Bird-eyes" are apparent where nails have backed out and lifted shingles above. Nails need to be resealed and loose shingles caulked.

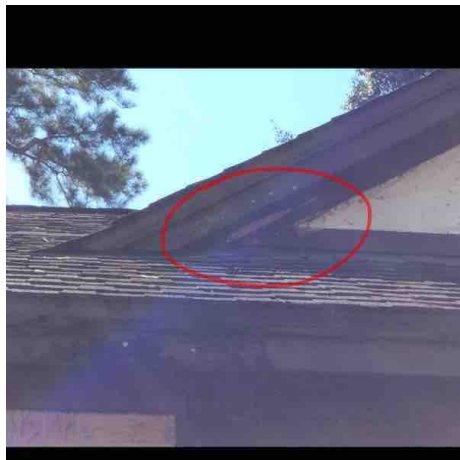
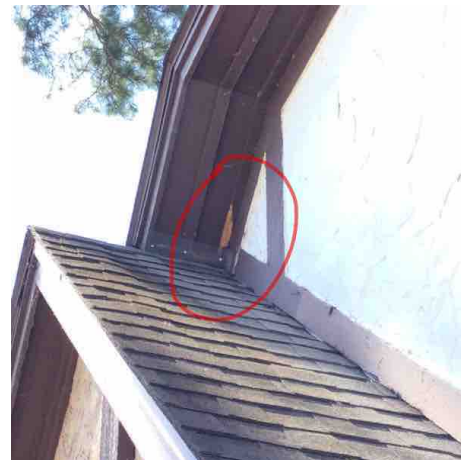
- Squirrels have damaged some areas of eaves while trying to chew their way into the attic. Damage in these areas needs repair and paint. Monitor all suspect areas for future damage. Recommend consulting a pest control company for recommendations on how to minimize future occurrences of damage.

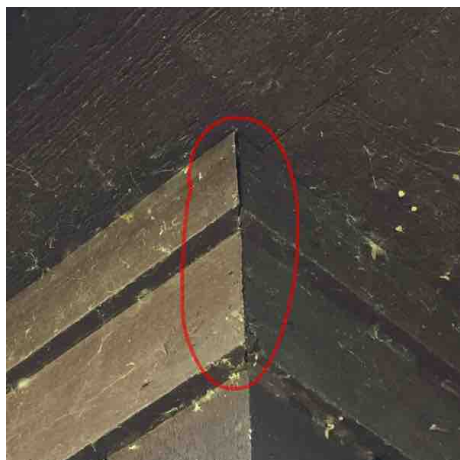
- Caulk and paint exposed eave/soffit/fascia/frieze board edges and joints.

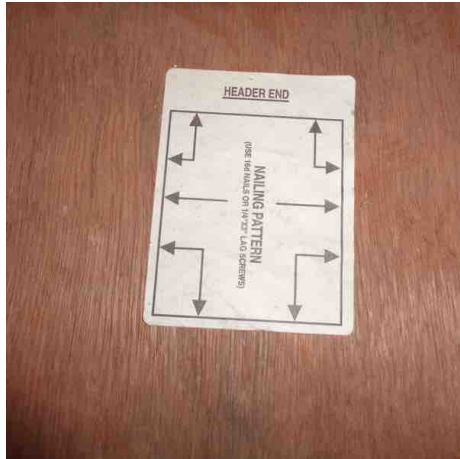
- Attic access ladder is not installed per manufacturer's instructions. Shims are missing in gaps between frame and building structure. Screws are not appropriate for installation; should be 16d nails or 1/4 inch lag bolts. See photo.

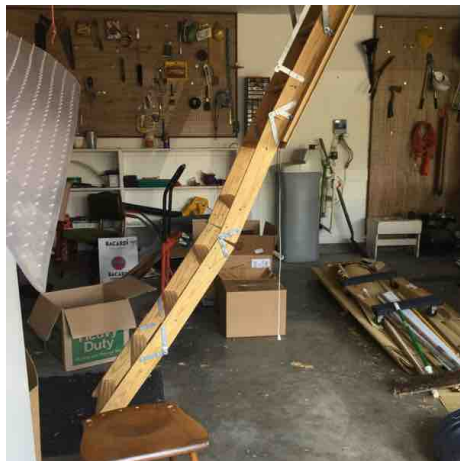
- Attic access ladder does not appear to be constructed of fire retardant material and could compromise integrity of garage fire stopping system.
- Attic access ladder has been modified and is doglegged and needs repair.

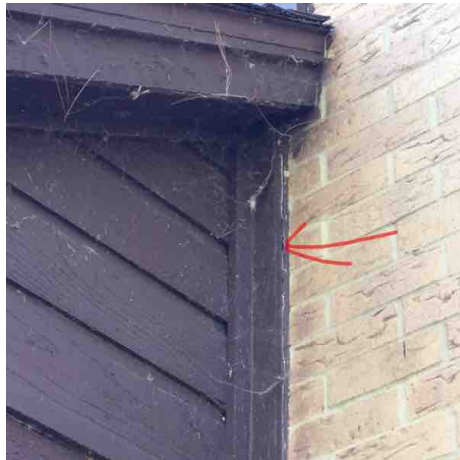
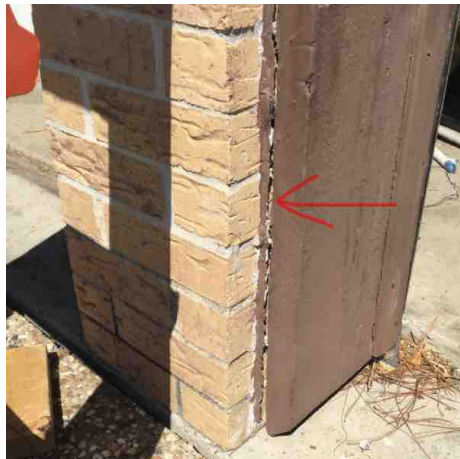
- Generally, caulking and sealing between siding/brick and structure should be refreshed throughout in order to close all gaps from moisture and insect infiltration.

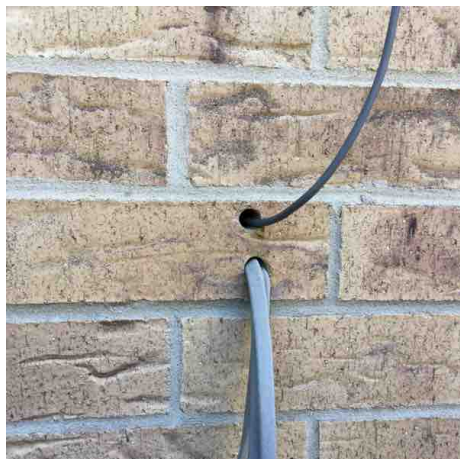
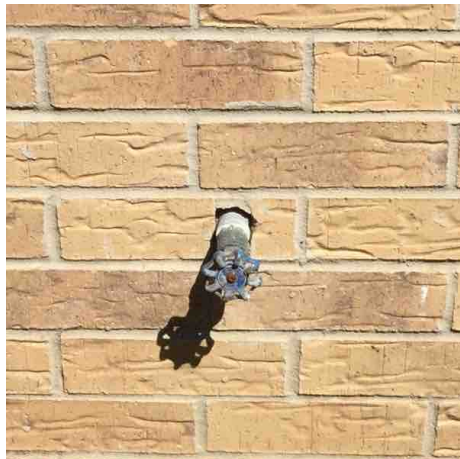
- Seal all exterior wall penetrations to prevent moisture and insect infiltration.

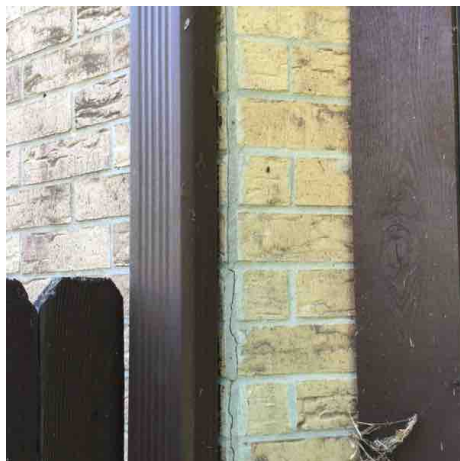
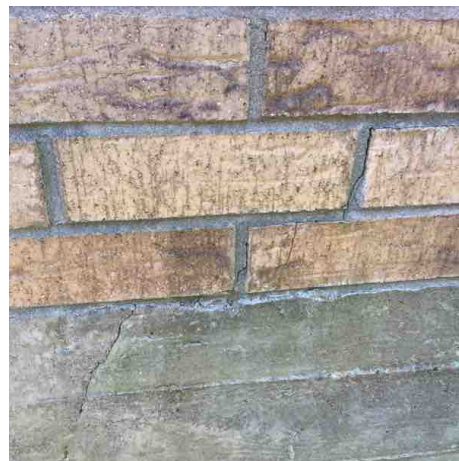
- Areas of masonry veneer are showing cracks which should be pointed up and sealed. These cracks appear to be a result of typical house settling and do not appear to be a structural concern. Monitor areas for future performance.

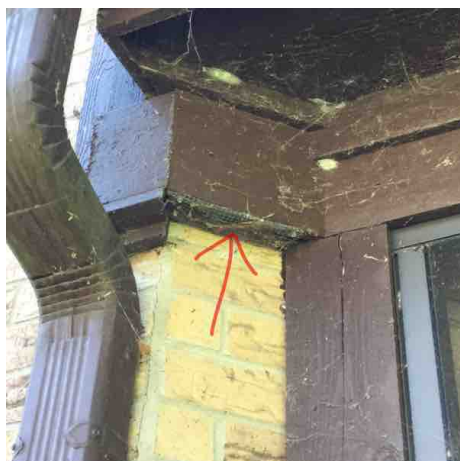
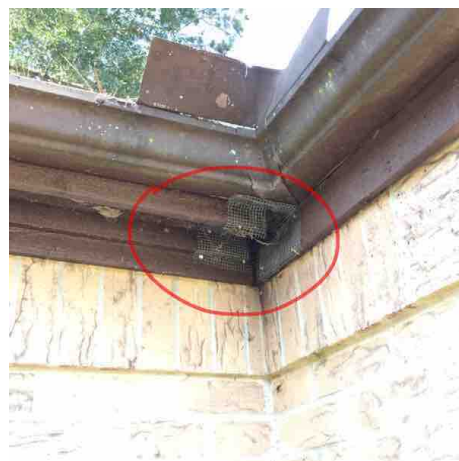
- Damaged eave components need proper repair.

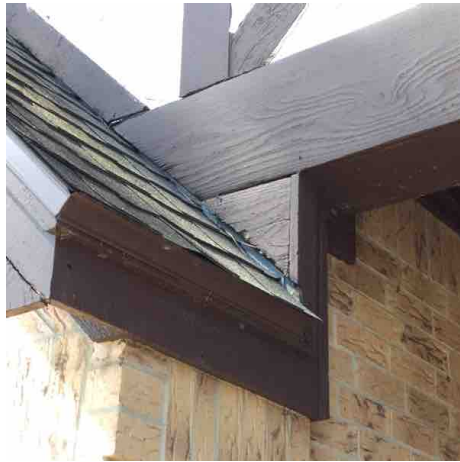
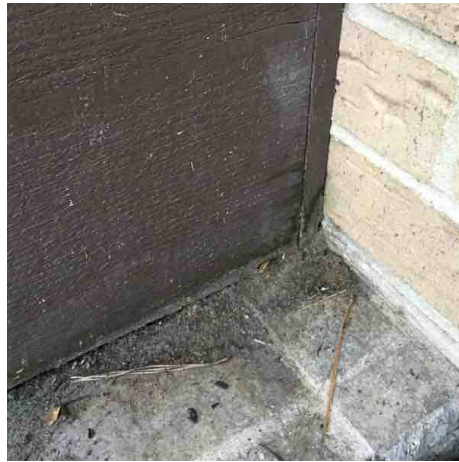
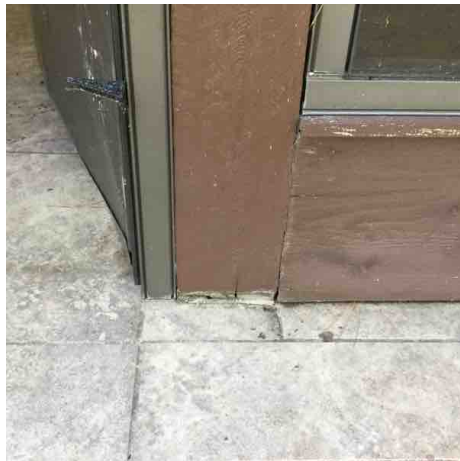
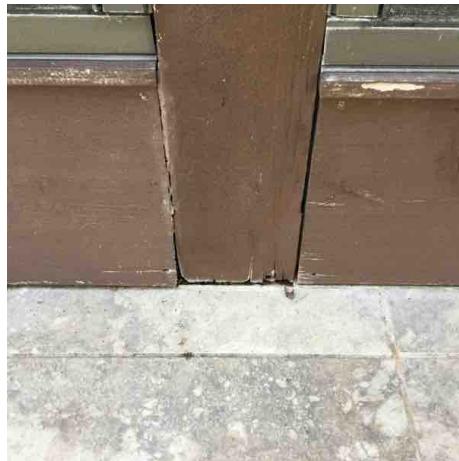
- Repair any moisture damaged siding and trim.

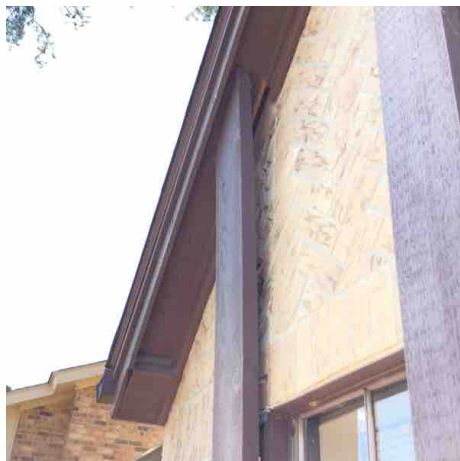
- Trim on front window needs repair.

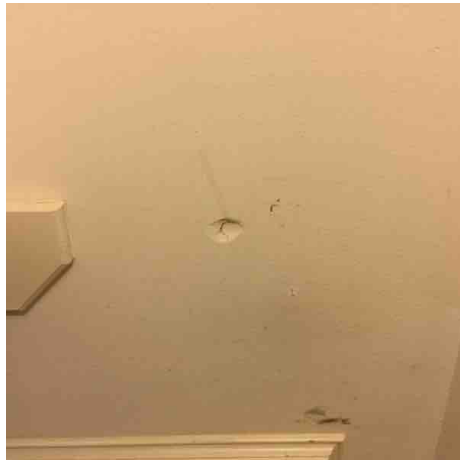
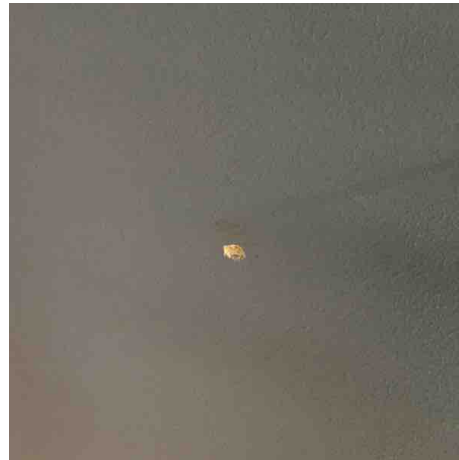
- Repair any damaged drywall

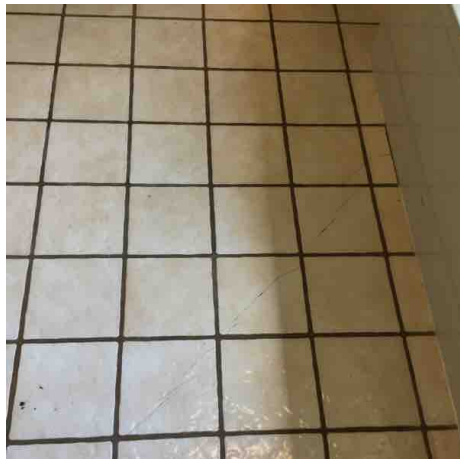
- Cracked floor tile in master bathroom will need repair.

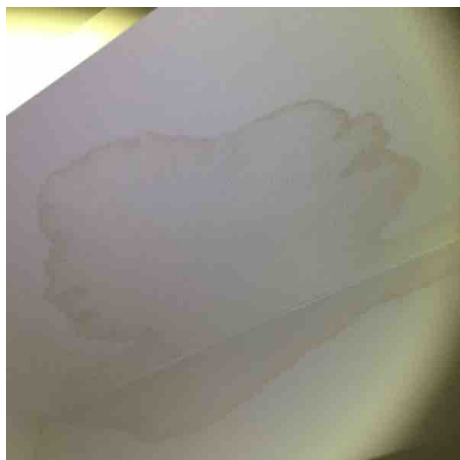
- Interior ceiling in hall linen closet has been wet at one time, but measured no excessive moisture upon testing. Repair damage and monitor this area for future performance.

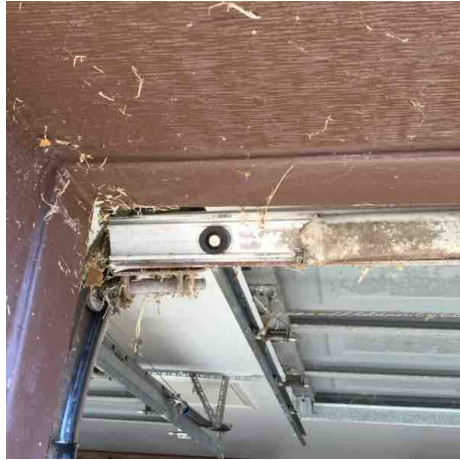
- **Recommend installing self closing hinges on fire rated door to garage.**
- Overhead garage door seal needs repair

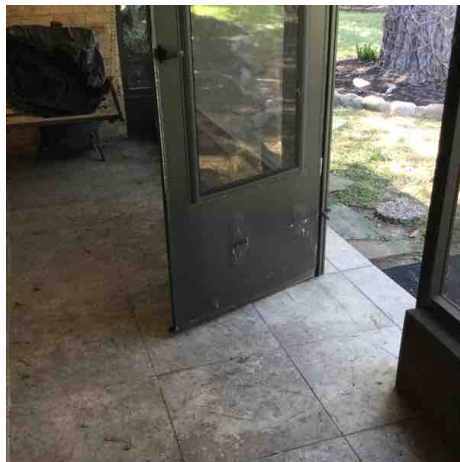
- Weatherstripping needs repair on front door.
- It could not be determined if the front door glass is tempered.
- Storm door off of the back patio needs replacement

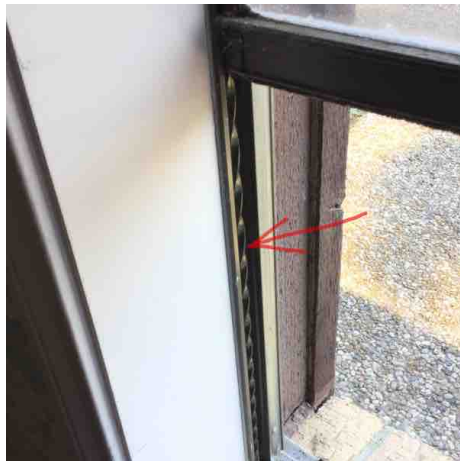
• **Several windows free-fell when tested. This can severely injure someone’s hand and needs to be corrected. Repair or replace the following window units:**

- **Master bath water closet**
- **Master bedroom (both)**
- **Middle bedroom**
- **Front bedroom**
- **Den (right of fireplace)**
- **Dining room (both)**

**Generally, the spiral balances have dropped on most windows and need repair.**

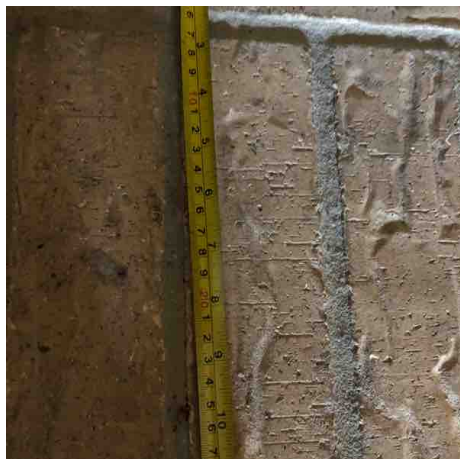
- **Best practices call for a minimum hearth depth of 16 inches beyond the edge of the firebox to combustible materials for this fireplace design. This one comes in at 11 inches.**

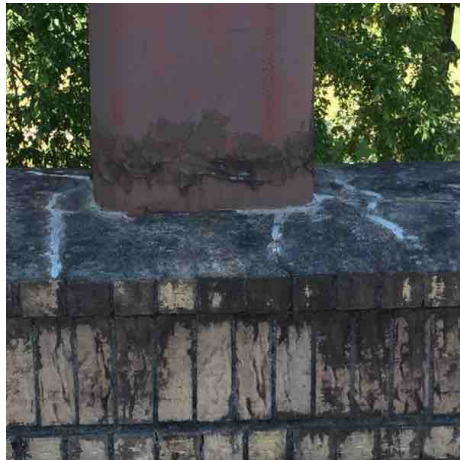
- Any cracks in chimney cap should be pointed up.

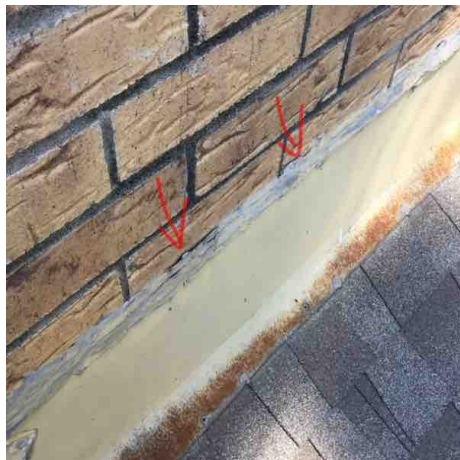
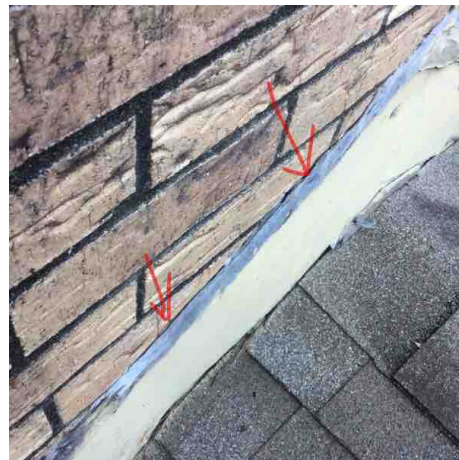
- Flashing along edges needs attention.

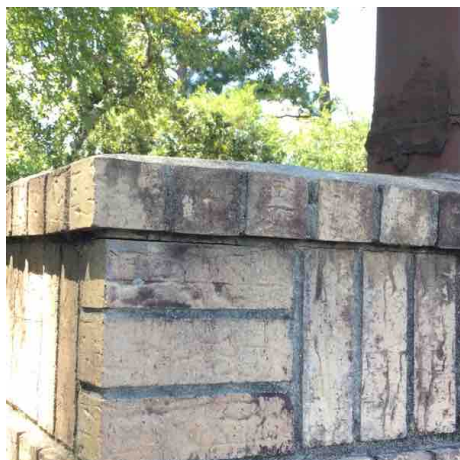
- Point up any cracks or gaps in brick joints

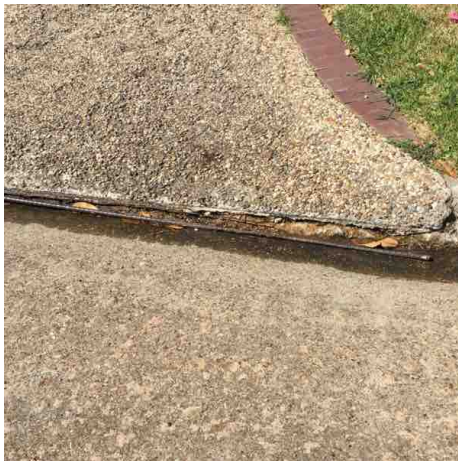
- Driveway needs repairs

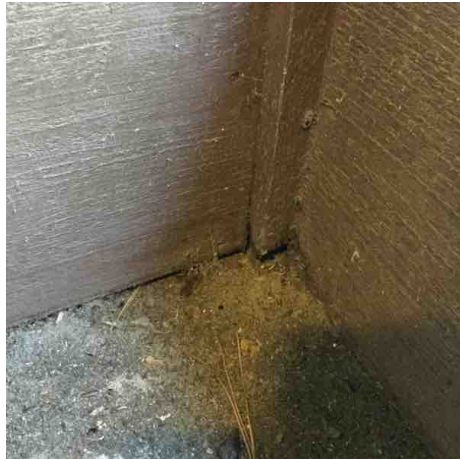
- Moisture damage to columns supporting rear porch overhang will need repair

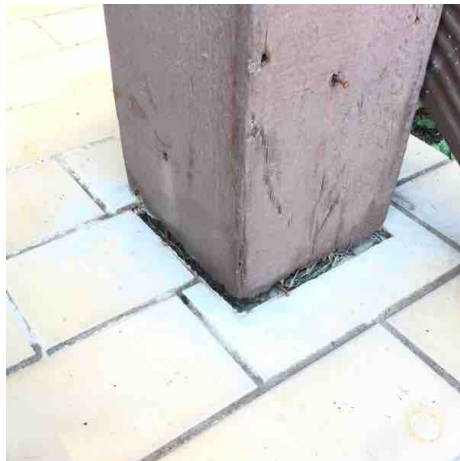
- Repair moisture damage to base of front porch column

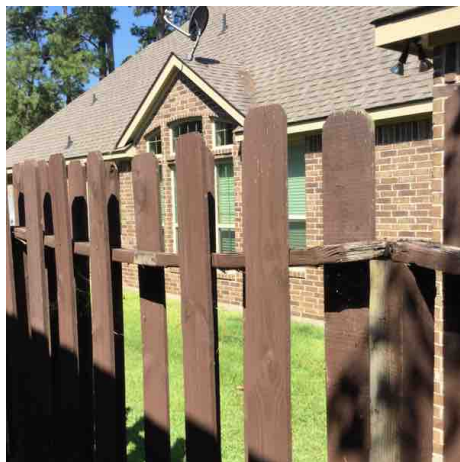
- Wooden fence will need repairs.

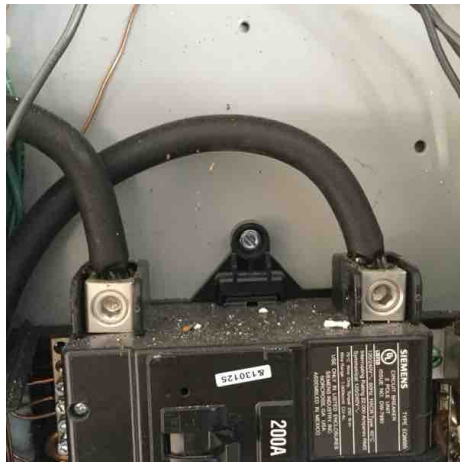
- Aluminum service entrance conductors were found to be present. Aluminum wiring itself is safe if proper connections and terminations are made without damaging the wire, and if using approved materials installed in accordance with accepted standards and the manufacturer's instructions. Temperatures taken with an infrared camera showed connections to be operating within safe temperature limits, however, it would be prudent to contract a qualified electrician to assure that all connections are adequate and safe.

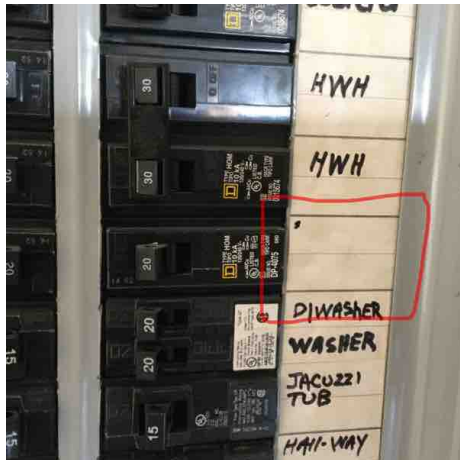
- 20 amp overcurrent device in position 22 in the service panel is not labeled.

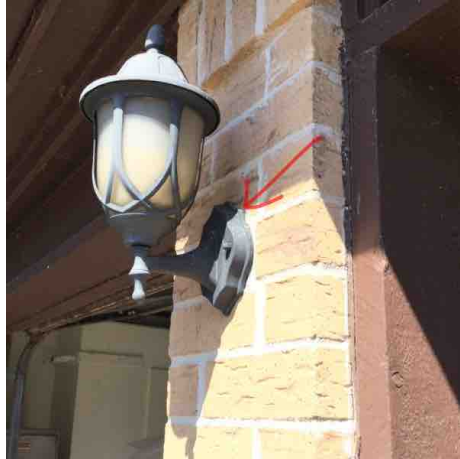
- Exterior light fixtures on vertical walls need sealing/caulking around top and side edges to prevent moisture from entering conductor penetration area.

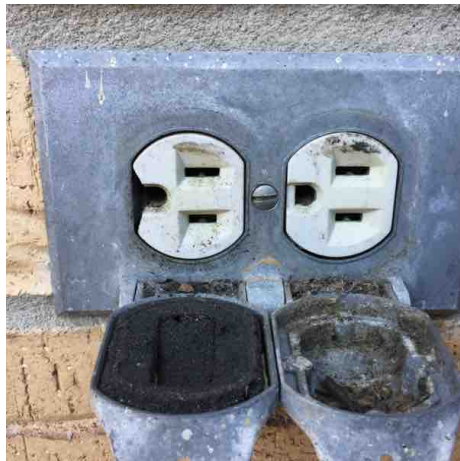
- Replace any damaged receptacles.

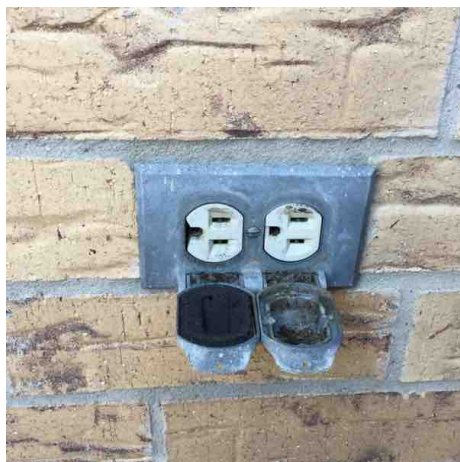
- Exterior weatherproof covers should be installed with the hinge up. Foam inserts also need replacement

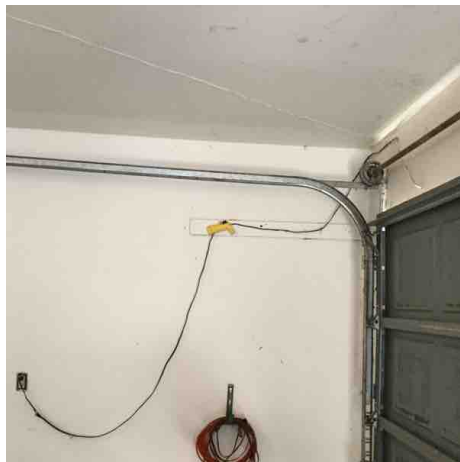
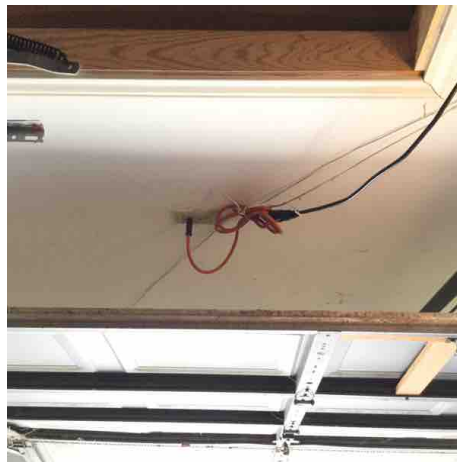
- Extension cords should not be used as permanent wiring.

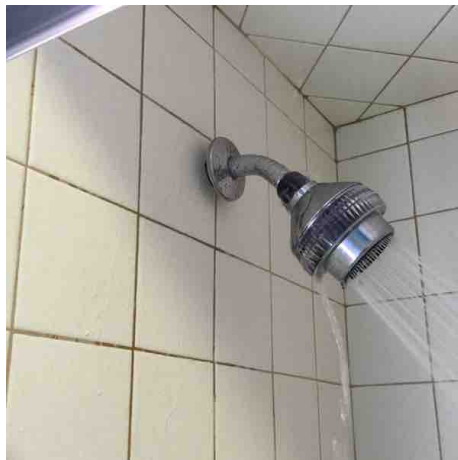
- Backflow preventers should be installed on each outdoor hose bibb.
- Half bath toilet base needs caulking to floor.
- Hot water supply faucet on hydrotherapy tub does not have a mechanical stop.
- Hall bath shower head leaks and needs repairs. Fixture also needs caulking to seal it to the wall.

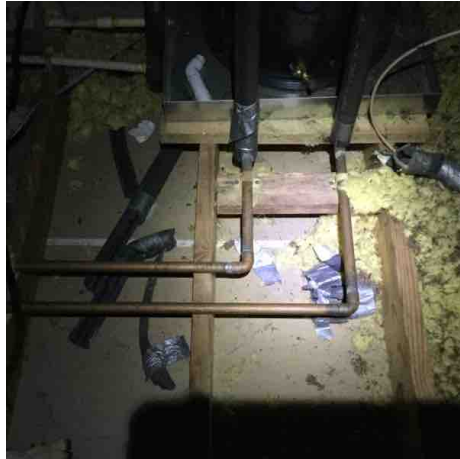
- Any exposed water piping in attic should be insulated or covered in insulation to protect it from potential freeze damage.

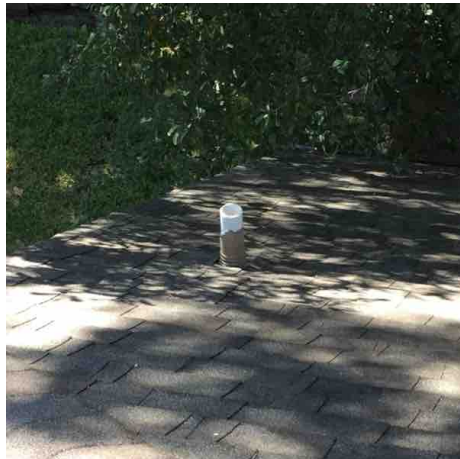
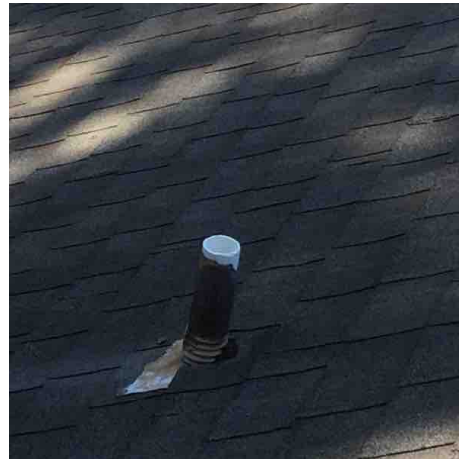
- Clothes washing machine drain and supply lines were not operationally checked.
- The tops of several leaded roof jacks have been damaged by squirrels. There is most likely water entering the house through these gaps at every rain event. Repair jack covers as soon as possible to avoid water related damage to interior walls. Consider replacement with non-leaded units.

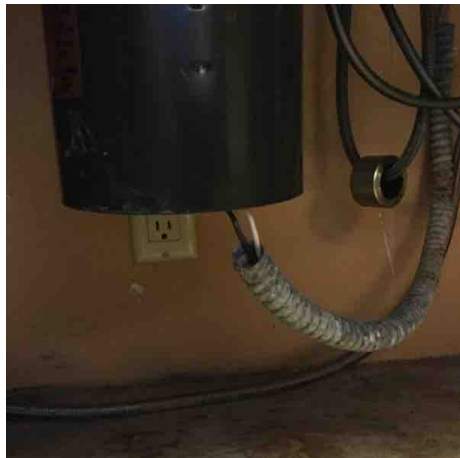
- Wire is unprotected where it enters the unit. Vibration from sharp edged bottom plate may eventually wear a hole in wire covering, or wiring could be pulled out of unit from stored materials. A clamp or grommet is recommended to protect and secure wiring at point of entrance.

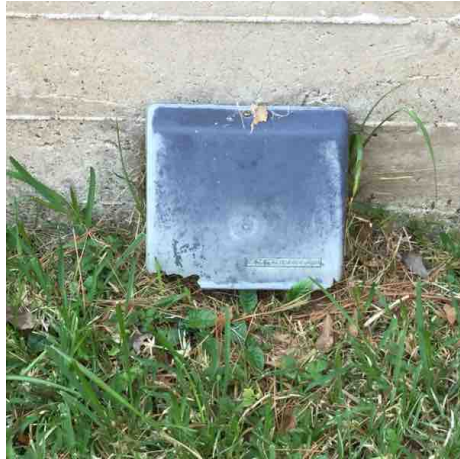
- Cover on Jenn-Air exhaust is damaged and needs replacement

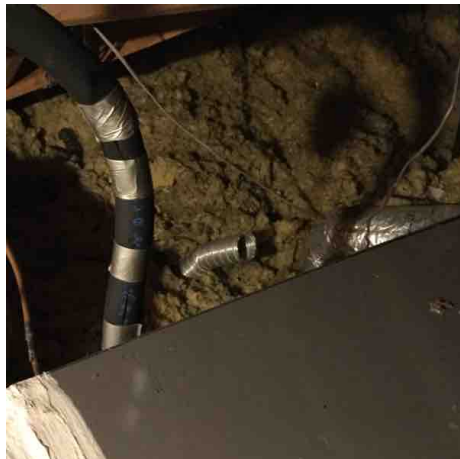
- Bathroom vents exhaust into the attic, creating an avenue for moisture infiltration into the attic area. Discharge should be routed directly to the outside through an approved vent.

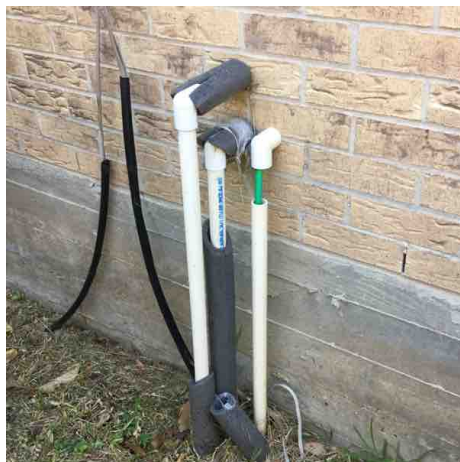
- Any exposed outdoor piping should be insulated to protect it from potential freeze.

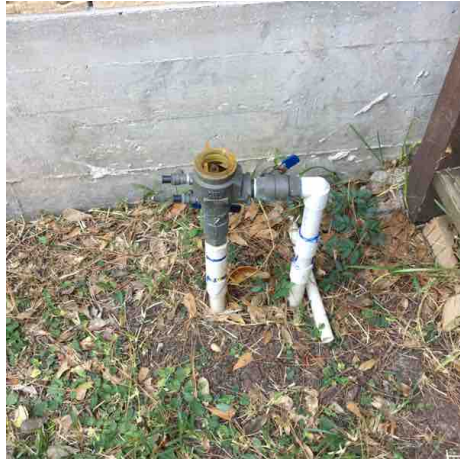
- Vacuum breaker needs repair.
