Foundation Repair of Texas

3911 Newcomen Dr. Houston

Inspection Notes:

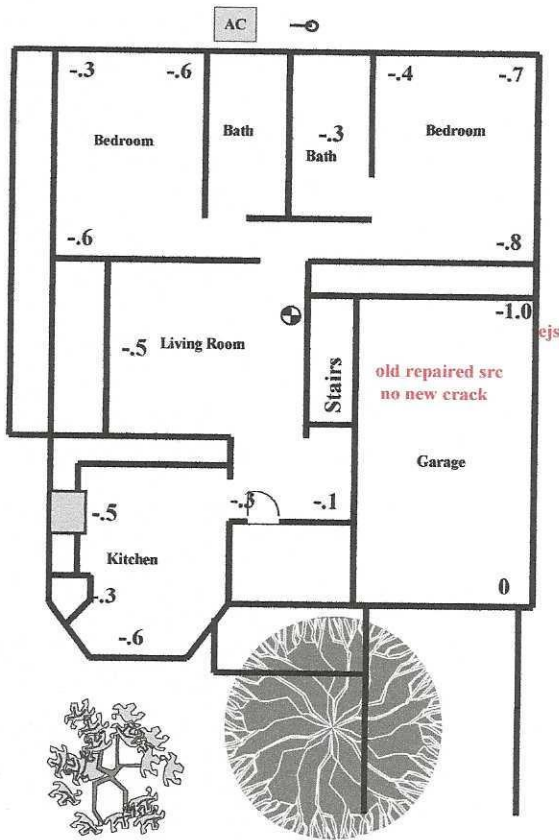
The home is within engineering tolerance limits, and appears to be stable with minimal stress. Recommend resealing expansion joint with new epoxy.
