## RESIDENTIAL INSPECTION REPORT

2132 Emerald Cove Drive  
League City TX 77573

Melody Hermes  
OCTOBER 31, 2019

# PROPERTY INSPECTION REPORT

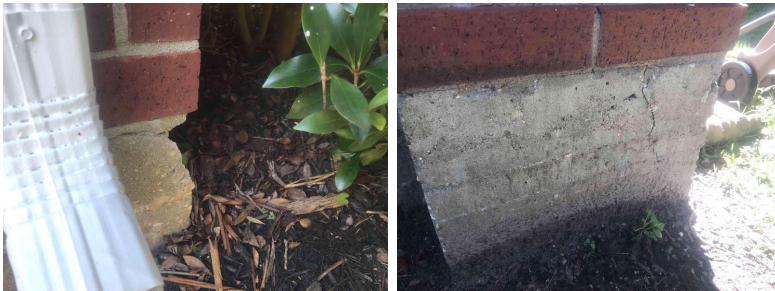
### 1: Slab: Shear Cracks

**Note:** Shear cracking ("corner pops") observed at foundation corners is not normally associated with structural movement or deficiencies.

Recommendation: Contact a handyman or DIY project

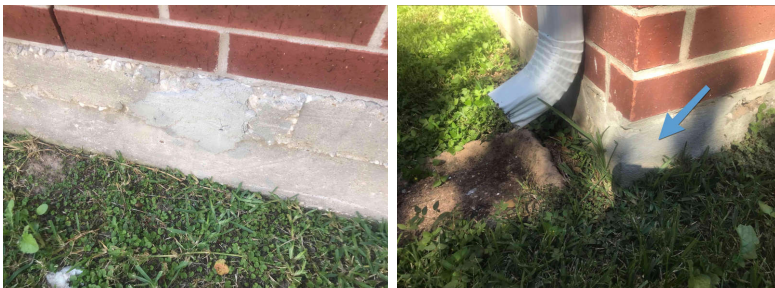
### 2: Slab- Note: Concrete Dressing

Concrete dressing was used to repair previous cosmetic flaws to the exposed foundation wall.

Recommendation: Recommend monitoring.

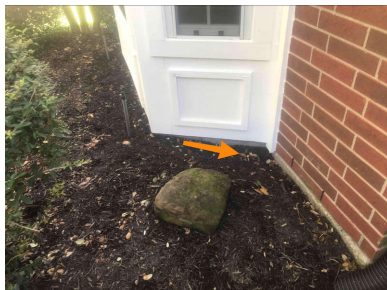
**1: Grading & Drainage: Negative Grading**

Grading was sloping towards the home in some areas. This can lead to water intrusion and foundation issues. Regrading by a qualified landscaping contractor or foundation contractor so that water flows away from the home is recommended.

Recommendation: Contact a qualified landscaping contractor

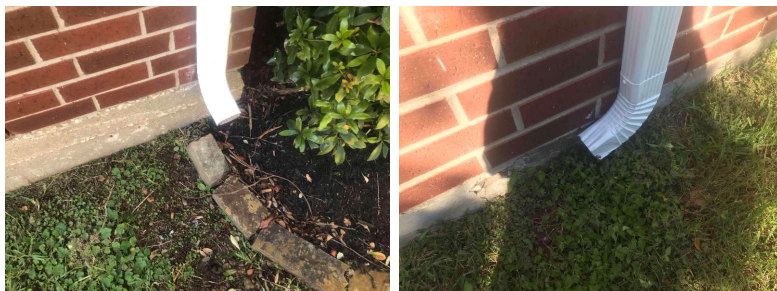
**2: Gutters & Downspouts: Missing Splash Blocks**

A splash block placed beneath the downspout elbow helps to disperse water away from the foundation and to prevent soil erosion. Remedy as needed.

Recommendation: Recommended DIY Project

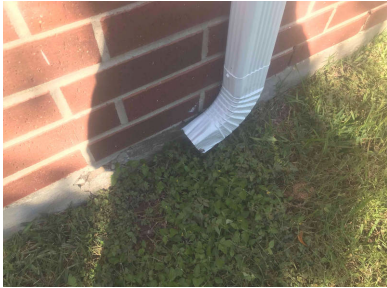
**3: Gutters & Downspouts: Improper discharge location**

The gutter system discharges to an improper location. Evaluate and remedy as needed.

Recommendation: Contact a qualified landscaping contractor

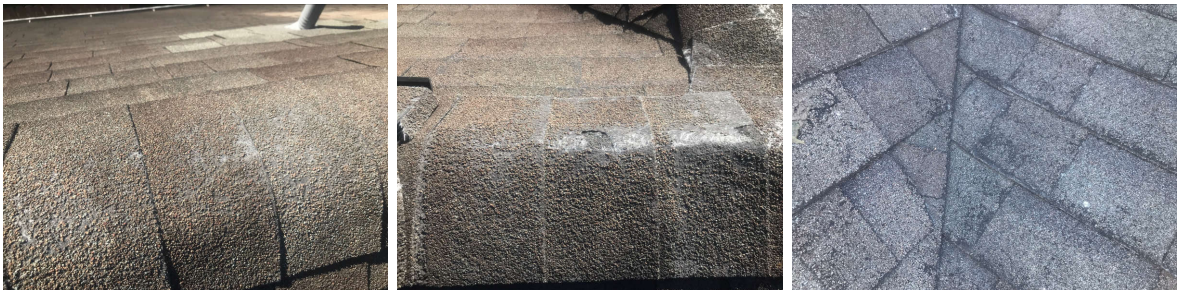
Excessive granule loss of the roofing shingles was observed exposing base layers of shingles. Granule loss indicates aging and wear of the roof covering. A full evaluation by a qualified roofing professional is recommended.

Recommendation: Contact a qualified roofing professional.

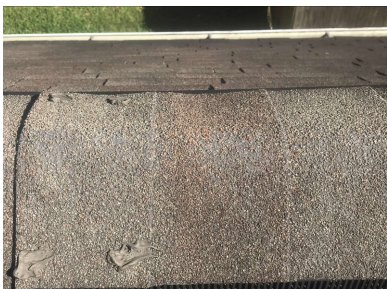
**2: Localized Granule Loss**

Localized granule loss on the shingle surface was observed. Among other things, this can be as a result of mechanical damage, impurities in the asphalt, or anomalies in the manufacturing process. Evaluation and repair by a qualified roofing professional is recommended.

Recommendation: Contact a qualified roofing professional.

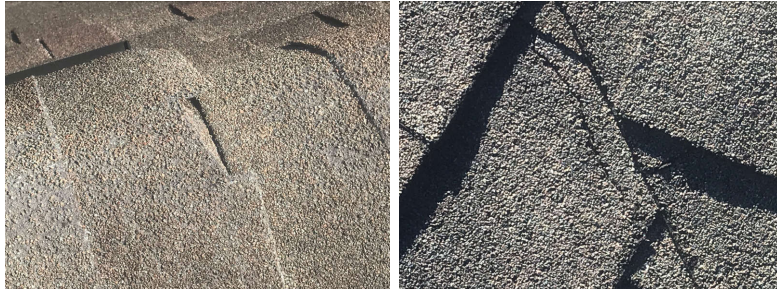
**3: Shingles Damaged/Torn/Missing**

Roof shingle material was missing, damaged, or torn in areas. Evaluation and/or repair by a qualified roofing professional is recommended.

Recommendation: Contact a qualified roofing professional.

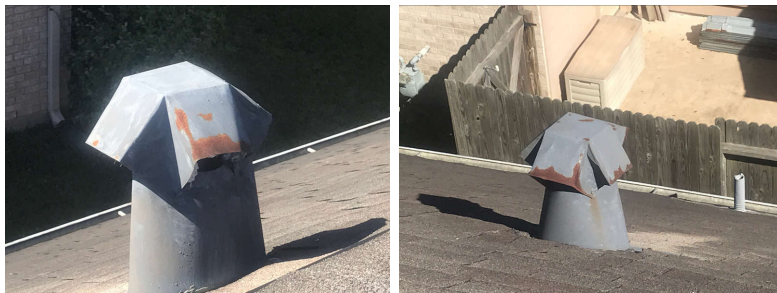
**4: Vents: Rusted Vent/Fan Cover**

The cover for an attic vent (or fan) is rusting. Remedy as needed.

Recommendation: Contact a qualified roofing professional.

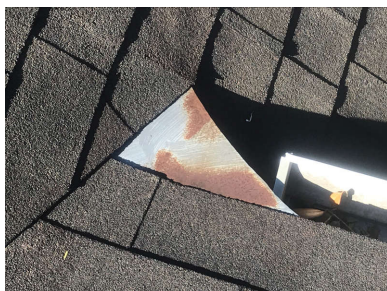
**5: Flashing: Rusted flashings**

Rusted flashings were present. Remedy as needed.

Recommendation: Contact a qualified roofing professional.

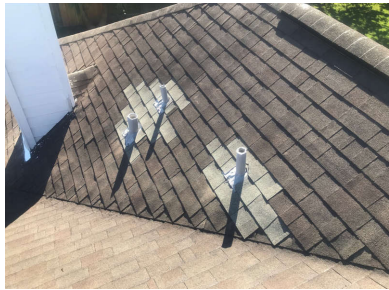
**6: Patched roofing materials**

Previous repairs or patched areas of the roofing were observed. Repair documentation from the seller/property owner is recommended in case warranty protections apply.

Recommendation: Contact a qualified roofing professional.

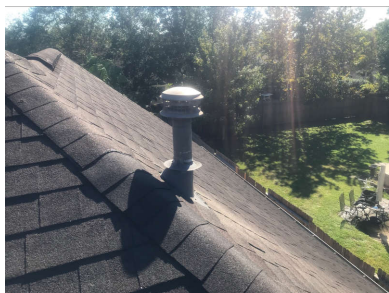
**7: Water Heater Flue Too Short**

Evaluate and remedy as needed.

Recommendation: Contact a qualified professional.

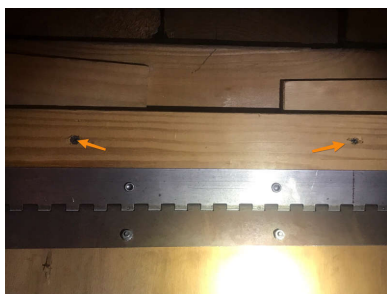
The attic access ladder frame was mounted with screws. Manufacturers generally recommend installation with 16D framing nails or lag bolts. Remedy as needed.

Recommendation: Contact a qualified professional.

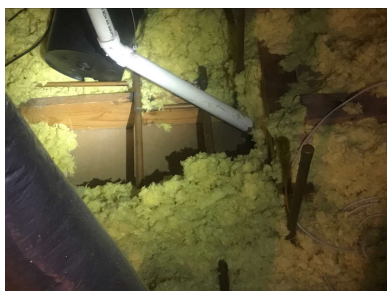
**2: Insulation: Insufficient**

Insulation depth was inadequate. Installation of additional insulation by a qualified insulation contractor is recommended.

Recommendation: Contact a qualified insulation contractor.

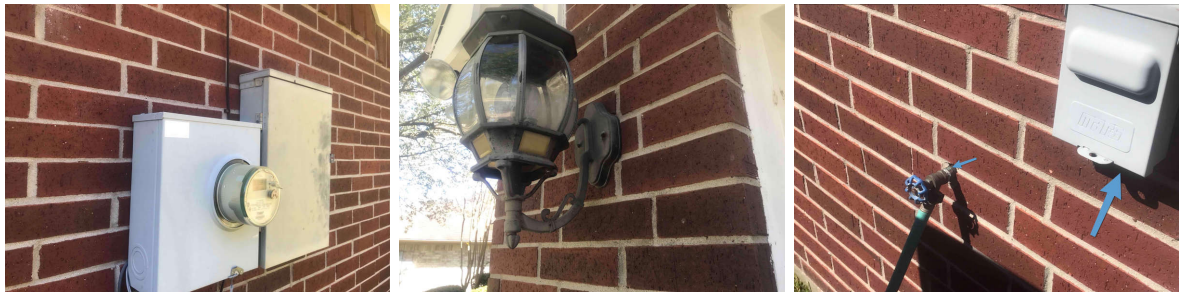
**Note:** Modern building practices recommend sealing around components that are mounted on or pass through the exterior wall to limit moisture intrusion.

Recommendation: Recommended DIY Project

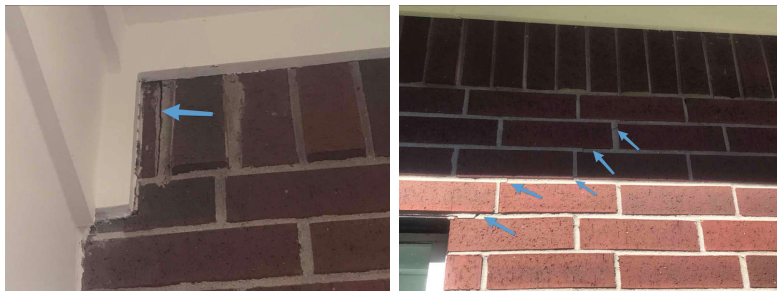
**2: Exterior Masonry: Minor Brick Cracks**

Cosmetic hairline cracks were observed in the masonry siding. Hairline cracks may be a result of thermal expansion of the veneer and/or normal structural movement. Monitoring is recommended.

Recommendation: Recommended DIY Project

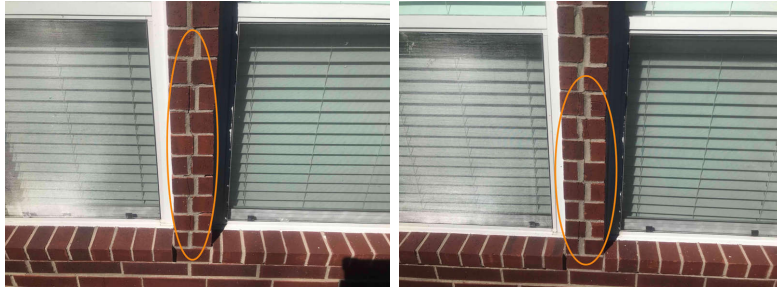
**3: Exterior Masonry: Cracks**

Cracks were observed in the brick/masonry siding. Common causes may include:

- building settlement,
- thermal expansion and contraction, or
- mechanical damage.

Cracked masonry or mortar may be cosmetic, but also may allow water into the wall which could damage the interior structure of the building. Cracks may grow with time at a constant (increasing or decreasing) rate and may open and close as seasons change. Remedy as needed.

Recommendation: Contact a qualified masonry professional.

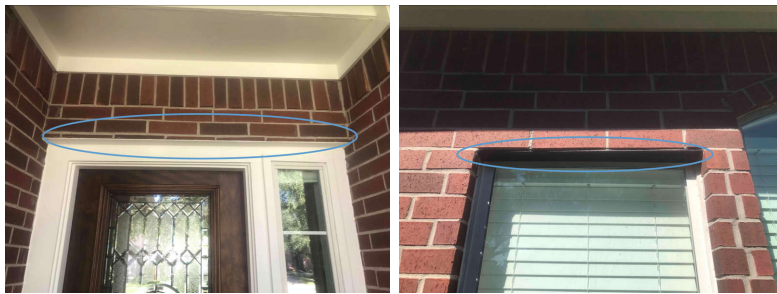
**4: Exterior Masonry: Weep holes not present over openings**

Weep holes were not installed in brick above steel lintels over windows and/or doors. Modern practices often utilize weep holes to prevent rusting of steel lintels supporting brick. If there is visible moisture damage to steel lintels or other building materials around these openings then this condition should be evaluated by a brick mason for possible correction. Otherwise the area should be monitored periodically.

Recommendation: Contact a qualified professional.

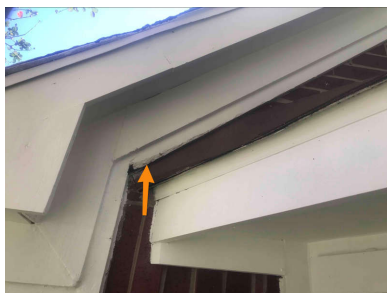
**5: Exterior-Fascia/soffits/eaves: Evidence of Wood Rot**

Wood rot/deterioration was observed. Evaluate and remedy as needed.

Recommendation: Contact a qualified professional.

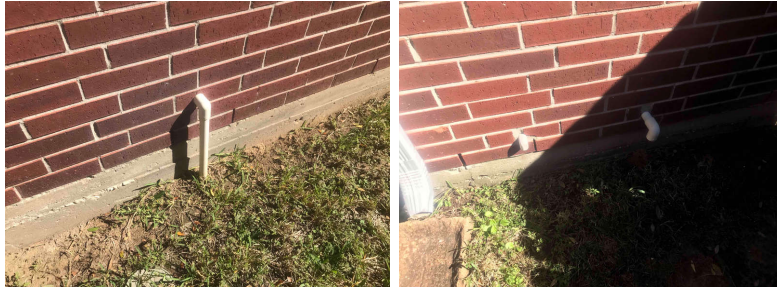
**6: Exterior: PVC Lines Unpainted**

All exterior PVC line should be painted to prevent UV damage and deterioration.

Recommendation: Contact a qualified professional.

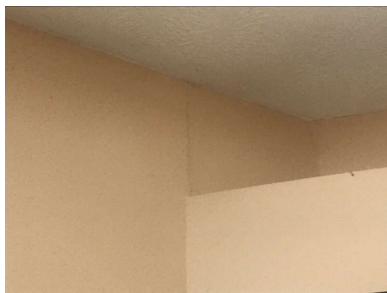
**7: Interior: Hairline Cracks on Drywall**

Hairline cracks were observed on the interior drywall. Hairline cracks may be related to the following:

Monitor and/or remedy as needed.

Recommendation: Recommend monitoring.

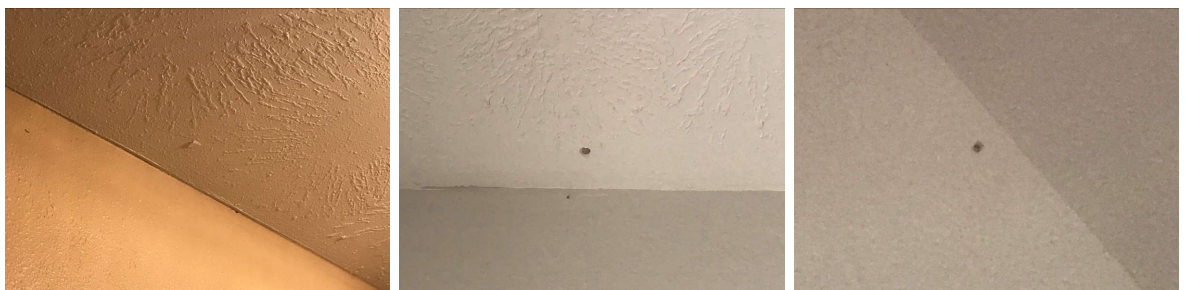
**1: Ceiling: "Popped" Nails**

"Popped" (loose) drywall nails are observed on the ceiling. This condition is typically considered cosmetic. Re-seat and seal as needed.

Recommendation: Contact a handyman or DIY project

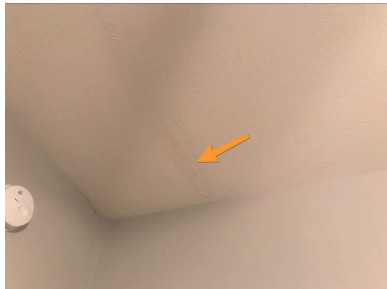
**2: Ceiling: Evidence of Previous Moisture Contact**

Wall structure showed signs of previous water intrusion. Tested negative for moisture at the time of the inspection. Evaluate and remedy as needed.

Recommendation: Contact a qualified professional.

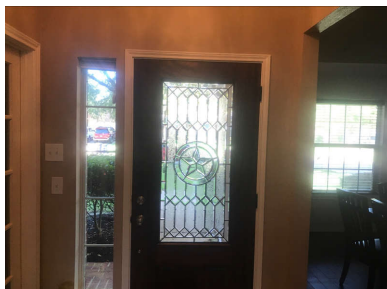
**1: Door: Sticks/Difficult to Operate**

Door sticks and is tough to open. Remedy as needed.

Recommendation: Contact a handyman or DIY project

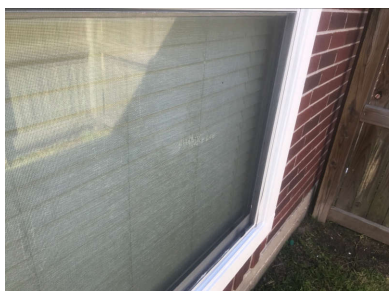
**1: Missing/Damaged Screen(s)**

One or more windows are missing a screen or had a damaged screen. Replacement of screens is recommended.

Recommendation: Contact a qualified window repair/installation contractor.

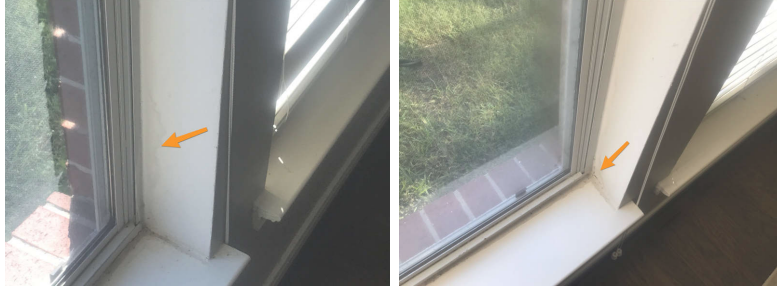
**2: Evidence of Previous Moisture Contact**

Wall structure showed signs of previous water intrusion. Tested negative for moisture at the time of the inspection. Evaluate and remedy as needed.

Recommendation: Contact a qualified professional.

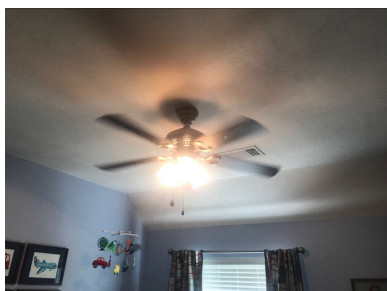
**1: Ceiling Fan Defects**

Further evaluation is recommended.

Recommendation: Contact a qualified professional.

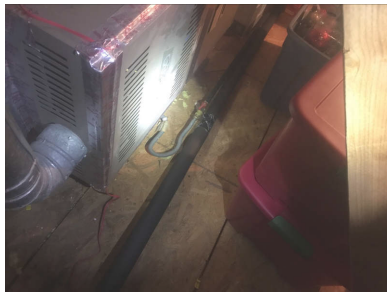
**1: Gas piping: Missing Sediment Trap (Drip Leg)**

Sediment traps are installed to help prevent sediment in the gas piping from getting into the gas valve or burner area of an appliance and causing problems. Remedy as needed.

Recommendation: Contact a qualified professional.

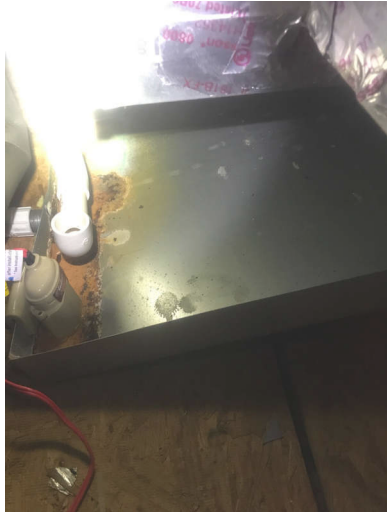
**1: Condensate system: Rusted Emergency pan**

The emergency overflow pan is rusted. Further evaluation by an HVAC professional is recommended.

Recommendation: Contact a qualified HVAC professional.

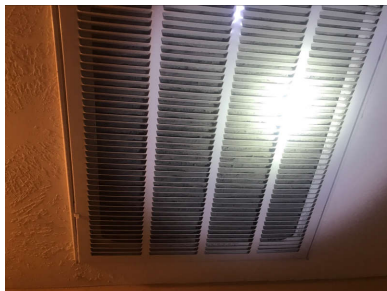
**1: Filter: Requires Replacement**

The furnace filter may have been beyond its expected lifespan. Replacement is recommended.

Recommendation: Recommended DIY Project

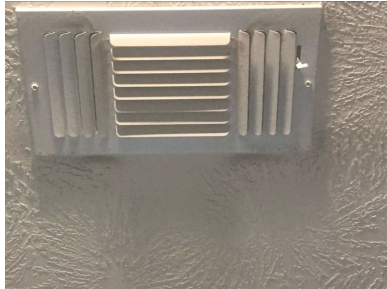
**3: Visible substance observed on Supply Register**

A dark substance was observed on an air supply register in the home. This is typically dust that has collected upon condensation which has developed on supply registers. Servicing and cleaning of the system by a qualified HVAC contractor is recommended, as this can be a result of excessive water vapor/humidity in the conditioned air.

Recommendation: Contact a qualified HVAC professional.

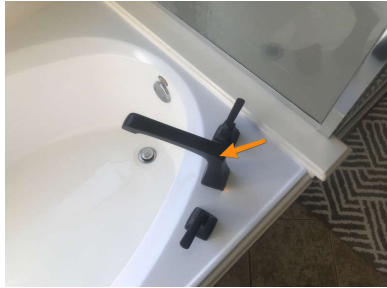
**2: Fixtures: Loose**

The faucet was loose. Remedy as needed.

Recommendation: Contact a qualified plumbing contractor.

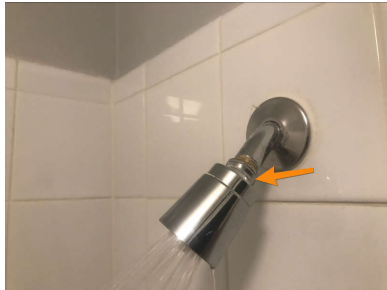
**3: Shower: Showerhead leaks/sprays**

Water leaked/sprayed around the showerhead during operation. Remedy as needed.

Recommendation: Contact a qualified plumbing contractor.

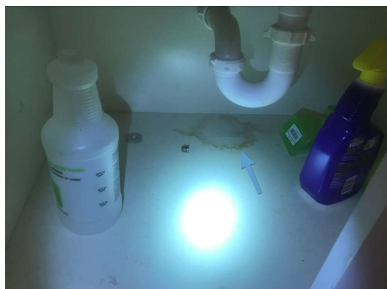
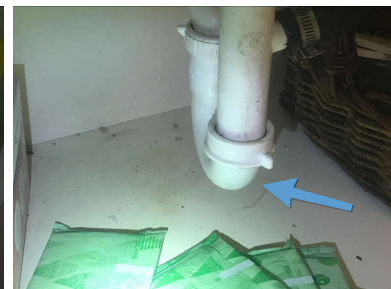
**1: Note: Evidence of Previous Leak**

**Note:** Evidence of a previous leak was noted under the sink. No leaking occurred at time of inspection and the area remained dry.

Recommendation: Recommend monitoring.

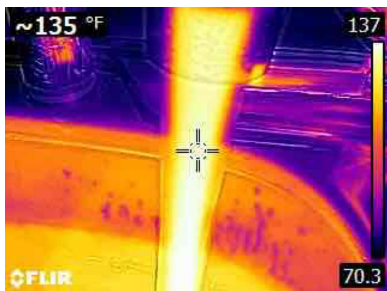
The hot water temperature was measured and exceeds 125-Degrees F, which can cause burns from scalding. Refer to the Operating Instructions in the manual for this specific unit for detailed instructions on setting the proper water temperature for your needs. Contact a licensed plumber for further information.

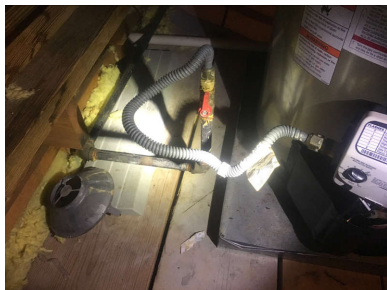
**2: Gas Water Heater: Missing Sediment Trap (Drip Leg)**

Sediment traps are installed to help prevent sediment in the gas piping from getting into the gas valve or burner area of an appliance and causing problems. Remedy as needed.

Recommendation: Contact a qualified professional.

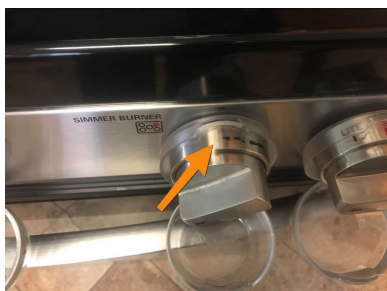
**1: Cooktop Control Knob Graphics**

The control knob graphics had worn off or were missing.

Recommendation: Contact a qualified professional.

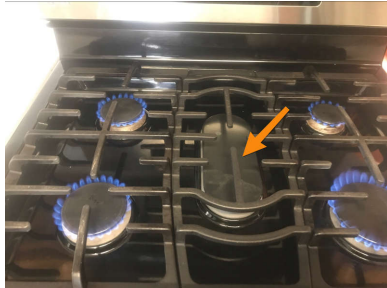
**2: Burner/Element Not Functioning**

One or more burners/heating elements did not heat up when turned on. Evaluation and remediation by a qualified professional is recommended.

Recommendation: Contact a qualified handyman.

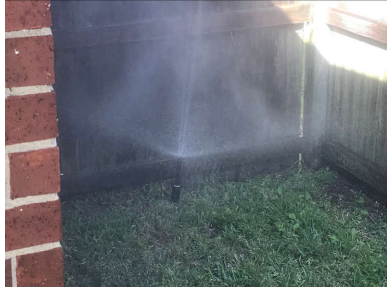
**2: Broken Sprinkler Heads**

One or more sprinkler heads were broken. Replacement is recommended.

Recommendation: Contact a qualified professional.
