RESIDENTIAL INSPECTION REPORT

2132 Emerald Cove Dr
League City TX 77573

Jacob Perren
DECEMBER 4, 2019

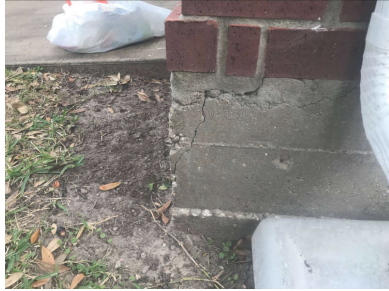
1: Slab: Shear Cracks

Note: Shear cracking ("corner pops") observed at foundation corners is not normally associated with structural movement or deficiencies.

Recommendation: Contact a handyman or DIY project

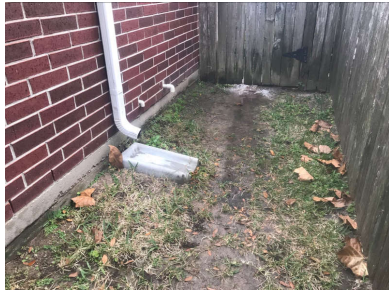
1: Grading & Drainage: Standing Water

Right side

Standing water was observed which could indicate poor drainage and/or grading. Monitoring and/or having landscaping contractor remedy drainage/grading is recommended. Grading & Drainage:

Recommendation: Contact a qualified landscaping contractor

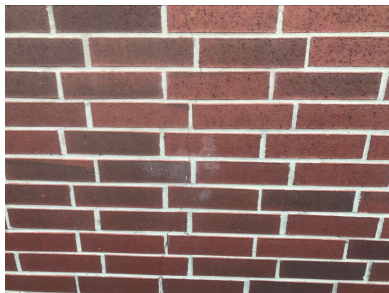
1: Exterior Masonry: Minor Brick Cracks

Cosmetic hairline cracks were observed in the masonry siding. Hairline cracks may be a result of thermal expansion of the veneer and/or normal structural movement. Monitoring is recommended.

Recommendation: Recommended DIY Project

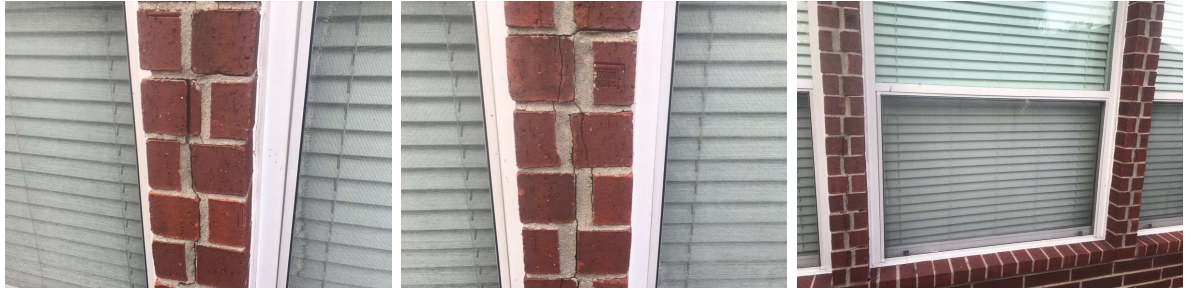
2: Exterior Masonry: Cracks

Rear at master bedroom

Cracks were observed in the brick/masonry siding. Common causes may include:

thermal expansion and contraction, or mechanical damage.

Cracked masonry or mortar may be cosmetic, but also may allow water into the wall which could damage the interior structure of the building. Cracks may open and close as seasons change.

Recommend evaluate the 2 narrow columns of brick at the master bedroom windows and remedy or repair as needed.

Recommendation: Contact a qualified masonry professional.

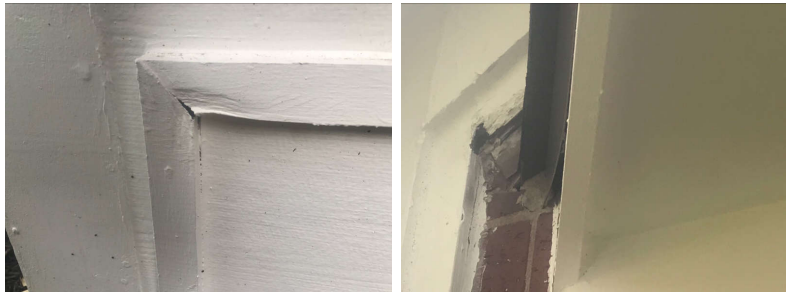
3: Exterior: Trim missing, loose, or damaged

Light rot front left bay window and above it at left
Sections of exterior trim were either missing, loose, or damaged. Remedy as needed.

Recommendation: Contact a qualified professional.

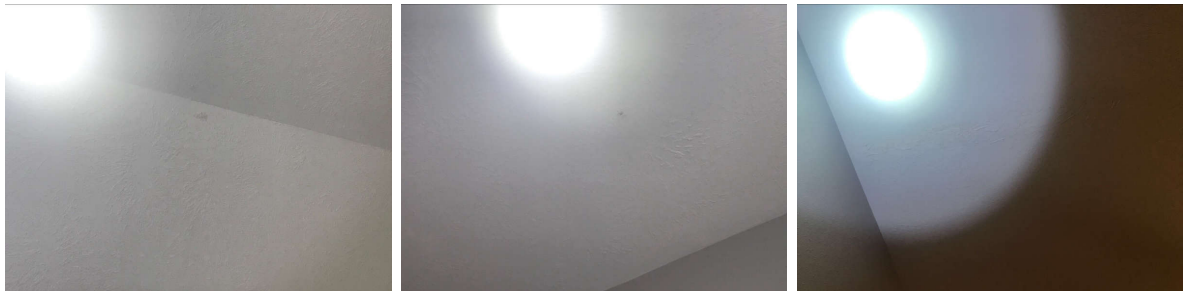
1: Note: Patched Ceilings

Various

Patched ceiling areas were observed at the time of inspection. Obtaining all previous work documentation is recommended.

Recommendation: Contact a qualified professional.

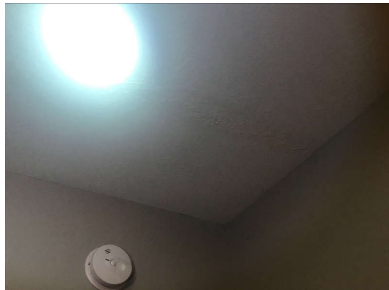
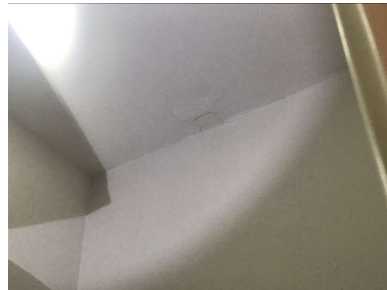
3: Ceiling: Evidence of Previous Moisture Contact

Front right bedroom and closet

Ceiling structure showed signs of previous water intrusion. Tested negative for moisture at the time of the inspection. Evaluate and remedy as needed.

Recommendation: Contact a qualified professional.

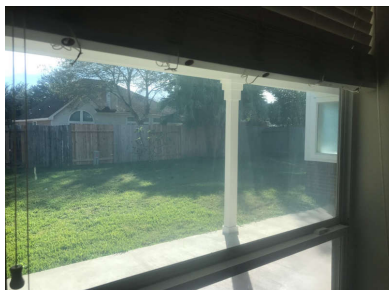
1: Evidence of a Failed Seal

Breakfast Area

Observed condensation between the window panes, which indicates a potentially failed seal. Evaluation and remediation by a window professional as necessary.

Recommendation: Contact a qualified window repair/installation contractor.

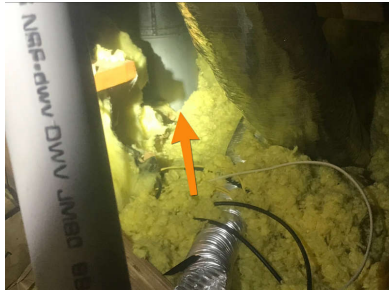
2: Flue: Insulation against flue

The metal chimney flue should have a minimum two inch clearance from combustible material. Remedy as needed.

Recommendation: Contact a qualified professional.

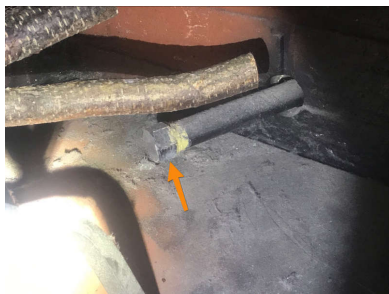
3: Gas line is plugged

Inoperative.

Recommendation: Contact a qualified professional.

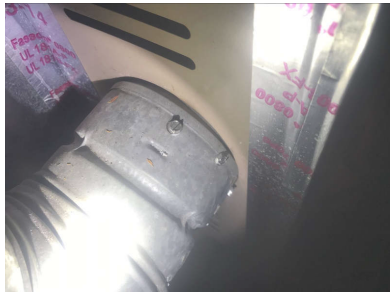
1: Venting: Sheet metal screws in pipe

Sheet metal screws were installed through the furnace vent pipe. Remedy as needed.

Recommendation: Contact a qualified professional.

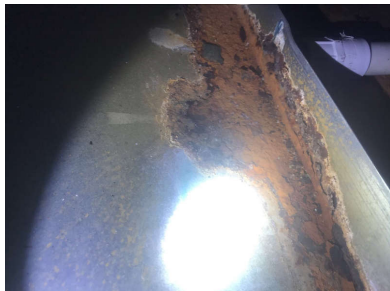
1: Condensate system: Rusted Emergency pan

HVAC Equipment

The emergency overflow pan is rusted. Further evaluation by an HVAC professional is recommended.

Recommendation: Contact a qualified HVAC professional.

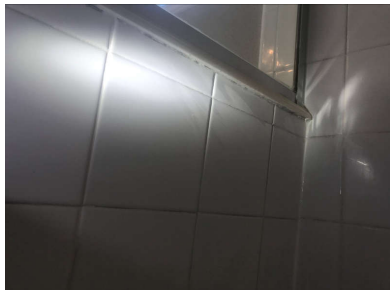
3: Shower: Missing/Deteriorated Caulking or Grout

Master Bathroom

Recommendation: Contact a qualified professional.

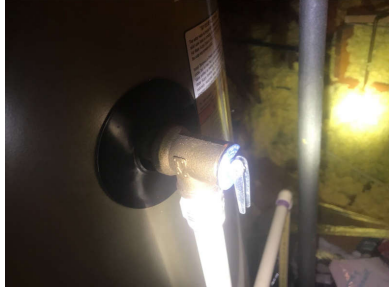
1: TPR Valve Note: Replacement may be needed

The manufacturer recommends replacement of the pressure relief valve every three years to ensure proper emergency function. The inspector does not test TPR valves due to safety hazard or possible damage to unit.

Recommendation: Contact a qualified professional.

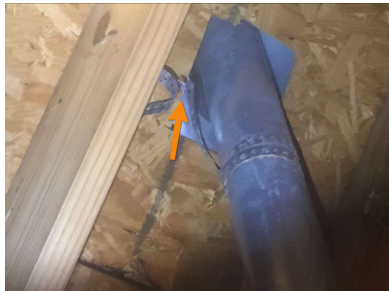
2: Venting system: Missing vent pipe strap

The water heater combustion vent pipe was not properly supported/secured with strapping. (Strap broke) Remedy as needed.

Recommendation: Contact a qualified professional.

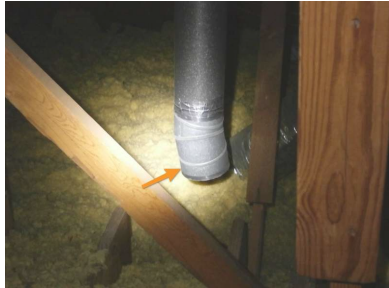
1: Vent pipe open to attic

The exhaust fan in the kitchen recirculates. However, there is a vent pipe and vent cap as viewed in the attic. The vent pipe is open on one end. Evaluate and remove or remedy as needed.

Vent pipe attached at vent cap but detached at base

Recommendation: Contact a qualified professional.

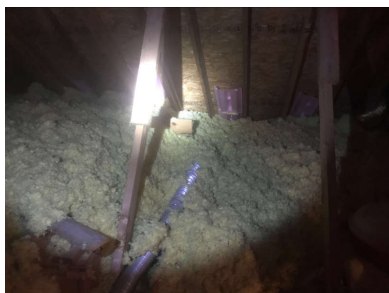
1: Vents Into Soffit

The exhaust fan(s) vented to the eave soffits in the attic. Newer building standards recommend exhaust fans discharge through the roof.

Recommendation: Contact a qualified professional.

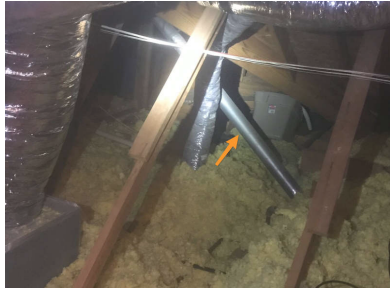
1: Cleaning Vent Recommended

Cleaning of the dryer exhaust vent is recommended as normal maintenance and to prevent excessive lint build-up in the line. Travels up through the attic and out the roof.

Recommendation: Contact a qualified professional.

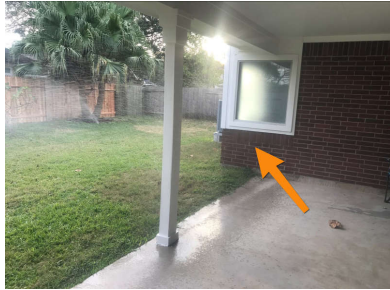
1: Adjust heads aimed at structure

Zone 5 at master shower wall

Sprinkler heads were spraying the structure. Sprinkler heads should be adjusted to spray away from the structure(s). Remedy as needed.

Recommendation: Contact a qualified professional.

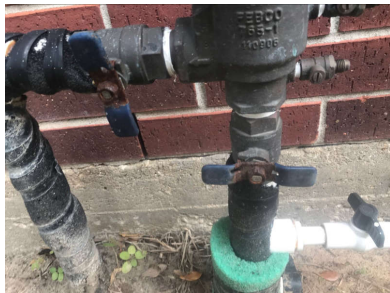
2: Rusted valve handles

One or more valve handles were rusted. Remedy as needed.

Recommendation: Contact a qualified professional.
