PROPERTY INSPECTION REPORT

Concerning: **10217 Teneha Street, Houston, Texas 77033**

By: **Scott Gillis # 22819**

April 25, 2019

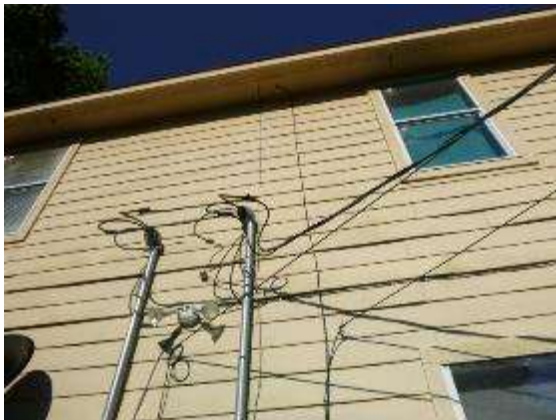
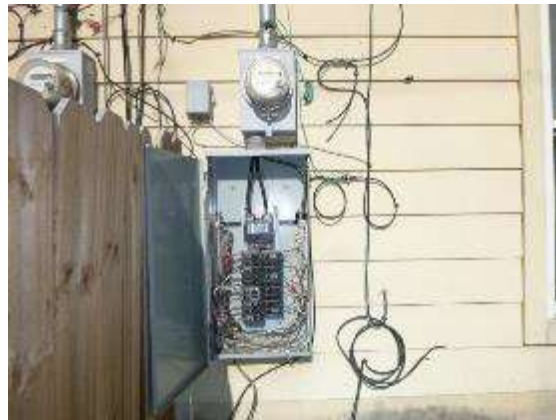
Unit A Electrical Service

The electrical service to Unit A is provided by a 120/240 volt, single-phase, 125-ampere overhead service to a meter and breaker panel located at the rear of the house. The breaker panel was manufactured by Cutler Hammer, and was rated at 200-amperes. The size of the service entrance conductors into the breaker panel was not visible, but appeared to be #2/0 aluminum, and the branch circuit wiring from the panel was copper. The wiring in the house was a 3-wire grounded system.
(Information)

The electrical service to Unit B is provided by a 120/240 volt, single-phase, 125-ampere overhead service to a meter and breaker panel located at the rear of the house. The breaker panel was manufactured by Cutler Hammer, and was rated at 200-amperes. The size of the service entrance conductors into the breaker panel was not visible, but appeared to be #2/0 aluminum, and the branch circuit wiring from the panel was copper. The wiring in the house was a 3-wire grounded system.
(Information)

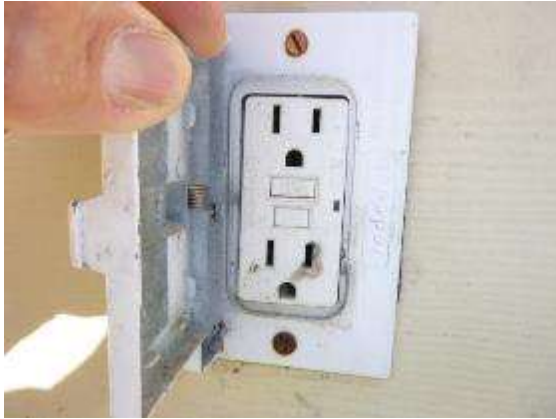
An outlet(s) was observed that was discolored on the cover plate, apparently due to a short circuit of some item that was plugged in at one time. It is recommended that further investigation be done to determine if the outlet has been damaged, and any repairs made.

Locations included: Unit A, at the back porch.

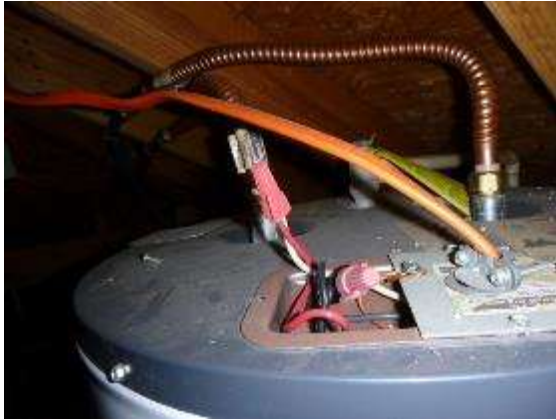
An open junction box(es) was observed.

Locations included: Unit B water heater 240-volt connection at the top of the unit.

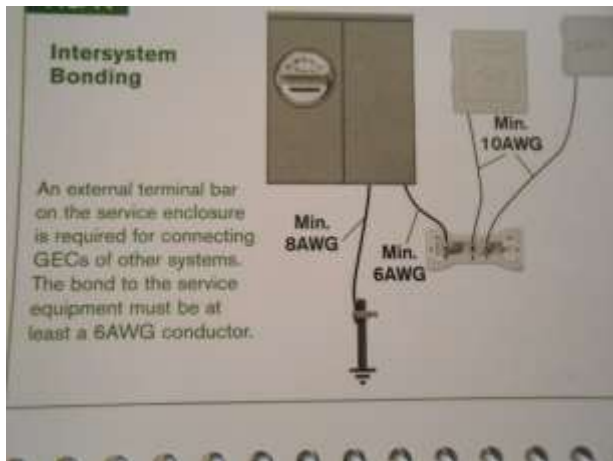
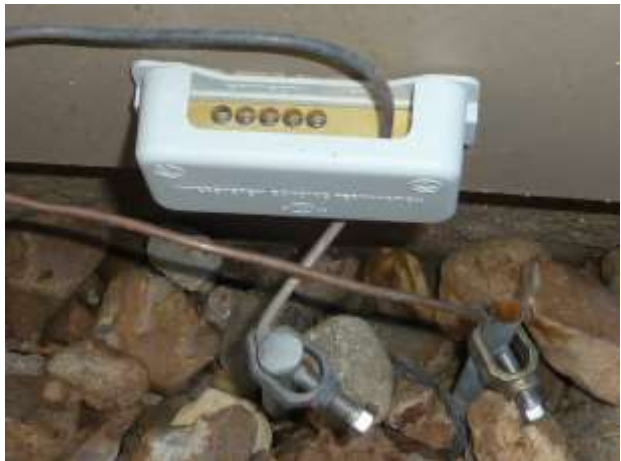
HEI file photo of low voltage block

The grounding conductor to the ground rod was not equipped with the grounding block for the low voltage service.

Obtain Cost Estimate

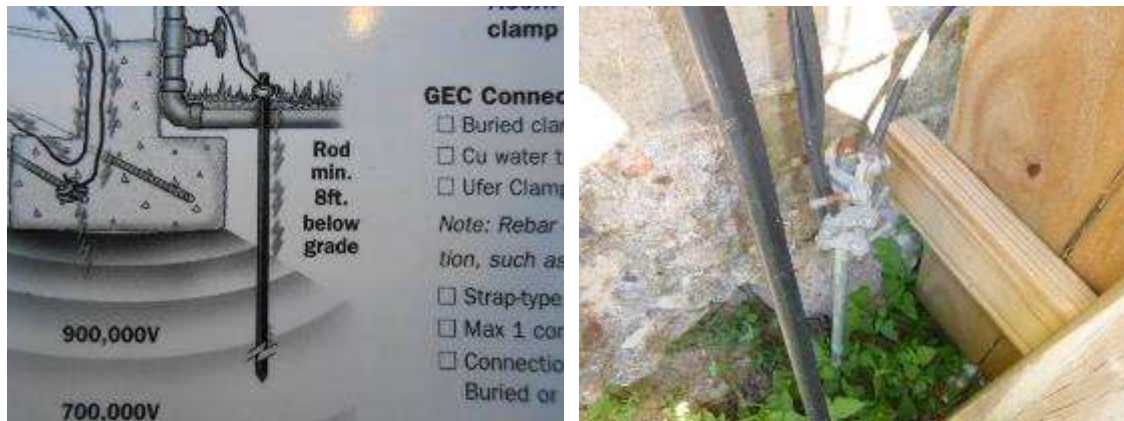
The ground rod was sticking out of the ground a few inches, and, since ground rods are typically 8 feet long and all 8 feet of the rod are required to be in the ground, it is recommended that the ground rod be pounded down flush with the top of the ground. The clamp on the rod should be an acorn clamp is approved for direct burial in the ground.

Obtain Cost Estimate

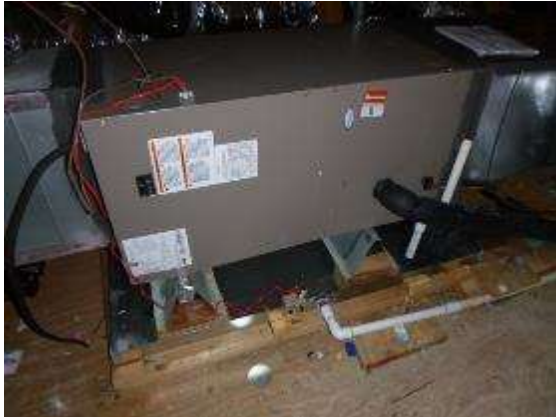
Unit A electric furnace

No items requiring repair were observed at the time of the inspection for the heating performance of the Unit A electric furnace. The electric furnace was heating the air 25 degrees, which is adequate.

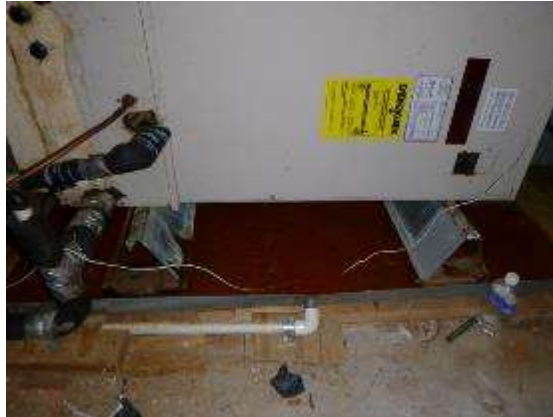
The Unit B electric furnace had a less than normal temperature differential across the heating coils (only 15 degrees). Have a service company find the source of the problem, and make any necessary repairs.

Due to the age and/or condition of the Unit B electric furnace, it is the opinion of the inspector that the unit has only a limited amount of remaining life.

Further investigation is recommended.

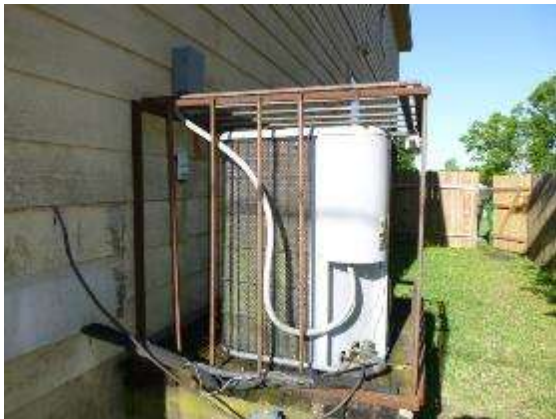
Unit A Condenser

No items requiring repair were observed at the time of the inspection for the operation of the condensing unit(s).
 (Information)

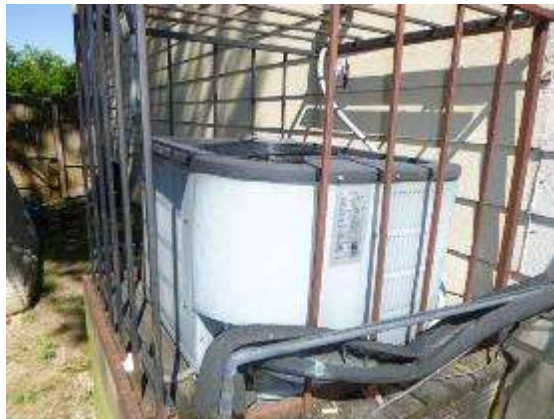
Unit B condenser

The Unit B condensing unit was functional at the time of the inspection. However, due to the age and/or condition of the equipment, it is our opinion that it has only a limited amount of life remaining, and it would be a prudent thing to have the unit thoroughly checked by a licensed air conditioning service company. It is pointed out for your information that recent changes in the law require for all manufacturers of air conditioning systems to produce equipment with a minimum SEER rating of 14.

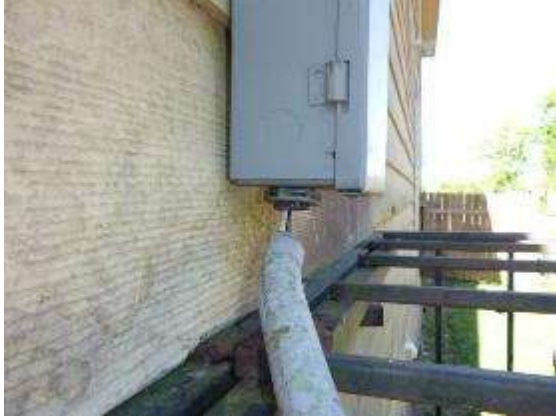
The conduit on the Unit A power wire is not watertight, and needs repair.

Obtain Cost Estimate

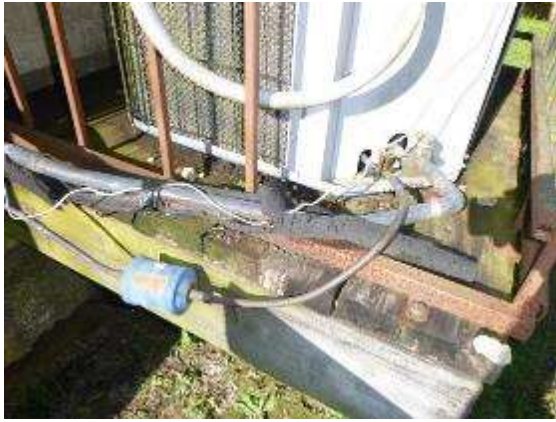
The insulation for the Unit A low-pressure refrigerant line was partially missing.

Obtain Cost Estimate

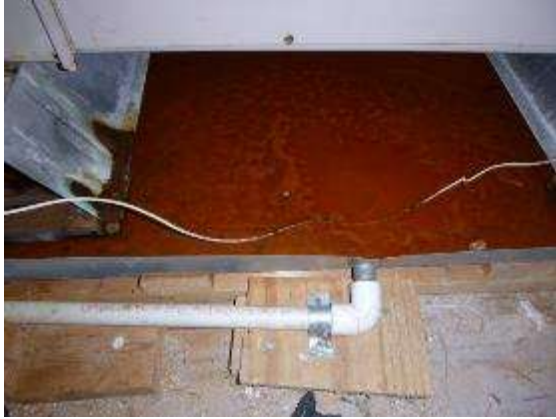
Standing water was observed in the Unit B auxiliary drain pan under the evaporator coil. This can indicate a clogged primary drain line, or some other problem with the evaporator coil. Have a service company find the source of the water in the pan, and make any necessary repairs.

Obtain Cost Estimate

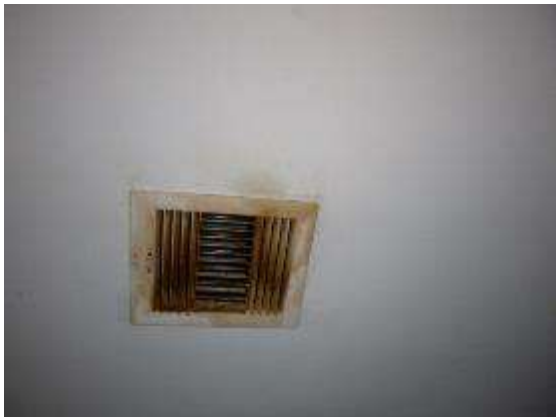
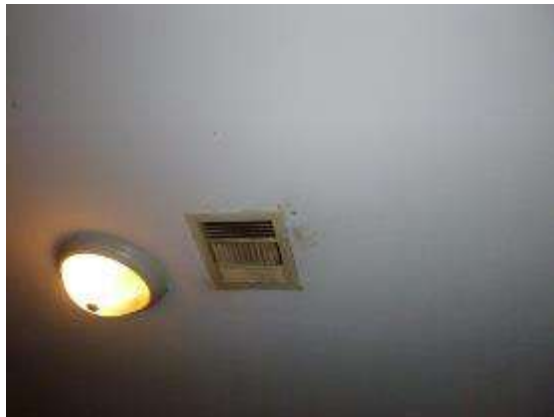
The registers at both units A and B and adjacent ceiling areas in the rooms were covered with debris that has passed through the air conditioning ductwork. Have a service company check the inside of the ductwork to determine if there is a build-up of debris, and to clean the ducts if necessary.

Obtain Cost Estimate

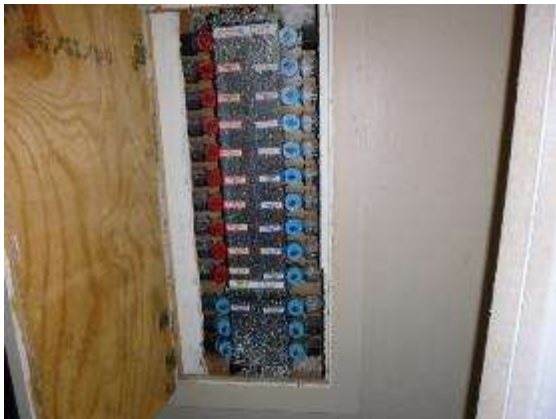
The manifolds for the PEX piping systems, with the individual shut off valves for the hot and cold water, were located at the utility rooms.

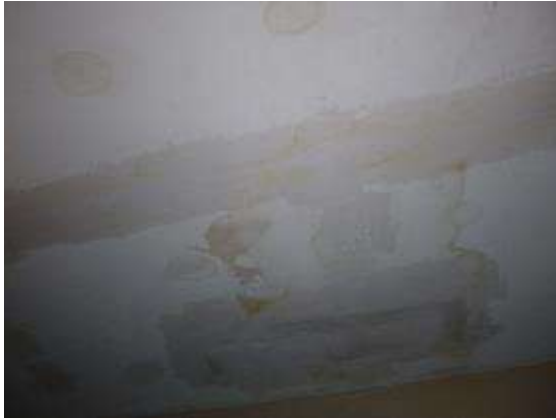
Unit A kitchen ceiling

Water stains were observed on the ceiling at Unit A and Unit B. This is located under the upstairs bathrooms, indicating a current or previous plumbing leak at the bathrooms. Have a plumber find the source of the leak, and make any necessary repairs.

Locations included: Unit A and Unit B kitchens.

Obtain Cost Estimate

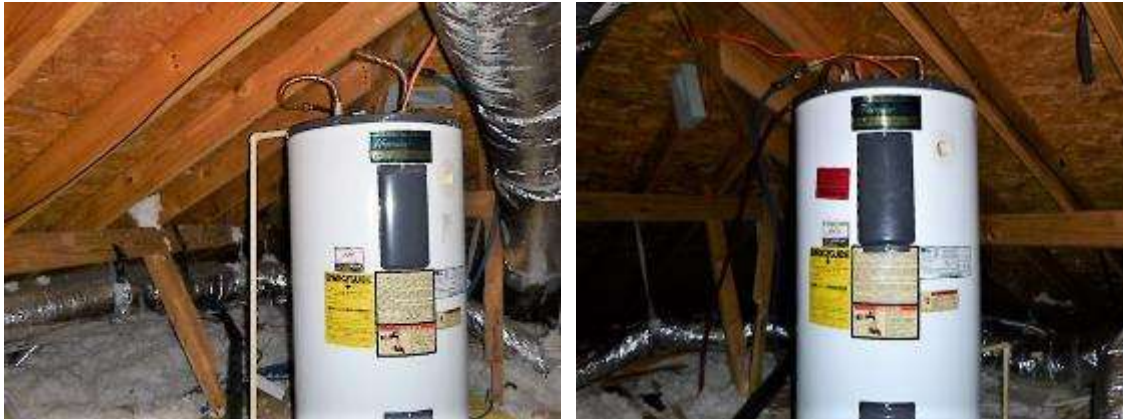
ELECTRIC WATER HEATER

The hot water for each Unit was provided by a 40-gallon electric water heater manufactured by American in 2007 and located in the attics. The water piping from the water heaters was observed to be PEX.

The water heaters were functional at the time of the inspection. However, due to the age and/or condition of the equipment, it is the opinion of the inspector that they have only a limited amount of life remaining. Normal life expectancy of a water heater in the Houston area is approximately 7 to 10 years.

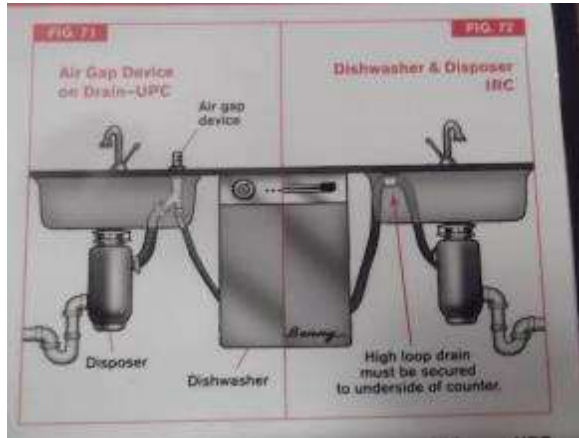
The drain lines under the sinks were not equipped with an anti-siphon device, nor were they looped up so that the top of the loop is at least six inches above the entrance of the drain line into the disposal. It is recommended at least that the drain line be looped to prevent the water from the garbage disposal from siphoning back into the dishwashers, or an anti-siphon device installed.

Obtain Cost Estimate
