HEDDERMAN ENGINEERING, INC.

REF: CONDITION OF PROPERTY SURVEY

At your request, a visual survey of the house located at 10217 Teneha Drive, Houston, Texas, was made by Mr. Ruben Martinez and Mr. Scott Gillis.

10217 Tenaha Drive

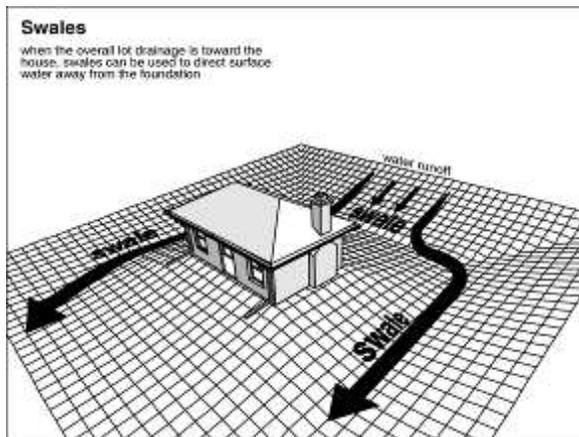
The perimeter drainage around the property appeared to generally be adequate. It was not raining at the time of the inspection and, therefore, it could not be determined with certainty if water would pool at any localized low areas around the property. Further investigation with the homeowner is recommended to determine if there are any drainage problems or standing water after a rain.

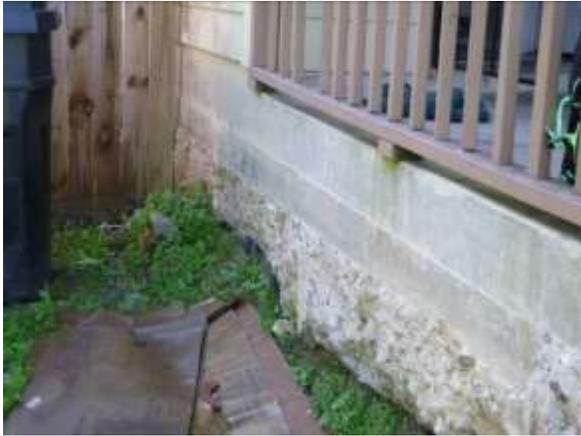
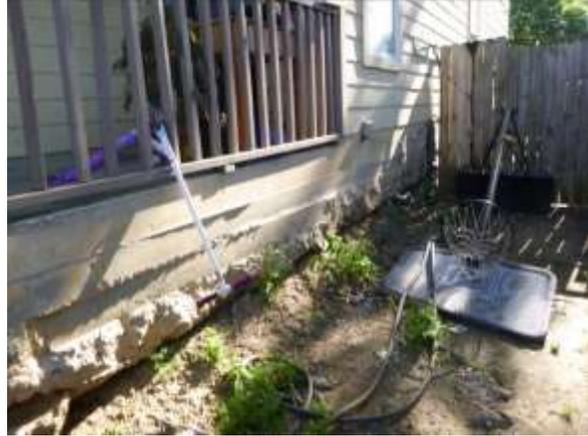
The foundation concrete around the house was observed to be honeycombed due to poor original construction workmanship. The honeycombed area should be grouted to present a smooth surface finish.

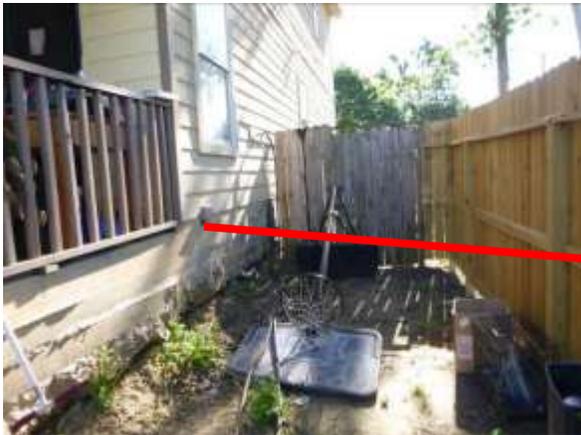
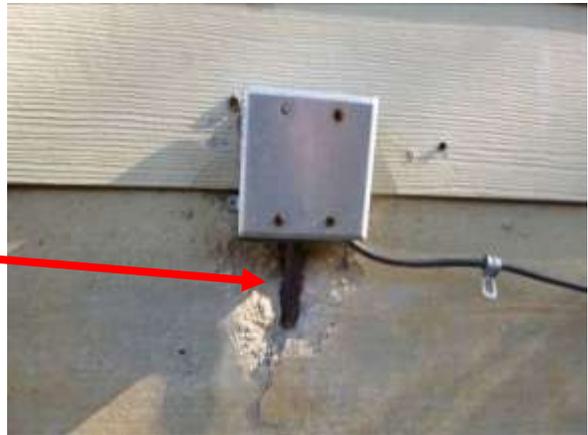
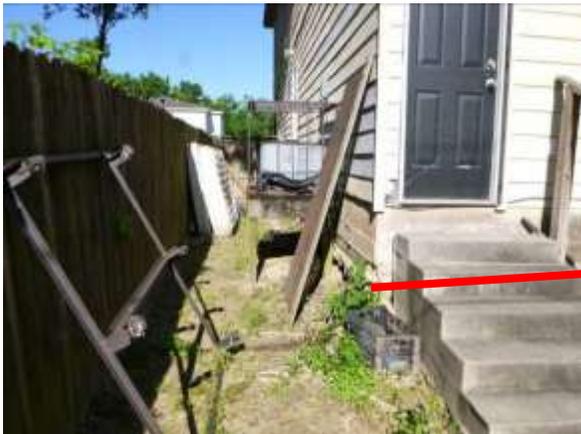
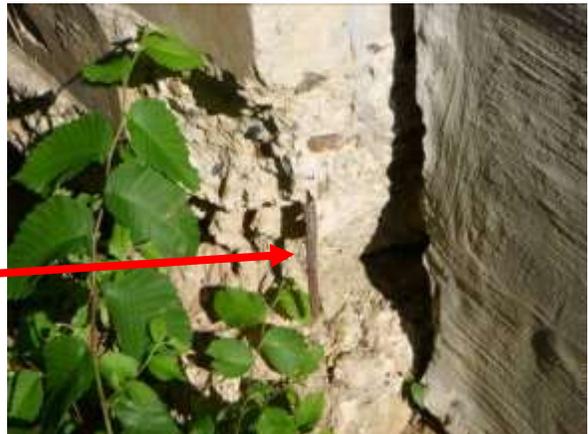
The face of the foundation concrete was spalled, and the reinforcing steel used in the construction of the foundation was observed to be exposed. The rust should be removed from the rebar, and the rebar grouted to prevent further deterioration.

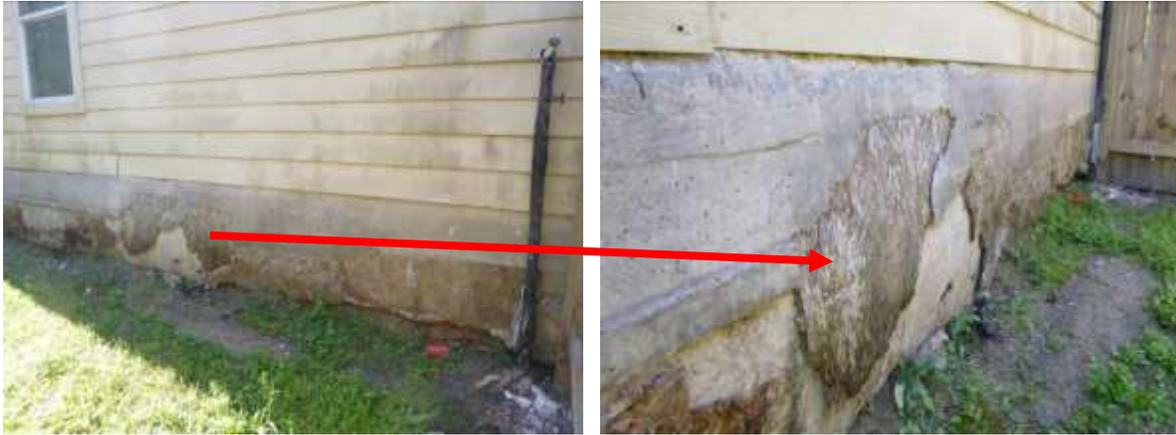
Locations included: north side

We observed wood form boards at the face of the foundation and it is recommended that the form boards be removed to eliminate a conducive condition for infestation by wood destroying insects.

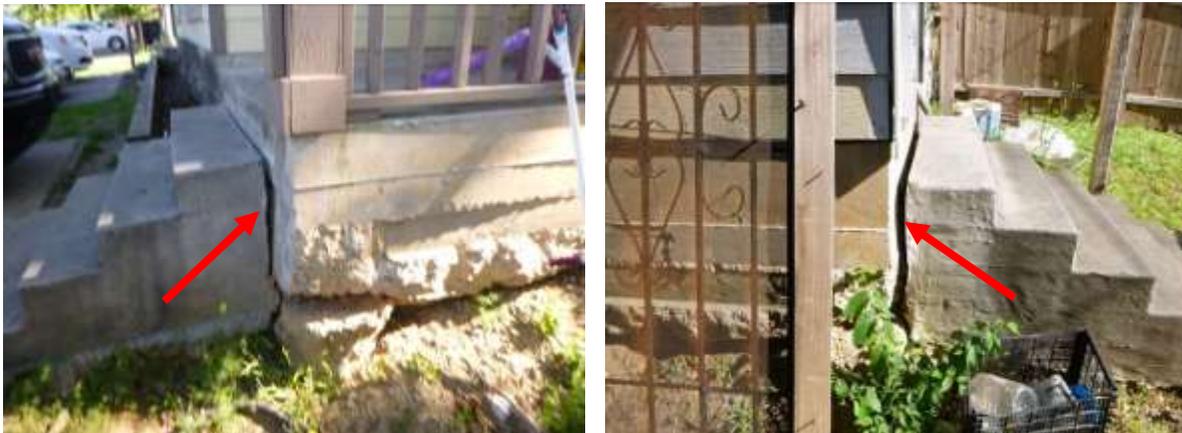
We observed the exterior concrete stairs at the Unit B were separated from the foundation slab, and needs to be repaired.

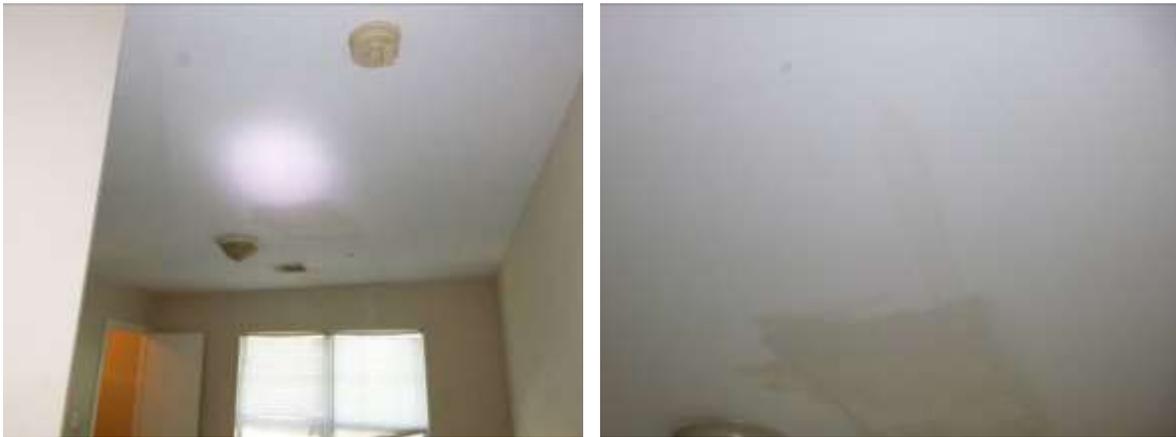
Locations included: Unit B 2nd floor southwest bedroom

After observing the interior of the structure, evidences of roof leaks were visible, where the ceiling was water stained. It is recommended that a roofing contractor be contacted to find the source of the leaks, and to make any needed repairs.

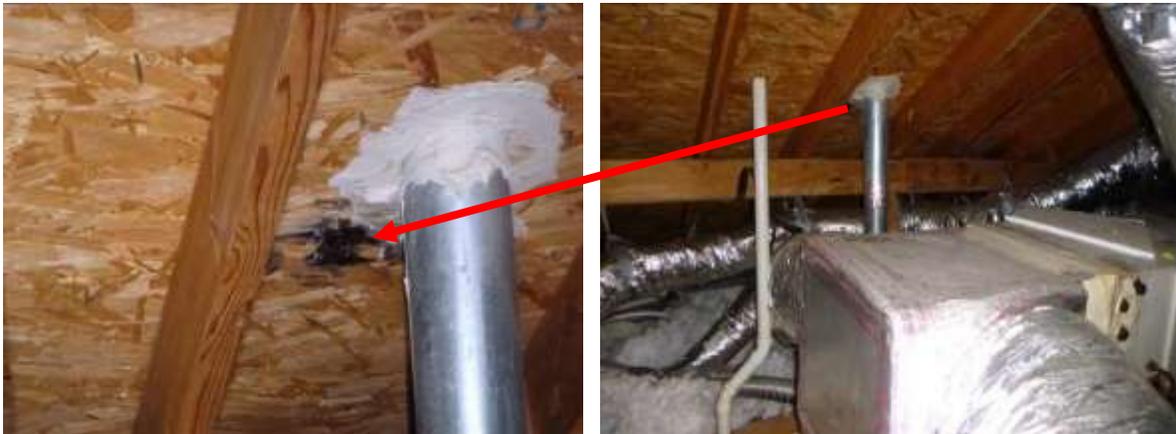
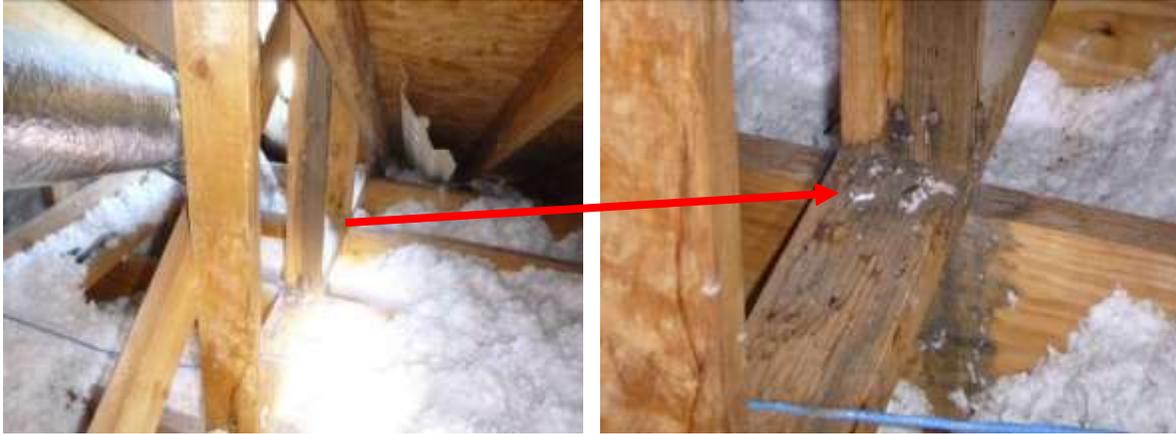
Locations included: Unit B furnace vent pipe, above the southwest bedroom

After observing the interior of the structure, evidences of roof leaks were visible in the attic, where the roof decking and/or roof framing members were water stained. It is recommended that a roofing contractor be contacted to find the source of the leaks, and to make any needed repairs.

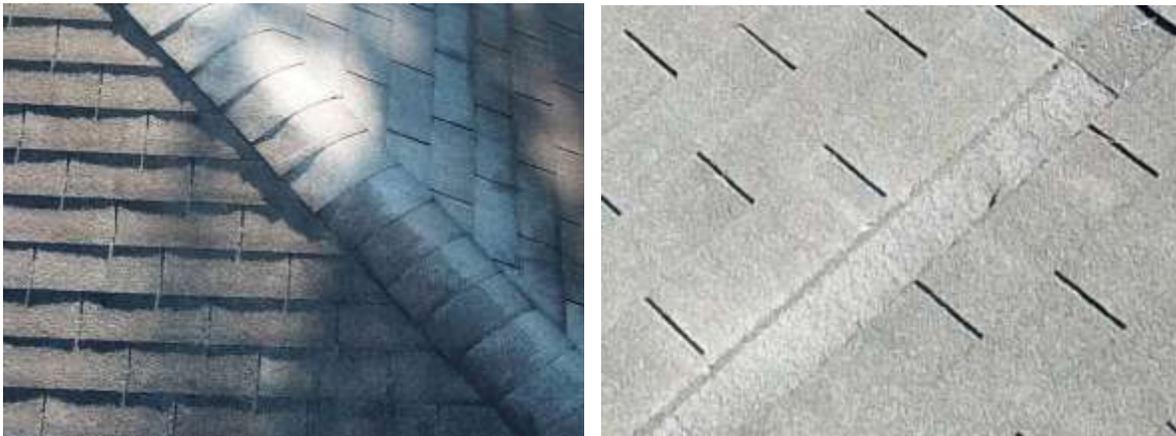
The composition roof surface was showing evidences of some deterioration, including shingles that were brittle, discolored, curling on the edges, starting to crack, and starting to lose their aggregate.

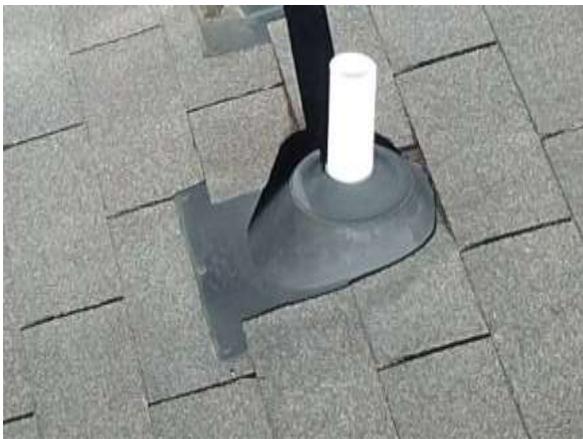
We observed one or more PVC plumbing vent pipes at the roof that were not painted. PVC will deteriorate in the sunlight, and the pipes need to be painted to prevent deterioration.

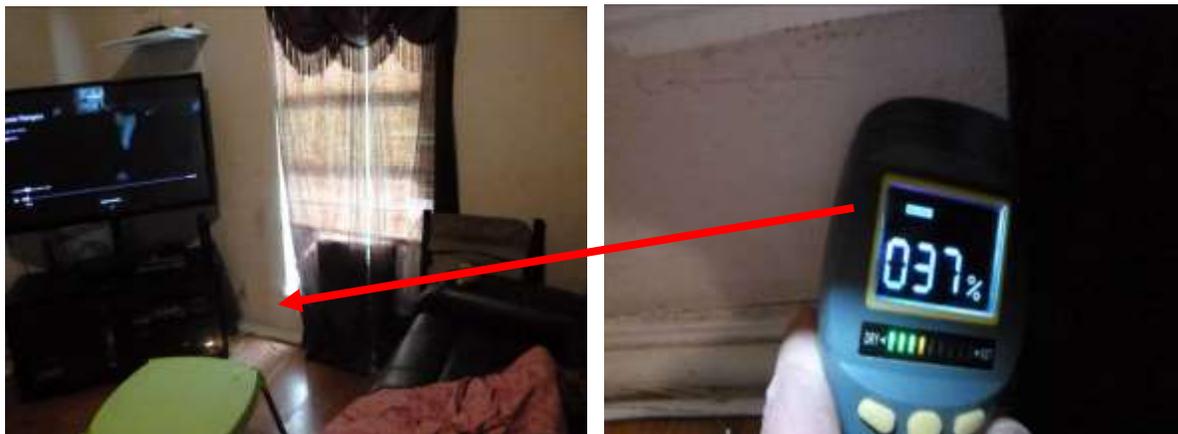
Locations included: southeast family

Our moisture meter showed a higher than normal reading.

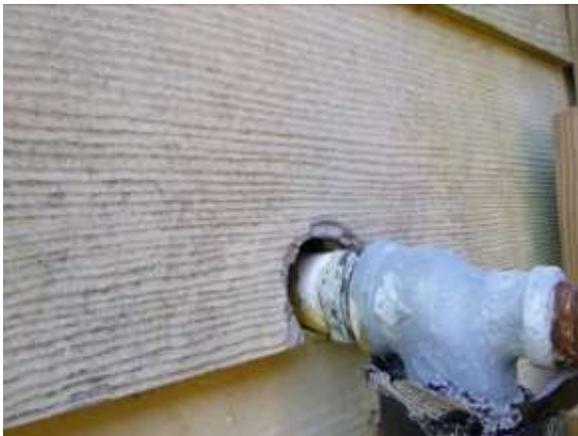
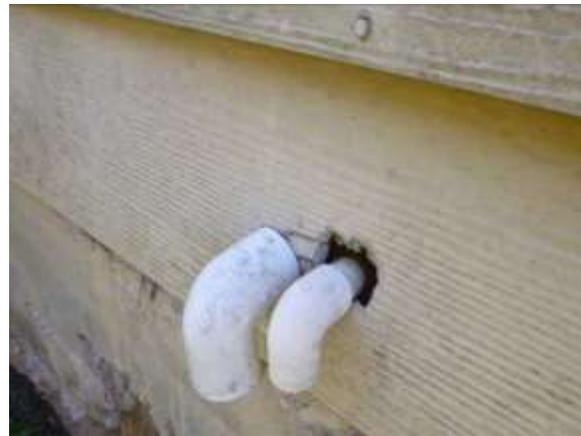
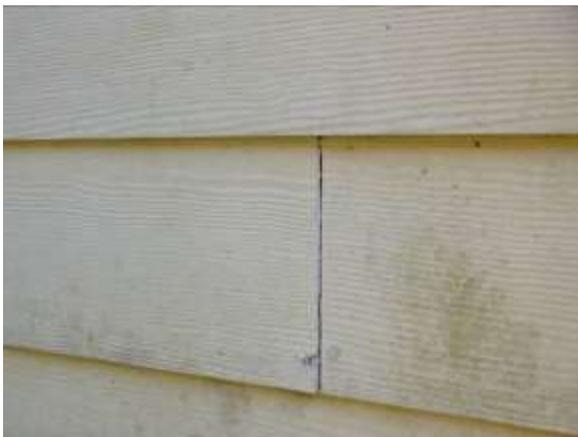
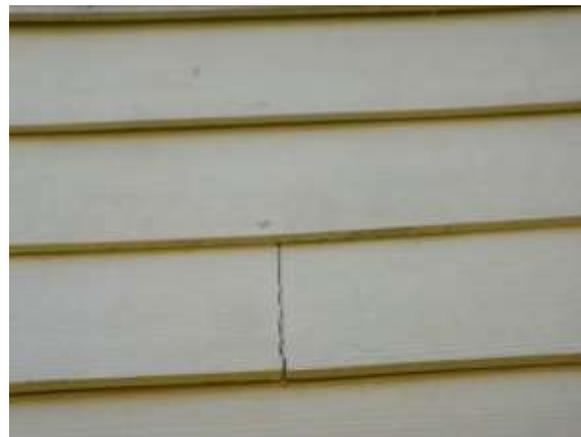
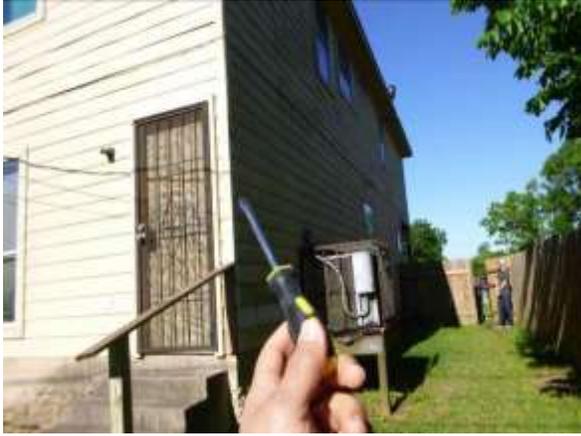
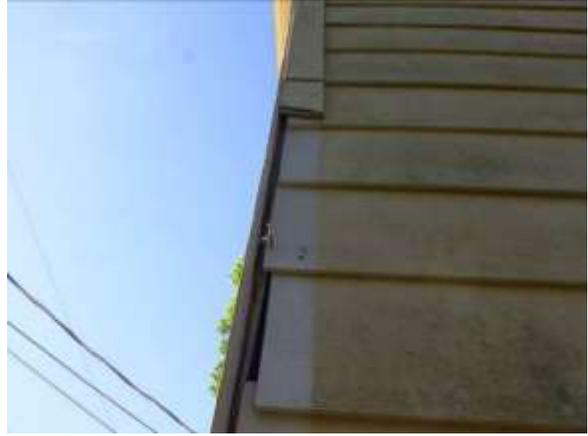
A substantial vulnerability to water penetration was observed at penetrations/openings through the exterior building envelope, and it is recommended that all penetrations/openings be sealed against water penetration. Typical examples on a structure may include light fixtures, air conditioning refrigerant lines, water piping, gas piping, vent caps, windows, doors, expansion joints, etc. Below is a representative sample of locations and/or photographs showing some, but not necessarily all, locations where there is a vulnerability to water penetration. Have a contractor provide a cost estimate to seal all vulnerable areas on the exterior building envelope against water penetration.

- The air conditioning refrigerant lines need to be sealed where the lines penetrate the building envelope.
- Piping penetrations, including the gas line and hose bibbs
- The siding, where many openings due to split wood, missing trims, separations, vertical joints, etc. were visible

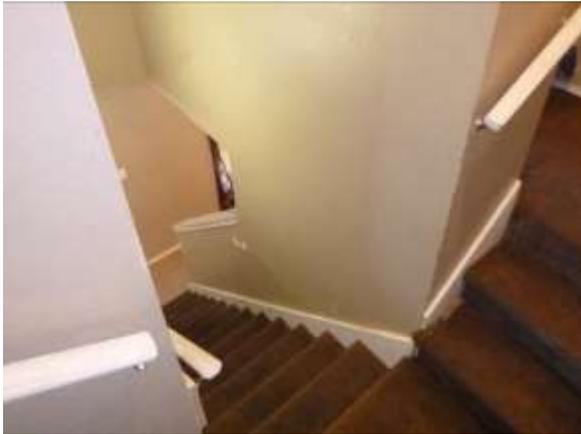
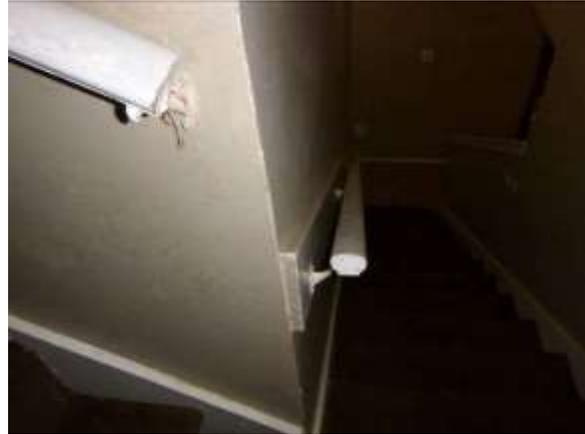
The handrails for the stairway were not constructed according to the current building code standards, which is expected given the age of the house. Therefore, the ends of the handrails do not terminate into the wall, which could allow loose clothing or a purse or bag to catch on the open end, causing tripping and/or falling down the stairs.

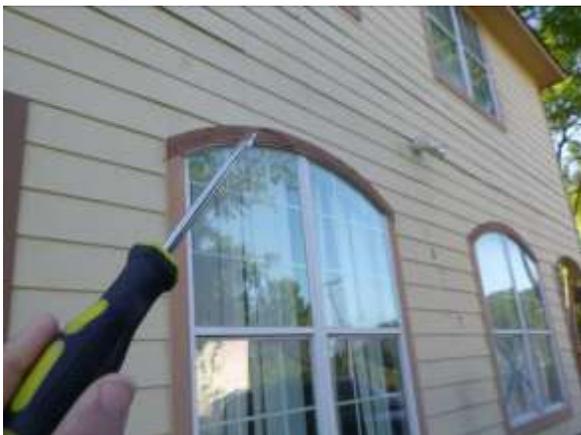
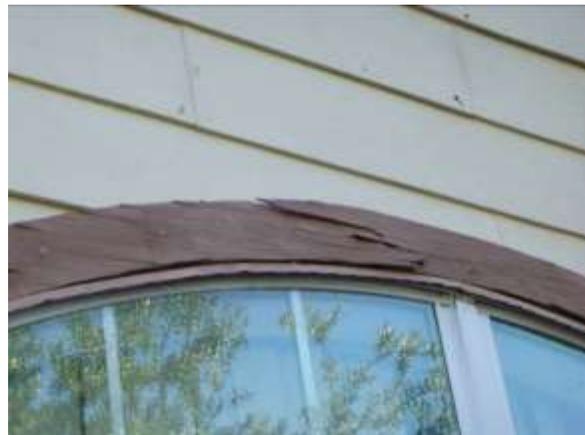
Wood rot was observed and it is recommended that the damaged wood be replaced. It is pointed out that additional damage could be present under the rotted material that will not be visible until the outer rotted materials are removed. Below is a representative sample of wood rot observed during the inspection, showing some, but not necessarily all, of the wood rot on the house. Have a service company determine the entire scope of wood rot throughout the house, and provide a cost estimate to replace all rotted wood.

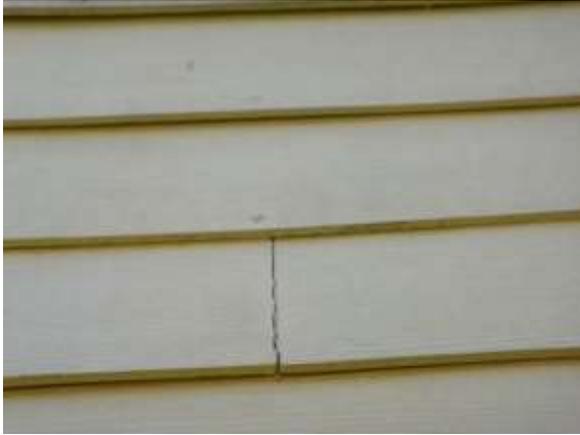
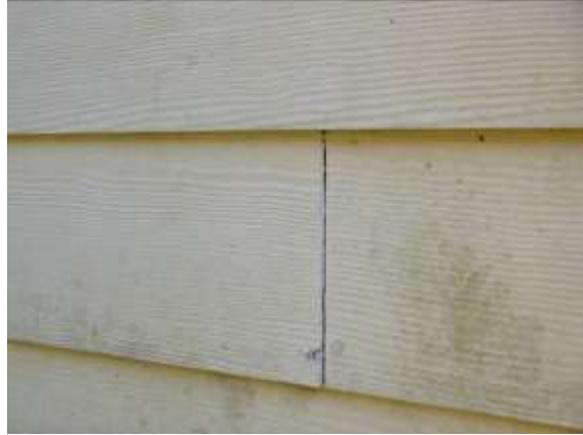
The siding was unsealed at the vertical joints which can allow water to penetrate behind the siding. It is recommended that the vertical joints be caulked to prevent water penetration.

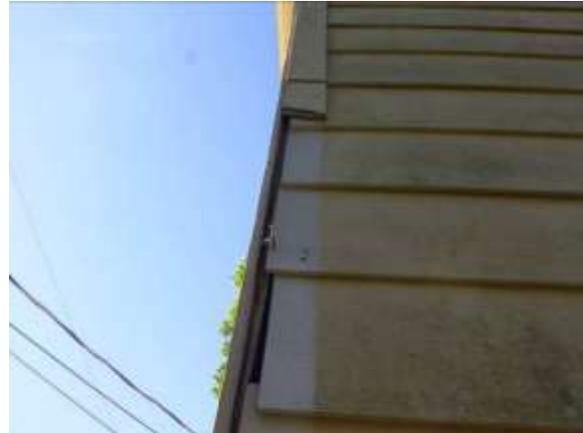
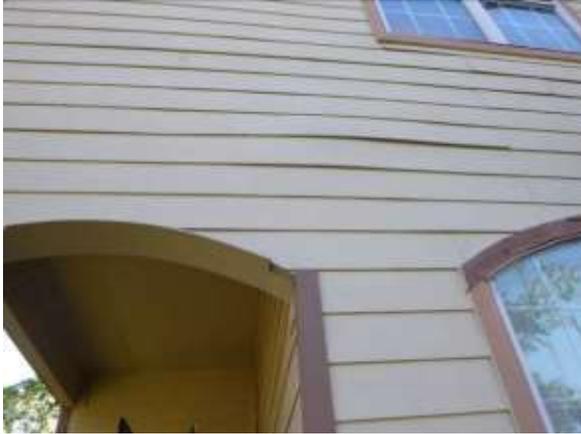
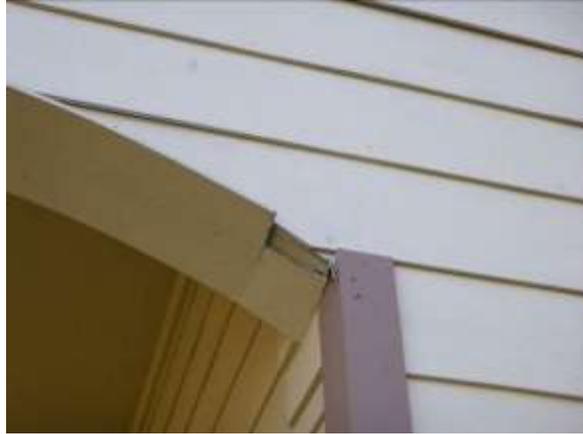
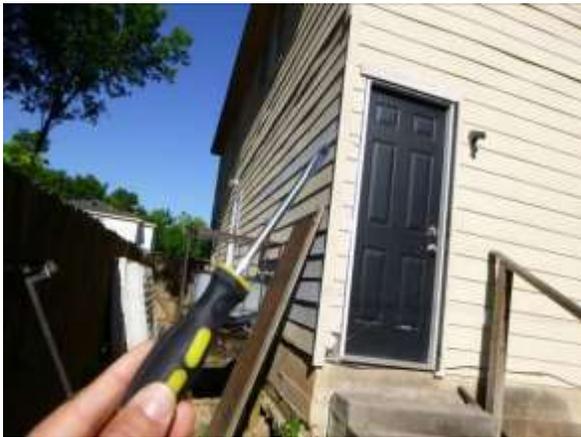
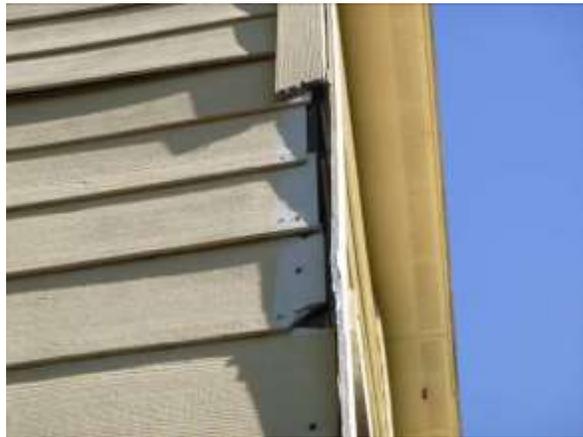
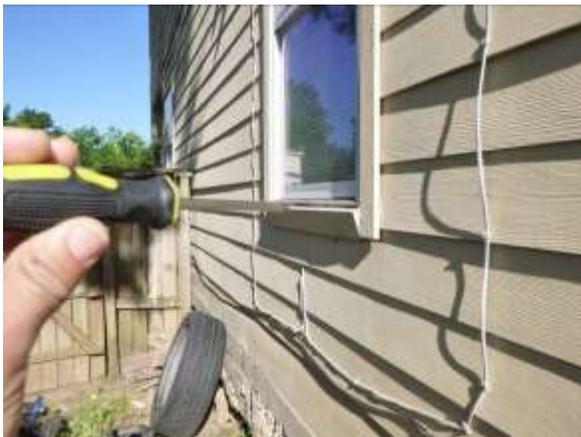
The siding around the house was damaged/broken and needs to be repaired.

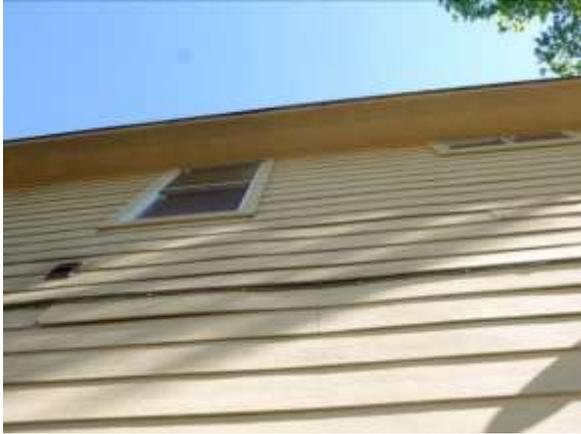
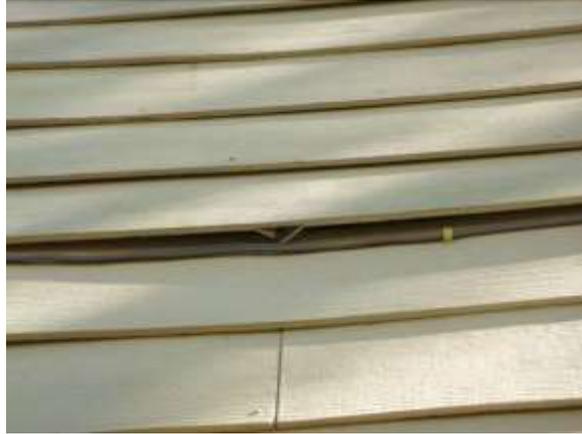
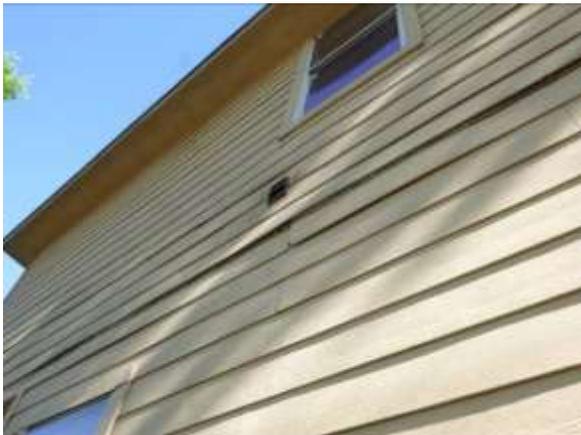
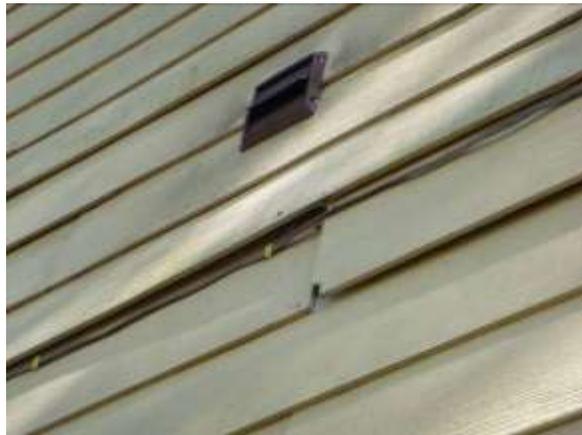
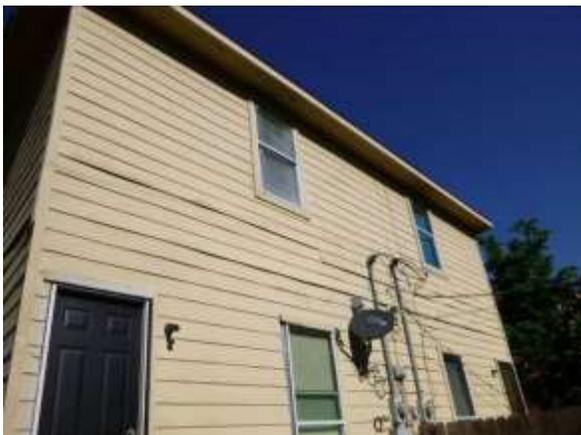
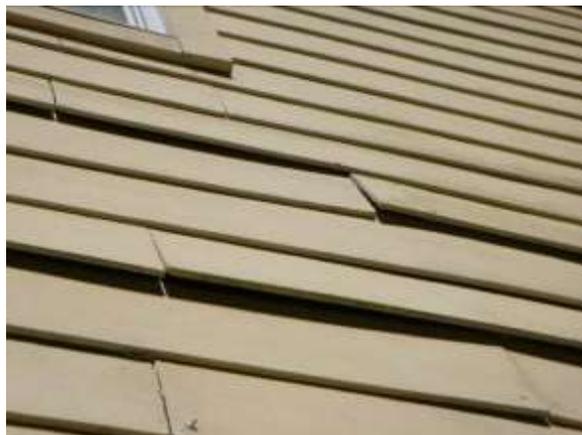
The siding around the house was loose/warped and need to be resecured.
Obtain Cost Estimate

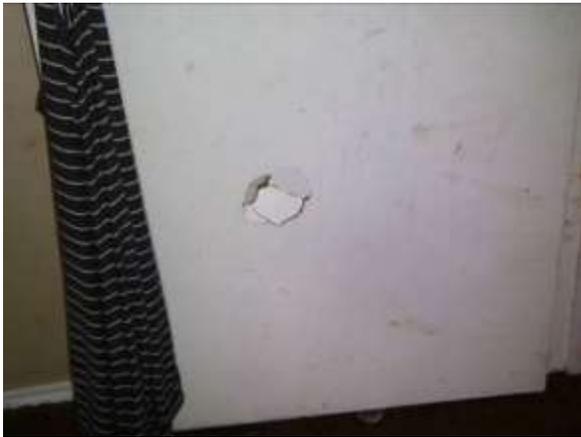
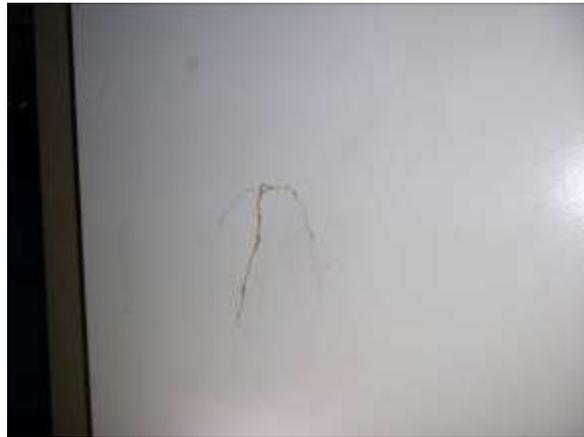
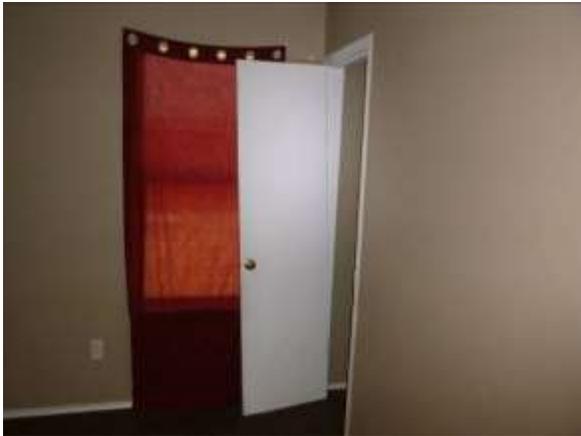
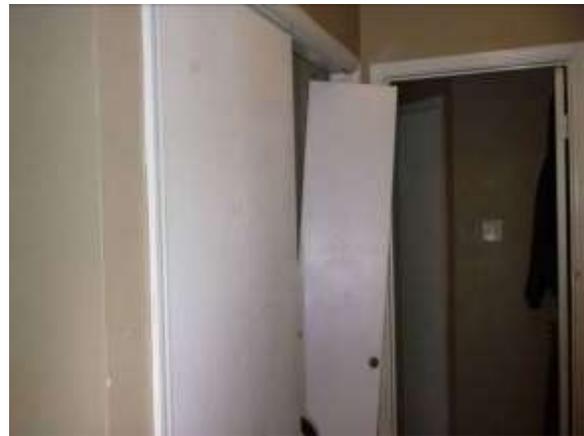
Locations included: Unit A bedrooms

We observed a door(s) that was damaged, and needs to be replaced.

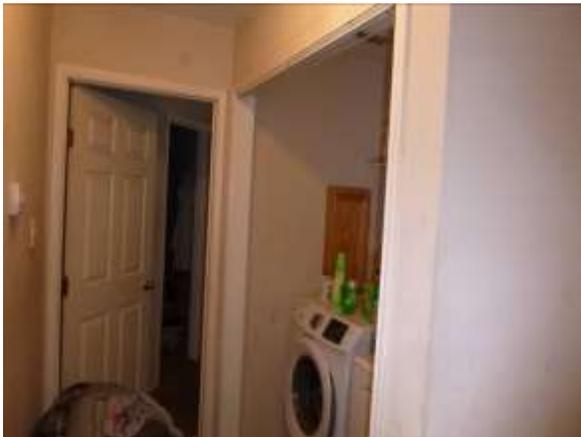
Locations included: Unit B utility room

We observed a door(s) that were missing, and need to be replaced.

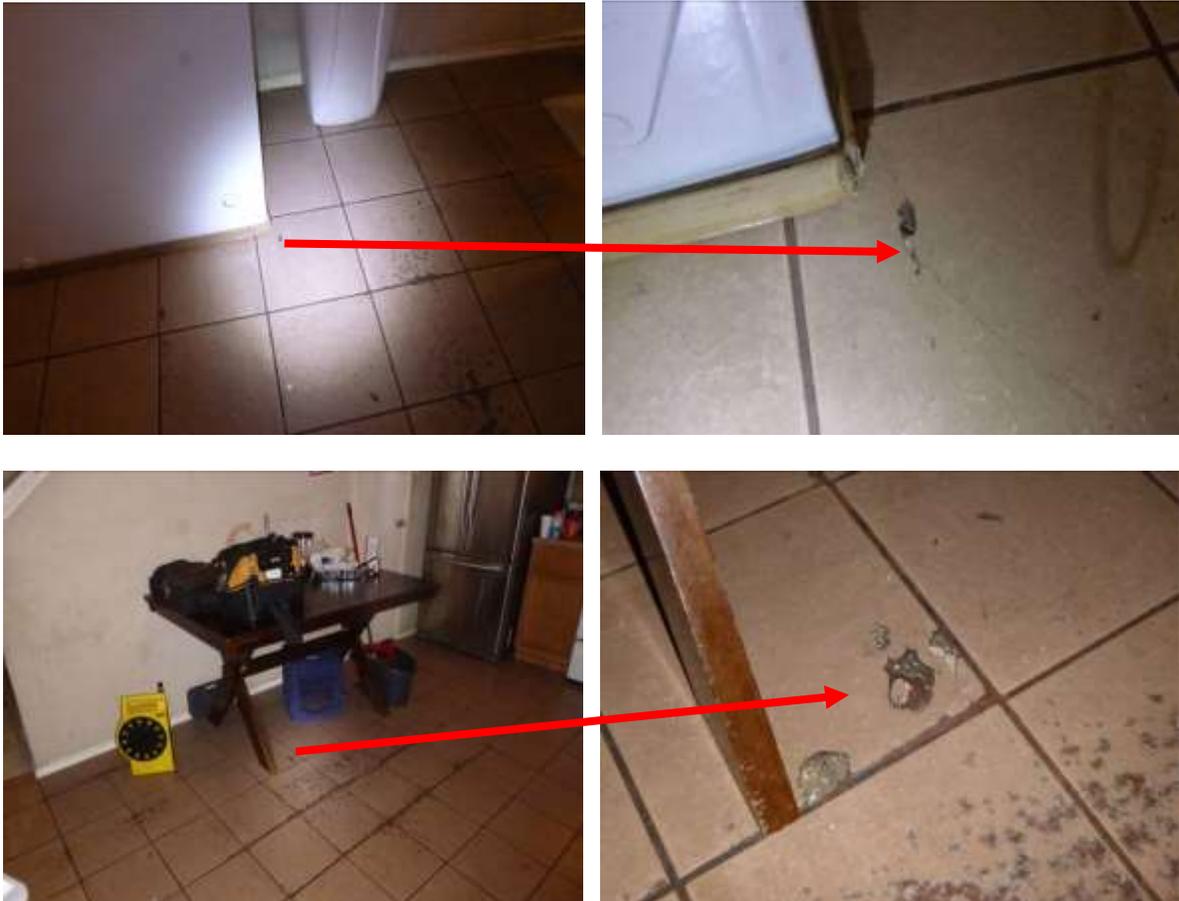
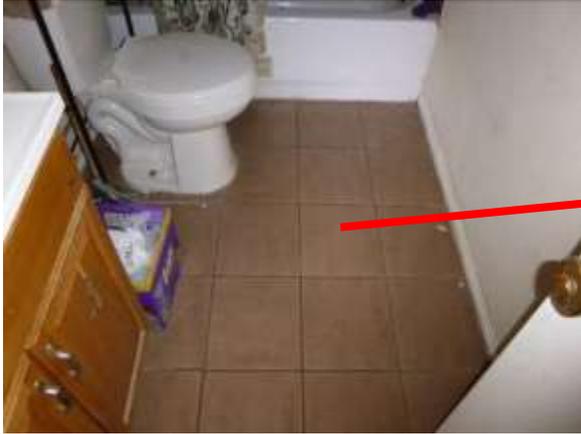
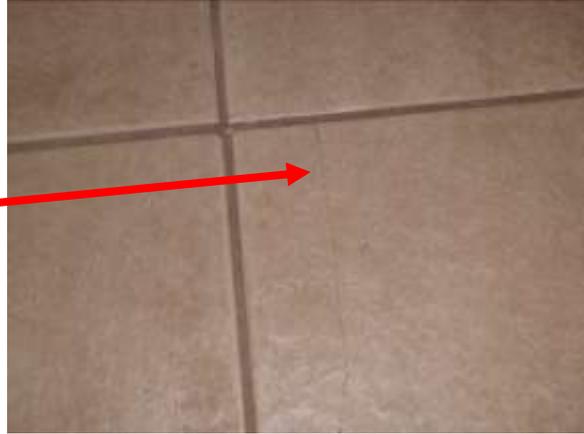
Floor tiles were cracked and it is recommended they be replaced.

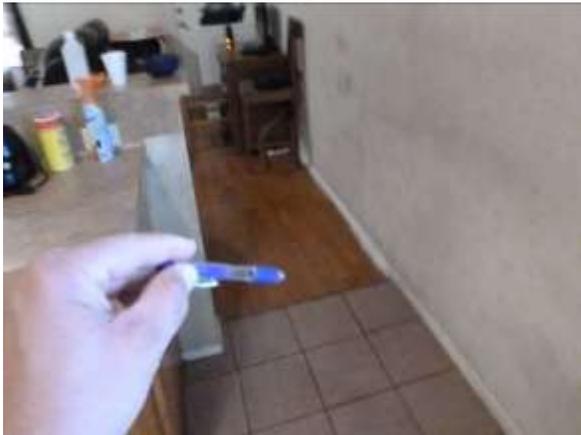
Floor tiles were loose and need to be repaired.

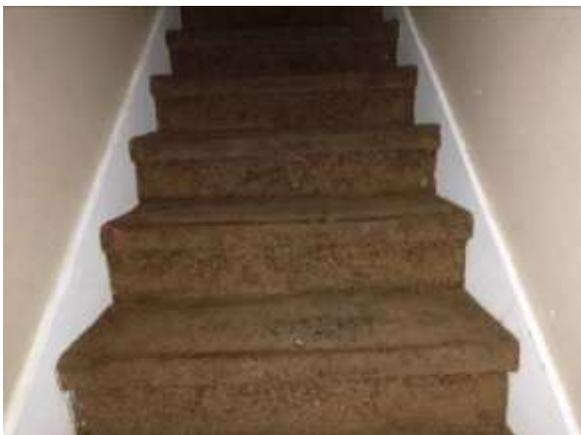
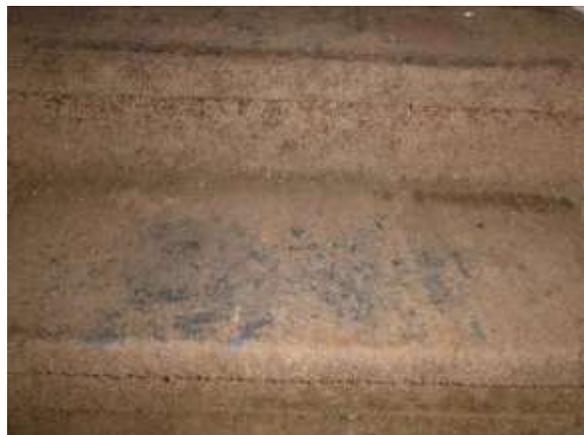
The carpet was damaged, and needs to be repaired or replaced.

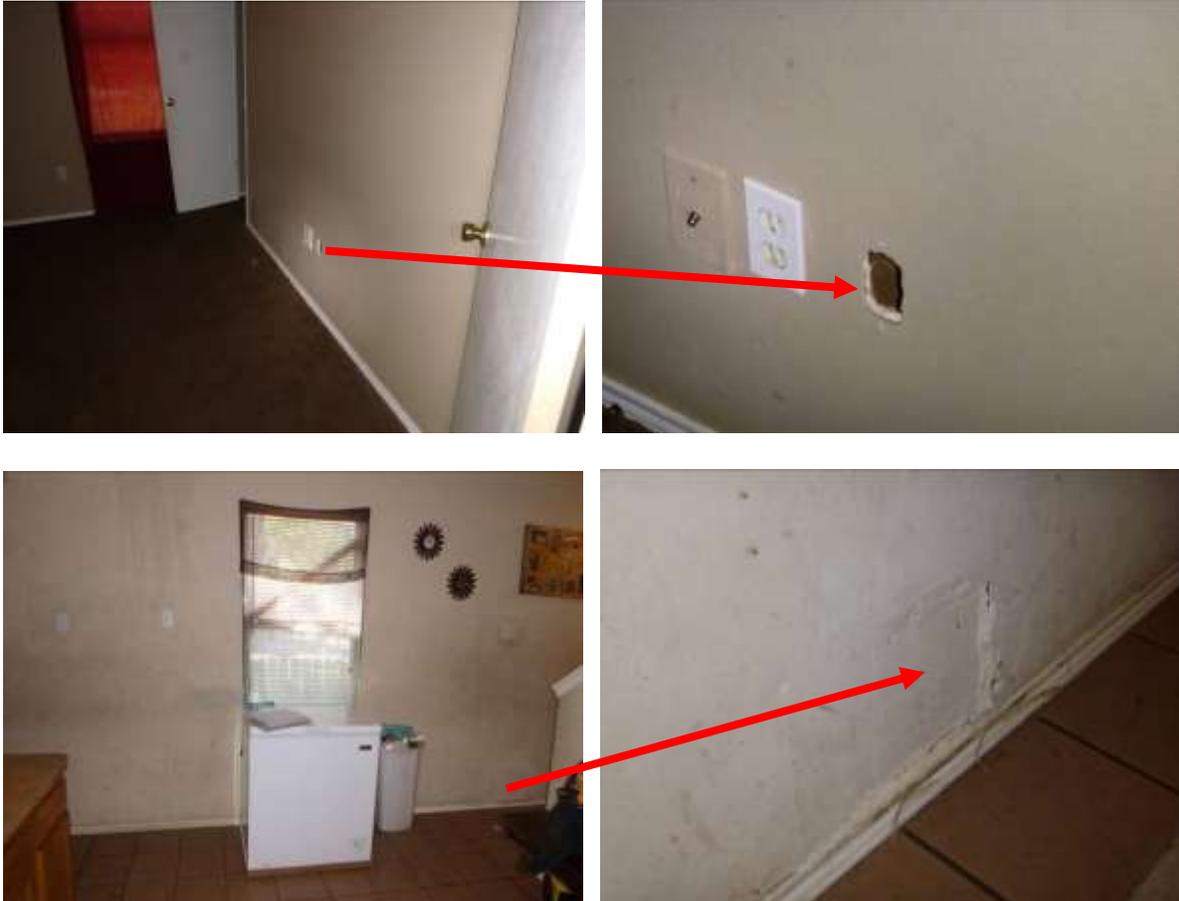
The sheetrock was damaged and needs to be repaired.

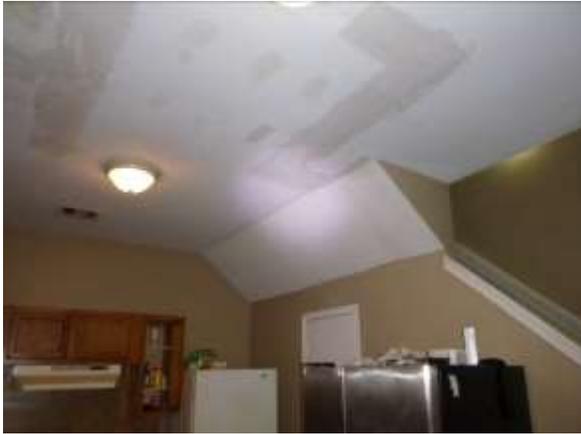
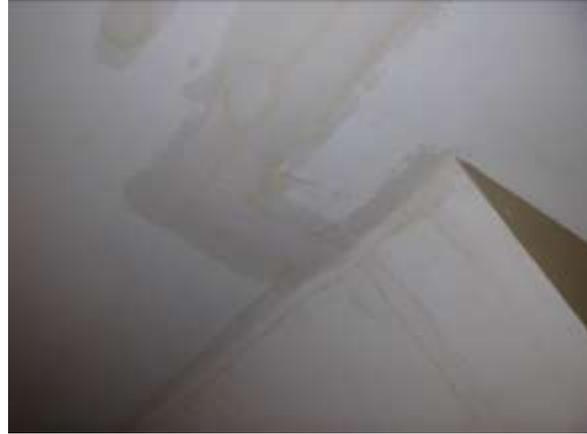
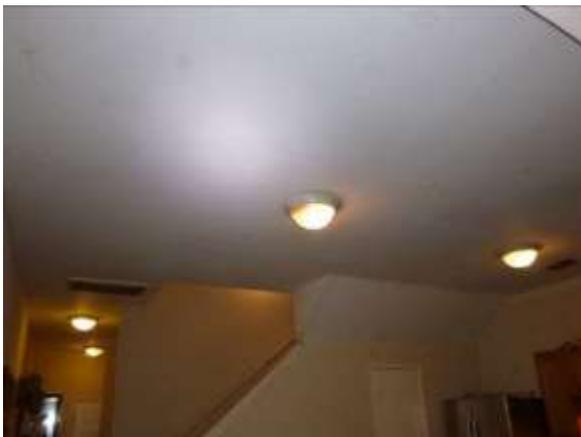
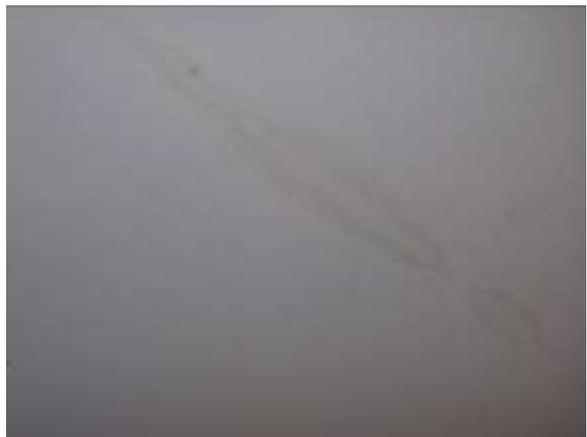
Locations included: kitchen of both units

Water stains were observed at the ceiling. This is located under an upstairs bathroom, and the stain(s) appear to be related to plumbing leaks. Have a plumber and/or a service company find the source of the water stains, and provide a cost estimate for any needed repairs.

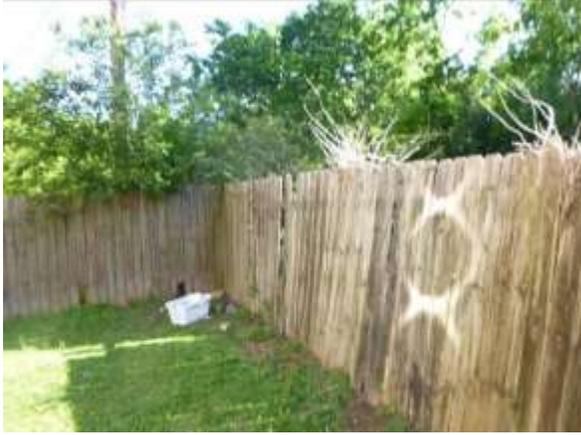
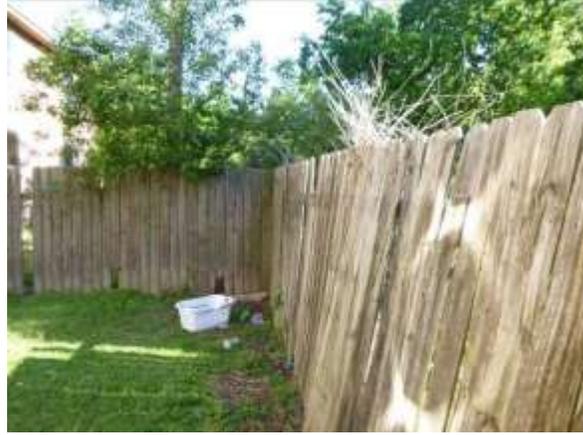
The wood fence was leaning, and is in need of repair.
