HouseCheck
Property Inspection Report

210 Birchwood Dr, Spring, TX 77386
Inspection prepared for: Chris Shannon
Real Estate Agent: Travis Foote - INETO Real Estate Services

Date of Inspection: 6/3/2019 Time: 1:00 PM
Age of Home: 1975 Size: 2609
Order ID: 619

PROPERTY INSPECTION REPORT

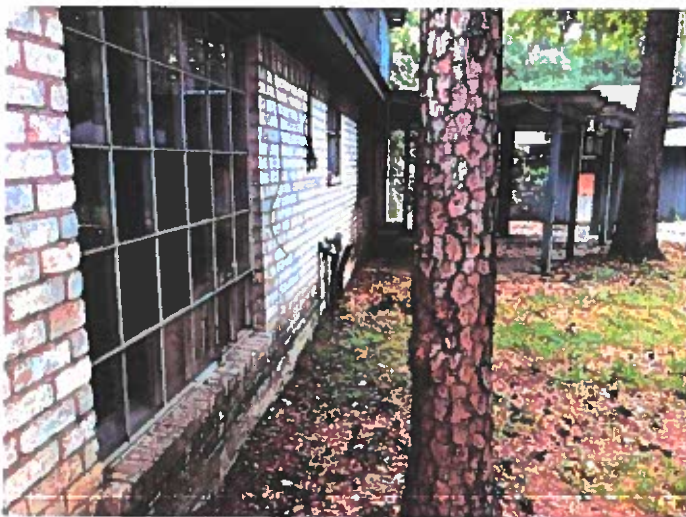
- There is/are a tree(s) at the back side(s) of the structure that is too close to the foundation. The growth of the tree over time can cause foundation damage. Trees should be no closer than 6 feet from the foundation.
- Exposed rebar was observed along the wall of the foundation at one or more of the following locations: front. The rebar should be concealed to prevent damage to the rebar and the concrete.

Tree at right rear

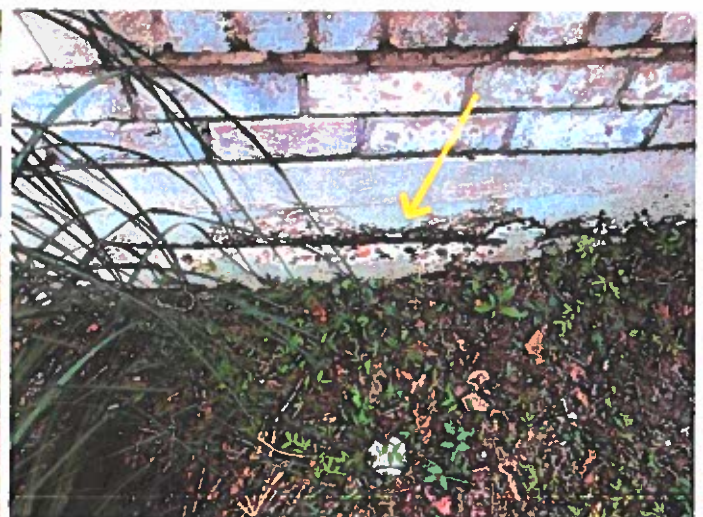
Exposed rebar at left front

Rebar repaired

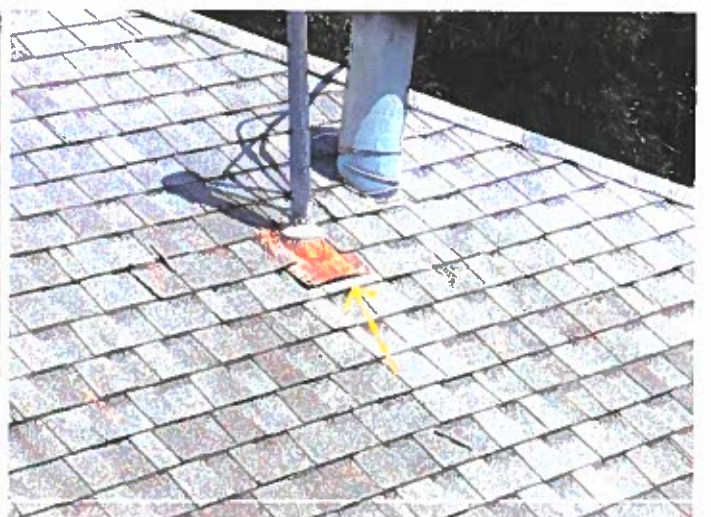
- All deficiencies noted in red should be further evaluated by a roof professional.
- **Lifted flashings at base of mast for service entrance conductor, . This can allow water penetration under flashing. Flashing should be flush with roof covering.**
- **Current standards mandate all plumbing vent stacks extend a minimum of 6 inches above the roof slope. One or more were observed to not meet this standard.**
- **Furnace vent pipe heavily rusted. This can allow moisture penetration.**

Lifted / rusting flashing.

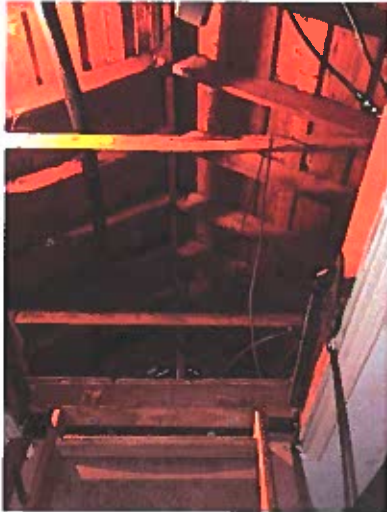
Rafters without adequate collar ties

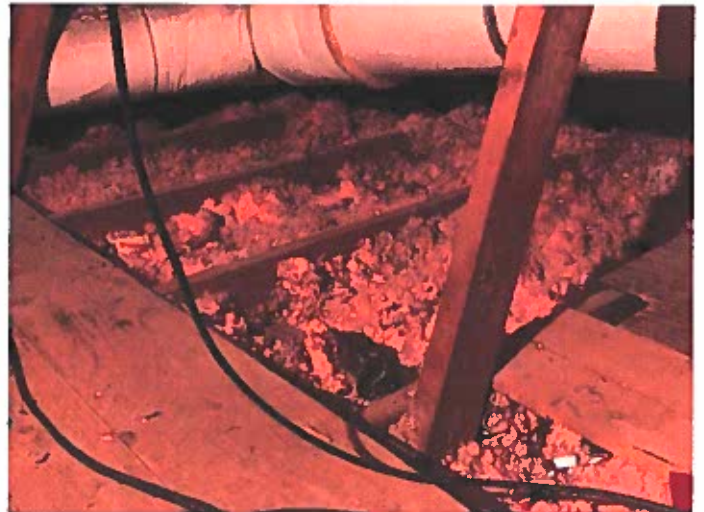
• Insufficient insulation was noted in the attic space per today's current standards. Improvements to the insulation may increase energy efficiency.

Attic insulation

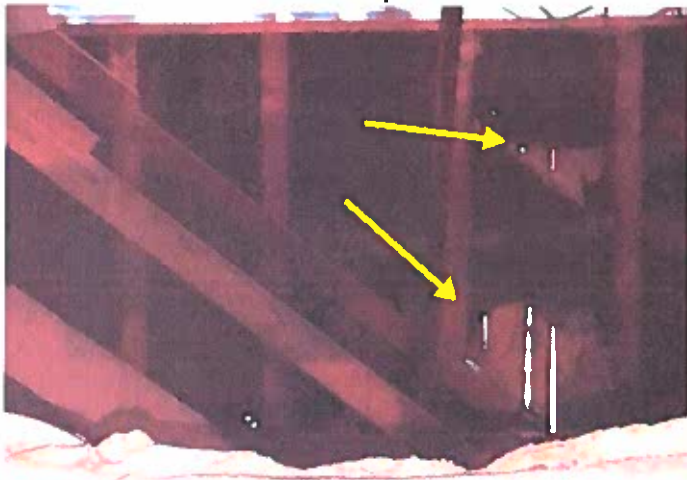
• Moisture barrier damaged / missing at gable end walls in attic. This can allow moisture to penetrate siding and in to structure.

Gable wall missing moisture barrier

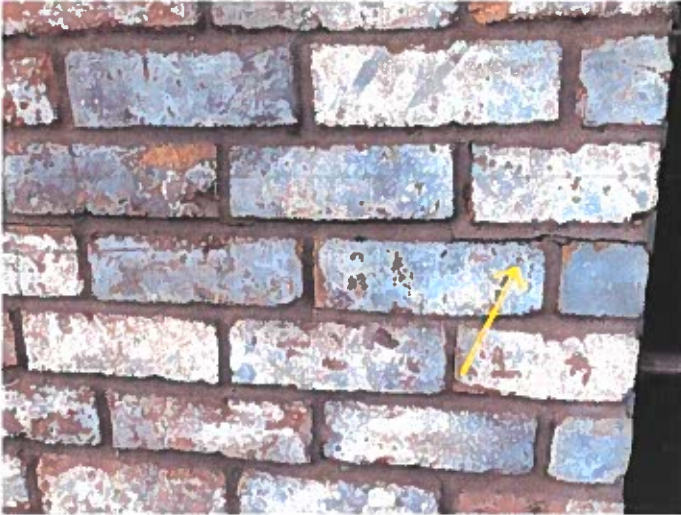
- Cracks were observed at mortar/brick exterior wall at , backside(s) of the residence. Significant cracks need attention due to possible problems with wall and foundation settlement. Many buildings settle with minor wall and foundation cracking visible at some point. Cracks should be sealed to prevent moisture intrusion, monitoring for further movement, and having a structural engineer evaluate further, should the cracks enlarge beyond their current size.
- Holes in siding at rear. This can allow rodent entry in to structure.
- Siding at garage in contact with soil. This will result in wood rot and can attract wood destroying insects.
- Wood rot and water damage present at wood siding in multiple areas of structure. This can allow moisture penetration through siding and in to underlying framing material, which may also have rot or damage present.

Rear brick wall

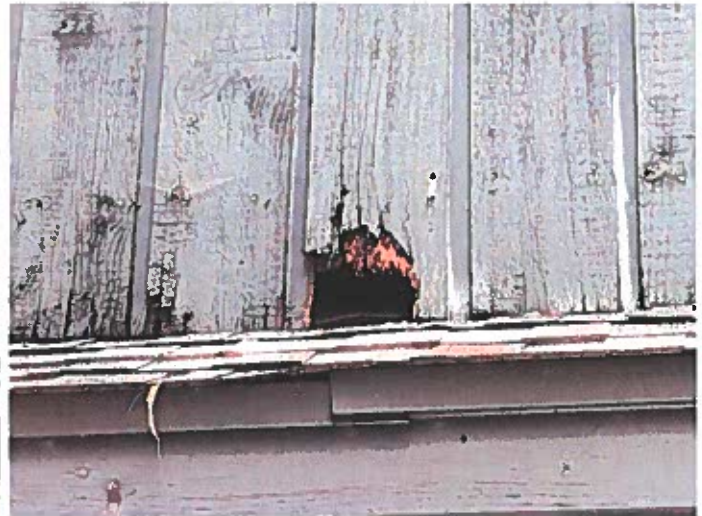
Hole in siding at rear

Siding has been repaired or replaced

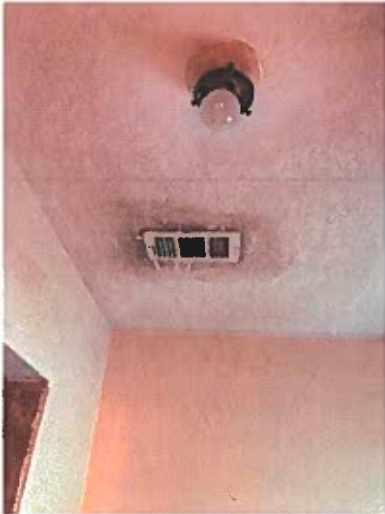
Biological growth was noted in hall bathroom ceilings and is likely present in other areas.

- Biological growth noted in ceiling of hall bathroom. Recommend further evaluation by licensed mold technician.
- Floor coverings damaged / missing throughout home.
- Ceiling above upstairs hallway water damaged. Area dry at time of inspection.
- Garage ceiling water damaged

Hall bathroom ceiling

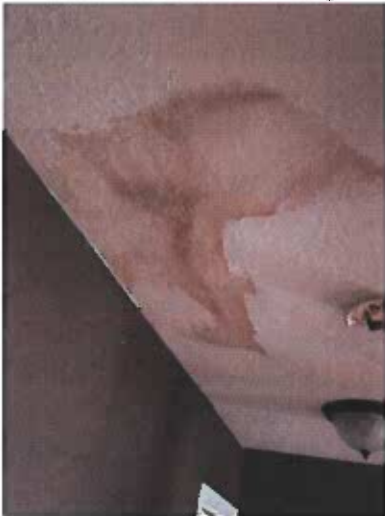
Ceiling above upstairs hallway water damaged.

*Roof inspected
Repaired garage roof
All floors replaced*

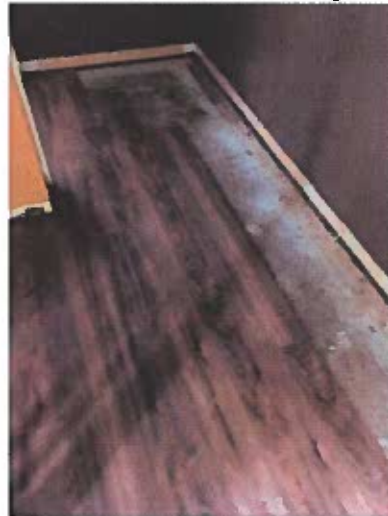
Damaged floor covering

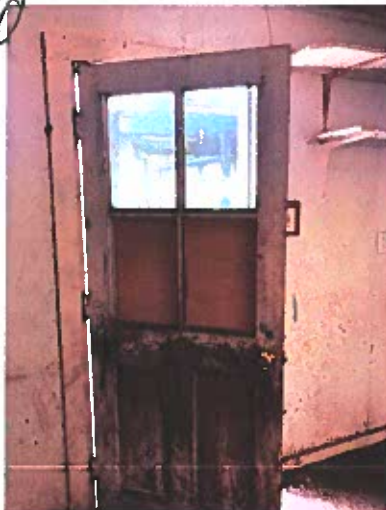
Garage door

- Master bedroom door frame damaged, door does not latch
- Door to garage does not open properly, has broken window panes.
- Several interior doors damaged, have broken hinges and are missing doorknobs.
- Right front secondary bedroom missing closet door.

replaced

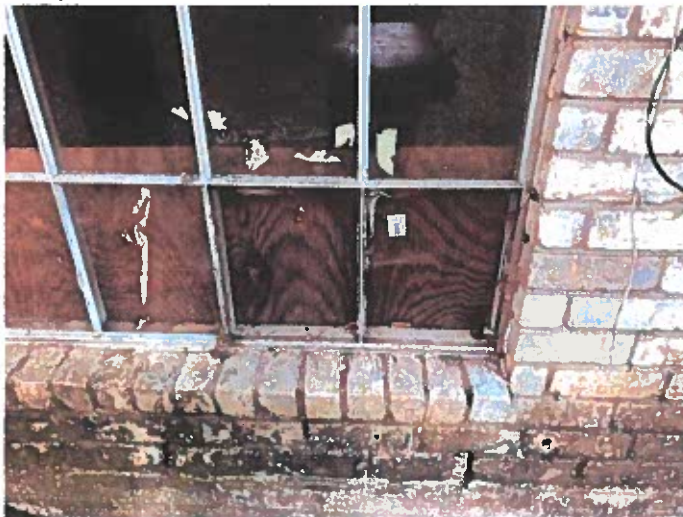
Rear window

- Note: Windows are single pane (likely original glazing and installation). Updating single pane windows can be beneficial for energy efficiency and/or ease of operation.
- Several windows missing screens at the time of the inspection.
- Window at right rear has broken panes

Window panes replaced

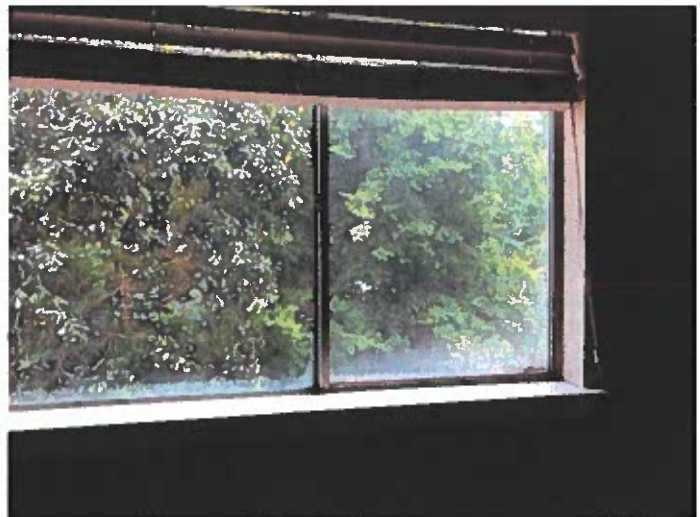
Single pane window without screen

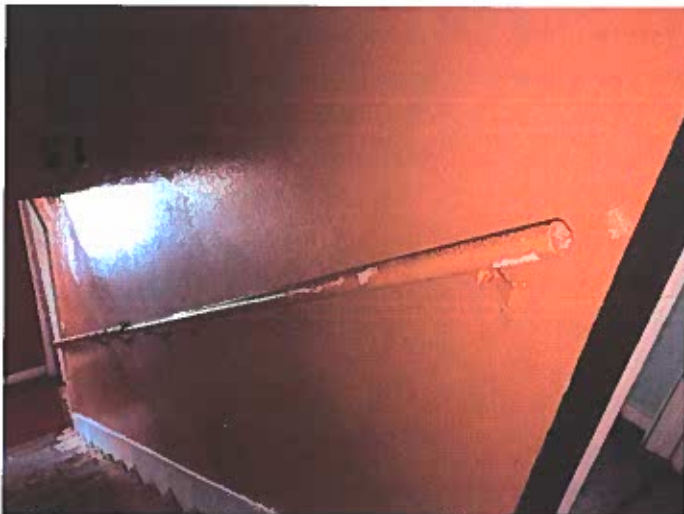
Handrail

- Inadequate baluster spacing is present to the stairway railing. (4" maximum spacing allowed.)
- The hand railing does not terminate in contact with the wall at the interior stairway.
- Balcony guard at top of stairway loose. This is a safety hazard.

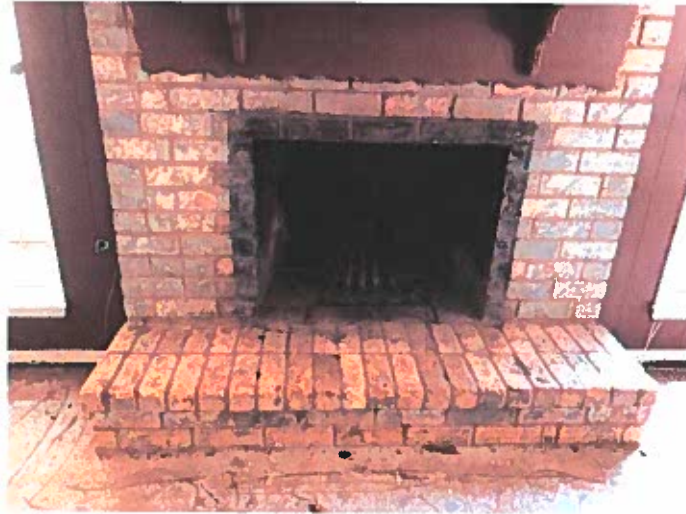
Fireplace

- I was not able to access top of chimney during inspection due to height of roof.
- **Missing damper clamp on the fireplace flue. A damper clamp is required for a gas-fueled fireplace.**
- **Damper in fireplace rusted.**

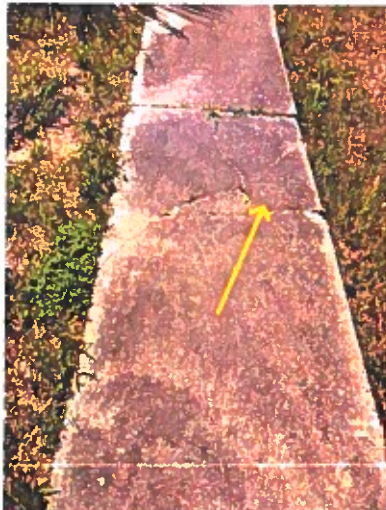
Front walkway

- Walkway at the , frontside(s) of the residence has lifted / uneven sections. This condition can create a trip hazard.
- Roof of pergola has significant water damage and wood rot.
- Wood rot and water damage at base of pillars supporting breezeway.

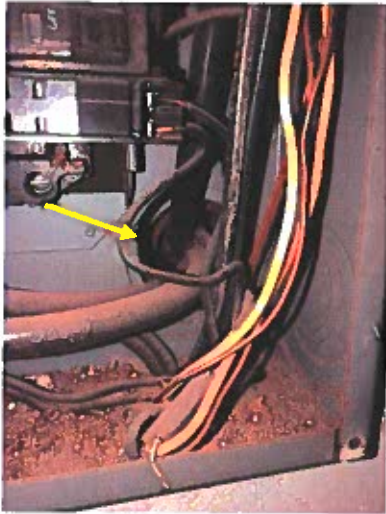
- Service panel does not have bushings installed at openings where circuits pass through panel enclosure. This can result in damage to wiring.
- Sub panel for pool equipment heavily rusted, cover does not fit properly, not safe to remove. Panel appears to be at end of useful life. Recommend further evaluation by licensed electrician.

Holes in enclosure without bushings

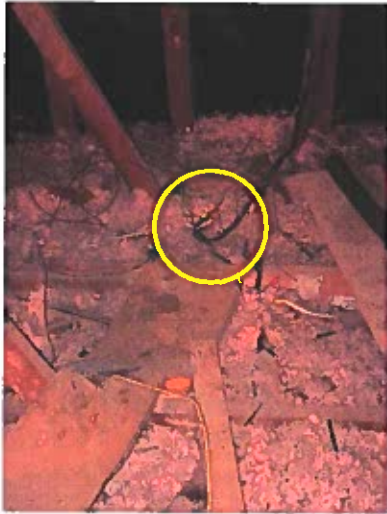
- All deficiencies noted should be evaluated and repaired by a licensed electrician.
- Exposed wire splices are present at multiple locations in the attic space(s). All wire splices should terminate with wire caps inside of a proper junction box to prevent electrical arcing or overheating/fire hazards.

Open wire splice

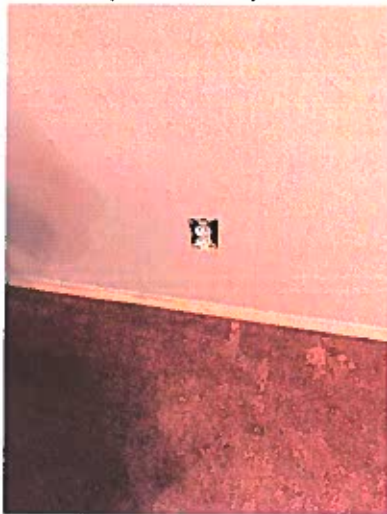
- Several light fixtures missing or not properly installed
- Several receptacles missing covers. This is a safety hazard.
- Smoke detectors are missing in the following locations: , master bedroom, , upstairs left bedroom, , upstairs right bedroom, , upstairs front bedroom, , upstairs back bedroom, , living room. Recommend installation of hardwired, interlinked smoke detectors with battery back-up systems.

Receptacle missing cover

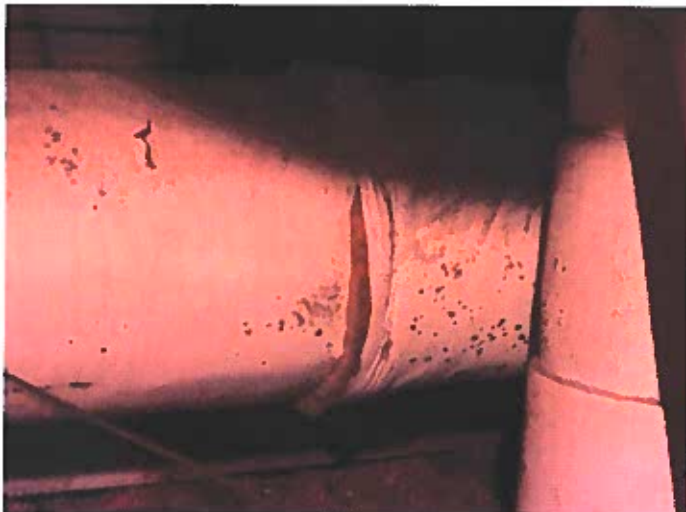
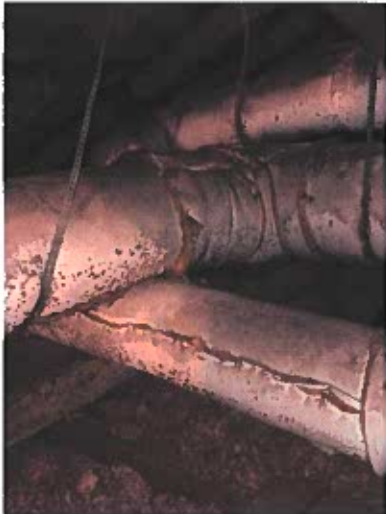
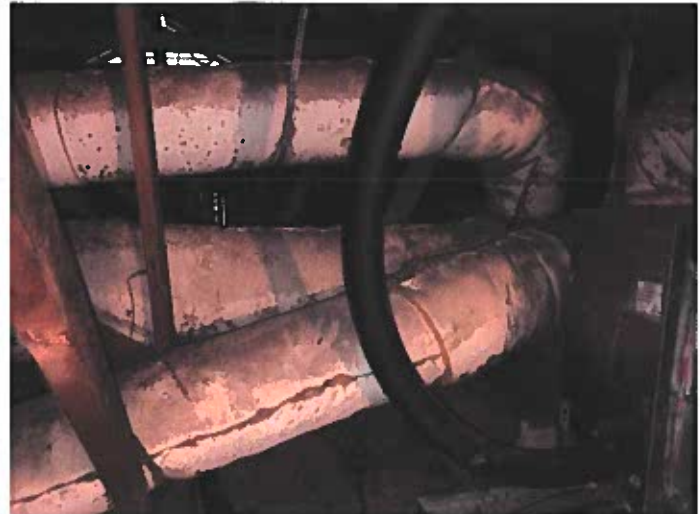
• Large amounts of organic growth were noted on the outer surfaces of the plenum and attached duct work. Recommend further evaluation by licensed mold consultant and/or a licensed HVAC contractor.

Ductwork with biological growth

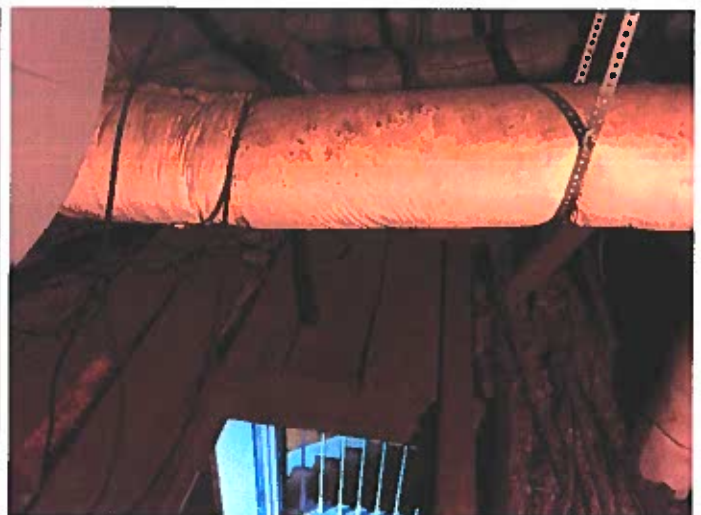
• Attic walkway to HVAC equipment impeded by ductwork. Under current standards equipment installed in attic is required to have a 24" wide unobstructed walkway.

Ductwork blocking walkway

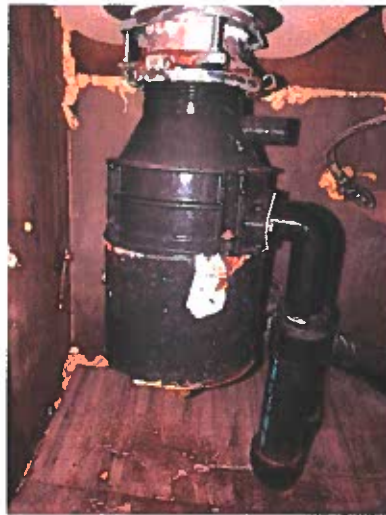
Food waste disposer

- The disposal was inoperable at time of inspection. The unit may need to be replaced, there may be a foreign object stuck inside, or there could be an electrical/mechanical issue with the unit. I recommend further evaluation.
- Rust is present on the exterior of the disposal. This could be an indication of past/present leaks.

Replaced disposal

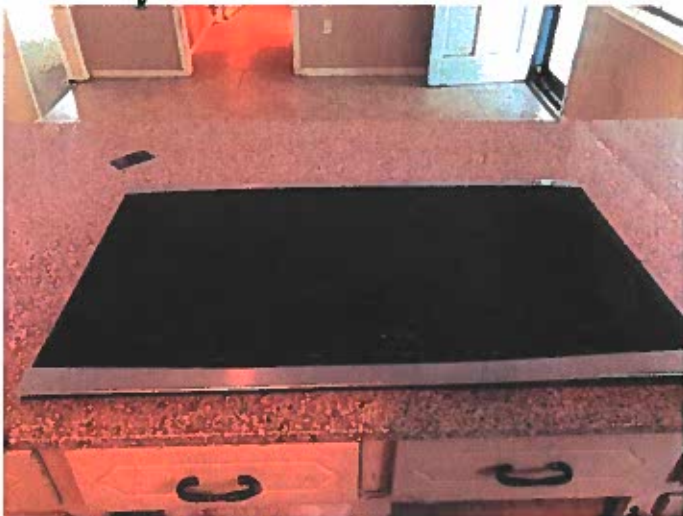
Electric cooktop

- Cooktops: electric
- Oven : electric
- Both ovens operated/tested. The top oven tested at 400 degrees, registered at 390 degrees. Bottom oven tested at 400 degrees, registered at 390 degrees.
- **Circuit for cook top not fully enclosed in conduit.**
- **Cook top not functional at time of inspection.**

Replaced cook top

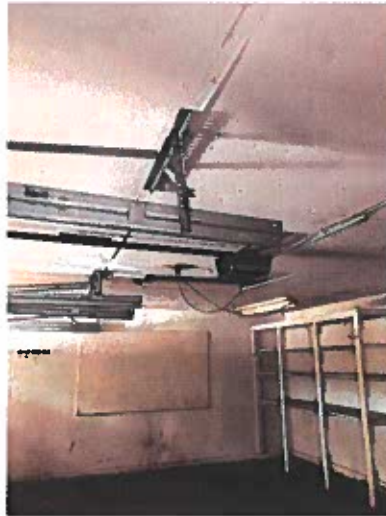
- All deficiencies noted should be evaluated and repaired by an garage door installation professional.
- Garage door operator old, does not have modern safety features including photoelectric sensors. This is a safety hazard. Recommend replacement of operator for safety of occupants.
- Garage door track not properly secured.
