INSPECTION DIMENSION

PROPERTY INSPECTION REPORT

Concerning: 427 LAURA LANE
(Address or Other Identification of Inspected Property)

By: DON MIDURA TREC PI # 375 11/30/2017
(Name and License Number of Inspector) (Date)

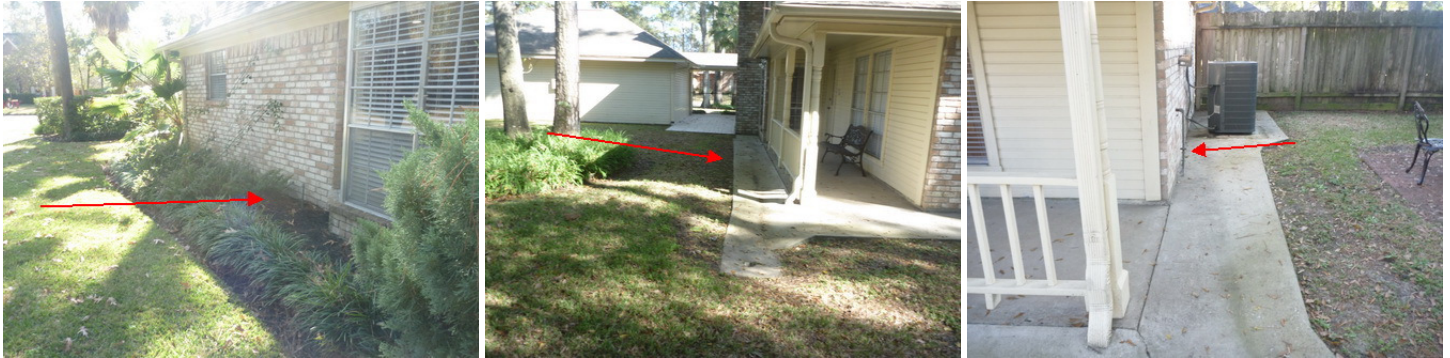
1. A. FOUNDATIONS: See Comments in the Main Body of the Report.
2. B. GRADING /DRAINAGE: Adjust the finish grade / flower beds to achieve 4"-6 inches of concrete foundation grade beam exposure and to insure for a positive slope to channel water away from the building.
3. The finish floor of the patio area between the house and garage is installed up to / over the exterior finish wall materials increasing the potential for moisture intrusion and insect activity.
4. The concrete pad at the left side of the home is improperly sloped.

*Examples of high soils and negative drainage sloping conditions

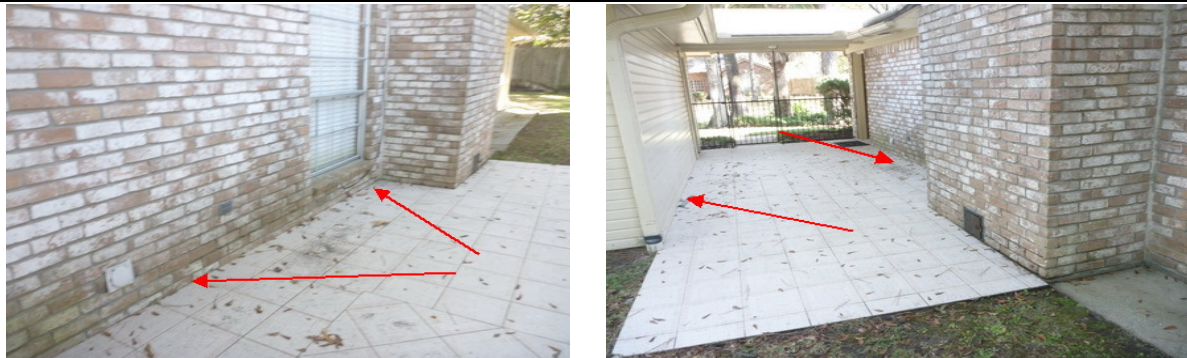
5. The concrete driveway is cracked / broken and heaved at the front of the garage creating a trip hazard.
6. Portions of the perimeter yard wood fencing are damaged.
7. A concrete culvert with under-ground drains has been installed in the rear yard adjacent to the patio area in an apparent attempt to control rain water run-off – (the effectiveness of this approach to control the drainage flow is unknown).
8. A professional drainage control contractor should be contacted to examine the site to determine an effective remedy

*Patio flooring installed over the exterior finish wall materials

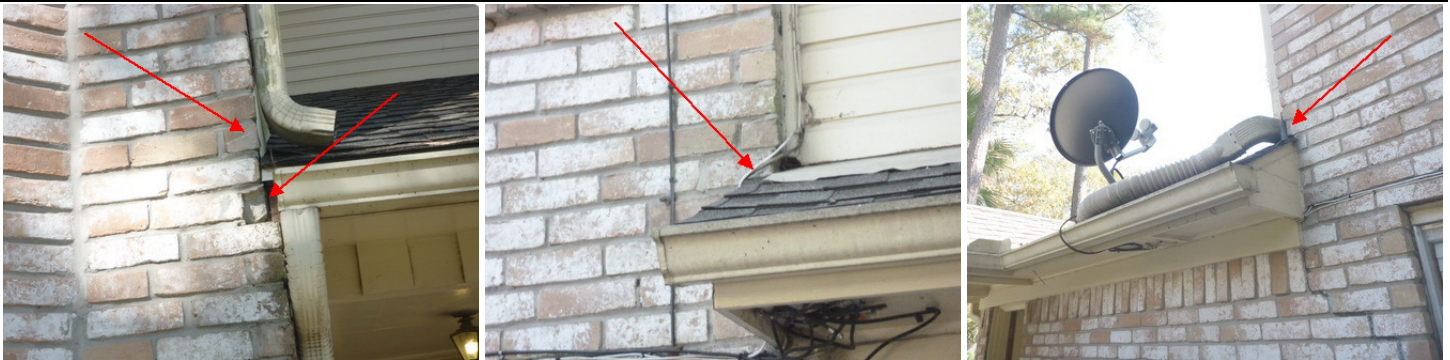
- 9. C. ROOF COVERING MATERIALS: Install additional attic/ soffit venting to achieve 1 SF of Net Free Venting Area / 150 SF of attic space.
- 10. The metal flashings are not complete at the brick / shingle juncture at various locations – (ex) left of the entry porch and rear wall.

*Roof / flashing installation errors – sources for water penetrations

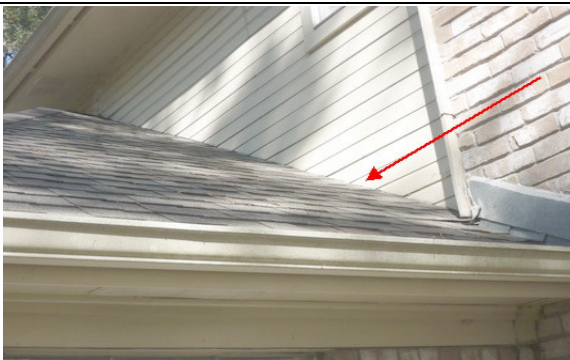
- 11. The siding at the 2nd story rake walls is installed with insufficient separation from the roof surface.
- 12. Install kick-out flashings at the horizontal fascia / vertical walls – roof junctures to direct the flow of water from the walls below.
- 13. Repair the damaged / leaky rain gutters.
- 14. Water stains were observed at the underside of the roof decking in the attic space at the water tank vent penetration.
- 15. A roof contractor should be contacted to make all repairs / improvements as needed to insure leak free performance.

*Insufficient roof covering / siding separation

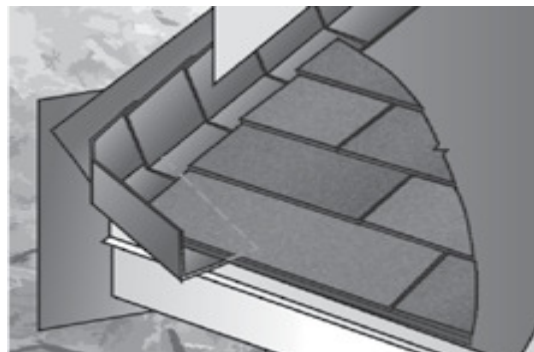
*Install kick-out flashings

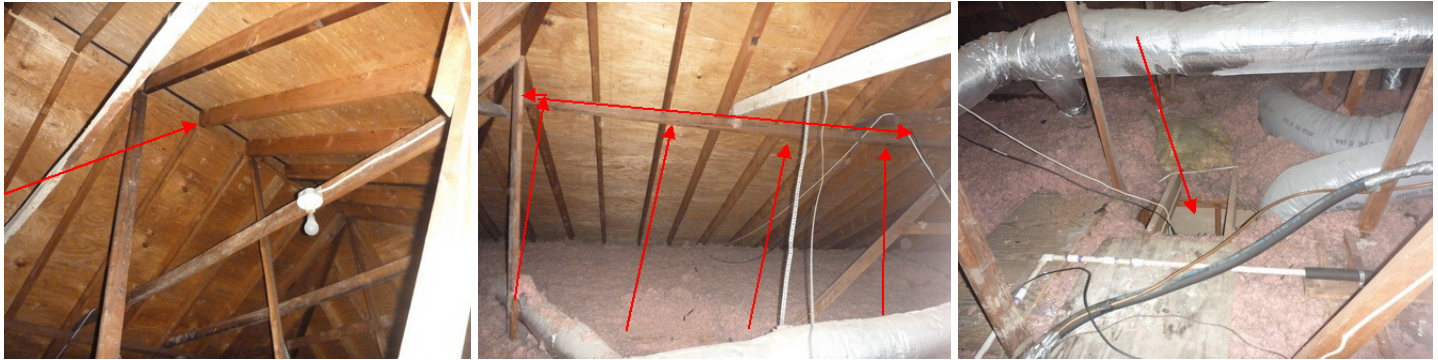
- 16. D. ROOF STRUCTURE and ATTICS: Stiffen the existing / install additional ridge bracing and rafter support.
- 17. The ridge boards are undersized – (see exposed heels at the rafters plumb cuts).
- 18. Fire block and insulate above the open duct chase in the upper attic. Install cold wall insulation where missing – (water tank attic storage area).
- 19. Note: the attic area above the garage is not safely accessible.

*Examples of under-sized ridge boards and insufficient bracing

*Fire-stop / insulate open chase

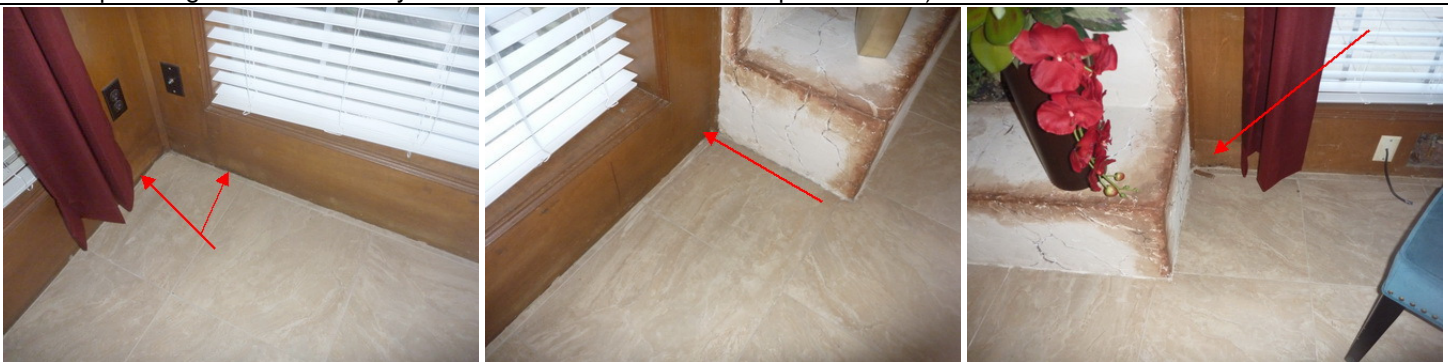
- 21. E. WALLS: Caulk / seal at all penetrations in the exterior finish wall materials – (ie) utility lines, fixtures and electrical panels.
- 22. Replace the decayed – damaged exterior trim and siding materials – *house and garage).
- 23. Evidence of water intrusion is apparent at the base board areas in the family room /rear wall – (see decayed paneling /trim at the rear yard and at either side of the fireplace hearth).

*Evidence of moisture intrusion with visibly decayed interior trim

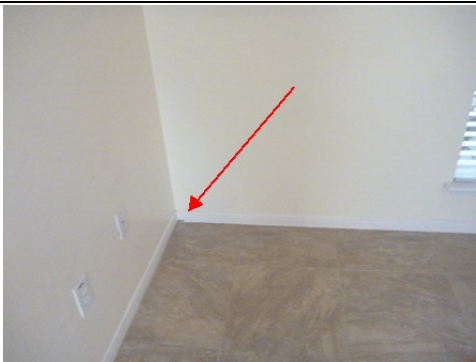
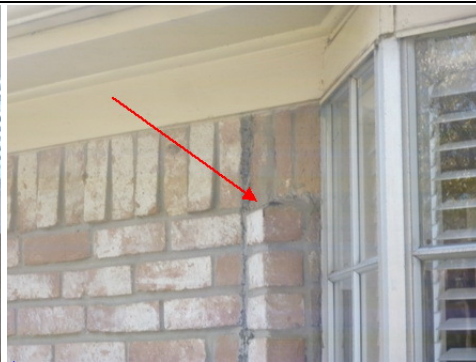
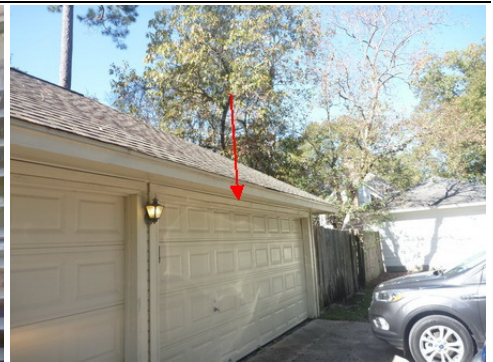
*Moisture damaged base trim-left rear 1st floor **Redo brick veneer *OH garage door frame header deflection

28. E. Contd: The frame header at the 16' OH/ garage door is noticeably deflected.
 29. Evidence of water leaking is apparent at the upper and side window returns at the rear wall in the main living room most likely as the result of missing or faulty easter barrier flashings.

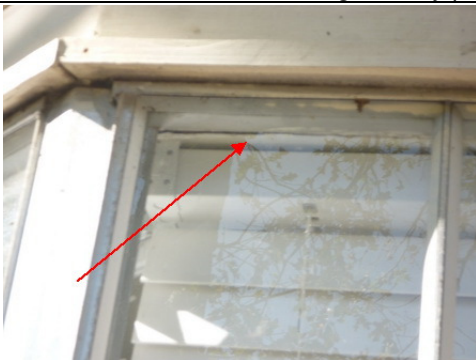
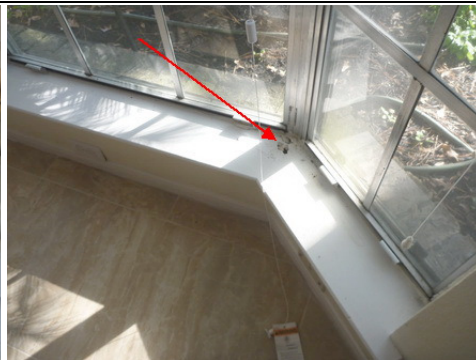
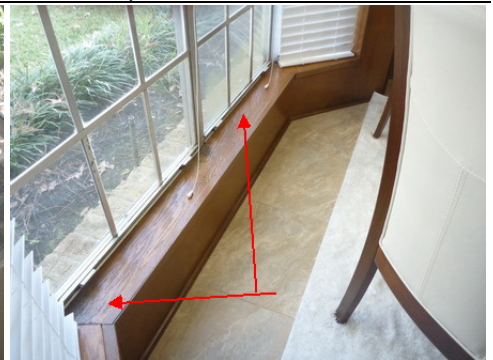
34. H. WINDOWS: Evidence of water leaking is apparent at the upper interior window returns at the bay window – front / left room.
 35. Install screens where missing.
 36. Repair damaged window screens.
 37. Replace the damaged glazing strips at the exterior window glass.
 38. The windows are difficult to open and in the sleeping areas could be considered as an emergency exit restriction.
 39. Several of the windows are secured or sealed shut.
 40. Water and or possible insect damage are apparent at the interior window sills in the front left room and breakfast area – (note: the condition of the construction materials inside of the wall cavities is unknown).
 41. The windows are in generally poor condition and the client has been advised that replacement would be advisable

*Evidence of water leaking-top of windows *Interior sills/ possible frame damage – front room and breakfast area

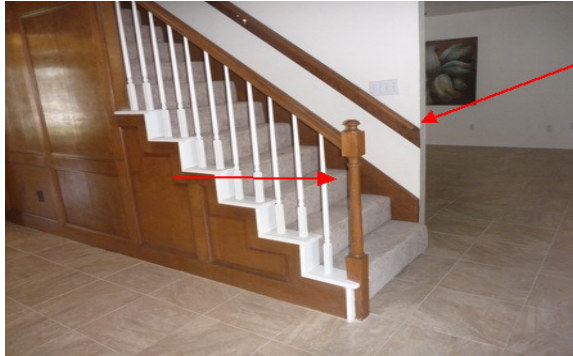
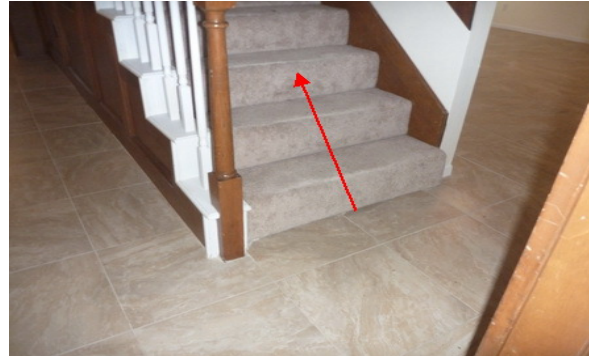
- 42. I. STAIRWAYS: The baluster spacing at the barrier rails exceed 4".
- 43. The hand rail should return back to the side wall at the ends.
- 44. The hand rail at the top of the stairwell is too low.
- 45. The riser height should not exceed 7 3/4" or vary by more than 3/8" from the others.
- 46. The tread depth is too narrow

*The baluster spacing exceeds 4"; the handrails should return back to the side walls; riser height variance

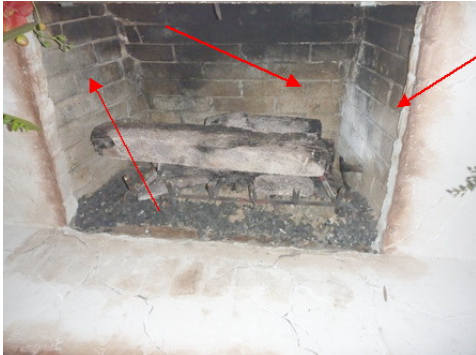
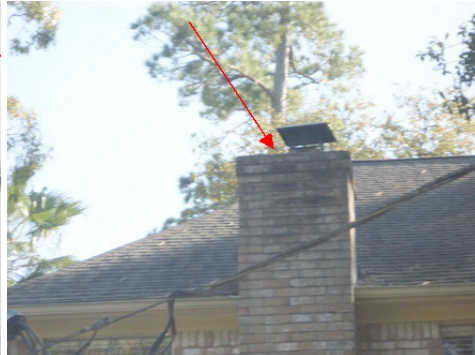
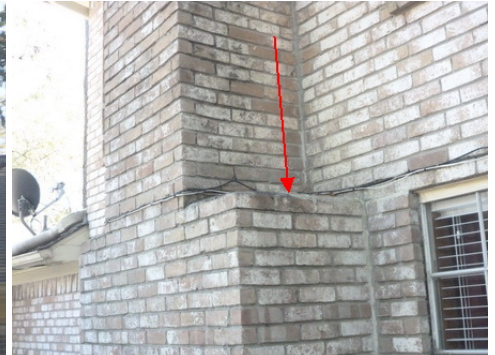
- 47. J. FIREPLACE and CHIMNEYS: Install a bracket for the damper to prevent full closure for the gas log assembly.
- 48. Evidence of water / moisture intrusion is apparent at the interior masonry firebox – (visible efflorescence and rusting at the lintel and damper).
- 49. Install metal cap flashings at the top of the chimney chase and exterior horizontal brick above the smoke chamber.
- 50. A masonry contractor / fireplace – flashing waterproofing specialist should be contacted to make all repairs / improvements as needed to insure safe – leak free performance.

*Evidence of water /moisture seepage into the firebox. *Install metal cap flashings at the horizontal masonry surfaces

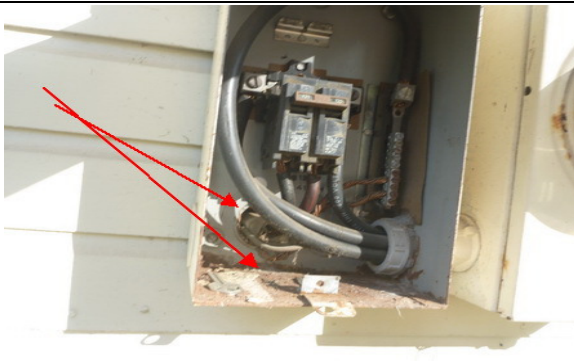
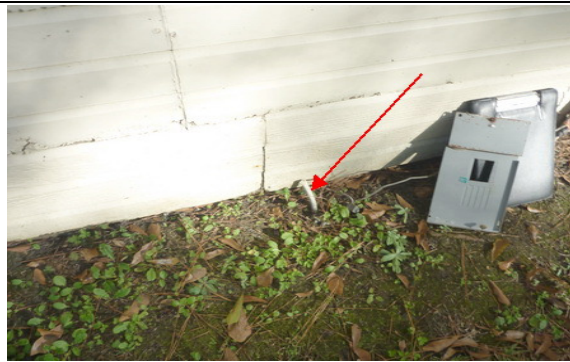
- 51. A. SERVICE ENTRANCE and PANELS: the interior of the main disconnect switch box is rusted – (faulty water-resistant cover) – replacement recommended.
- 52. Electrical wiring is entering the panel without an appropriate insulator at the knockout opening.
- 53. The ground rod should be driven fully into earth

*Rust / water entry into panel; missing insulator; drive ground rod fully into earth

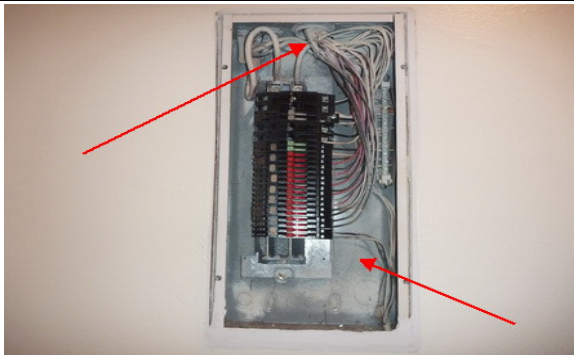
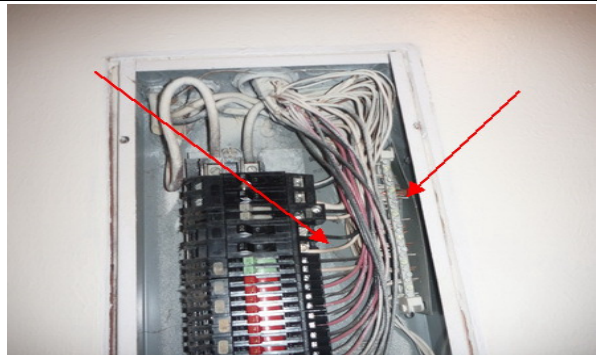
- 60. The neutral wires used as “hot” conductors should be permanently re-identified.
- 61. Install clamps for the single pole circuit breakers at the 220 amp circuits.

*Over-bundled wires; paint contaminated buss; separate the neutral / grounds; identify neutrals used as “hot” conductors

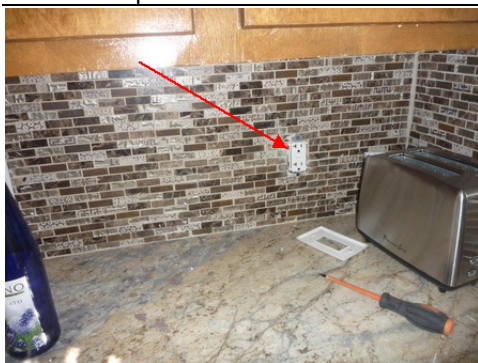
*Install box extenders

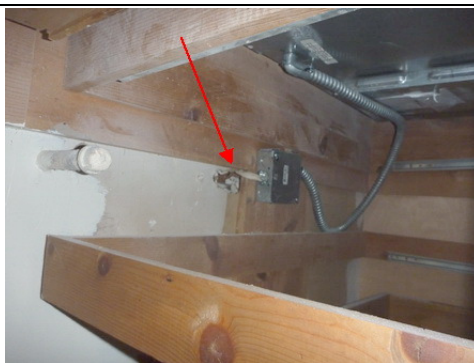
*Install conduit

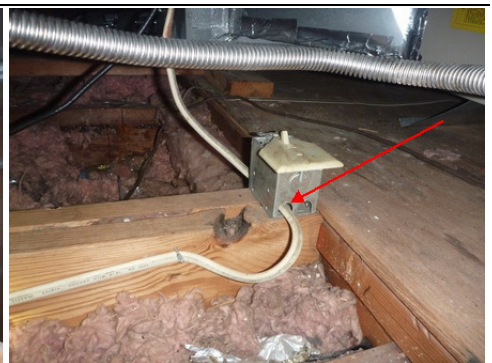
*Install insulator at knockout

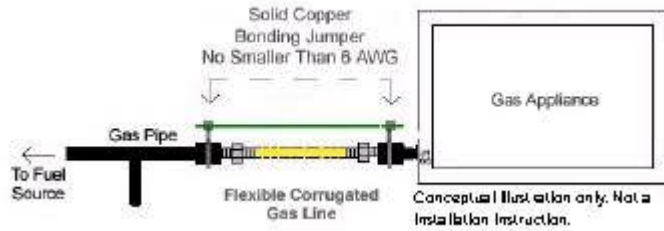
83. Install bonding jumpers at all metal gas piping interrupted by metal flex lines – (the NEC Section 250-104(b) reads as follows: “Metal Gas Piping. Each aboveground portion of a gas piping system upstream from the equipment

shutoff valve shall be electrically continuous and bonded to the grounding electrode system).

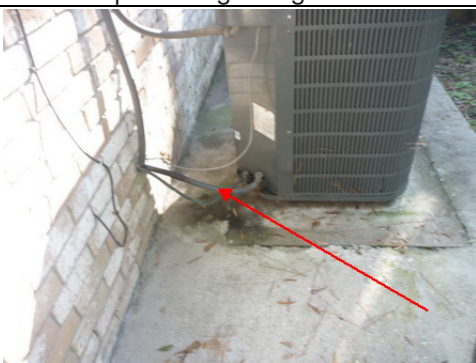
*Insulate the refrigerant line

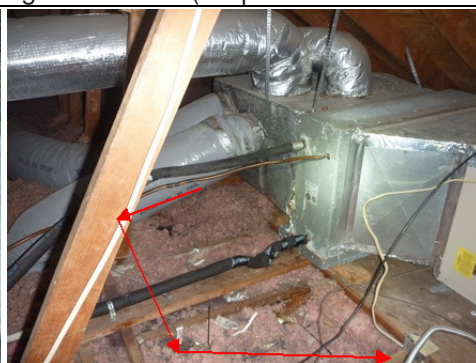
*Provide a walk path/ work platform

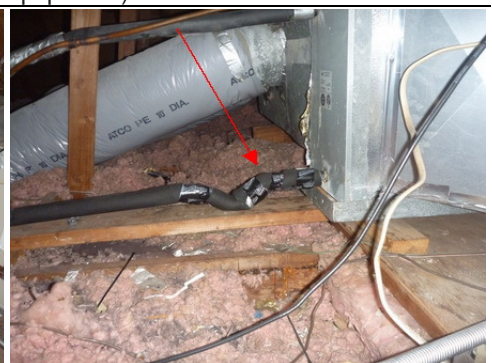
*Install a riser vent

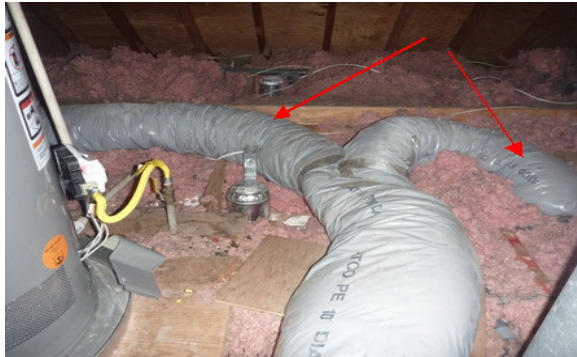
*Replace fiberglass insulated ducting

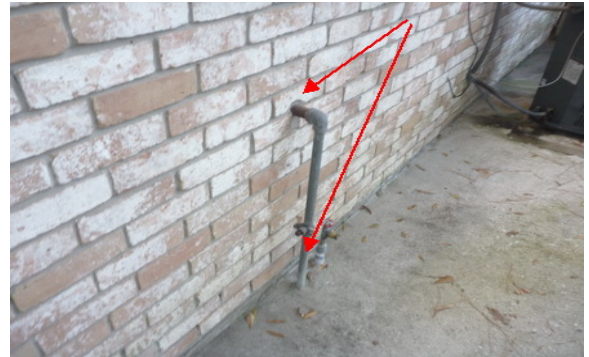
*Install protective sleeves for the gas pipe

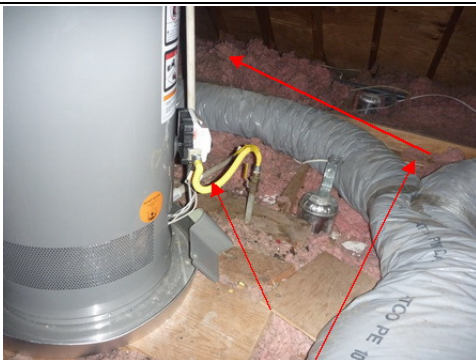
*Provide a work platform

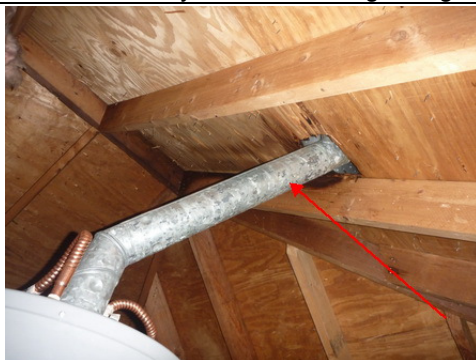
*Strap vent piping

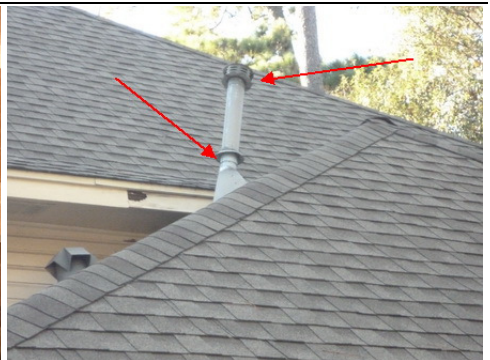
*Adjust storm collar and breather cap

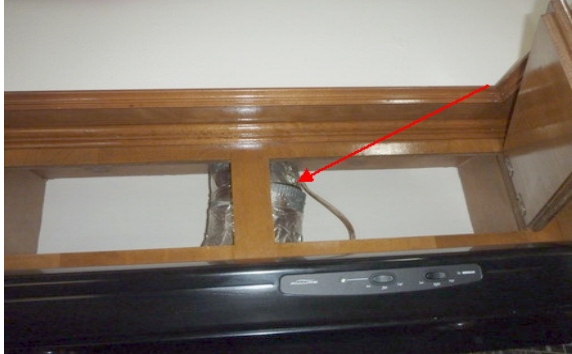
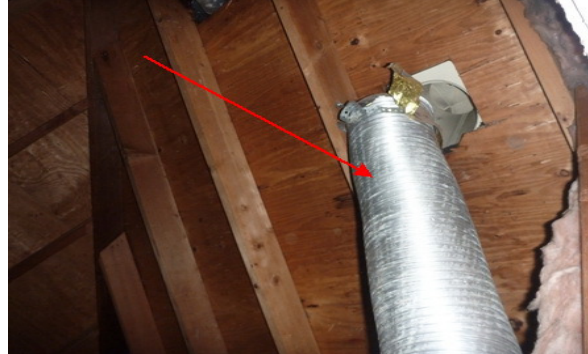
132. C. RANGE HOOD AND EXHUAST SYSTEMS: Repair the vent piping in the upper cabinet and the vent should be solid smooth wall extending through to the exterior – (see attic space above).

*Seal vent pipe in cabinet and solid smooth wall piping is required thru to the exterior
