Property Inspection Report

Concerning:
526 Magnolia Bend St,
League City, TX 77573

By:
Cory Alan Haddox, P.E.
Professional Real Estate Inspector
License No.: 20464
2635 North Spring
Spring, TX 77373

Issued: 18 May 2019
Revision: 0

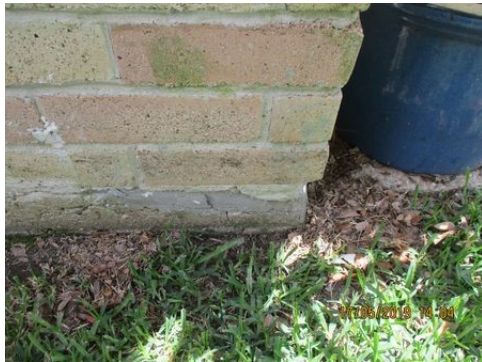
Photo 1

1. A corner crack was noted at the front left corner of the foundation. See Photo 1.

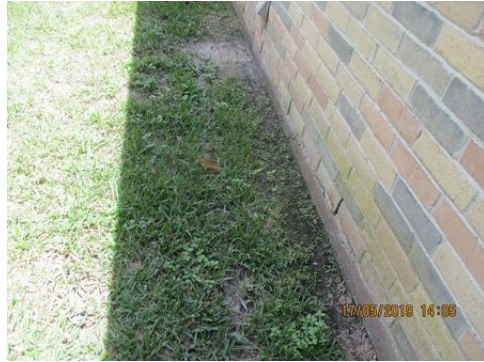
Photo 2

1. The yard and landscaping were found to be sloped to drain towards the foundation in a few places. See Photos 2 and 3.
2. The gutter downspout at the back left of the house was noted to be filled with debris. See Photo 4.

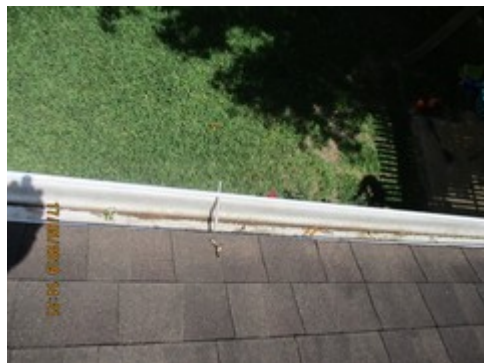
Photo 6

4. Some of the gutters were found to not be secured to the trim board properly. See Photo 6.
5. The landscaping at the front of the house was observed to have been recently pulled back from the foundation in some places, but was still noted to be built up above the brick line in others. See Photos 7 through 10.

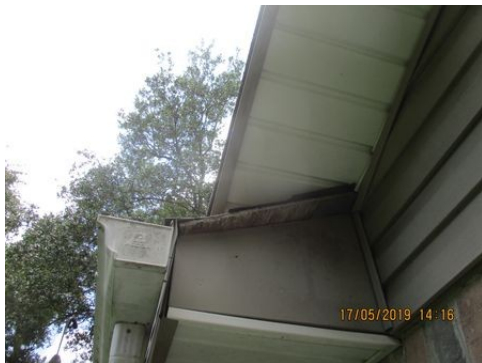
Photo 11

1. An uncovered and deteriorated piece of the roof decking was noted on the right side of the house. See Photo 11.
2. Tree limbs were found to be touching the roof surface at the front right corner of the house. See Photo 12
3. The flashing at the top edges of the roof was noted to be unpainted. See Photos 13 through 18. It is expected that flashing would be painted in order to avoid ultra-violet degradation.
4. As well, some exposed and rusted nails and unsealed seams were observed in several places on the flashing. See Photos 13 and 17 through 20.
5. Some damaged shingles were found. See Photo 21.
6. The small section of roof at the front of the house was noted to be without the sidewall flashing. See Photo 22.

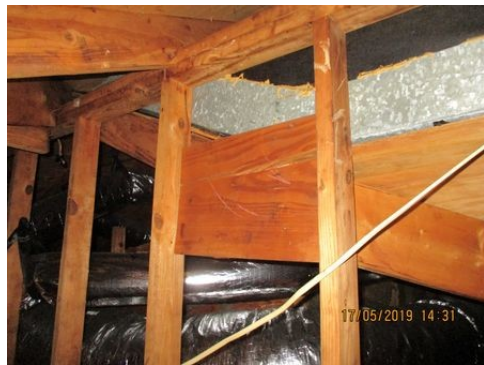
Photo 25

1. A piece of the attic framing was noted to be damaged. See Photo 25.
2. The attic ladder was found to have some missing hardware. See Photo 26.

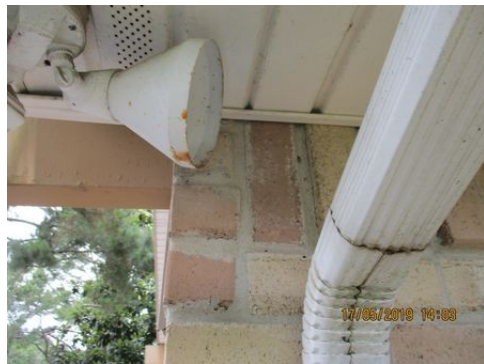
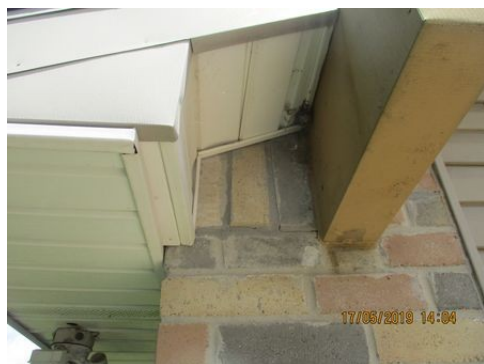
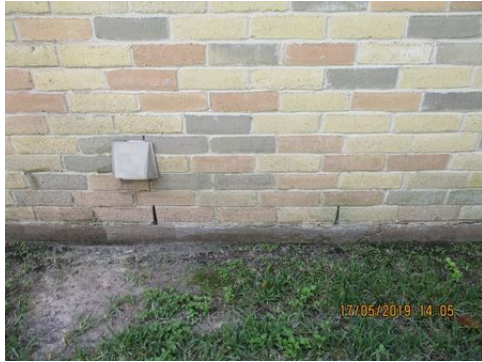
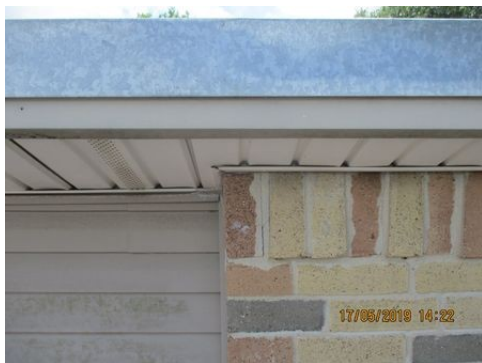
1. Several brick and mortar separations were noted on the exterior walls. See Photos 27 through 35.
2. The caulk in the exterior brick wall expansion joints was found to be deteriorated and separated. See Photos 36 and 37.
3. The caulk on the trim and siding was observed to be deteriorated and separated in several places. See Photos 38 through 50.
4. Openings were noted above the beams at the front of the garage. See Photos 51 and 52.
5. The trim and siding were found to be damaged in a several places. See Photos 53 through 65.
6. The tile was observed to be cracked near the shower head in the master bathroom shower. See Photo 66.

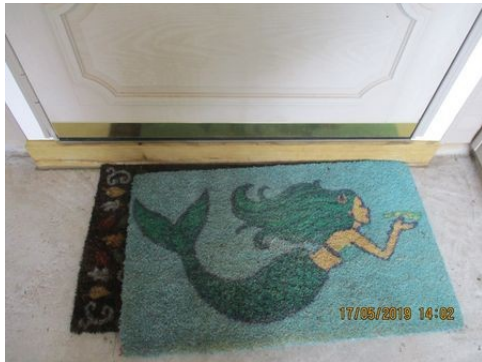
Photo 67

1. The front and back doors were found to have a piece of unpainted wood underneath. See Photo 67.
2. A garage entry door is expected to be 1-3/8 inches thick and to be self-closing. This garage entry door was noted to be less than the expected thickness and to not be self-closing. See Photo 68.
3. As well, the door handle for this door was observed to be loose. See Photo 69.
4. The closet by the front door was found to rub the frame.
5. The back right bedroom closet door was noted to not latch.
6. The master bedroom shower door was observed to have a loose handle.
7. The laundry doors were found to be misaligned and rub together when they were shut. See Photo 70.

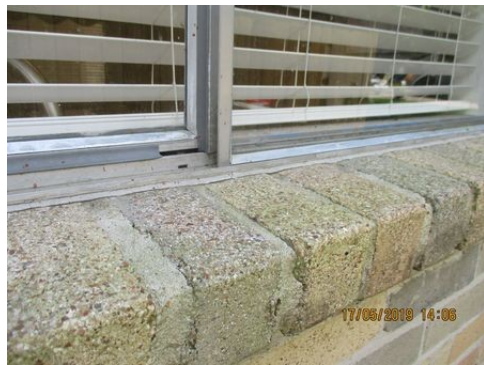
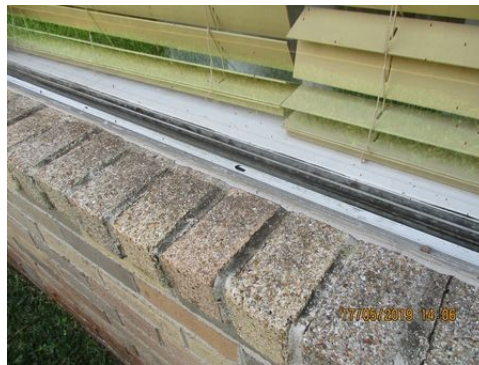
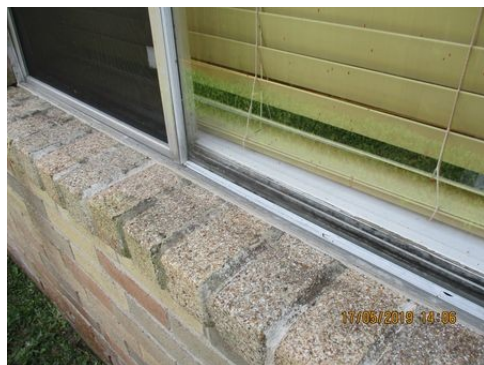
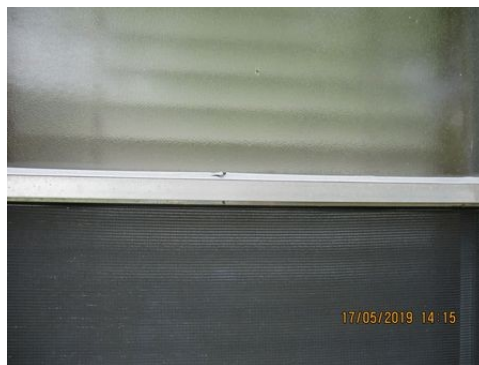
1. Some of the windows were noted to have deteriorated window seals. See Photos 71 through 74.
2. The caulk around some of the windows was observed to be deteriorated. See Photos 75 and 76.
3. Some of the windows were found to be without window screens.
4. The window screens at the back left window were noted to have bent frames. See Photos 77 and 78.
5. Windows that are less than 18 inches off of the floor are expected to be made of safety glass. Some of the windows in the house were noted to be less than 18 inches off of the floor but to not be made of safety glass or labeled as such.

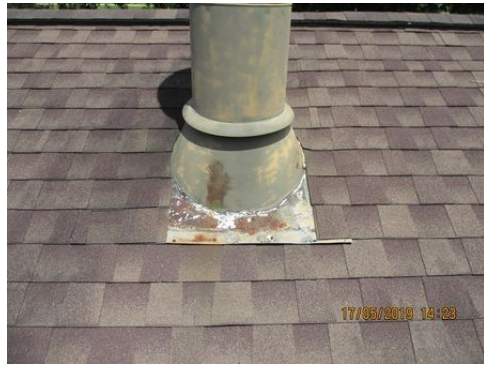
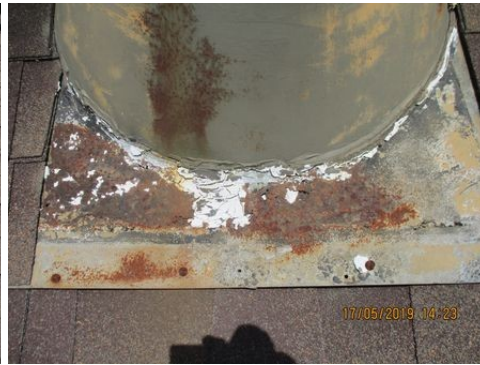
1. The chimney flashing was noted to be rusted. See Photos 79 and 80.
2. The chimney screen was found to be damaged. See Photo 81.
3. Brick and mortar separations were observed above the fireplace. See Photos 82 and 83.
4. The fireplace front cover was noted to not be secured in place properly.
5. It is recommended to have the fireplace cleaned and serviced before use.

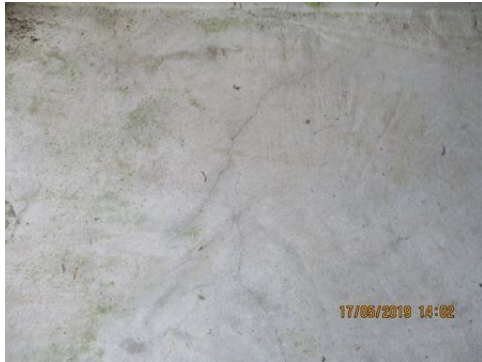
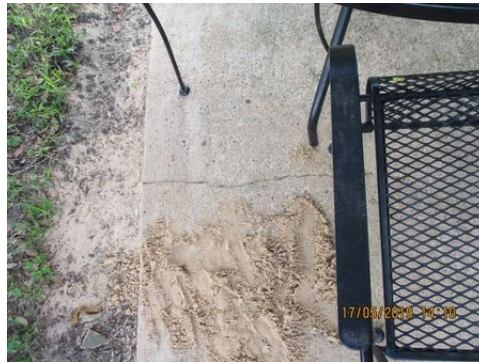
1. The front and back patios were noted to have cracks in the concrete. See Photos 85 through 88.
2. The back patio cover was found to move when pushed. It is recommended to have the cover further evaluated for the possible addition of bracing.

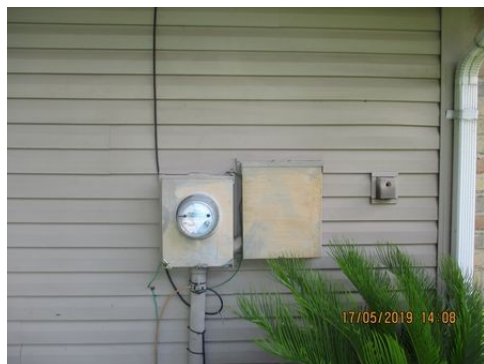
Photo 89

1. The 150 amp panel was observed to be Brand Bryant and was found to be located at the back left of the house. See Photo 89.
2. The panel was noted to not be labeled completely. See Photo 90.
3. Some replacement breakers of a different brand than the panel were observed in the panel. This could be a safety hazard.
4. Due to the age, it is recommended to have the panel further evaluated for replacement.

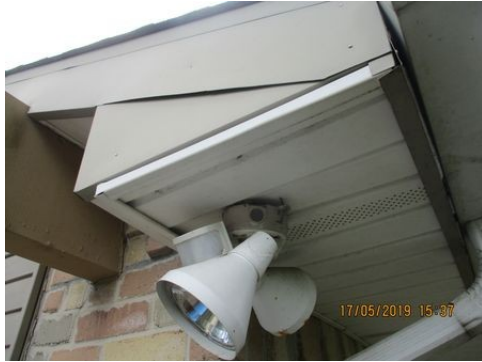
Photo 91

1. The exterior light fixture at the front right of the garage was found to not be secured to the eave properly. See Photo 91.
2. As well, pests were noted to have a nest built in one of the fixtures. See Photo 92.

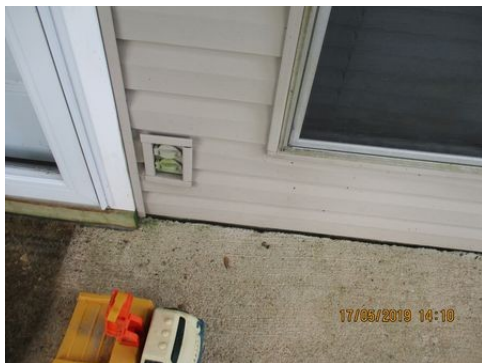
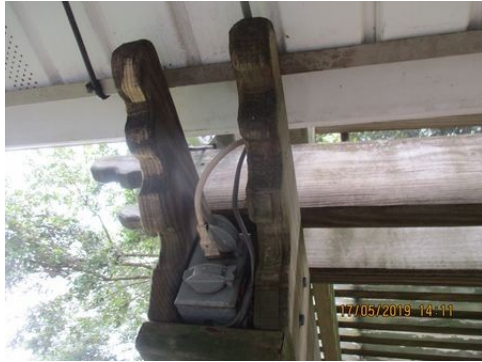
3. The exterior light fixture at the front left of the garage was observed to have a cover that had fallen off. See Photos 93 and 94.
4. Ground Fault Circuit Interrupter (GFCI) receptacles were noted to be missing or not labeled in several locations. GFCI receptacles should be in all wet and exterior locations. See Photos 95 through 98.

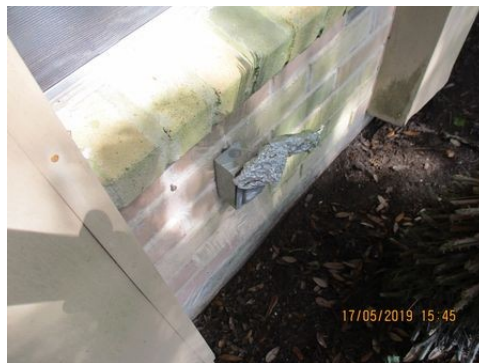
Photo 96

5. As well, the receptacle at the front of the house was found to not be secured to the wall properly. See Photo 96.
6. The wiring at the back patio cover was observed to be run outside of a conduit. See Photos 99 through 101.

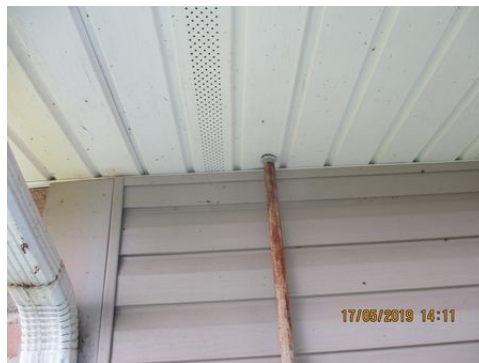
Photo 102

7. A rusted conduit was noted at the back right corner of the house. See Photo 102.
8. It is expected that an exterior receptacle would be located near an exterior door. No exterior receptacle was found near the front door.

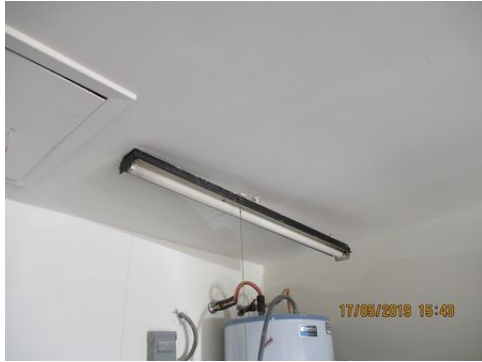
Photo 103

9. A light fixture at the back of the garage was observed to not be secured to the ceiling properly. See Photo 103.
10. A wire termination outside of a junction box was noted in the attic. See Photo 104.

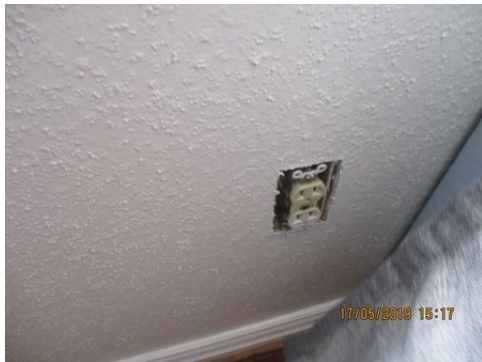
Photo 105

11. An uncovered receptacles was found in the master bedroom. See Photo 105.

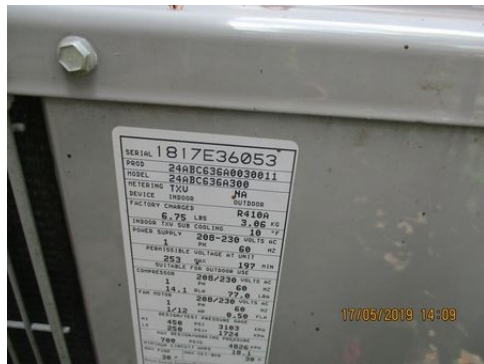
Photo 106

1. The exterior AC unit was observed by the serial number to have been manufactured in 2017. See Photo 106.
2. It is recommended that both the heating and cooling systems be serviced before use and annually thereafter.

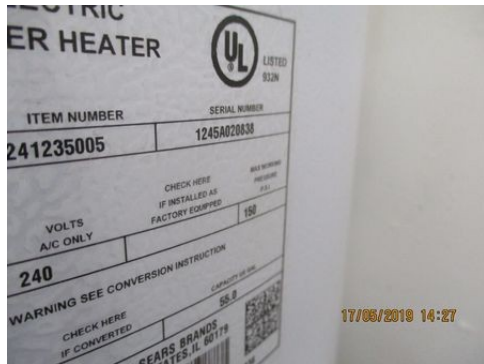
Photo 112

1. The water heater was found by the serial number to have been manufactured in 2012. See Photo 112.

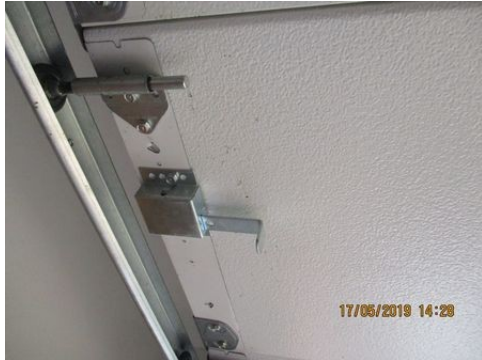
Photo 113

1. Garage doors with automatic openers are expected to have locks that have been disabled. This garage door was noted to have a lock that had not been disabled. See Photo 113.

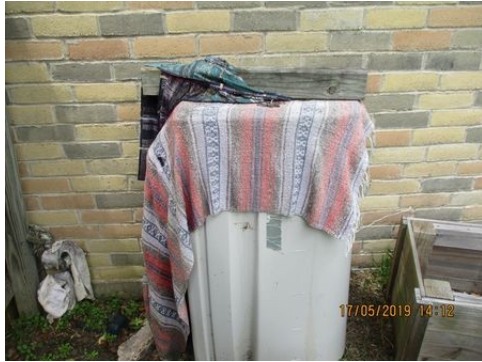
Photo 114

1. An unused water softener system was noted on the right side of the house. See Photo 114. It is recommended to discuss the reason for this system with the current home owner.

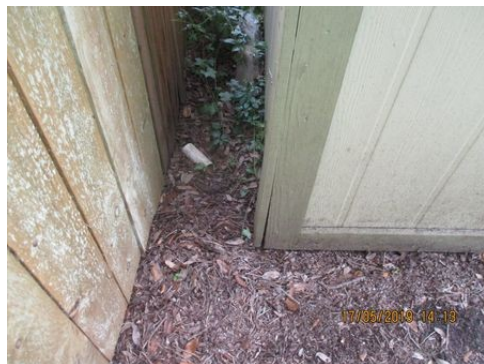
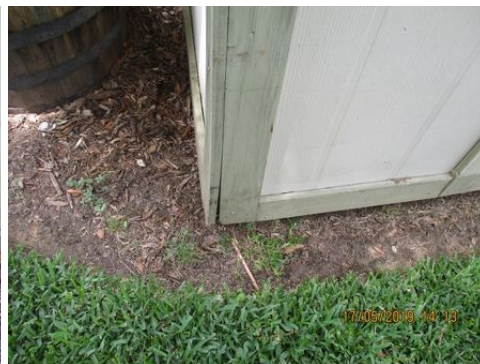
1. The trim and siding were found to be damaged and separated. See Photos 116 through 118.
2. The door was noted to be damaged. See Photo 119.
3. The hole for the light fixture above the door was observed to not be sealed properly. See Photo 120.
4. Ground Fault Circuit Interrupter (GFCI) receptacles were noted to be missing or not labeled in the shed. GFCI receptacles should be in all wet and exterior locations.
5. The receptacle on the outside of the shed was found to be missing the cover. See Photo 121.
