Total Home Inspection

Property Inspection Report

141 Clear Water W, Montgomery, TX 77356
Inspection prepared for: David Wisdom
Real Estate Agent: Kathy Hinds - Abby Realty

Date of Inspection: 11/11/2019 Time: 9:00 AM
Age of Home: 1996 Size: 1987
Weather: Cloudy - 70s

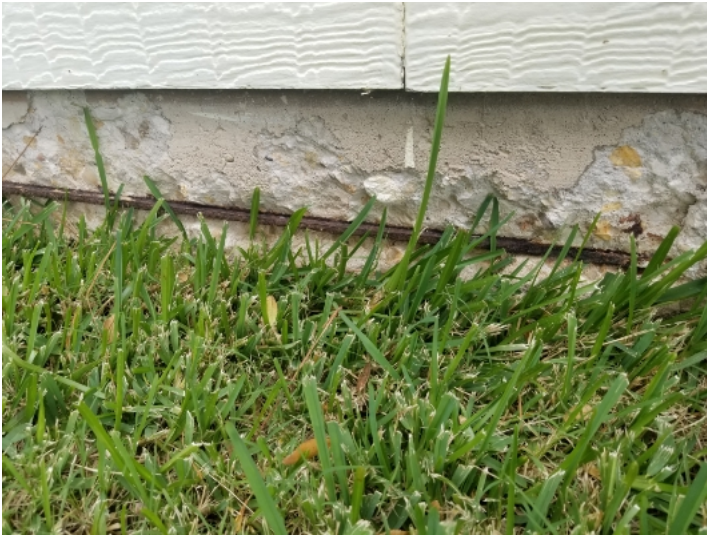
Steel rebar was exposed on the left side and should be treated and re sealed to prevent additional oxidation.

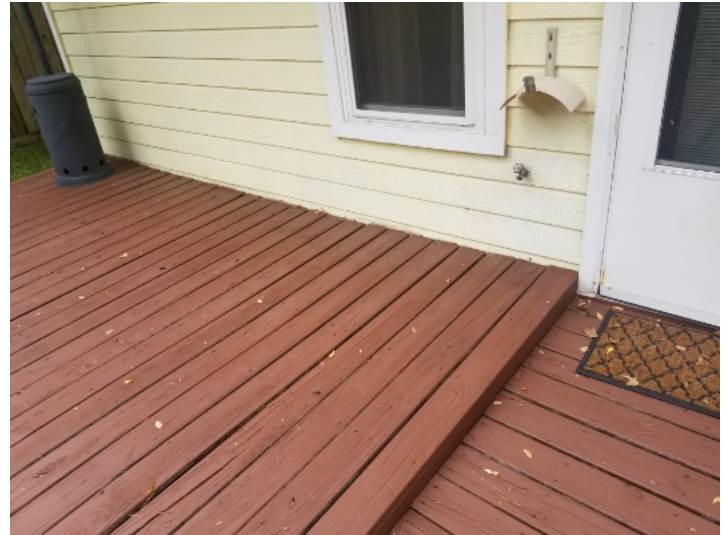
Some of the foundation was not visible due to decking.

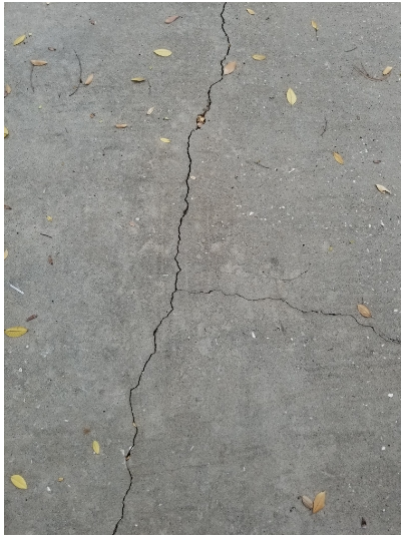
There were cracks on flat work around the home and in the garage.

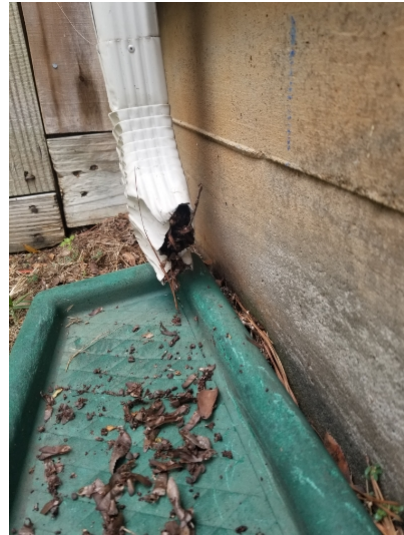
Downspout was pinched and may be clogged. Gutters are in need of some general repairs. Gutters should also be properly secured and pitched, joints should be sealed to prevent leakage and gutters cleared to promote water flow.

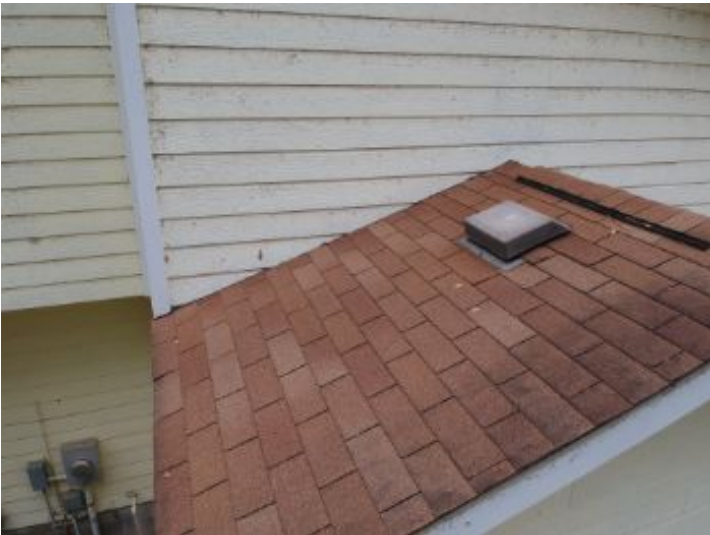
Siding was touching the roof surface on the left side. In our opinion, siding should be at least 1" from the roof surface.

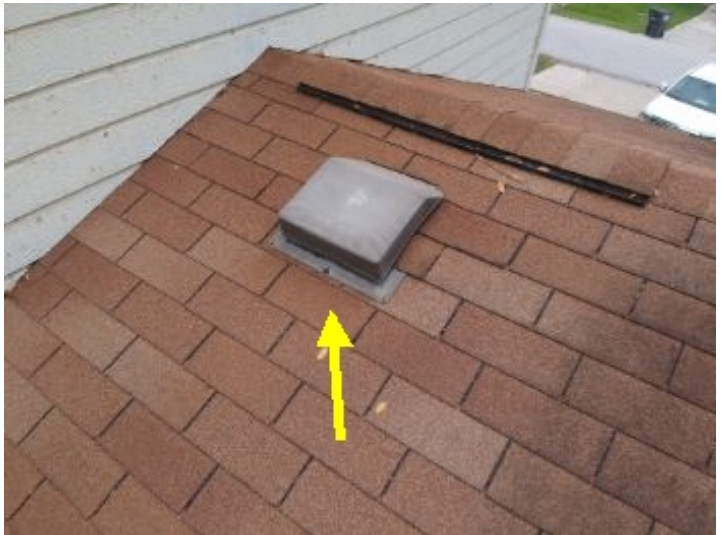
Exposed fasteners were noted at some shingles and roof flashings. These should be properly sealed.

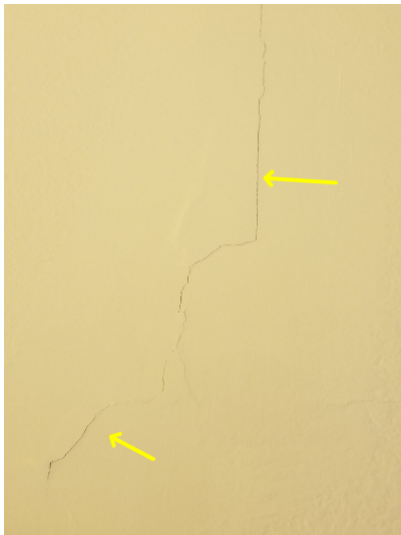
Some drywall cracks were noted around the home.

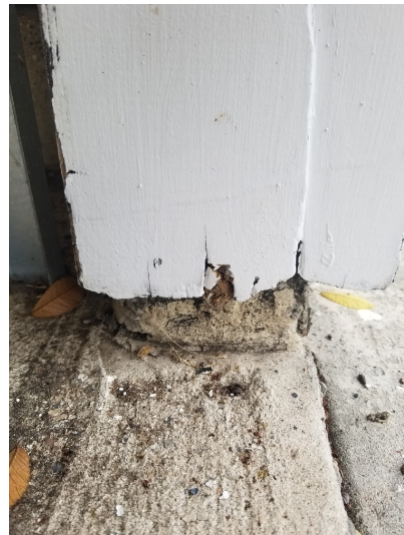
Deterioration of trim/siding was observed at the garage frame, some corner trim and rear entry door trim.

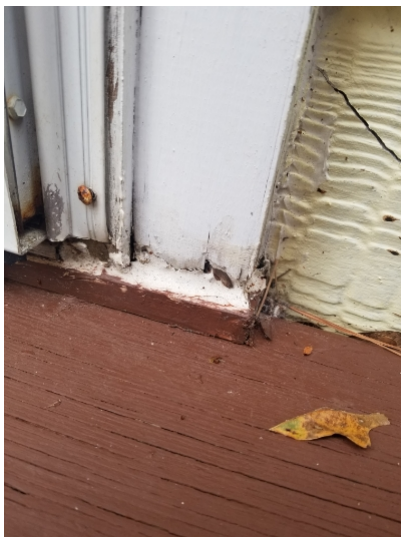
Deterioration of trim/siding was observed at the garage frame, some corner trim and rear entry door trim.

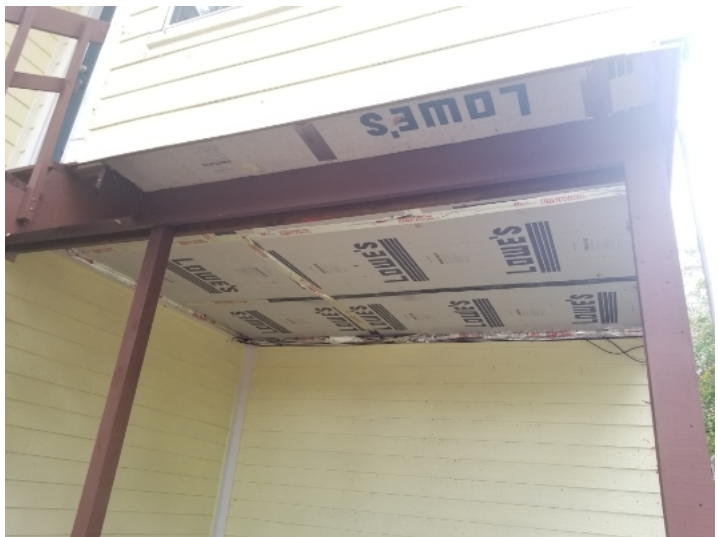
Sheathing insulation below 2nd level den may require a protective covering. Common building standards state that sheathing insulation materials are installed under or behind siding or roofing. We recommend further evaluation by a qualified professional.

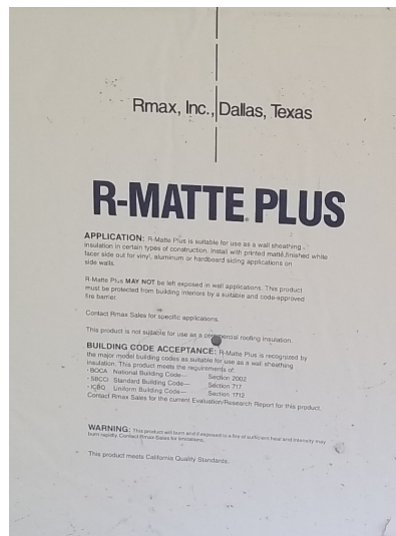
Sheathing insulation below 2nd level den may require a protective covering. Common building standards state that sheathing insulation materials are installed under or behind siding or roofing. We recommend further evaluation by a qualified professional.

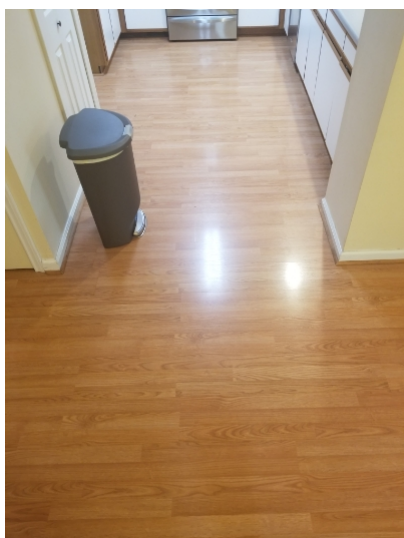
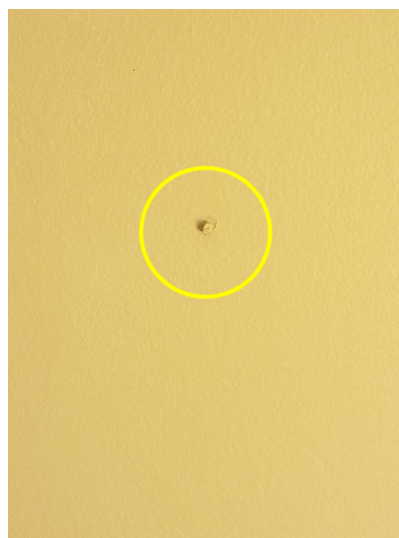
Upper floors were noisy in some areas. This may be due to loose sub flooring under the floor coverings.

Exposed or protruding drywall fasteners were noted on the 2nd level.

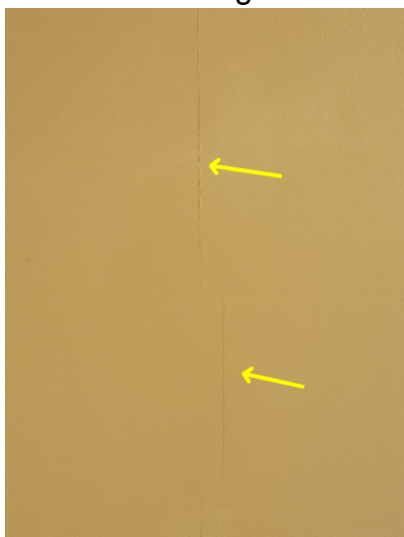
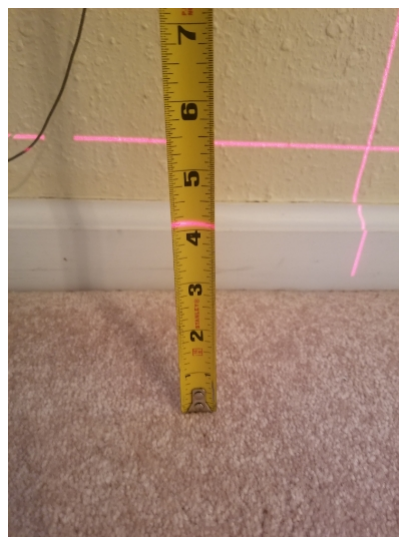
Ceiling cracks were noted on the 2nd level. In our opinion, there did not appear to be excessive deflection or settlement in these areas.

Some floor differential was noted in the 2nd level den. It is not uncommon for 2nd levels to show some differential, however, these measurements could be significant. For further evaluation we recommend consulting with a qualified contractor.

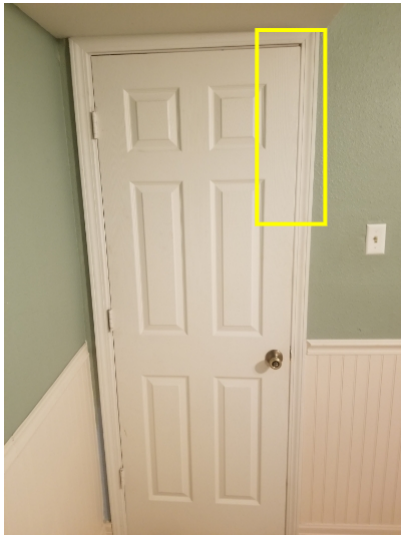
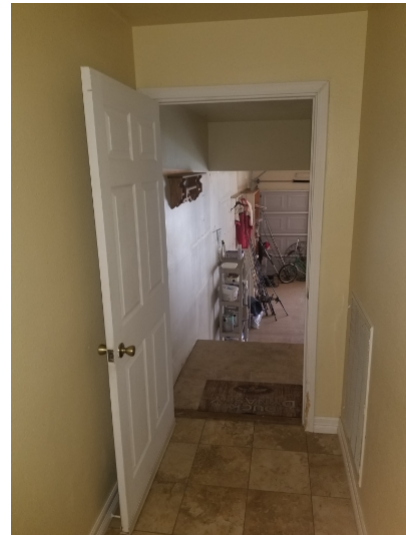
The 1st level bathroom and front bedroom doors were not square and contacting the frame and may require adjustment.

Self closing hardware was missing or ineffective at the garage pedestrian door.

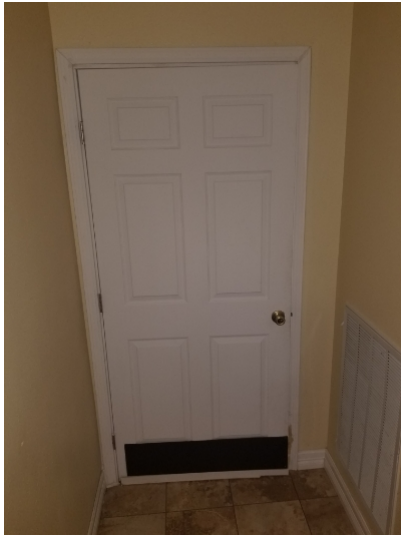
Garage door should be a solid core door. Hollow core doors are not rated to be installed at entries or exits.

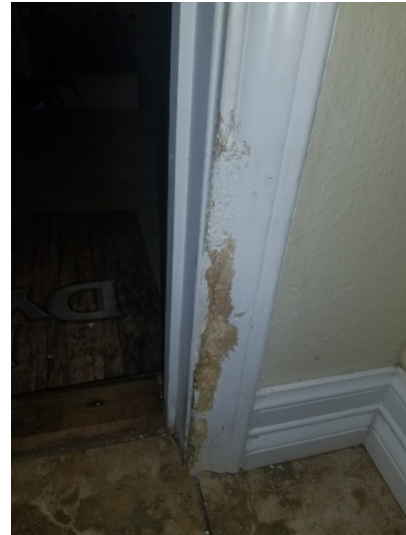
Garage door trim was damaged.

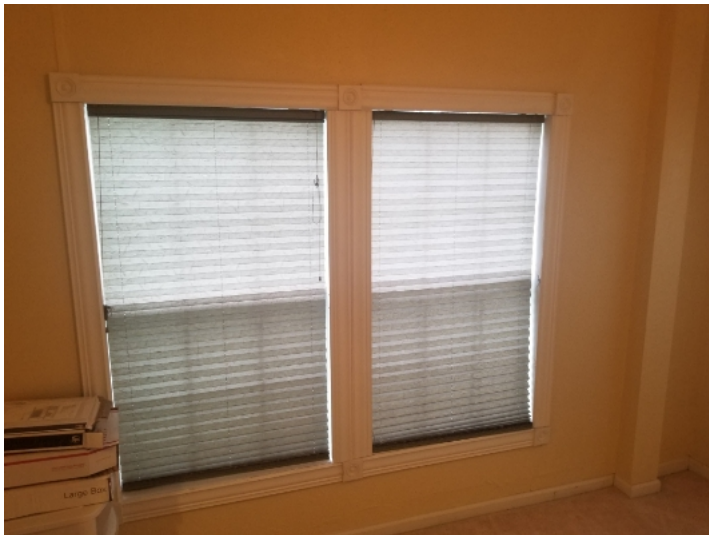
Broken/Cracked blinds were noted at multiple windows.

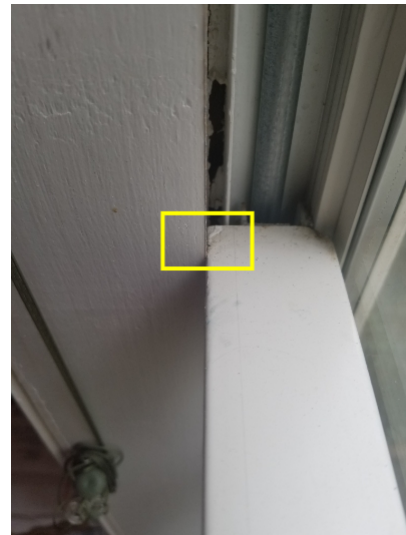
Some windows were not square and were contacting the frame.

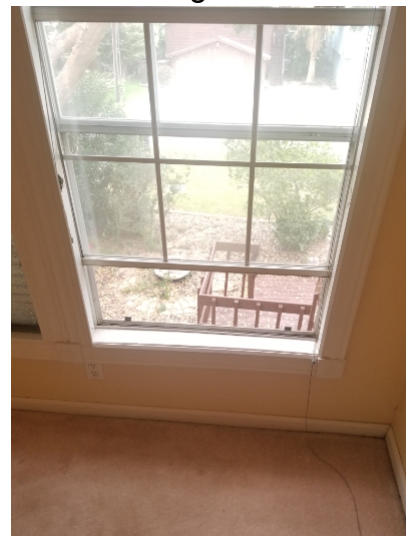
Windows on the upper level within 24" of the floor may present a fall hazard to children. Fall protection should be considered at all windows with an outside fall height greater than 72 inches that are within 24 inches from the inside floor.

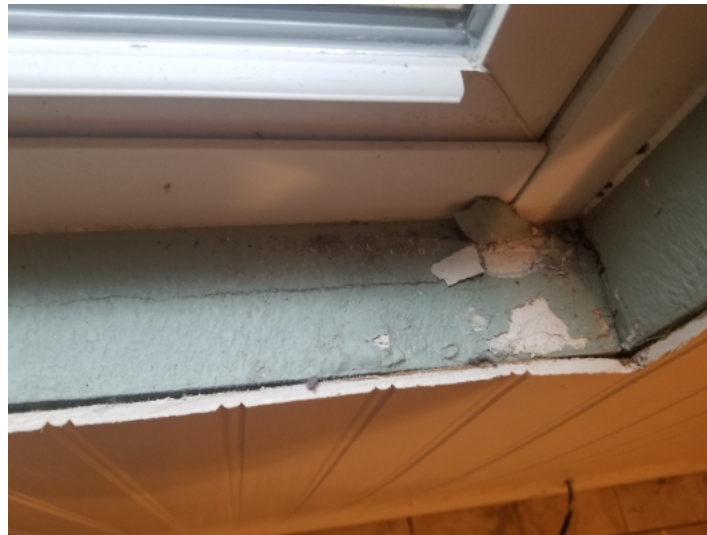
Some interior window sills showed signs of paint deterioration. This may be caused by typical condensation at window frames. Moisture was not present at the time of inspection.

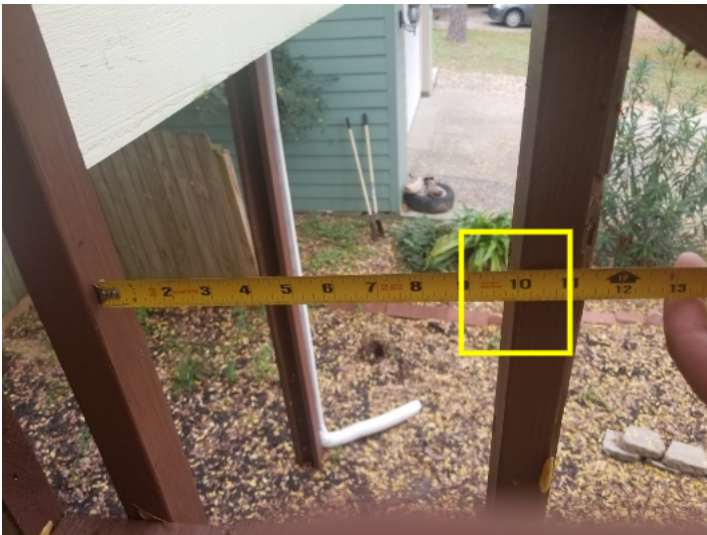
Common building code limits baluster spacing to 4 inches as a matter of child safety related to entrapment. Spacing was measured at 10 inches.

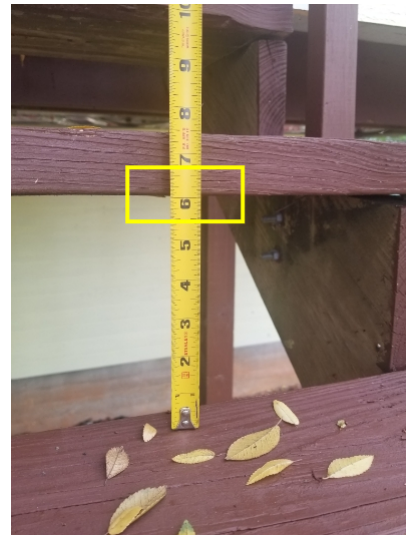
The lower openings are required to be 4 inches or smaller. Openings were measured at 6 inches.

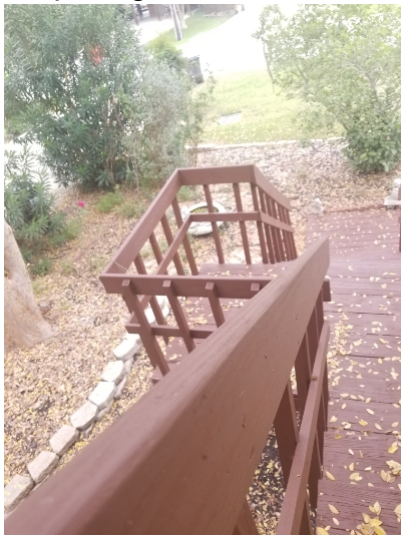
The entry stairway hand rails are not properly constructed. Common code requires them to be a Type 1 or Type 2 hand rail and no less than 1 and half inches between handrail and wall.

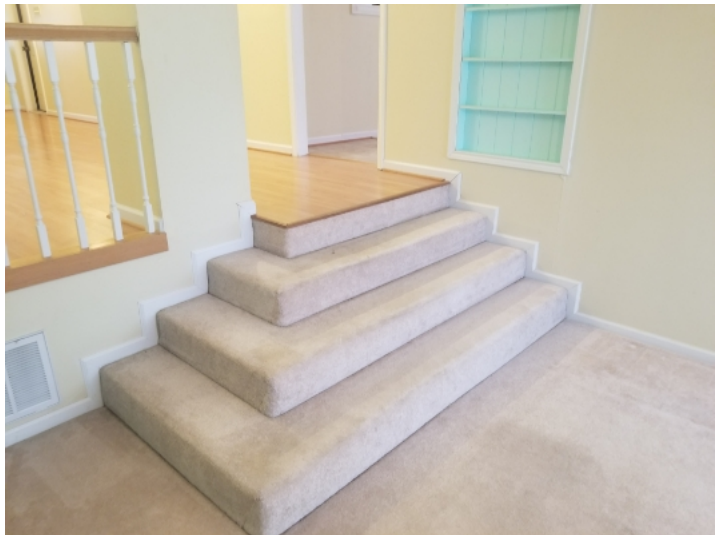
Handrails are missing at 2nd level living room and garage. Handrails are required at any stairway where 4 or more risers are present.

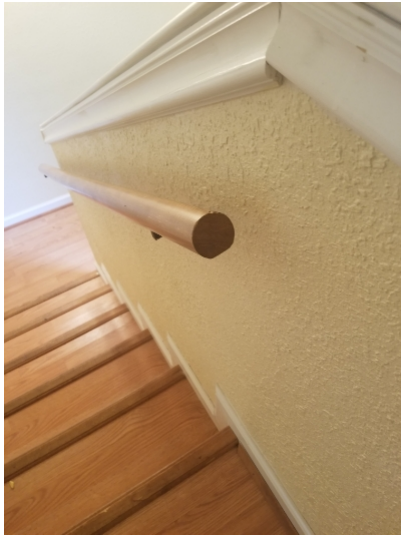
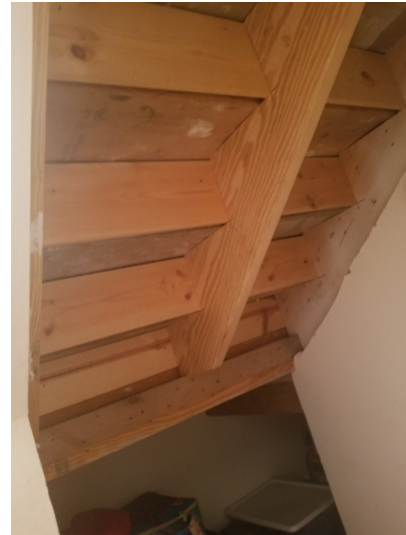
Handrails were not continuous to the walls. Open ended handrails may catch clothing or other items on a person resulting in trips or falls.

The underside of the interior stairway should be properly finished 1 hour fire rated drywall.

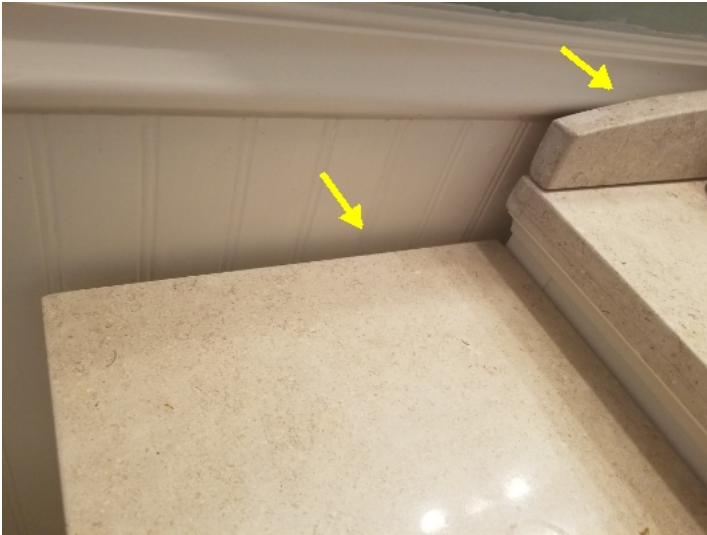
Intersections between counters and tile/wall contained gaps. Caulking improvements should be made to prevent water from entering these areas.

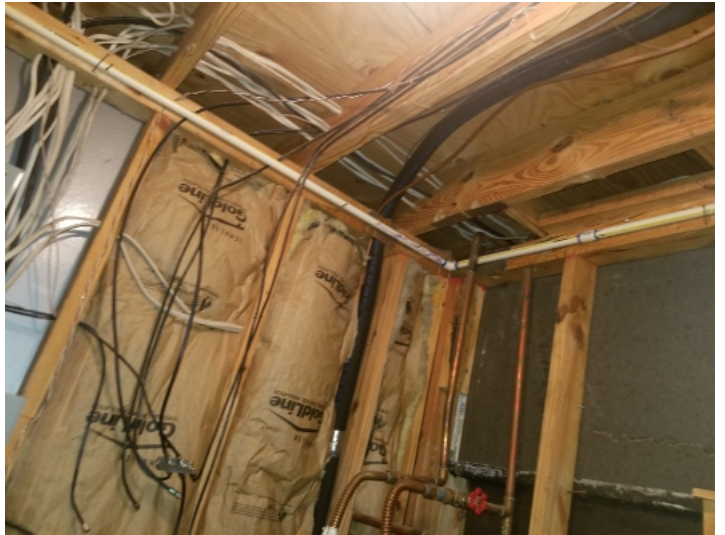
Utility room/closet should be finished with at minimum 1 hour fire rated drywall.

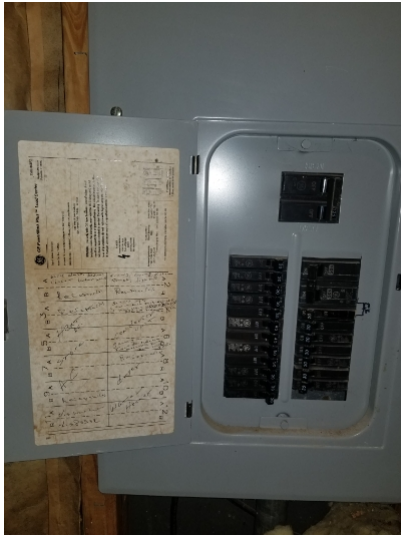
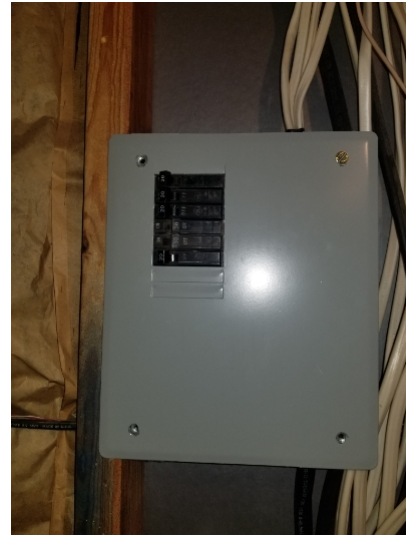
Electrical Systems Service Entrance and Panels All breakers for the panel boxes and/or sub panels must be clearly and permanently labeled for identification of particular circuit.

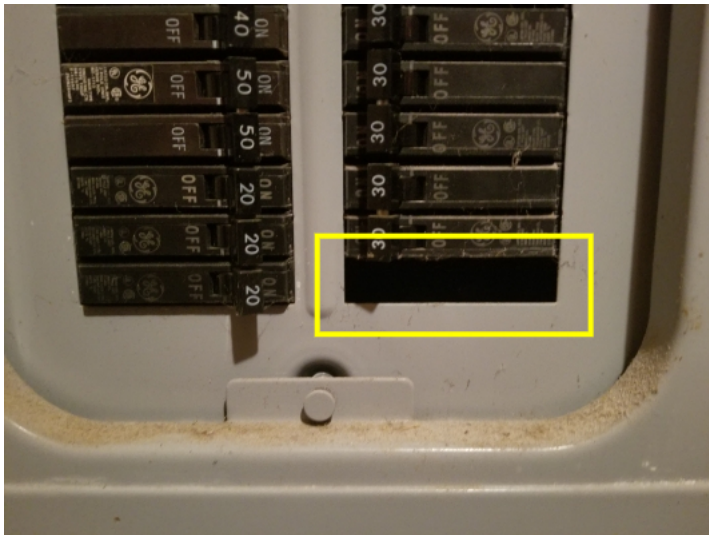
There were missing knockouts in the dead front cover. Interior of panel was exposed.

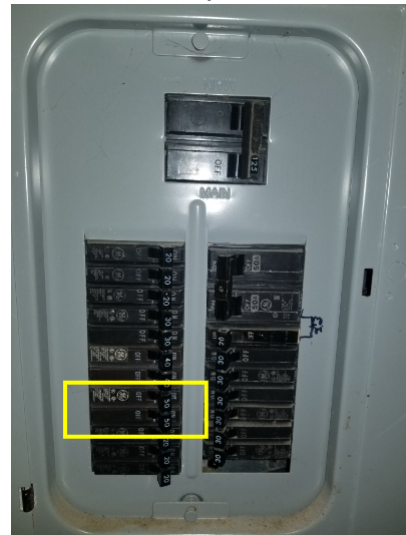
Breaker in electric panel is labeled as 50 amps. Max breaker on the condenser should be 40 amps per the manufacturer's label. Breaker is possibly oversized.

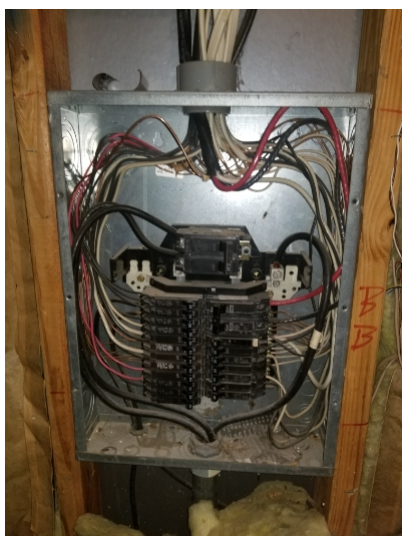
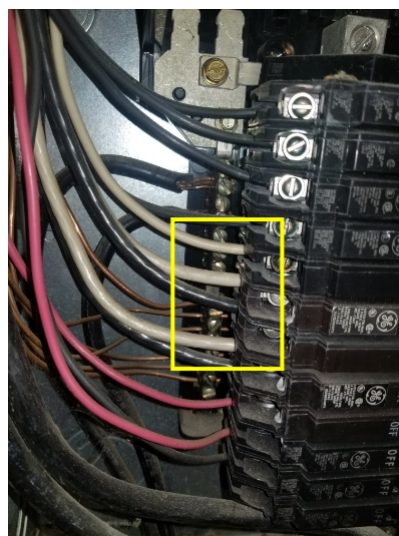
Electrical Systems Service Entrance and Panels White wires were connected directly to breakers in the panel. Typically white wires should be designated as neutral only. These should be marked appropriately.

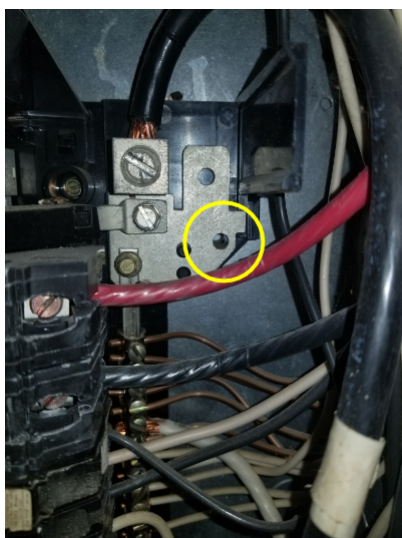
Electric panel enclosure did not appear to be bonded/grounded.

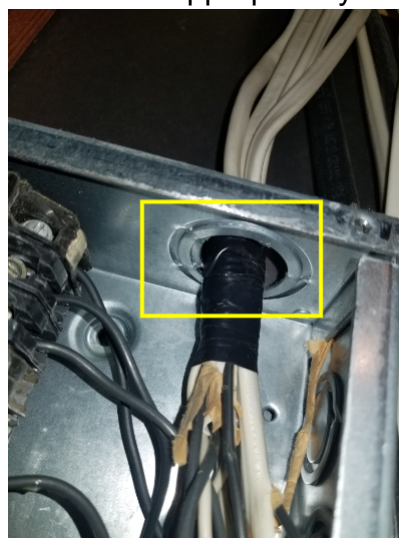
There is wiring entering the panel without the proper protective bushings. Wiring that enters the panel should be protected where it enters the panel by a bushing to prevent the sharp edges of the panel box from damaging the wiring.

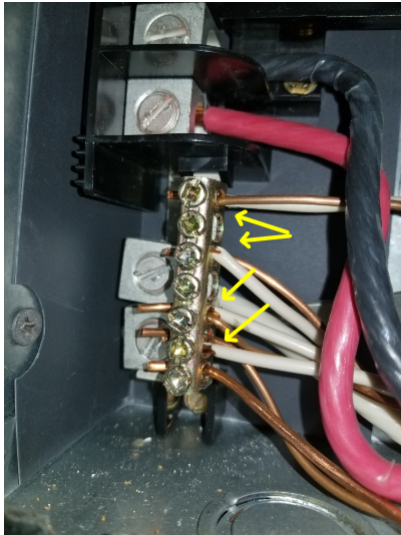
There were neutral/ground wires in the panel that were sharing spots on the bus bar.

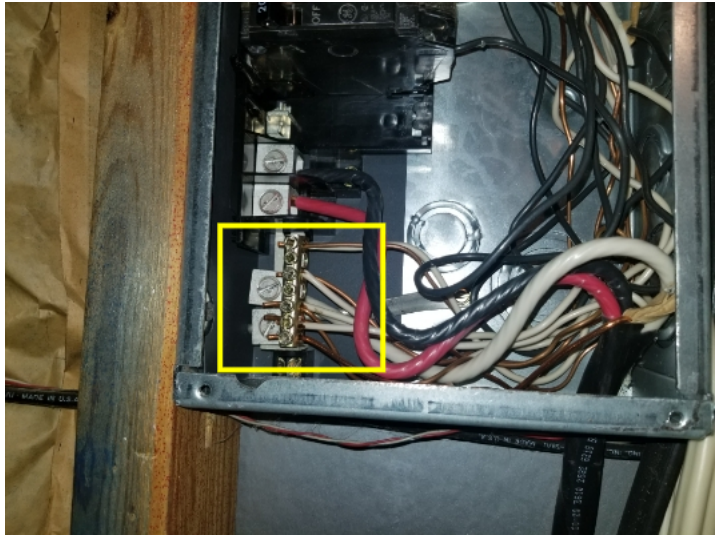
Neutral and ground wires were bonded in the electrical sub panel. Common practice requires that these be separated in any sub panels. This should be further evaluated and by a qualified electrician.

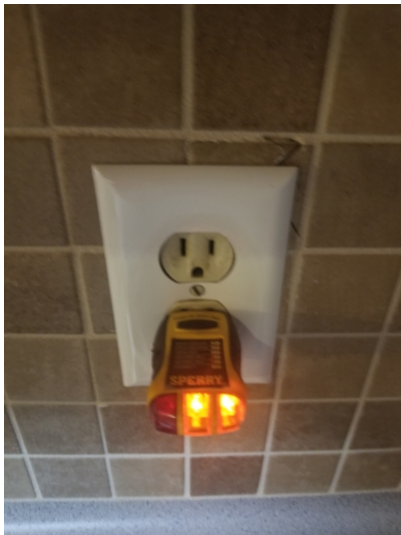
Not all outlets in the kitchen were ground fault protected.

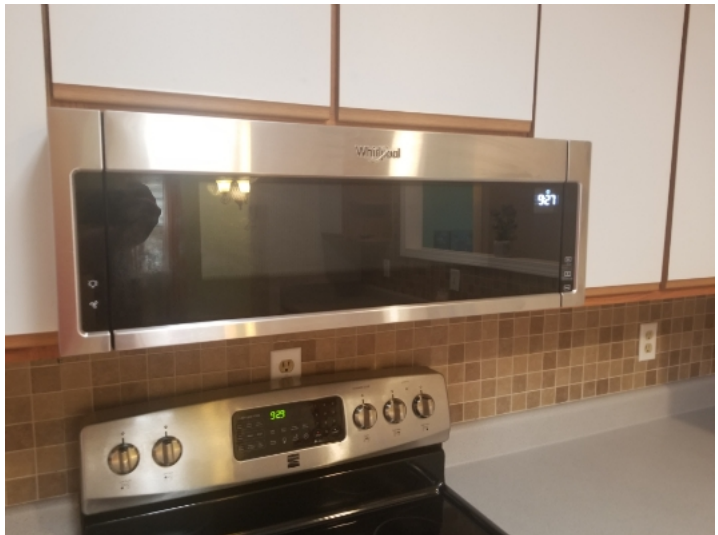
Microwave was connected to kitchen GFCI outlets. Kitchen appliances should be on the own dedicated branch circuit.

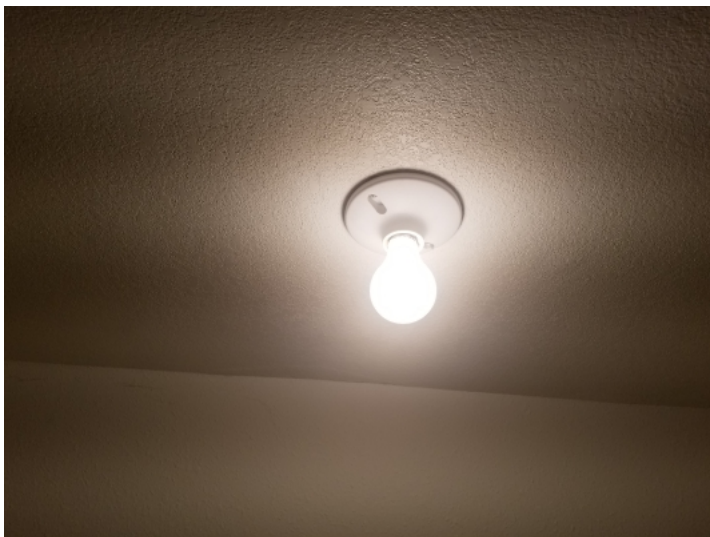
Open incandescent lighting was located in some closets and may be a fire hazard.

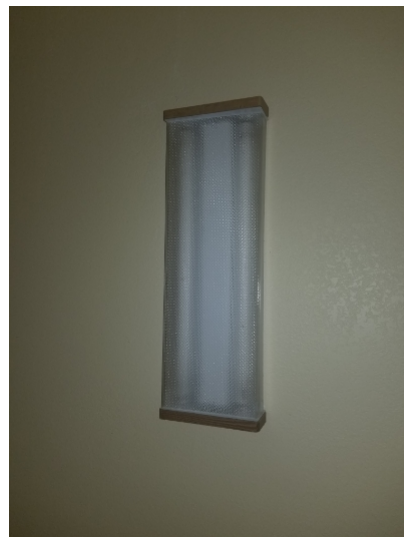
Fixture was not functioning in the laundry room. Light bulbs were not tested.

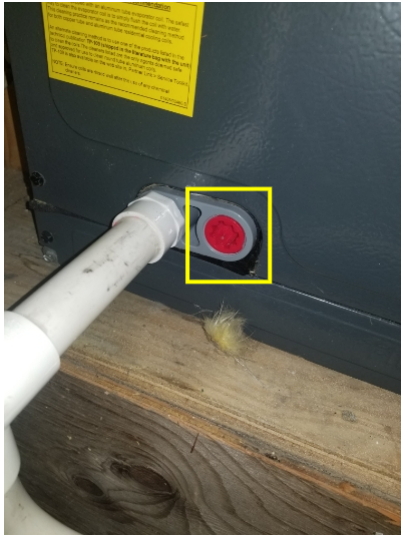
Secondary drain line was capped. This should be piped and routed to the emergency pan.

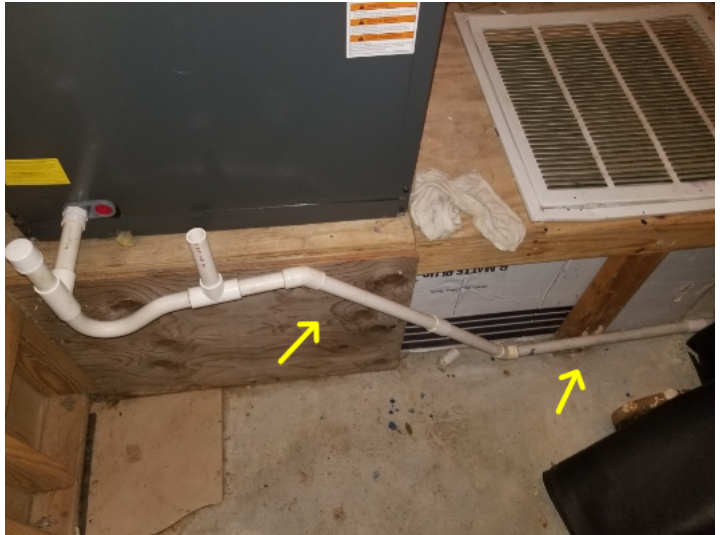
Main drain line was not completely insulated. These lines should be fully insulated in unconditioned spaces.

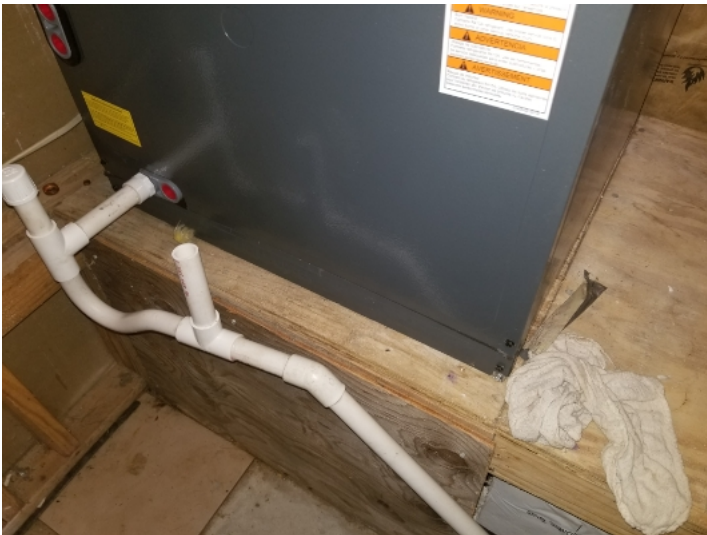
There was no emergency drain pan for the evaporator unit.

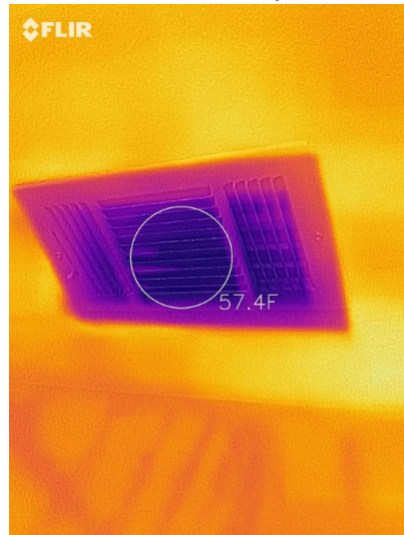
AC appeared to be cooling properly. Temperature differential measured (75-57=18) between air supply and registers. Typical range should be 15 to 20 degrees.

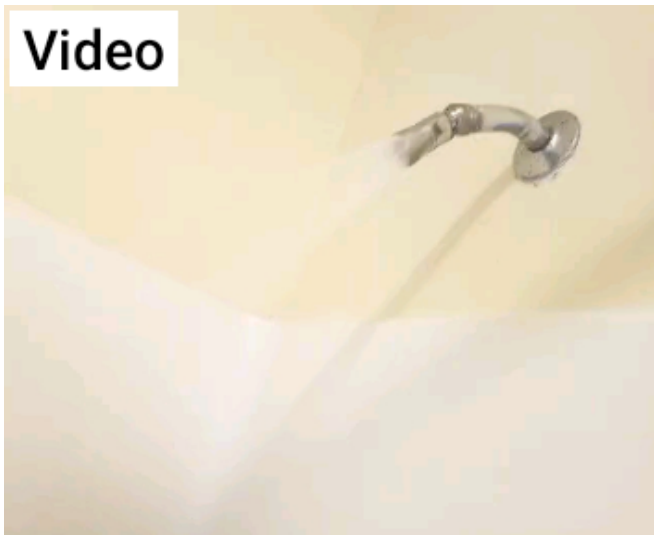
Shower diverter was not working properly in master bathroom.

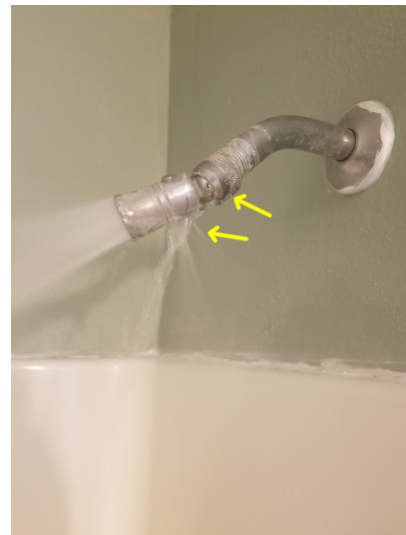
Shower head was leaking in the master bathroom and 1st level bathroom

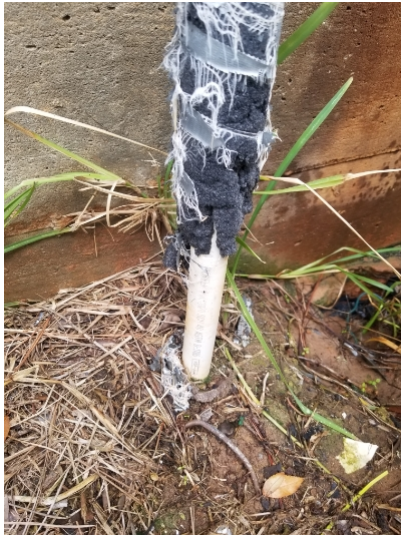
Insulation was missing from main water supply piping on the exterior of the building.

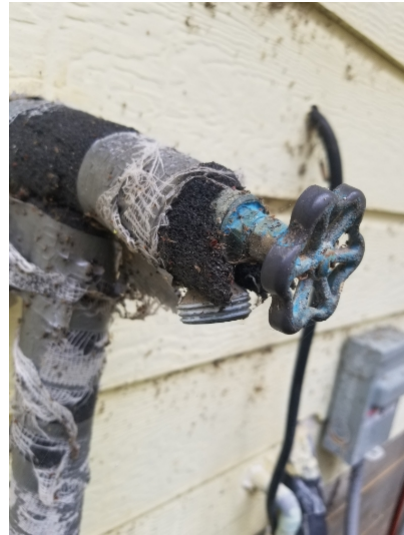
No backflow prevention devices were observed on exterior hose bibs.

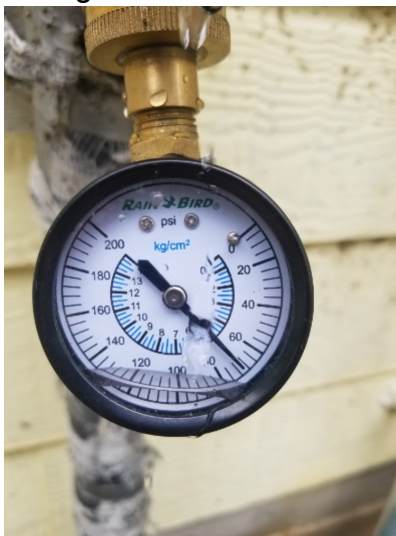
Static water pressure was observed to be: 70 psi. The acceptable range for residential water pressure is 40 to 80 psi.

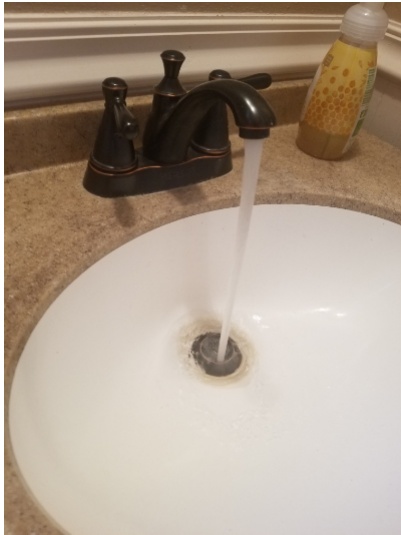
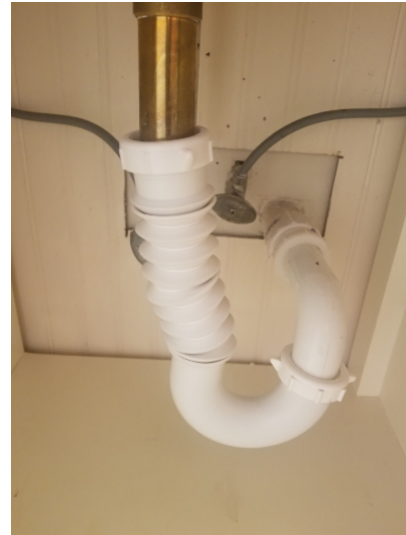
Sink stopper not working/missing in the 2nd level half bathroom and master bathroom. Flex drain piping was observed at some traps and is easily clogged.

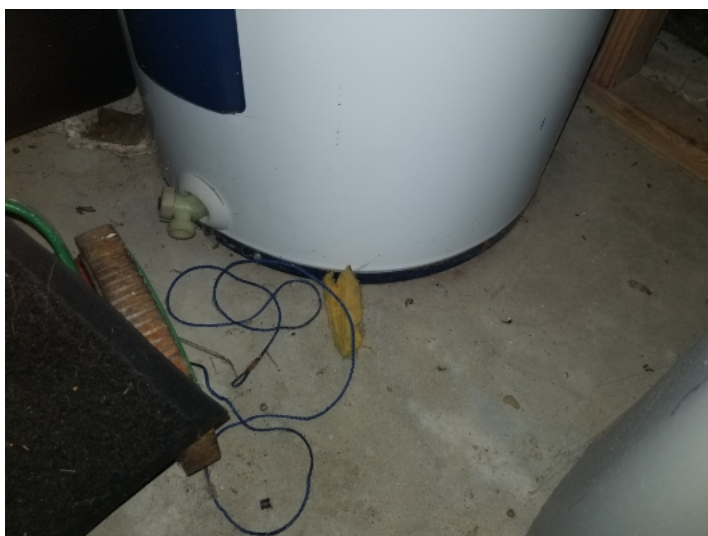
Water heater was missing the drain pan and is a required item in areas that leakage may cause damages.

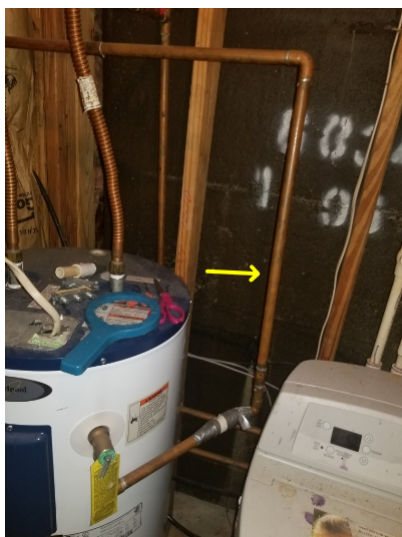
Temperature and pressure relief valve drain pipe should be gravity fed and sections were observed that did not meet this requirement.

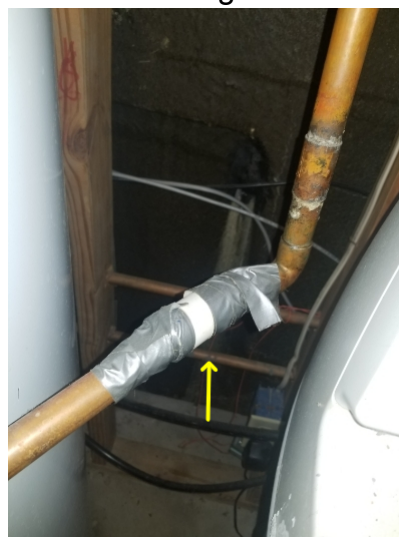
Temperature pressure relief valve was taped using duct tape. This is not a proper repair and some be evaluated by a qualified plumber.

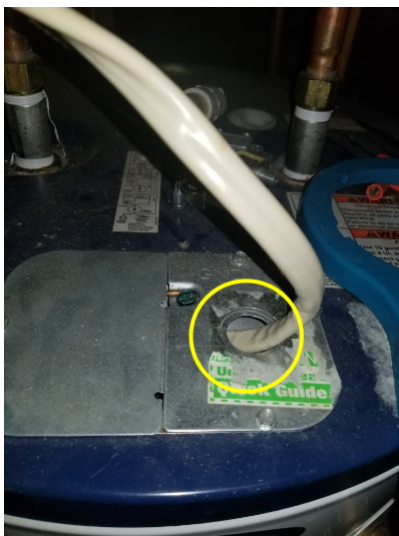
Electrical wiring was not properly secured/protected at point of entry.

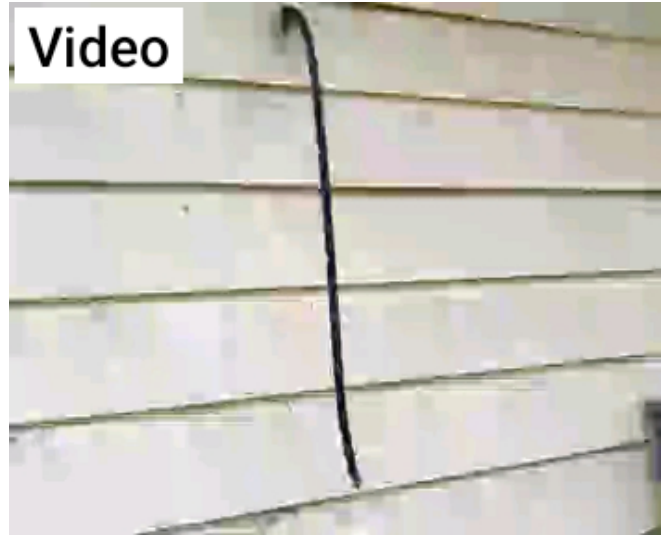
Slow drip was observed at the left side from a tube penetrating the wall. Origin is unknown. Constant dripping of water at the exterior foundation can cause adverse movement in the foundation and/or soil erosion.

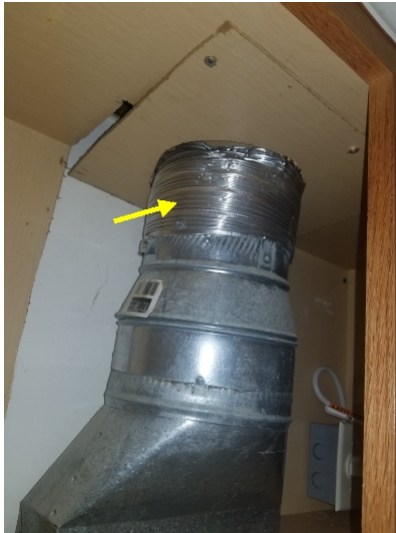
Vent duct was constructed of material not rated for this application. Vent duct should be smooth surfaced single wall duct, to prevent build up of grease.

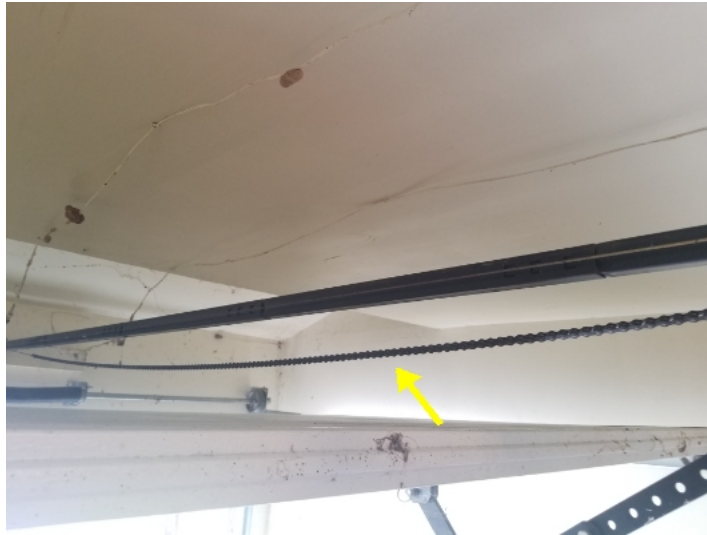
Garage door opener has a loose chain and may require adjustment.

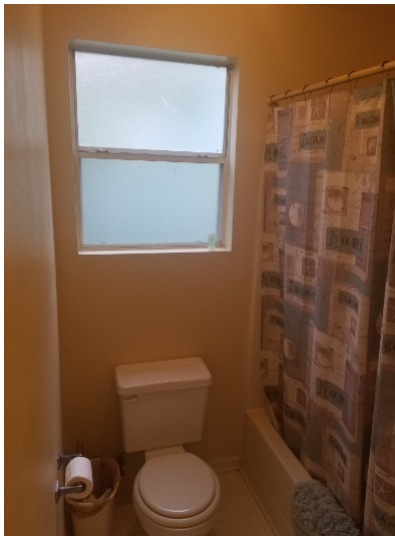
Bathrooms relied on the window for ventilation. This method of reducing moisture may not be sufficient.
