ENGINEERING OPINION
INSPECTION OF FOUNDATION REPAIR AND LEVELING
RESIDENCE AT 332 10TH STREET, DICKINSON, TEXAS, 77539
Date of Inspection: March 29, 2019
Date of Report: April 1, 2019

ENGINEERING OPINION
INVESTIGATION OF FOUNDATION PERFORMANCE
RESIDENCE AT 332 10TH STREET, SAN LEON, TEXAS, 77539
Dates of Inspection: January 24, February 15, 2019
Date of Report: January 27, 2019

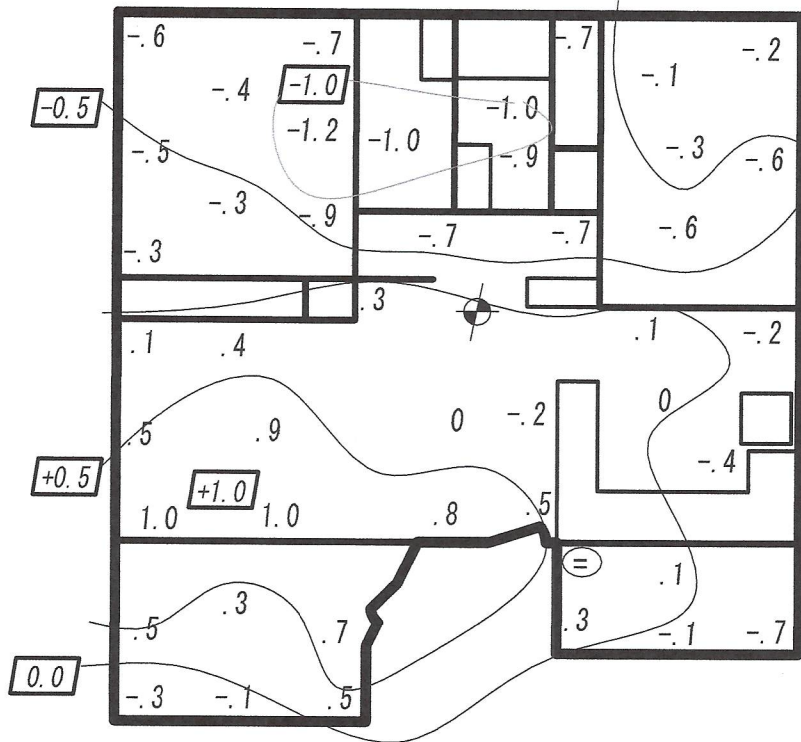
POST-LEVELING FLOOR SURFACE ELEVATIONS, UPPER LEVEL

An elevation survey throughout both levels was performed using a Technidea Zipllevel. The floor elevations fall within the generally accepted standard for foundation repair performance. See attached survey.

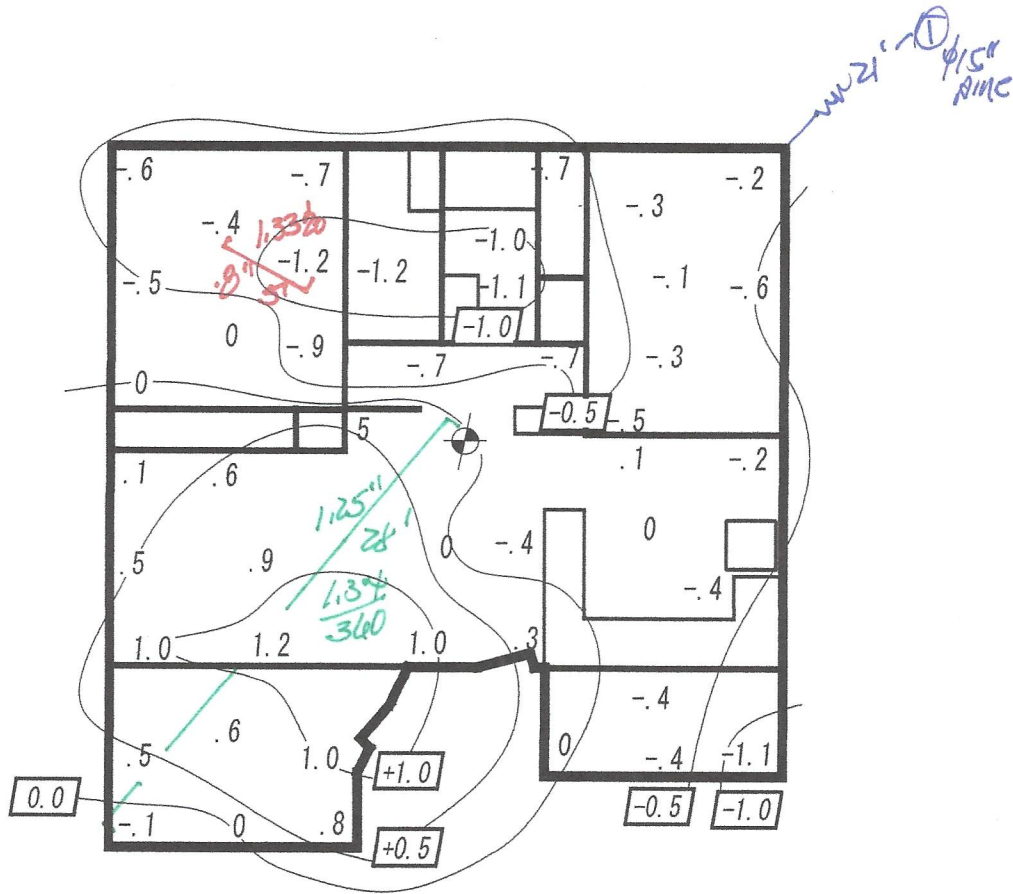
FLOOR SURFACE ELEVATIONS AND OBSERVATIONS

An elevation survey throughout the house was performed using a Technidea Zipllevel. The reference zero was the middle interior. The elevations have a range of 2.4 inches, highest at the front-left interior, lowest at the back-middle interior. The foundation generally has a high and a low area.

The elevation deflections measured as bending of a straight line calculate to 1.34/360 (1.34 inches in 28 feet, green line, worst case) which exceeds the generally accepted criteria for foundation performance and repair of 1.00/360 (1 inch bend in 30 feet).

The elevations measured as tilting of a level line across the foundation do not exceed the generally accepted criteria for foundation performance (not repair) of 1.00% (2.4 inch difference across 20 feet).

The elevations measured as slope of floors calculate to 1.33% (.8 inches in 5 feet, red line, worst case), which approaches 2.00% (1.2 inch difference across 5 feet).

Adjust the foundation framing connection to the posts to level the living area floors.

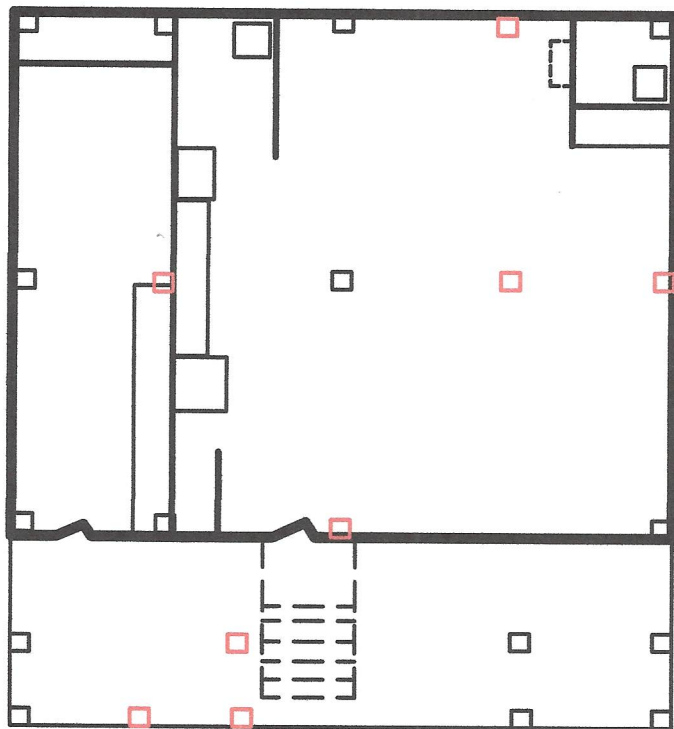
CONDITIONS AT GRADE LEVEL

Inspection of the 4x8 and 8x8 posts supporting the living level found several posts almost completely deteriorated at grade level. See attached figure.

There was structural damages observed at several of the support posts.

□ Observed rot at base of wood posts

Replace the structurally damaged posts.
