Addendum to Seller's Disclosure Notice relating to the real property and improvements located at 4315 Dorothy Street, Bellaire, Texas 77401

HEDDERMAN ENGINEERING, INC.

REF: CONDITION OF PROPERTY SURVEY

4315 Dorothy

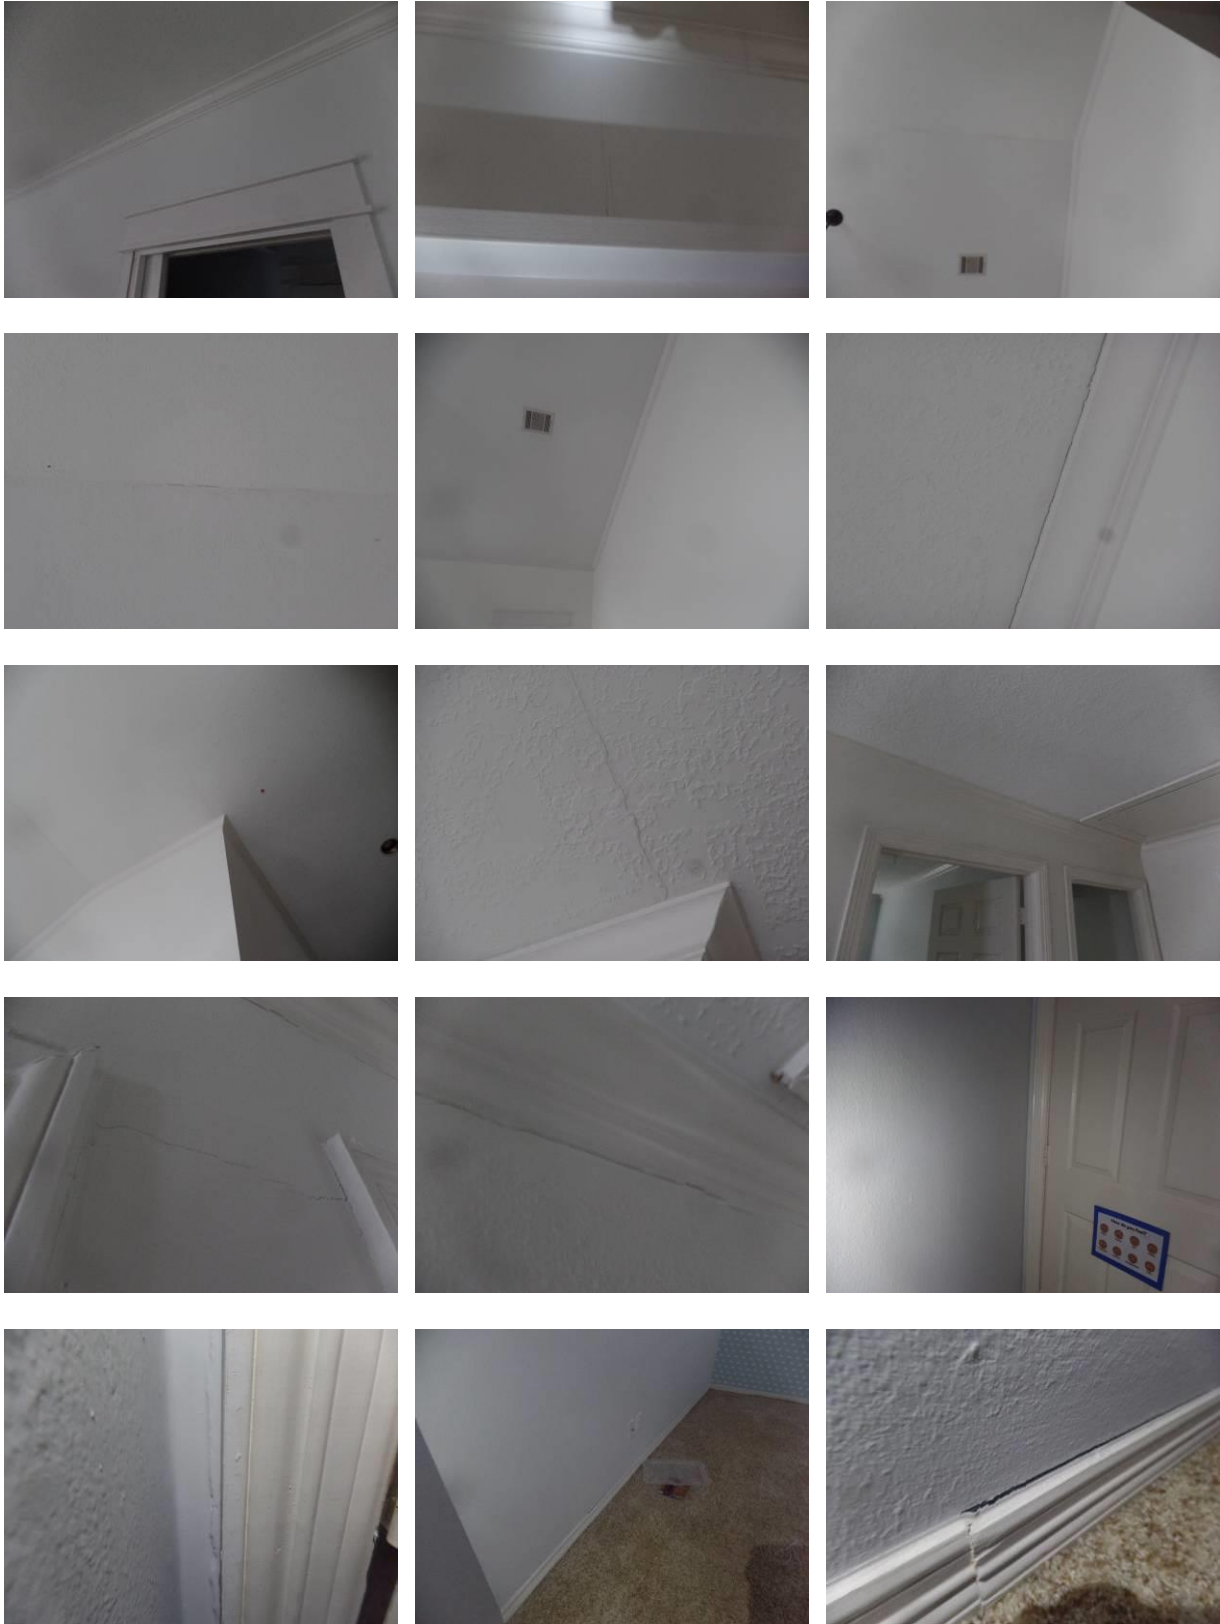
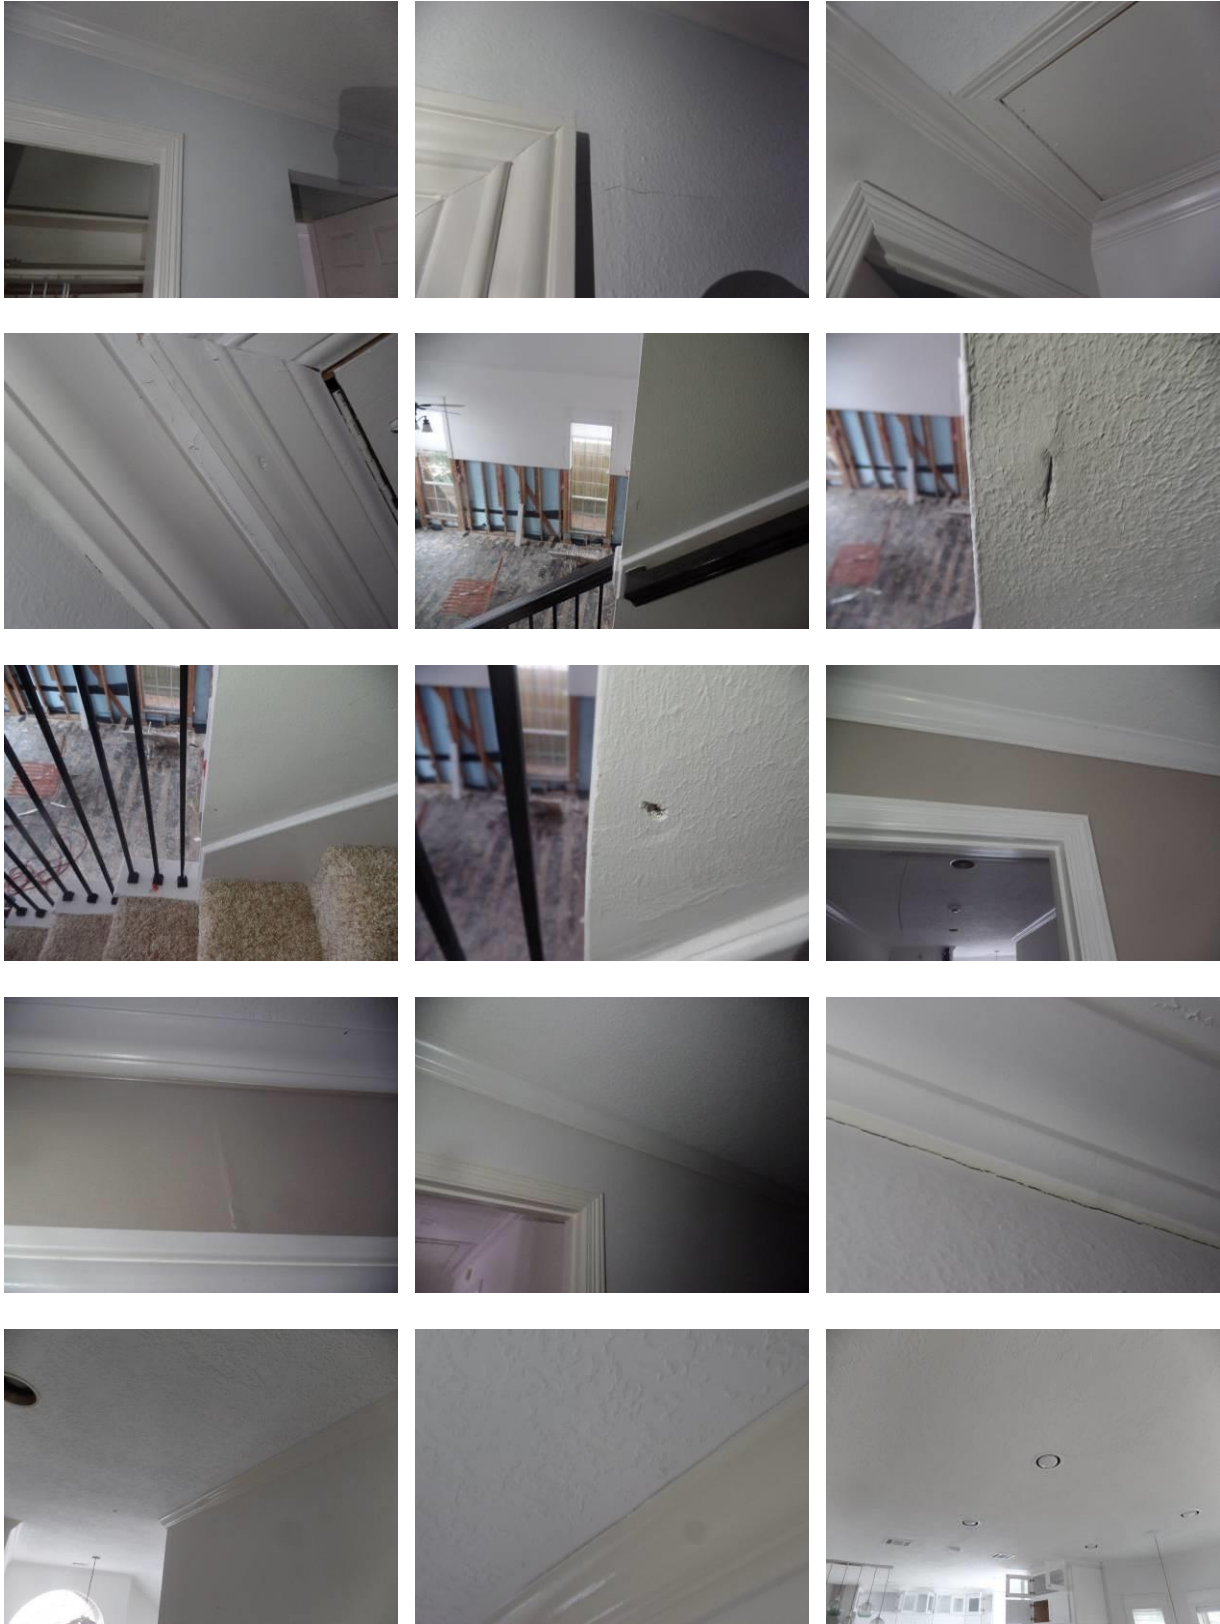
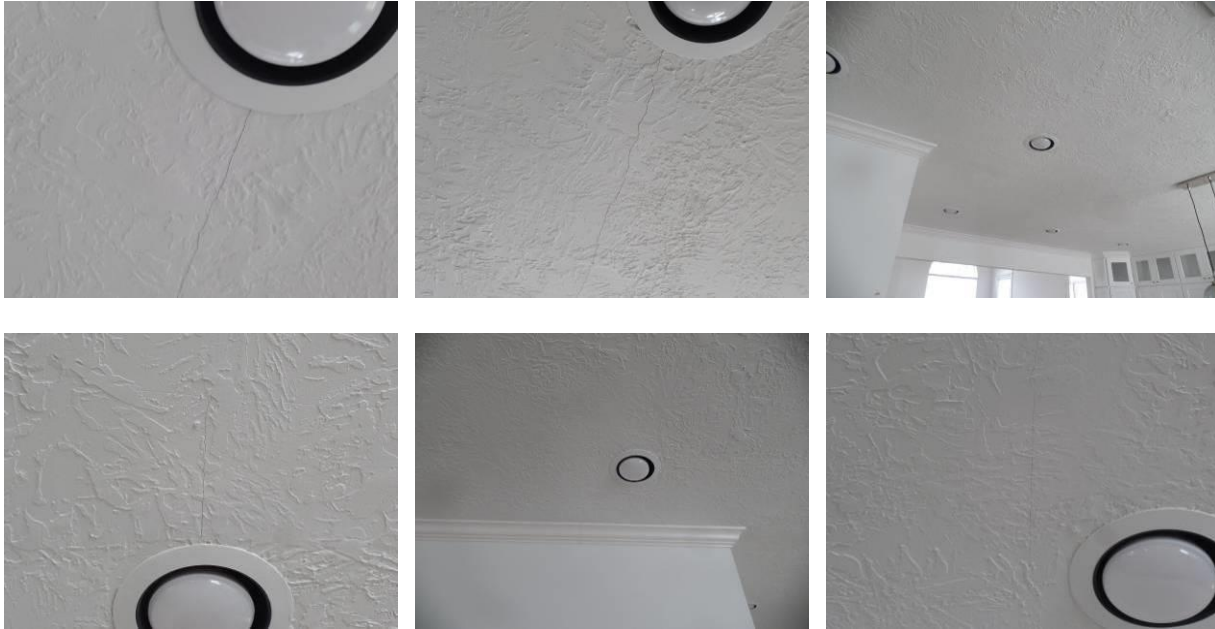
Sheetrock cracks, patches, compression ridges, and separations on crown moldings and base moldings were observed throughout the second floor of the house, and the ceiling at the kitchen/breakfast area. Based on our overall evaluation of the foundation, it is our opinion that these cracks are related to framing deflections, probably due to undersized framing members. Further investigation is recommended to determine the exact cause of the deflections and cracking, and to provide a cost estimate for all needed repairs.

Obtain Cost Estimate

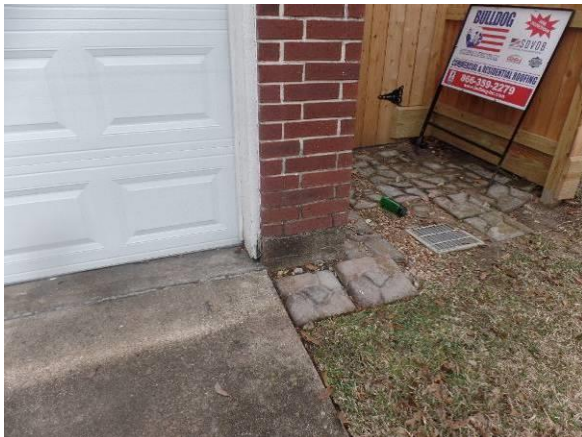
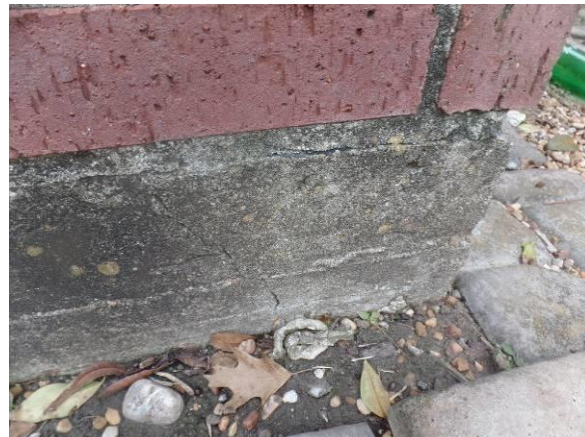
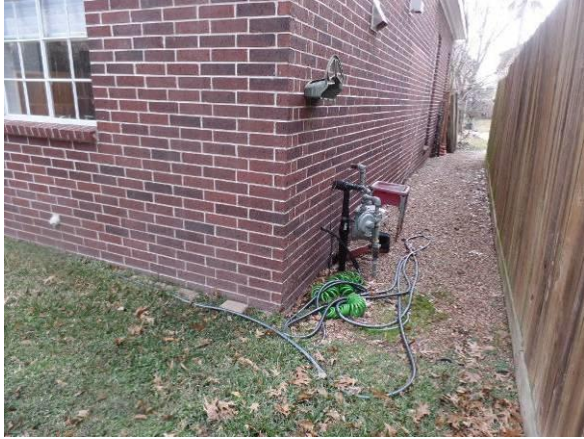
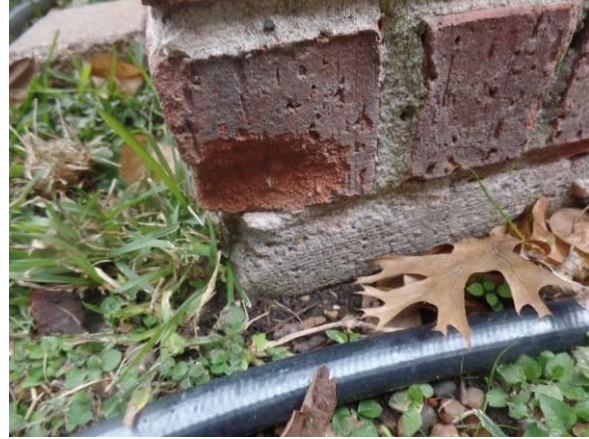
Locations included: northwest, southeast

The corner of the foundation was observed to be chipped. This condition is typically caused by differences in thermal expansion between the brick veneer and the concrete foundation. Also, this condition can be caused by a lack of reinforcement in the corner of the foundation during original construction. In our opinion, this condition does not affect the overall structural integrity of the foundation.

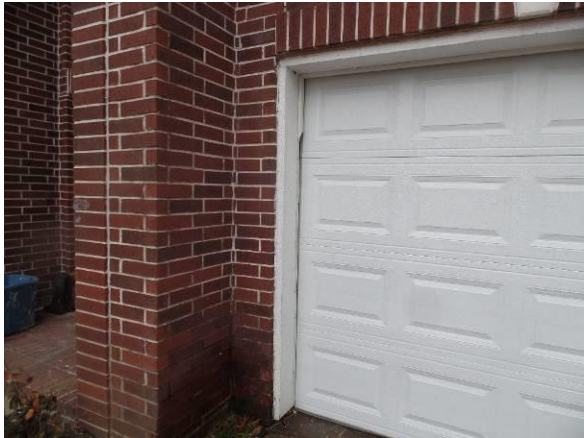
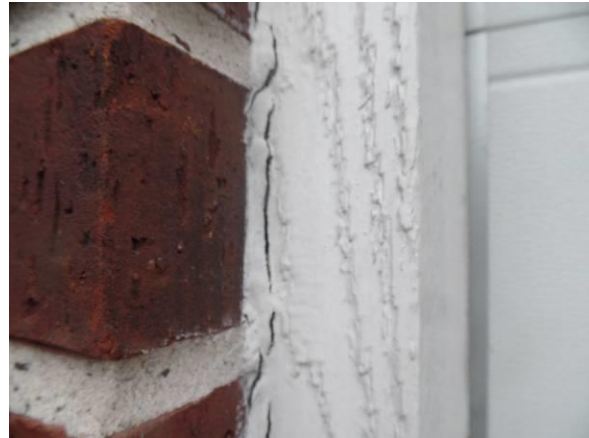
- The garage door frame was separated from the exterior brick veneer approximately 1/8 inches

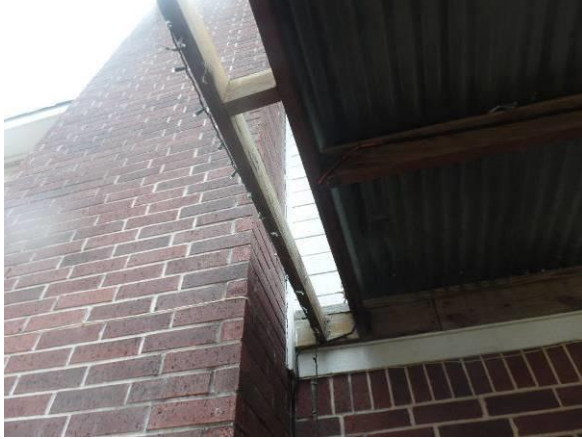
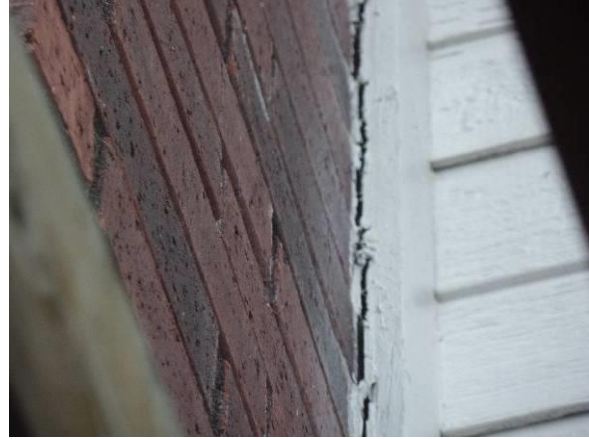
- The chimney was separated from the approximately 1/8 inches.

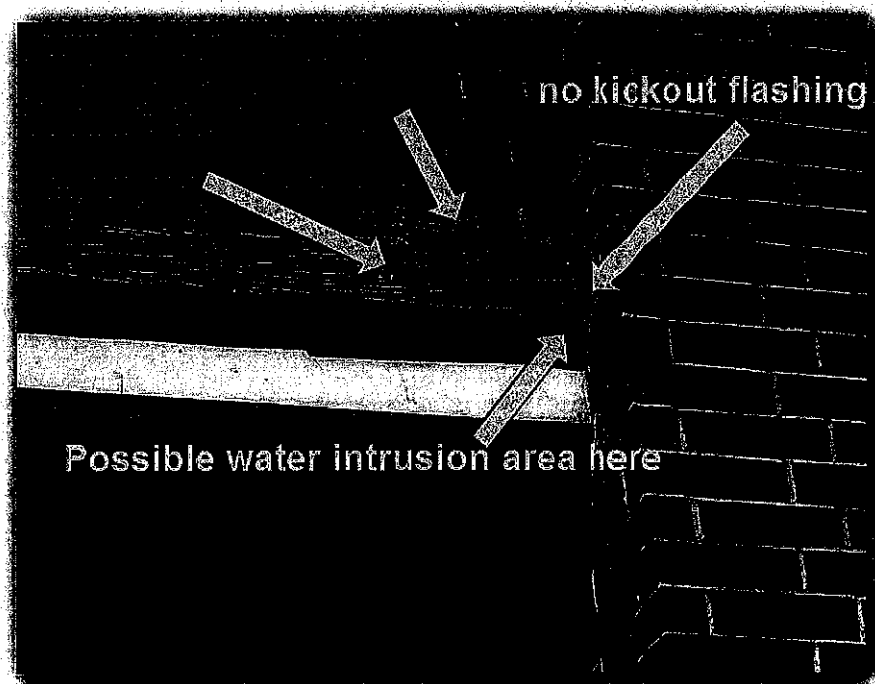
Brick chimney not properly flashed and counter-flashed. Roofing tar is not a substitute for properly installed flashing.

The roof covering material, with particular regard to the flashing at the chimney, does not appear to be correctly installed, does not appear to be of the correct construction flashing material, and repairs that have been performed in the past appear inadequate and do not appear to be of "workmanlike" quality. Step Flashing was not observed, was not correctly inserted into the mortar joint, and did not appear to be counter flashed properly. No kickout flashing was observed.

I recommend a qualified, reputable roofing contractor be consulted for the corrections and repairs that are needed to make repairs to the areas of the roofing and flashing material and installation thereof.
