October 29, 2019

RE: Foundation Inspection
Job #18607

10311 Meadow Lake Lane

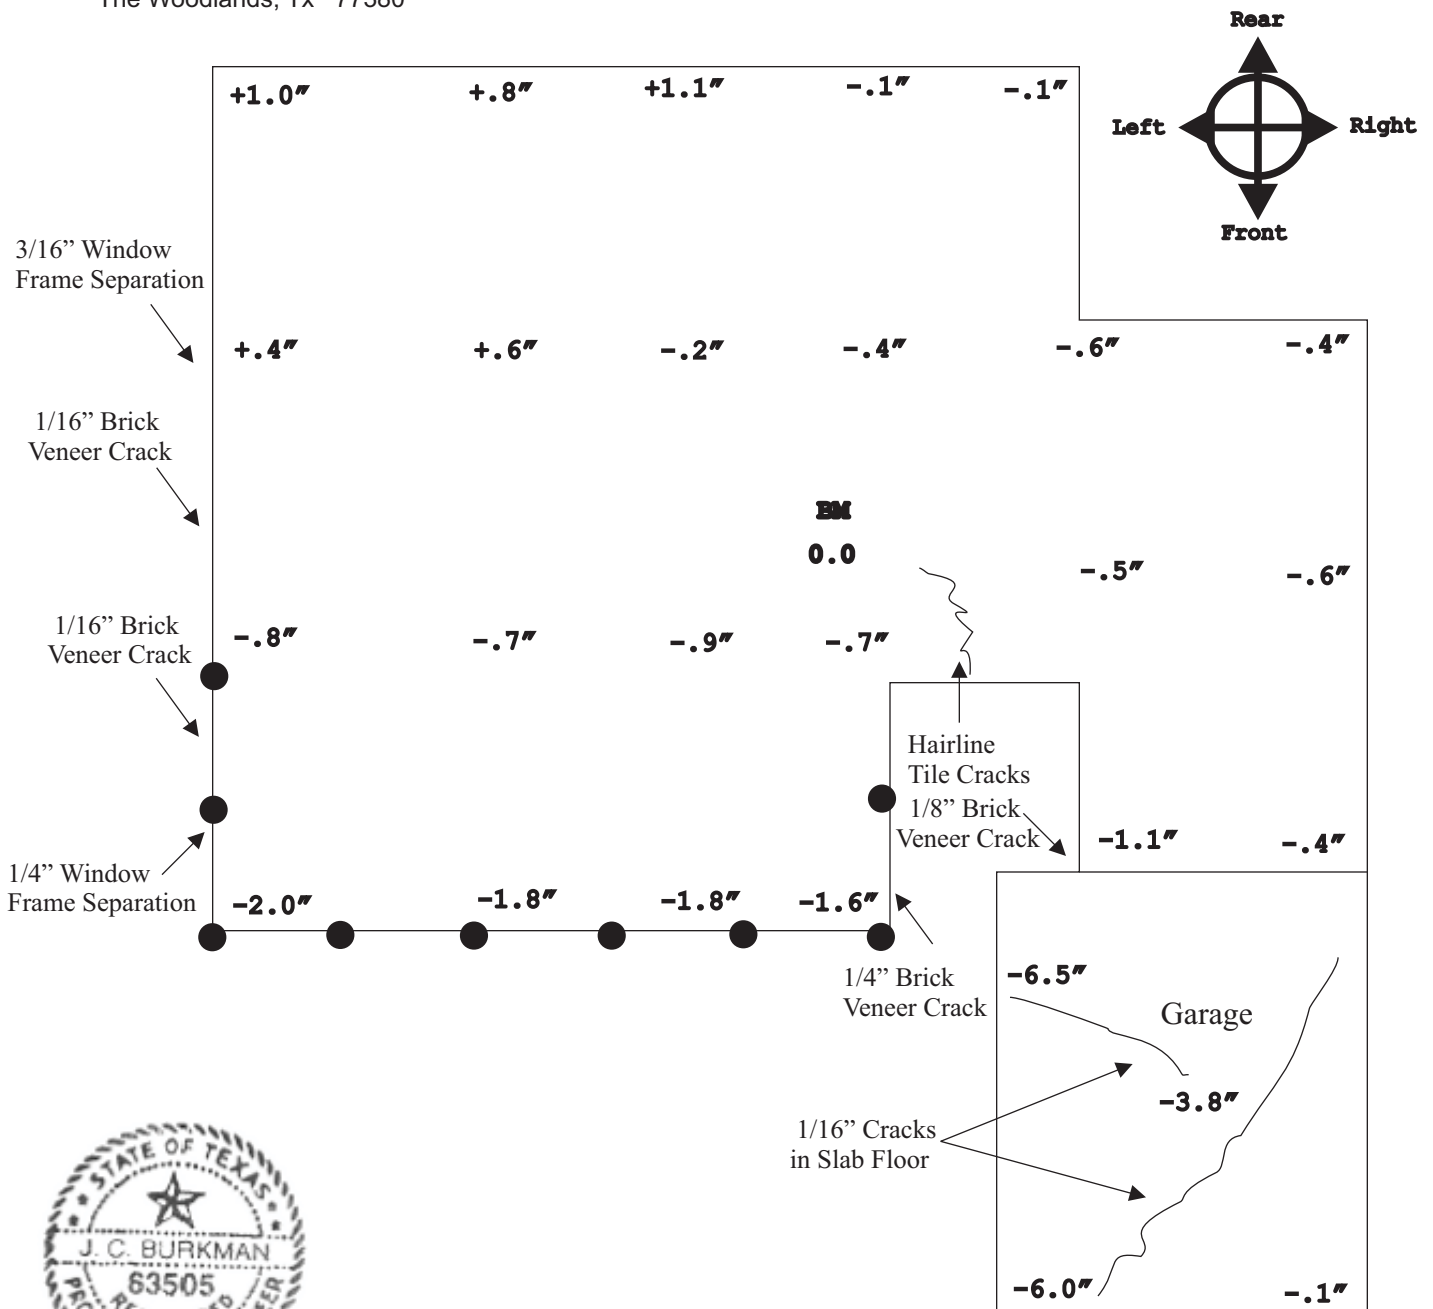
The foundation inspection did reveal the existence of a marginally non-functioning slab, as evidenced by floor elevations, window frame separations, uneven front bedrooms door clearances, sheetrock cracks in front bedroom, bubble levels, cracks in the floor tile of front entry and brick veneer cracks. Rafters observed in the attic were relatively construction tight at the ridge board.

Spreadsheet calculations were performed utilizing the FPA (Foundation Performance Association's SC-13-1 Calculation Spreadsheet) resulting in a deflection ratio of L/120 and tilt ratio 28% of 1% which is excessive and will require foundation repair with piers. This spreadsheet and report was reviewed and this engineer has taken into consideration the recommendations and guidelines of the TBPE (Texas Board of Professional Engineers), ASCE (American Society of Civil Engineers), ACI (American Concrete Institute), and TRCC (Texas Residential Construction Commission).

Approximately nine exterior piers will need to be installed along the *front section* of the house, as depicted on the attached diagram. The reasonable placement is based on the opinions and engineering judgment of this engineer. The piers should be of either *driven piles* or a *bell bottom design* and described as follows:

- set on approximately 7 foot centers – Average Lift 1.5”
- drilled to load bearing soils between 16 to 22 feet
- shaft diameters 8 to 10 inches, using 3 #3 steel rebar tied in a triangle
- bell diameter 20 to 24 inches, 8” shaft diameter minimum
- pier top reinforced with 6 #3 rebar, minimum dimensions are 20” x 24” and 12” deep
- minimum 5 sx mix or at least 3000 psi compressive strength
- shim with 3000 psi compressive strength precast blocks and steel.
