Morúa Real Estate Inspections, Inc.

PROPERTY INSPECTION REPORT

22711 Merrymount Dr., Katy, TX 77450

Juan Carlos Morúa License #5903 2/18/2020

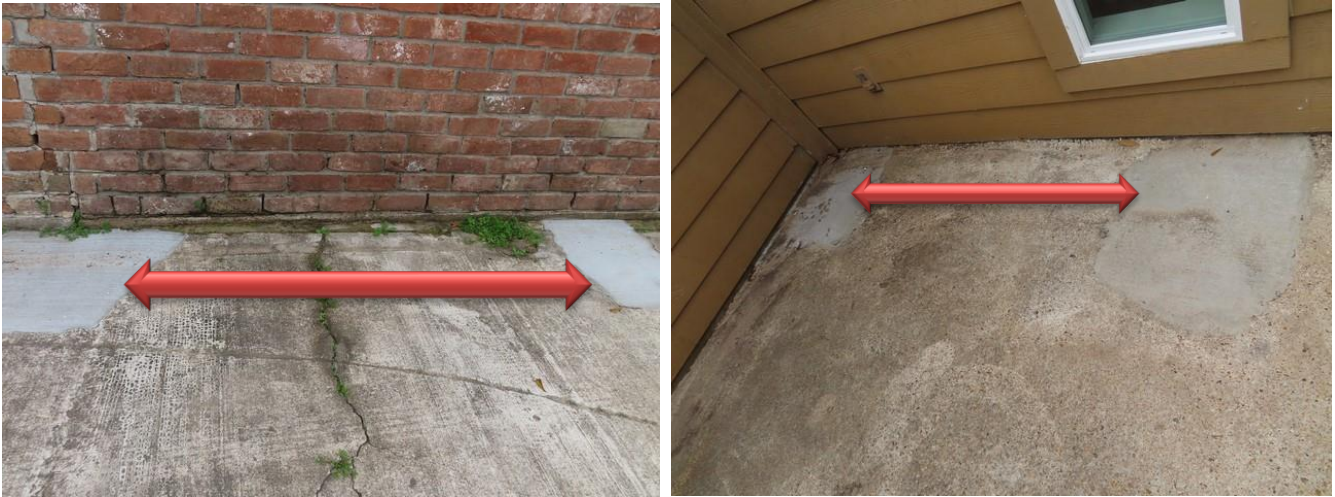
Previous Foundation Work

Indications of possible foundation repairs were observed.

Recommendation: Refer to the structural engineer's report, if available, for further information of repairs, warranty and proper maintenance of the foundation.

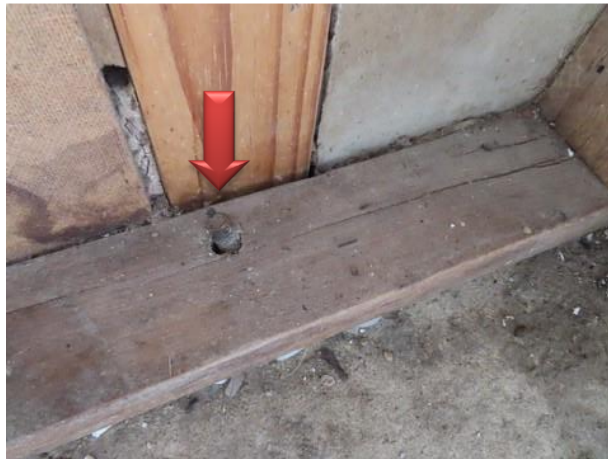
At garage, sill plate did not appear to be anchored properly. The horizontal 2x4 at the bottom of the exterior wall that rests on the foundation wall is called the sill plate. The sill plate must be bolted to the foundation wall using anchor bolts so the wall does not move or slide. Spacing of anchor bolts in the sill plate can be no more than 6 feet on center and be within 12 inches of any sill plate joints.

Recommendation: Employ the services of a structure specialist to further investigate and follow suggestions to correct issues.

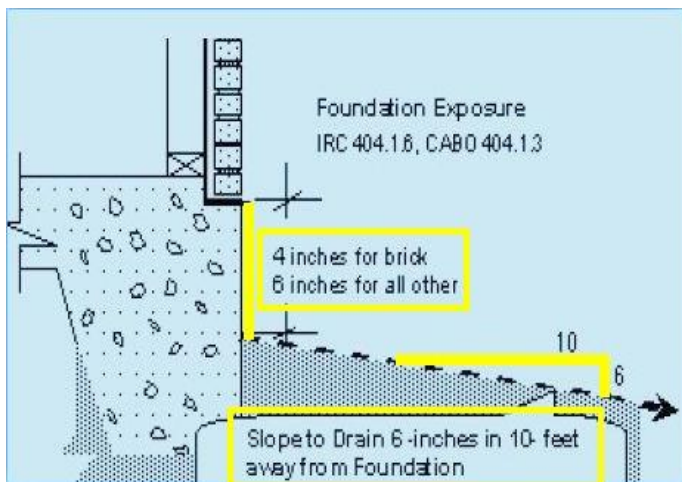
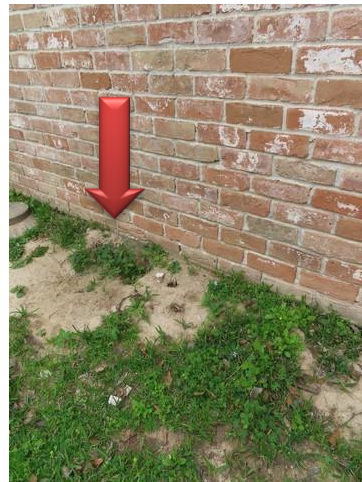
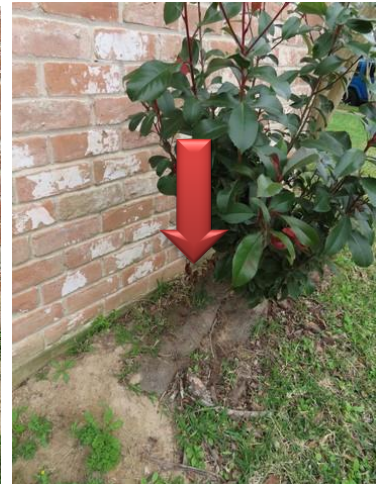
Ground is uneven. Uneven surface will become trip hazard.

Industry standard recommends 4-6 inches of slab exposure around the structure and that the terrain slopes away from the house as to drain surface water off the site.

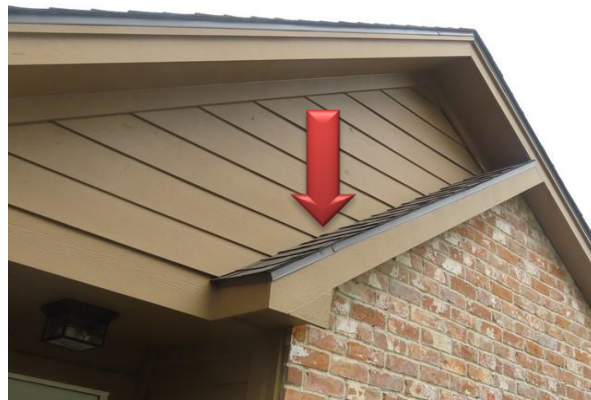
Trim/Siding:

There is not separation between trim/siding and roof junctions and/or flashing was not observed. The absence of flashing or separation between trim and roofing allows moisture to enter and remain behind trim, which leads to wood rot.

Recommendation: Employ the services of a roofing specialist to properly install flashing/create separation as prevent wood decay.

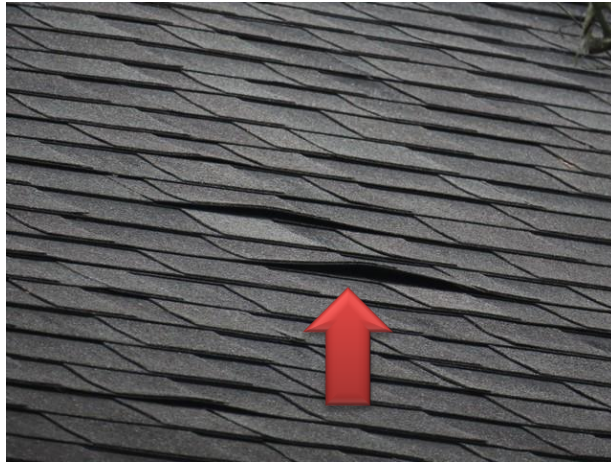
Raised Shingles

Lifted asphalt shingles were observed at the front of the house. Lifted shingles create the possibility for water intrusion into the roofing structure. Lifted shingles are prone to falling off in high winds.

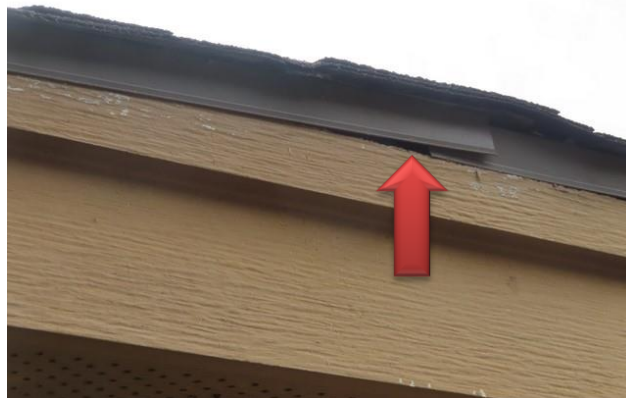
Raised flashing

Lifted flashing/shingles were observed at the rear, by back entry. Lifted flashings/shingles create the possibility for water intrusion into the roofing structure. Flashing/shingles are prone to falling off in high winds.

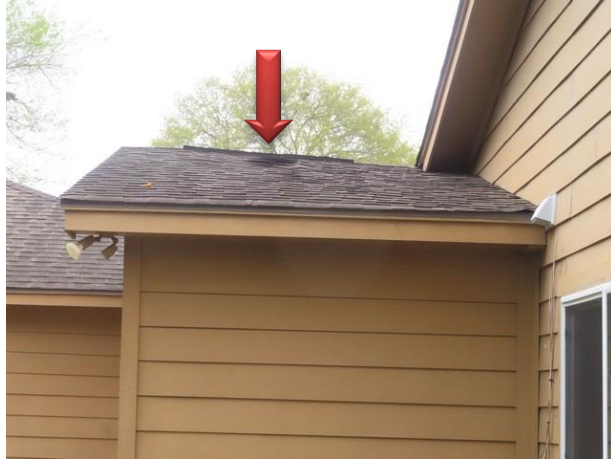
Deflection:

At rear, it appears that roofing material has deflection and roof appears to slope toward the house.

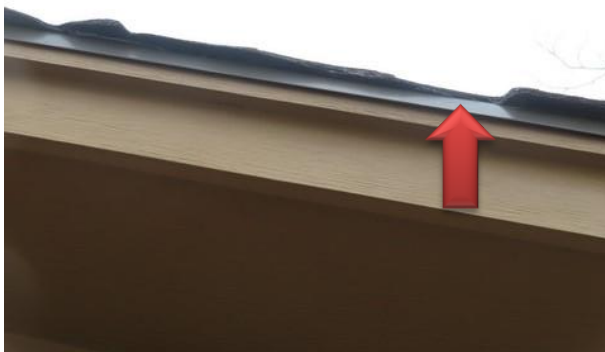
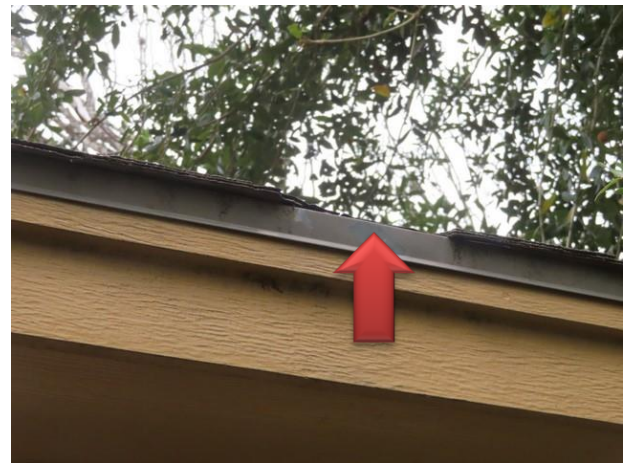
Tree limb:

Tree limbs were observed to be making contact with roofing material. Tree limbs should be kept trimmed to help prevent damage to the roof.

The starter course was observed to be damaged/not extend past edge as to prevent moisture intrusion into roofing/trim area.

Recommendation: Trim limbs away from roof/sides of house at a minimum of 4 feet.

Recommendation: Employ the services of a roofing specialist to properly repair/secure or replace shingles as necessary.

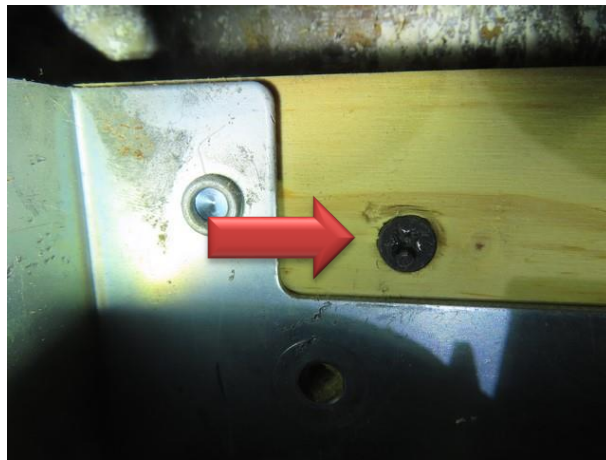
**Improper fasteners:**

Pull down attic stairs are installed with improper fasteners. Improper fasteners may have reduced shear strength and may not support pull-down ladders weight rating, thus causing a possible hazardous condition. Approved fasteners for attic pull-down stairs are 16d penny nails or ¼" x 3" lag screws.

Recommendation: Install adequate fasteners for safety.

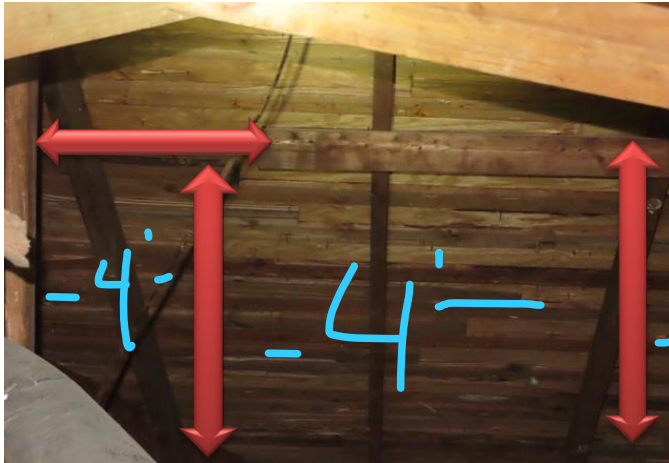
**Attic supports**

Purlins struts were not installed at 4 foot intervals. 2x4 struts and ridge braces exceeding 8 feet length shall be doubled, to prevent deflection

Recommendation: Employ the services of a roofing contractor to evaluate condition and recommend options for repairs/replacement

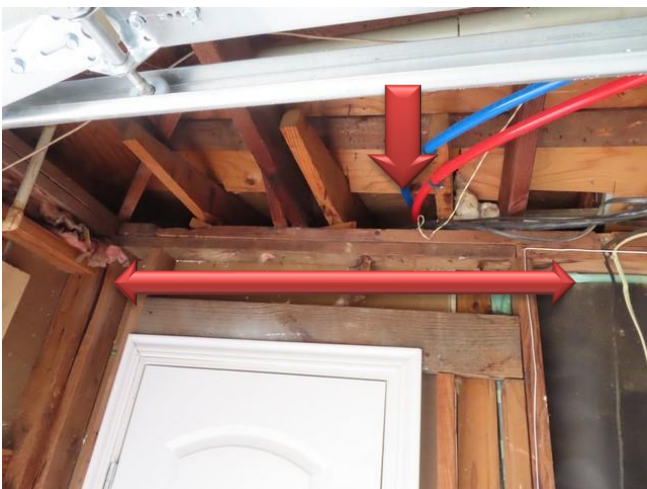
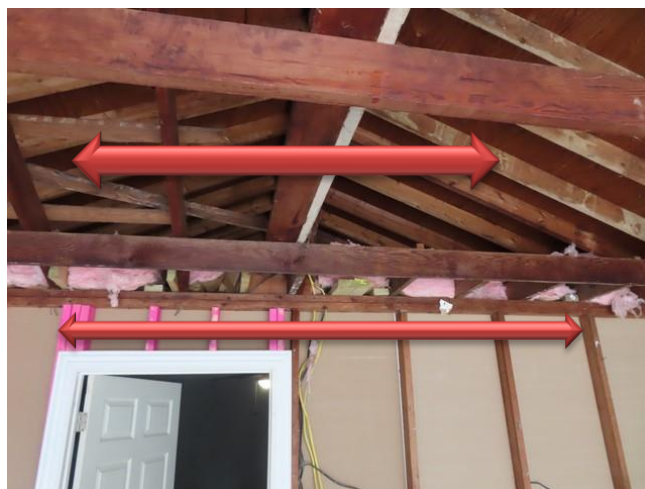
Fire Stops

At garage walls and ceiling, all penetrations and walls adjacent to living areas should be fire-blocked.

Recommendation: Install and/or sealed sheetrock to prevent gases from garage area from migrating into the remainder of the house and to create fire blocking.

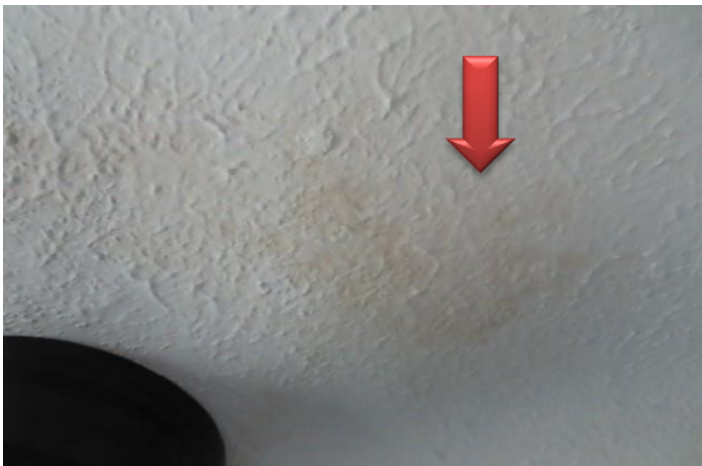
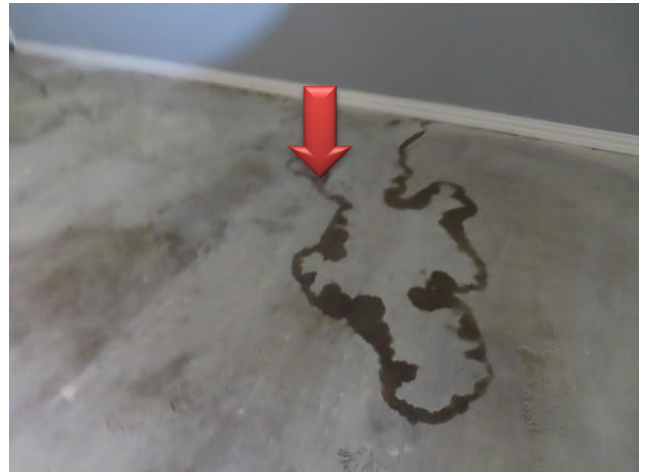
What appears to be moisture stains were observed at rear bedroom and garage rear addition floor. Moisture intrusion was not determined.

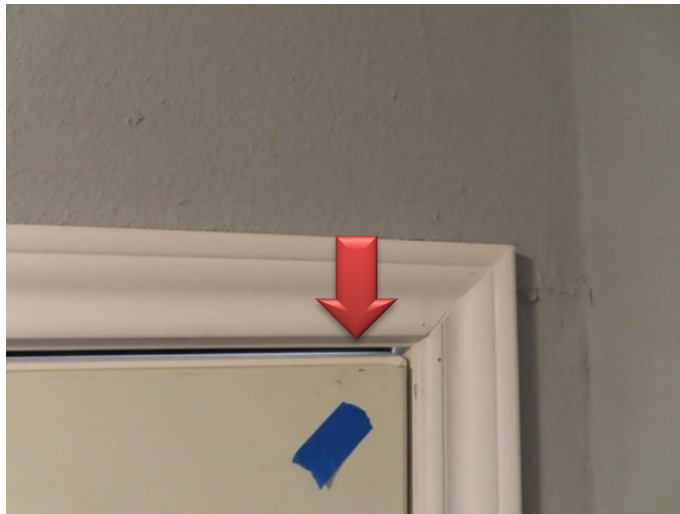
The weather stripping/lower door seal is damaged at side exit.

Recommendation: Replace weather stripping/seal.

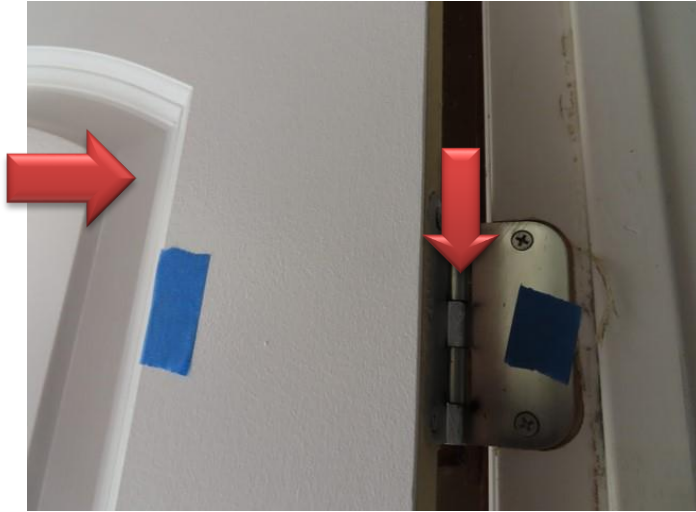
**Door from garage**

Door at garage to main house appears to be too small.

Recommendation: Replace or repair door/self-closing hinges for improved safety for occupants.

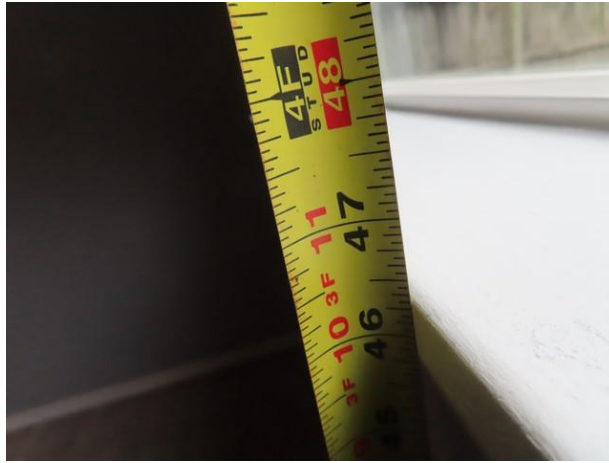
Bedroom window sills are over 44 inches from surface. This is a safety concern as easy egress is not present.

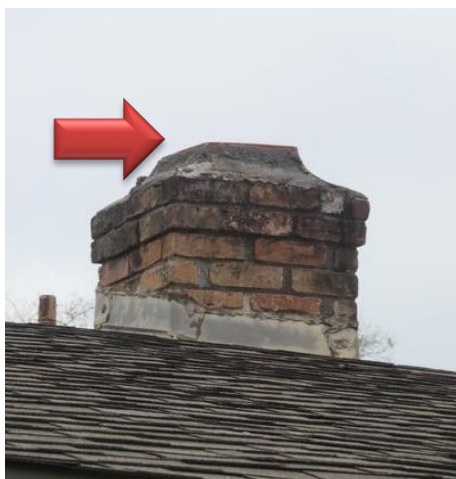
Cap

Exterior cap appears to be missing. Opening becomes pest and moisture penetration point.

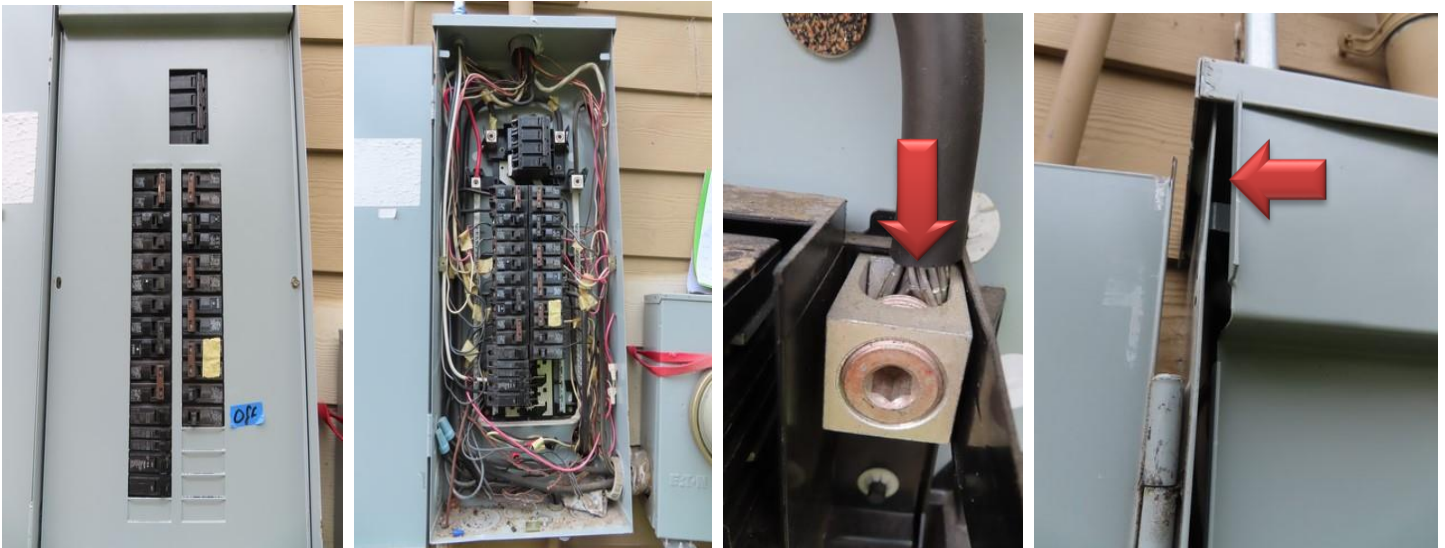
The main service conductors in the main breaker panel do not appear to have antioxidant paste applied to the aluminum service conductors. Junction can oxidize and causes resistance thus the conductors can get very hot and melt the insulation on conductor(s).

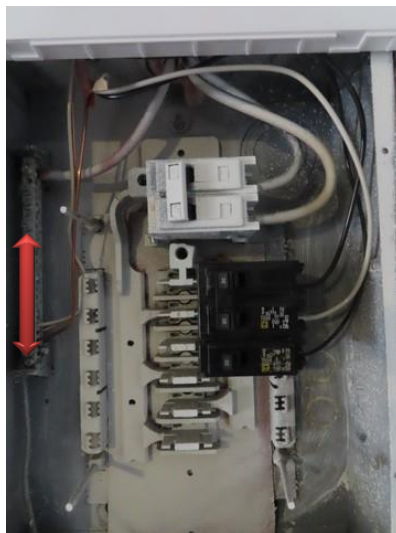
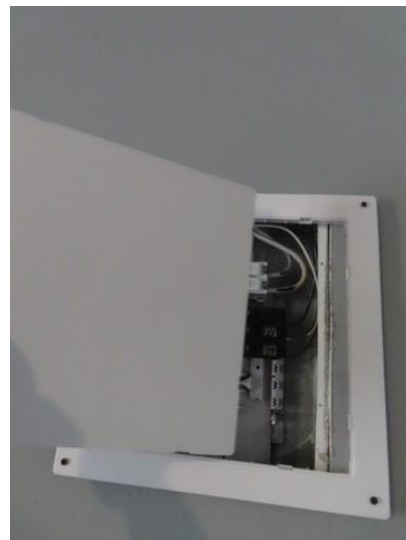
The ground & neutral wires are installed on the same connecting bar. They should be kept separate bars.

Recommendations: Employ the services of a licensed electrician to address issues as per current safety standards.

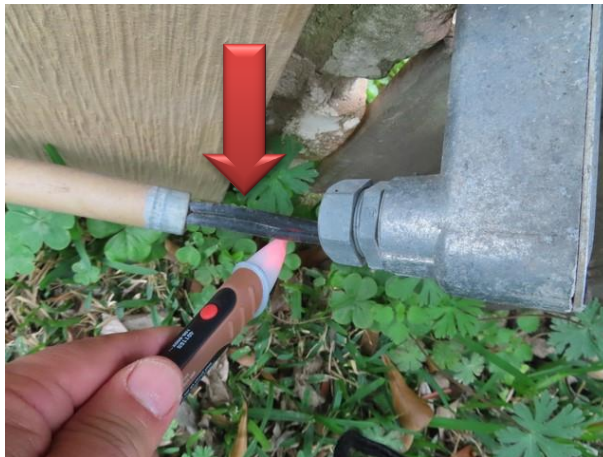
Exterior light fixture wiring is not fully encased in liquid tight conduit.

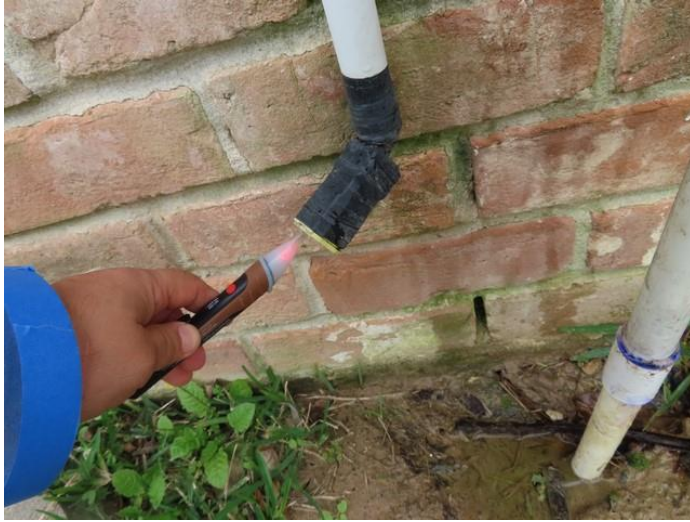
Junctions not in box:

Wiring not in junction box at east wall. Wiring is not adequate for service. A dedicated receptacle should be installed at this location. The absence of connection in a box creates possibility for shock hazard.

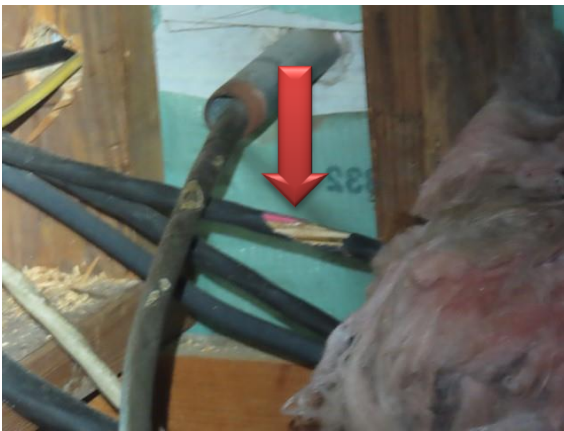
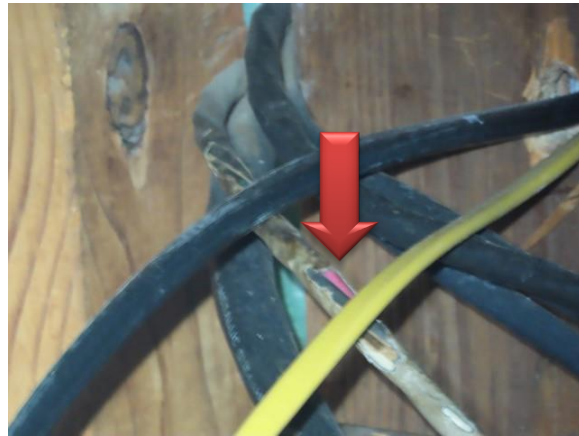
Wiring/Insulation:

Wiring insulation at attic appears to be damaged. Issue could be a safety hazard.

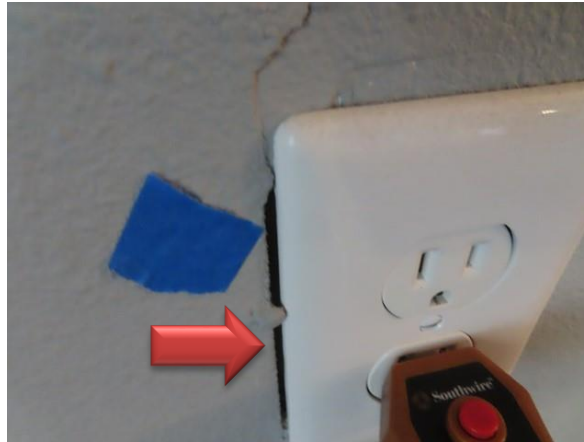
At several locations (receptacles and light switches), cover plates are too small. There is direct access to "HOT" areas.

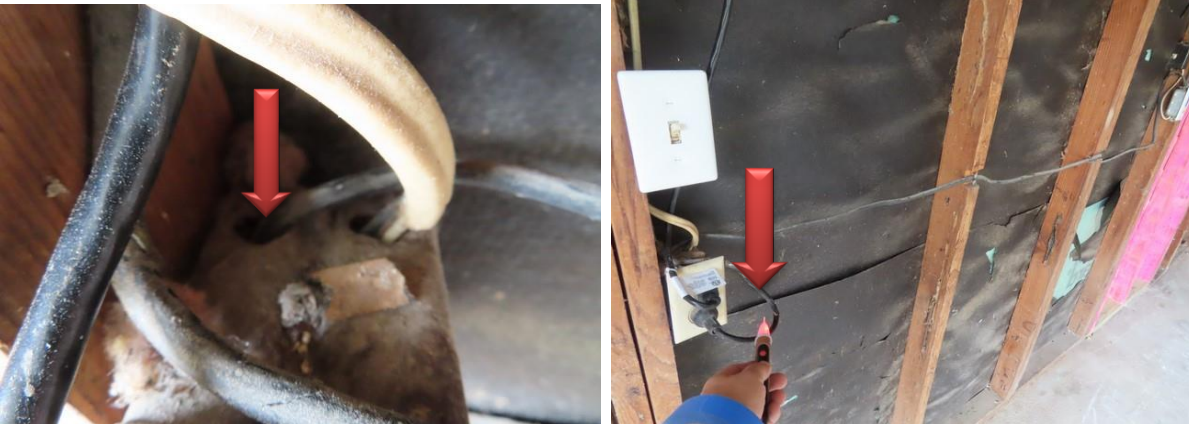
At garage, wires are not protected at box penetration. Additional fixtures are improperly connected via extension cord.

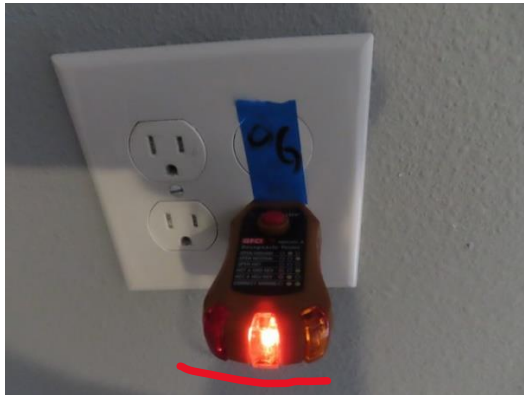
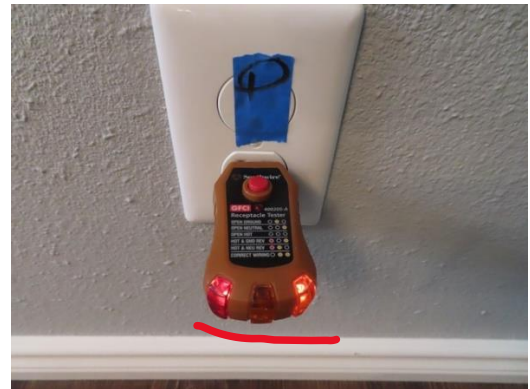
Several outlets are not grounded.

A sample of locations identified with blue tape.

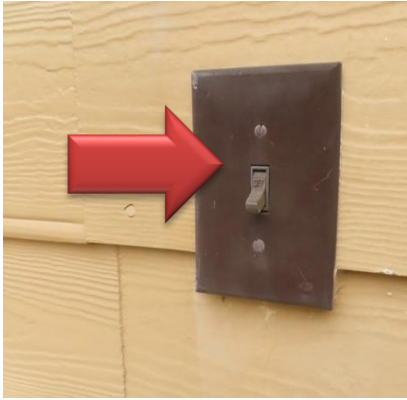
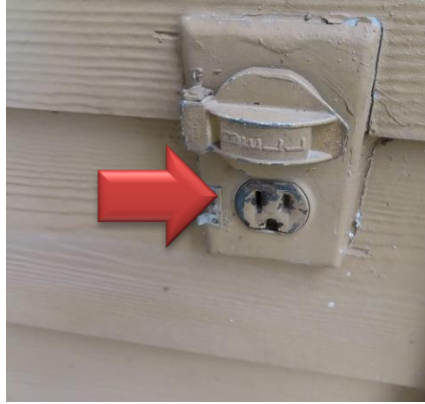
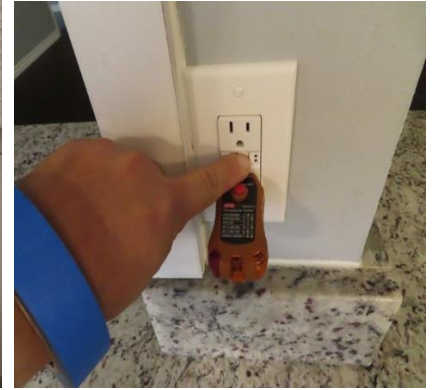
Exterior outlets and light switches are missing waterproof covers. This poses shock hazard.

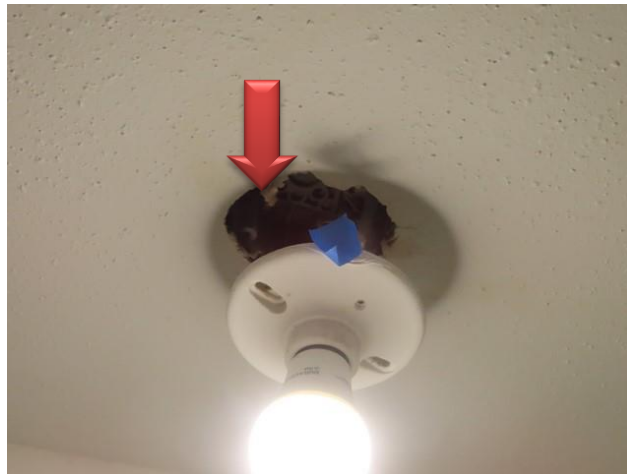
At closet, light fixture is not properly installed.

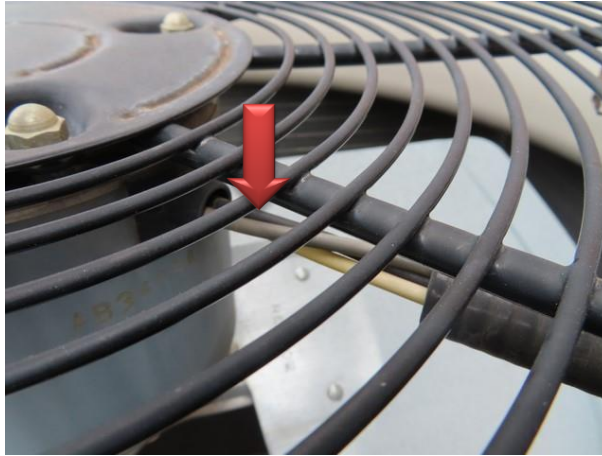
At top of cabinet, lines are not protected. Insulation can deteriorate and cause cabinet to become electrically charged.

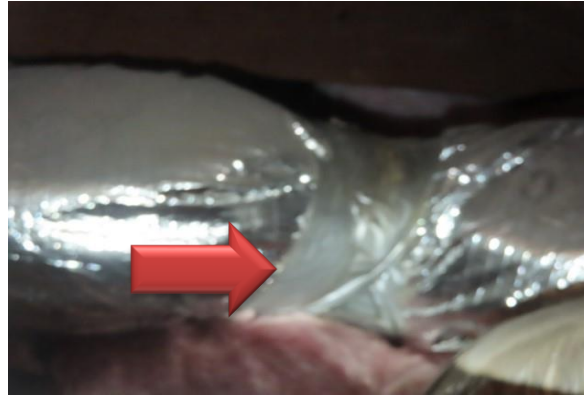
Duct junctions are inappropriately made with DUCT Tape.

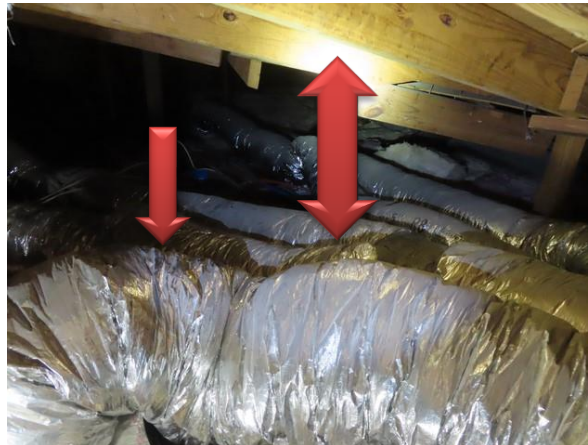
Ducts are making contact. When ducts make contact, it creates condensation. This condensation could lead to moisture related issues in your attic space.

Ductwork is lying on the attic floor. This could cause condensation between the duct work and insulation. The ducts need to be hung from the rafters with straps. Improperly supported ducts produce improper airflow. The ducts should be properly aligned and supported.

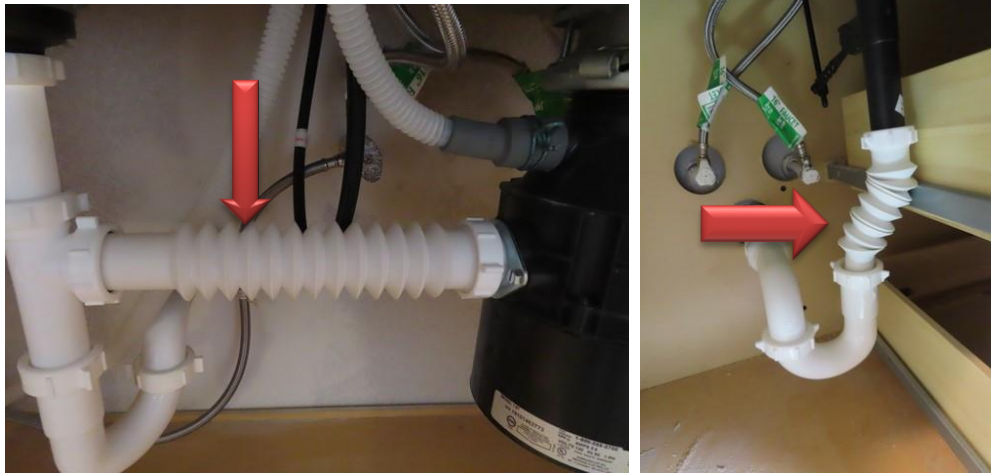
At kitchen and bathroom sinks, drain line configuration appeared to be inappropriate. Corrugated lines are prone to becoming obstructed.

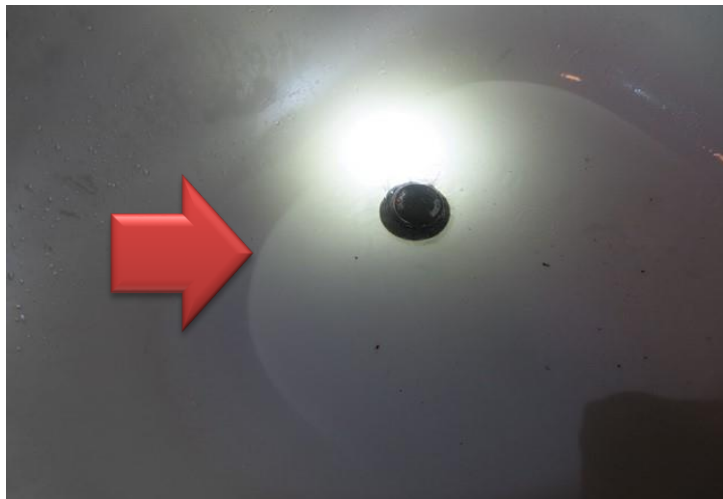
At master bath, water drainage was observed to be slower than usual, suggesting that an obstruction may exist.

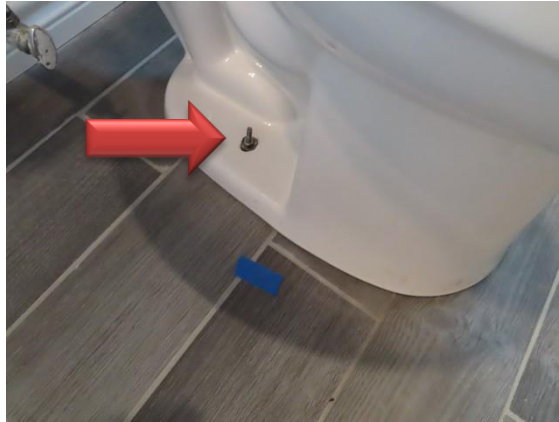
The toilet in the hallway bath is loose at the floor. Loose toilet pedestals can ruin the wax seal between the pedestal and the soil pipe, resulting in leaks and often rotting flooring beneath the toilet.

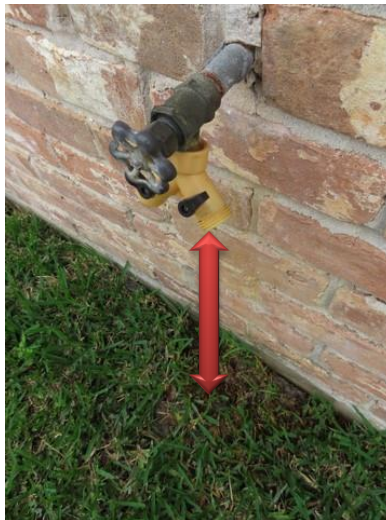
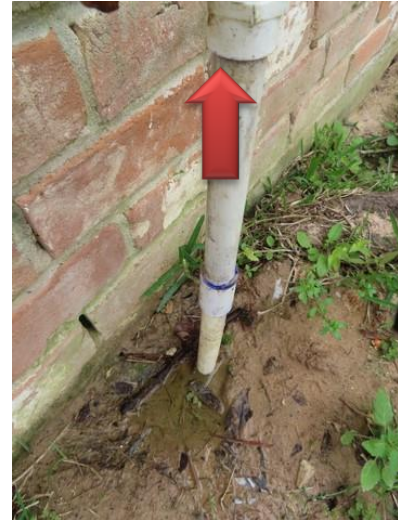
Leakage was noted at east and west water lines/hose bibs.

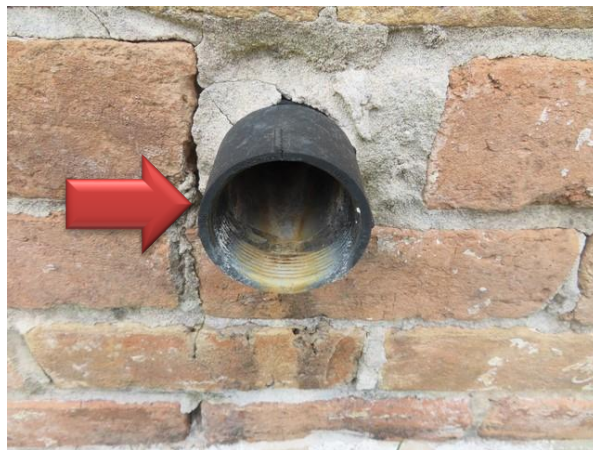
At west wall, plumbing line is missing cleanout cover. Per stains on line, line could/or could have been obstructed.

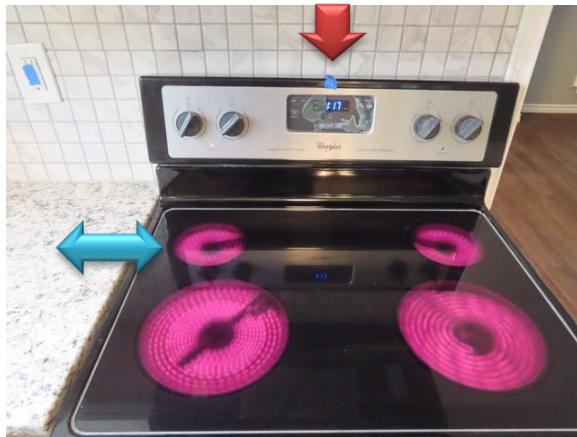
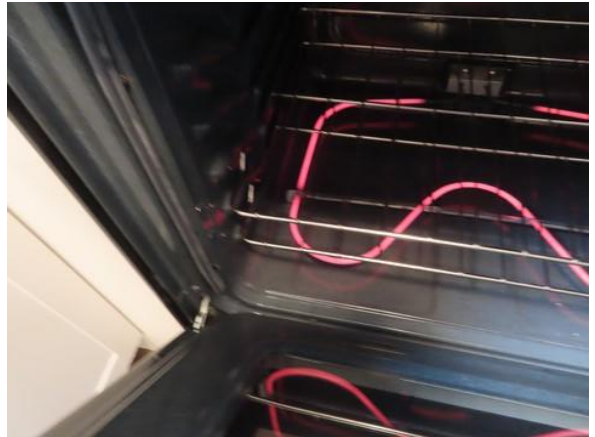
FYI- Monitor combustibles at side of cook top as there is no designated separation between counter top and burners and this poses safety concern.

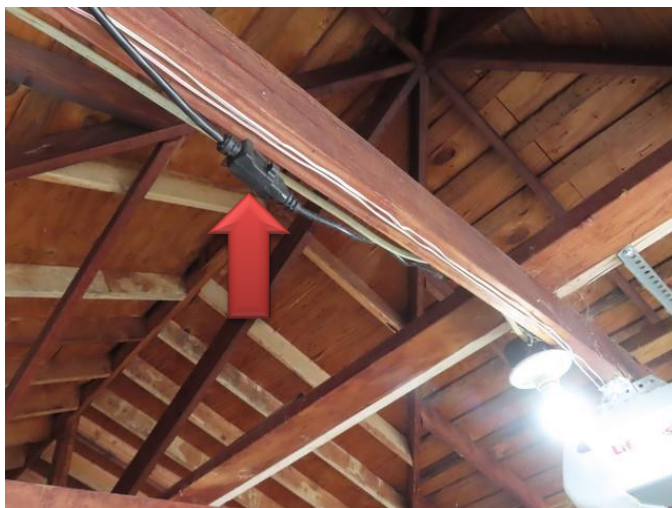
A temporary (extension cord) wiring was used to power the automatic garage door opener. Properly install a dedicated outlet in the vicinity of the automatic garage door opener. All electrical repairs should be performed by a licensed electrician.

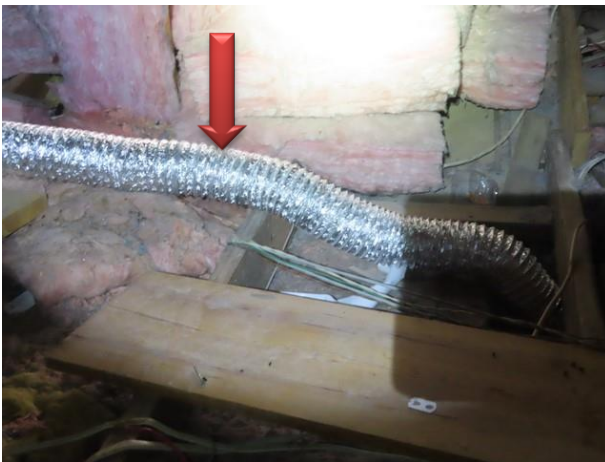
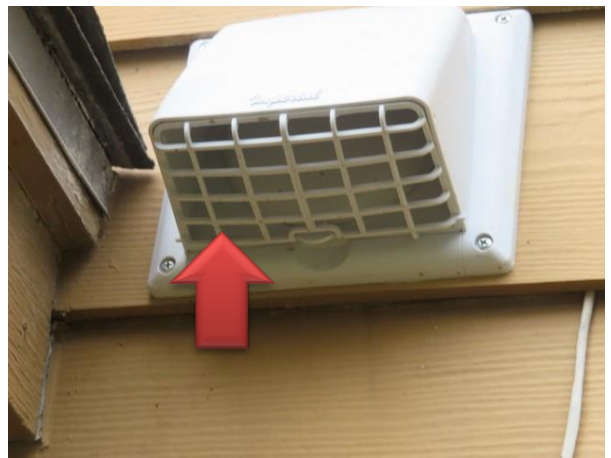
Dryer vent line has a mesh exterior cover. This will cause lint to accumulate and conditions becomes a fire hazard.
