Moisture Assessment Report

Edwards McReynolds

1616 Castle Ct

7/18/2019

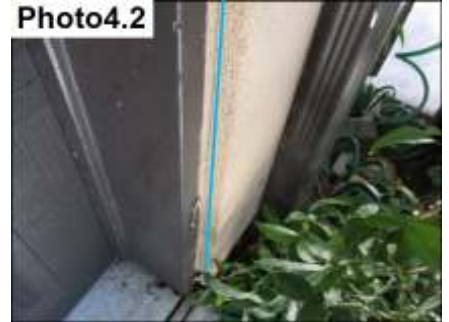
Photo4.2

Door Trim Sealants/ Maintain

Grid Location	Item Description	Moisture Readings	Substrate Condition	Observations
Blue Line	Door Trim Sealants			The door trim sealants are present in this location. The inspector states that this is a positive detail and suggests to maintain all sealants in an effort to prevent moisture intrusion. Please refer to photos #4.2, #4.3 and #4.4 for more detail.

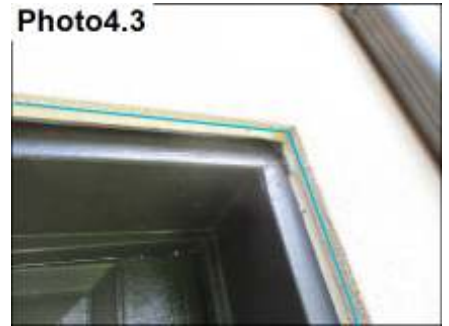
Photo4.3

Door Trim Sealants/ Maintain

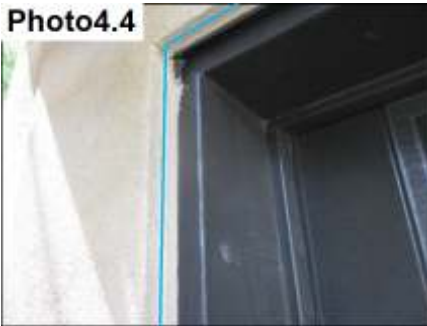
Photo4.4

Door Trim Sealants/ Maintain

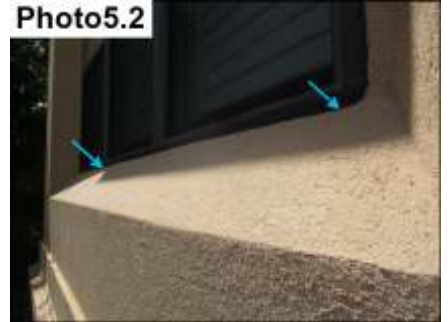
Photo5.2

Window Sealants/ Maintain

Grid Location	Item Description	Moisture Readings	Substrate Condition	Observations
Blue Arrows	Window Sealants			The window sealants are present in this location. The inspector states that this is a positive detail and suggests to maintain all sealants in an effort to prevent moisture intrusion. Please refer to photos #5.2, #5.3 and #5.4 for more detail.

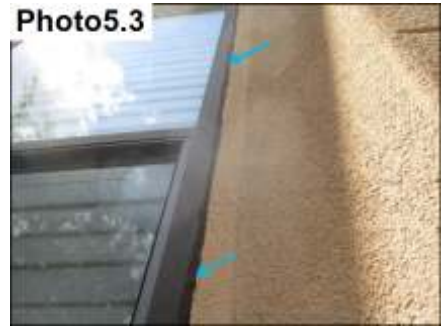
Photo5.3

Window Sealants/ Maintain

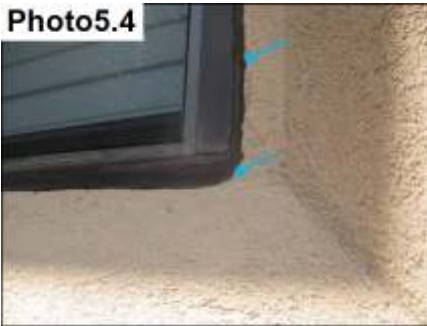
Photo5.4

Window Sealants/ Maintain

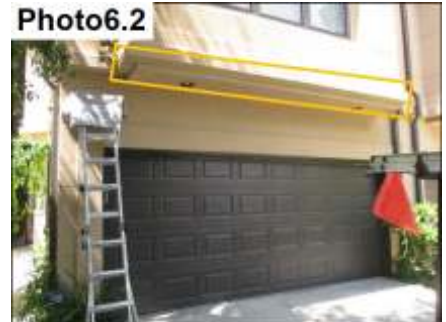
Photo6.2
Semi-Firm Substrate/ Install Relief

Grid Location	Item Description	Moisture Readings	Substrate Condition	Observations
Orange Box	Semi-Firm Substrate			The substrate in this bottom of the bumpout wall is semi-firm. The inspector suggests to have a qualified stucco waterproofing contractor to install a relief in an effort to allow proper moisture evacuation. Please refer to photos #6.2, #6.3, #6.4 and #6.5 for more detail.
D5	Bottom Of Bumpout Wall	17%	Firm	A moisture probe was made at the bottom of the bumpout wall. The substrate was firm with no damage noted at this time.
E5	Bottom Of Bumpout Wall	22%	Semi-Firm	A moisture probe was made at the bottom of the bumpout wall. An elevated moisture reading was noted with a semi-firm substrate.
G5	Bottom Of Bumpout Wall	21%	Semi-Firm	A moisture probe was made at the bottom of the bumpout wall. An elevated moisture reading was noted with a semi-firm substrate.
G6	Garage Header	20%	Firm	A moisture probe was made at the garage header. An elevated moisture reading was noted with a firm substrate.

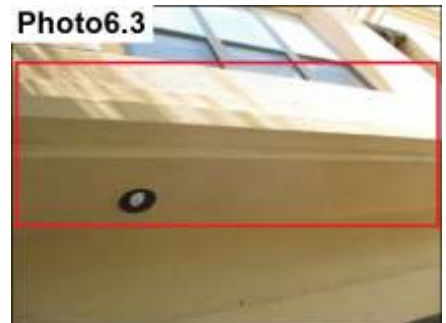
Photo6.3
Semi-Firm Substrate/ Install Relief

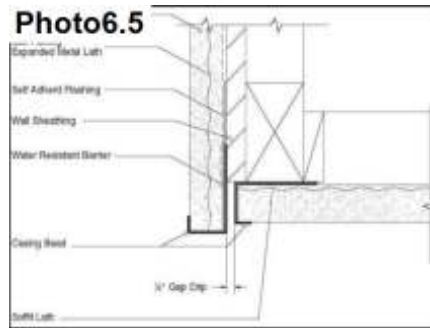
Photo6.5
Proper Detail

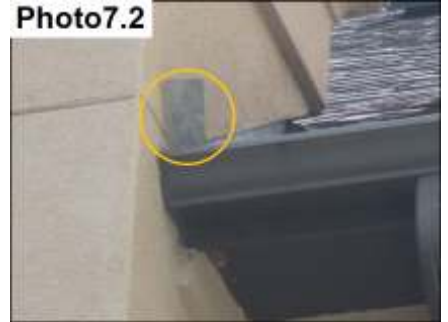
Photo7.2

Kickout Flashing Sealants/ Seal

Grid Location	Item Description	Moisture Readings	Substrate Condition	Observations
Orange Circles	Kickout Flashing Sealants			The kickout flashing sealants are separated or missing. The inspector suggests to have a qualified stucco waterproofing contractor seal this area with NP1 or low modulus sealant in an effort to prevent moisture intrusion. These types of sealants are of high quality and compatible with stucco and other termination points. Please refer to photos #7.2 and #7.3 for more detail.
Pink Circles	Water Stains			Water stains are noted in this area. The inspector suggests to clean as needed. Please refer to photo #7.4 for more detail.

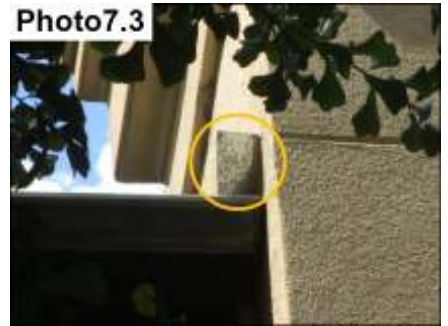
Photo7.3

Kickout Flashing Sealants/ Seal

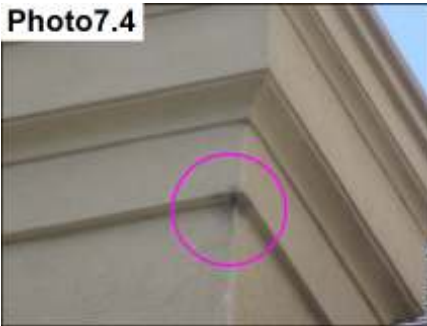
Photo7.4

Water Stains/ Clean

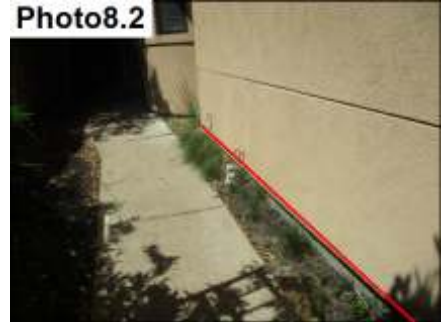
Photo8.2

Black Plastic/ Cut

Grid Location	Item Description	Moisture Readings	Substrate Condition	Observations
Red Line	Black Plastic			Black plastic has been noted in this area. This is when the substrate has been sealed with black plastic, which creates a reservoir to hold moisture. The inspector suggests to consult with a qualified stucco waterproofing contractor to cut the black plastic in an effort to prevent the substrate from rotting. Please refer to photos 8.2, #8.3 and #8.4 for more detail.

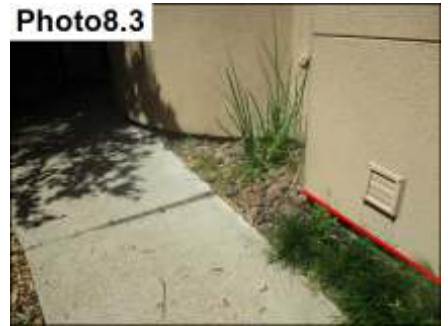
Photo8.3

Black Plastic/ Cut

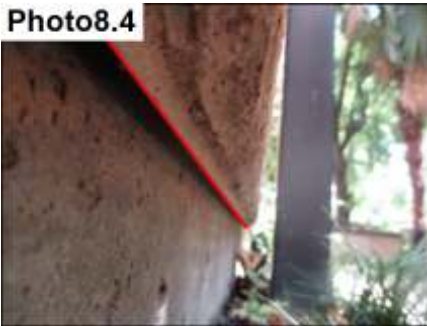
Photo8.4

Black Plastic/ Cut

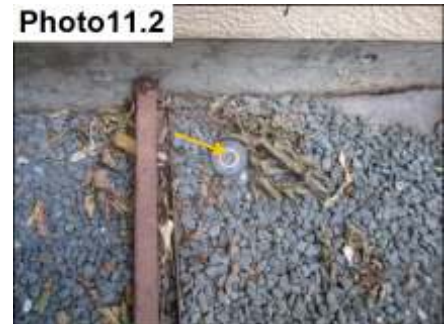
Photo11.2

Sprinklers/ Redirect

Grid Location	Item Description	Moisture Readings	Substrate Condition	Observations
Orange Arrow	Sprinklers			Sprinklers have been noted on this home. The inspector suggests to always redirect sprinkler heads away from the system and windows as needed in an effort to prevent moisture intrusion. Please refer to photo #11.2 for more detail.
Blue Arrows	Penetration Sealants			The penetration sealants are present in this location. The inspector states that this is a positive detail and suggests to maintain all sealants in an effort to prevent moisture intrusion. Please refer to photos #11.3, #11.4 and #11.5 for more detail.

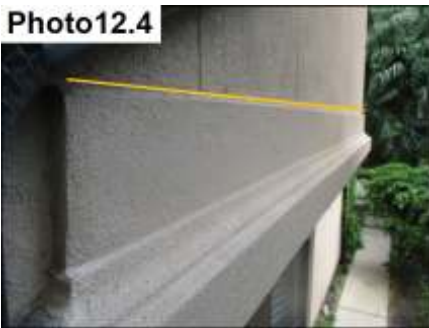
Photo12.4

- The foam/stucco termination sealants are deteriorating. The inspector suggests to have a qualified stucco waterproofing contractor seal this area with NP1 or low modulus sealant in an effort to prevent moisture intrusion. These types of sealants are of high quality and compatible with stucco and other termination points. Please refer to photos #12.4, #12.5 and #12.6 for more detail.

Foam/Stucco Termination Sealants/
Seal

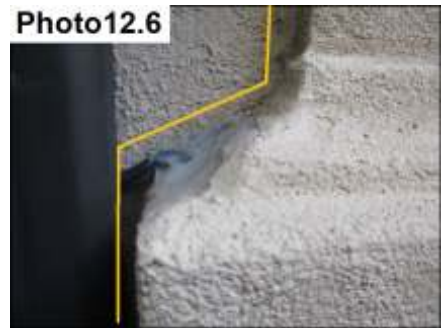
Photo12.6

Foam/Stucco Termination Sealants/
Seal

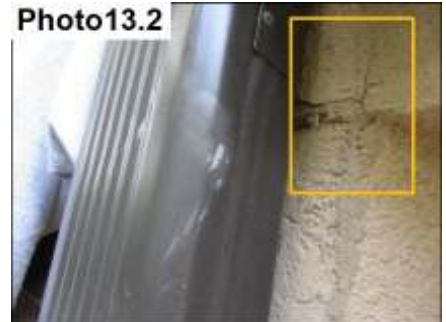
Control Joint Cracks/ Seal

Grid Location	Item Description	Moisture Readings	Substrate Condition	Observations
Orange Boxes	Control Joint Cracks			Control joint cracks are noted in this location. The inspector suggests to have a qualified waterproofing contractor seal these cracks for aesthetic purposes only. Please refer to photos #13.2, #13.3 and #13.4 for more detail.
Yellow Line	Bottom Wall Without Relief			The bottom wall in this location does not have a relief but the substrate is firm and dry. The inspector suggests no modification at this time. Please refer to photos #13.5 and #13.6 for more detail.
D3	Bottom Wall	16%	Firm	A moisture probe was made at the bottom wall. The substrate was firm with no damage noted at this time.

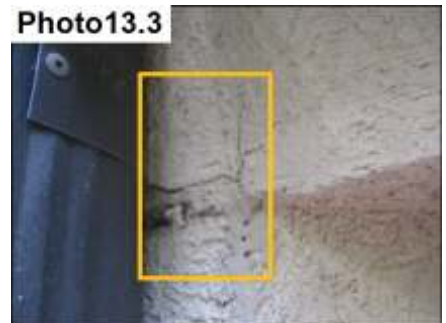
Control Joint Cracks/ Seal

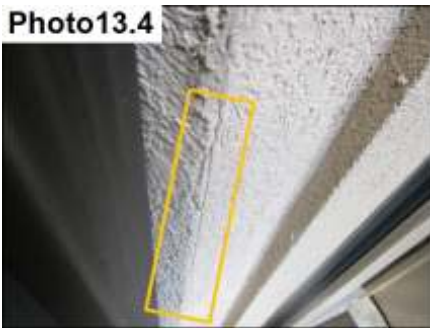
Control Joint Cracks/ Seal

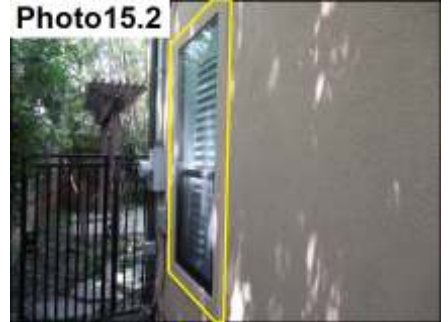
Photo15.2

Window Trim/Stucco Termination Sealants/ Seal

Grid Location	Item Description	Moisture Readings	Substrate Condition	Observations
Yellow Boxes	Window Trim/Stucco Termination Sealants			The window trim/stucco termination sealants are deteriorating. The inspector suggests to have a qualified stucco waterproofing contractor seal this area with NP1 or low modulus sealant in an effort to prevent moisture intrusion. These types of sealants are of high quality and compatible with stucco and other termination points. Please refer to photos #15.2, #15.3, #15.4, #15.5 and #15.6 for more detail.

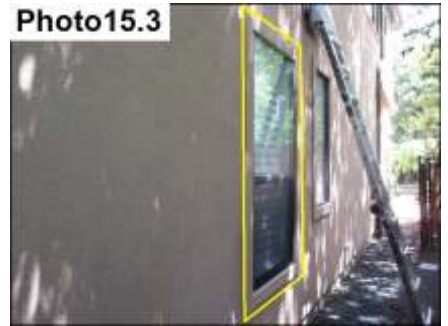
Photo15.3

Window Trim/Stucco Termination Sealants/ Seal

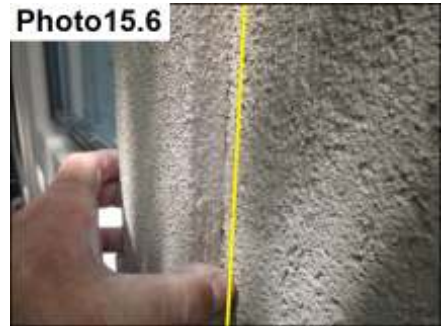
Photo15.6

Window Trim/Stucco Termination Sealants/ Seal

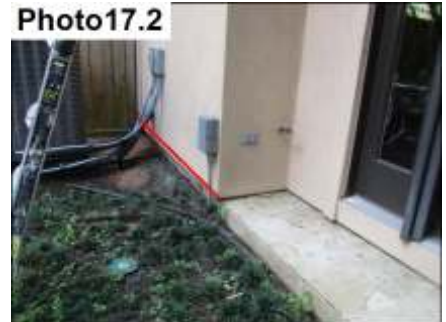
Photo17.2

Black Plastic/ Cut

Grid Location	Item Description	Moisture Readings	Substrate Condition	Observations
Red Lines	Black Plastic			Black plastic has been noted in this area. This is when the substrate has been sealed with black plastic, which creates a reservoir to hold moisture. The inspector suggests to consult with a qualified stucco waterproofing contractor to cut the black plastic in an effort to prevent the substrate from rotting. Please refer to photos #17.2, #17.3 and #17.4 for more detail.
Yellow Line	Bottom Wall Without Relief			The bottom wall in this location does not have a relief but the substrate is firm and dry. The inspector suggests no modification at this time. Please refer to photo #17.5 for more detail.

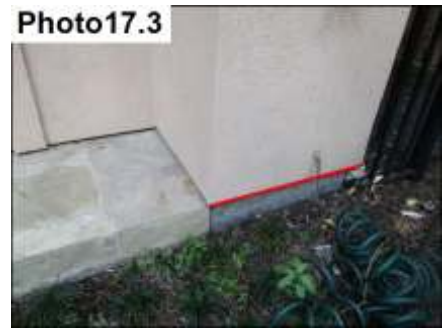
Photo17.3

Black Plastic/ Cut

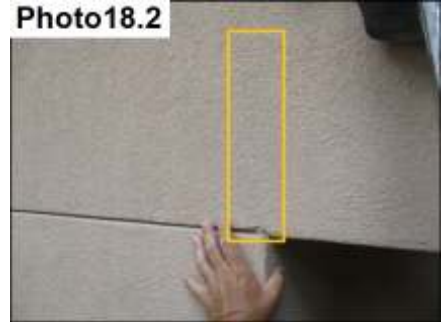
Photo18.2

Cracks/ Seal Or Repair

Grid Location	Item Description	Moisture Readings	Substrate Condition	Observations
Orange Boxes	Cracks			Minor cracks are noted in this location. The inspector suggests to have a qualified stucco waterproofing contractor seal or repair these cracks in an effort to prevent moisture intrusion. Please refer to photos #18.2, #18.3 and #18.4 for more detail.

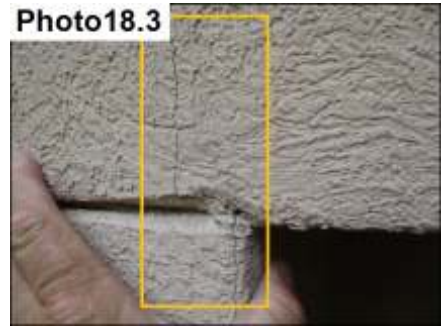
Photo18.3

Cracks/ Seal Or Repair

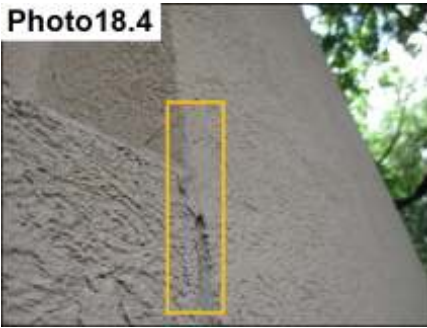
Photo18.4

Cracks/ Seal Or Repair

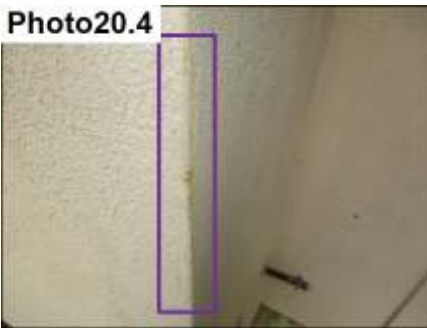
Photo20.4

- Rust stains are noted in this area. The inspector suggests to clean this location with a wire brush and paint as needed. Please refer to photo #20.4 for more detail.

Rust Stains/ Clean And Paint
