Property Inspection Report

22211 Wether Burn Ln, Katy, TX 77449

Date of Inspection: 6/8/2018 Time: 8:30 AM

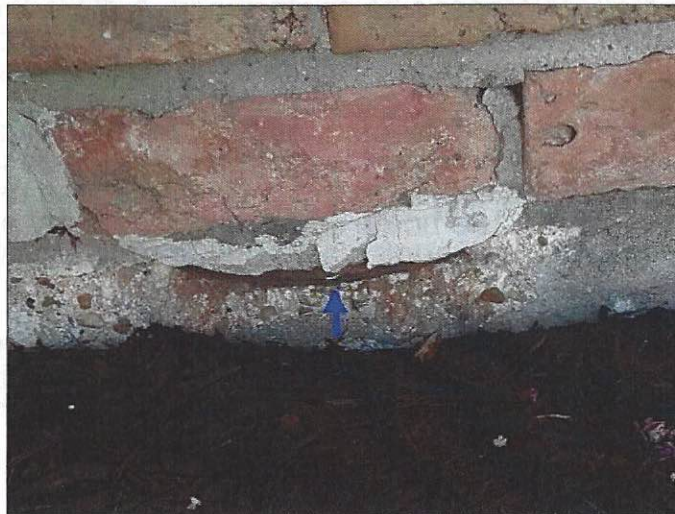
A.1. -Portions of the foundation rebar or metal is exposed at the sides of the slab. Recommend coating with a rust inhibitor and sealing to help prevent further deterioration. Mainly at - garage right

-Portions of the foundation rebar or metal is exposed at the sides of the slab. Recommend coating with a rust inhibitor and sealing to help prevent further deterioration. Mainly at - garage right

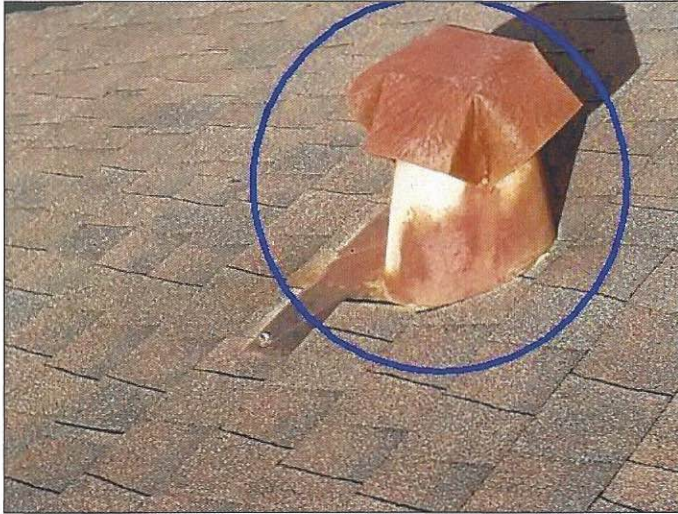
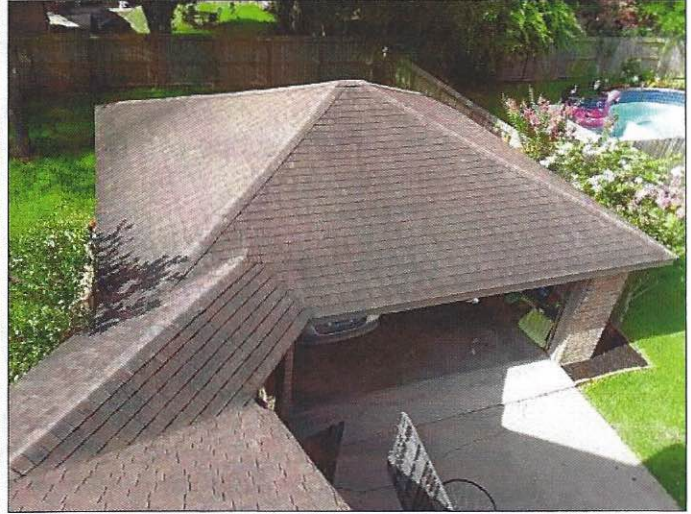
C.4. -There are signs of rusted flashings on the rooftop. We recommend painting or replacing all rusted or deteriorated flashings as needed.

-There are signs of rusted flashings on the rooftop. We recommend painting or replacing all rusted or deteriorated flashings as needed.

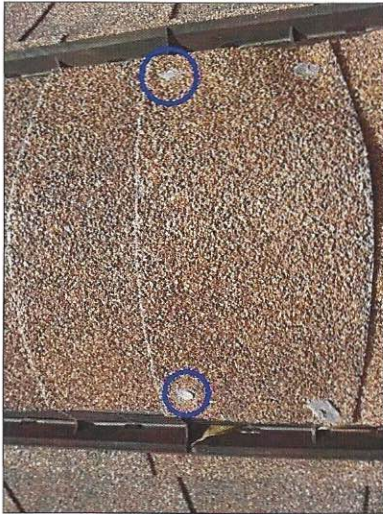
C.3. -All exposed nails and fasteners on roof should be sealed at all penetrations, ridges and roof to wall connections.

-All exposed nails and fasteners on roof should be sealed at all penetrations, ridges and roof to wall connections.

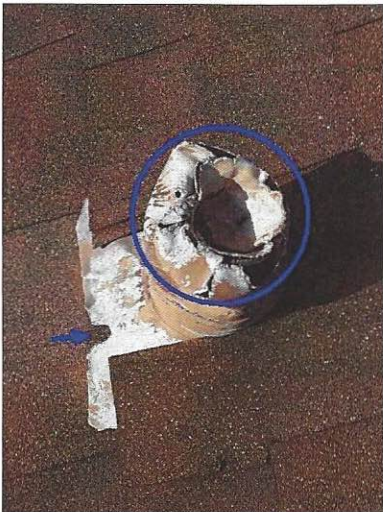
-Damage was noted to the lead roof jack flashings. This is a common occurrence due to squirrels getting on roof, recommend a roofing specialist check all lead roof jacks for repair or replacement as needed depending on the extent of damage and check entire roof for other issues that may be of concern. (Squirrel resistant roof jacks are now available through many roof companies)

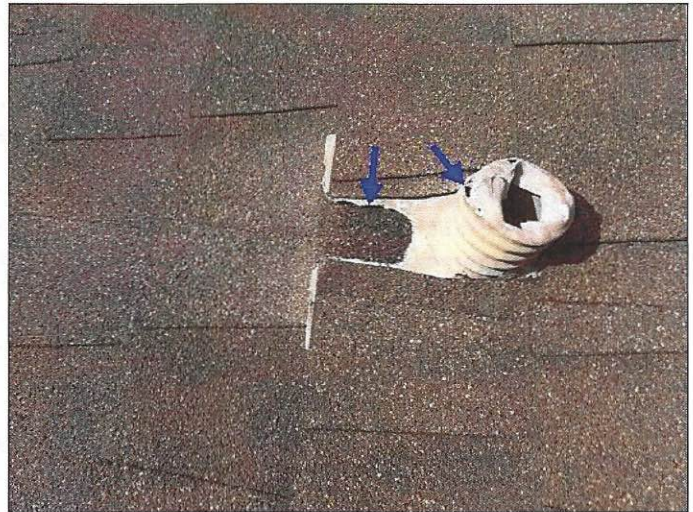
C.2. -Damage was noted to the lead roof jack flashings. This is a common occurrence due to squirrels getting on roof, recommend a roofing specialist check all lead roof jacks for repair or replacement as needed depending on the extent of damage and check entire roof for other issues that may be of concern. (Squirrel resistant roof jacks are now available through many roof companies)

-Damage was noted to the lead roof jack flashings. This is a common occurrence due to squirrels getting on roof, recommend a roofing specialist check all lead roof jacks for repair or replacement as needed depending on the extent of damage and check entire roof for other issues that may be of concern. (Squirrel resistant roof jacks are now available through many roof companies)

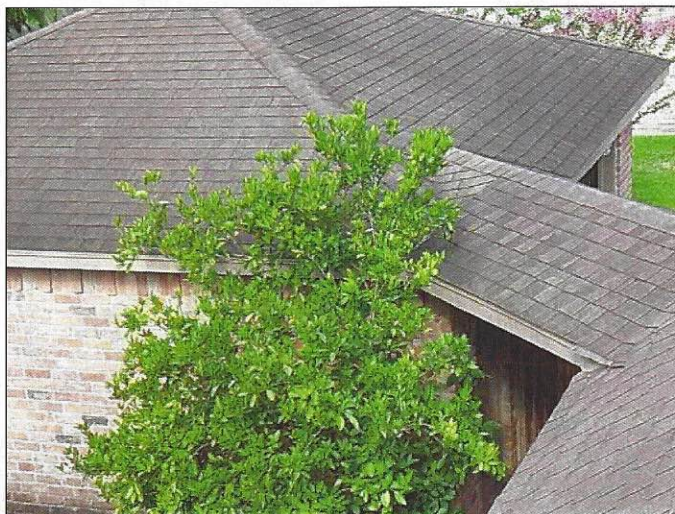
C.1. -Tree limbs should be kept trimmed at least 5' from roof to help prevent damage to the roof during windy conditions.

-Tree limbs should be kept trimmed at least 5' from roof to help prevent damage to the roof during windy conditions.

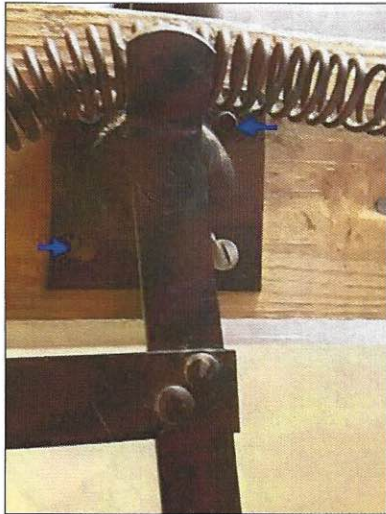
-The attic pull-down stairs are not supported properly. It should be hung with 16 penny nails or lag screws in the empty hole at the bracket on the hinge side of the stairway and on the side hinge.

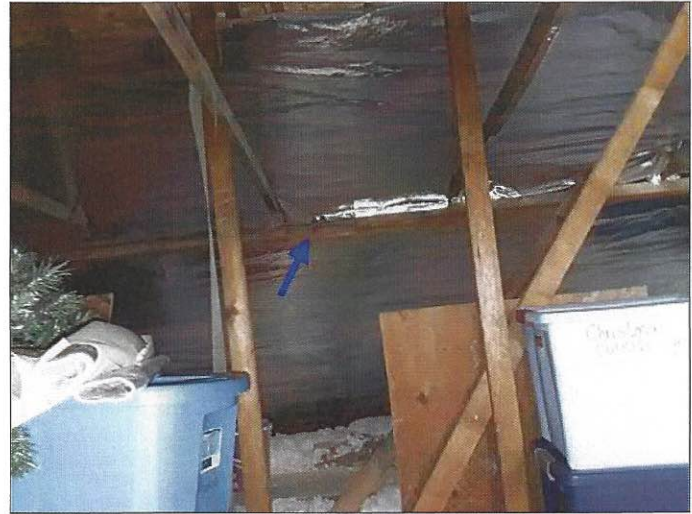
-The purlin should be at least as large as the rafters they support and the purlin braces should be no more than 4' apart.

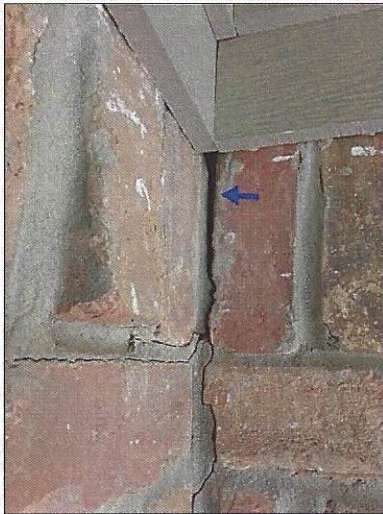
E.1. -Seal all gaps and holes in brick or siding to help prevent moisture intrusion. Mainly at - front porch

-Seal all gaps and holes in brick or siding to help prevent moisture intrusion. Mainly at - front porch

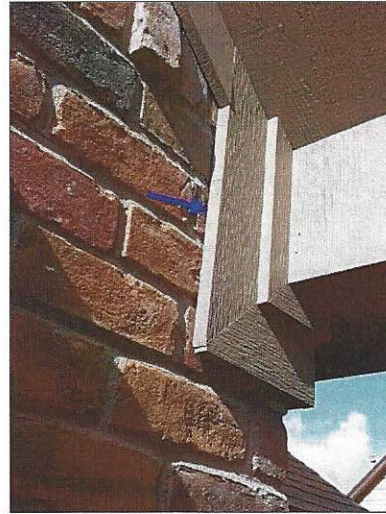
-Recommend sealing between the trim and brickwork to help prevent water penetration. Mainly at - front right

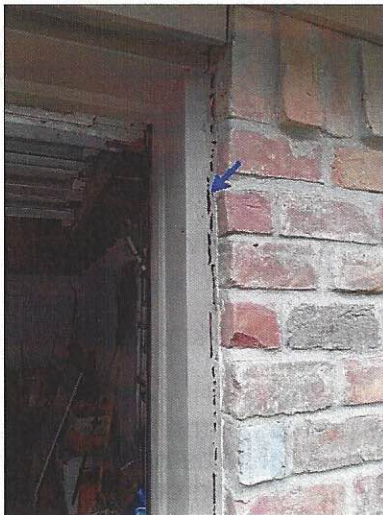
E.2. -Recommend sealing between the trim and brickwork to help prevent water penetration. Mainly at - front right, garage

-Recommend sealing between the trim and brickwork to help prevent water penetration. Mainly at - garage

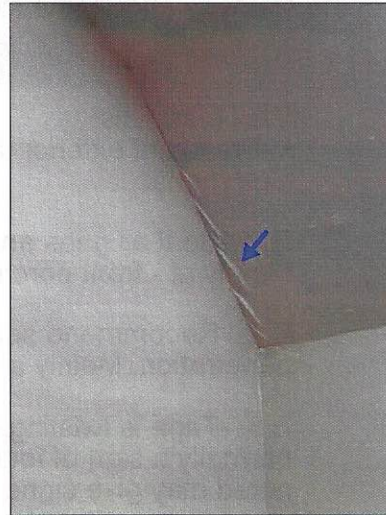
E.3. -Tape is twisting due to movement in the corners of the drywall, this is normally a sign of foundation movement or structural settlement, other movement noted may give signs of the cause. Mainly at - master bedroom

-Tape is twisting due to movement in the corners of the drywall, this is normally a sign of foundation movement or structural settlement, other movement noted may give signs of the cause. Mainly at - master bedroom

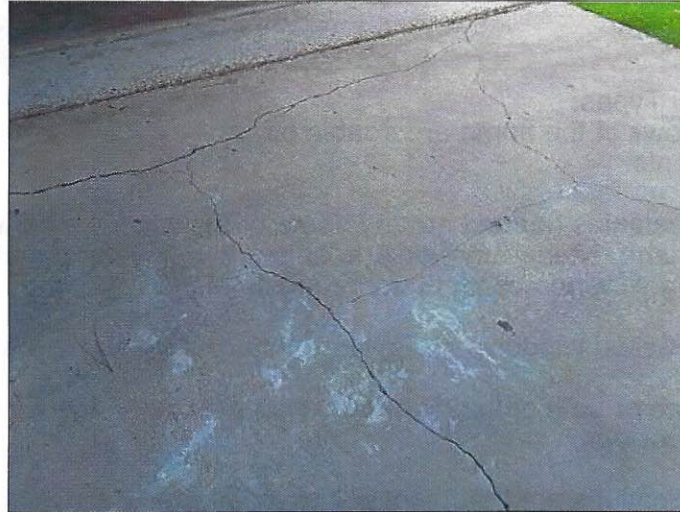
F.1. -Cracks were noted in the pavement. These are cosmetic in nature at this time. Recommend sealing to prevent further deterioration. Mainly at - Driveway

-Cracks were noted in the pavement. These are cosmetic in nature at this time. Recommend sealing to prevent further deterioration. Mainly at - Driveway

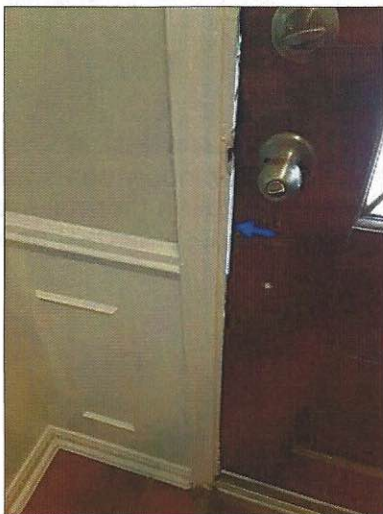
G.2. -There is visible light noted around the door. Mainly at - front door

-There is visible light noted around the door. Mainly at - front door

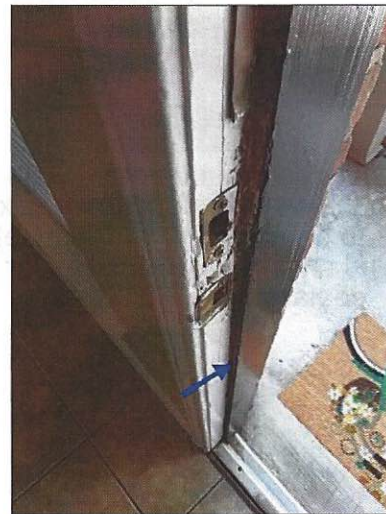
G.1. -The weather strip is missing around the door, causing it to not seal properly. Mainly at - back door

-The weather strip is missing around the door, causing it to not seal properly. Mainly at - back door

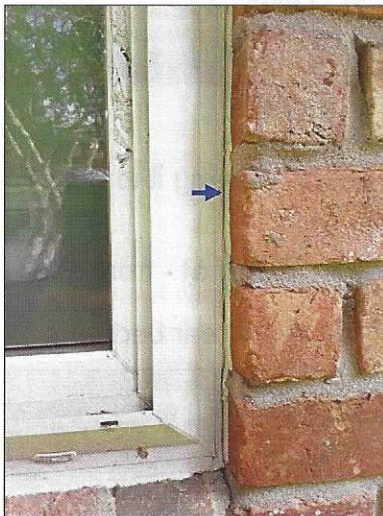
H.1. -Sealant is needed around some of the windows between the window framing and exterior brickwork to help prevent water penetration, recommend checking all windows for proper sealant. Mainly at - rear

-Sealant is needed around some of the windows between the window framing and exterior brickwork to help prevent water penetration, recommend checking all windows for proper sealant. Mainly at - rear

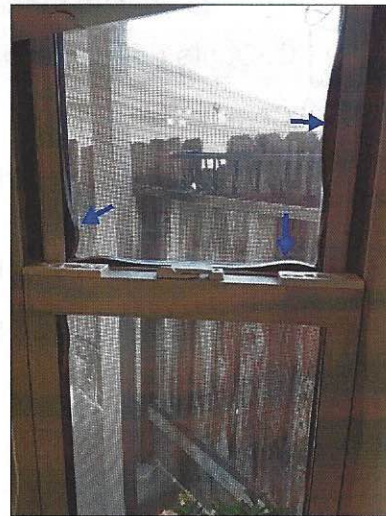
H.4. Indications are that the window seals are defective and may lead to a broken thermal seal in the future. Mainly at- breakfast nook

Indications are that the window seals are defective and may lead to a broken thermal seal in the future. Mainly at- breakfast nook

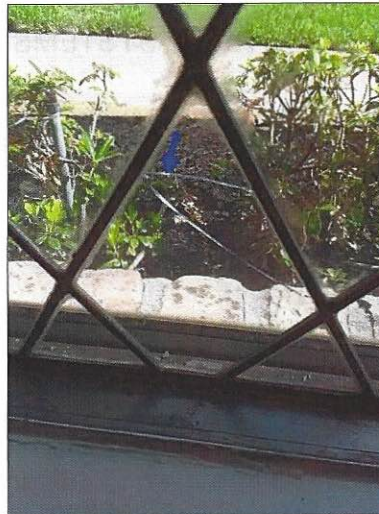
H.2. -Cracked windowpane(s) were noted. Mainly at - front

-Cracked windowpane(s) were noted. Mainly at - front

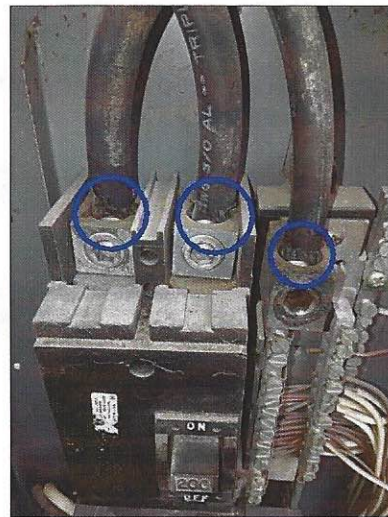
-There is no antioxidant on main aluminum feeds to the panel box. This should be used to help prevent overheating.

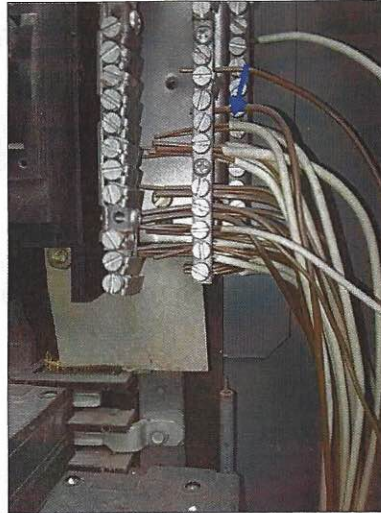
-There are more than one neutral wire located under the same screw. Neutral wires should be separated to individual screws.

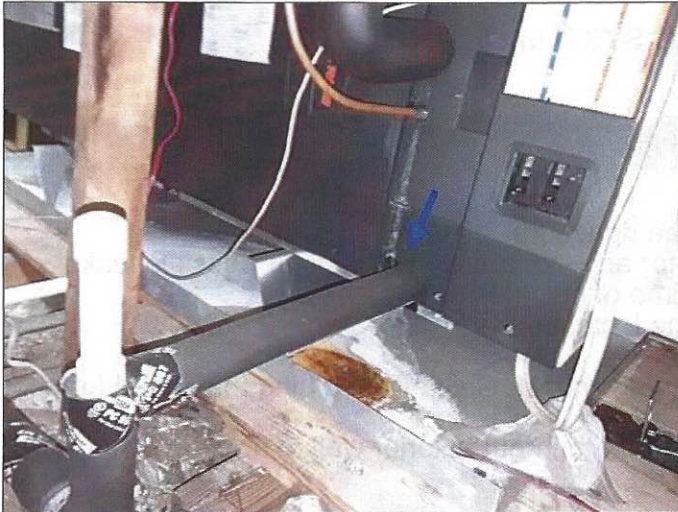
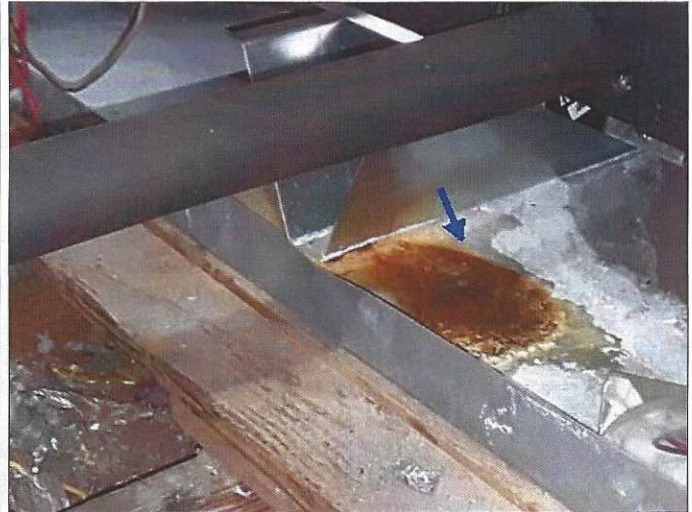
B.2. -The evaporator is missing the secondary drain line to the exterior or to the pan in case main condensation line becomes clogged, recommend adding a secondary drain or high water shutoff to drain line to help prevent water damage to ceilings.

-The evaporator is missing the secondary drain line to the exterior or to the pan incase main condensation line becomes clogged, recommend adding a secondary drain or high water shutoff to drain line to help prevent water damage to ceilings.

-There is water noted in the A/C pan. This is an indication that the main condensation line is clogged, recommend contacting an A/C specialist to remove clog and restore drain to normal operating procedure. It is also recommended to have the unit checked for proper operation and for cleanliness.

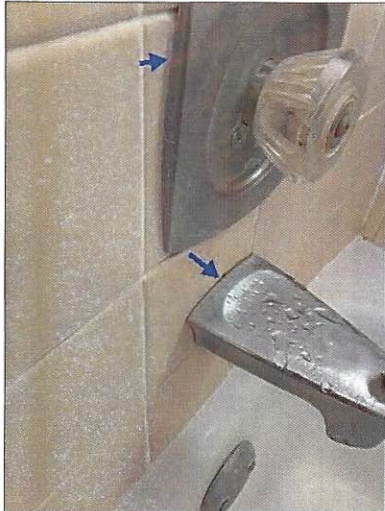
-All tub shower faucets and spouts should be sealed to help prevent water penetration behind the fixture.

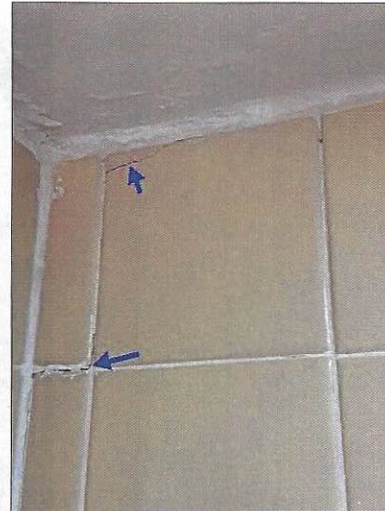
-Cracked or missing tiles were noted in the tub shower surround or shower stall, recommend repairs to help prevent water penetration to underlying materials. Unable to determine the condition of underlying materials. Mainly at - master bathroom

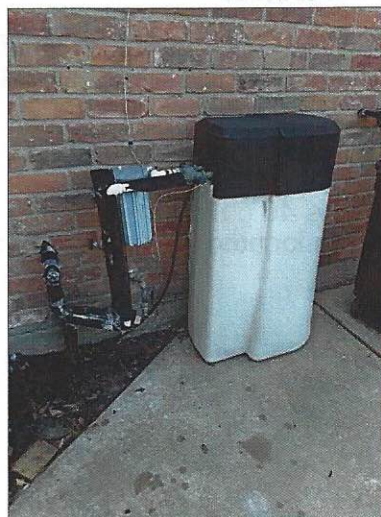
E.1. -There is a water softener installed on the property. Water softeners are not part of a normal home inspection, therefore we recommend a full evaluation of the water softener system by a licensed plumber.

-There is a water softener installed on the property. Water softeners are not part of a normal home inspection, therefore we recommend a full evaluation of the water softener system by a licensed plumber.

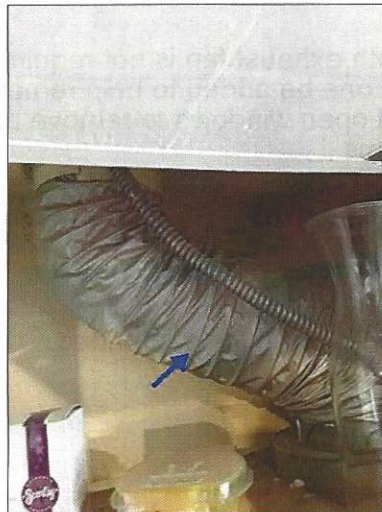
C.2. -Range/cooktop vents should be made of smooth pipe not corrugated pipe so that grease does not accumulate in crevasses. This is a potential fire hazard and should be corrected.

-Range/cooktop vents should be made of smooth pipe not corrugated pipe so that grease does not accumulate in crevasses. This is a potential fire hazard and should be corrected.
