Home Inspection
4625 Cherry St
Santa Fe, TX. 77510

PROPERTY INSPECTION REPORT

Concerning: 4625 Cherry St, Santa Fe, TX 77510
(Address or Other Identification of Inspected Property)

By: James Ezell, Lic #21864 04/17/2020
(Name and License Number of Inspector) (Date)

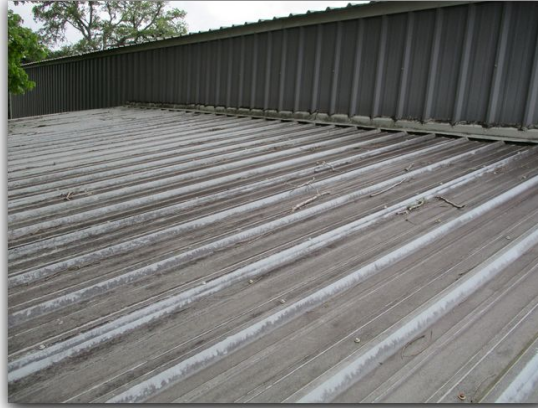
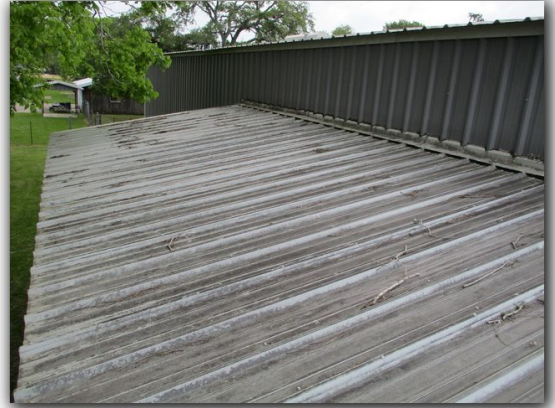
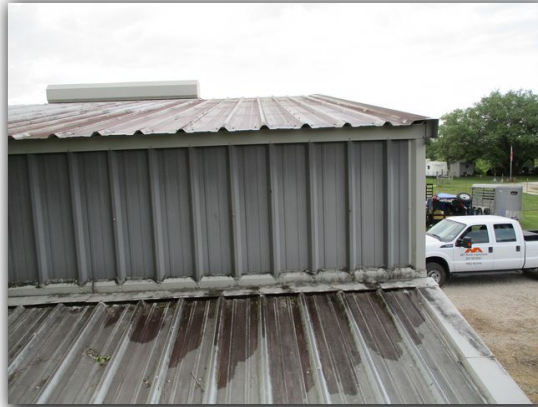
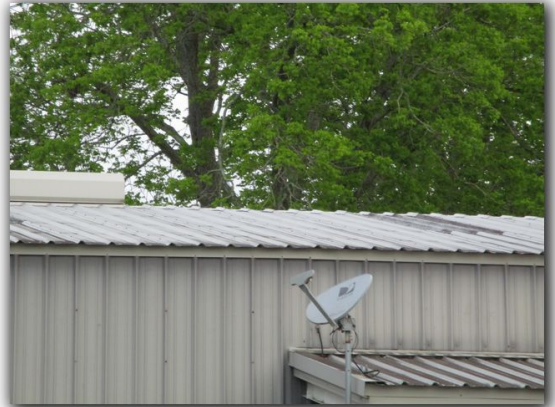
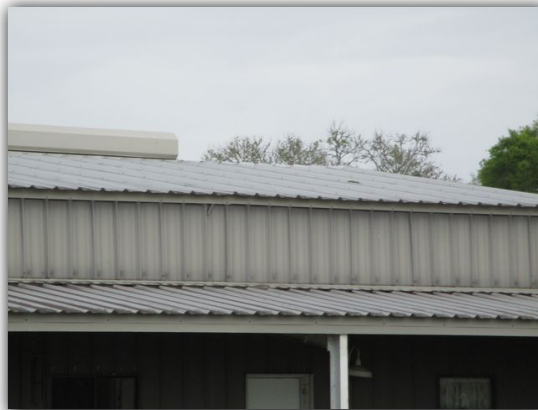
- Due to the height of the roof, not all areas were accessible for inspection. The

accessible/visible areas of the roof surface appear to be in overall good condition at this time.

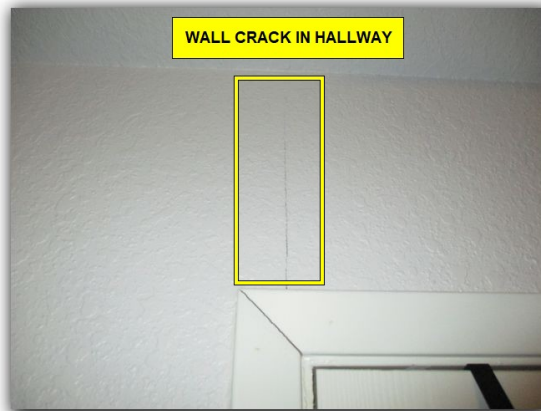
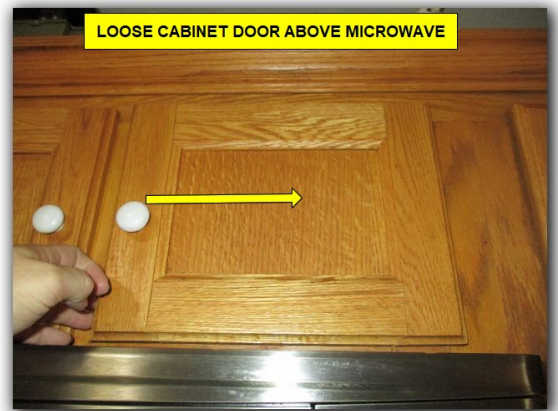
- There are defects on the interior drywall, paint, trim and cabinetry in areas throughout the home. The damage appears to be minor and consistent with the age and occupancy of the home.

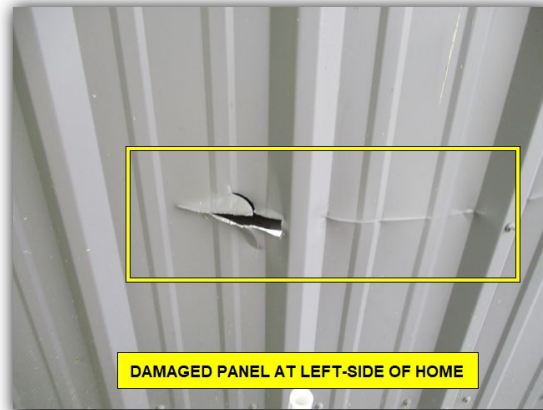
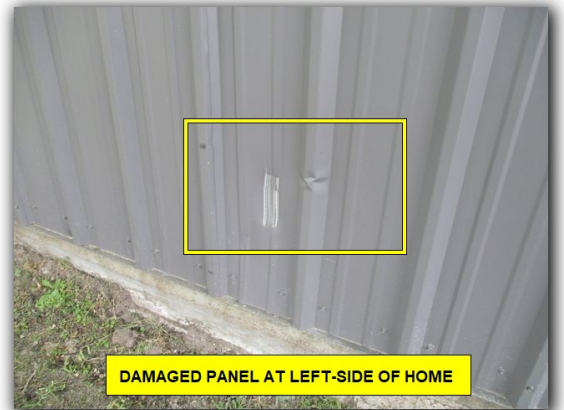
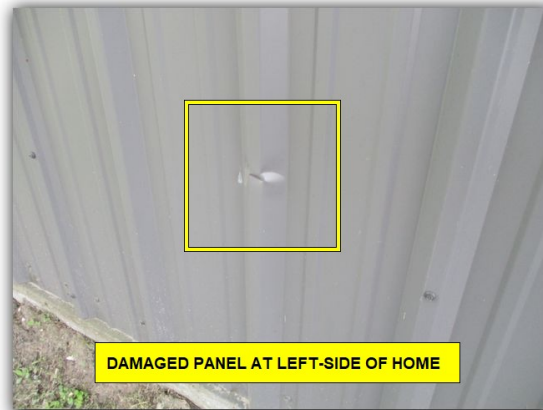
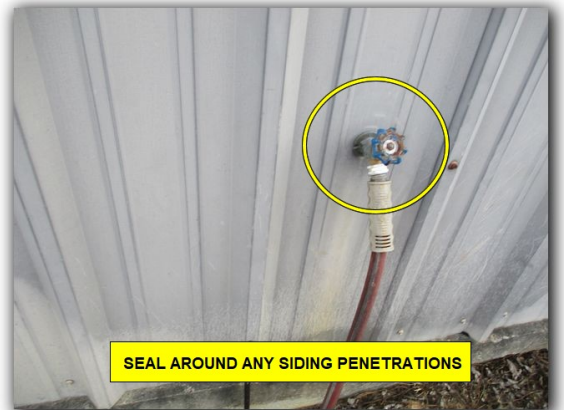
- There are damaged siding panels located at the left-side of the home. There is a ripped hole in one of the panels and dents on two of the panels.
- It is recommended that any penetrations in the metal siding be properly sealed to prevent possible leaks.

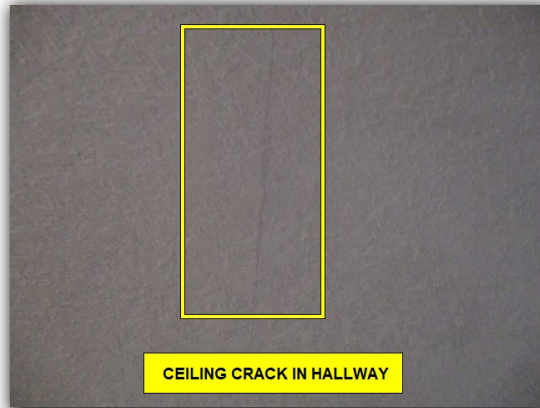
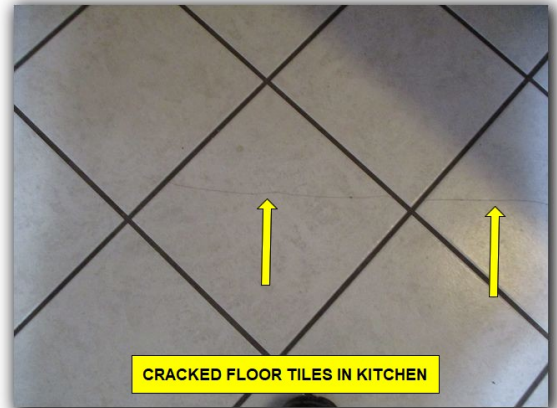
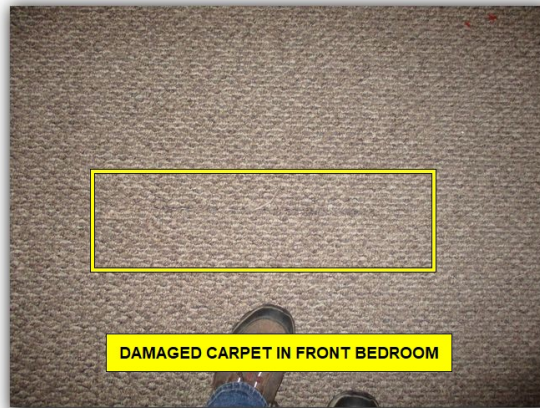
- There is a minor crack on the hallway ceiling drywall. Recommend the crack be repaired as necessary.
- There are two cracked floor tiles in the kitchen (near stove/sink area).
- There are damaged areas on the carpeting in areas.

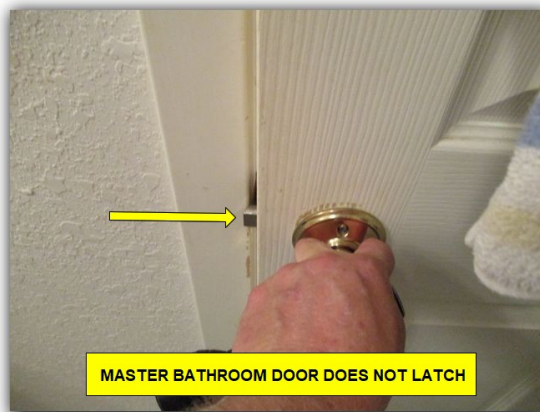
- The door to the master bathroom does not latch properly. Recommend the door be adjusted for proper closure.

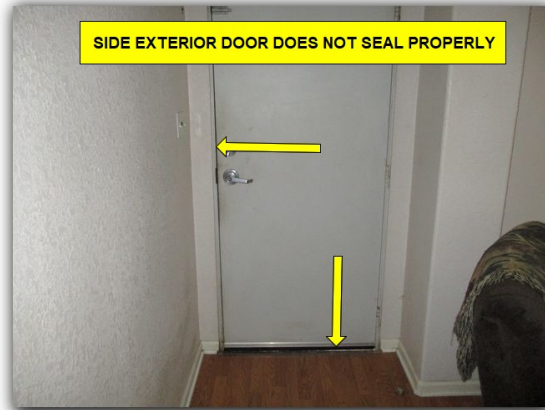
- The side exterior door does not seal properly. Recommend weather stripping be installed for a proper seal.

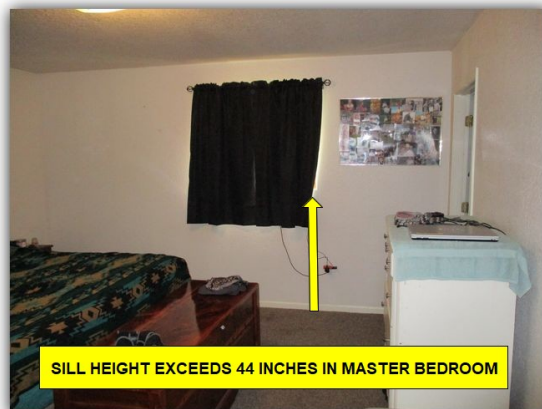
- The window sill height in the master bedroom exceeds 44 inches. This may pose an exit hazard during an emergency.

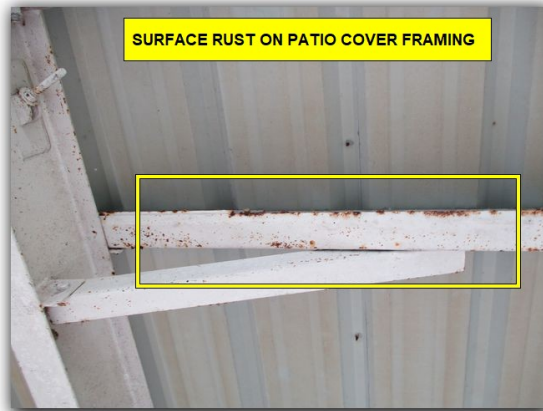
- There is surface rust on some of the roof framing members for the right-side patio cover. Recommend the rust be removed and the areas be re-painted as necessary.

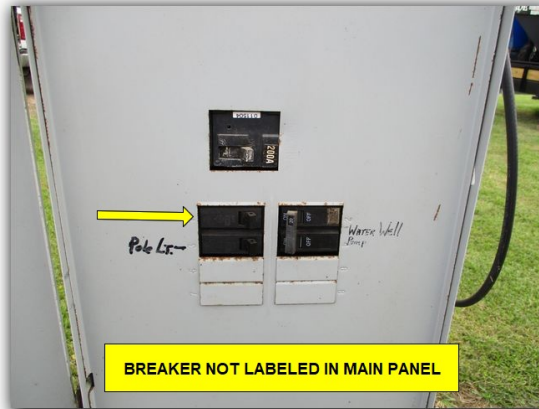
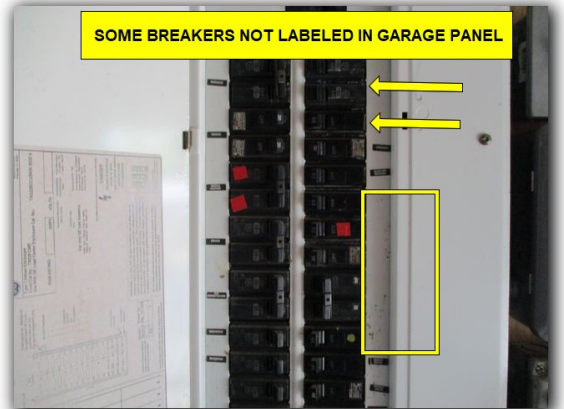
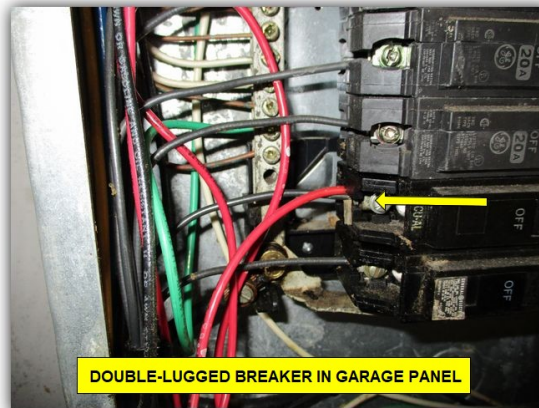
- Not all of the breakers are labeled in the main breaker panel (located on exterior pole) or in the interior breaker panel (located in garage area).
- There is a double-lugged breaker located in the garage breaker panel. This is when

more than one circuit wire is connected to a single breaker terminal.

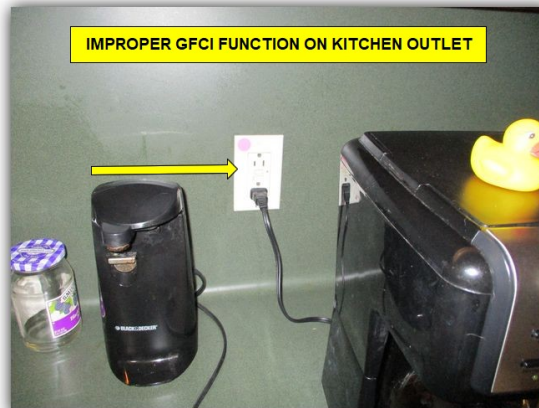
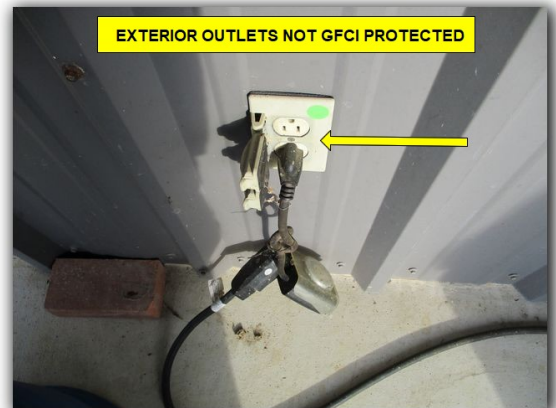
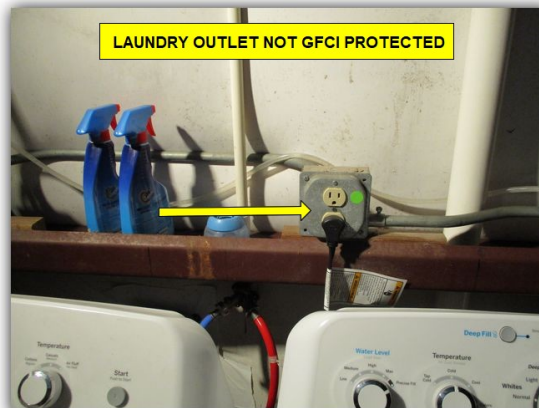
- The GFCI outlet located on the left-side of the kitchen counter top does not function properly. The outlet will not trip when tested. Recommend the outlet be replaced. This outlet is marked with a **PINK STICKER** for identification.
- The exterior and the laundry area outlets are not GFCI protected. These outlets are marked with **GREEN STICKERS** for identification.

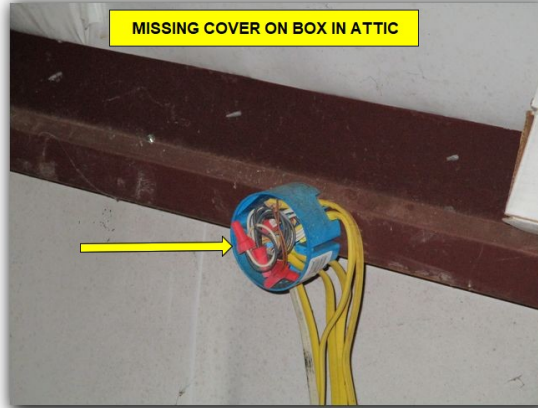
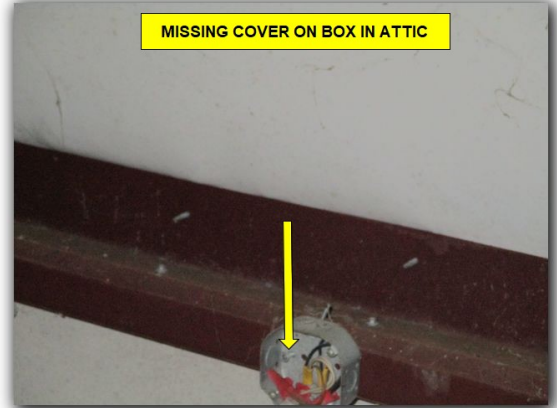
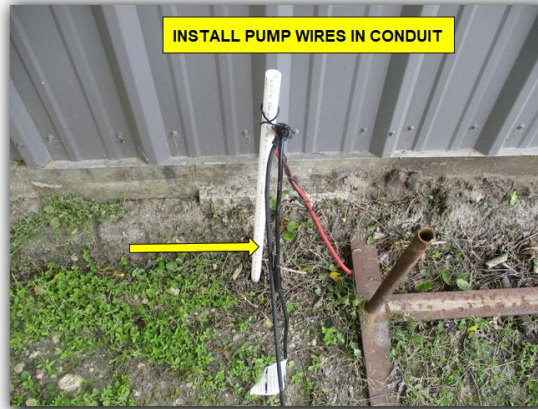
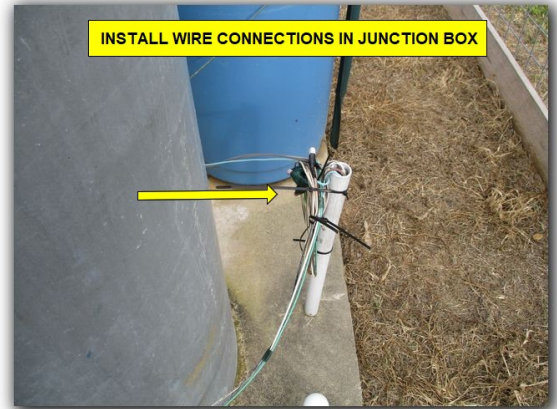
- Cover plates are missing from some of the electrical junction boxes located in the attic space. Recommend covers be installed.
- The exposed wiring for the drainage sump pump (located at the left-side of the home) should be installed in protective conduit.
- The exposed electrical connections for the water well pump should be installed

within a weather proof box.

- All electrical repairs should be performed by a licensed electrician.

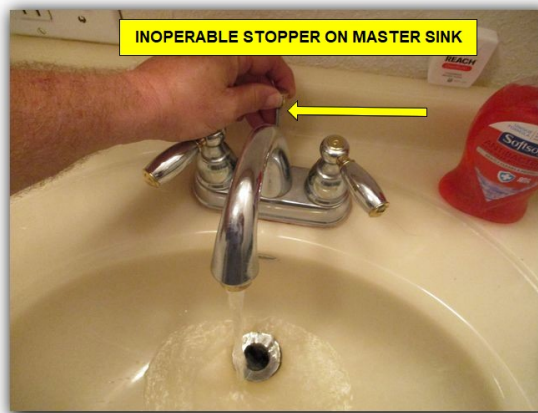
- The stopper is missing for the master bathroom sink.

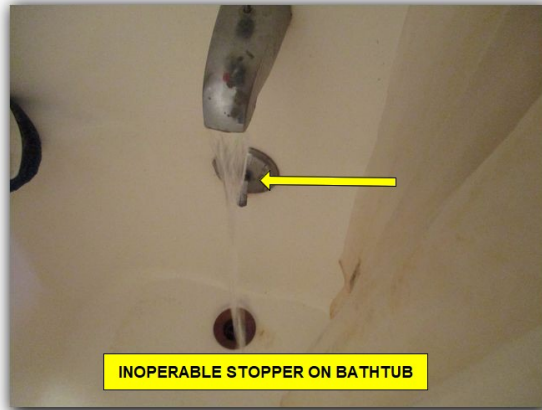
- The stopper mechanism for the bathtub does not function.

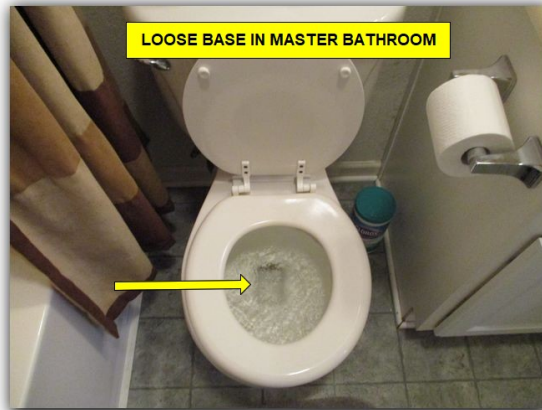
- The commode base in the master bathroom is loose. Recommend the base be properly tightened.

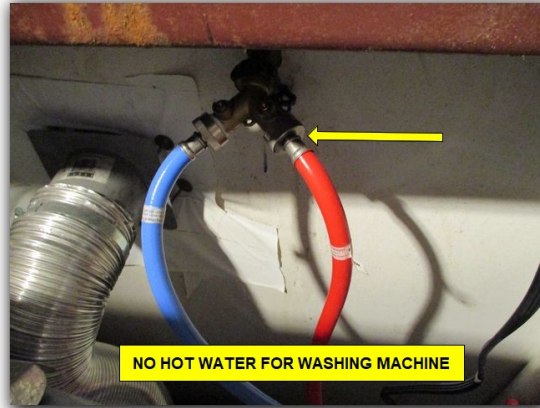
- There is no hot water supply for the washing machine.

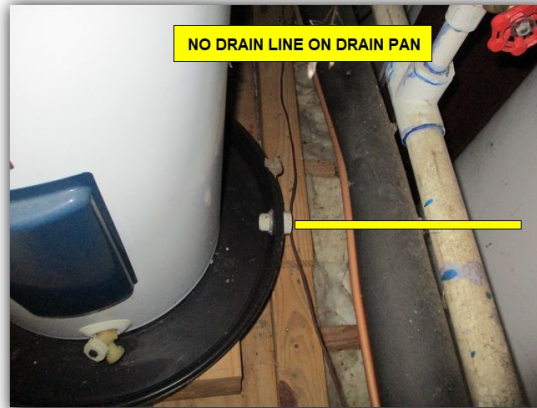
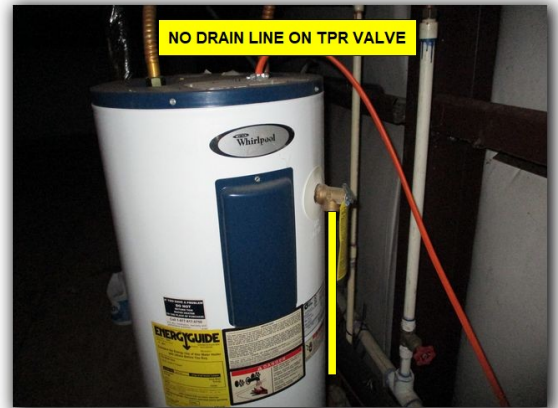
- There is no drain line plumbed to the exterior on the water heater drain pan or TPR valve.

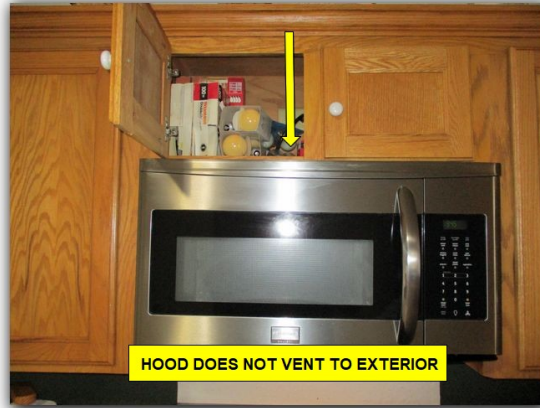
- The range vent hood does not vent to the exterior of the home (propane range/oven is in use). Recommend following the manufacture's instructions for venting the range/oven.

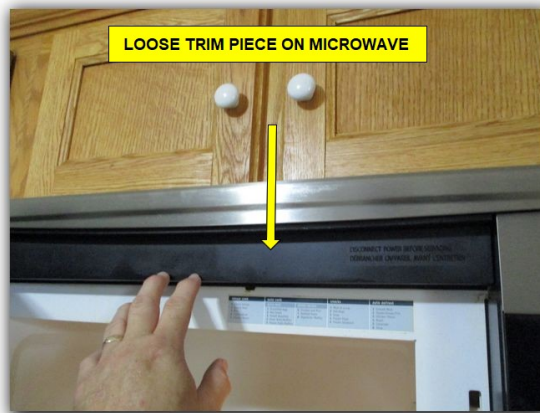
- The top trim piece on the microwave is loose.

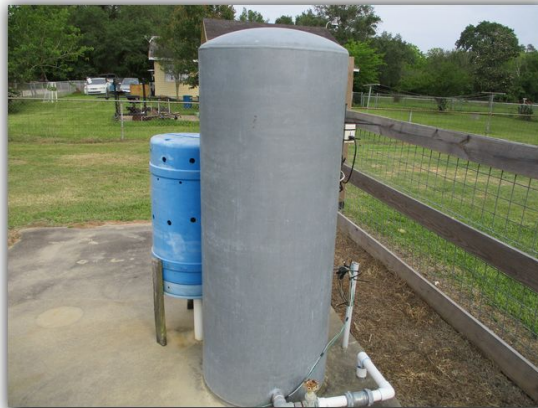
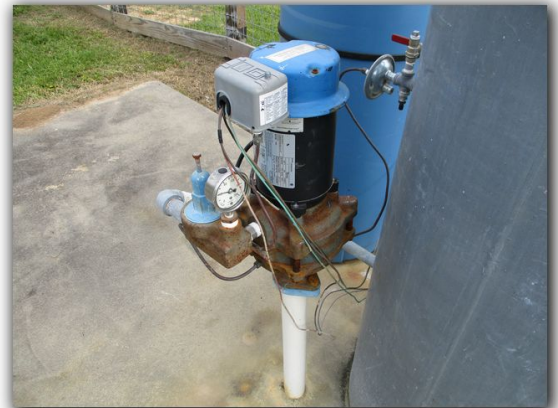
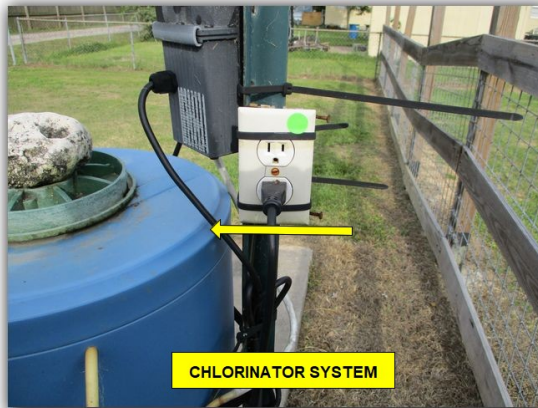
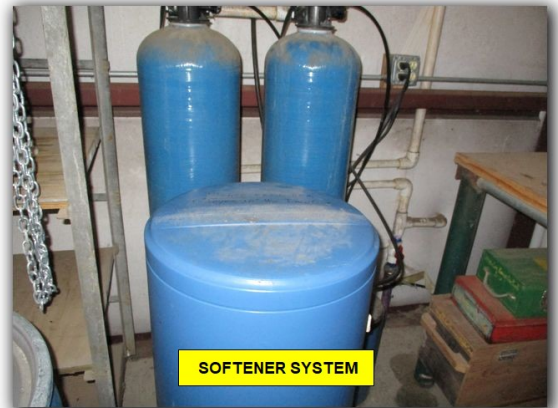
- The water well appeared to function properly at this time. The well pump cycled according to the installed 30-50 pressure switch. No leaks were observed on the exposed plumbing located at the well location.
- It is recommended that an enclosure be installed over the well equipment to protect it from the elements.
- A chlorination and softener system is installed on the home's water system. These systems were not inspected. It is recommended that any information on the function and care of the systems be obtained and reviewed.
