PROPERTY INSPECTION REPORT

Prepared For: Homer Balderas
(Name of Client)

Concerning: 4315 Walden Terrace Humble, Tx. 77396
(Address or Other Identification of Inspected Property)

By: Arturo Marquez TREC PI#2685 08/01/2019
(Name and License Number of Inspector) (Date)

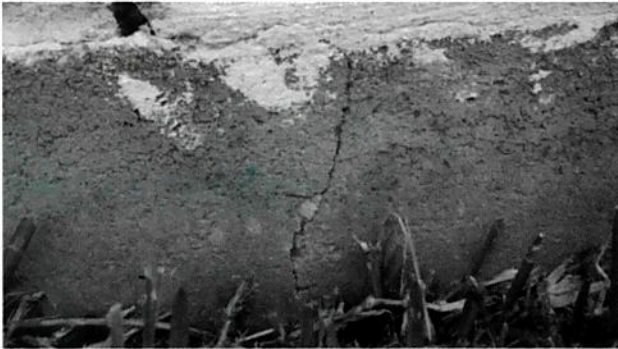
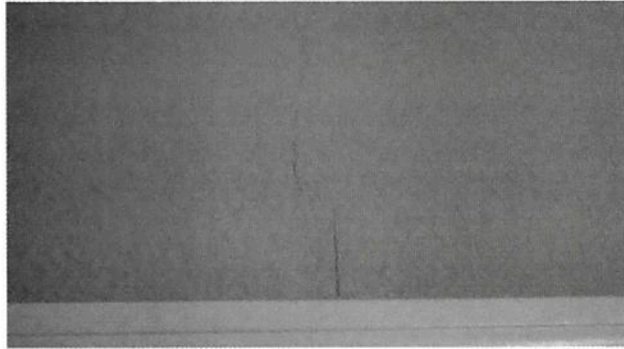
Comments: Cracks were observed on the right grade beam and on the upstairs front middle bedroom wall, [see sample pictures](#).

However, it is this inspector's opinion this foundation is currently performing its' intended function. None of the traditional signs of foundation problems/excessive differential movement were observed such as: deflections in the brick row, brick frieze boards pushed outwards, doors and windows out-of-square, doors and windows sticking, or gaping at attic framing members.

A monitoring and maintenance program should be initiated in an effort to minimize possible future differential movement.

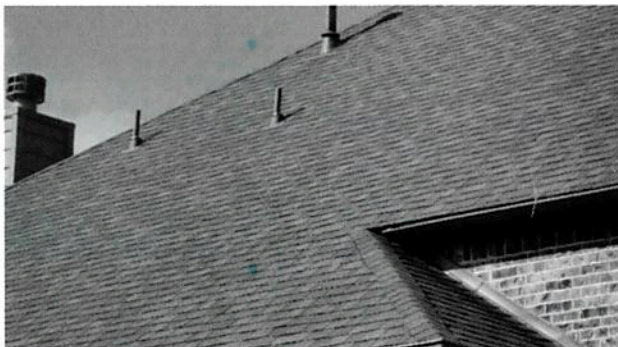
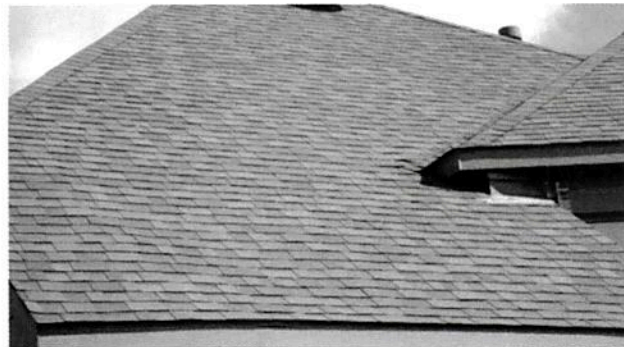
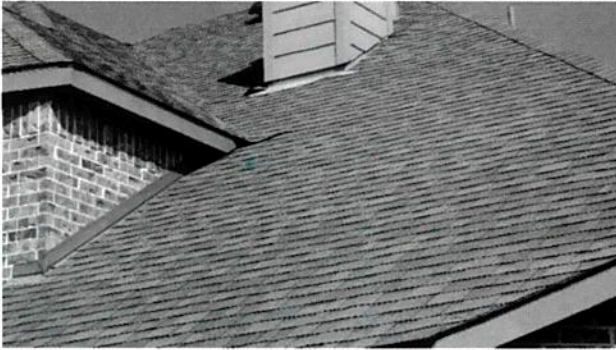
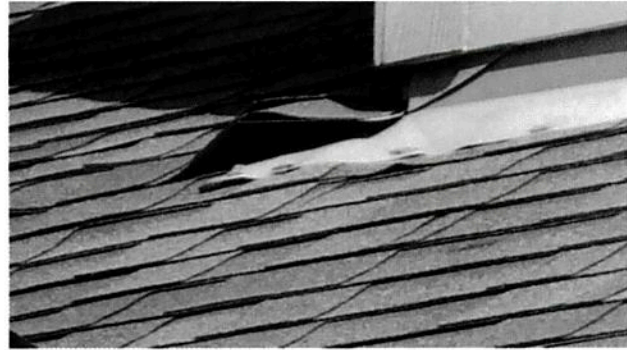
Comments: The overall condition of this roof covering was observed currently operable, [see sample pictures](#).

However, need to re-secure loose/uplifted flashing and shingle around the chimney, [see sample picture](#).

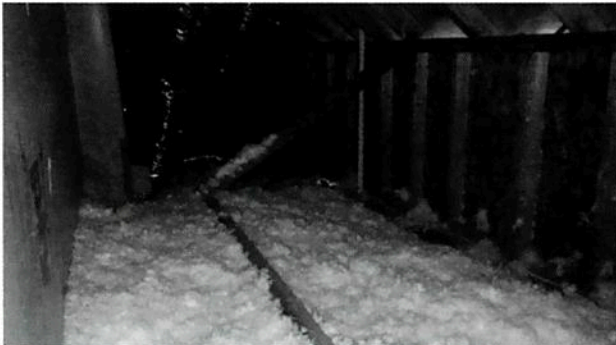
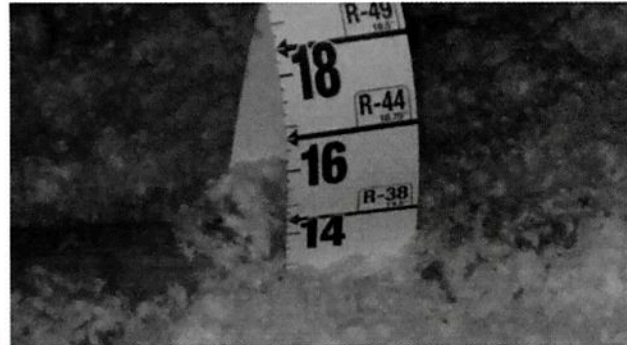
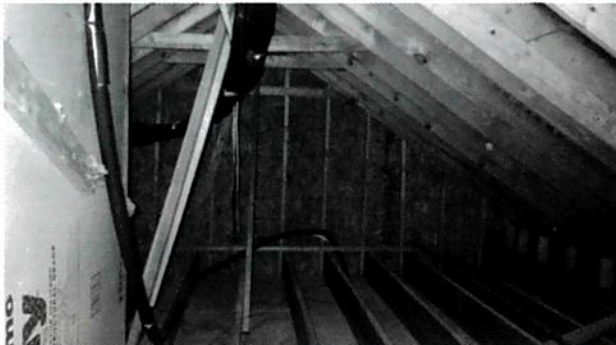
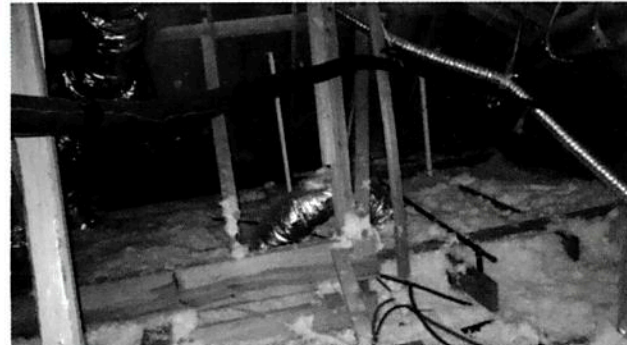
Comments: Visible components were observed currently operable, [see attic sample pictures](#).

However, the upstairs front right walk-in attic door panel is loose/not secured to wall.

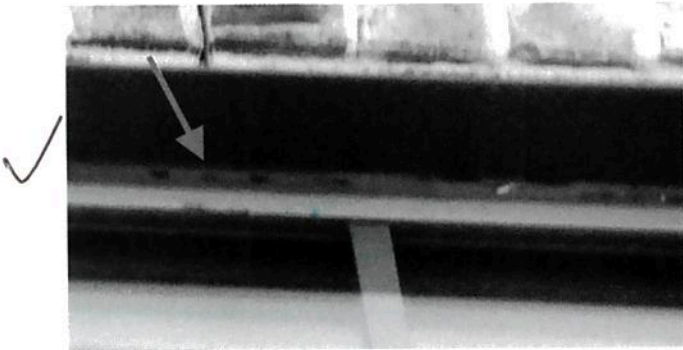
However, deteriorated sealant was observed on front left upper window frame/lintel junction and at downstairs right front window frame/brick veneer junction, see sample pictures.

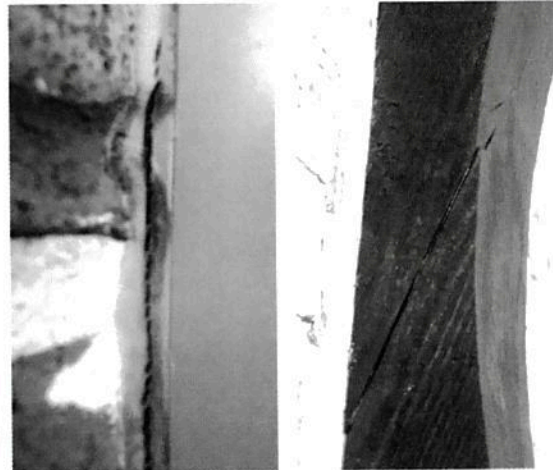
A couple of front wood corbels were observed split and in need of re-sealing, see sample picture.

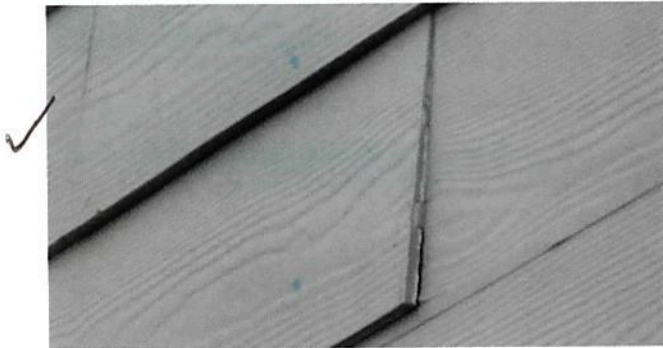
A loosening siding board was observed on right side, see sample picture.

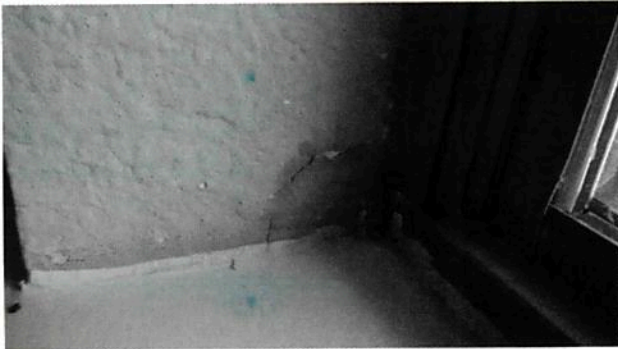
Moisture stains and/or deteriorated paint were observed on window casings in the upstairs front middle bedroom, and at upstairs family room right rear window, see sample picture; this indicates possible leaks and/or possible condensate problems.

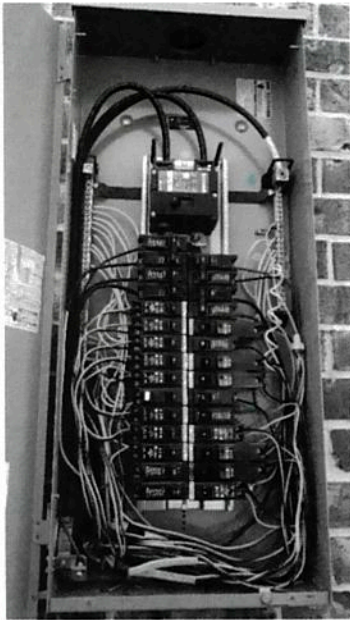
- A. **Service Entrance and Panels** *Comments:* Load calculations were not performed. This is an Eaton panel box with a 150amp main breaker and combination rated ARC-FAULT protection, see sample picture. Bonding was observed on gas piping. System was observed currently operable.

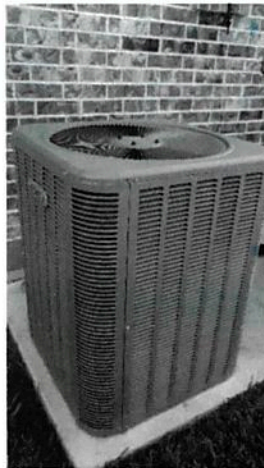
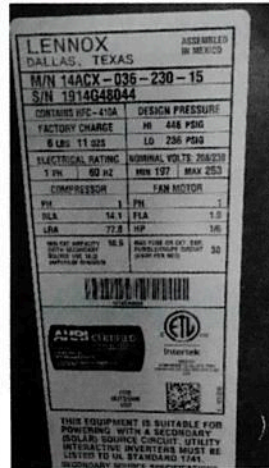
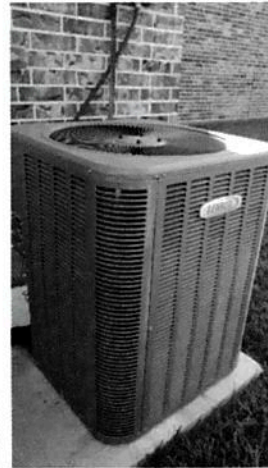
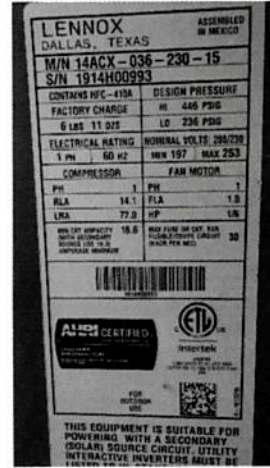
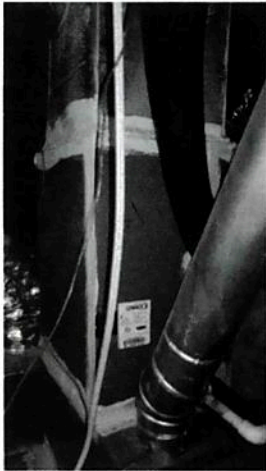
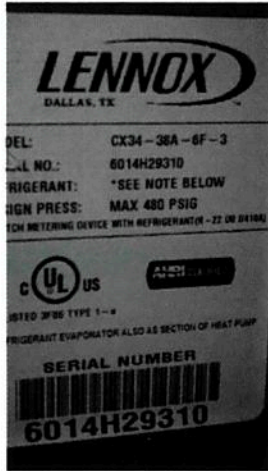
Comments: The I.D. plates on both condensers indicate these to be 2014, 3-ton models, [see sample pictures](#). The I.D. plates on both coils indicate these to be 2014 models, [see sample pictures](#).

A 13 degree temperature differential reading (59F.-72F.) was detected between the downstairs supply and return. A 13 degree temperature differential reading (59F.-72F.) was detected between the upstairs supply and return. Both systems were observed currently operable.

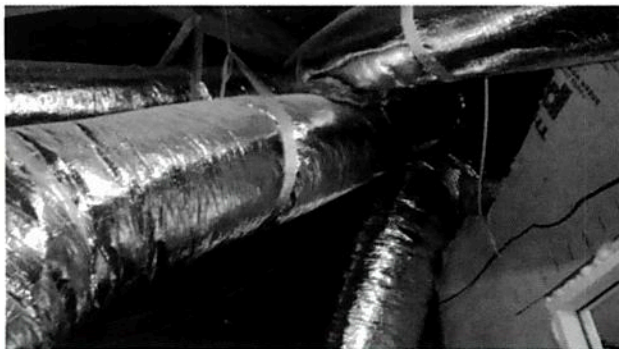
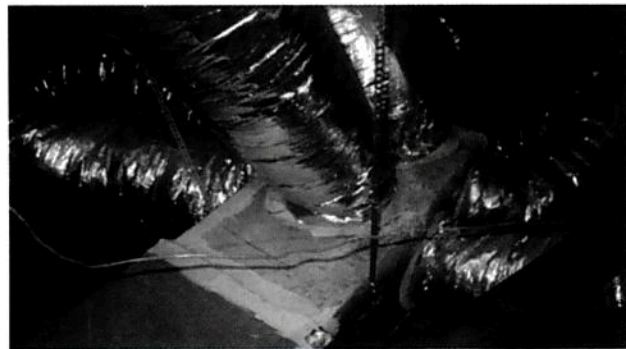
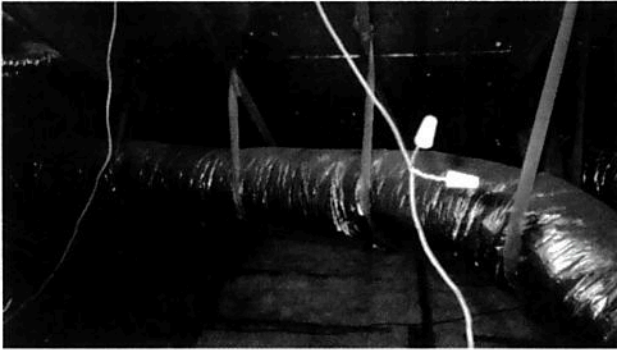
C. **Duct Systems, Chases, and Vents** *Comments:* Visible components were observed currently operable; however, no inspection was performed on duct interiors, [see duct sample pictures](#).

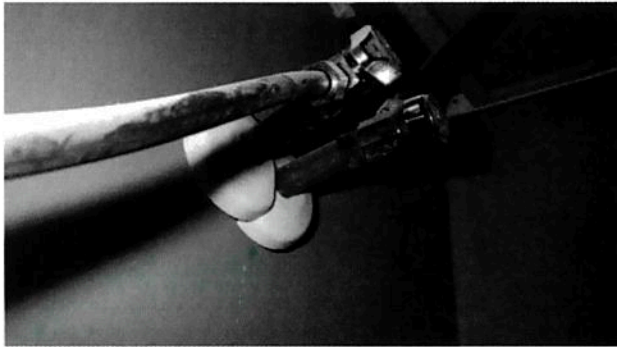
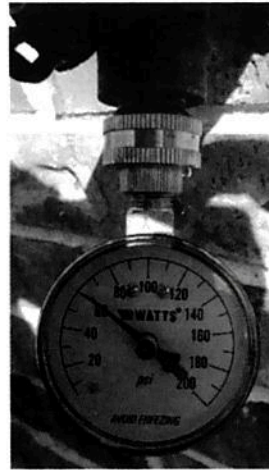
Comments: Partially visible pex-type water supply lines were observed, [see sample picture](#). System and fixtures were operated and observed currently operable, [see pressure sample picture](#).

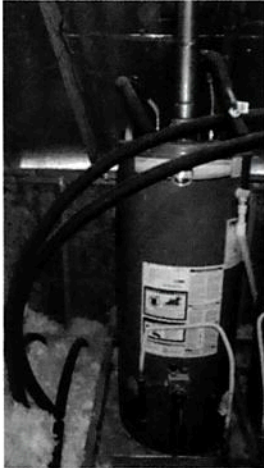
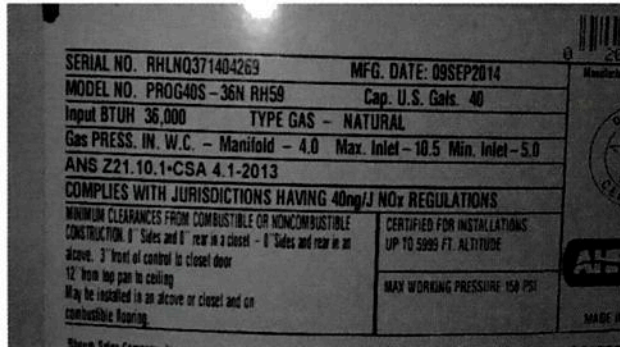
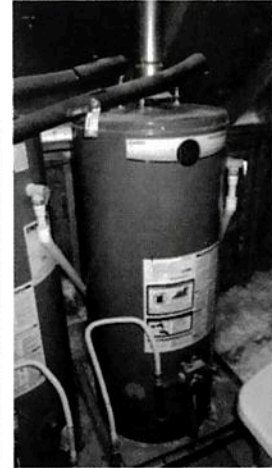
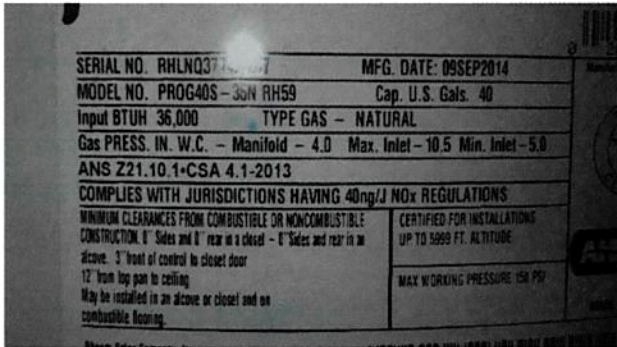
Comments: The I.D. plates on both units indicate these to be 2014 models, see sample pictures. Units were observed currently operable.

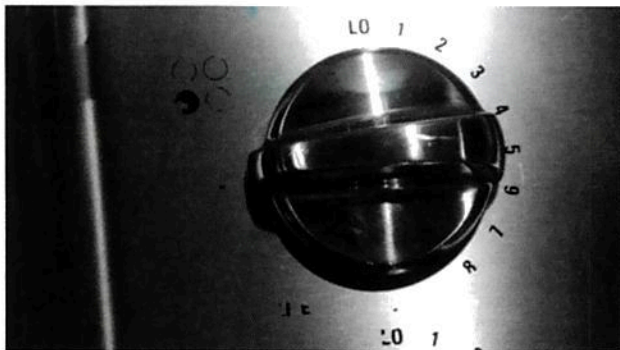
However, some of the lettering is not adequately legible on a couple of cooktop control dials, [see sample picture](#).
