Lone Elm Addendum A

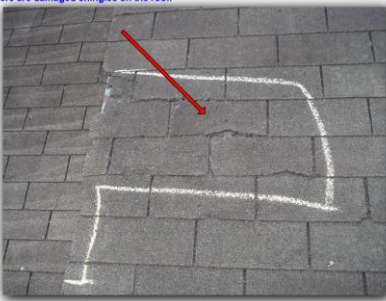
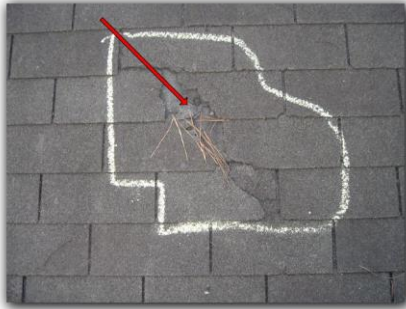
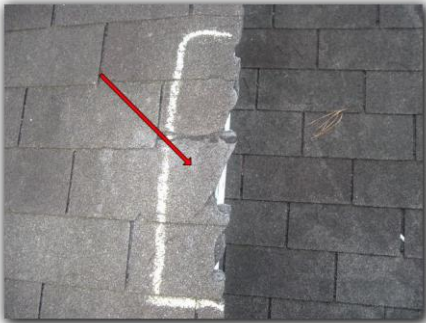
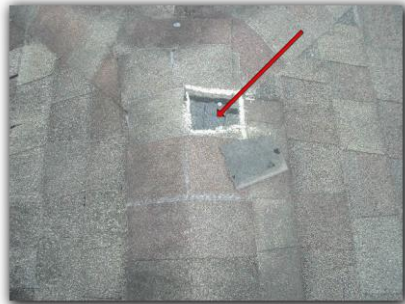
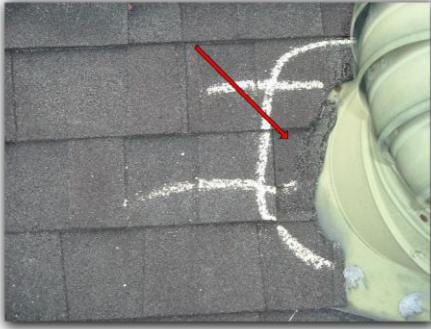
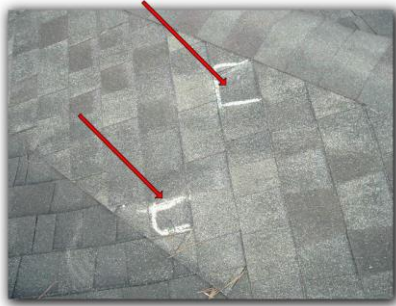
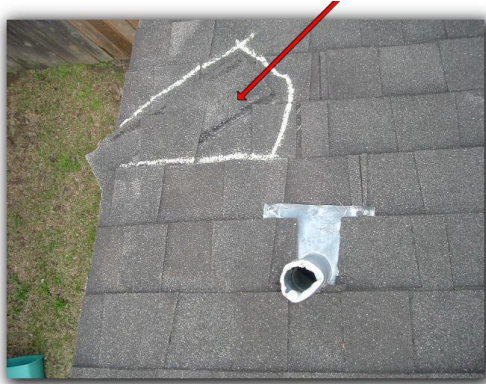
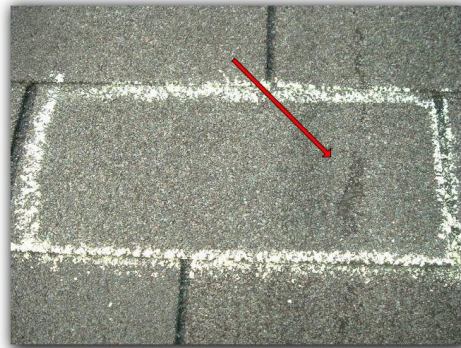
There are damaged shingles on the roof.

At the buyer's request, please have a new roof and decking put on the home by a certified roofing company:

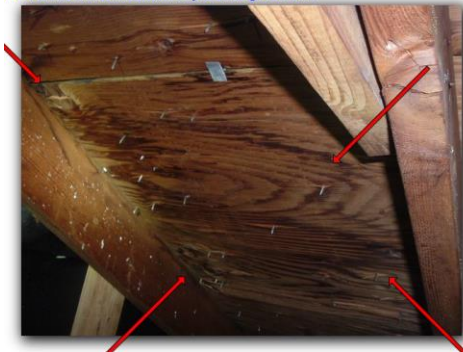
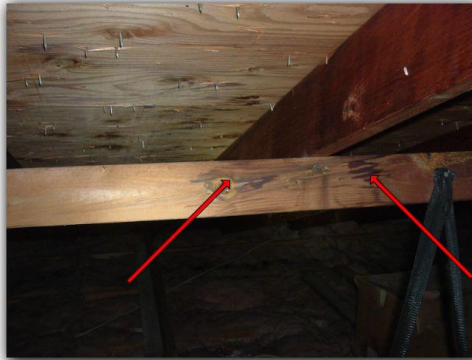
There is evidence of roof leaks/decayed decking in the attic.

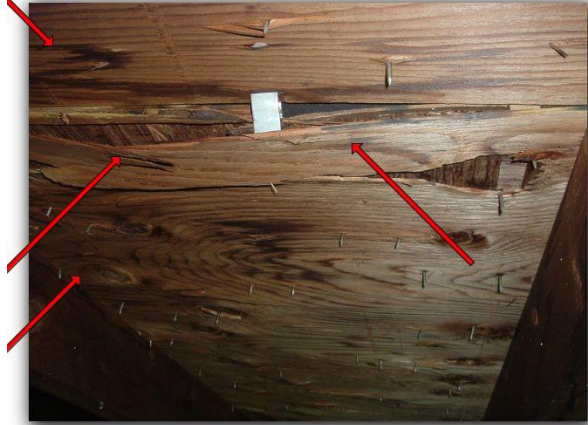
There is evidence of roof leaks/decayed decking in the attic.

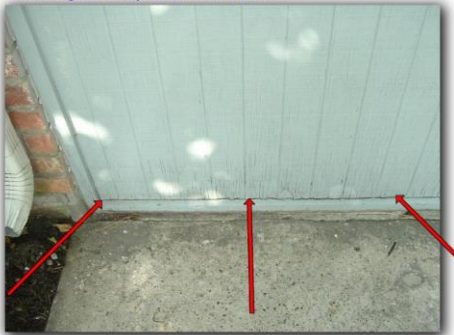
The wood siding is soft/decayed at the front of the house.

2. Please replace damage to fascia in front of the house, garage front, entry, and the holes in the siding/fascia at the rear of the house. There were rat traps in the attic where rats came in through the holes.

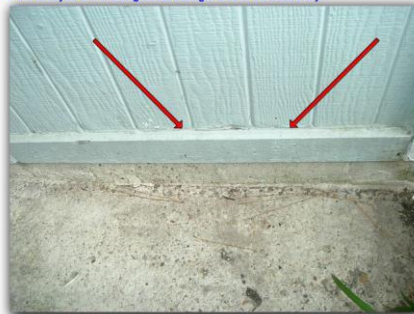
There is decayed wood siding/trim at the right area of the front entry.

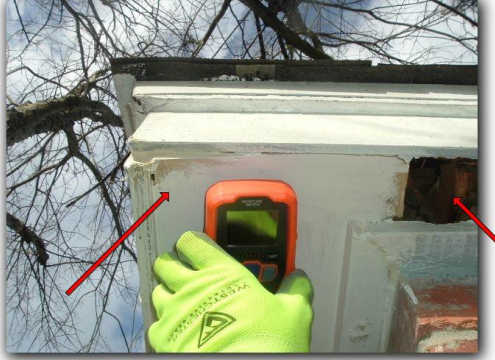
The soffit at the front of the house has active water penetration/decay.

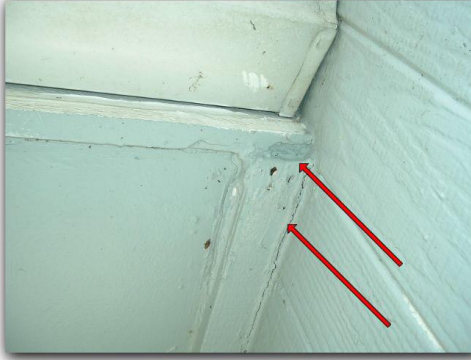
There is soft wood trim a the front of the house.

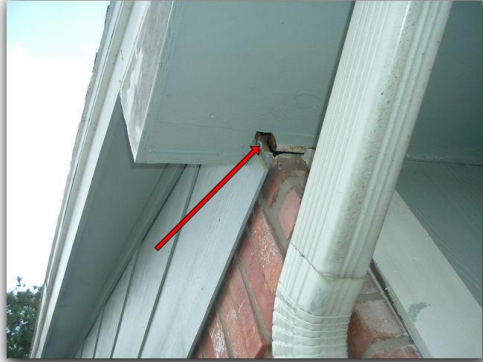
There is missing trim at the rear right of the house.

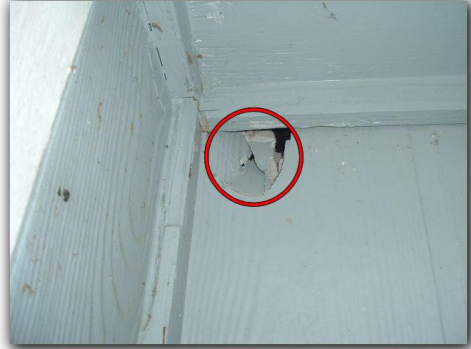
There is damaged siding at the upper rear of the house.

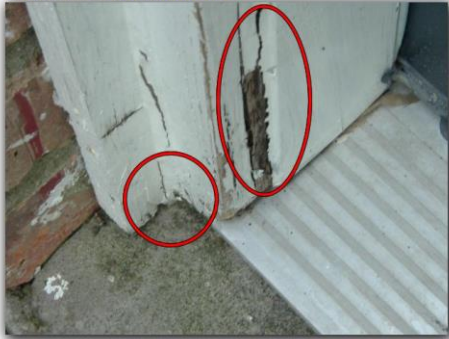
The left garage conversion door trim has decay.

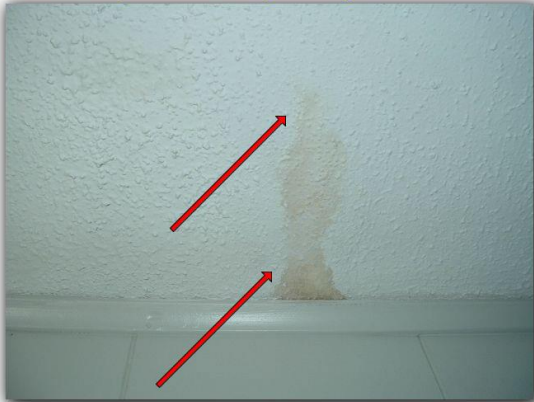
There is active water penetration on the utility room ceiling.

Please have a licensed plumber replace galvanized plumbing in converted garage room, converted bathroom, and utility room.

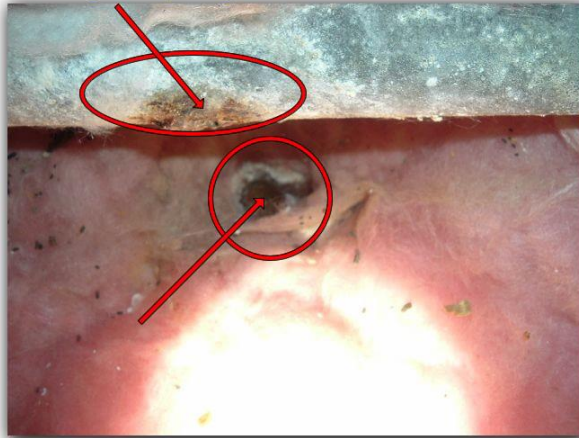
The rusted out galvanized plumbing in the attic leaks.

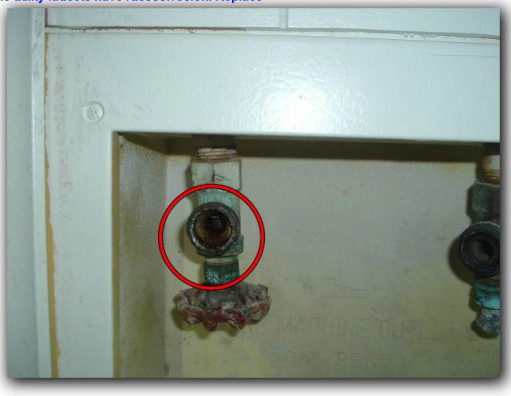
(1):

The utility faucets have rust/corrosion. Replace

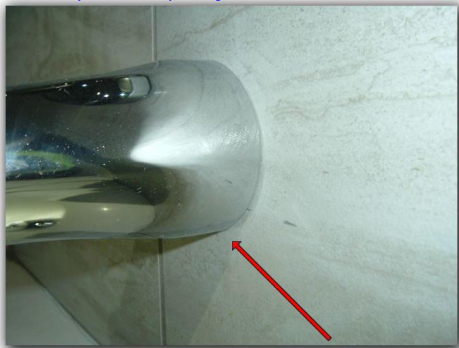
(2):

The master tub spout leaks water past the gasket.

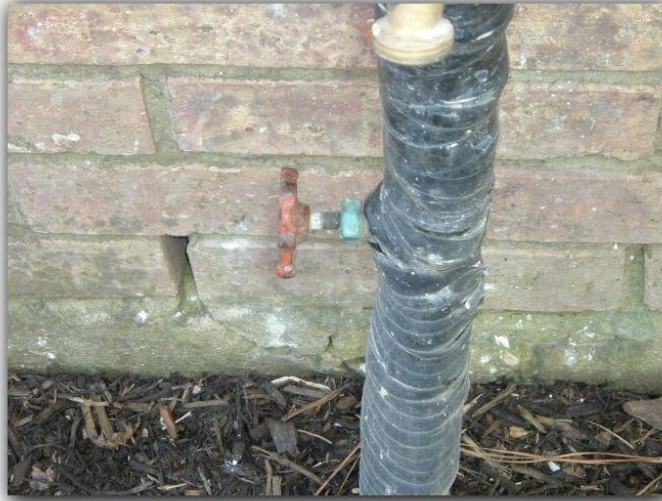
(3.)

The exterior faucets require vacuum breakers.

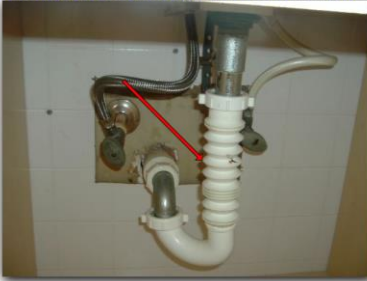
The accordion type drain is not approved for the garage conversion bathroom sink.

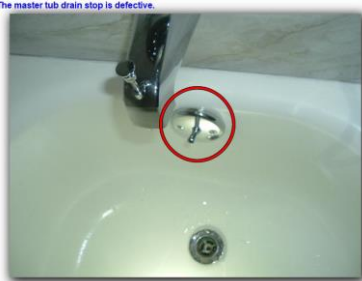
The master tub drain stop is defective.

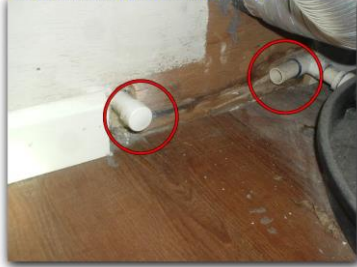
The emergency pan drain line was not connected to the exterior drain

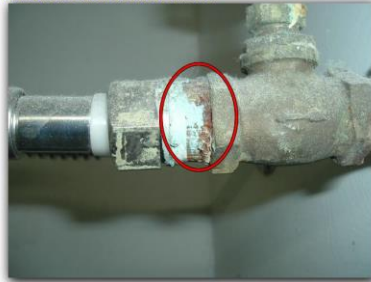
There is evidence of rust at the shut off connection

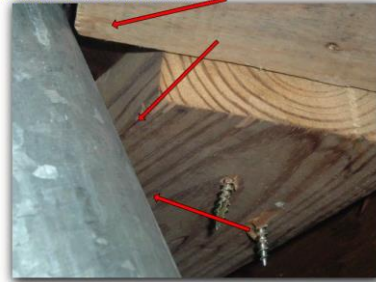
The fume pipe requires clearance from combustibles

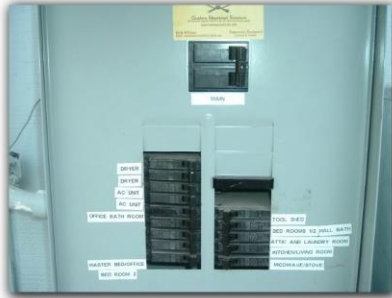
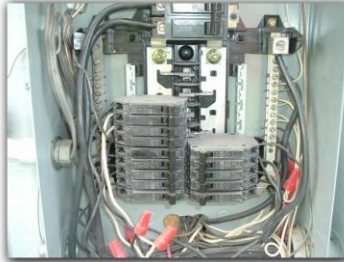
(A). The ground wire is not connected to a ground rod. There are missing knock outs at the dead plate. The breakers are not all labeled. The dead plate screw does not secure the dead plate. The protective wire grommet is missing. The panel box needs to be bonded. Recommend upgrading to combination ARC fault breakers to detect electrical shorts at all hallways, game rooms, closets, dining rooms and all similar areas. *This is an update from 2009.*

Please have a certified electrician complete the following:

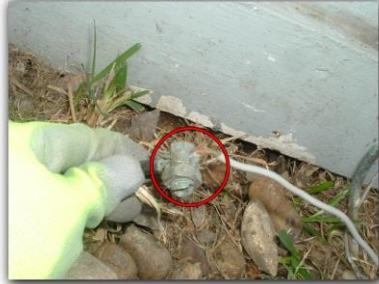
The ground wire is not connected to a ground rod.

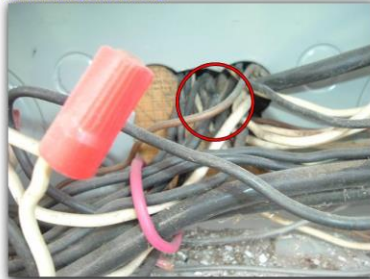
The protective wire grommet is missing.

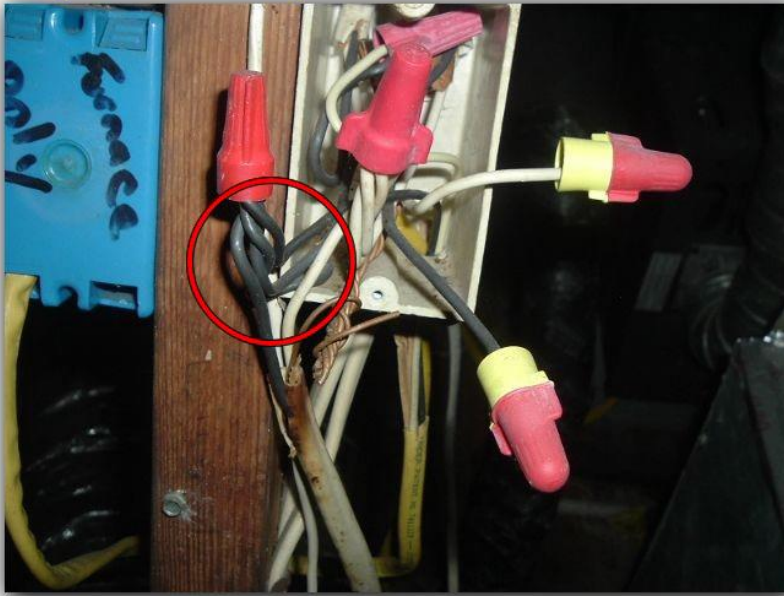
The wiring was not installed in the junction box in the attic and is a fire hazard.

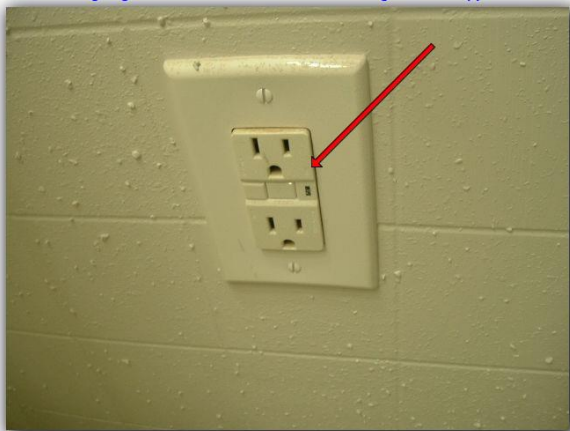
The GFCI at the garage conversion bathroom turns off the lights when tripped.

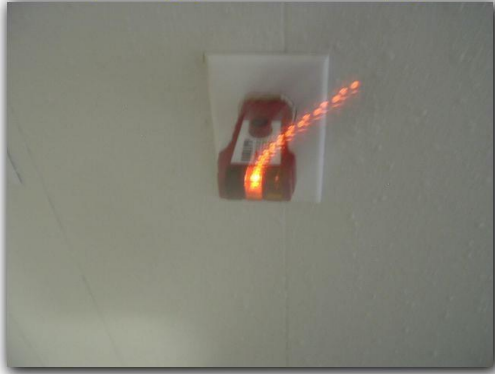
The front wall receptacle at the garage conversion bathroom tested open ground.

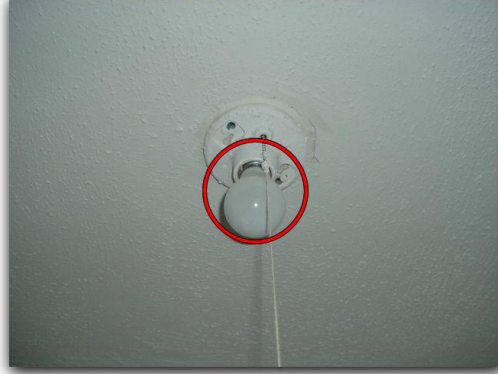
The uncovered closet light in the garage conversion was non functional and a fire hazard.

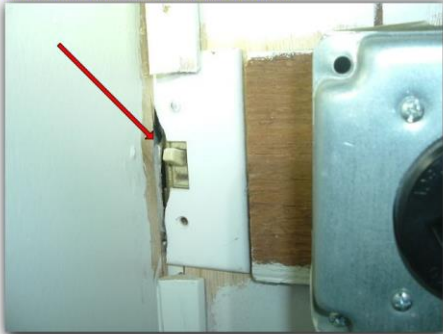
The left utility room wall switch is located too far in the wall.

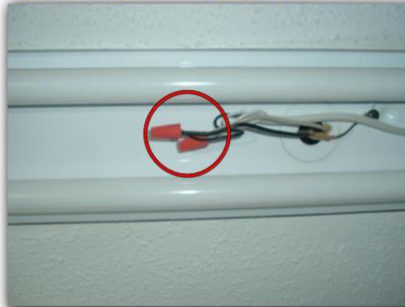
There are open electrical junctions at the utility room ceiling light

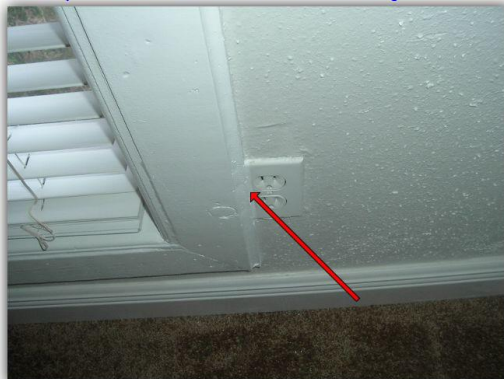
The wall receptacle was located behind the window trim at the rear right den wall.

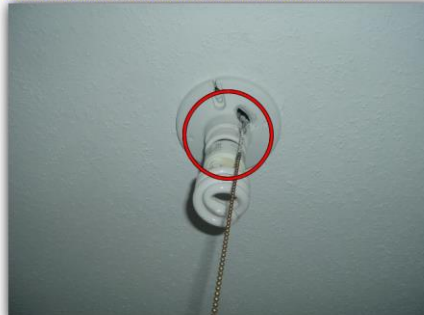
The rear right bedroom closet light fixture is defective and a fire hazard

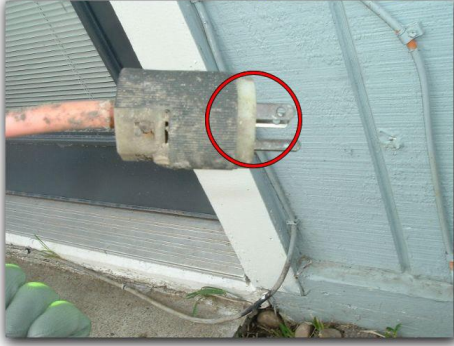
The extension cord at the rear of the house is not approved for branch wiring.

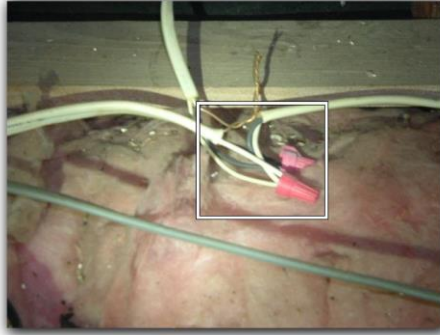
The open electrical junctions in the attic require junction boxes and are a fire hazard.

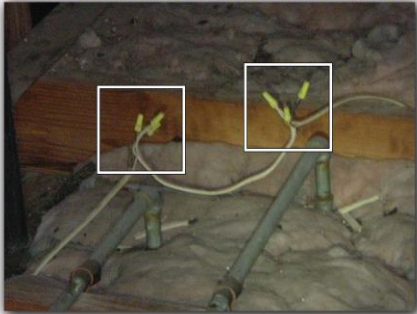
The open electrical junctions in the attic require junction boxes and are a fire hazard.

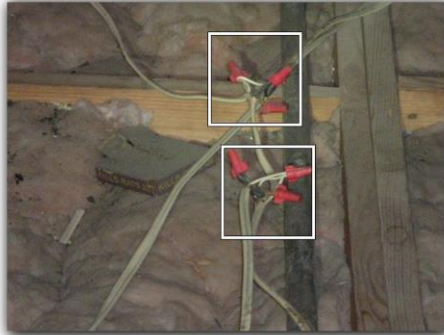
The open electrical junctions in the attic require junction boxes and are a fire hazard.

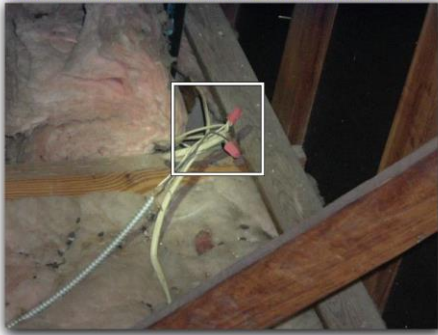
The open electrical junctions in the attic require junction boxes and are a fire hazard.

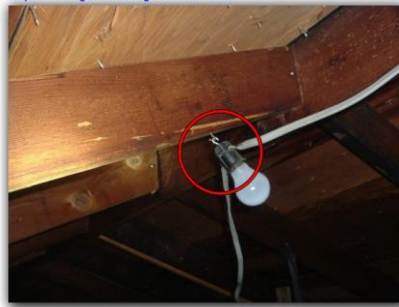
The exposed wiring at the attic lights is a fire hazard.

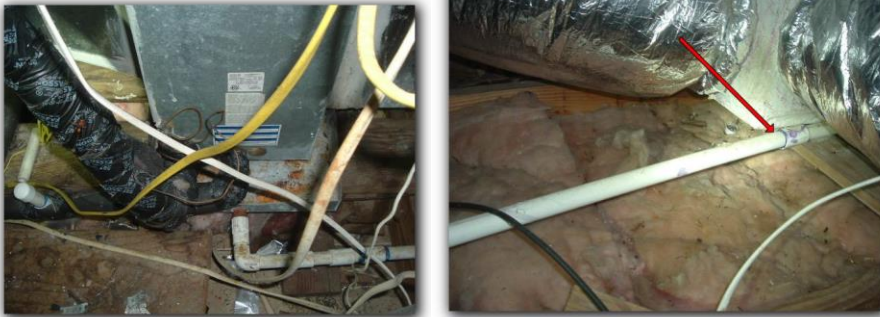
The emergency pan drain line has a negative slope to the drain

The emergency pan drain line has a negative slope to the drain. Code requires the pitch to be one quarter inch (1/4") per foot of length to eliminate water holdup in the pipe. Use 1/2" pitch or more. The emergency pan drain line was not terminated above a window. Have the A/C units serviced/repared and brought to current code, checked for freon leaks and meet home warranty requirements by a licensed/bonded contractor.

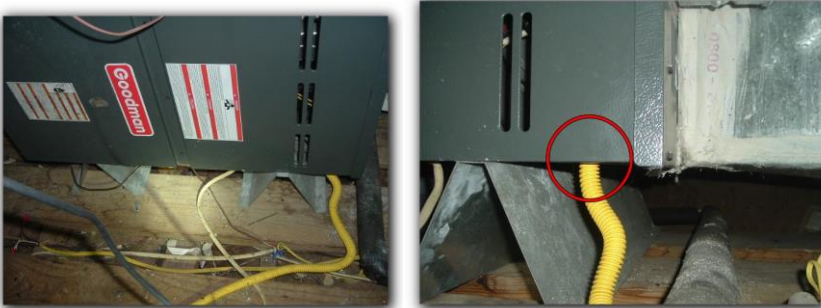
The gas flex line is not permitted in the appliance cabinet. Must be hard piped.

The gas line requires a sediment trap. The gas flex line is not permitted in the appliance cabinet. Must be hard piped. The fume pipe requires clearance from combustibles. The fume pipe requires a support strap. Have the gas heat unit serviced/repared/checked for cracks at the heat exchangers and brought to current code and meet home warranty requirements by a licensed/bonded contractor.

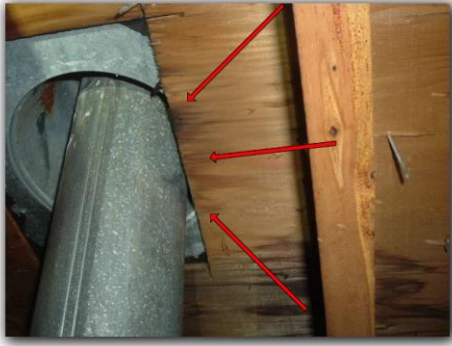
The fume pipe requires clearance from combustibles.
