PROPERTY INSPECTION REPORT

Concerning: 13208 Sage Meadow Ln, Pearland, TX 77584
(Address or Other Identification of Inspected Property)

By: Terrence Foster : trec #5182 10/24/2017
(Name and License Number of Inspector) (Date)

Visual Property Inspection

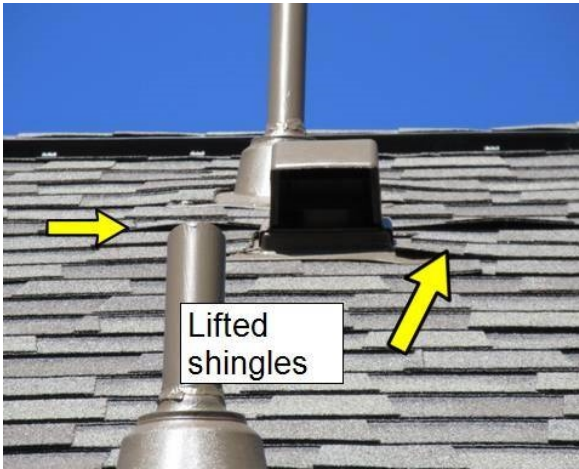
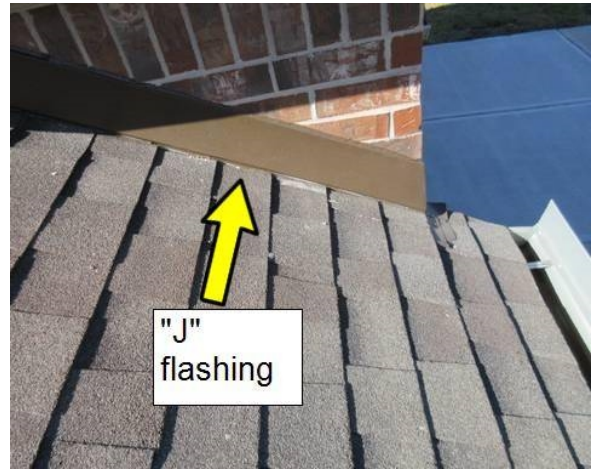
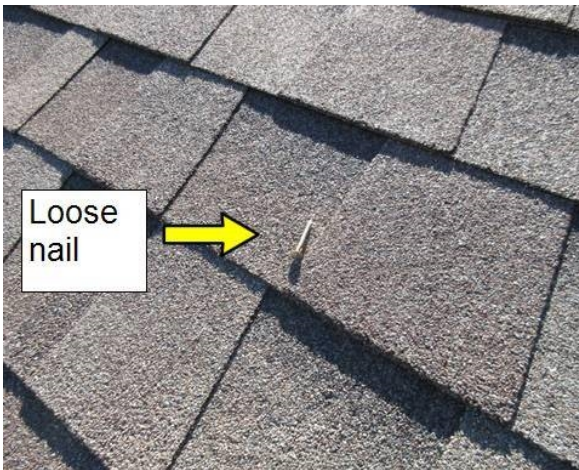
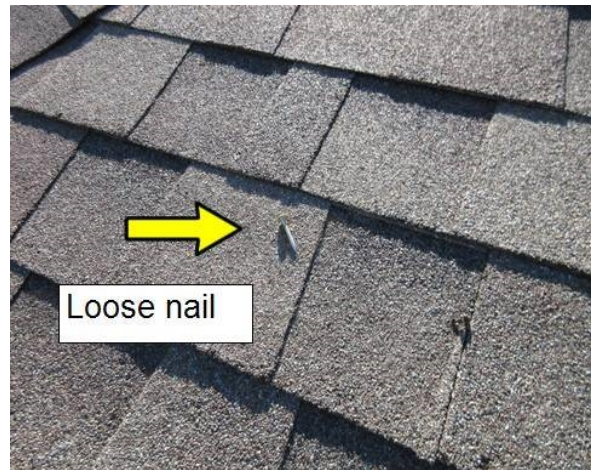
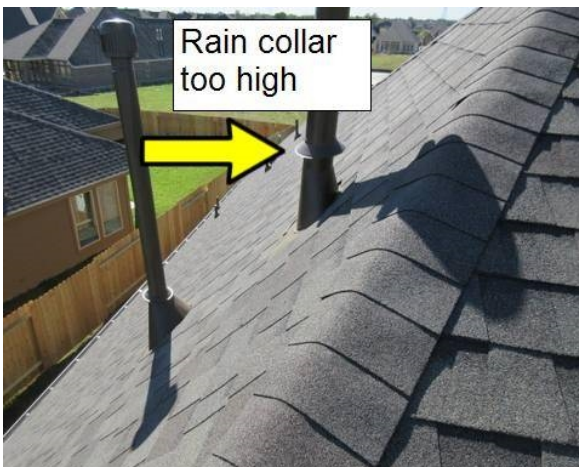
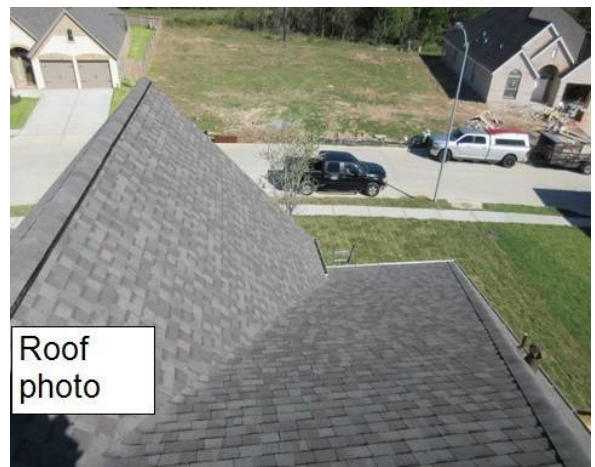
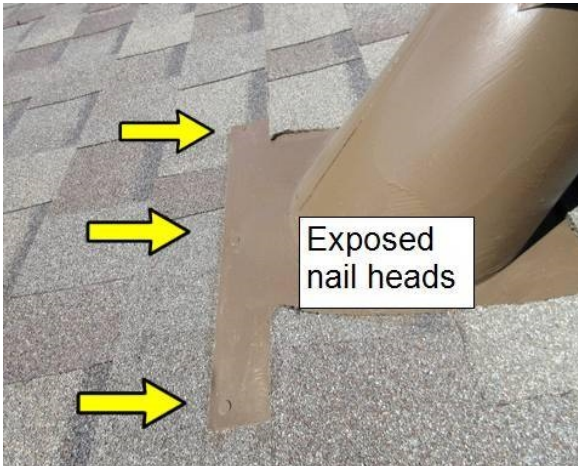
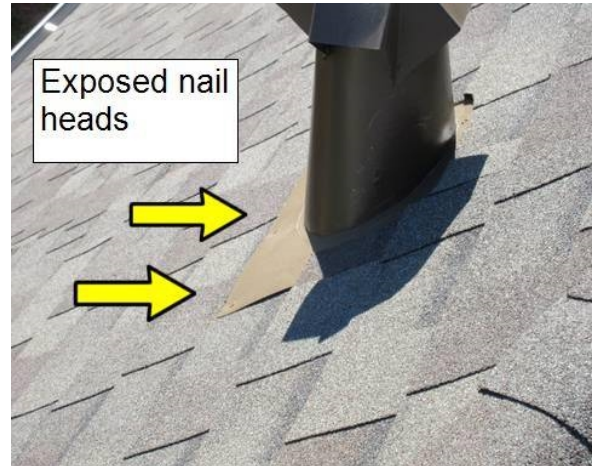
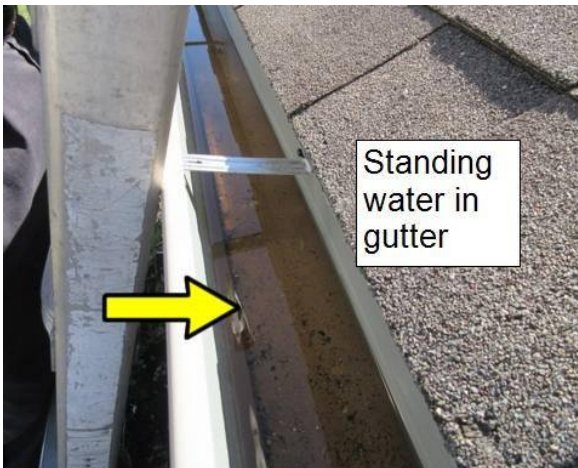
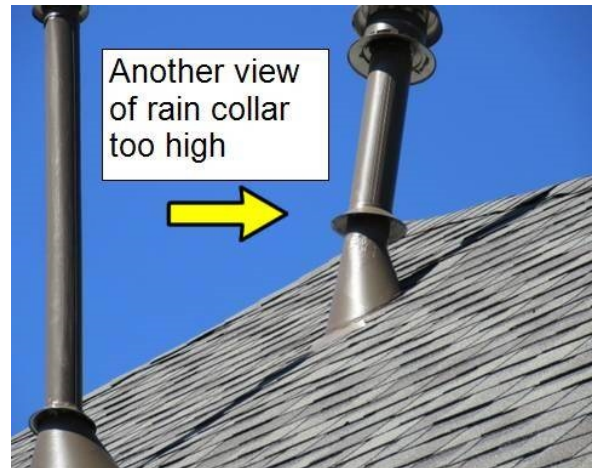
C. Roof Covering Materials

A couple of lifted shingles on the south side of the house near a boot jack, need to be properly secured down. Loose nails were found laying on the shingle surface in several areas, need to be removed. The rain collar for the furnace appears to be too high from the boot jack, this could possibly leak in the future. Need to install splash blocks at the ends of the gutters to reduce potential erosion issues. Exposed nail heads on the roof boot jacks on the west and southeast sides need to be properly sealed over with roof cement to reduce chance of roof leak issues. The roof flashing where the roof shingles meet the vertical wall has "J" type flashing, per current standards, it should be step flashing, this is a common practice for most builders to us "J" flashing instead of step flashing, recommend further evaluation by a qualified contractor, this type of construction is allowed in some jurisdictions. Gutter on the east side of the house does not have a proper slope to drain, has standing water in it, needs repair.

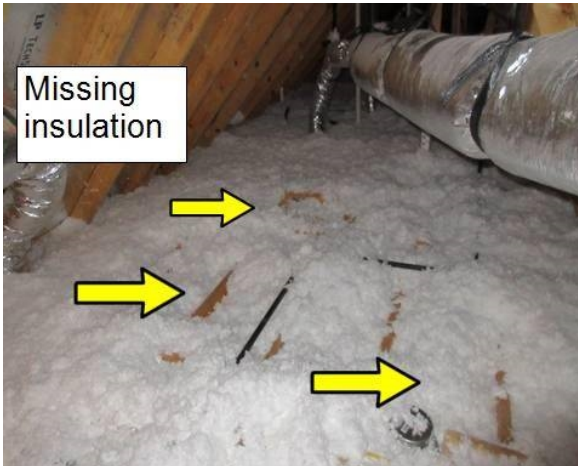
D. Roof Structures and Attics

There are no soffit vents along the north and south sides of the house, this is a common practice of Perry Homes to not install them on the sides of the house, recommend further evaluation to see if there is enough soffit venting for proper attic venting. Missing enough insulation in part of the south side of the attic, had only about 6 inches, needs repair.

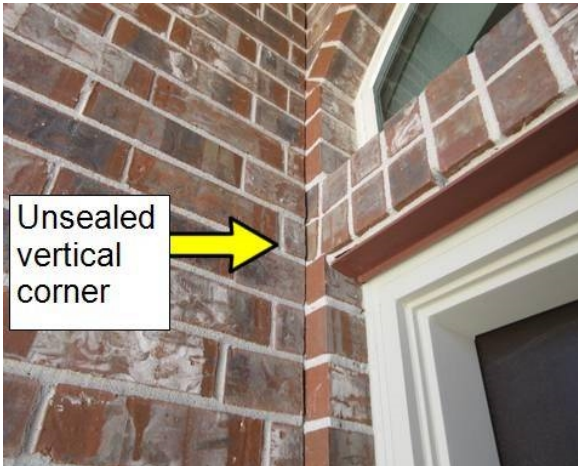
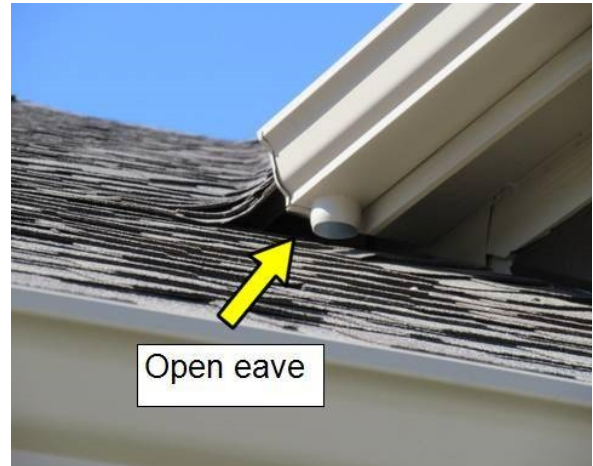
E. Walls (Interior and Exterior)

There are some areas around the eaves, soffits, overhangs on the exterior of the house that do not appear to be completely sealed up and can allow animals and such and get into the house, attic, these areas should be evaluated for being properly screened or covered to reduce this potential issue. The vertical inside corners on the exterior brick walls are not sealed, should be sealed to reduce chance of water penetration. it is part of their normal building standards for Perry Homes to not seal these corners.

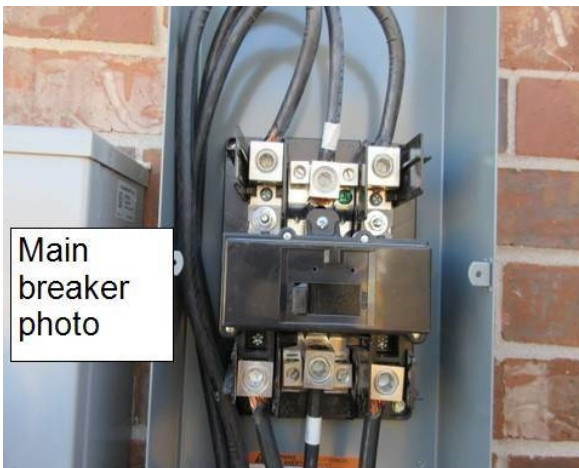
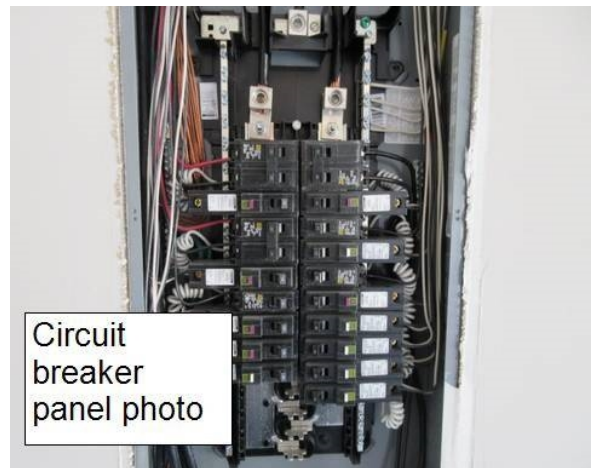
A. Service Entrance and Panels

Main service wire is copper. Main breaker is 200 amps, main panel rating is 225 amps. Panel is located on the exterior north side of the house, the circuit breaker panel is in the garage and is rated to 225 amps.

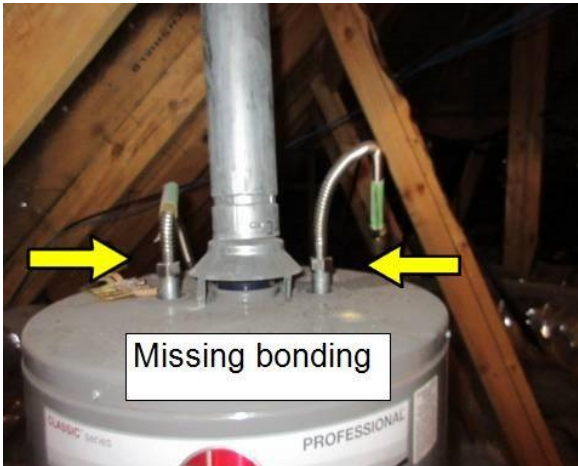
B. Branch Circuits, Connected Devices, and Fixtures

There should be a ground/bond connection at the hot water tank, did not appear to have one, this is a current requirement, should be evaluated and repaired as needed by a qualified contractor. The maximum rated breaker size for the A/C system is 35 amps, the actual breaker in the main panel is 40 amps, breaker appears to be oversized, needs further evaluation by a qualified contractor.

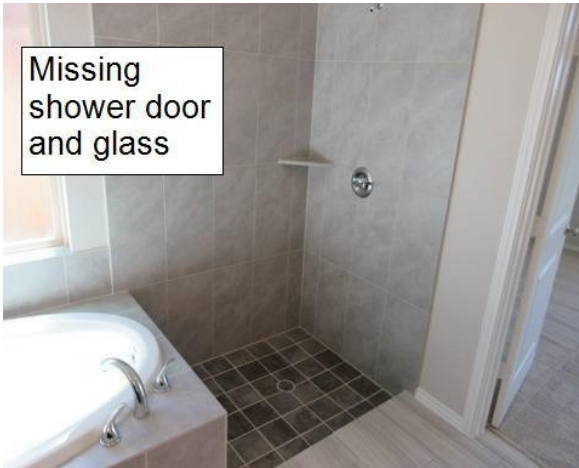
A. Plumbing Supply, Distribution Systems and Fixtures

The hall bathtub and master bath shower heads are missing. The master bath shower glass and shower door have not been installed, not able to test the shower. Hot water pressure on the master bathtub is somewhat low, needs evaluation. Missing the hall bathtub stopper.

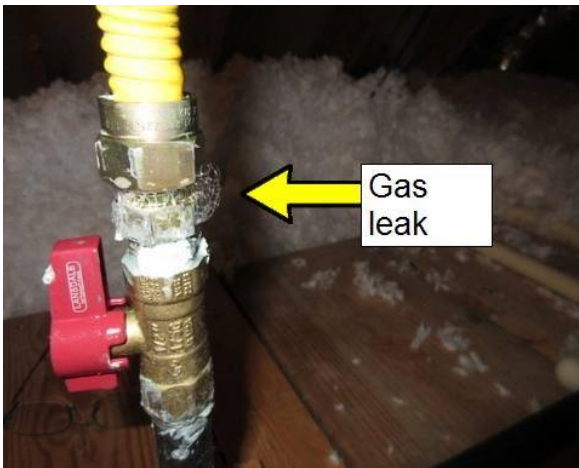
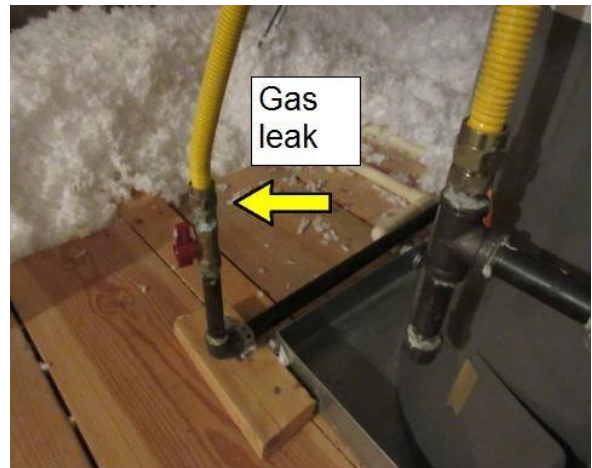
E. Other

Gas leak at the gas shut off valve area at the water heater, needs immediate repair.
 Gas lines are black steel with flex lines. This property was inspected for CSST (corrugate stainless steel tubing) gas line piping, which is a known safety hazard without proper bonding. Some recent studies have shown CSST piping to be a safety hazard even when properly bonded. All gas lines were not visible for inspection to verify if there is CSST piping in the house and all possible or required locations were not accessible for inspection. You should have further evaluation by a qualified contractor to determine the full condition and proper bonding of the CSST piping where it may exist in the house.
