Red Star Home Inspection

PROPERTY INSPECTION REPORT

Concerning: 7820 Jester St. Houston, TX 77051

Inspection Date: 05/08/2017

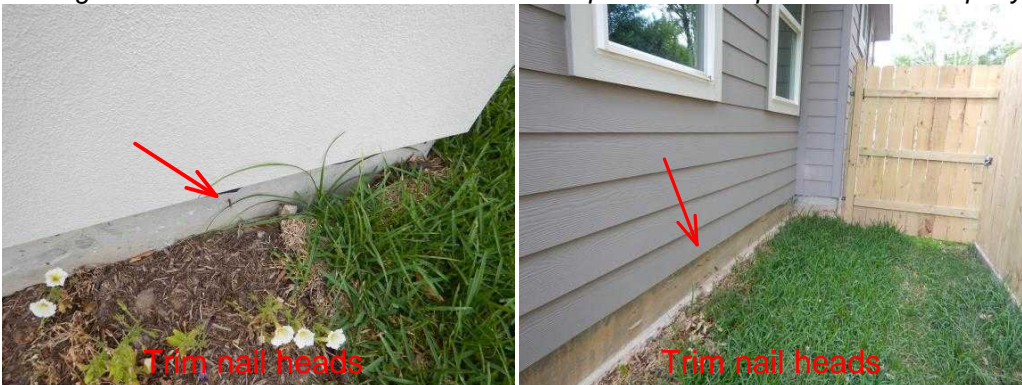
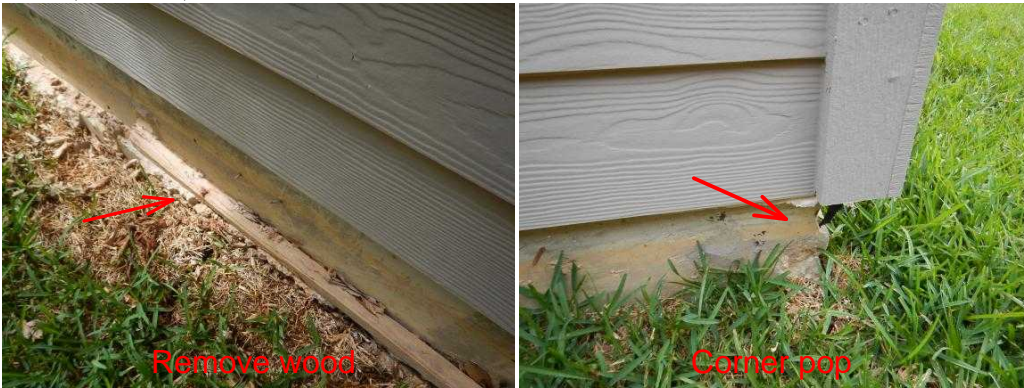
- Recommend trimming the exposed nail ends at multiple locations around the foundation wall to prevent injury.
- Wooden piece of the foundation form boards was present on the foundation wall along the left side. Recommend removing to prevent conducive conditions for Wood Destroying Insects.
- Corner pop was observed at the rear right corner of the foundation wall. Repair as needed.
- The foundation integrity appears to be performing the function intended. No visible differential movement was noted at the interior and exterior of the structure.

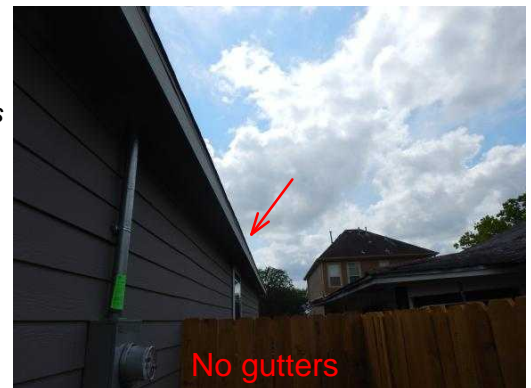
- No gutters were observed to be installed around the home, installation is highly recommended to prevent further erosion of the soil resulting in standing water near the foundation.

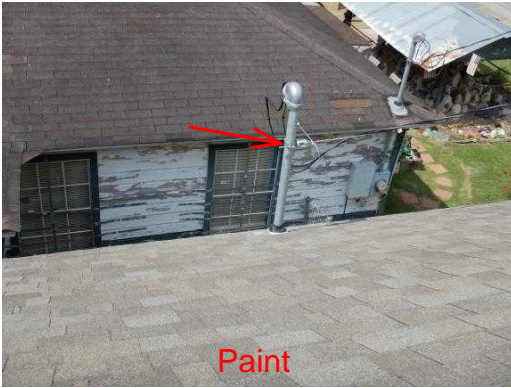
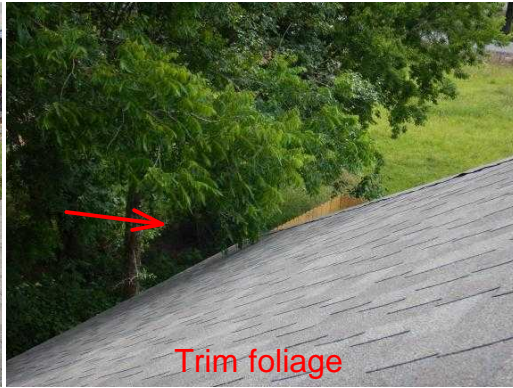
- Recommend trimming foliage in contact with the roof covering at the rear left portion of the roof covering to prevent damage to the shingles.
- Recommend painting the mast for the service drop to prevent it from rusting out prematurely.
- The roof covering appears to be performing as intended. No cracked or missing shingles were observed and the granules appear to be intact.

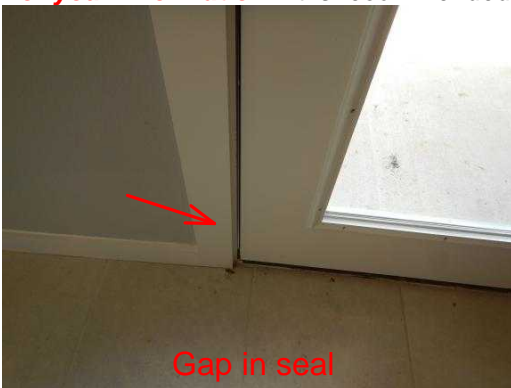
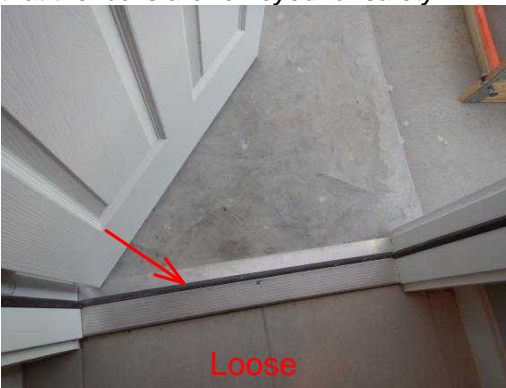
- Gaps were observed in the weather seal around the exterior doors. Repair as needed to prevent moisture, pest, and air intrusion.

- Threshold at the bottom of the garage door frame was loose. Secure as needed.

- Recommend adjusting the thumbblatch lock for the garage door to allow for easier operation.

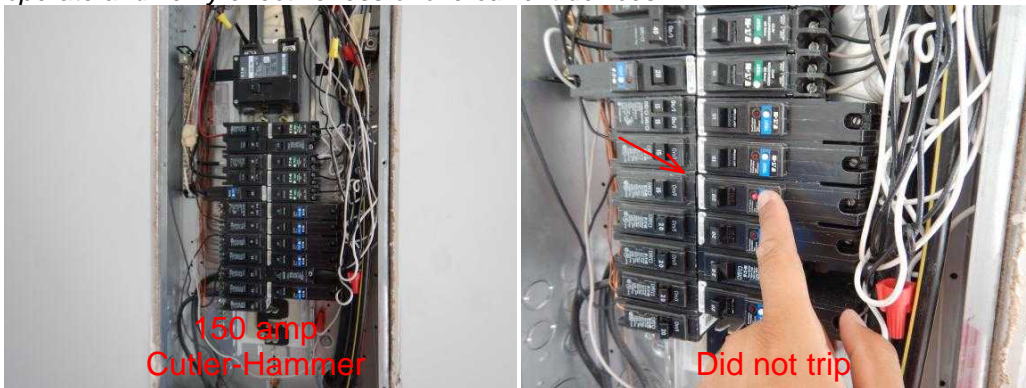
- GFCI breaker for the Kitchen circuit #1 did not trip when tested. Recommend further evaluation and repair.
- All other portions of the service entrance appears to be performing as intended at time of inspection.

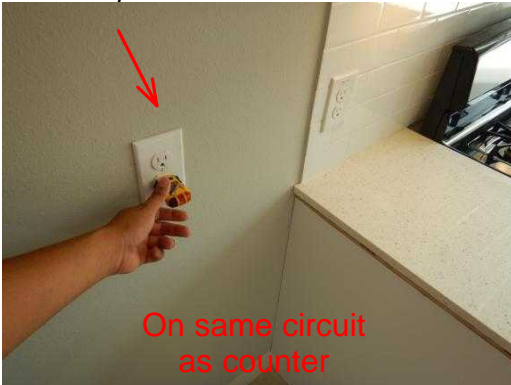
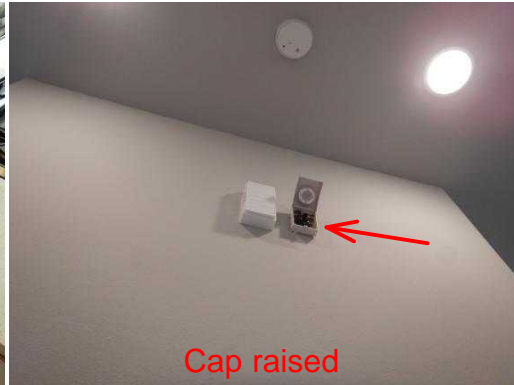
- The refrigerator outlet was observed to be on the same circuit as the counter top outlets. Recommend the refrigerator outlet be placed on its own circuit to reduce the chance of it tripping.
- All outlets were inspected for hot/neutral reverse, reversed polarity and open ground circuit. No issues were found at the time of the inspection.

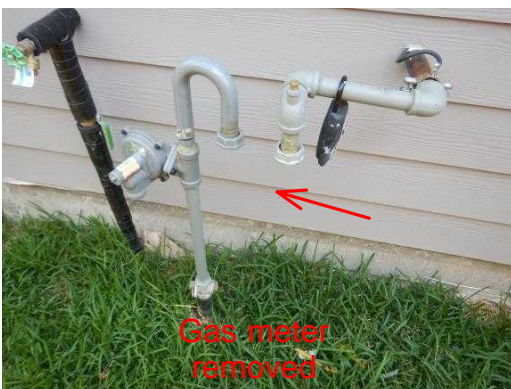
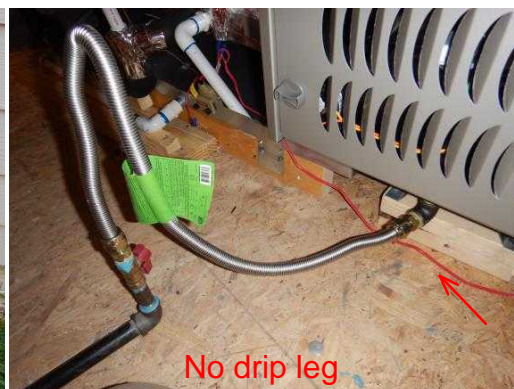
- A drip leg for the gas line was not installed for the furnace. A drip leg serves as a collection area for sediment to reduce the chance of clogged gas valves or burners.

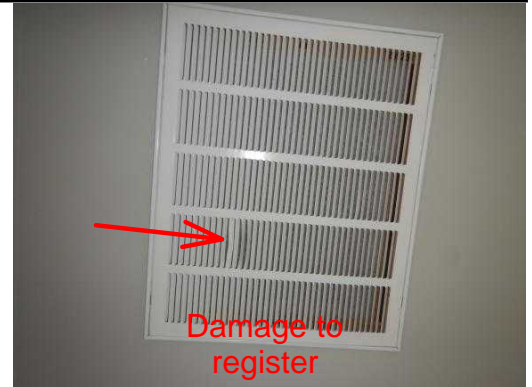
- The return air register in the left hallway was damaged. Repair as needed.
- All ducts and vents visually appear to be intact and in overall sound condition at the time of the inspection. Some areas of the ductwork were visually obscured from view.

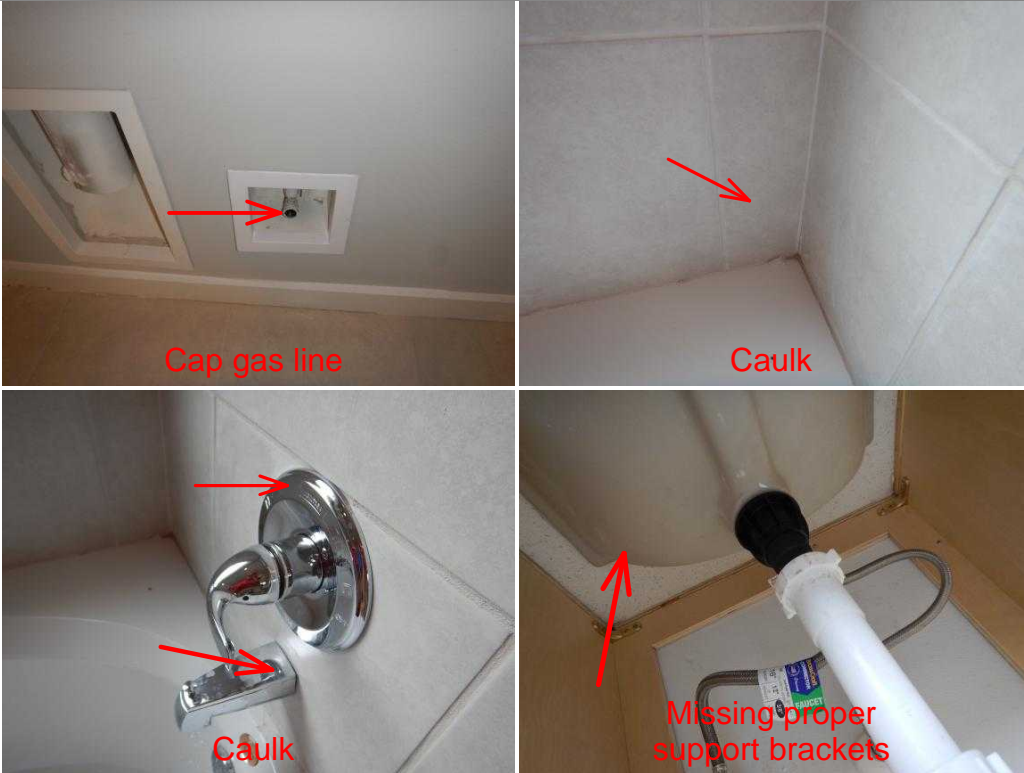
- No support brackets were installed for the under mount sinks in the bathrooms. Recommend correction to prevent sagging over time.
- All other portions of the sinks were performing as intended at time of inspection.

- Recommend caulking and sealing around all transitions and penetrations within shower enclosures to prevent moisture penetration.
- All other portions of the bathtubs and showers were performing as intended at time of inspection.

- Recommend capping the gas connection for the dryer if it will not be intended to be used. This will prevent it from being accidentally opened.
- All other portions of the washing machine connections were performing as intended at time of inspection.

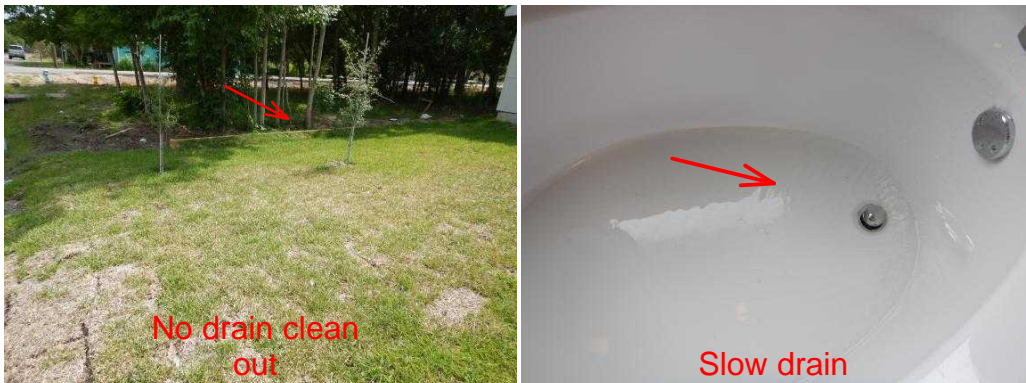
- Drain for the master bathroom tub was slow. Correct as needed to allow it to flow properly.
- No drain clean out was observed around the exterior. Recommend further evaluation and repair to allow the drain lines to be easily accessed and cleaned.
- All other drains, wastes and vents were performing as intended at time of inspection.

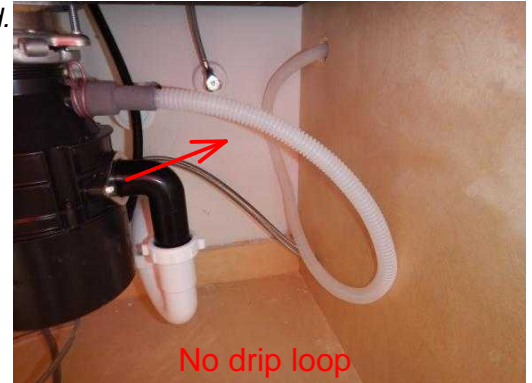
- The dishwasher completed a full cycle and was performing as intended at the time of the inspection.
- No drip loop or air gap installed for the dishwasher. This prevents dirty water in the sink from backing into the clean water used for the dishes. Recommend correction.

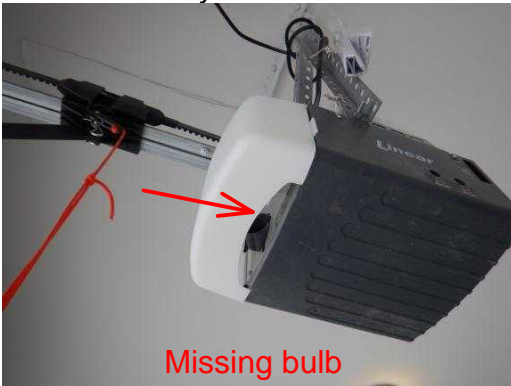
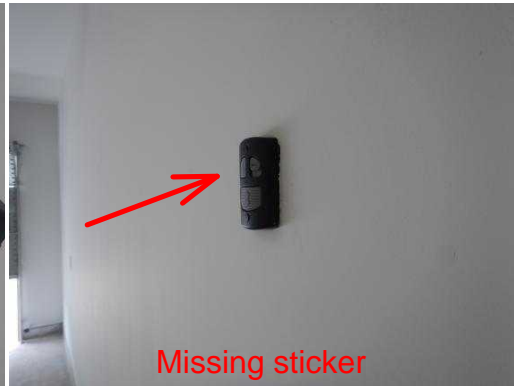
- Light for the garage door did not operate, due to the bulb missing. Correct as needed.

Note: Sticker was missing for the garage door operator button which indicates the proper safety and testing procedures for the unit.
