A.B Bowles Home Inspections

Property Inspection Report

3835 Palmer Meadows Court, Katy, Texas 77494
Inspection prepared for: Mitchell Wolski
Date of Inspection: 12/22/2018 Time: 10:00am
Age of Home: 2018 Size: 2268
Weather: Clear and sunny.
The outside temperature is 70°F.

Inspector: Ashley Bowles
License #20454
2923 McDonough Way, Katy, TX 77494

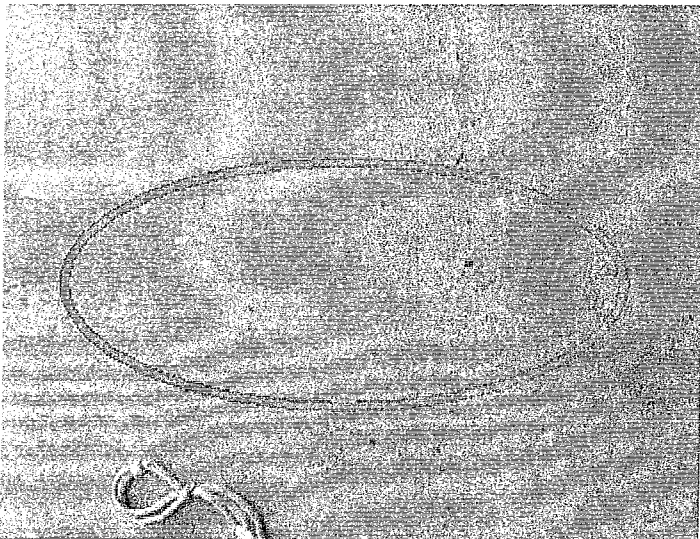
There are multiple cracks along the foundation floor of the garage. These appear to be shrinkage cracks.

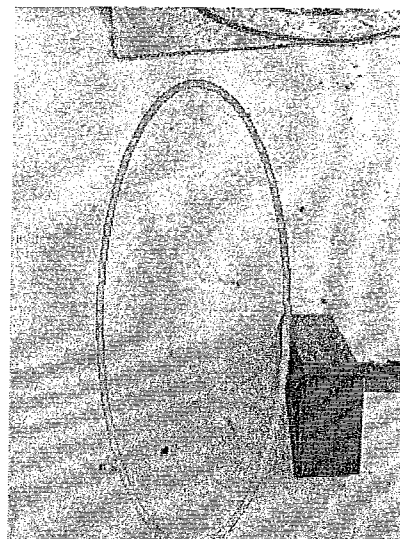
There are multiple cracks along the foundation floor of the garage. These appear to be shrinkage cracks.

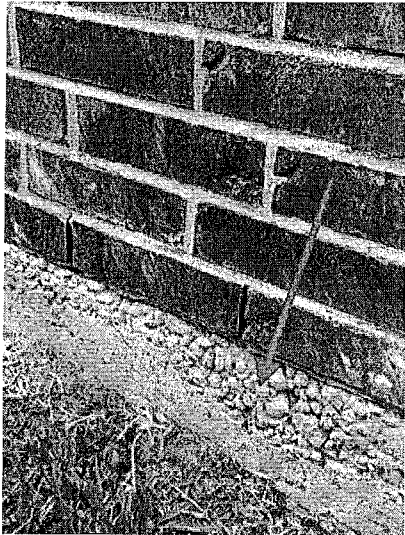
There is some honeycombing on the left-hand side of the house.

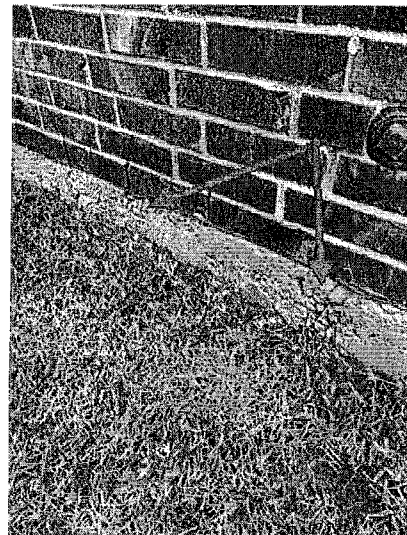
There is some honeycombing on the right-hand side of the house.

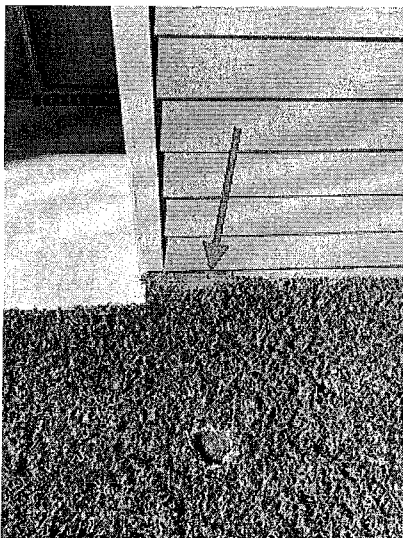
The grading at the back of the house is too high there should be 6 inches of clearance from the top of the ground to the bottom of the siding.

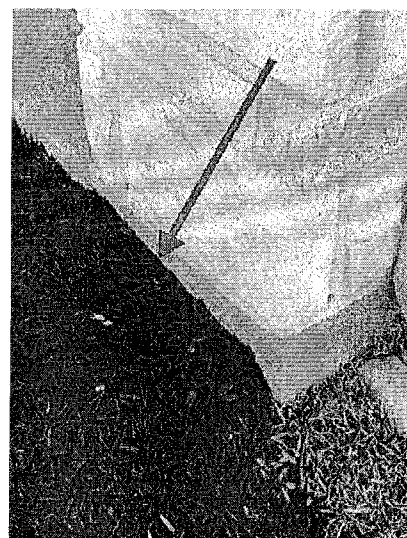
The grading at the front of the house is too high there should be 6 inches of clearance from the top of the ground to the bottom of the siding.

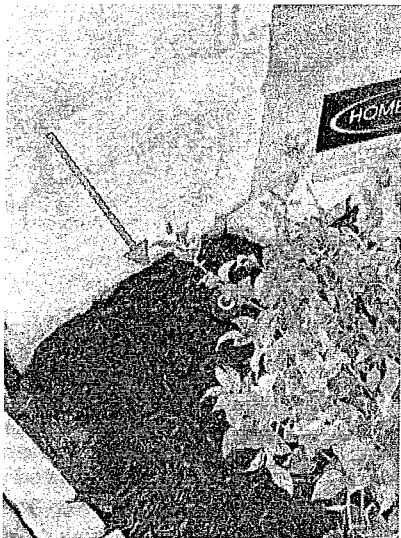
The grading at the front of the house is too high there should be 6 inches of clearance from the top of the ground to the bottom of the siding.

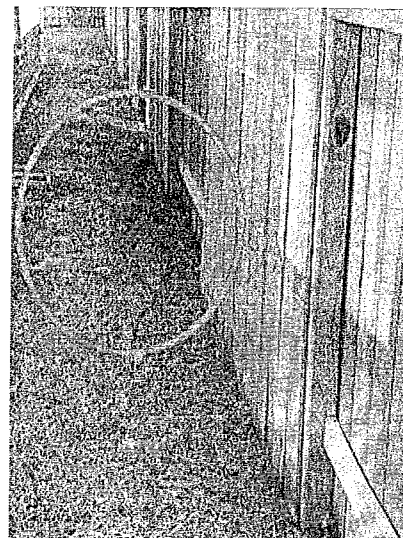
There appears to be excessive moisture on the right hand side of the house.

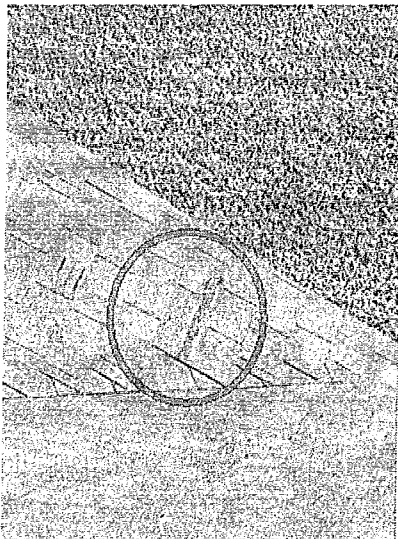
Damaged missing shingle at the back of the house.

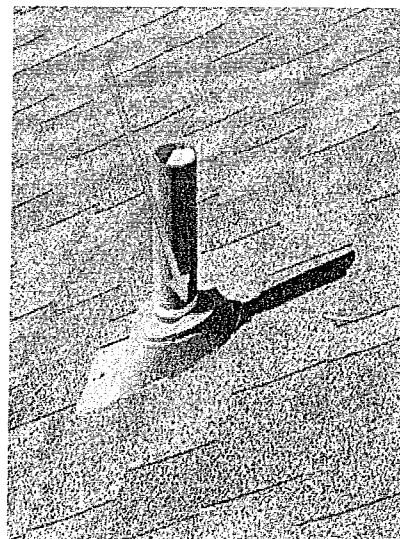
The roof jack right hand side of the house is not installed properly around the vent pipe.

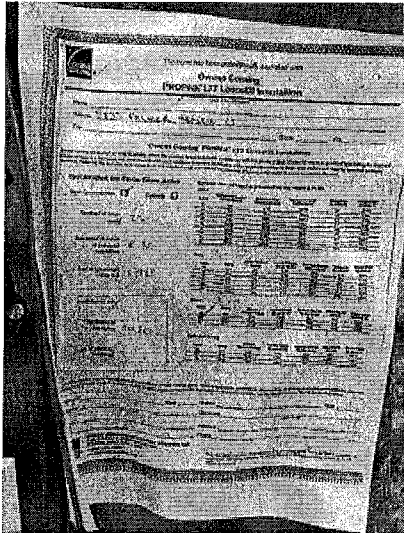
Insulation should be 10.5 inches deep.

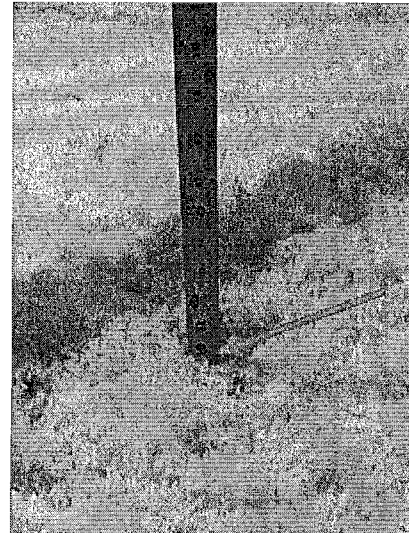
There are multiple locations where the insulation is not the minimum 10.5 inches in depth according to the information sheet posed in the attic space.

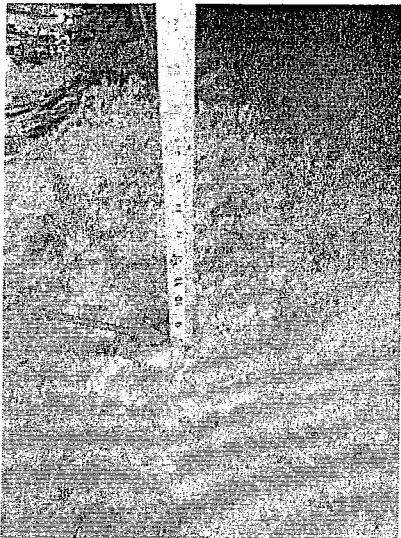
There are multiple locations where the insulation is not the minimum 10.5 inches in depth according to the information sheet posed in the attic space.

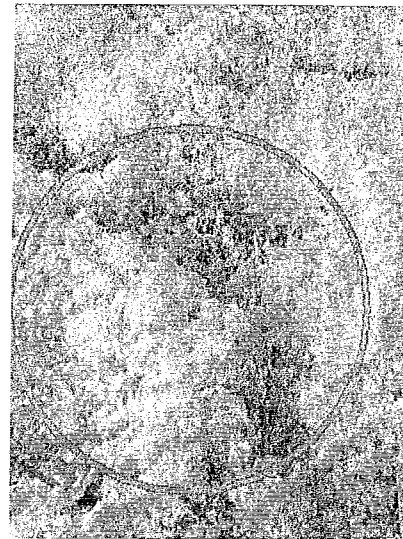
There are multiple locations where the insulation is not the minimum 10.5 inches in depth according to the information sheet posed in the attic space.

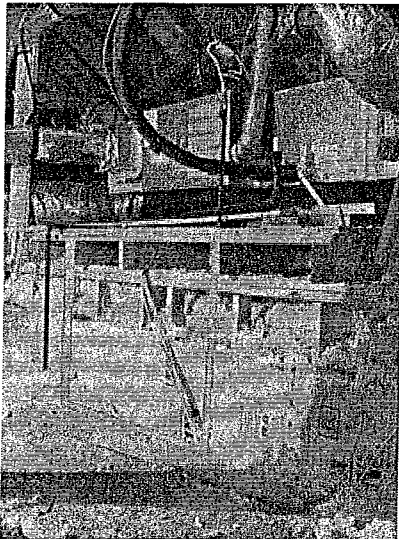
There is not a proper set of steps or ladder to access the equipment in the attic space.

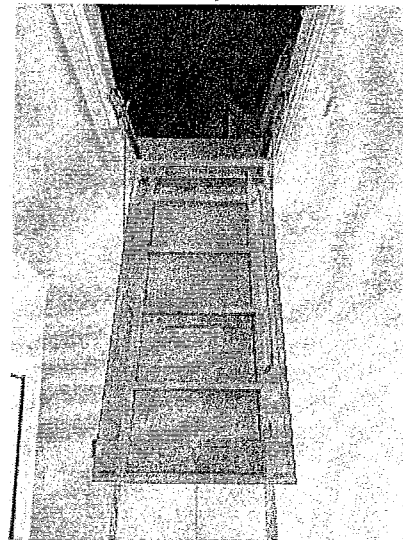
There is no stamp or indication that the attic access hatch is the proper fire retardant material.

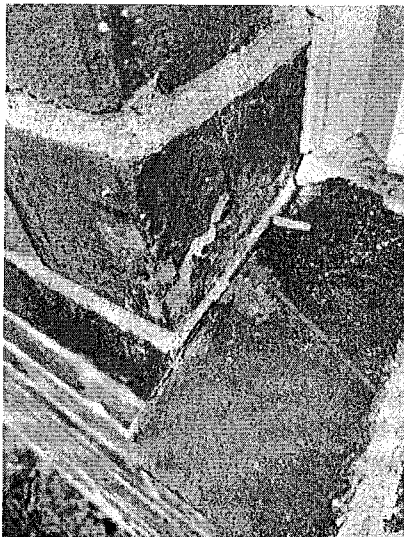
There are multiple locations around the house where there are cracks along the brick mortar joints of the windowsills.

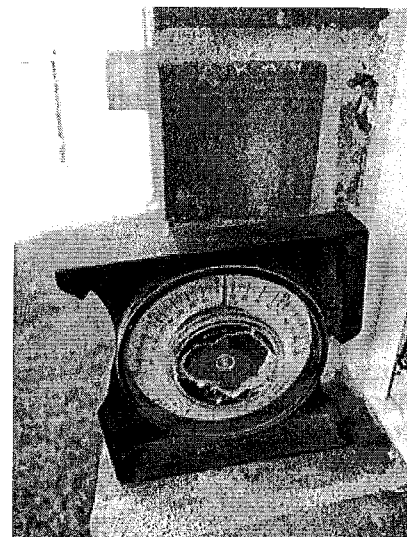
There are multiple locations around the house where the brick windowsill on the exterior do not have the proper slope. The windowsill should slope at a 15° angle away from the house.

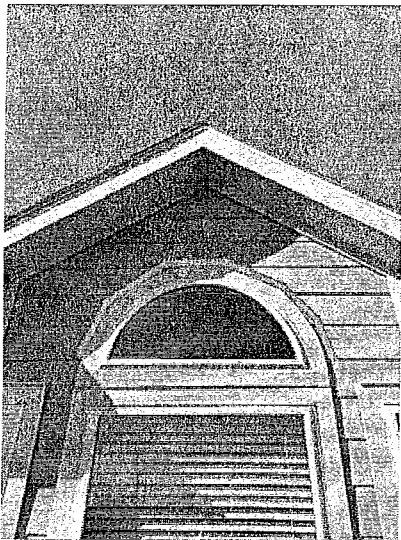
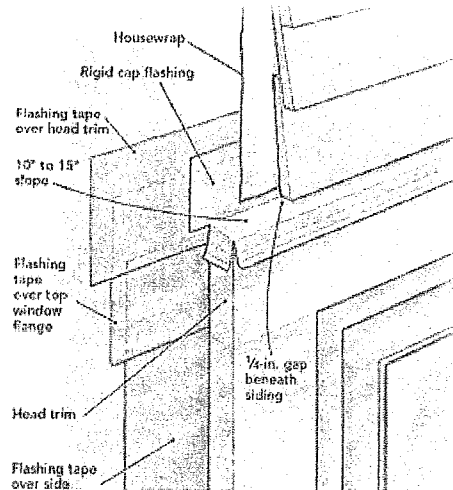
Missing flashing above the trim over the arched window at the back of the house.

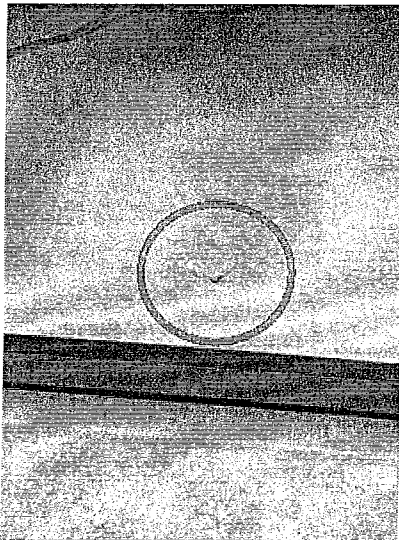
The bottom of the cabinet under the kitchen sink is damaged.

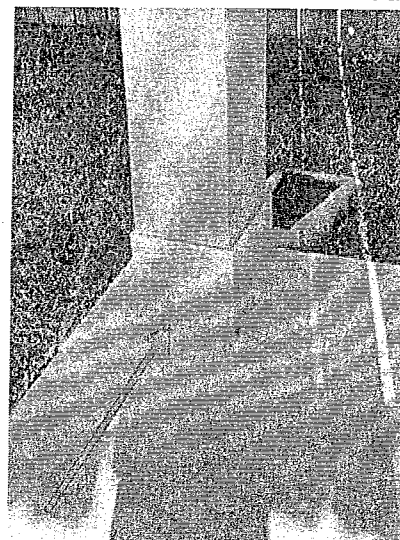
The trim at the bottom of the column at the back of the house does not have the proper clearance. There should be 1 inch of clearance from the top of the concrete to the bottom of the trim.

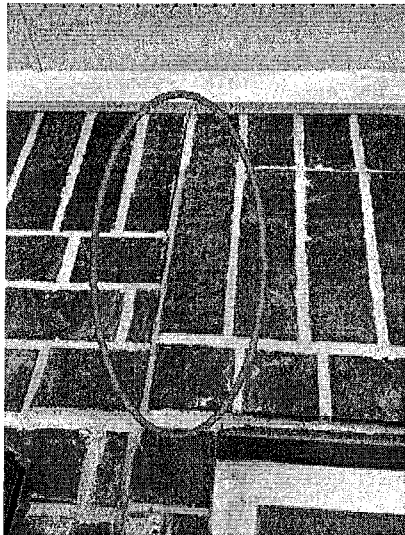
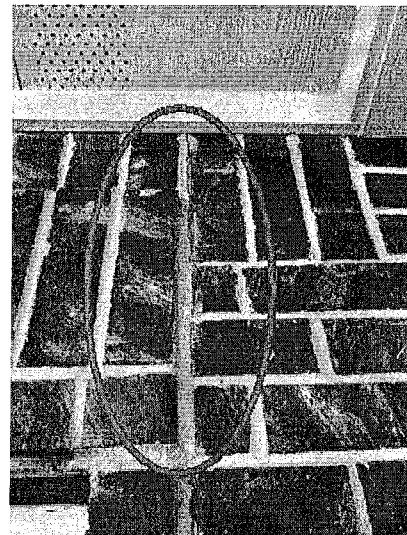
There are cracks along the brick mortar joints at the top corners of the garage door opening.

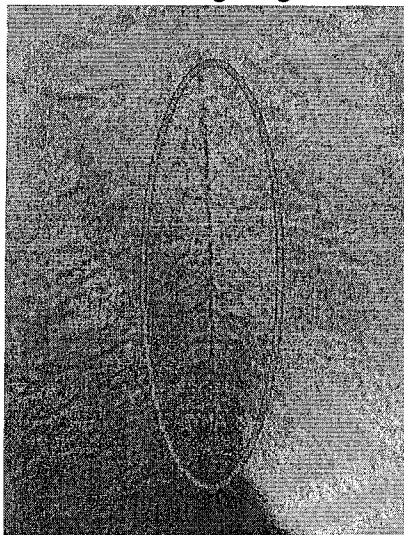
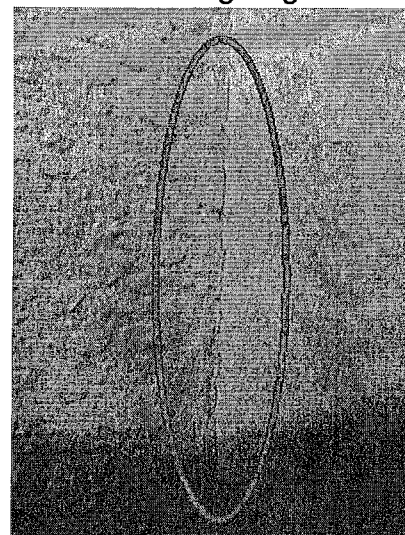
There are multiple locations around the house where there are cracks along the inside corner joints of the drywall.

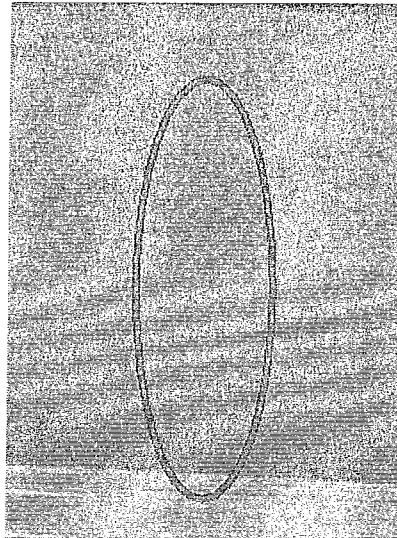
There is a crack in the drywall above the doorway in the office.

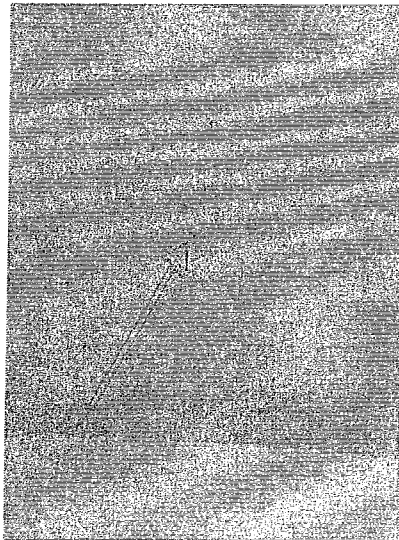
There is a nail pop on the ceiling at the back right corner of the master bedroom.

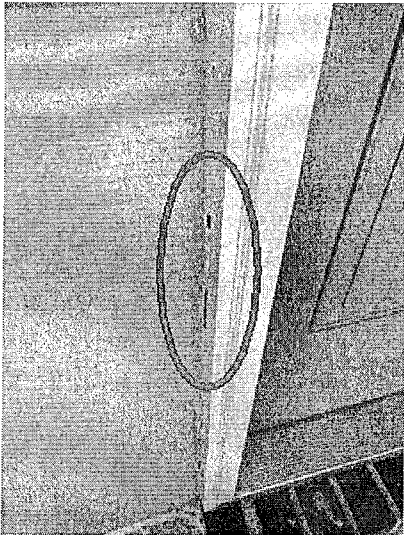
Caulking long the trim for the exterior door at the back of the house is starting to crack.

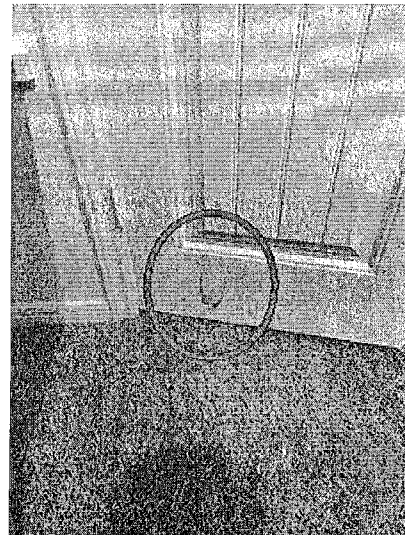
The master bathroom closet door is damaged.

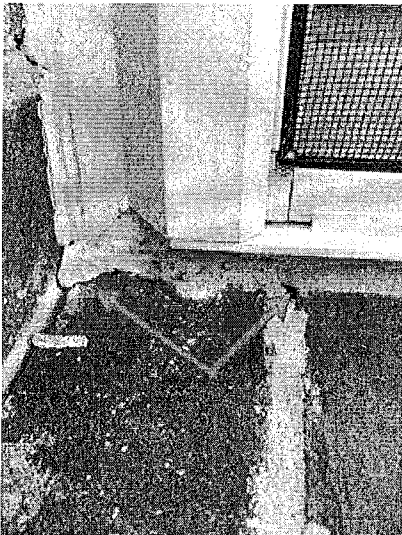
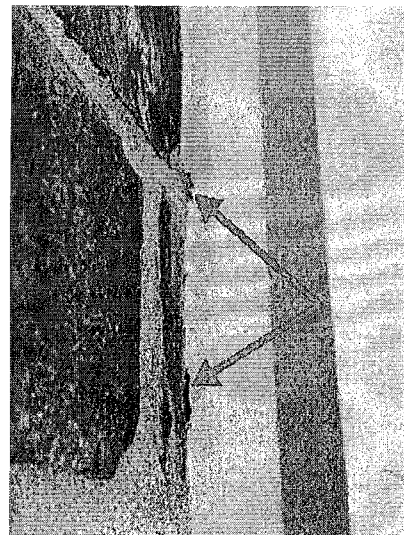
There are multiple locations where the caulking does not fully seal along the exterior side of the window frame.

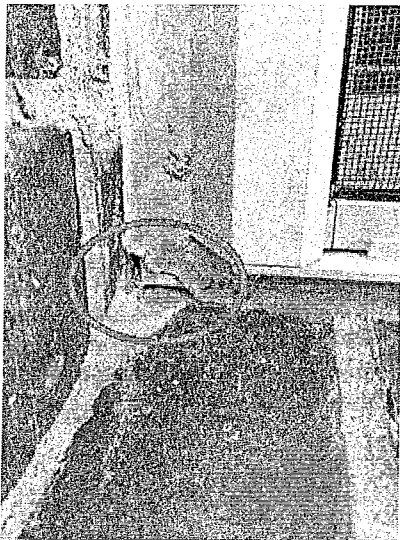
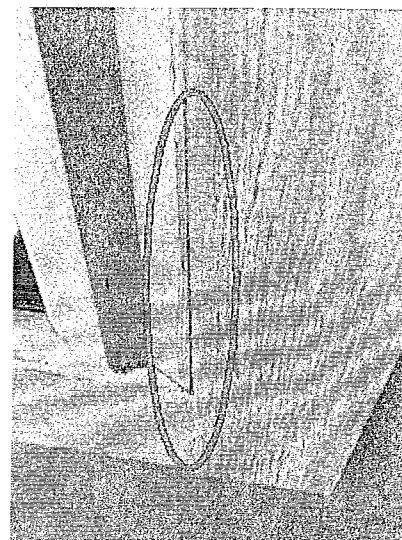
There are multiple locations where the caulk does not fully seal along the exterior side of the window frame.

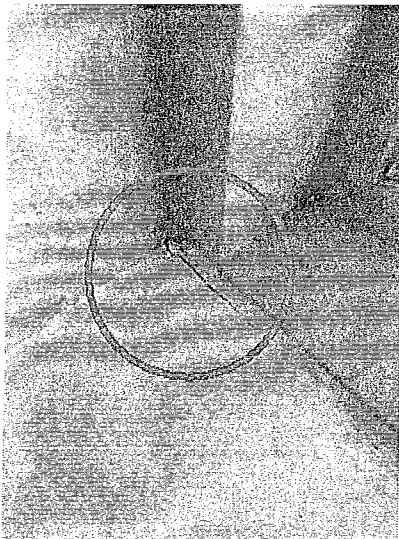
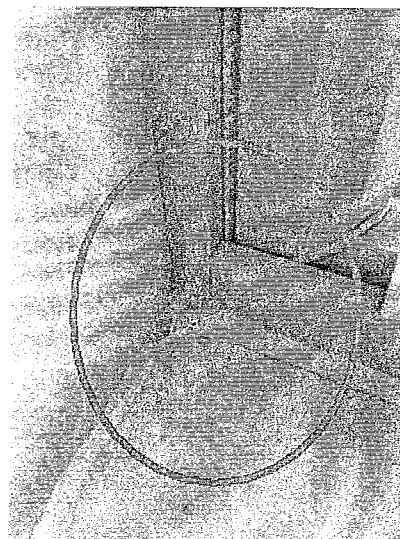
There are multiple locations around the house where the caulk on the interior side of the window frames is starting to crack.

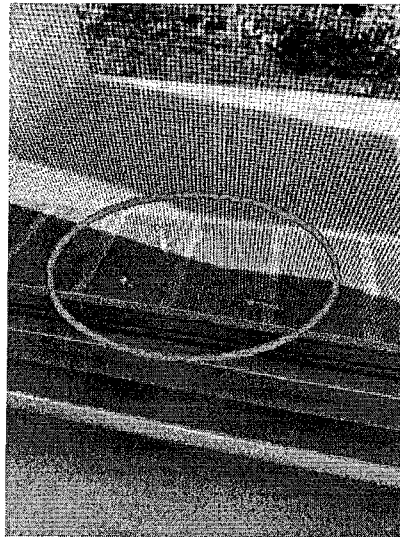
The window screen at the front right of the office is damaged.

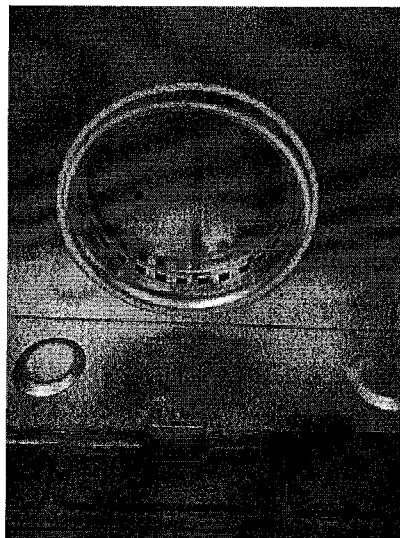
The flu damper is not in a permanently fixed open positions. Recommend installing a clamp or bracket on the flu damper to keep it in a permanently fixed open position.

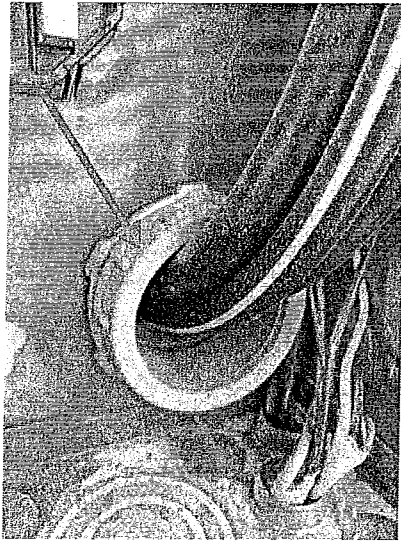
The collar that connects the electrical conduit from the meter to the electrical panel for the service entry wires does not have a ground wire attached.

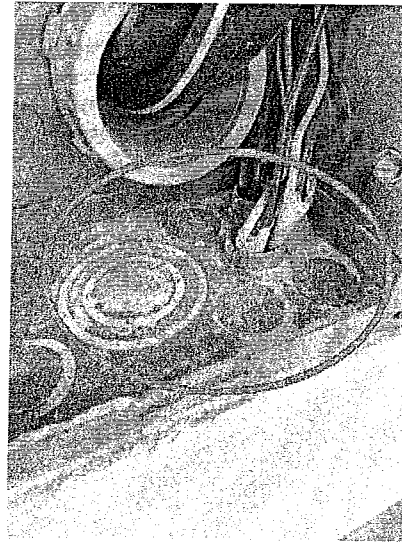
There is debris in the bottom of electrical panel.

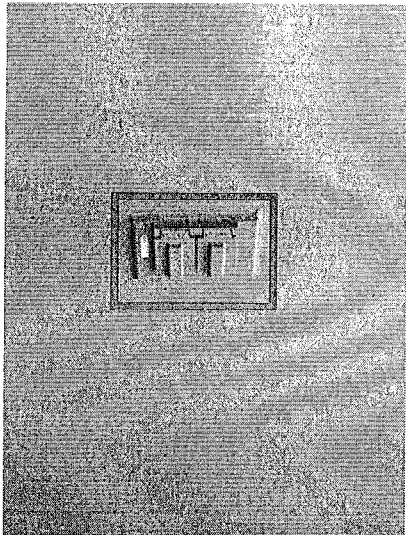
The electrical outlet on the exterior of the house at the back does not have the proper wet location cover.

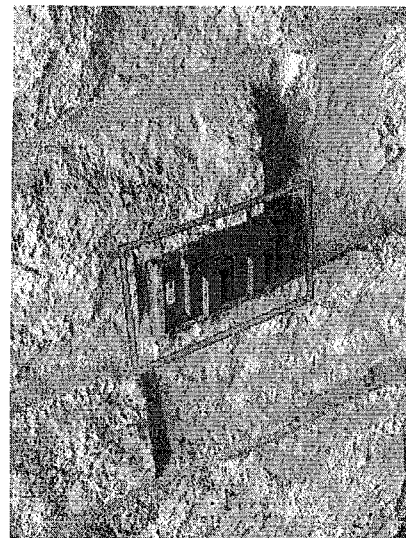
The electrical outlet on the exterior of the house at the front does not have the proper wet location cover.

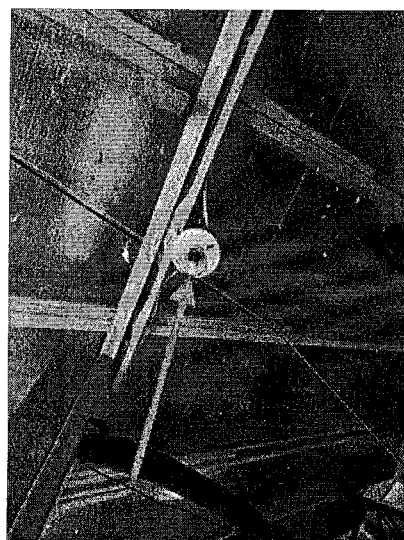
The light above the attic access hatch does not operate.

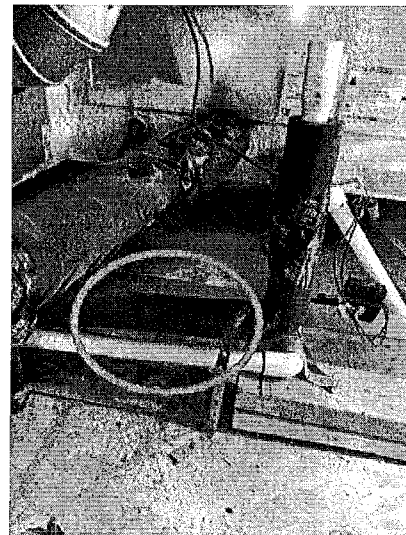
Missing P-trap on the primary drain for the condensing coil at the back of the attic space.

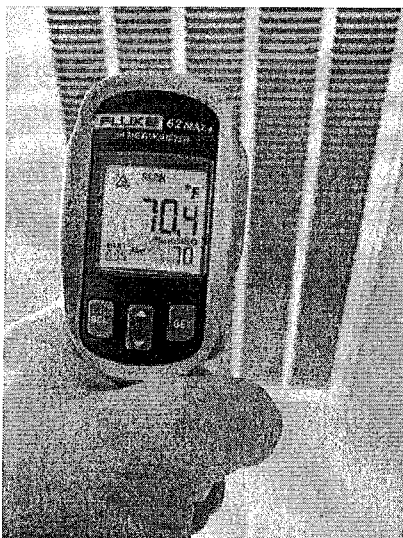
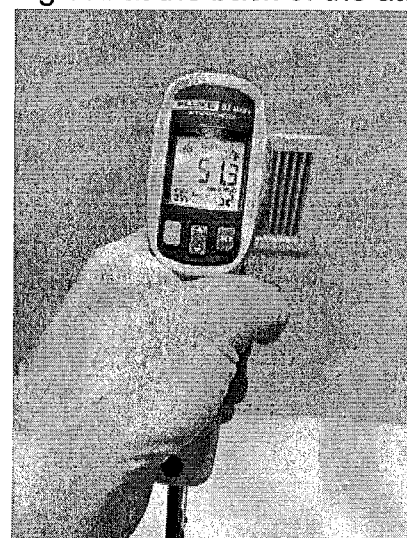
A/C temperature readings first floor are good. Return air temperature: 70.4°F. Supply air temperature: 51.3°F difference of 19.1°F.

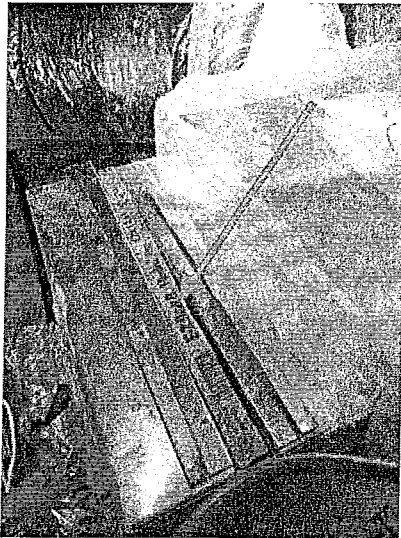
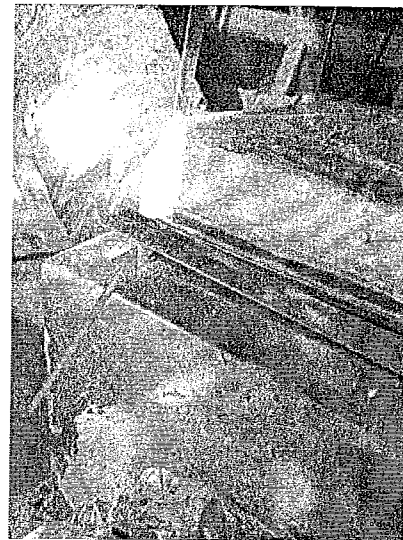
Filters are located by the heater in the attic space. The filter cover in the attic space is damaged

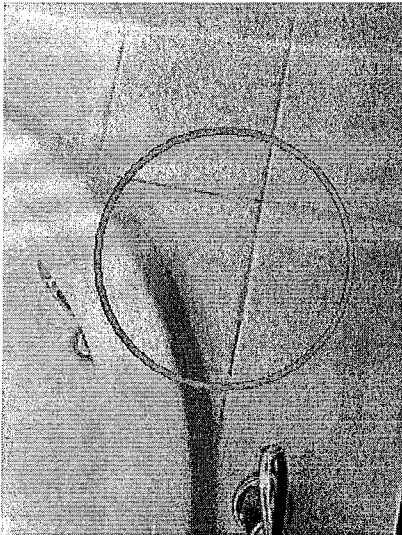
There are cracks and openings along the grout lines of the master bathroom tub surround.

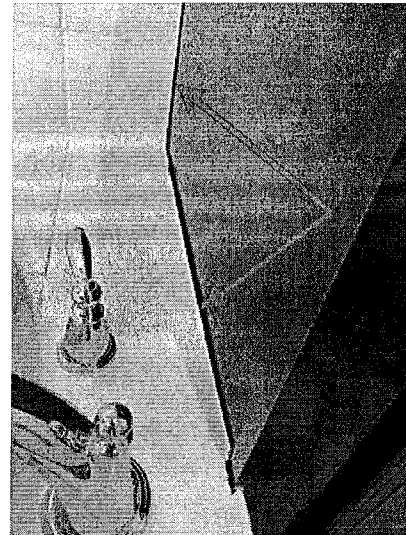
There is an opening between the master bathroom tub surround and the vanity cabinet.

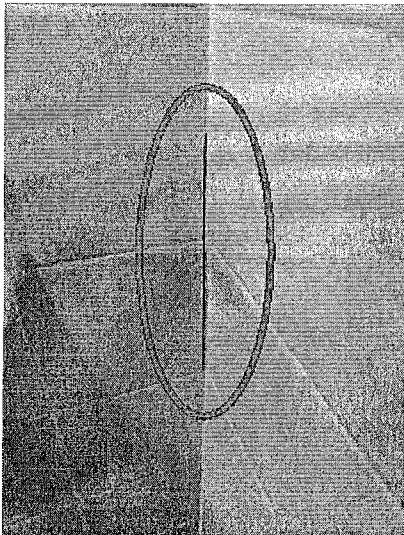
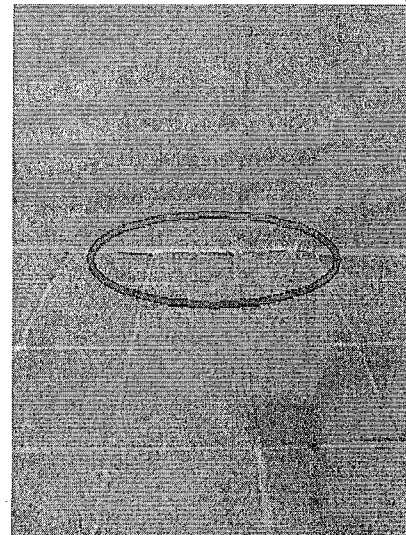
There are cracks along the inside corner joints of the master bathroom standup shower.

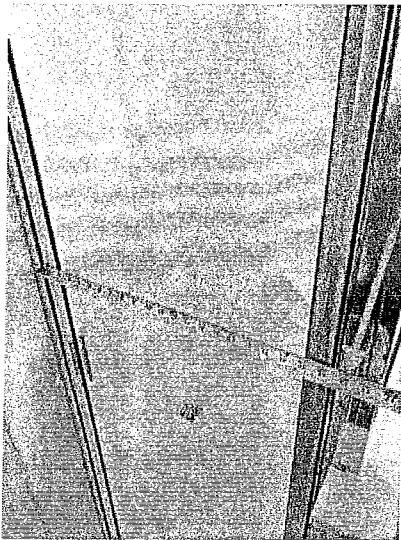
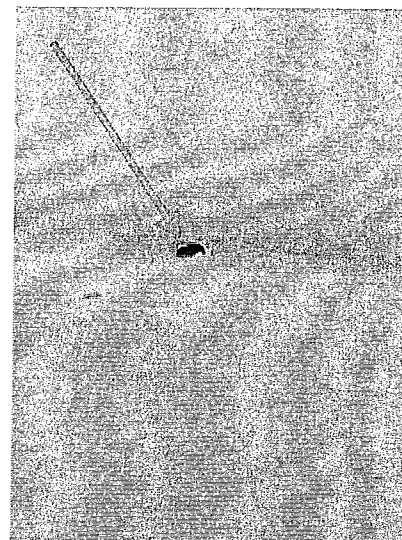
The master bathroom stand up shower door is too small. The minimum shower opening is 22 inches. There are multiple small openings along the guest bathroom tub surround.

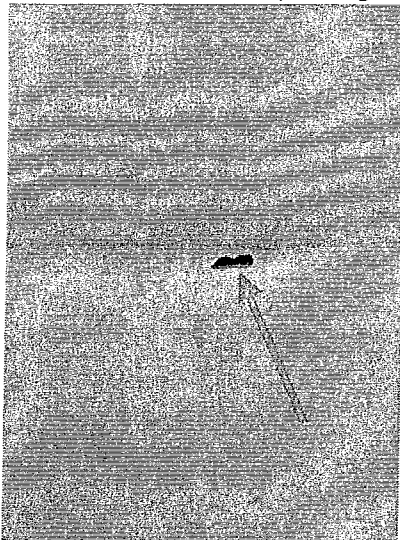
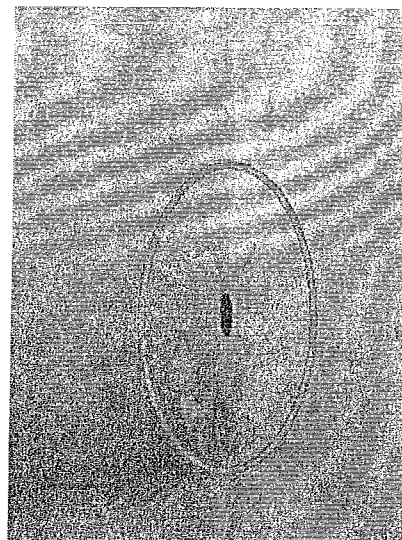
There are multiple small openings along the guest bathroom tub surround. There are multiple small openings along the guest bathroom tub surround.

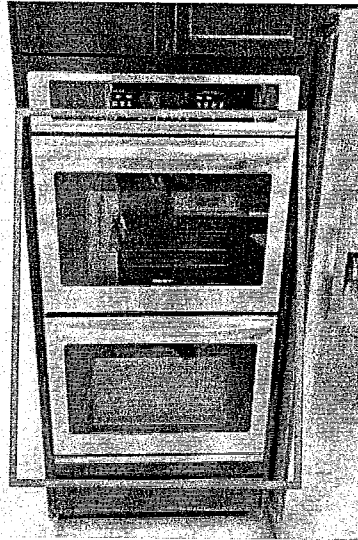
The ovens do not operate.

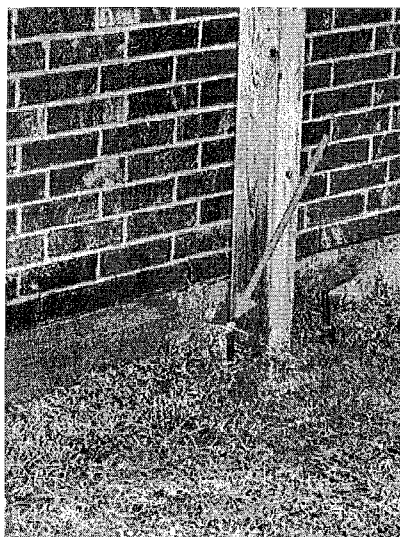
There are multiple locations where sprinkler heads should be adjusted.
