# Confidential Inspection Report

LOCATED AT:  
3219 Tamara Creek Ln  
Pearland, Texas 77584

INSPECTED ON:  
Monday, December 26, 2016

# PROPERTY INSPECTION REPORT

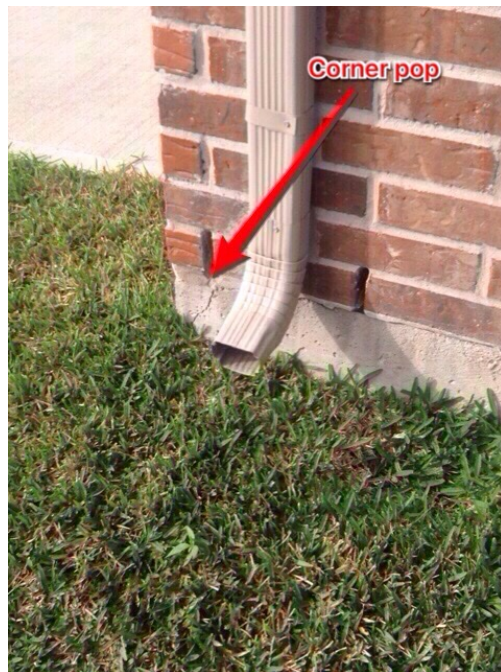
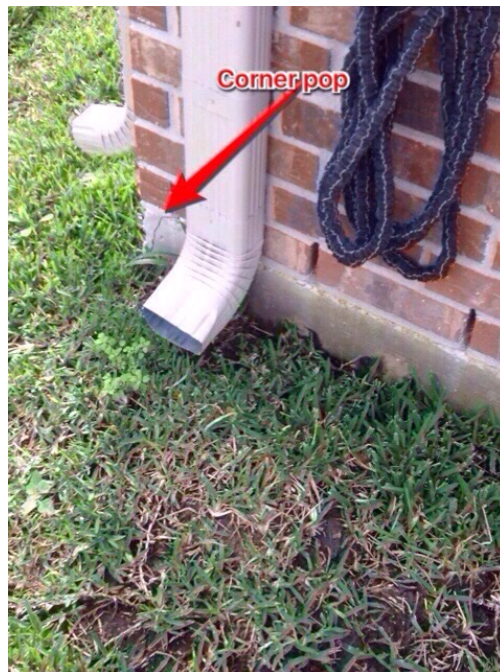
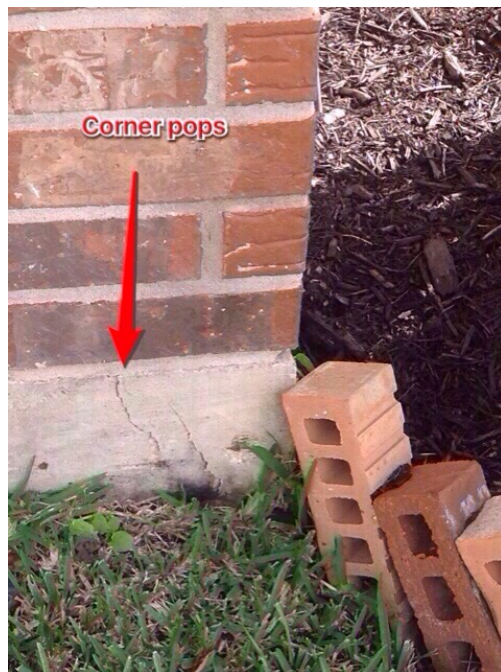
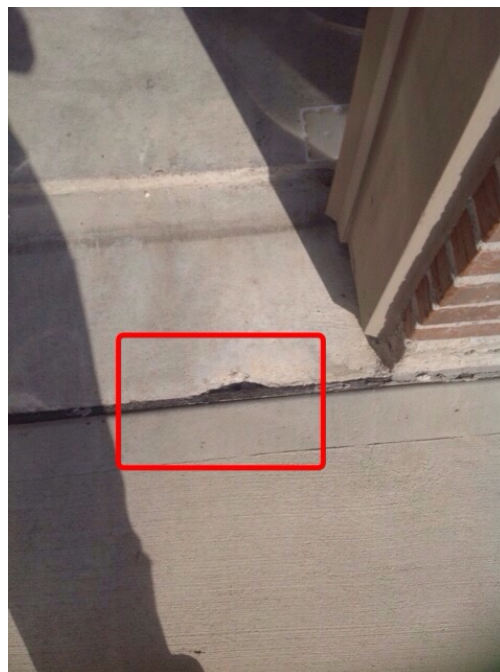
We noted minor cracks, within normal tolerances, at the. Corners. This type of cracking is often a result of shrinkage and/or minor settlement and usually does not affect the strength of the foundation. No action is indicated.

**1:** - We noted minor cracks, within normal tolerances, at the. Corners. This type of cracking is often a result of shrinkage and/or minor settlement and usually does not affect the strength of the foundation. No action is indicated.

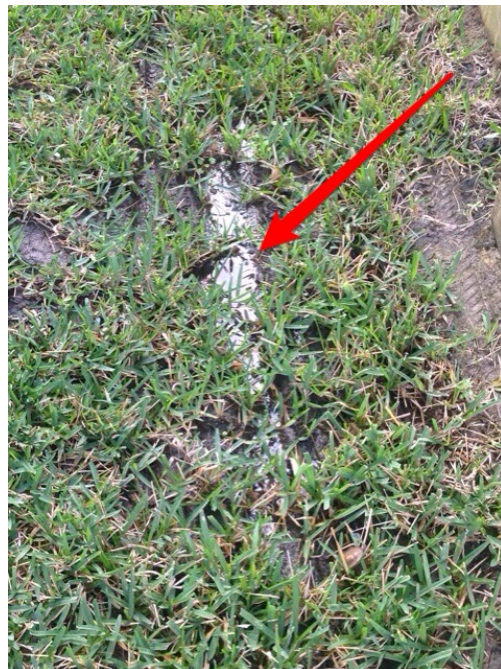
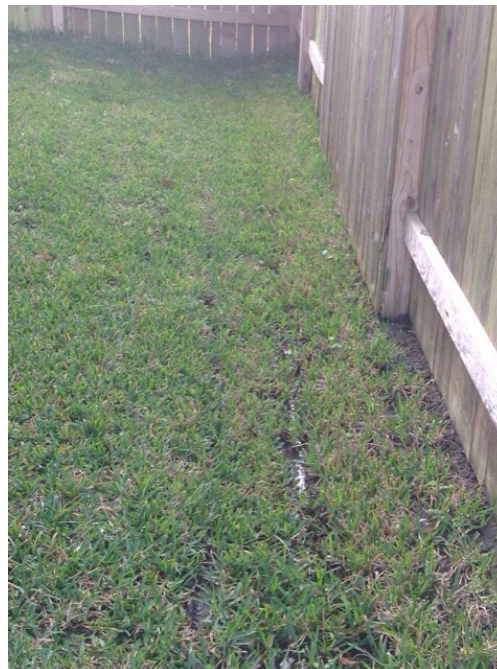
An examination of the grounds revealed standing water on the left side of home. The water does not appear to be directly affecting the structure, however, it is indicative of poorly drained and/or moisture retentive soil.

**3:** - An examination of the grounds revealed standing water on the left side of home. The water does not appear to be directly affecting the structure, however, it is indicative of poorly drained and/or moisture retentive soil.

Runoff water from the roof discharges next to the house. We recommend the downspouts be routed sufficiently away from the structure to prevent puddling, pooling, and saturation of the soil around the building.

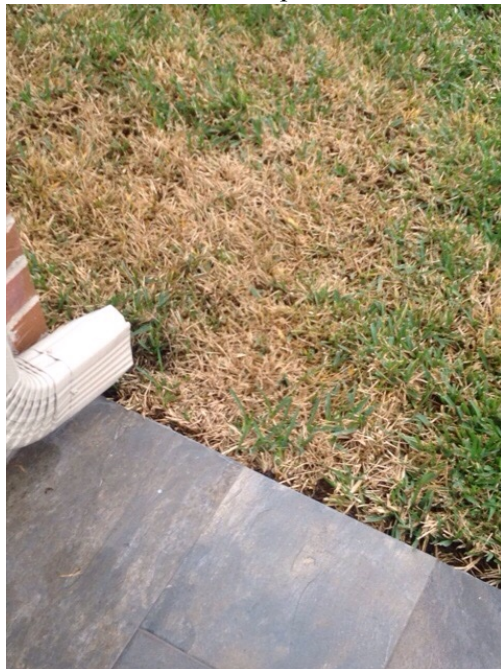
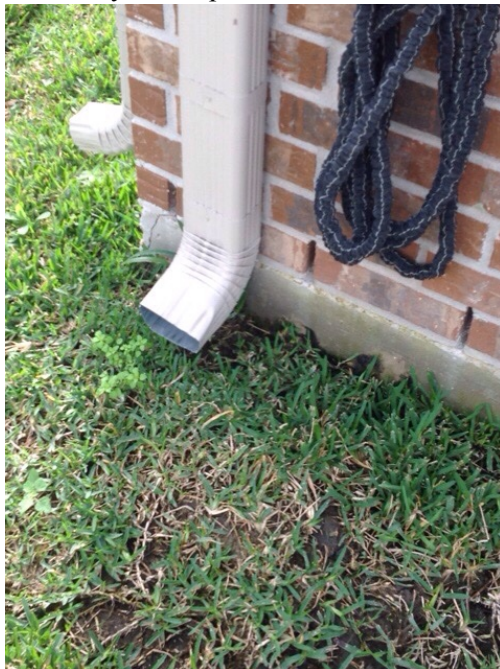
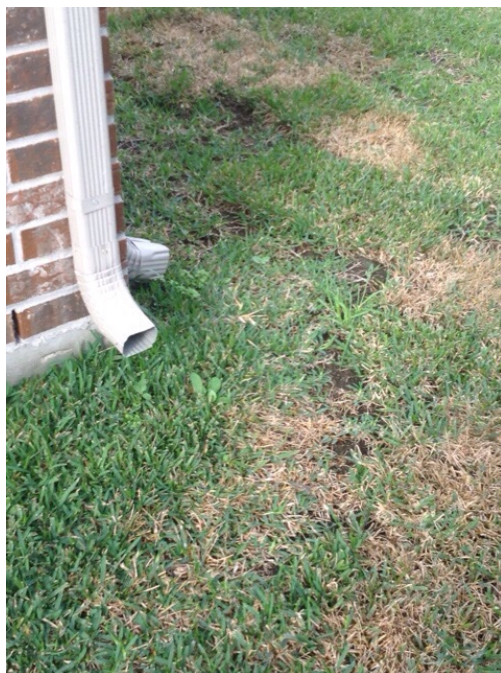
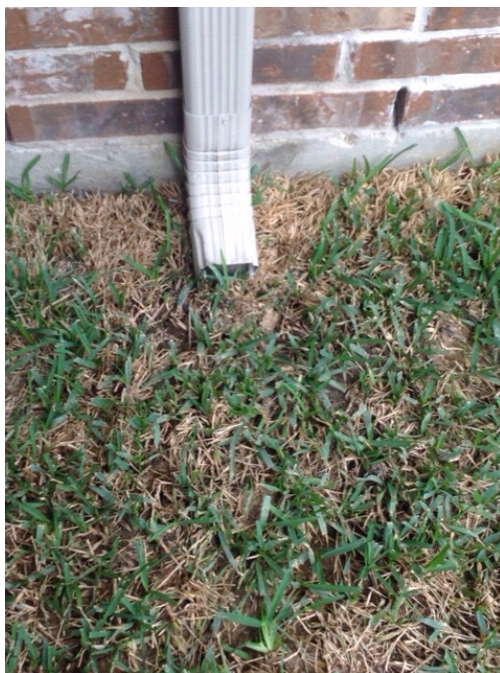
Splash blocks, directing water away from the foundation, were not at the base of every downspout. We recommend that a splash block be installed for every downspout.

**4:** - Splash blocks, directing water away from the foundation, were not at the base of every downspout. We recommend that a splash block be installed for every downspout.

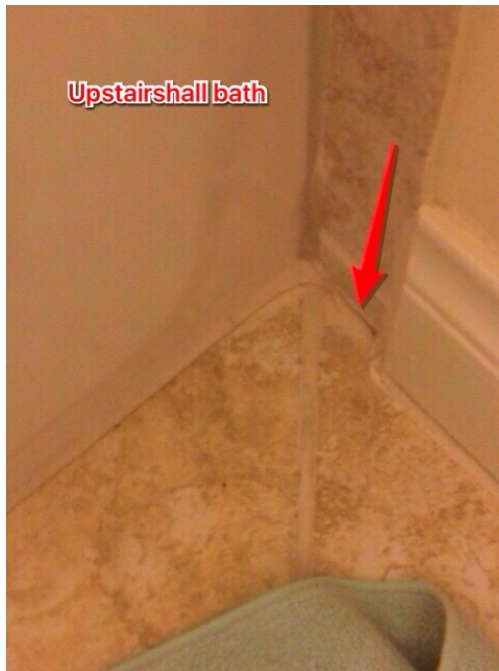
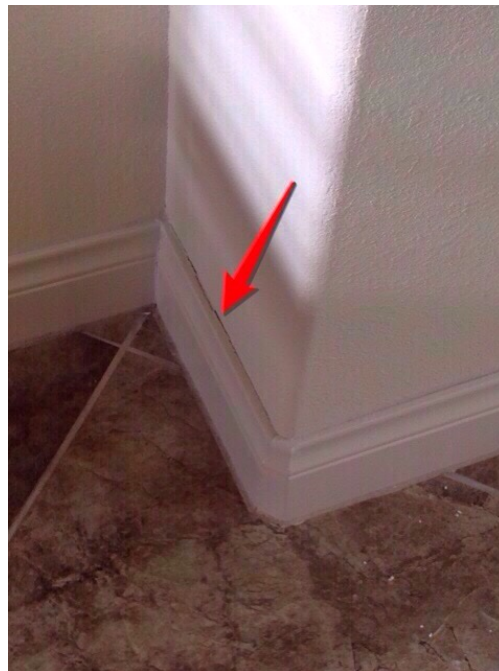
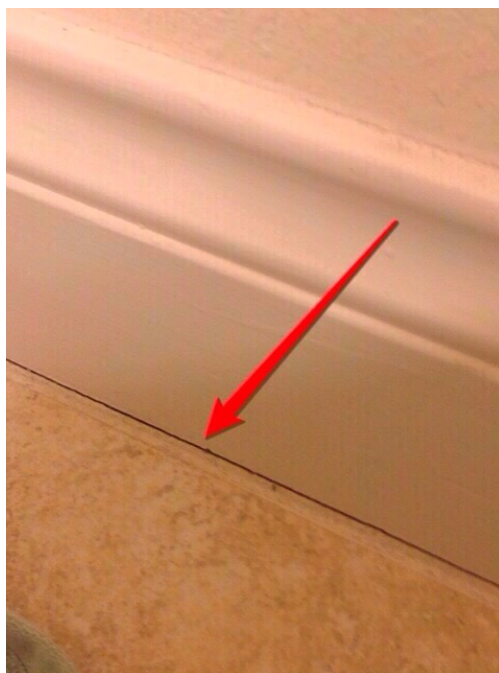
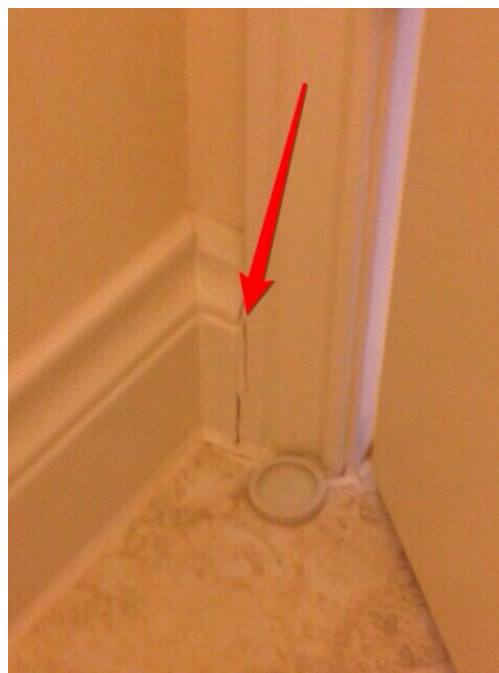
There are minor wall cracks. This type of cracking in this material is common and does not indicate a structural deficiency. These can be patched, prepared and finished in the course of routine maintenance.

**7:** - There are minor wall cracks. This type of cracking in this material is common and does not indicate a structural deficiency. These can be patched, prepared and finished in the course of routine maintenance.

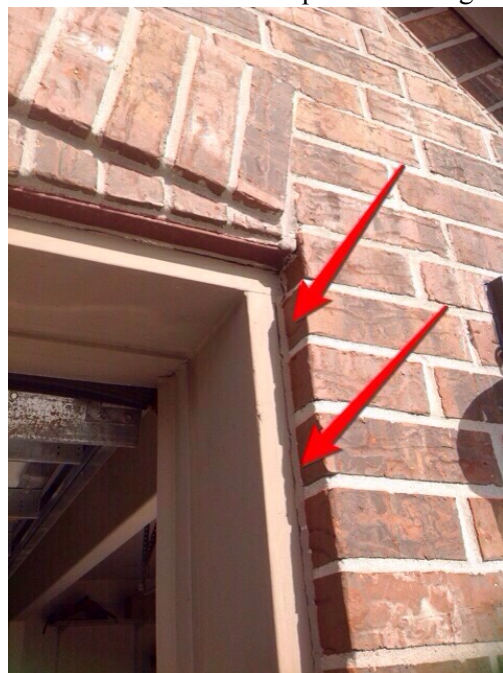
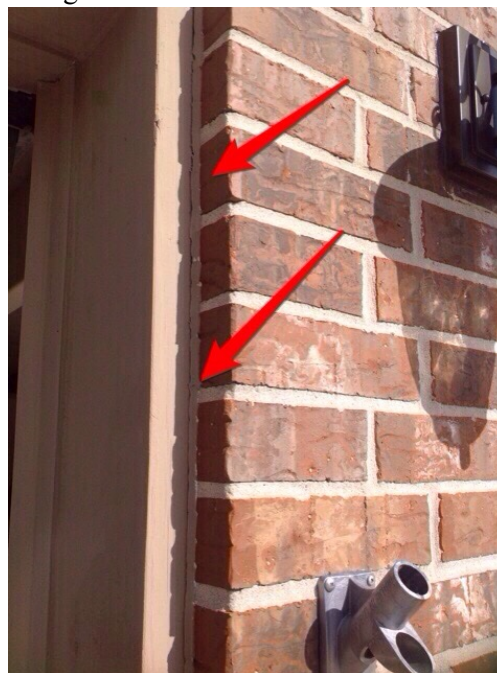
There are unsealed joints in the siding that may allow water penetration. We recommend the joints be caulked and sealed to prevent leakage and damage.

**8:** - There are unsealed joints in the siding that may allow water penetration. We recommend the joints be caulked and sealed to prevent leakage and damage.

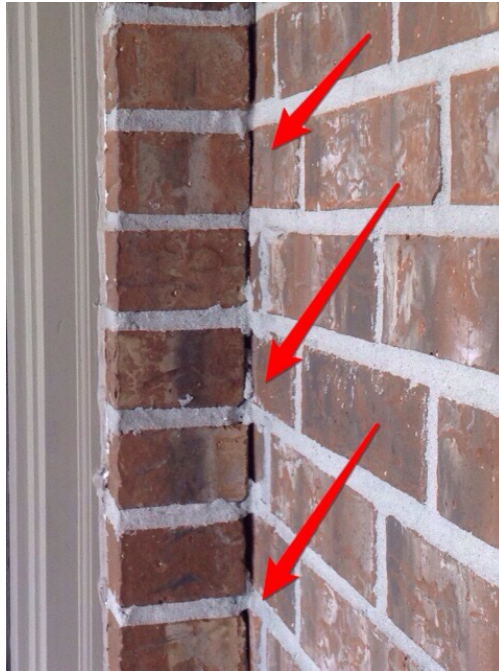
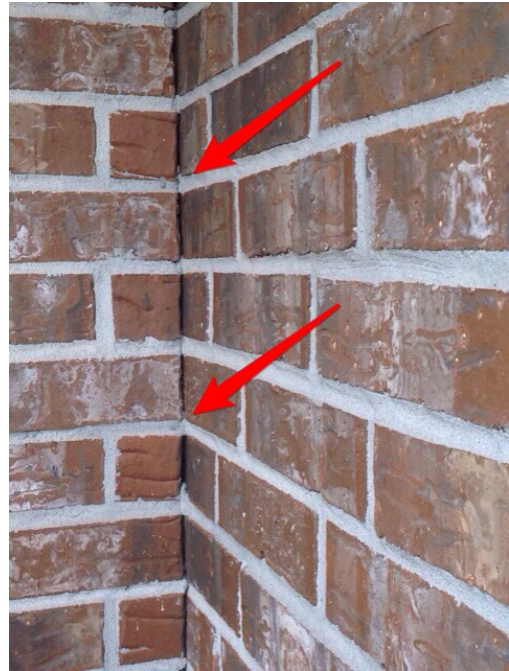
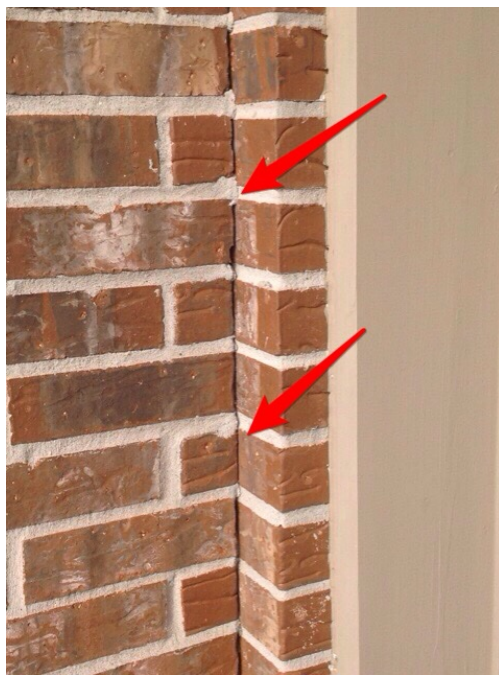
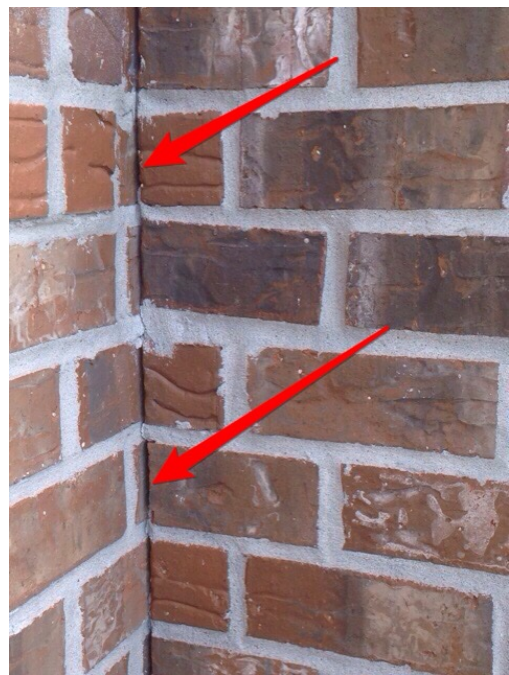
In this case, the veneer has pulled away from the building and/or has become unbonded from the wood frame. This is largely an aesthetic consideration, but we recommend sealing or covering gaps to prevent moisture and pest penetration.

**10:** - In this case, the veneer has pulled away from the building and/or has become unbonded from the wood frame. This is largely an aesthetic consideration, but we recommend sealing or covering gaps to prevent moisture and pest penetration.

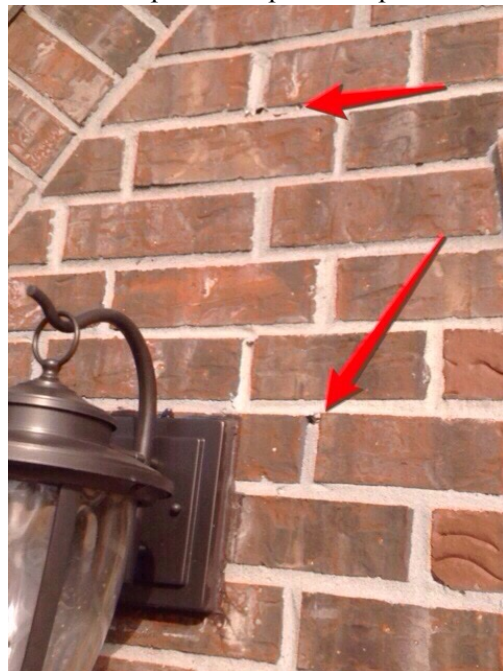
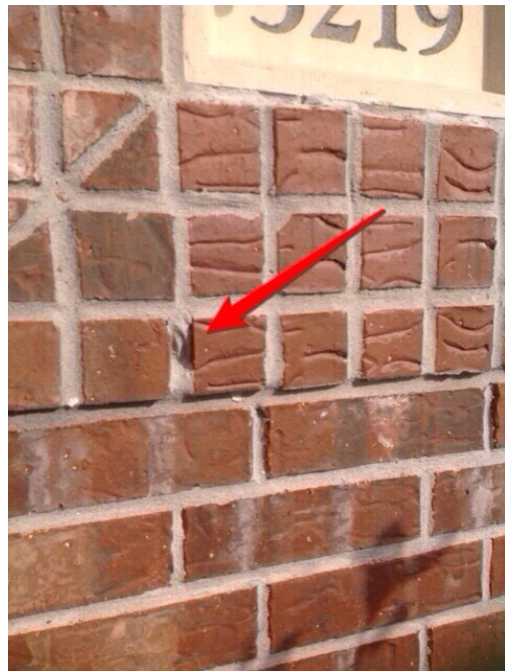
The mortar is deteriorated in some areas. To help prevent further damage, we recommend the mortar be repaired or 'pointed up'.

**11:** - The mortar is deteriorated in some areas. To help prevent further damage, we recommend the mortar be repaired or 'pointed up'.

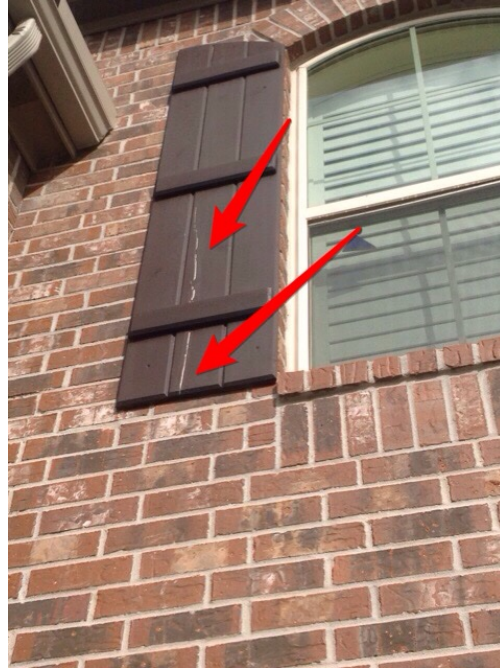
The windows appear to be properly installed and generally in serviceable condition. However there is a broken shutter on the front of the house.

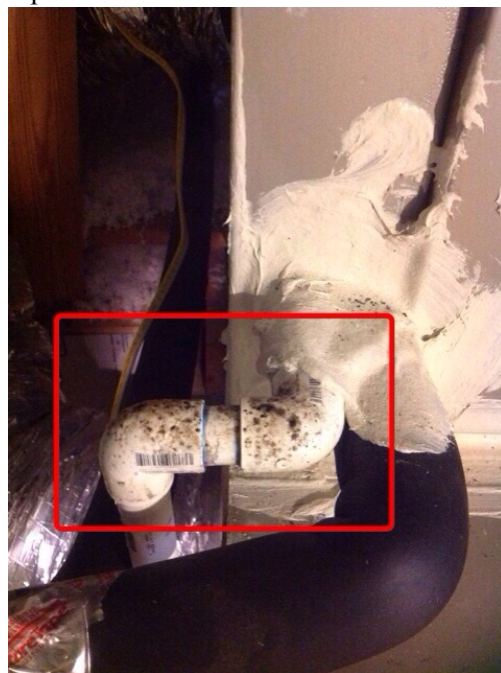
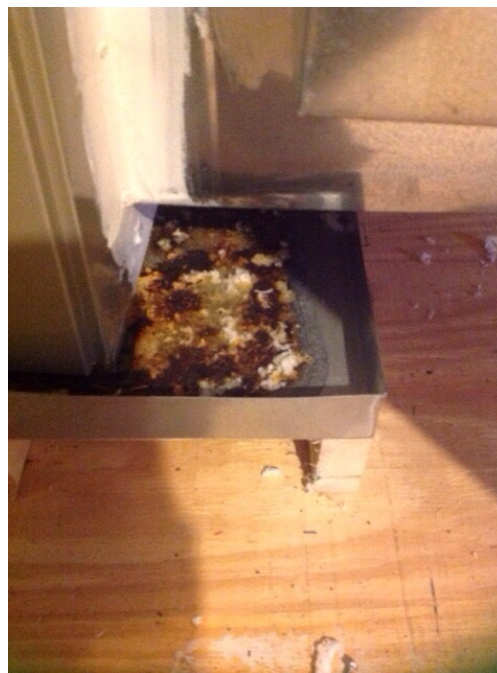
The environment around the furnace is unusually moist. Because of this high humidity, early replacement is forecasted.

**12:** - The environment around the furnace is unusually moist. Because of this high humidity, early replacement is forecasted.

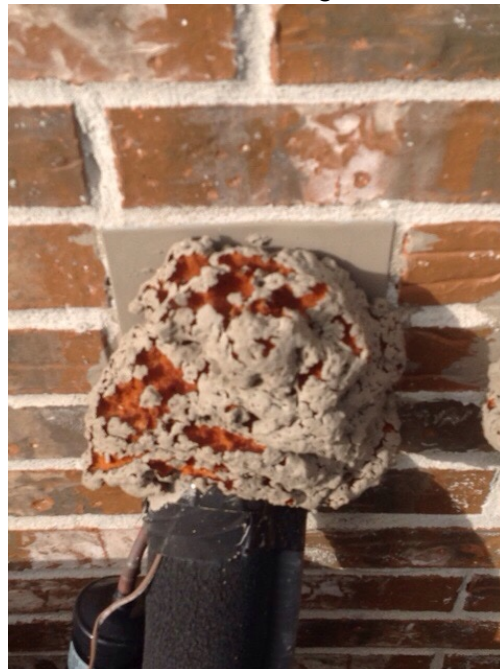
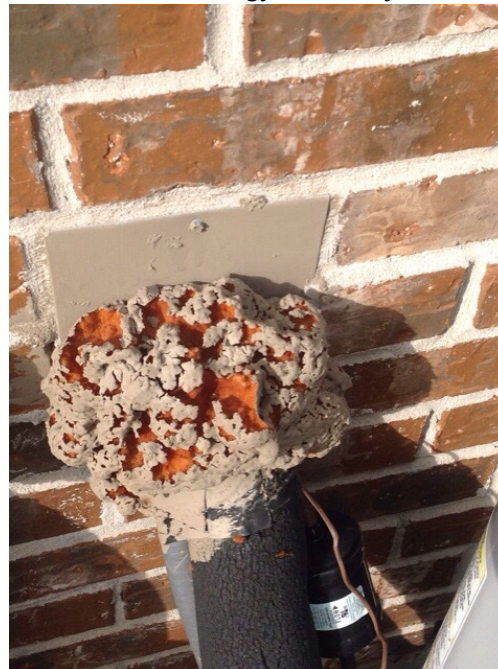
Insulation is deteriorated and missing from portions of the refrigerant lines in several areas. We recommend that all missing insulation be replaced to increase energy efficiency.

**14:** - Insulation is deteriorated and missing from portions of the refrigerant lines in several areas. We recommend that all missing insulation be replaced to increase energy efficiency.

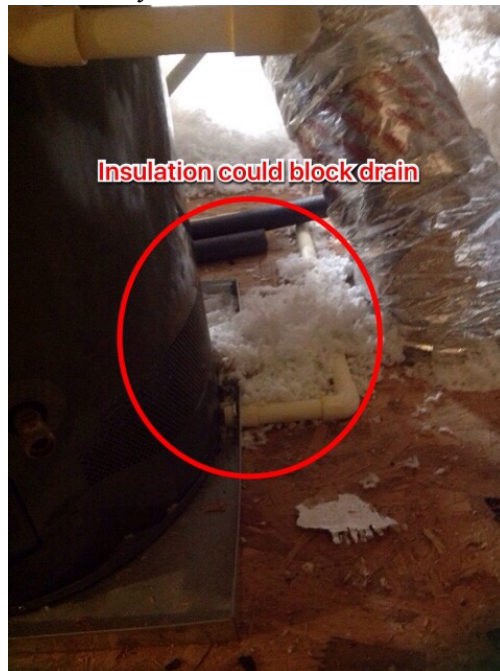
This is a newer water heater, was operating and with routine maintenance should be reliable for a number of years. However the insulation could block the drain.

**15:** - This is a newer water heater, was operating and with routine maintenance should be reliable for a number of years. However the insulation could block the drain.
