Home Inspection  
1302 Linwood Dr  
Wharton, TX. 77488

## PROPERTY INSPECTION REPORT

**Concerning:** 1302 Linwood Dr, Wharton, TX 77488  
(Address or Other Identification of Inspected Property)

**By:** James Ezell, Lic #21864 04/25/2020  
(Name and License Number of Inspector) (Date)

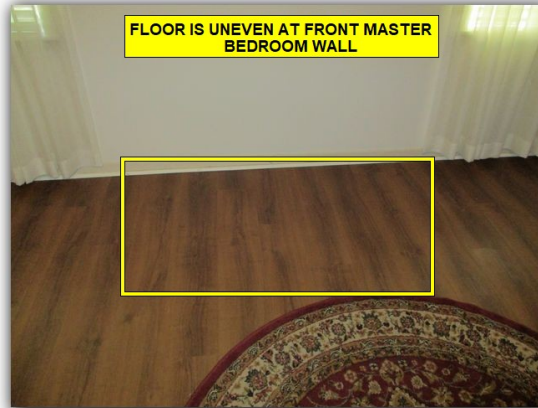
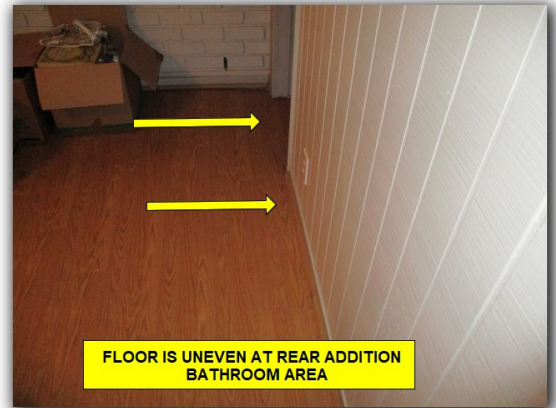
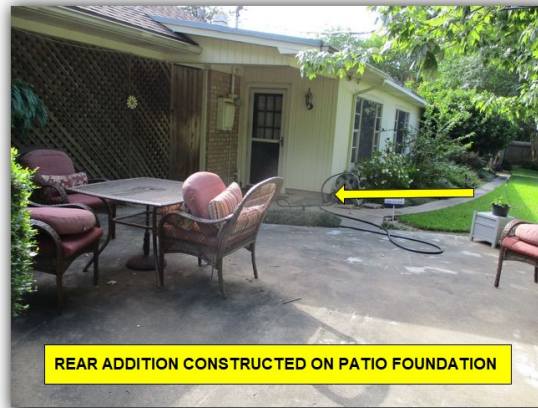
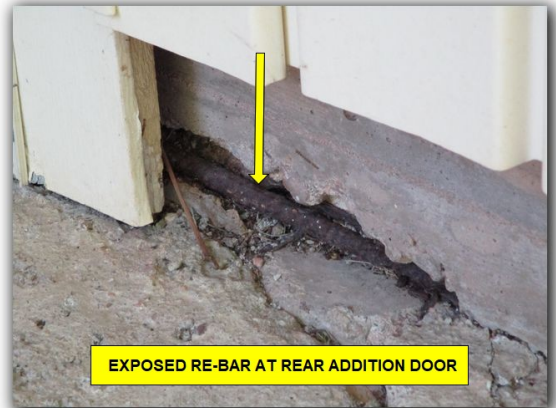
- There are signs of settlement and/or structural movement in areas on the exterior and interior of the home. There are cracks/separation on the exterior brick siding and on the interior drywall in areas throughout the home (see photos in wall section). The floor is uneven at the front wall of the master bedroom (below window area). The floor is also uneven at the doorway area to the rear addition bathroom.
- The rear living addition appears to have been constructed on the existing patio foundation. It could not be determined if the patio foundation is able to adequately carry the weight of the room addition walls and roof.
- There is exposed re-bar located on the rear addition foundation (below rear entry door).

- The foundation appears to be performing the function intended
- Structural movement and/or settling noted; however, the foundation is supporting the structure at this time.
- Signs of structural movement noted; suggest that an expert in this field be consulted for further evaluation of the structure and to provide suggestions as to what, if any, corrective actions should be taken.

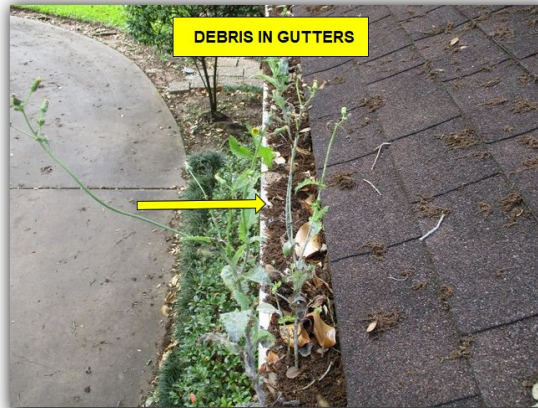
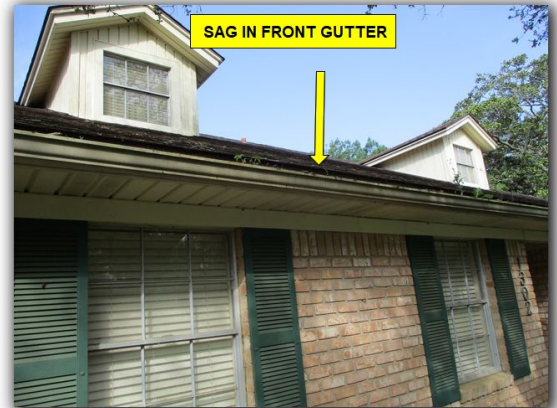
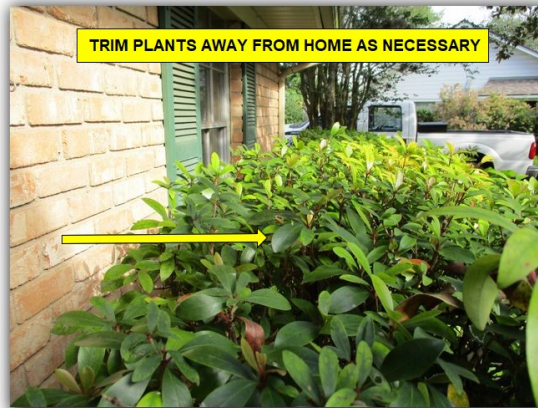
- There is debris throughout the gutter system. The weight of the debris is causing the gutter to sag at the front of the home. It is recommended that the debris be removed and the gutters be repaired to allow for proper drainage.
- Recommend trimming the plants and tree branches away from the home as necessary.

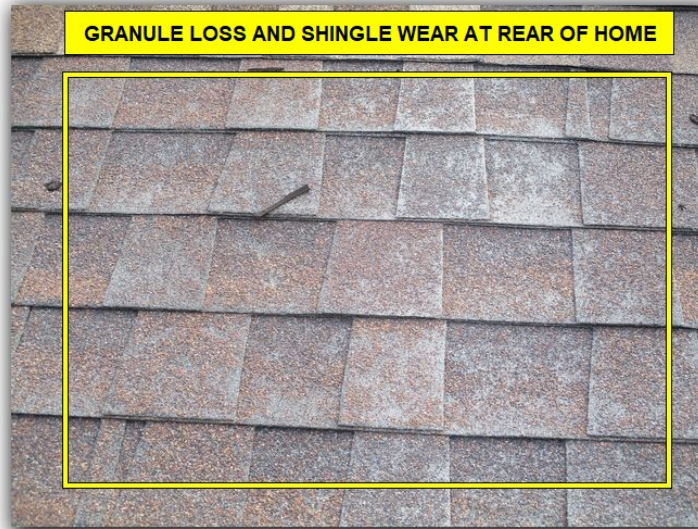
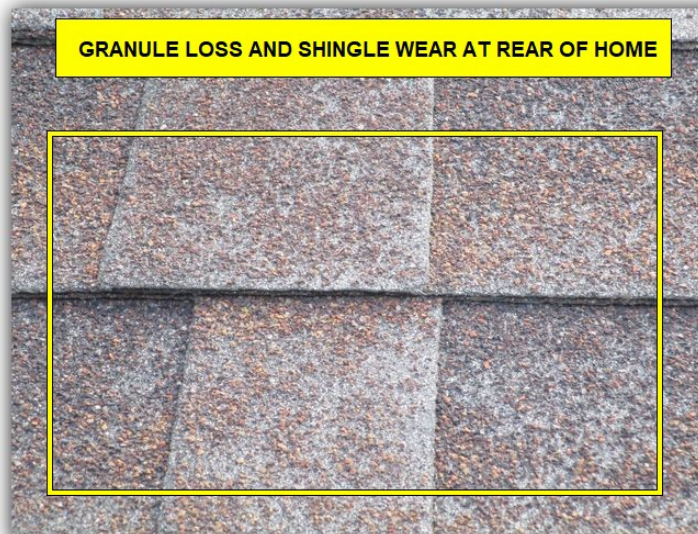
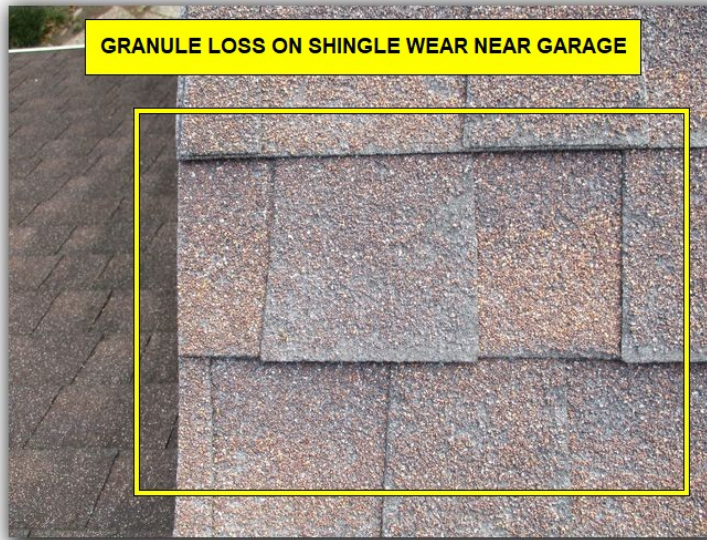
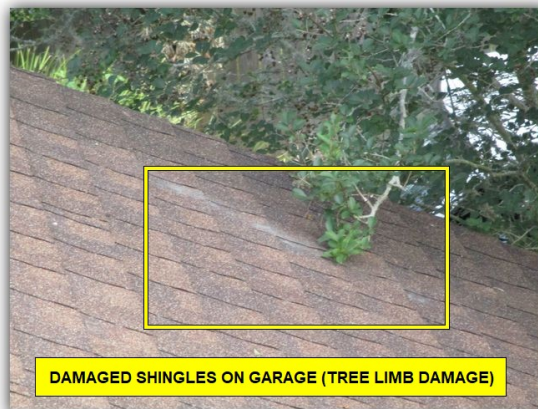
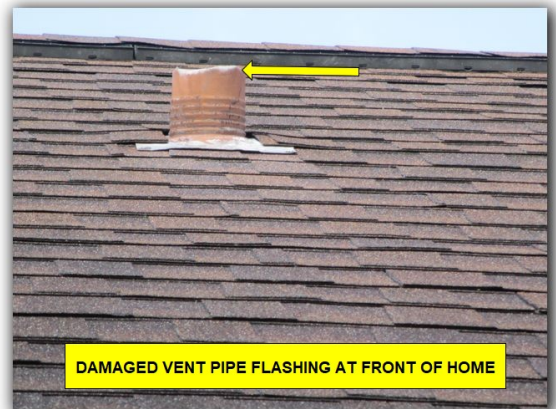
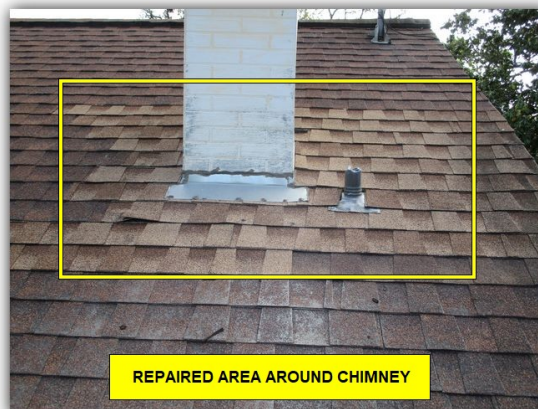
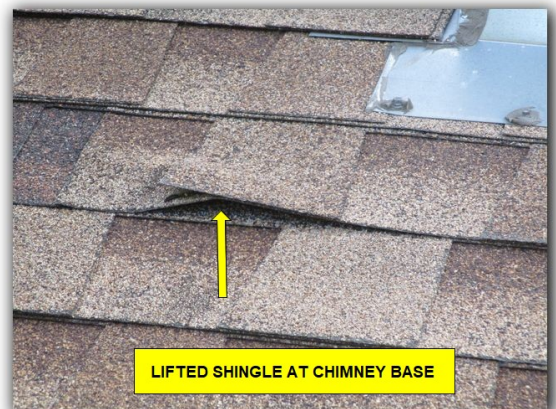
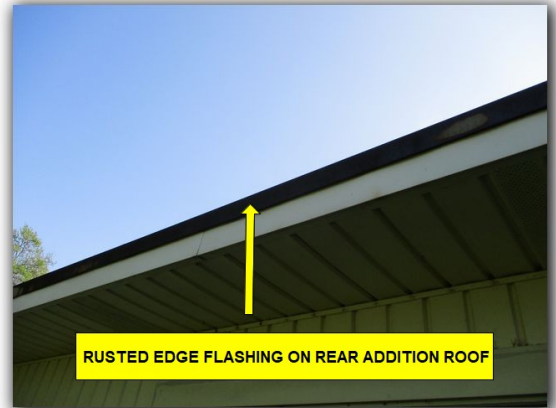
- Architectural style shingles are installed on the home and roll type roofing material is installed on the rear addition and left-side patio cover.
- There are signs of shingle wear such as granule loss and thinning in areas throughout the roof surface. This may indicate that the shingles are nearing the end of their useful remaining lifespan.

- There are damaged shingles at the front-side of the garage (at right gable end) from tree branch contact.
- The flashing for the front plumbing vent pipe is damaged (typical damage from squirrel activity).

- There is an uplifted shingle, caused by backed out roofing nail located below the base of the chimney.
- The wall-to-roof flashing located above the dining room window is uplifted.

- There is surface rust on the rear addition roof's drip edge flashing.
- It is recommended that the shingles and flashings be further evaluated by a qualified roofing contractor.

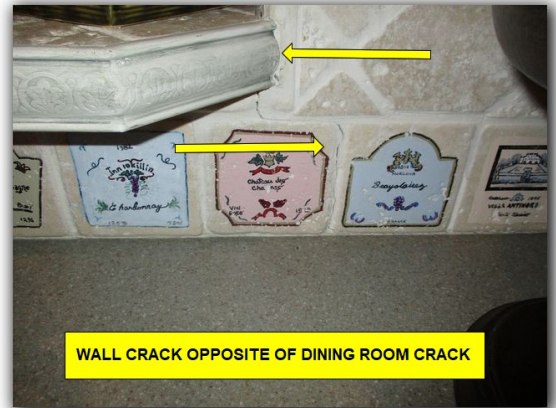
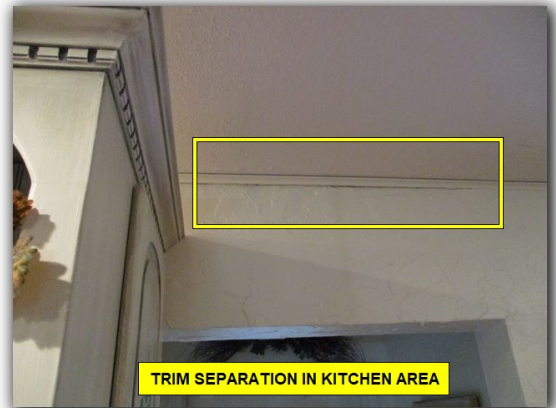
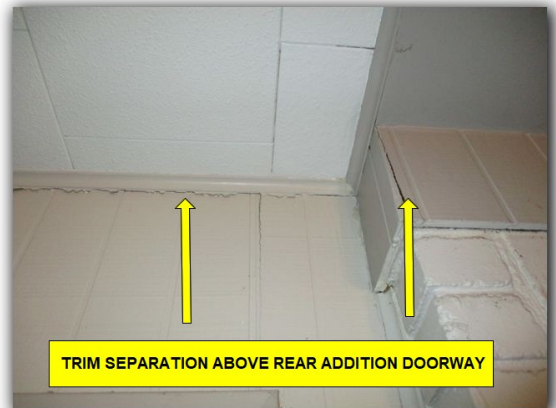
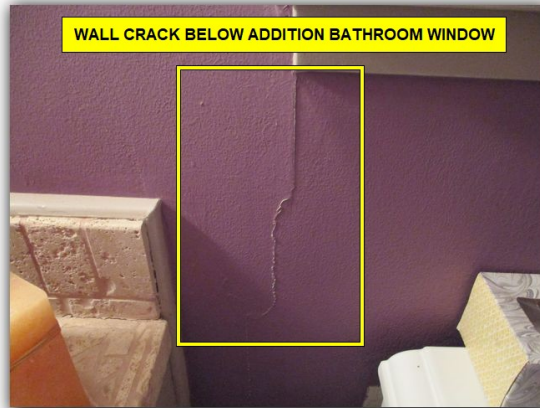
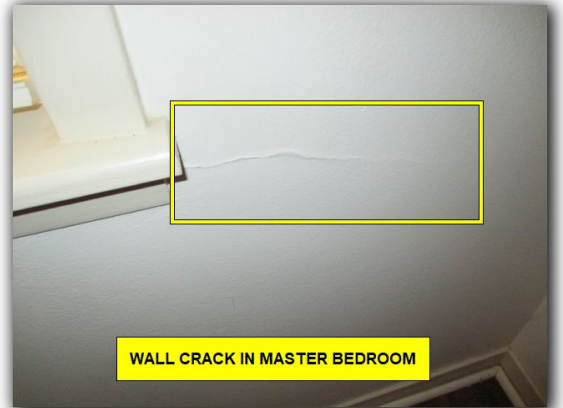
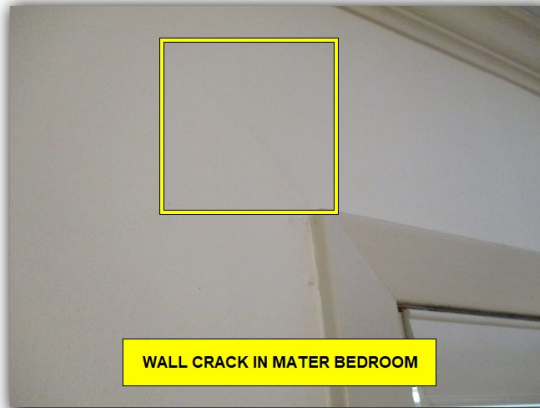
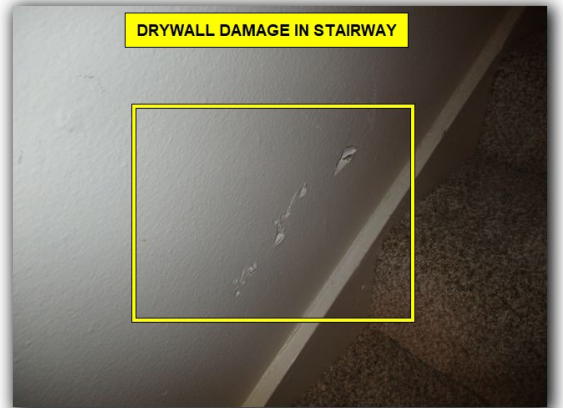
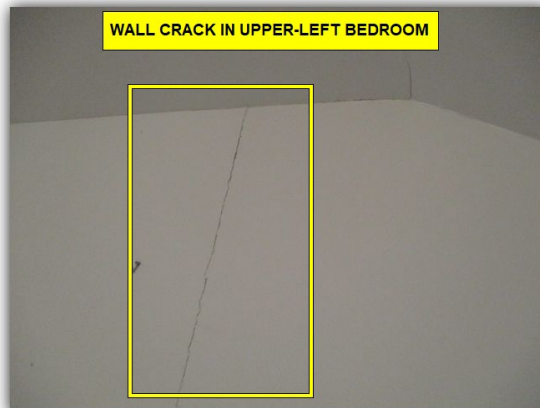
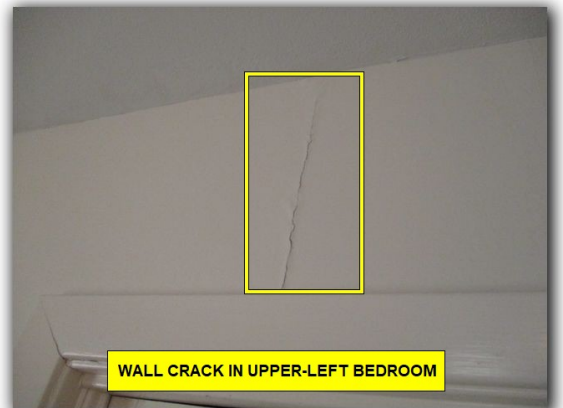
- There are cracks on the interior drywall along with minor paint and trim defects in areas throughout the home.

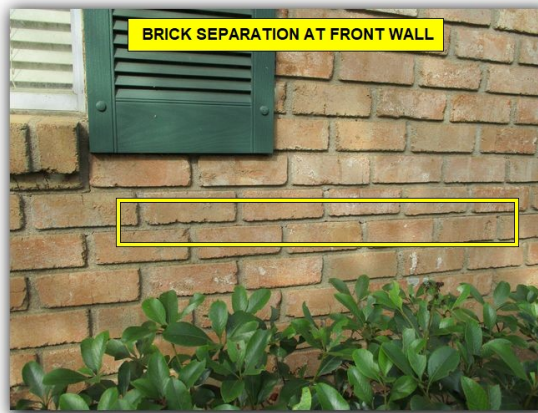
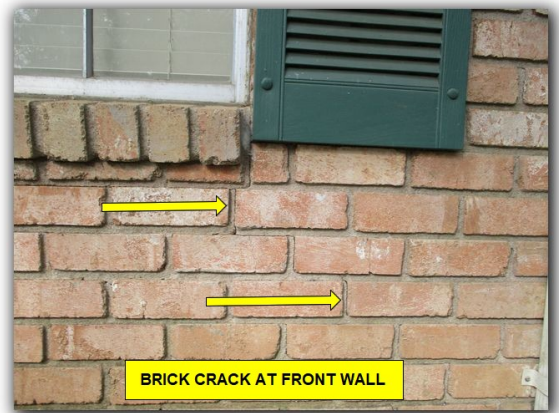
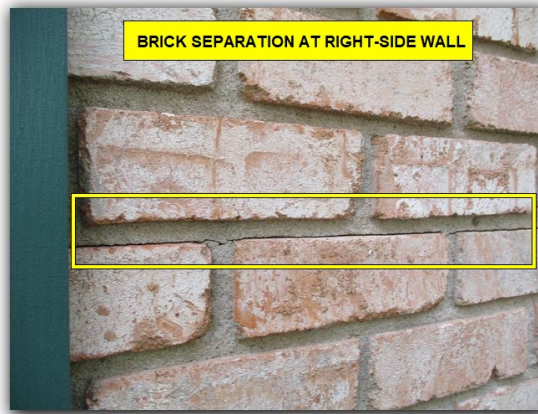
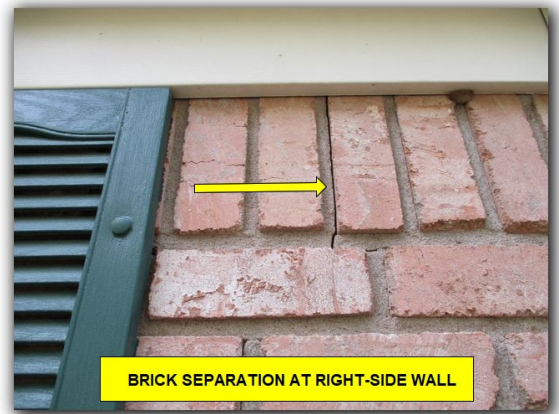
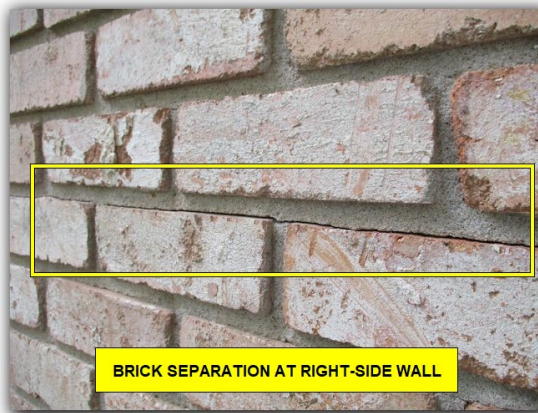
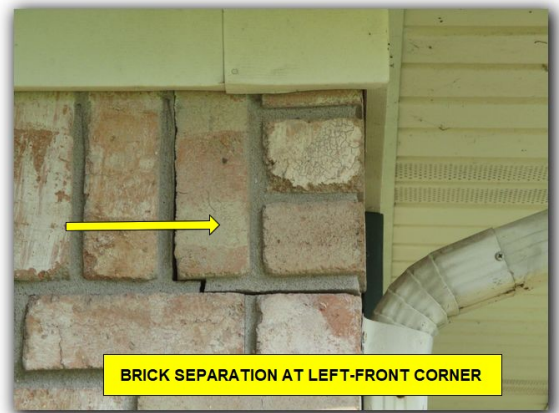
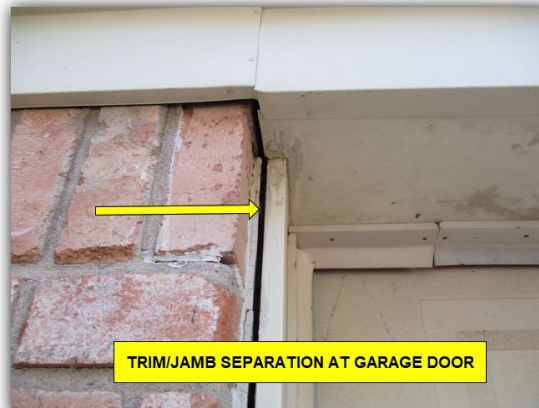
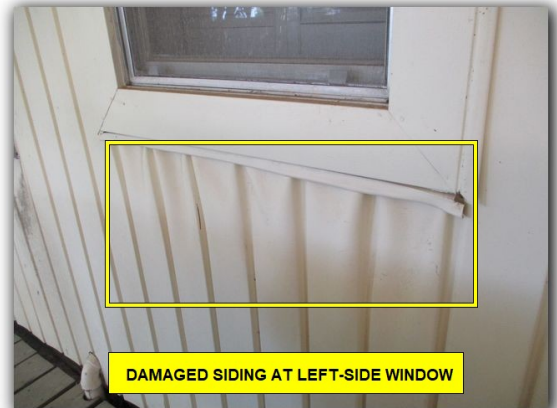
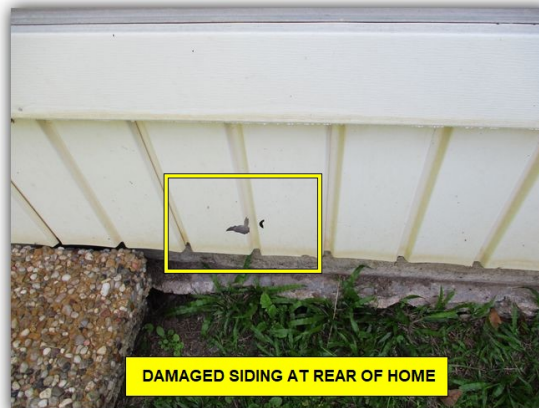
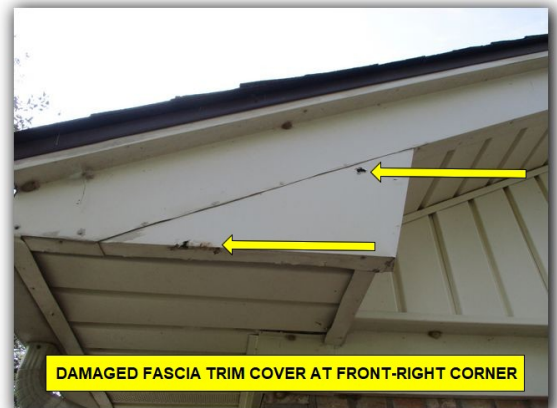
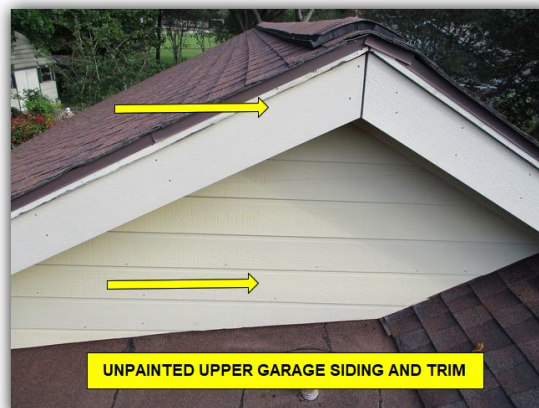
- There is cracking and separation on the exterior brick siding in areas around the perimeter of the home.
- The left garage door trim/jamb is separating from the brick siding.

- The vinyl siding is damaged at the left-side of the home below the window area (possible heat damage from outdoor grilling).
- There is minor damage on the vinyl siding in areas at the rear of the home.
- The rear upper gable end on the garage has newer fiber cement board siding and fascia trim that appears to not be painted. Recommend the siding and trim in this area be caulked and painted.
- Recommend sealing/caulking any gaps in the exterior siding, trim, around window frames, around light fixtures and electrical panels as necessary.

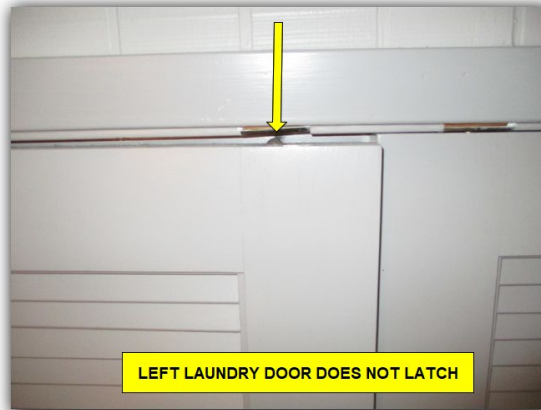
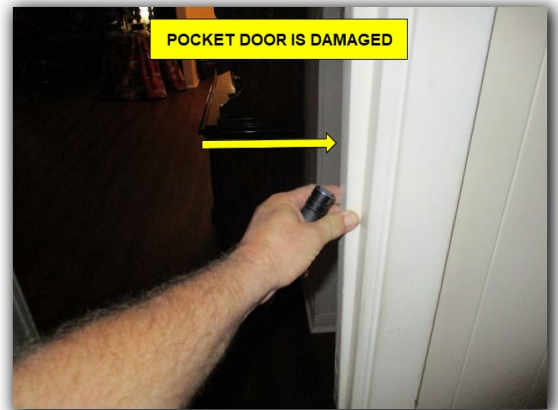
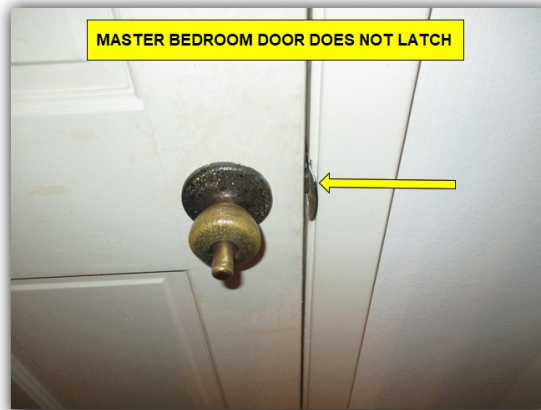
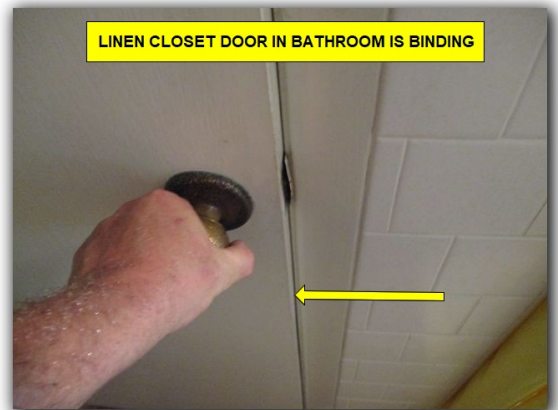
- The left laundry area door does not latch.
- The pocket door between the living room and dining area is damaged and does not open or close.
- The mater bedroom door does not latch.
- The linen closet door in the downstairs bathroom is binding..

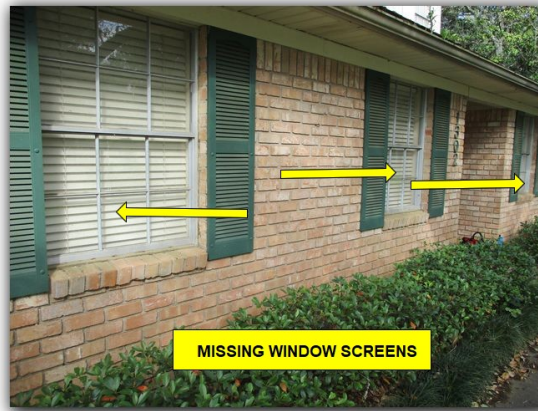
- The exterior window screens are missing.

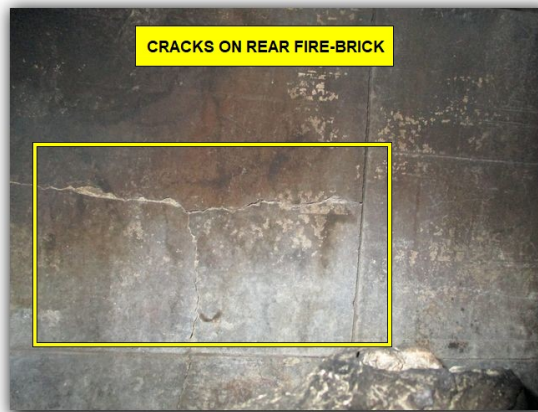
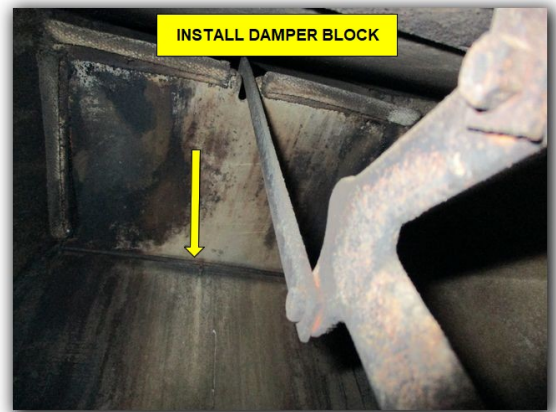
- There is cracking on the rear fire-brick panel in the fireplace. Recommend the cracks be sealed with a fire-resistant sealant.
- A damper block should be installed on the damper (gas log system is in use). This prevents the damper from closing fully.

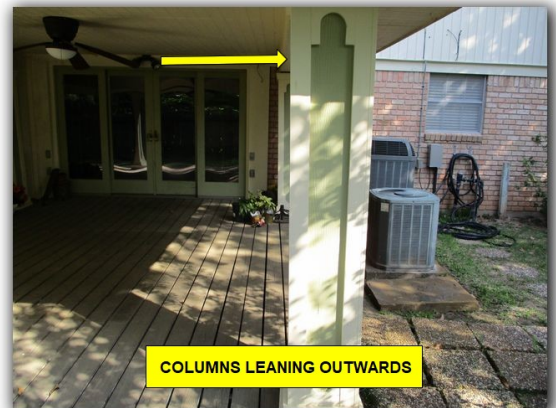
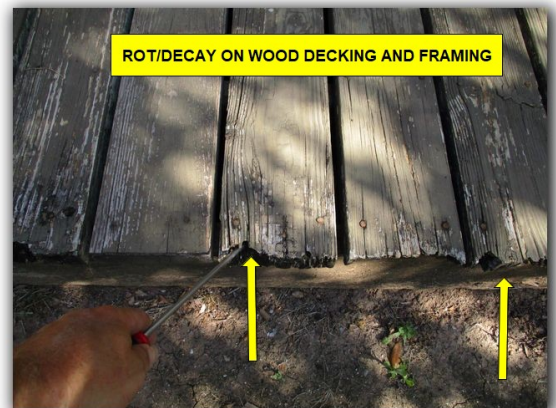
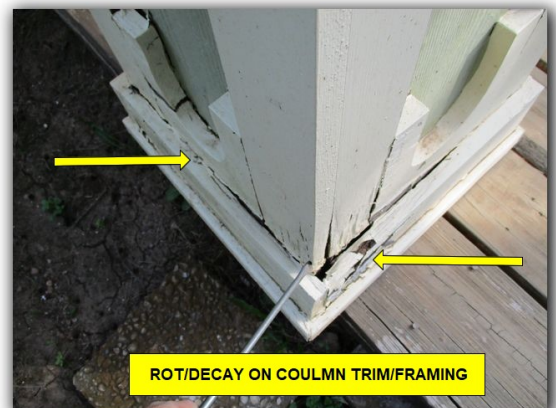
- The support columns on the left-side patio cover are leaning outwards. The columns appear to be resting on the deck surface and not on support blocks (difficult to verify due to the deck resting on grade). There are sags in the support beams that span the support columns. There is wood rot/decay on the column trim, deck boards and deck framing. It is recommended that the patio framing and supports be further evaluated by a qualified contractor.

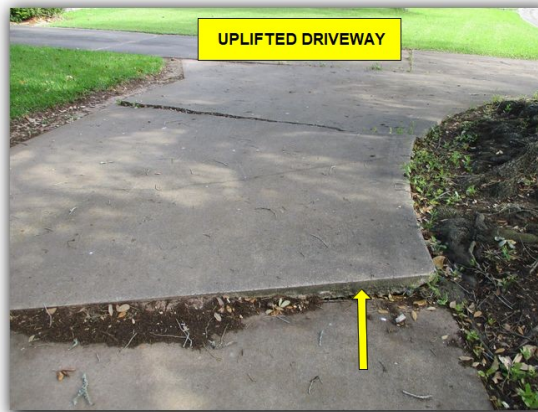
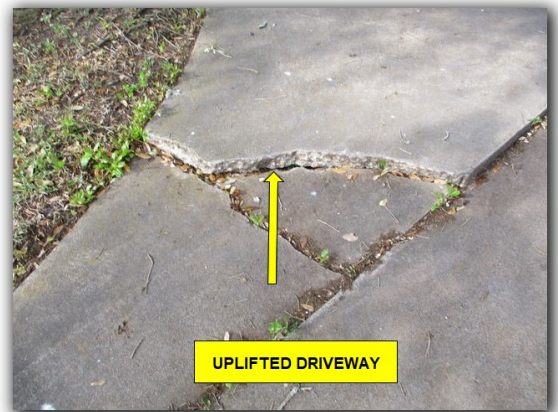
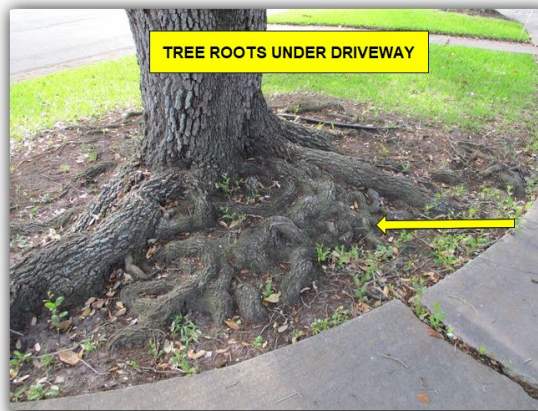
- The concrete driveway is severely uneven in areas. The concrete is uplifted in multiple areas. The tree roots from the adjacent trees are causing the driveway to lift. This poses a trip hazard. It is recommended that the driveway be further evaluated by a concrete contractor for the proper repairs.

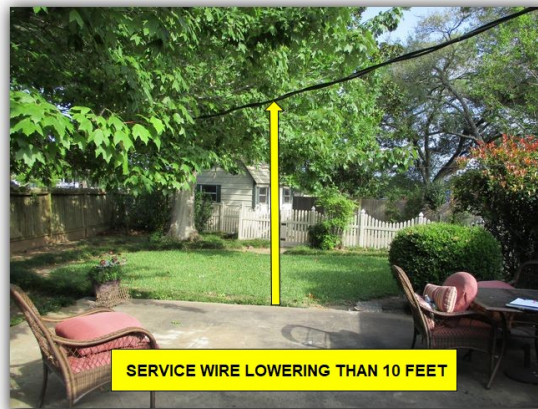
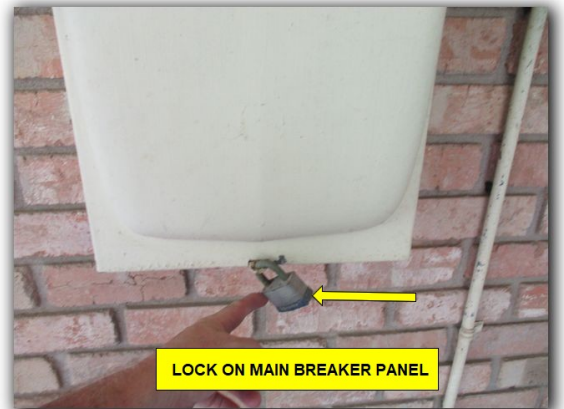
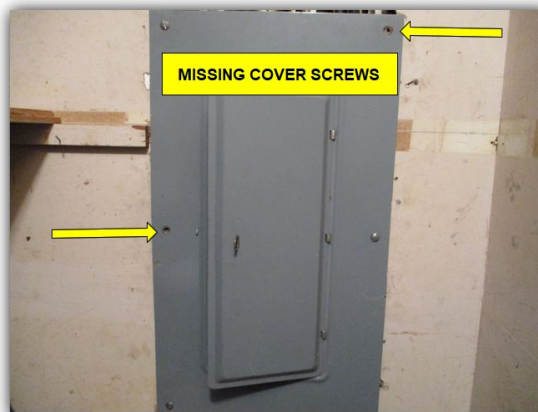
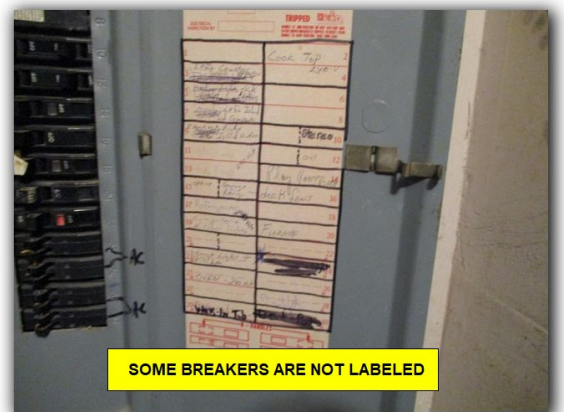
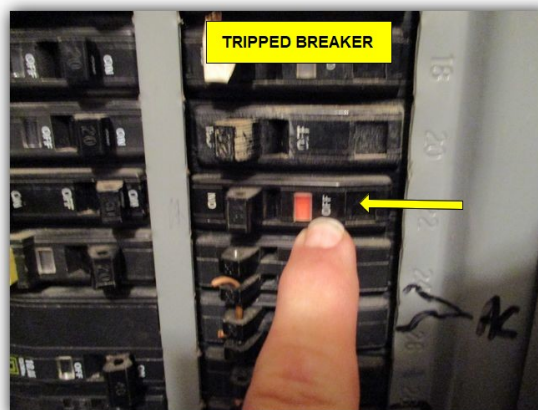
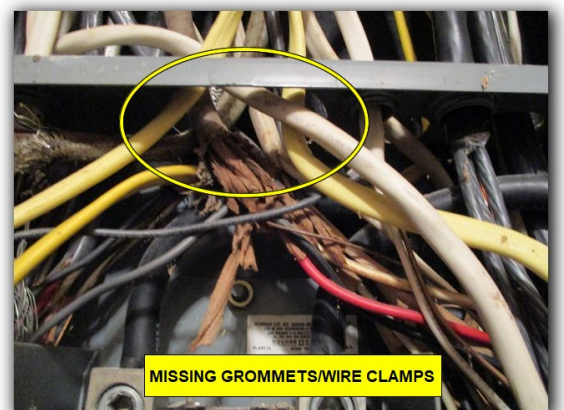
- The main service wire is less than 10 feet from ground level. This poses a possible risk for electrocution. It is recommended that the local electrical provider be contacted to raise the wire to the proper height.
- The ground rod and ground wire connection is buried beneath concrete and could not be viewed for inspection.

- There is a lock on the main fuse panel. The panel could not be inspected at this time.
- Some of the screws are missing on the garage breaker panel cover.
- Some of the breakers in the garage panel are not labeled.
- There is a tripped breaker in the garage breaker panel. It is unknown what circuit the tripped breaker controls or the reason for the tripped breaker.
- There are missing grommets or clamps on the the wires entering into the garage breaker panel. The grommets/clamps protect the wires from the sharp panel edges.

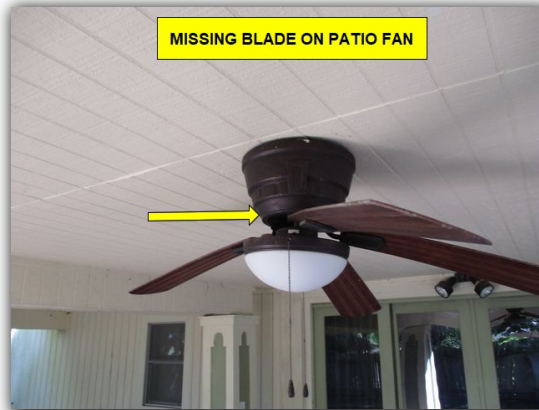
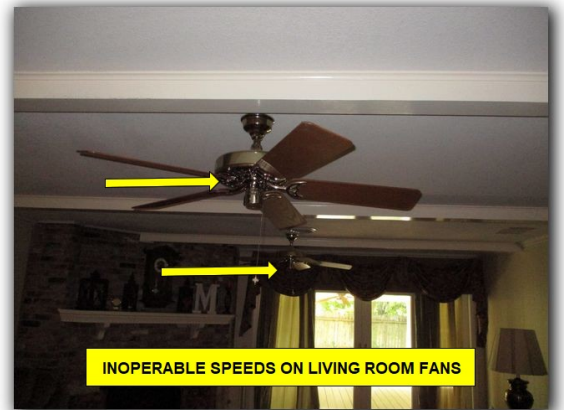
- One of the blades is missing on the rear patio ceiling fan.
- The ceiling fans in the living room only have one or two speeds.
- Some light fixtures are inoperable (possible burned out bulbs).

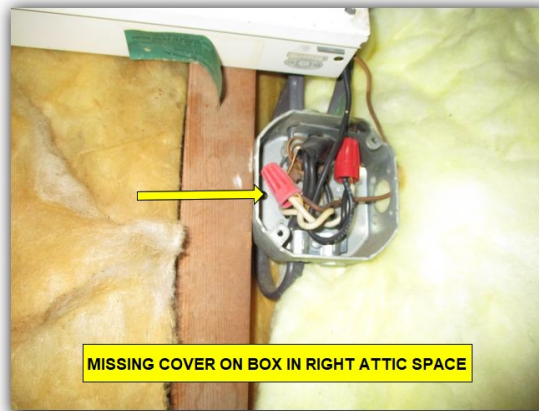
- The cover plate is missing from an electrical junction box located in the far right attic space (near doorway). Recommend a cover plate be installed.
- There appears to be a low voltage light system installed in areas. The system was not inspected for function.
- **It is recommended that all electrical concerns be further evaluated by a licensed electrician for the proper repairs.**

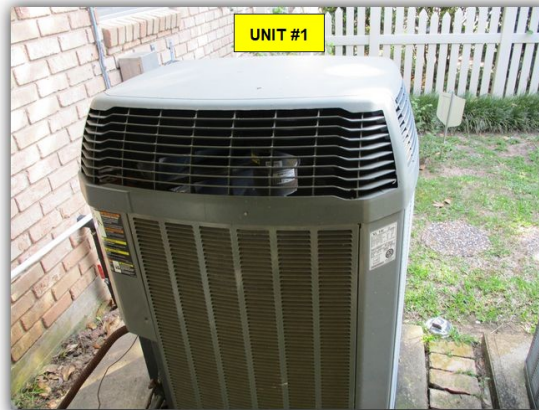
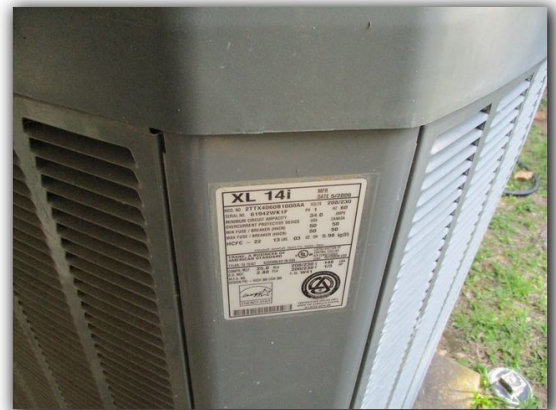
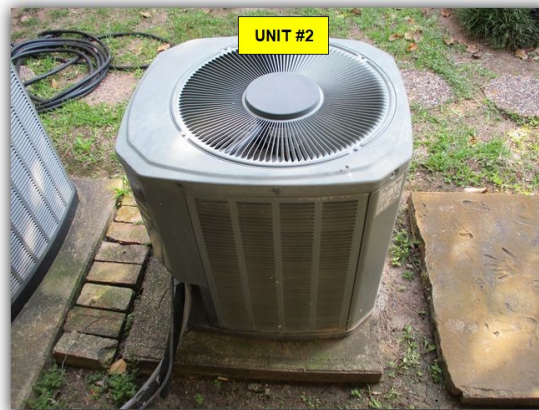
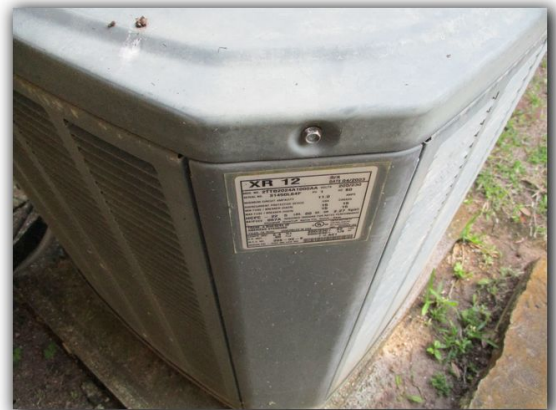
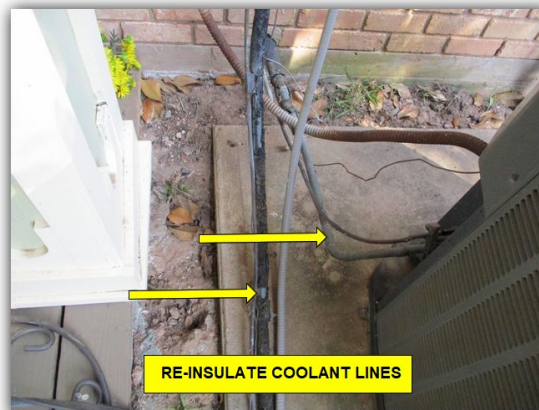
- Both the downstairs and upstairs A/C units appear to function properly at this time. It is recommended that the HVAC system be cleaned and serviced annually by a licensed HVAC Service Technician.
- Recommend re-insulating the coolant lines at the condenser units.

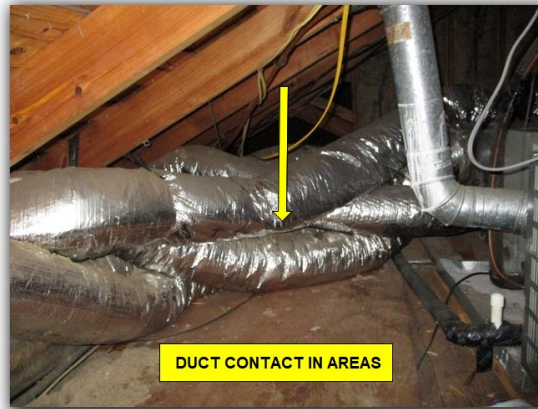
- The flexible ducting is contacting one another in areas. This may allow condensation to form at the points of contact. Recommend the ducts be separated to prevent the formation of condensation.

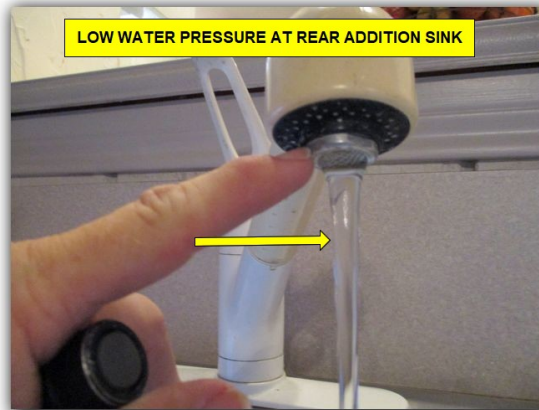
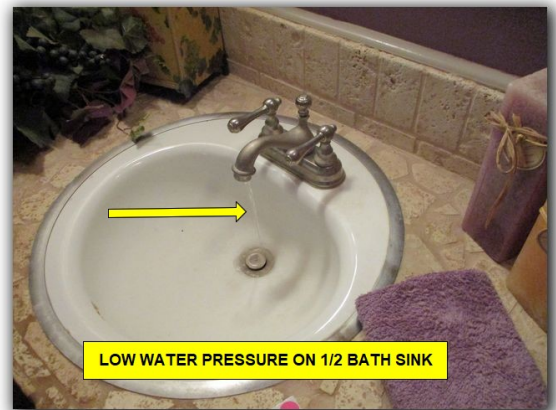
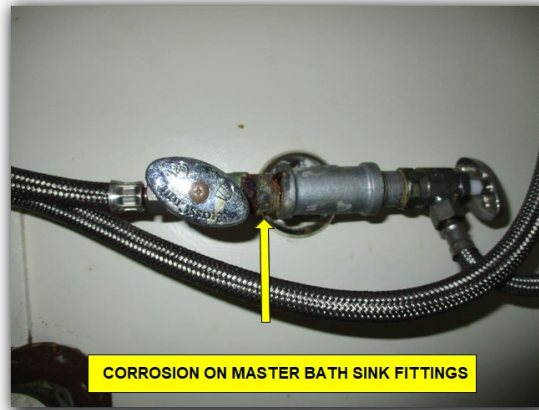
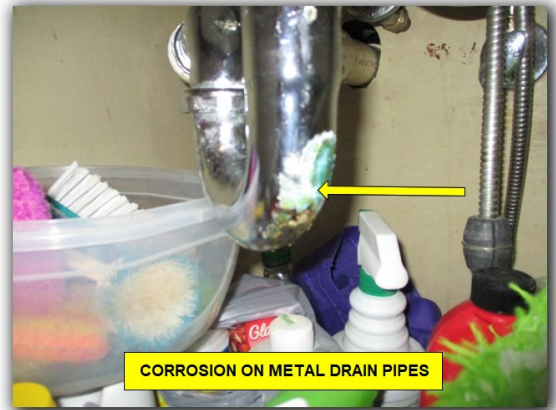
- There is low water pressure at the rear addition sink and the rear addition bathroom sink.
- There is rust/corrosion on some of the galvanized fittings located beneath the master bathroom sink.
- Metal "P" trap drain lines are installed on the sinks throughout the home. Metal drain pipes are prone to corrosion and leaks. Recommend metal "P" trap pipes be replaced with PVC.

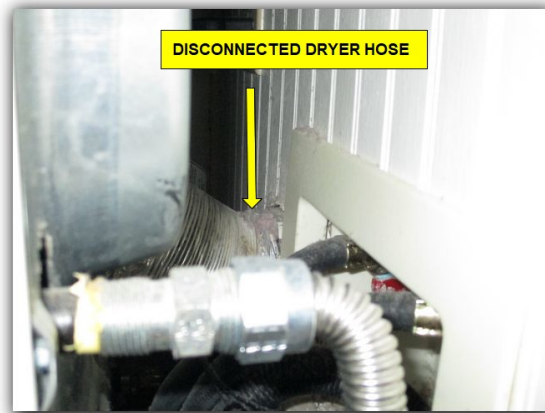
- The vent hose for the dryer is disconnected from the wall vent connection.
- All components of the dryer vent system could not be visually inspected. Recommend the vent system be thoroughly cleaned prior to use.
