PROPERTY INSPECTION REPORT

Concerning: 27906 Skyhaven Lane, Fulshear, TX 77441
(Address of Inspected Property)

By: Jason Fielding, 21810 10/08/2018
(Name and License Number of Inspector) (Date)

A re-inspection was performed on 7/3/2019 at the request of the buyer to include items marked as deficient on the initial report.

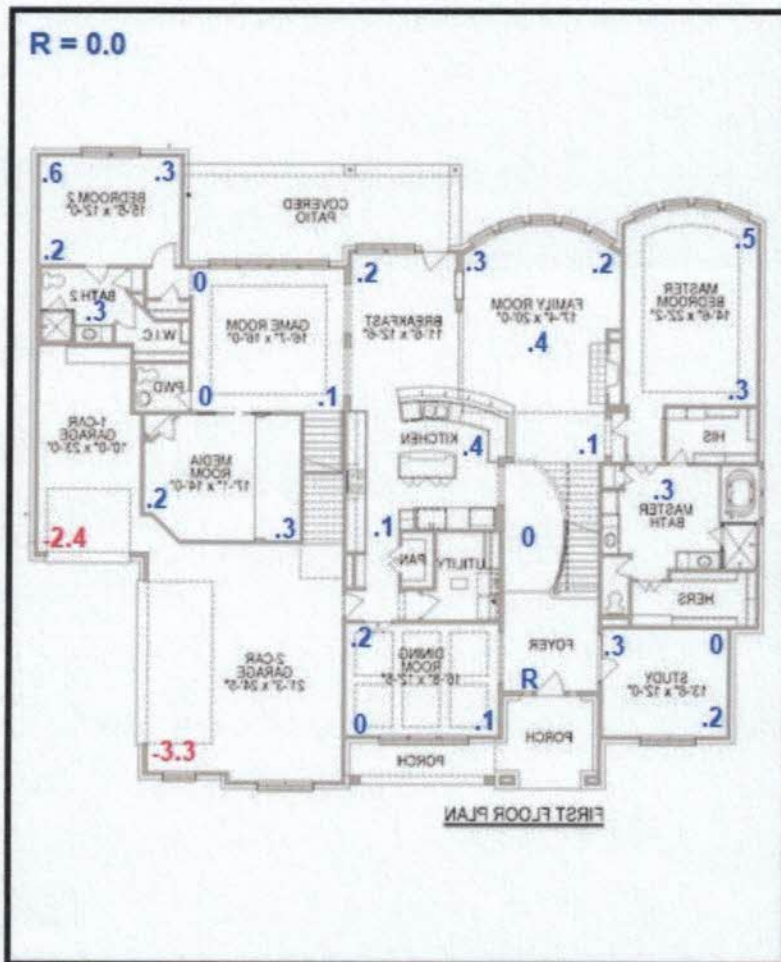
A foundation elevation survey was conducted during the inspection. The floorplan below represents data gathered using a Zip Level or similar instrument and adjusting for floor covering height differences. i.e. differences between tile, carpet and wood flooring. Measurements are listed to the nearest 1/10th of an inch. Greatest variance was .6"

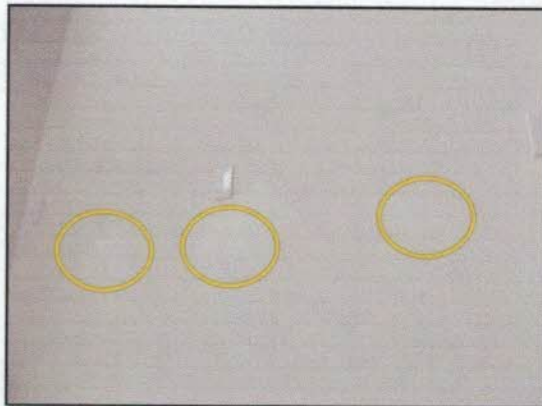
Work in progress at time of inspection. Deficiency/anomaly repaired.

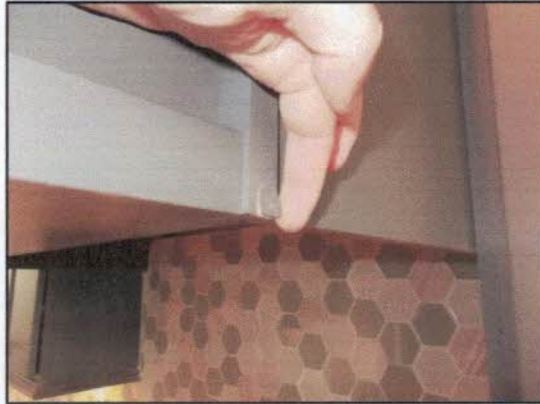
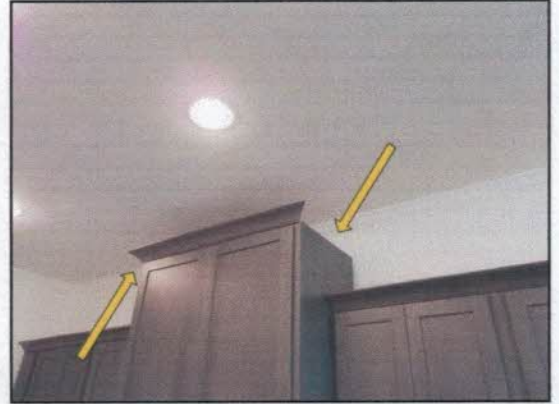
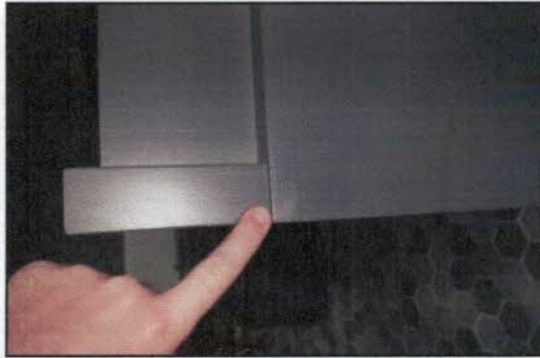
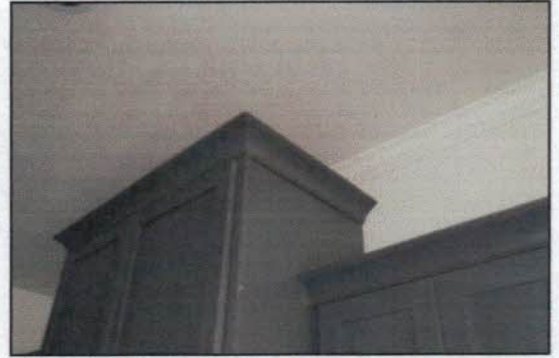
Buyers Concern: Chipped area of trim at range hood exhaust and missing crown molding in same area. **Deficiency/anomaly repaired.**

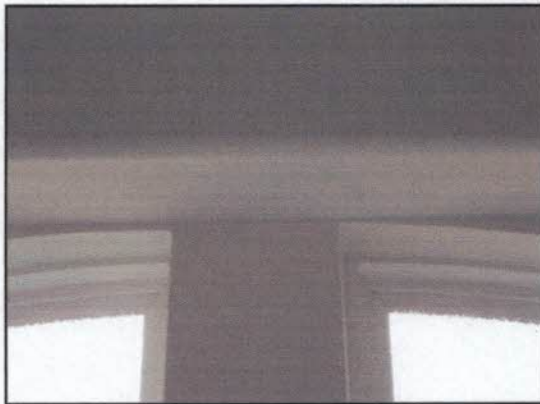
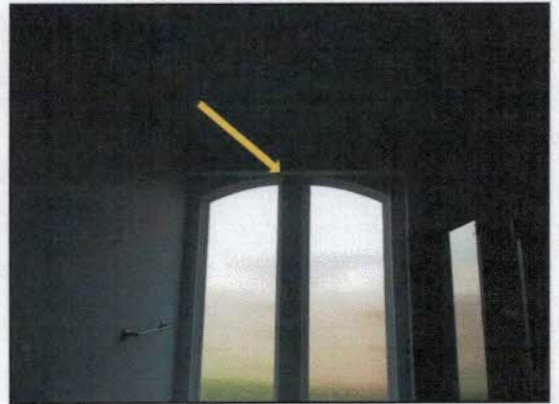
Cosmetic cracks and/or repaired cracks in sheetrock observed over some doors, windows, and/or corners; master bath. **Deficiency/anomaly not repaired.**

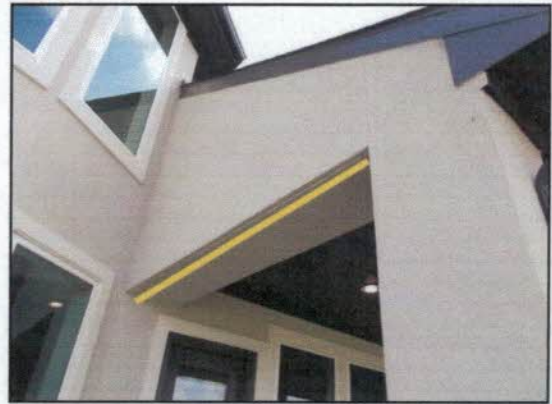
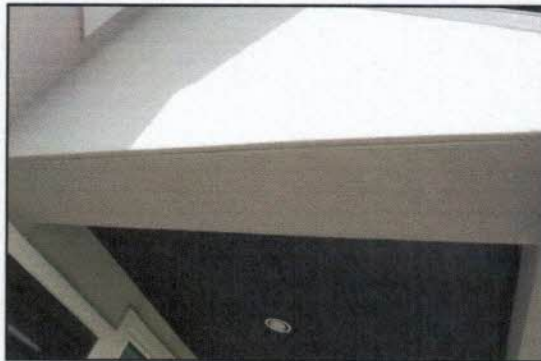
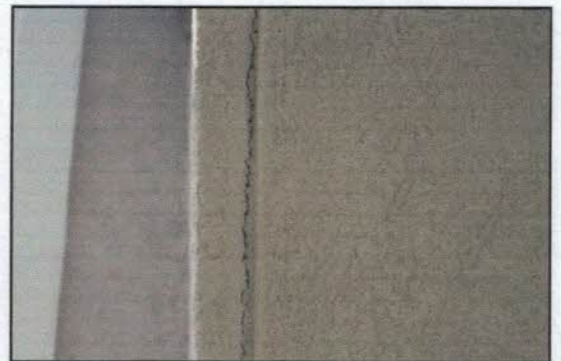
Repaired By
Builder

Did not observe weep screed at bottom of the stucco wall, where it intersects with the soffit. The drainage plane should be kept free of paint and debris. The following diagram depicts a "best practice" procedure as defined in the Texas Lathing and Plastering Contractor's Association (TLPCA) Stucco Resource Guide. This detail provide a means for moisture to exit from behind the stucco if the wall assembly leaks (we seldom see a weep screed at these locations on most stucco homes / buildings). If this exhibits a problem with moisture collecting in this area, a weep screed should be installed. **Deficiency/anomaly not repaired.**

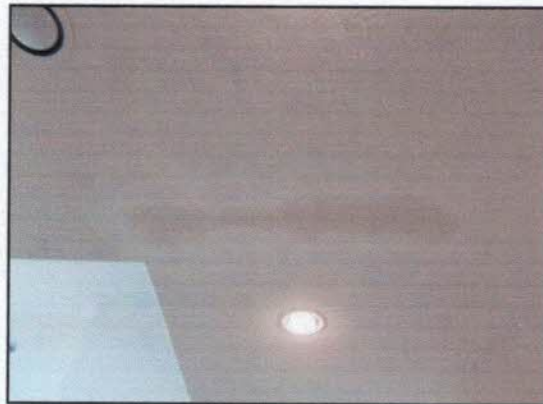
Work in progress at time of inspection. Deficiency/anomaly repaired.

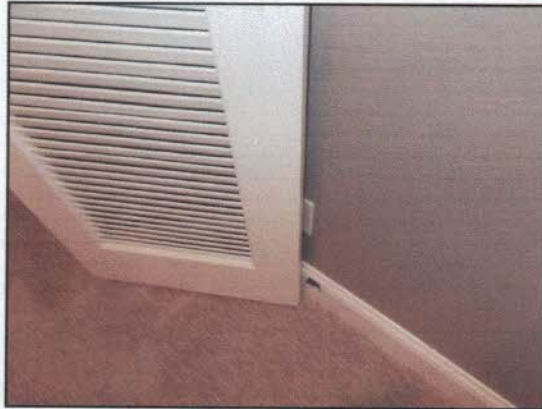
Missing or non-functioning door stop behind one or more doors to prevent damage to sheetrock; media room closet. Deficiency/anomaly repaired.

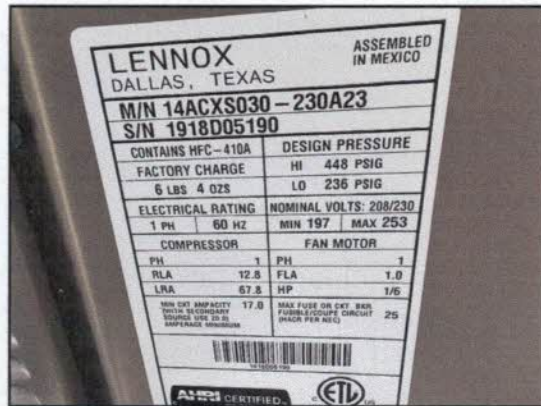
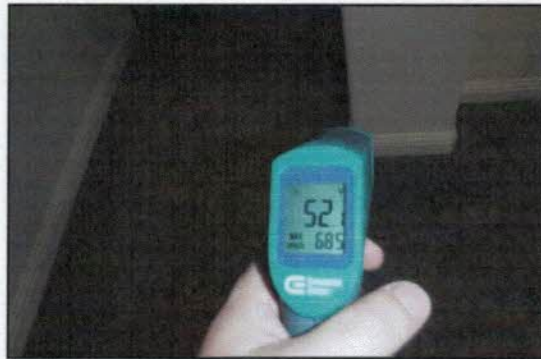
Recommend qualified/licensed HVAC technician service/repair/replace as needed. Not cooling well. Deficiency/anomaly repaired.
--

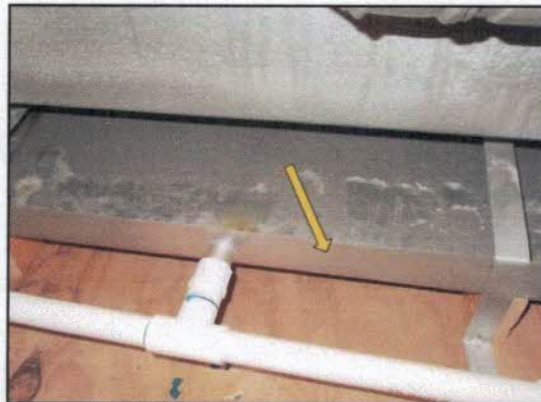
Buyers Note: Did not observed an overflow protection device installed on the emergency drain pan. The overflow switch will shut your system down if it detects water in the pan to help prevent water damage to your ceiling.

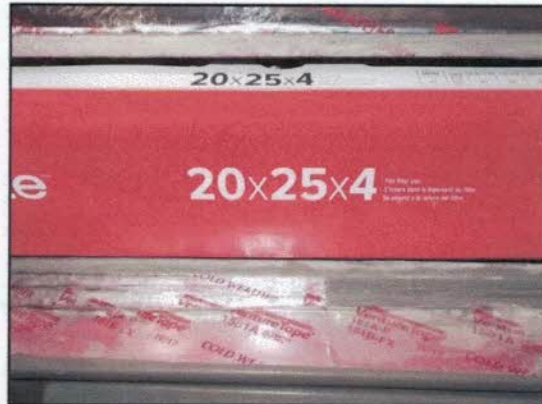
Media air filter(s) located in attic that requires changing/cleaning every 6 months, recommend checking guide for proper maintenance information.

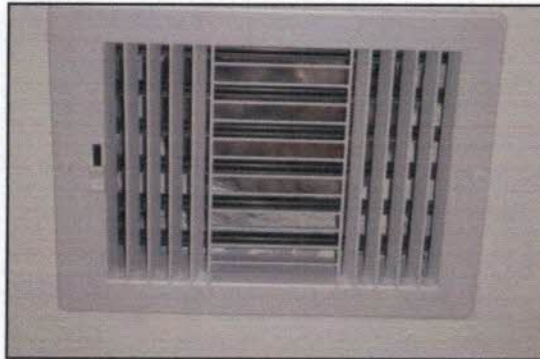
Return air filter is dirty.

Register in 1st floor guest bedroom blocked by insulation.

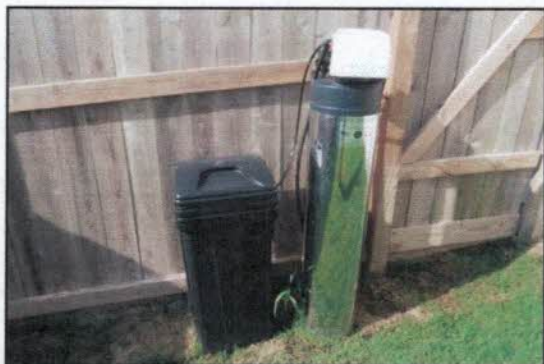
Water softener, treatment and filtration type of equipment was not checked/inspected.
